Inspection Photos

API: 011-06174

Operator: CHOLLA PETROLEUM INC

Inspection Date: 6/26/2024

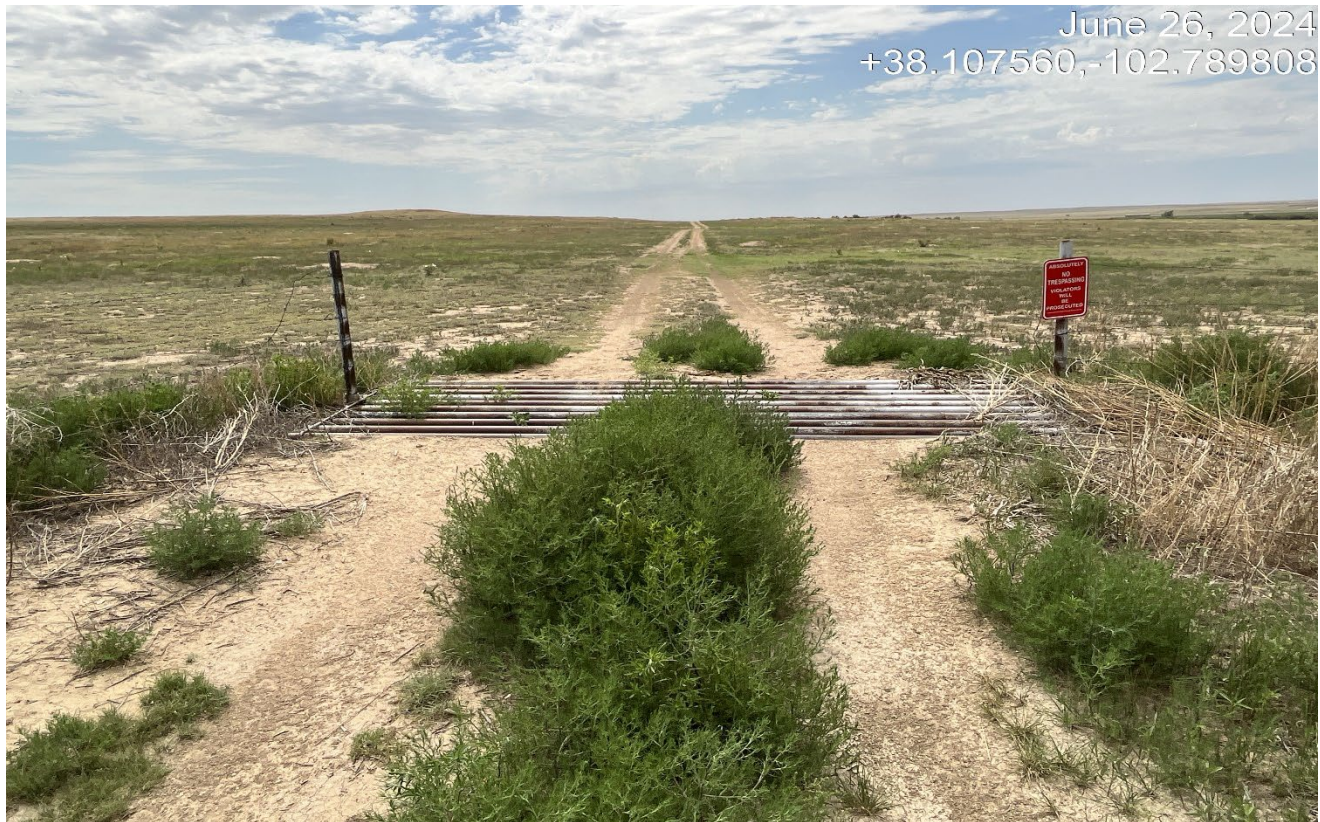
Photo 1. Facing southeast toward the access road. The road has not been reclaimed and the cattlegurd remains.

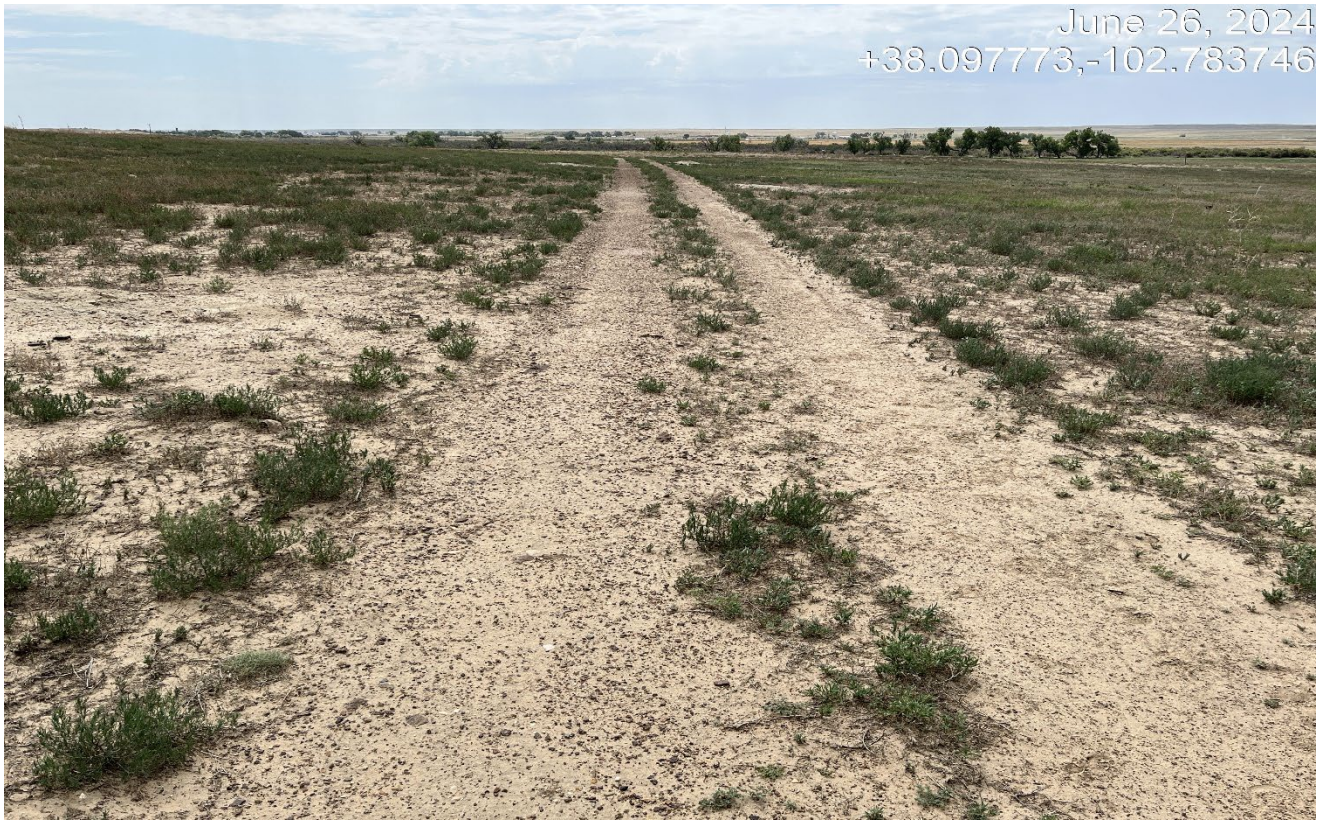
Photo 2. The two track road has not been reclaimed and soils are compacted along the road.

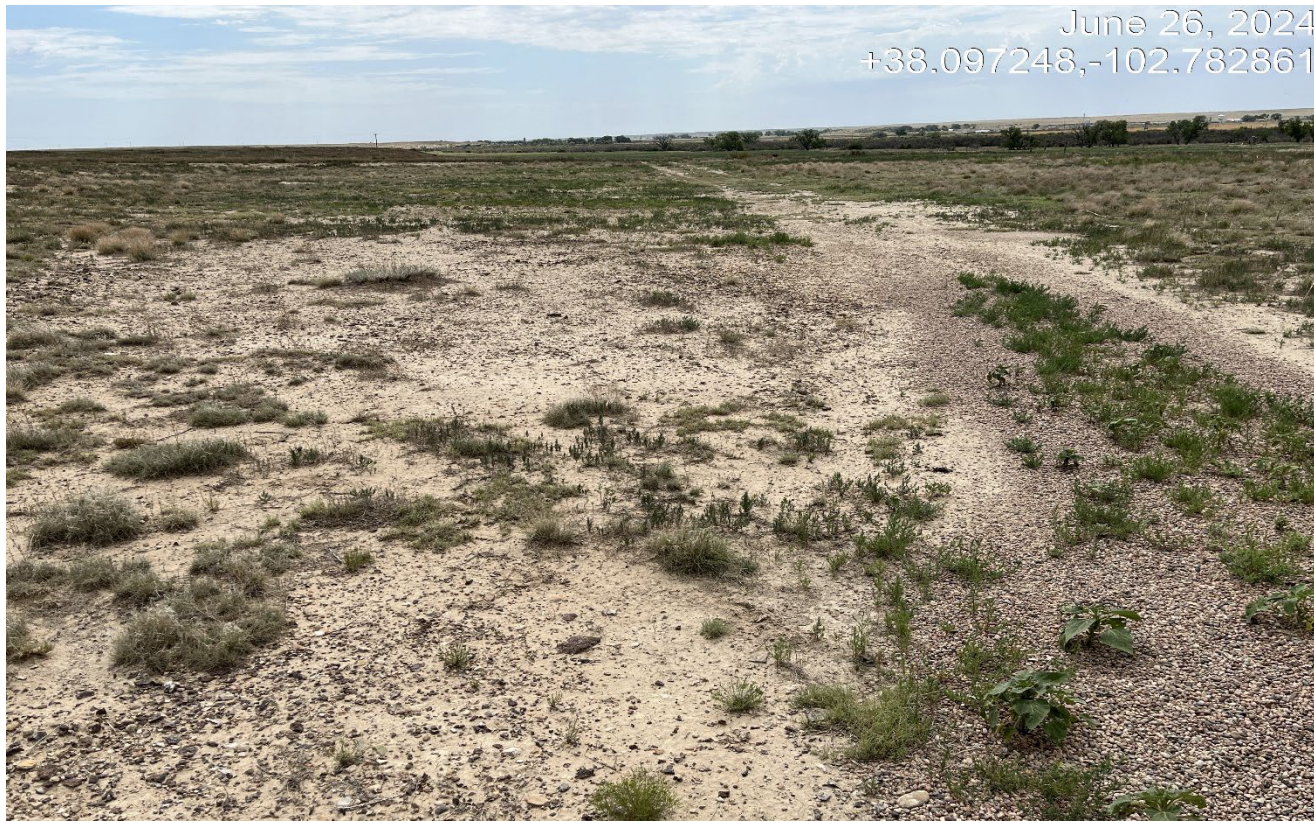
Photo 3. Facing southwest toward the location. There area areas of the location that are bare of vegetation.

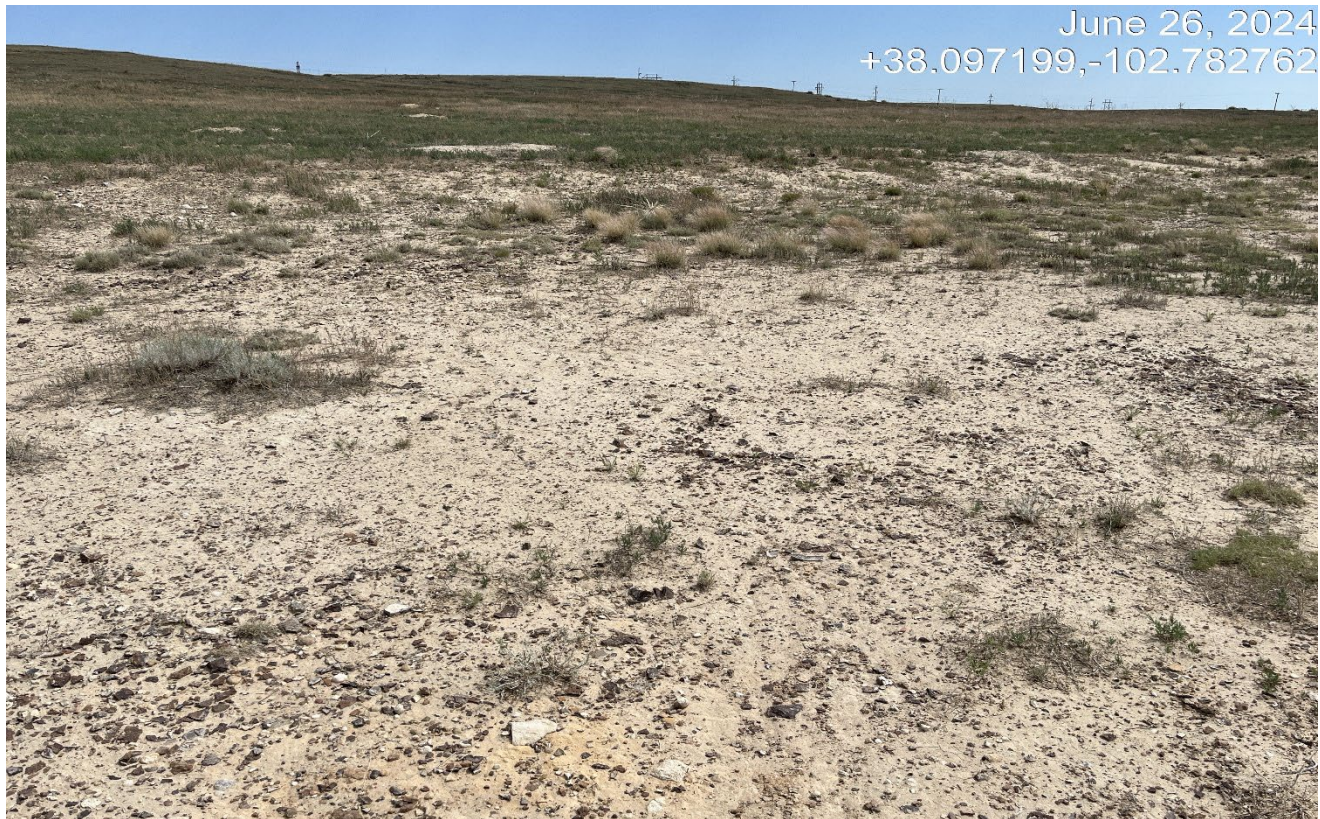
Photo 4. Facing east at the location. This area has not been reclaimed and has no vegetation.

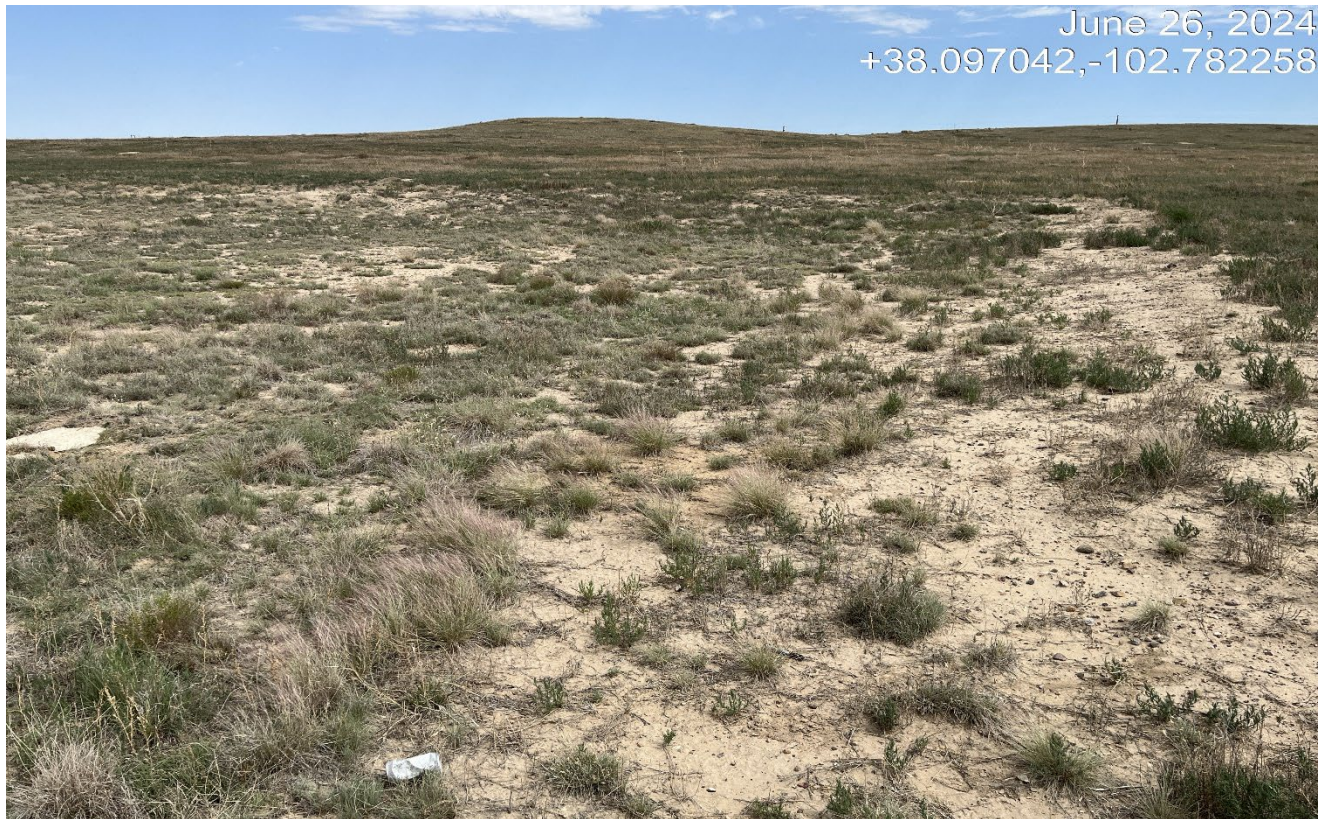
Photo 5. East side of the location facing north. There is an outline of the cut slope which is not revegetated.

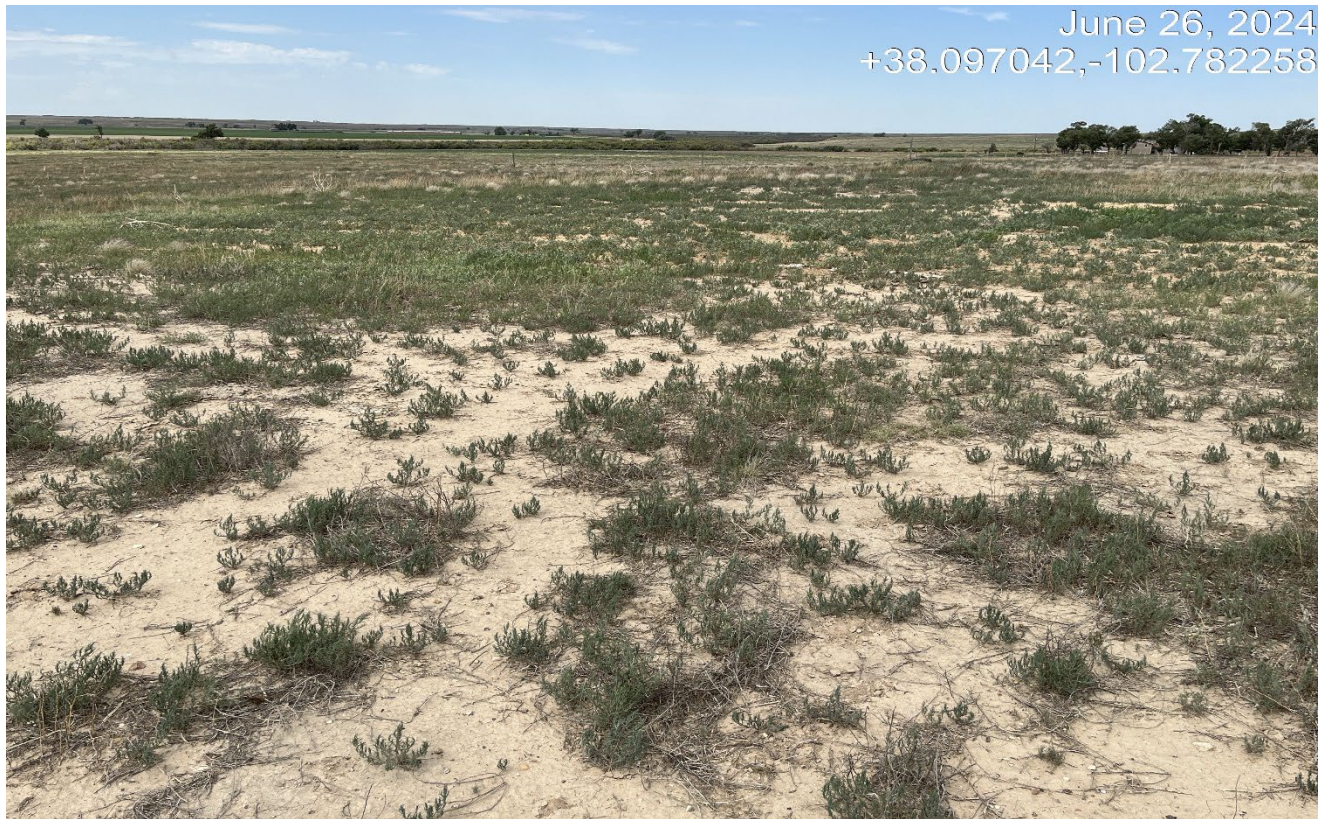
Photo 6. Facing southwest at the location. This entire are consists of mostly undesirable weeds. It appears there was a drilling in this area from historic imagery.

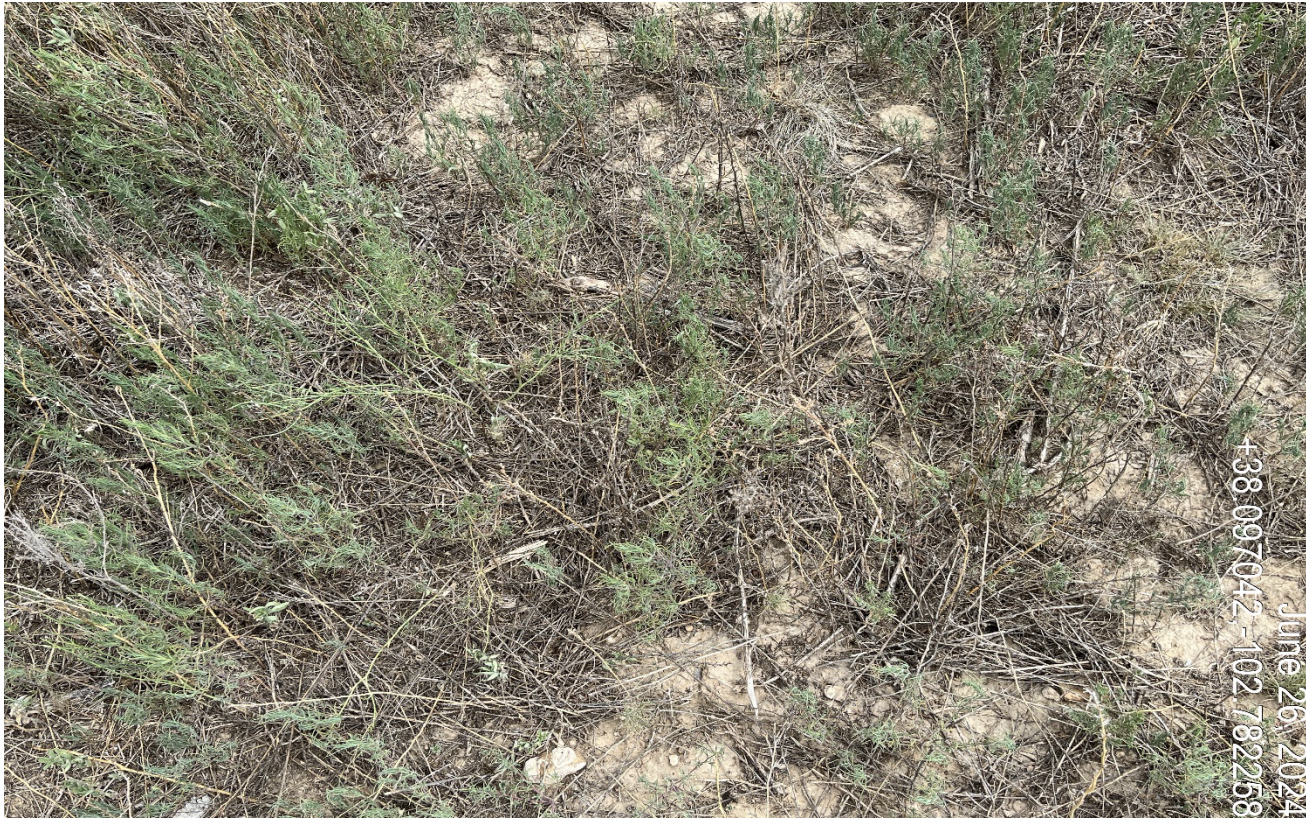
Photo 7. View of vegetation shows undesirable weeds (Russian thistle).

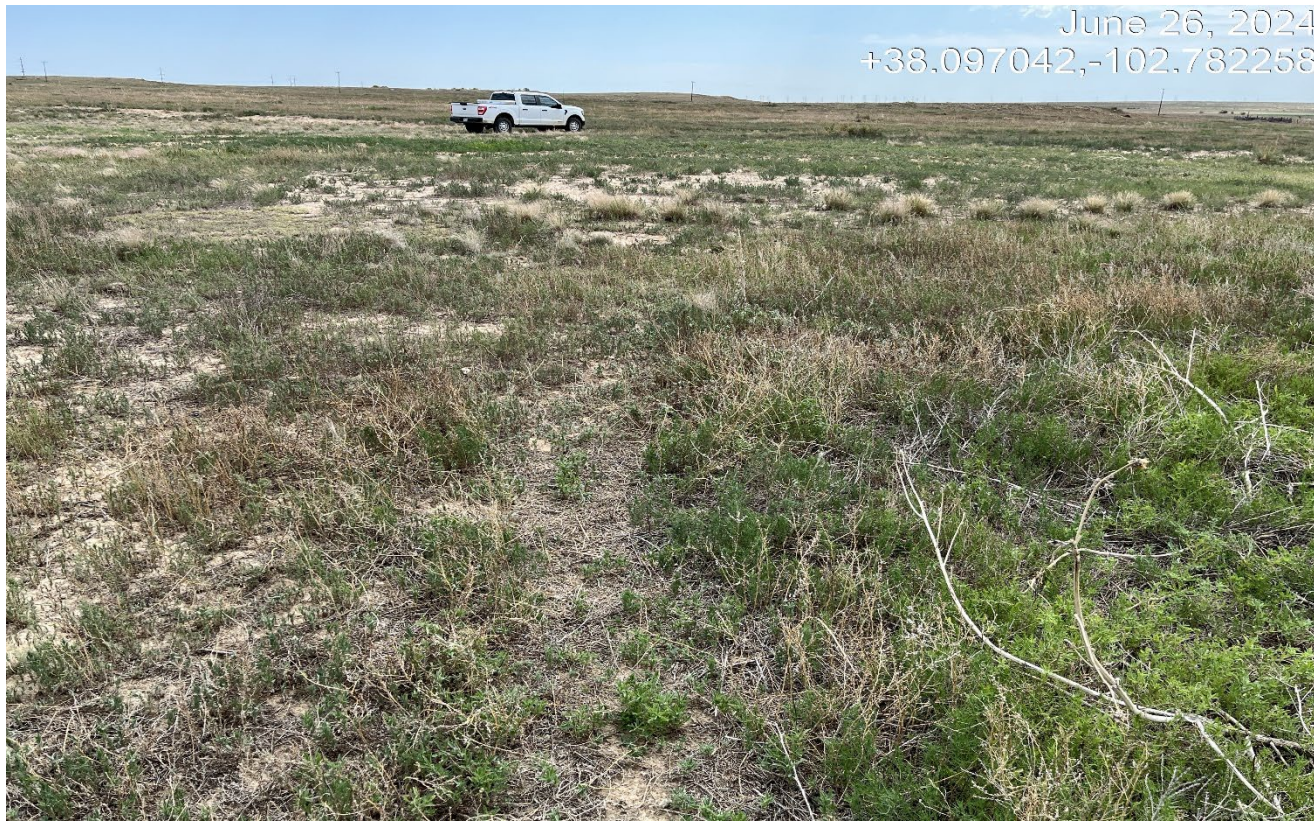
Photo 8. South side of the location facing northeast. This entire are consists of mostly undesirable weeds. It appears there was a drilling in this area from historic imagery.
