Inspection Photos
Location Name: Linnebur 24-1
Location ID: 320225

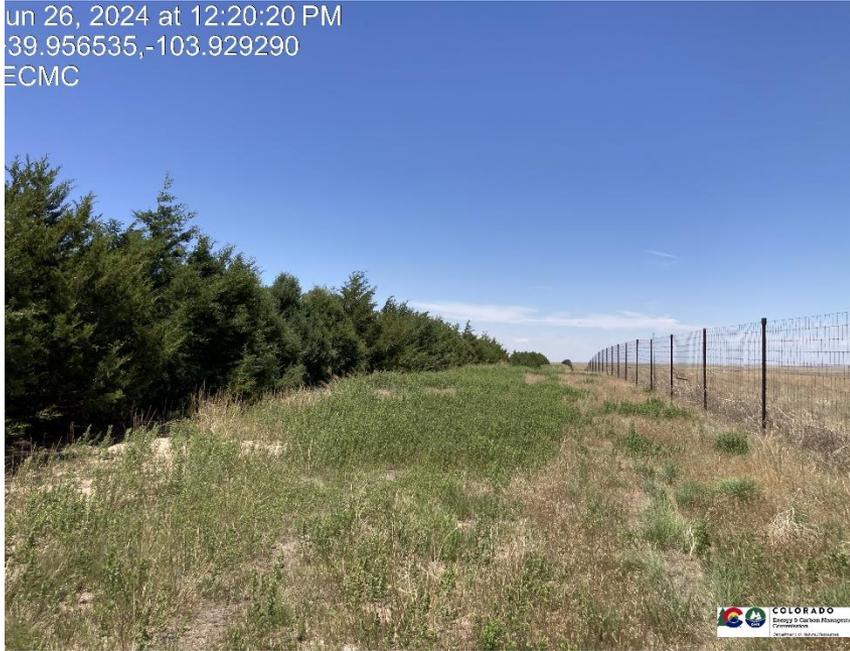
Pic 1 weeds unmanaged on lease road

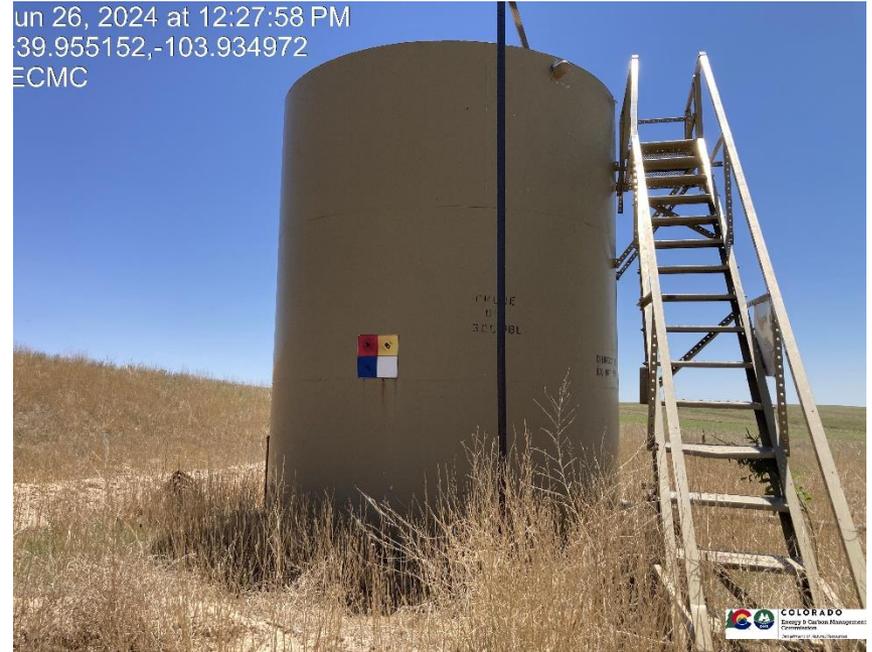
Pic 2 tank placard is inadequate/ weeds unmanaged

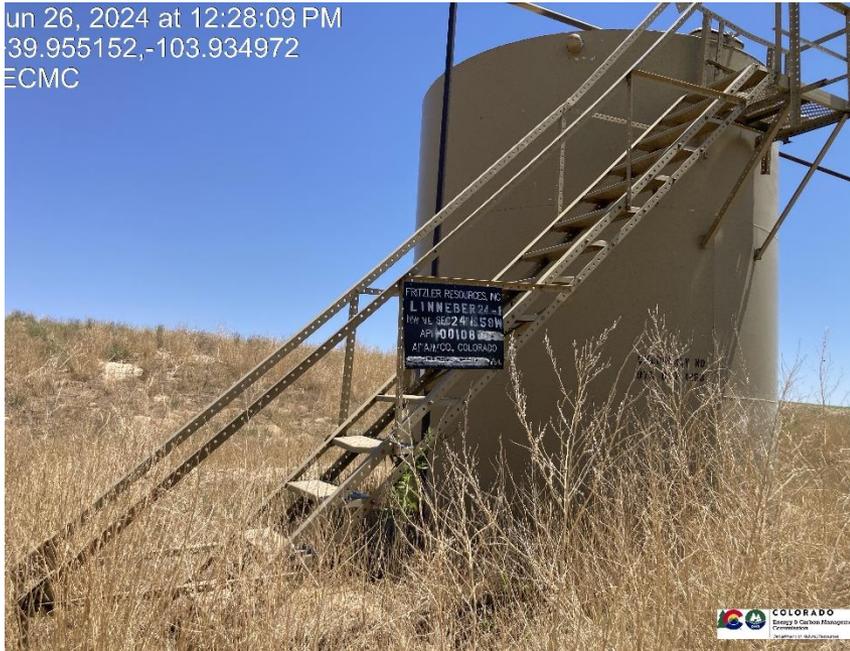
Pic 3 sign is inadequate

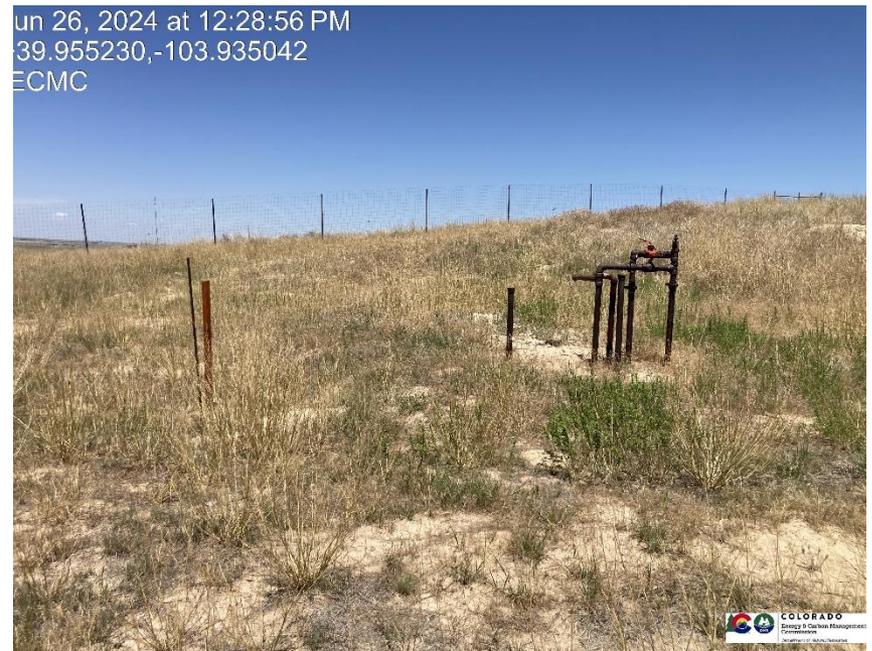
Pic 4 risers on location are not LOTO

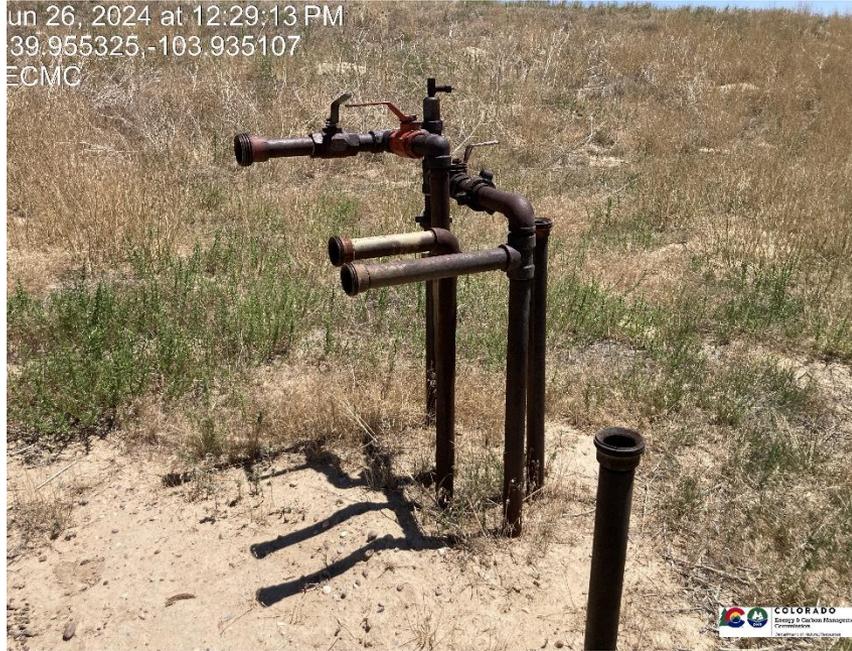
Pic 5 Risers are not LOTO

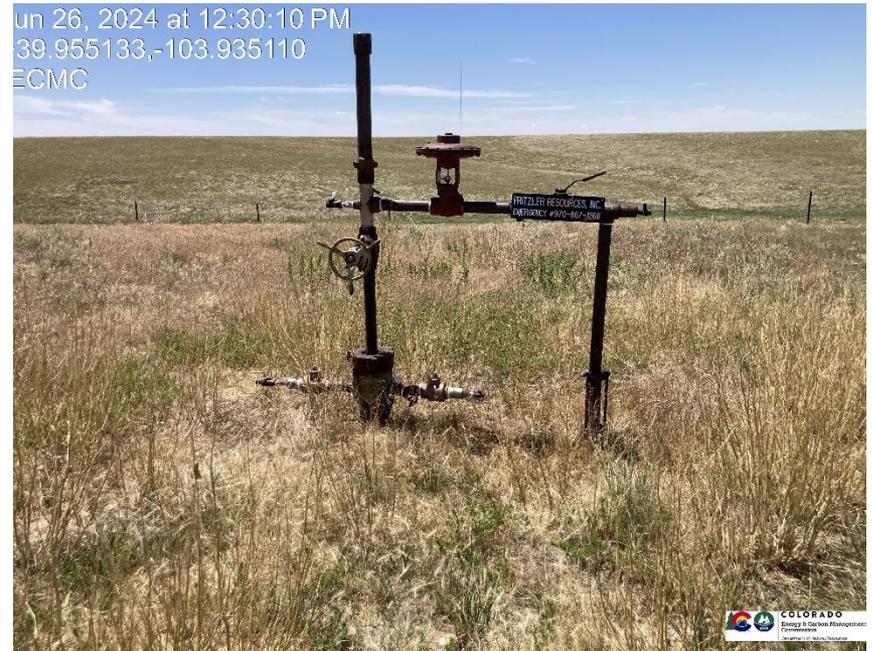
Pic 6 Wellhead sign is inadequate

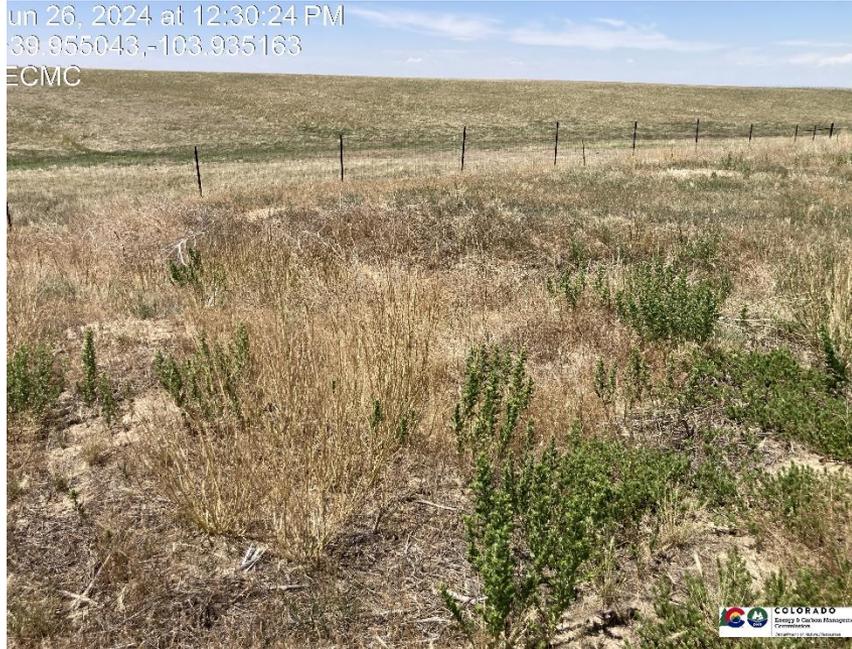
Pic 7 stormwater damage on south end of location

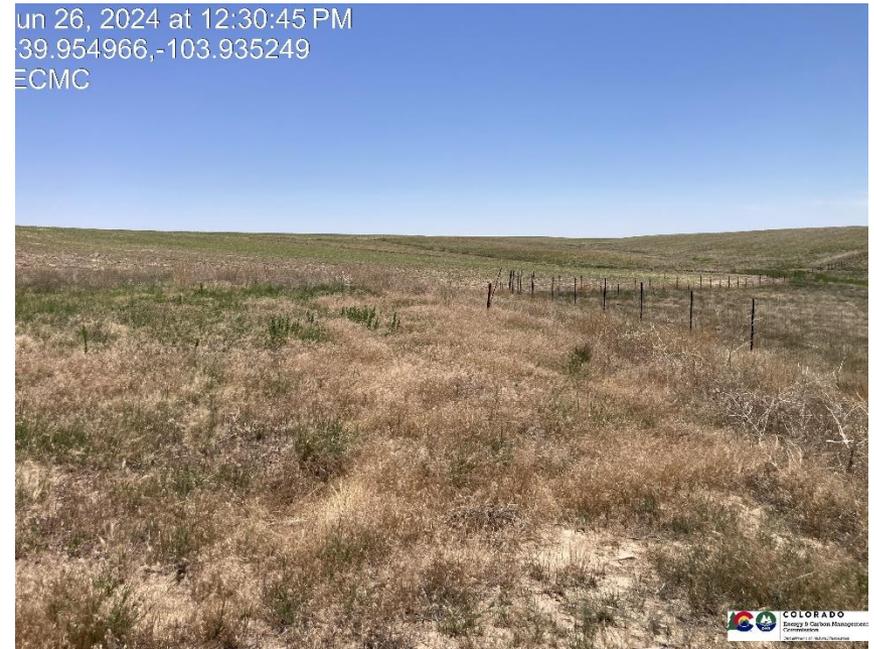
Pic 8 Anchors are not marked correctly, needs to be highly visible.

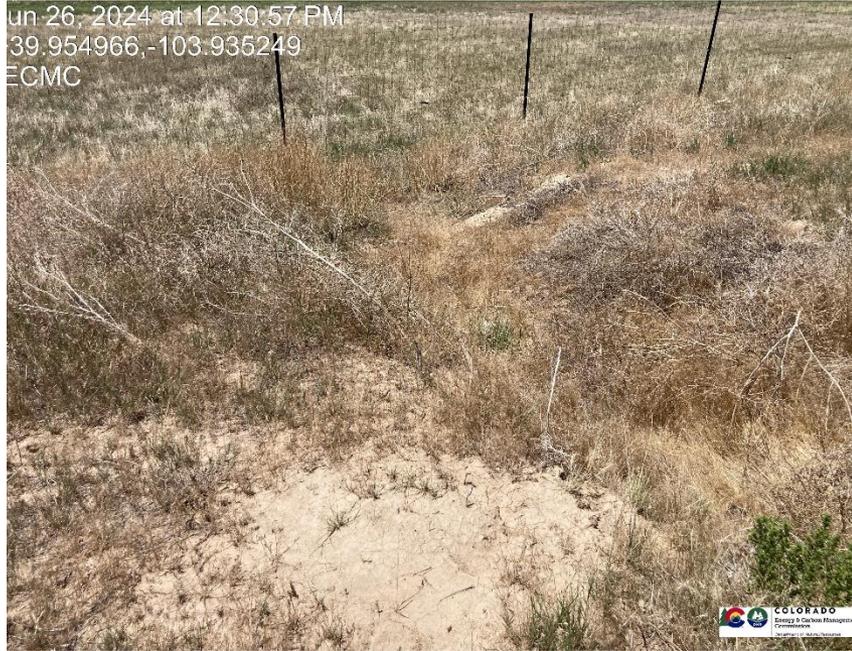
Pic 9 stormwater damage on south end of location

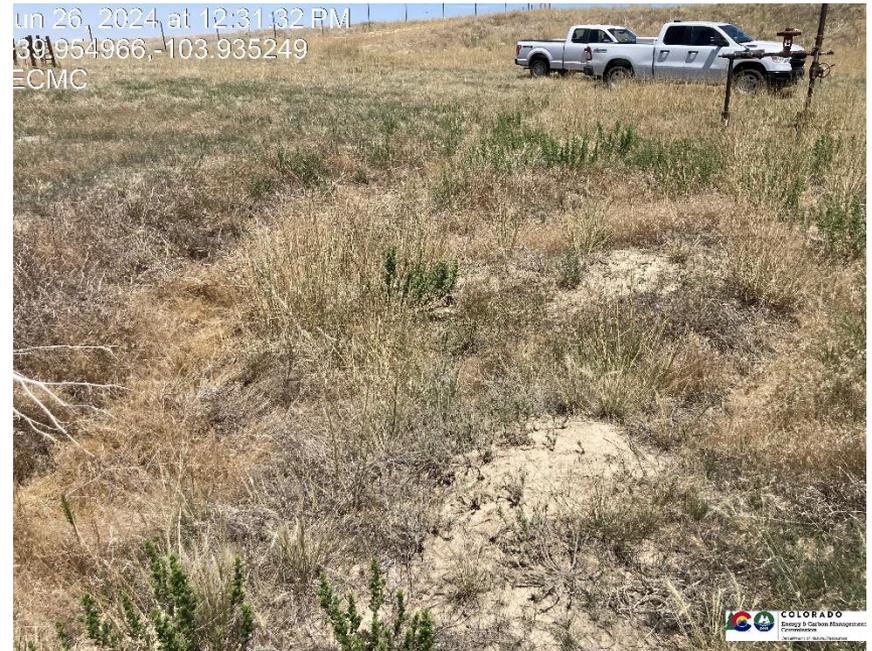
Pic 10 stormwater damage on south end of location

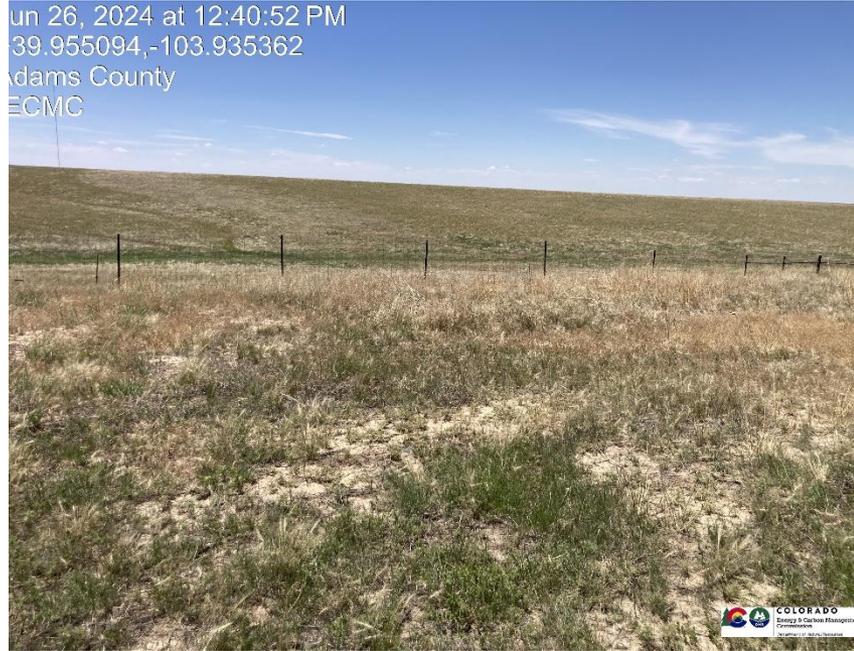
Pic 11 Pit has been filled, no form 27 on file

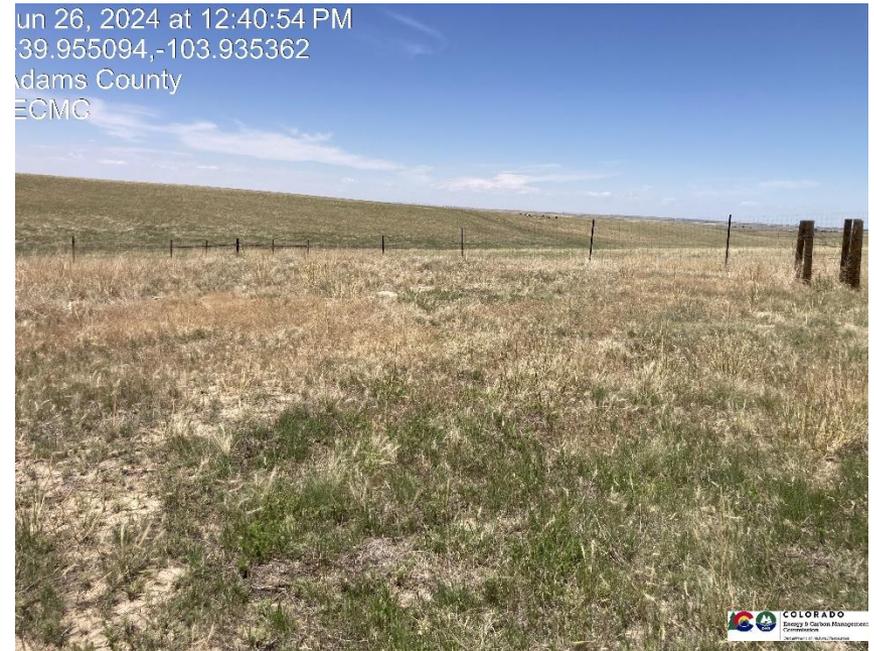
Pic 12 Pit has been filled no form 27 on file

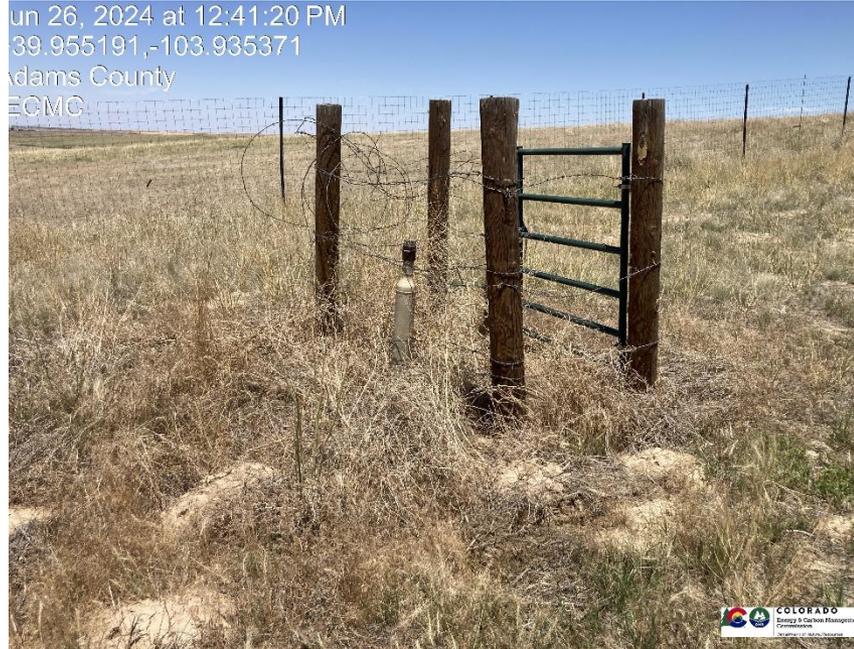
Pic 13 riser is lot LOTO
