**Inspection Photos**  
**Location Name: Linnebur 4**  
**Location ID: 319762**

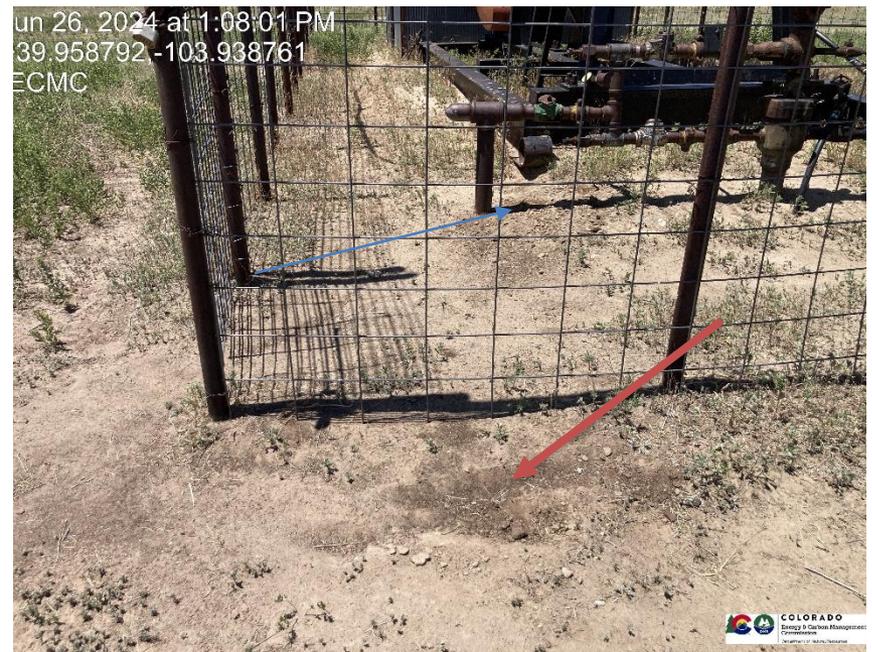
**Pic 2 Stained soil was covered by dirt, red arrow shows where dirt was shoveled to cover contaminated soil by wellhead.**

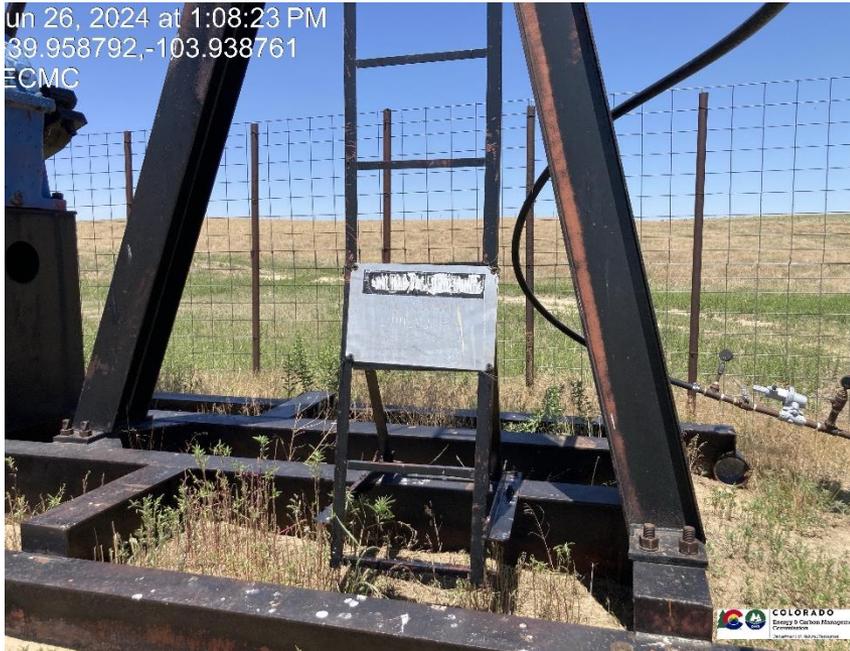
**Pic 3 wellhead sign is inadequate**

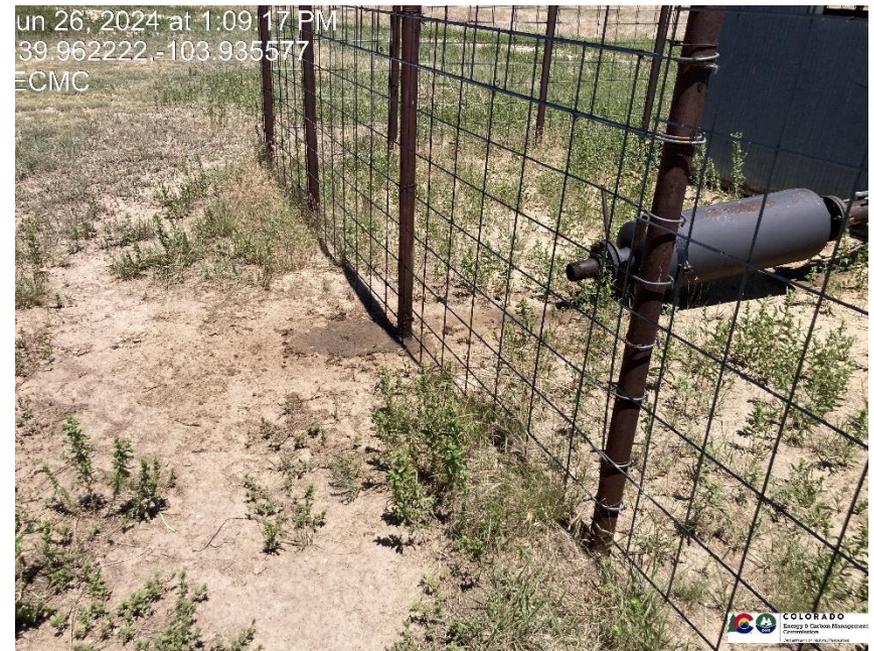
**Pic 6 contaminated soil covered with other dirt to cover contaminated soil.**

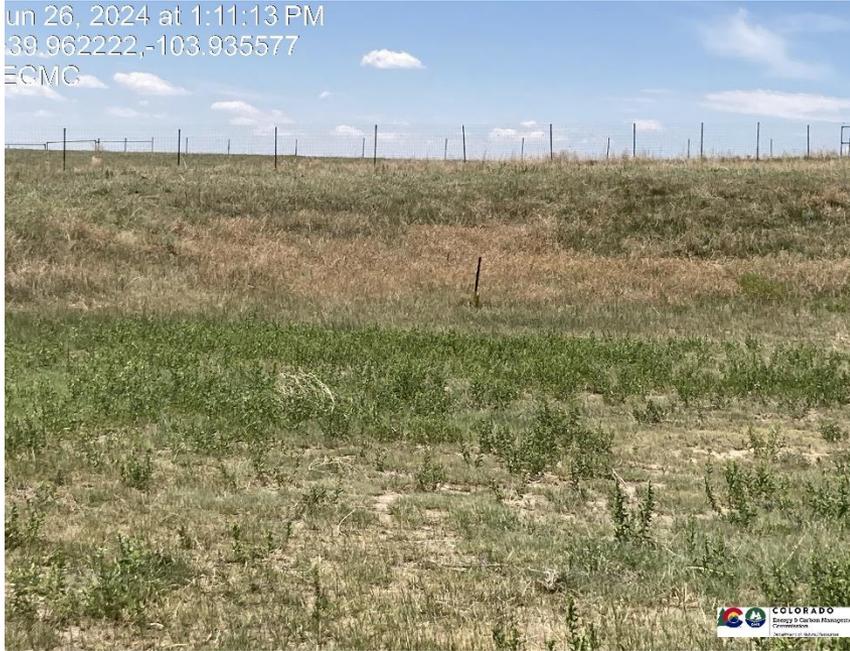
**Pic 7 deadmen are not properly marked**

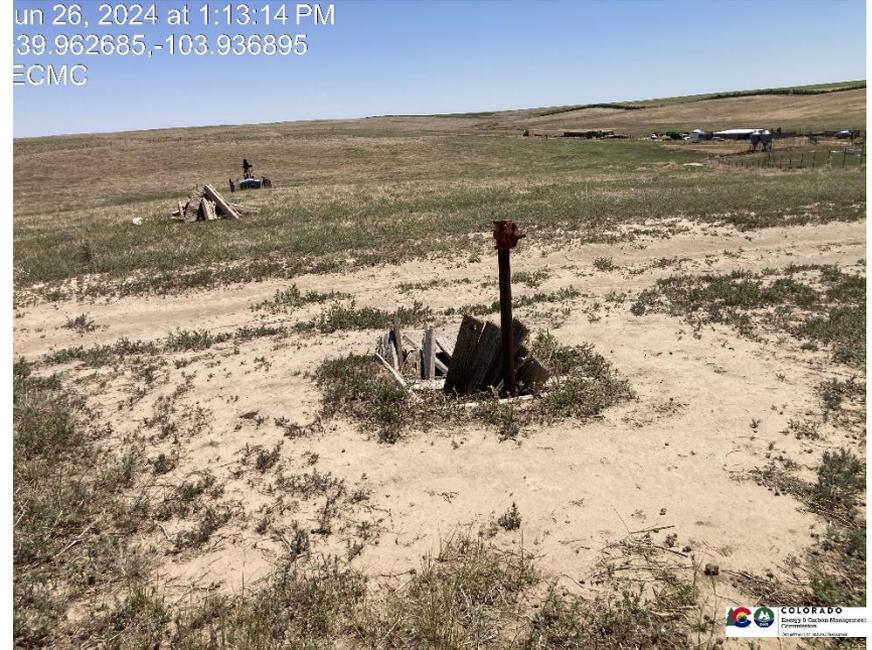
**Pic 8 Riser is not LOTO**
