Catamount Energy Partners  
Carpenter 2/Carpenter 1S  
Inspection 714000865 Remedial Report

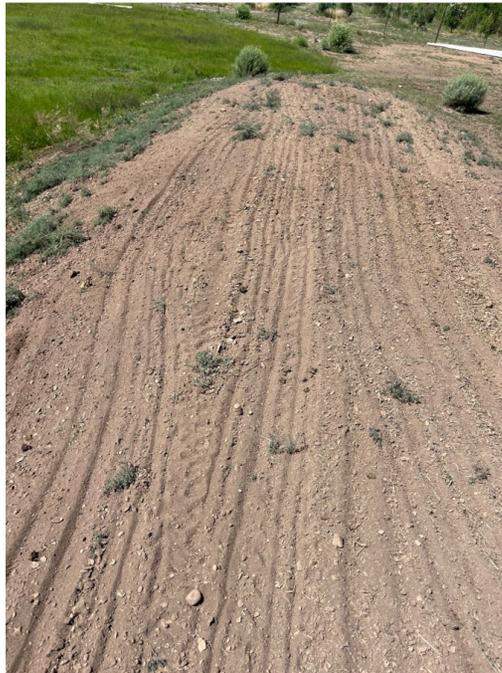
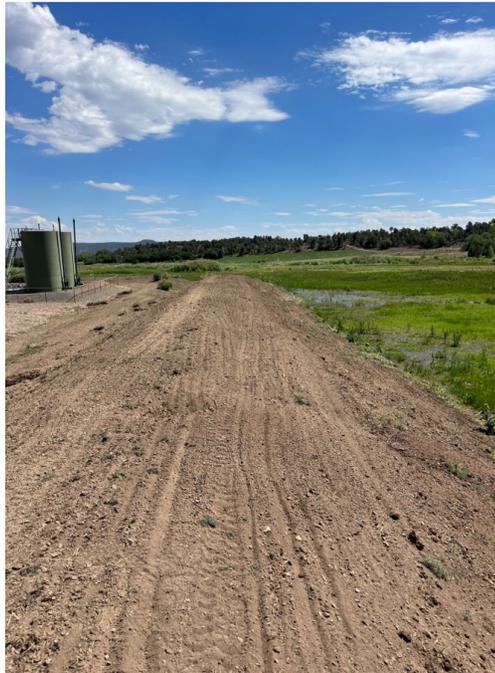
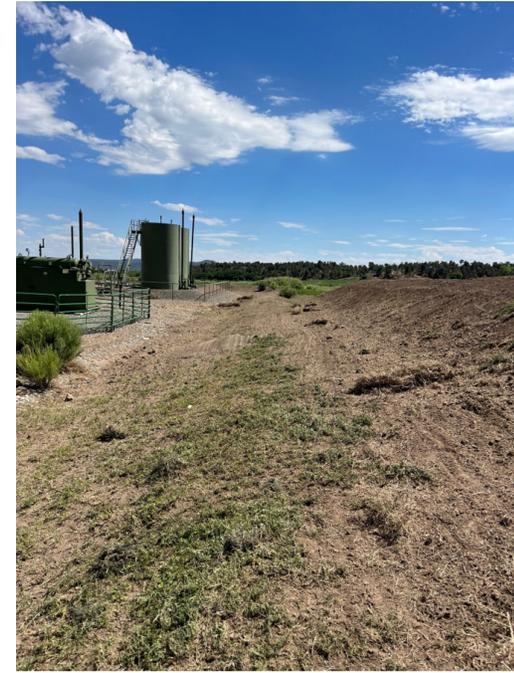
Comment: Western interim reclamation areas support little to no vegetation and are dominated by field bindweed in some areas. Spot seeding/hydro mulch activities conducted in 2022 were unsuccessful as no vegetation has established on western cut slopes.

Harrowed and seeded sparse and bare soil areas

Corrective Action: Spot seeding needs to be conducted within portions of the interim reclamation areas with poor revegetation. Comply with rule 1003.f treat/remove weeds. 7/31/2024 CA given for fall seeding window.

Action Taken: Harrowed and seeded bare slopes, removed weeds.

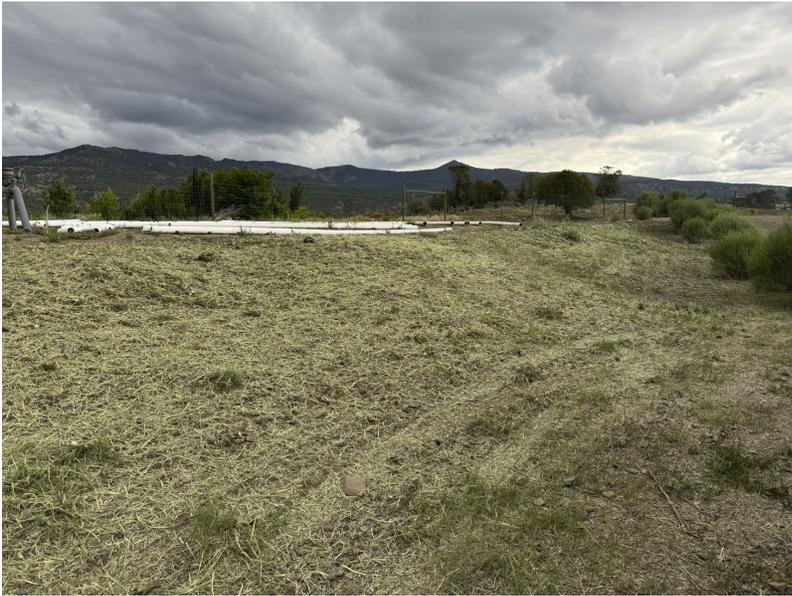
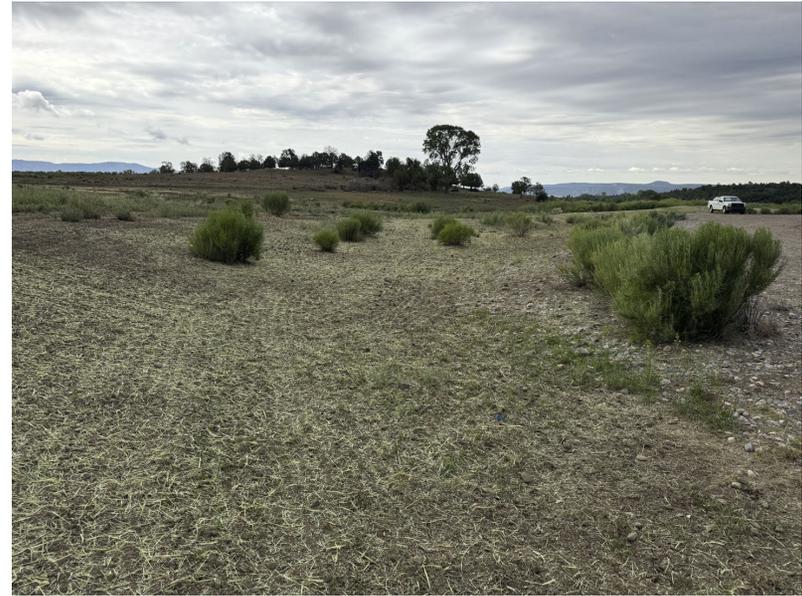
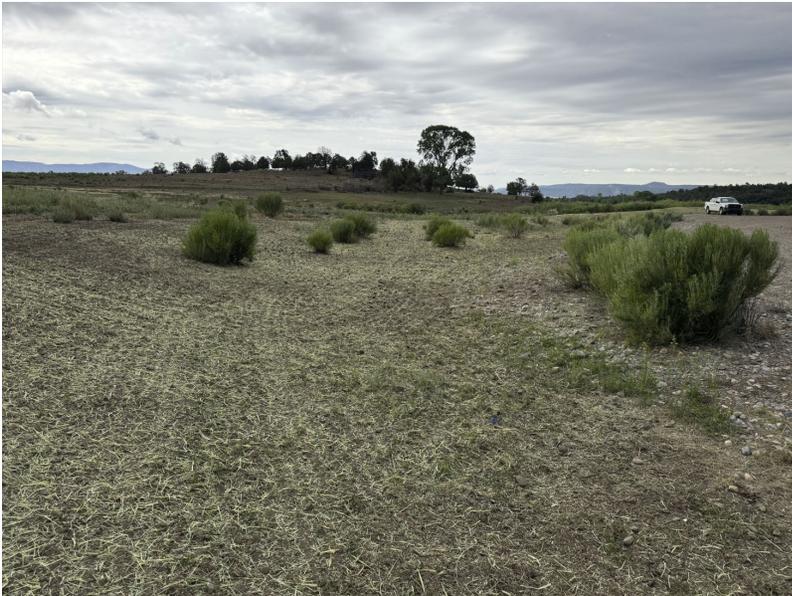
Comment: Western portions of interim reclamation show exposed/bare soils. No storm water BMPS/stabilization measures were observed.

- Hydromulched bare soil areas where seeding/harrowing occurred

Corrective Action: Storm water BMPs and erosion controls (ie: mulch, hydromulch, straw blankets, etc.) need to be installed and maintained on portions of the project area sparse and bare soils until soils are stabilized with desirable perennial vegetation.

Action Taken: Installed wattles and seeded/mulched areas with exposed/bare soils.

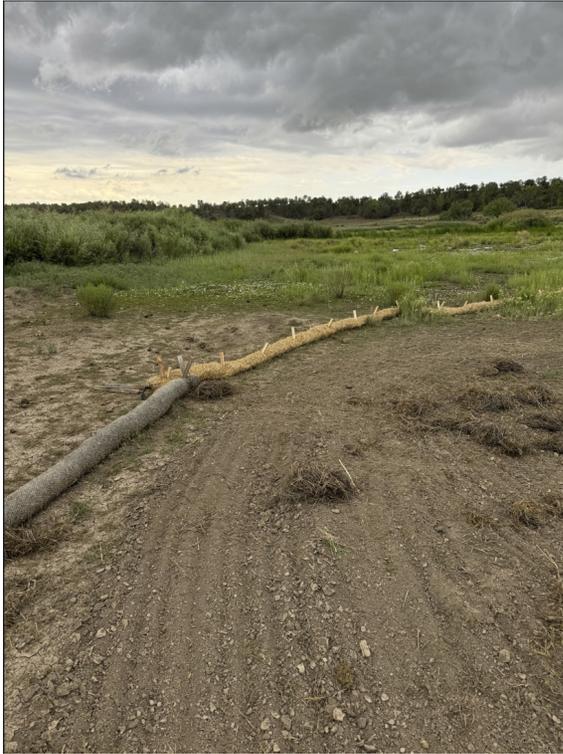
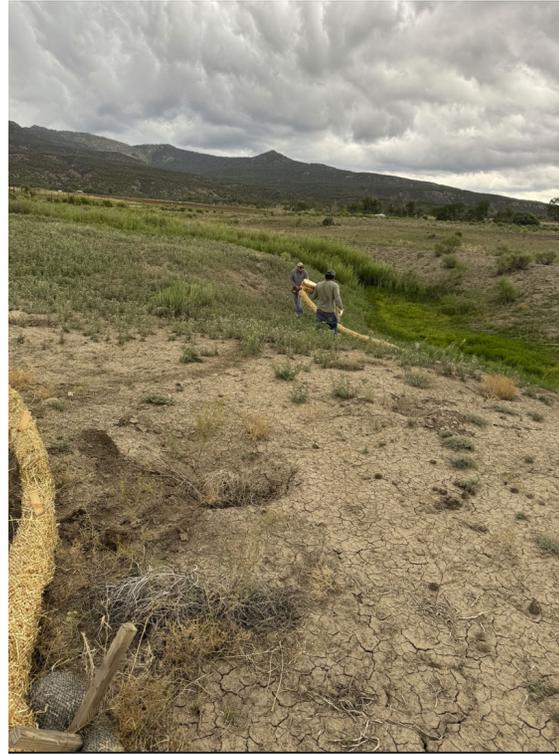
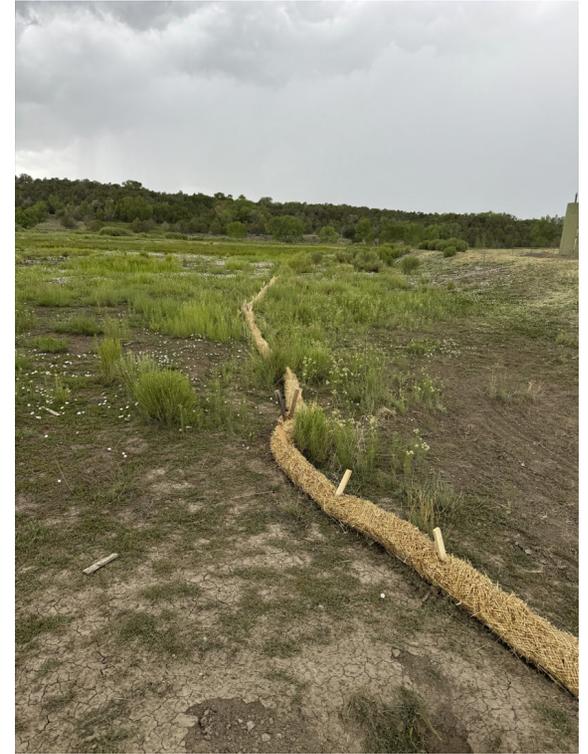
- Installed wattles around bare soil areas
