Inspection Photos

06/25/2024

Operator: ENERGY INVESTMENTS INC - 10469

Location ID: 316782

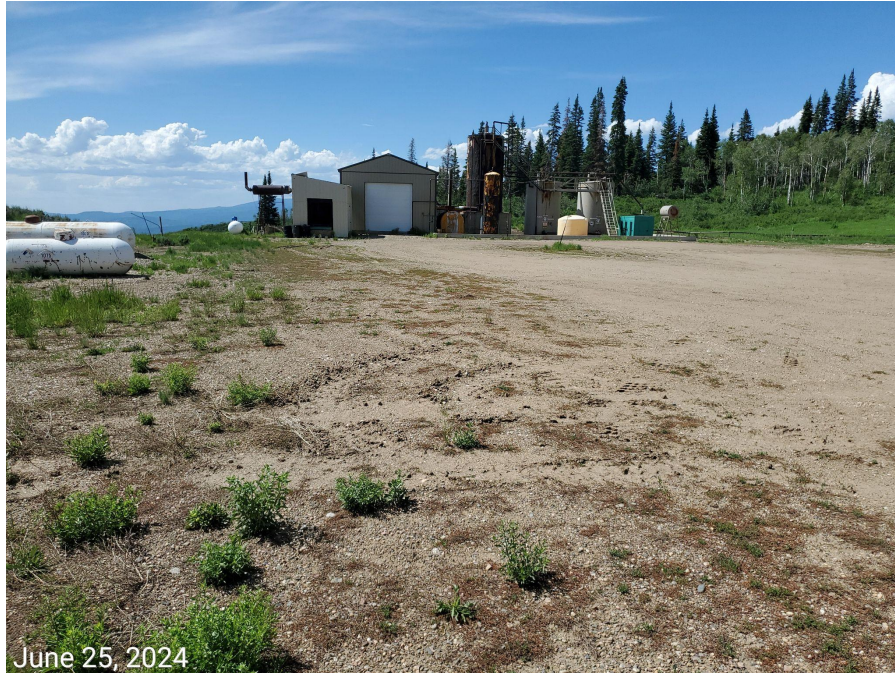
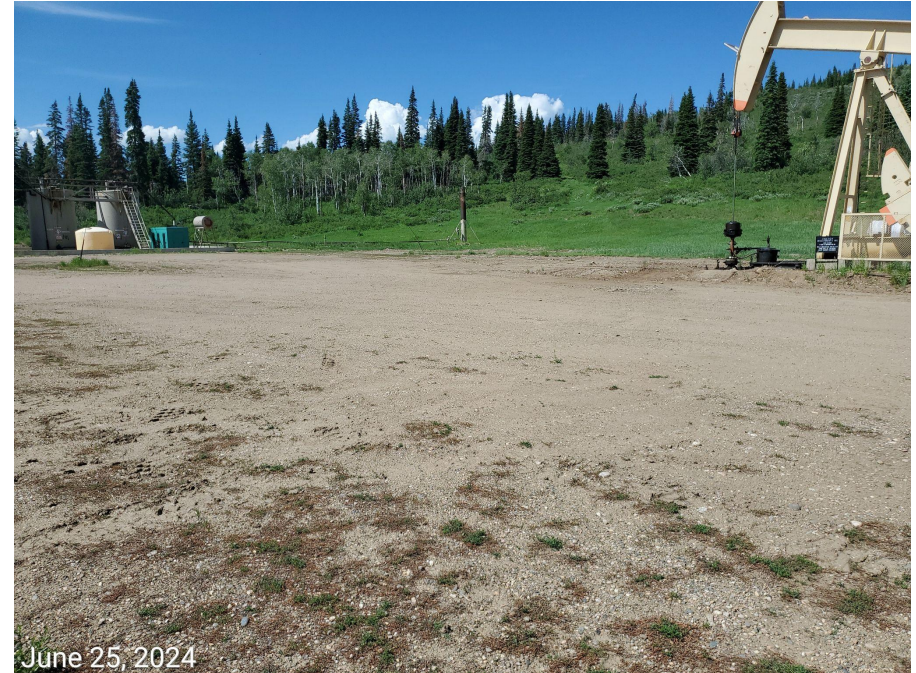
Photo 1: Photos 1-2 taken from the west end of the Location. Photos provide an overview of the Location from northwest, north, east, to southeast.

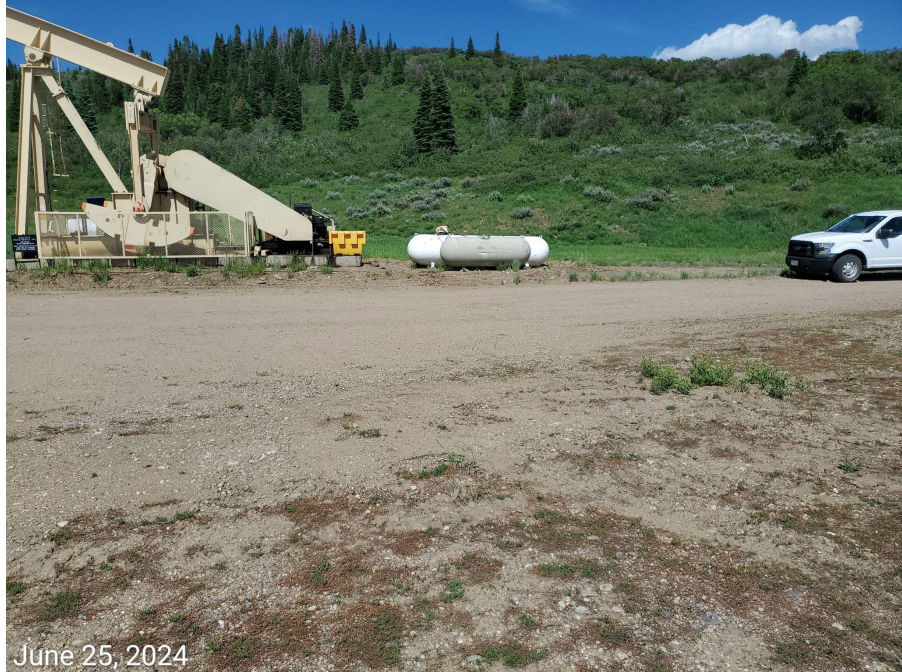
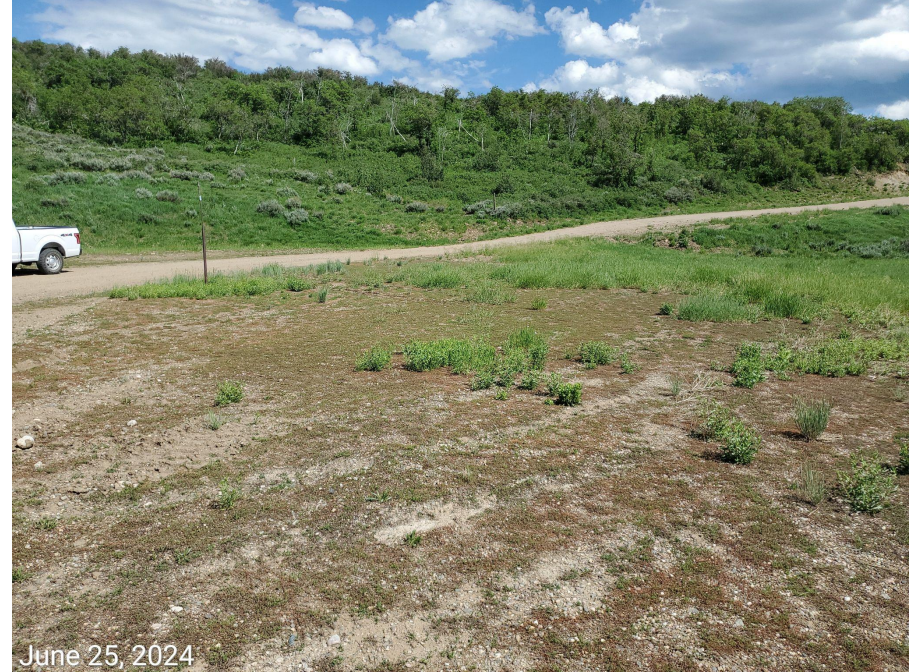
Photo 2: See comments under photo 1.

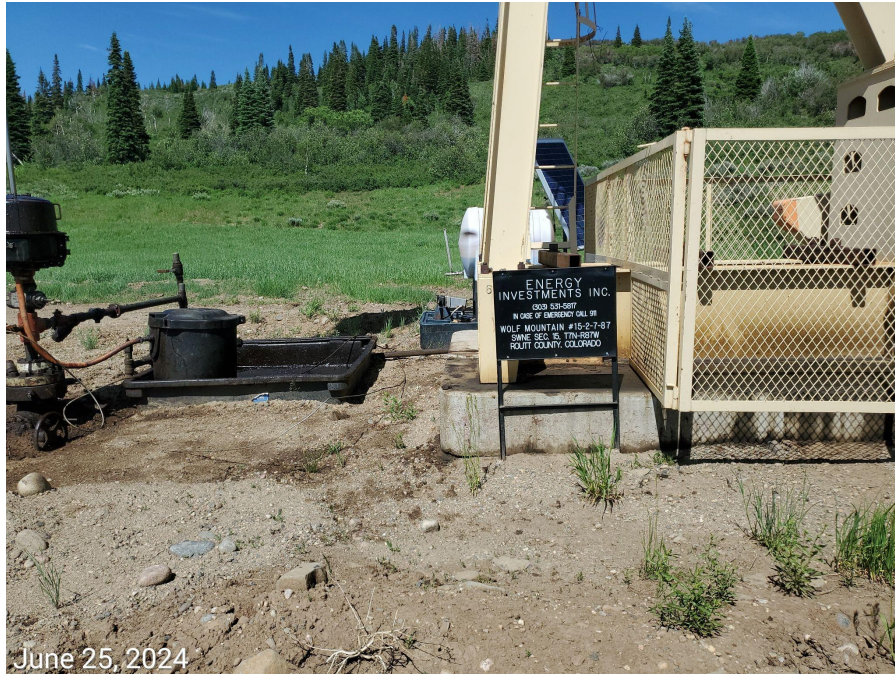
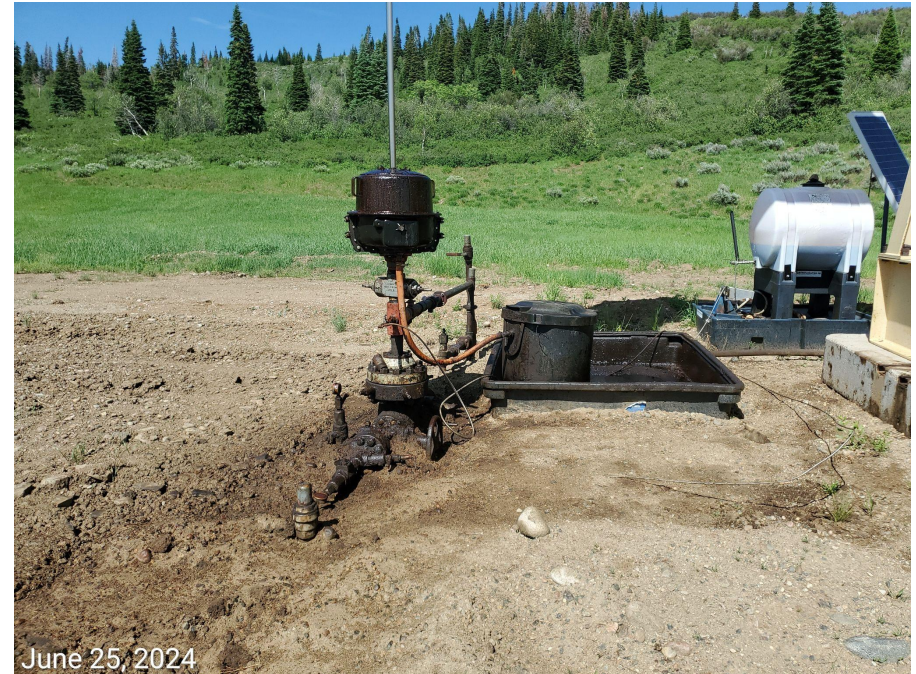
Photo 3: Photos 3-5 taken from the wellhead. Photo shows stained soils / impacts due to a leak at the wellhead.

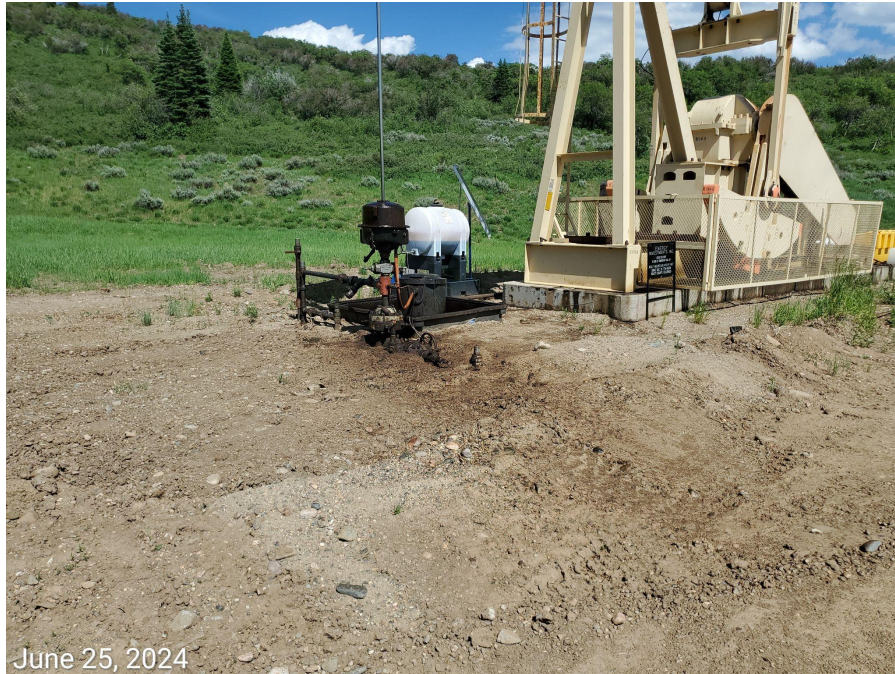
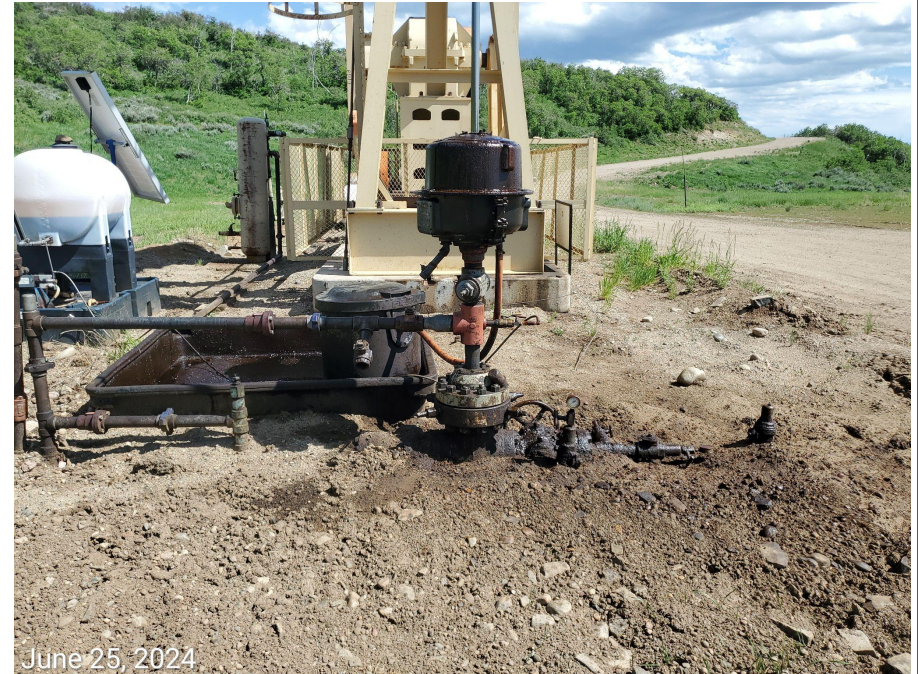
Photo 4: See comments under photo 3.

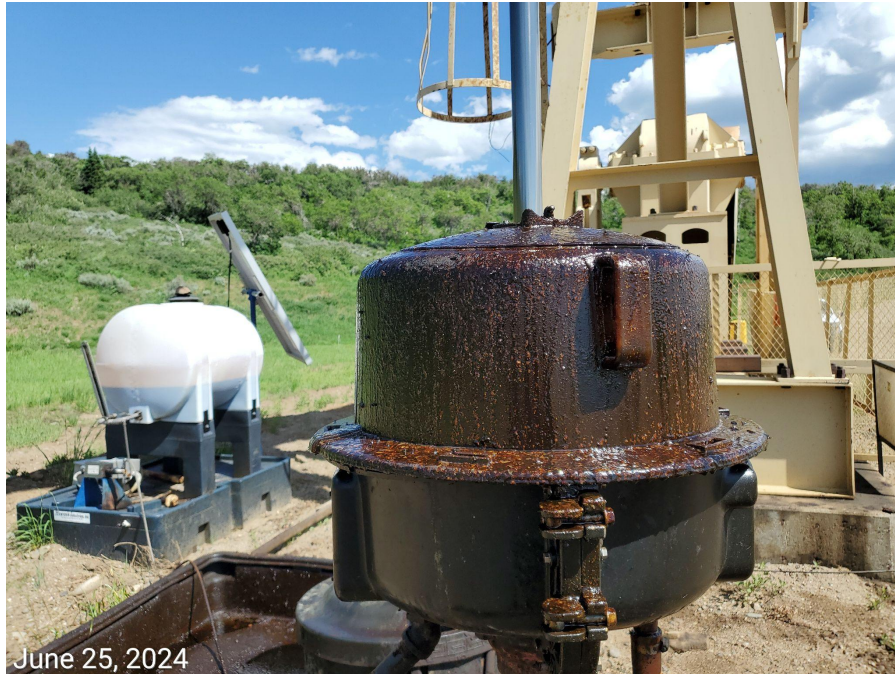
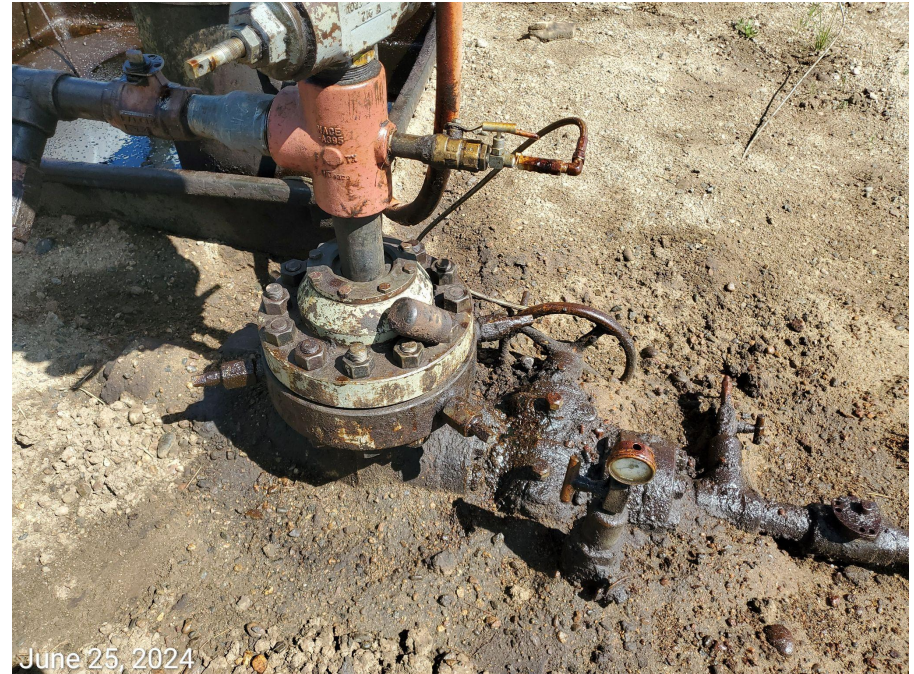
Photo 5 See comments under photo 3. Fluids appear to be actively leaking from well and stuffing box.

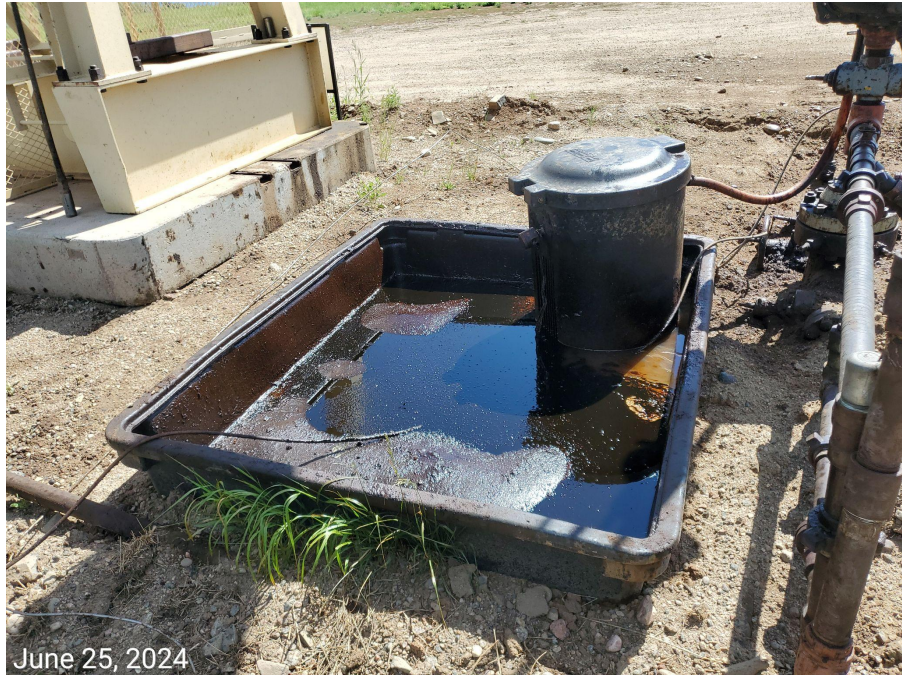
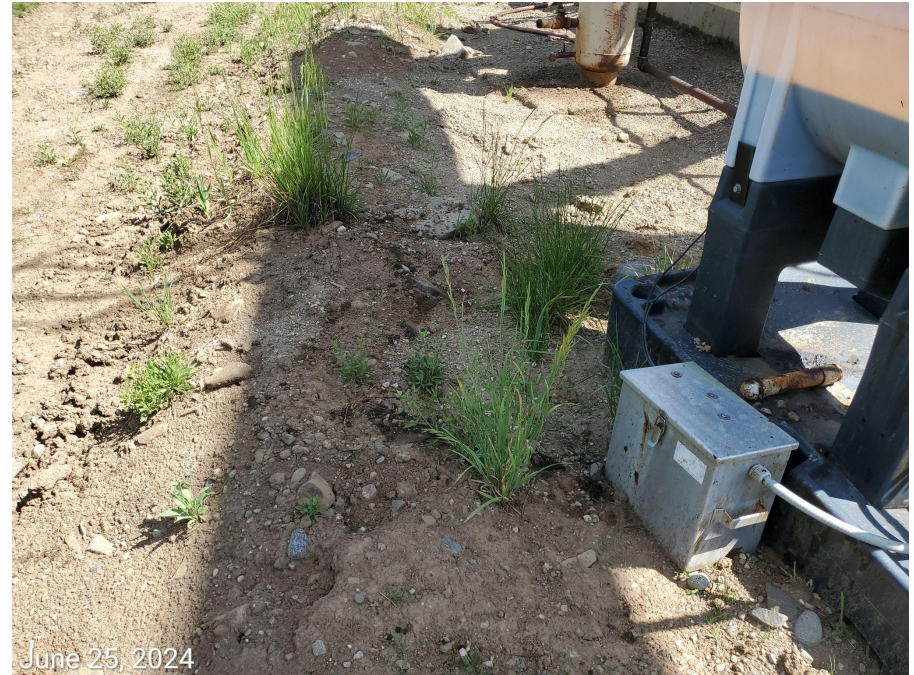
Photo 6: Photos taken from the well. Photo left shows fluids within the secondary containment measure. Photo also shows wildlife protection measures are missing from the containment BMP. Photo right shows additional soil staining around the well.

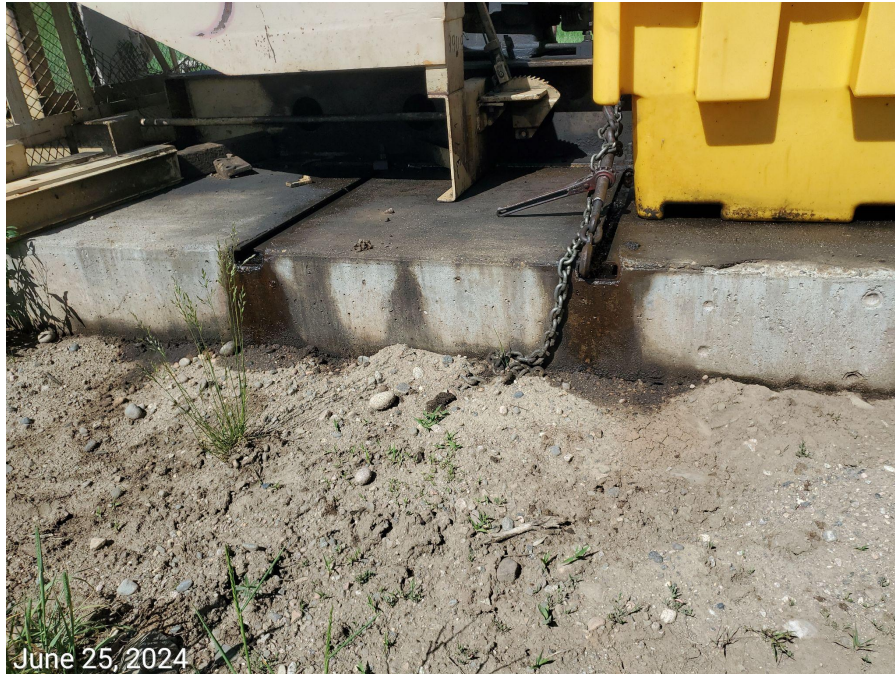
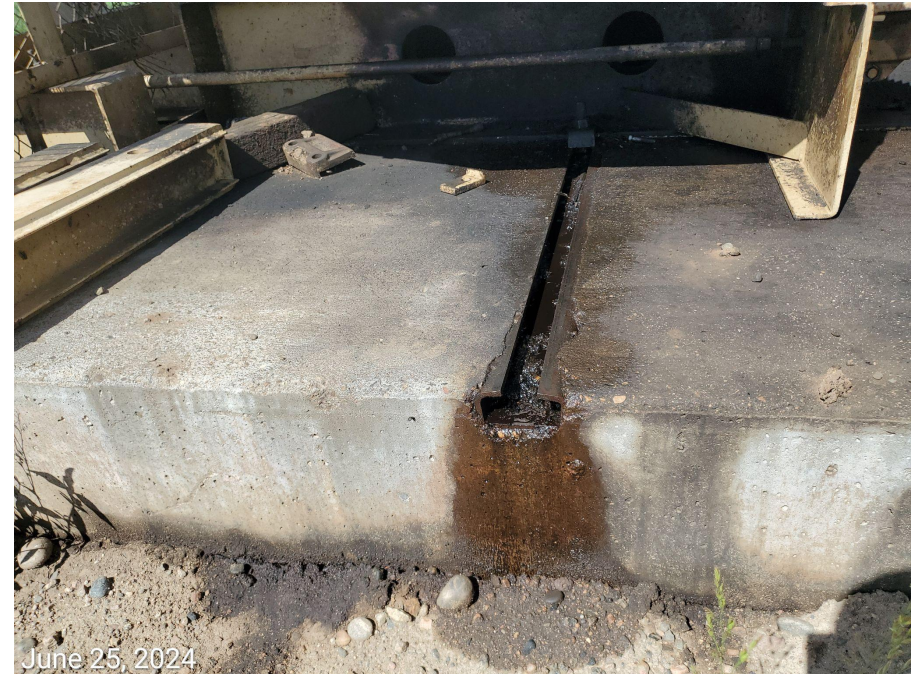
Photo 7: Fluids leaking from motor of the pump jack, resulting in stained soils.

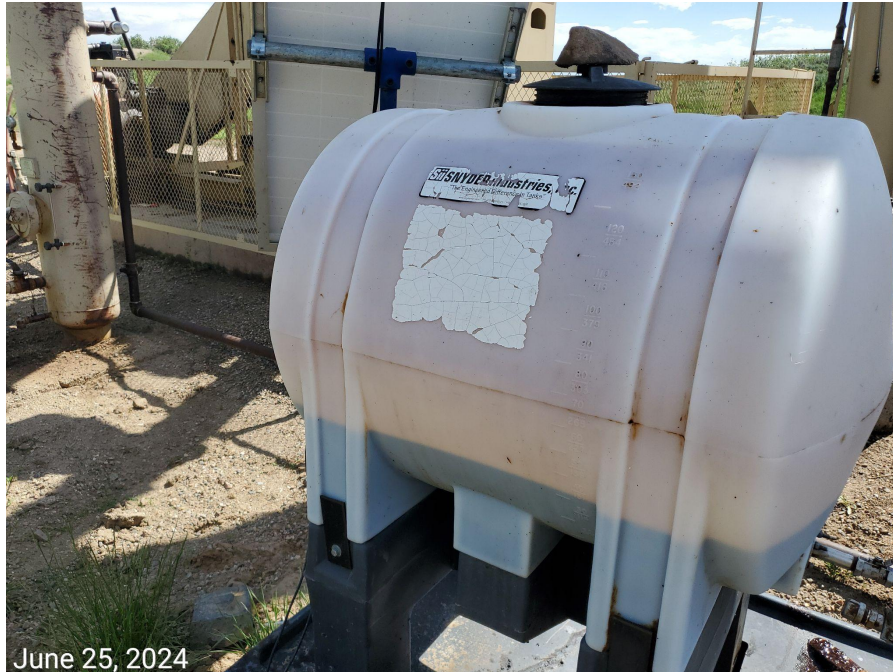
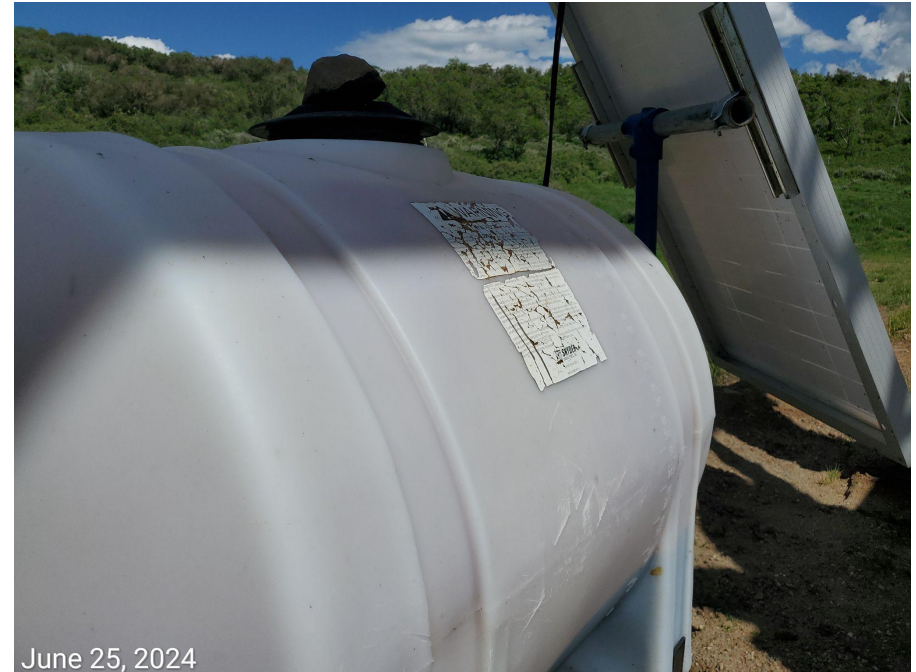
Photo 8: Container label adjacent to well is no longer legible.

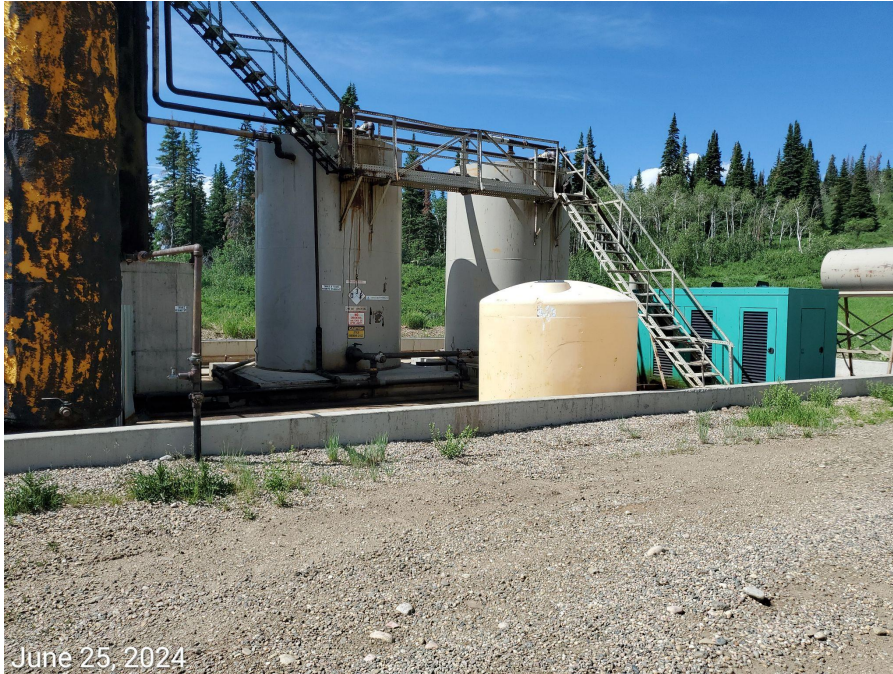
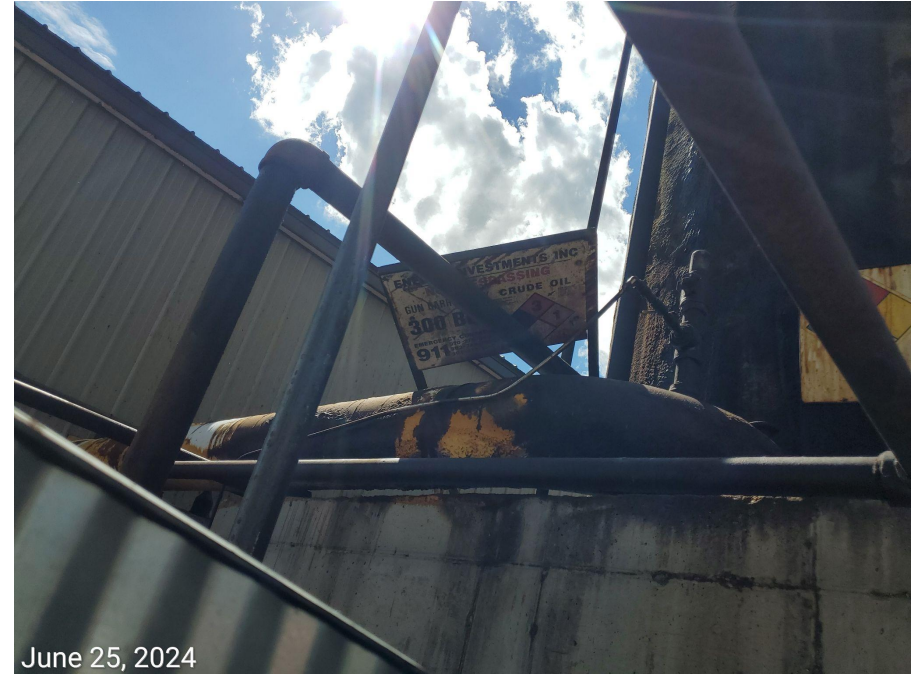
Photo 9: Photos taken from the tank battery facility on the north end of the Location. Photo left shows signage has not been posted at the battery facility. Photo right shows signage at the crude oil tank has not been maintained.

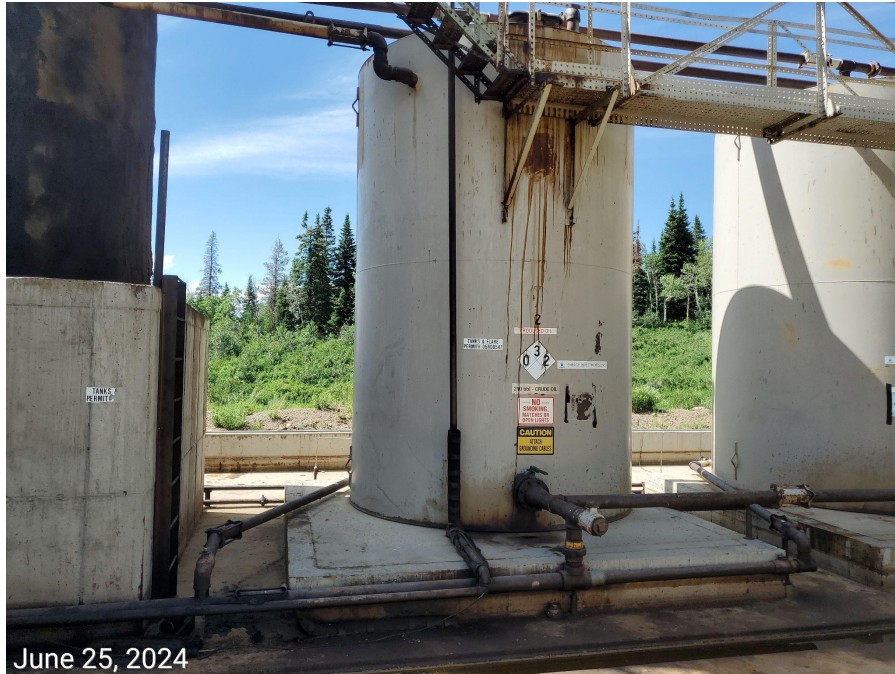
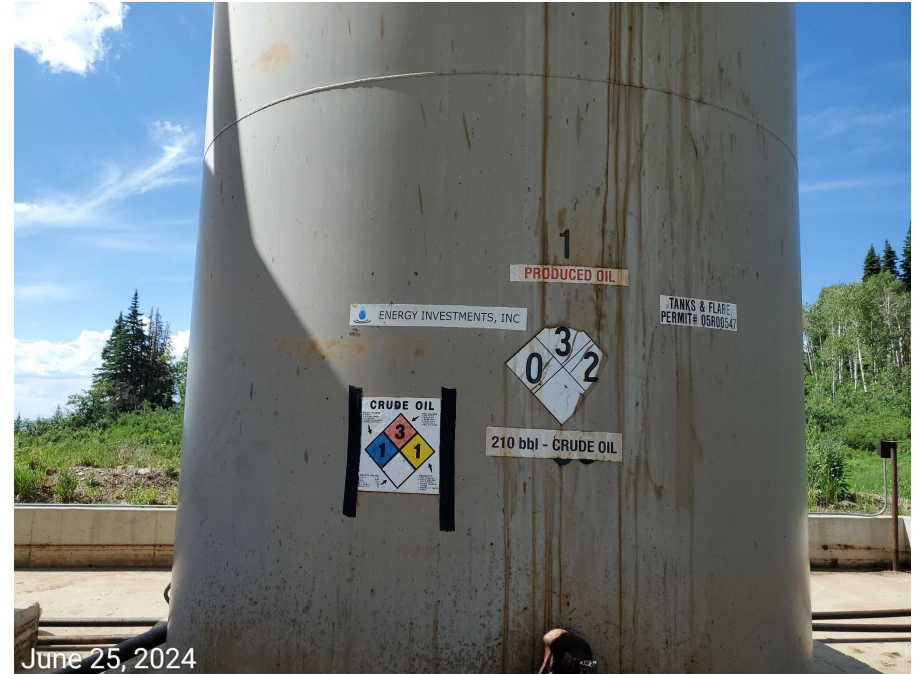
Photo 10: Tanks at battery facility missing Operator emergency contact number.

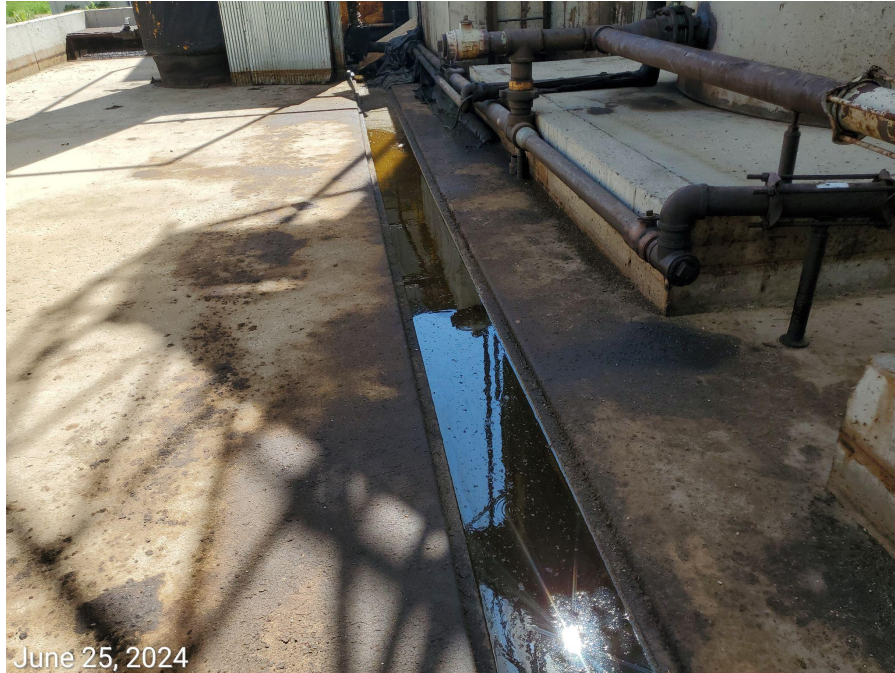
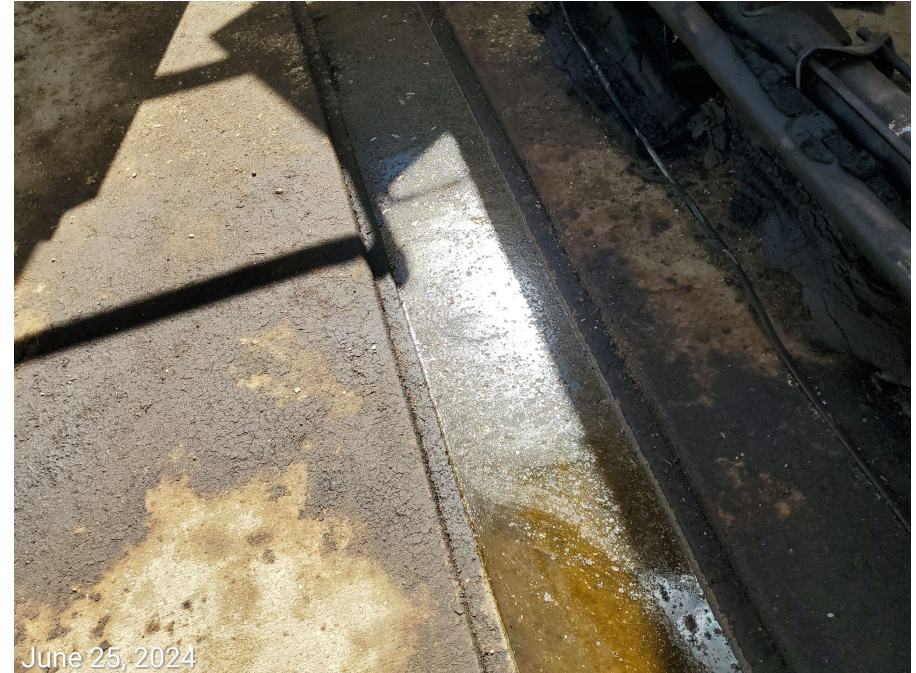
Photo 11: Photos 11-13 taken from the tank battery facility on the north end of the Location. Photos shows fluids/spills within containment.

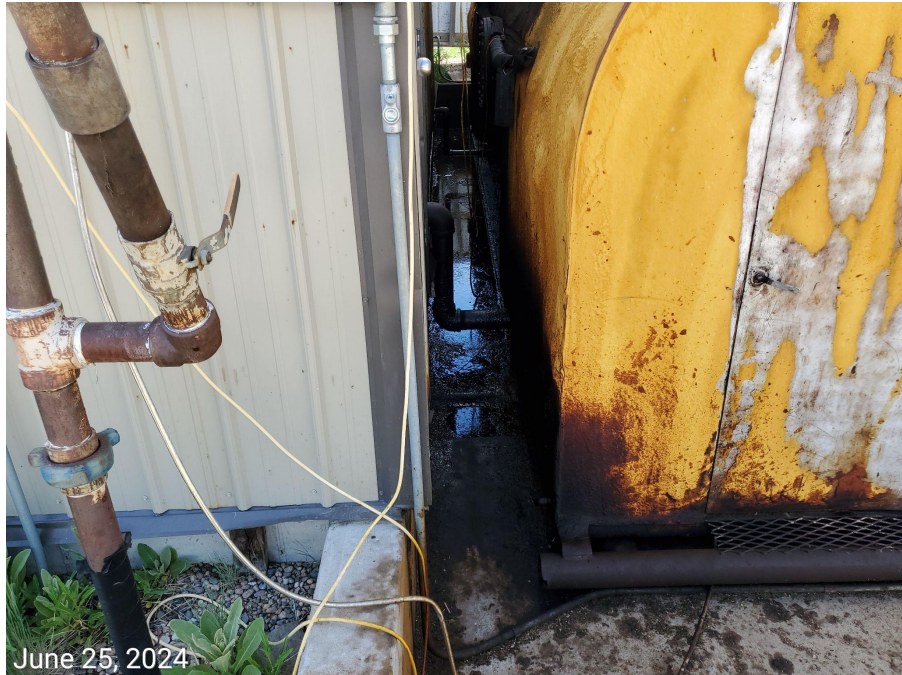
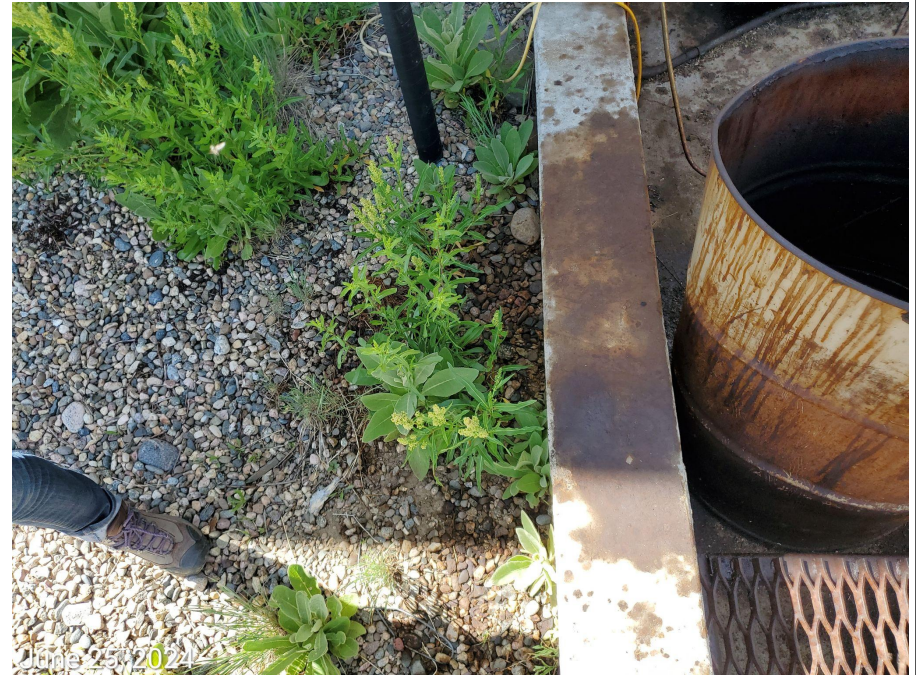
Photo 12: See comments under photo 11. Photo right also shows stained soils next to battery facility.

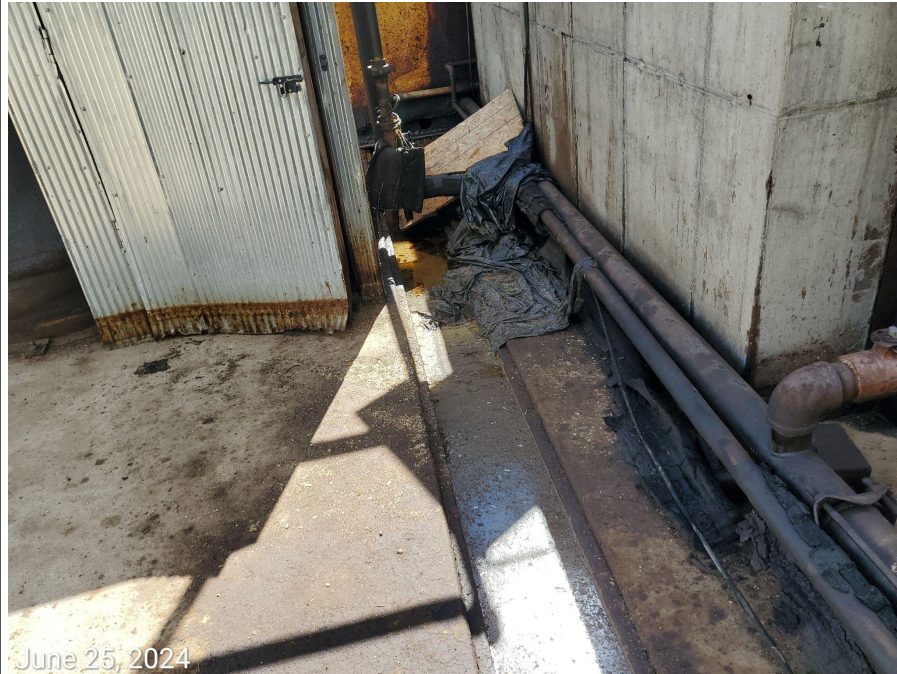
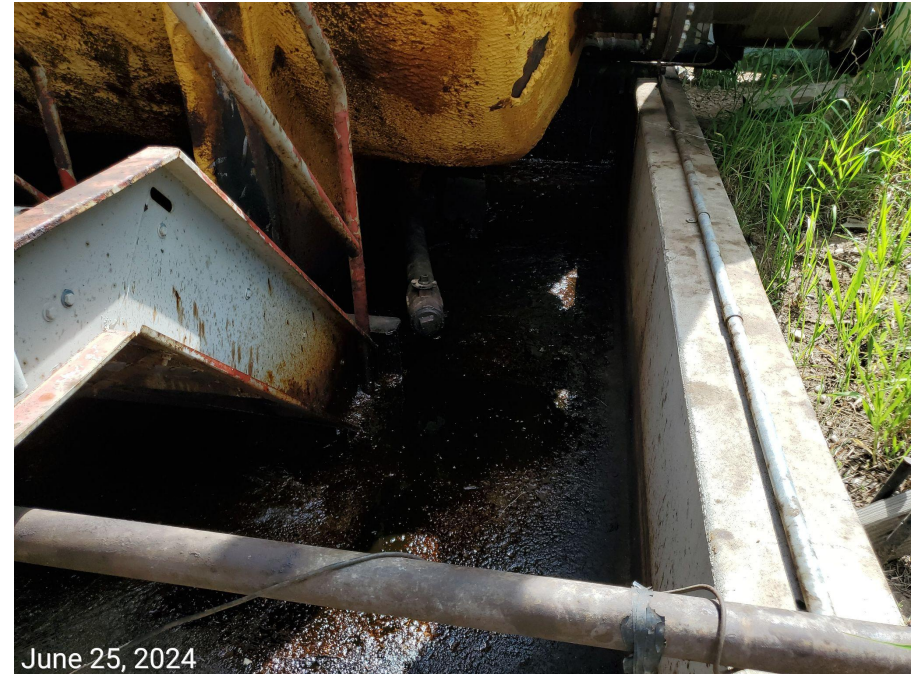
Photo 13: See comments under photo 11.

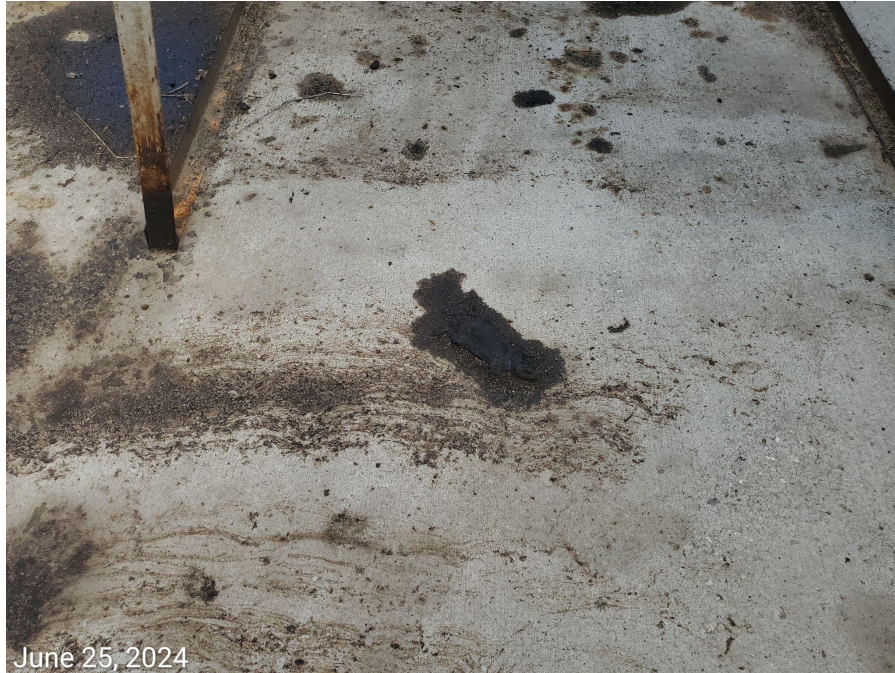
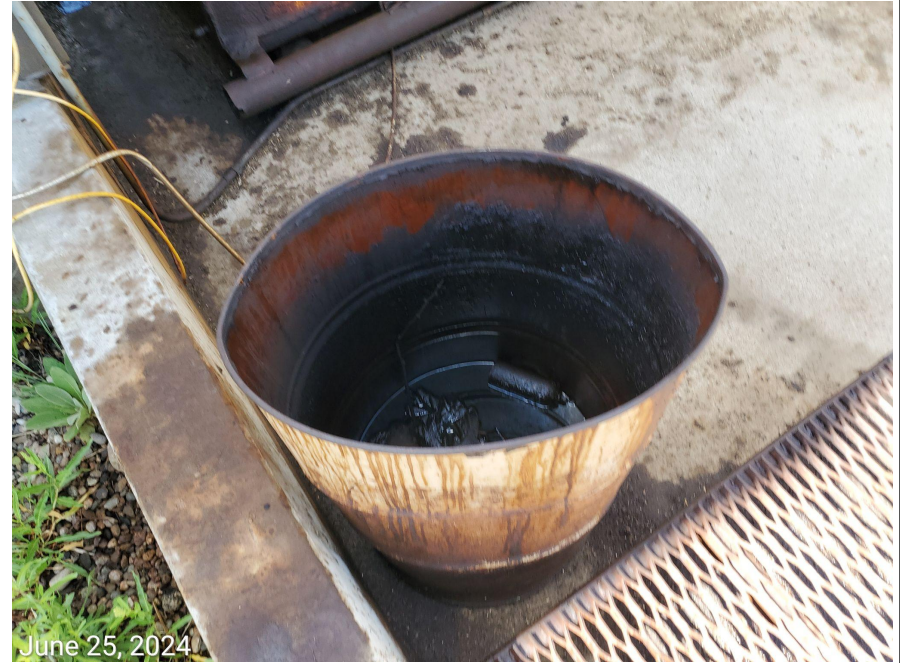
Photo 14: Photos right shows wildlife mortality within the tank battery facility containment. Photo right shows an open barrel containing unknown fluids. Wildlife protection measures missing or insufficient.

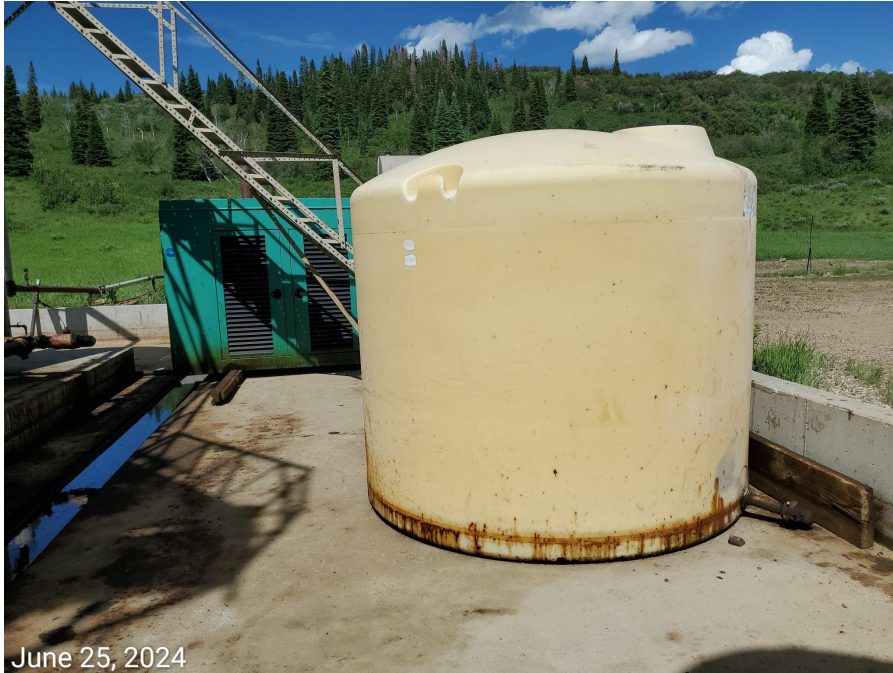
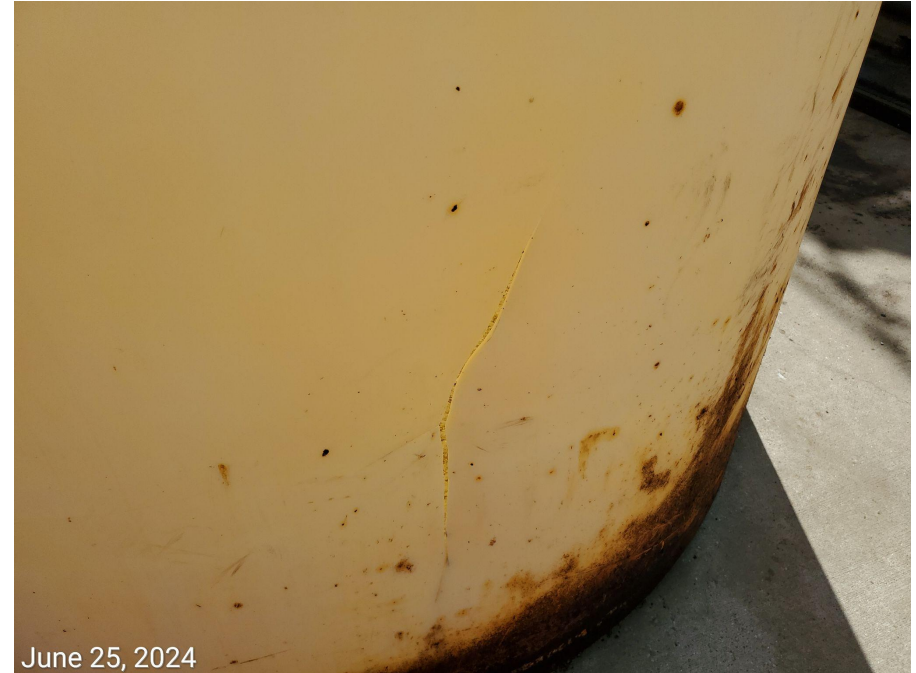
Photo 15: Unused tank with crack observed stored at the battery facility. Tank requires removal.

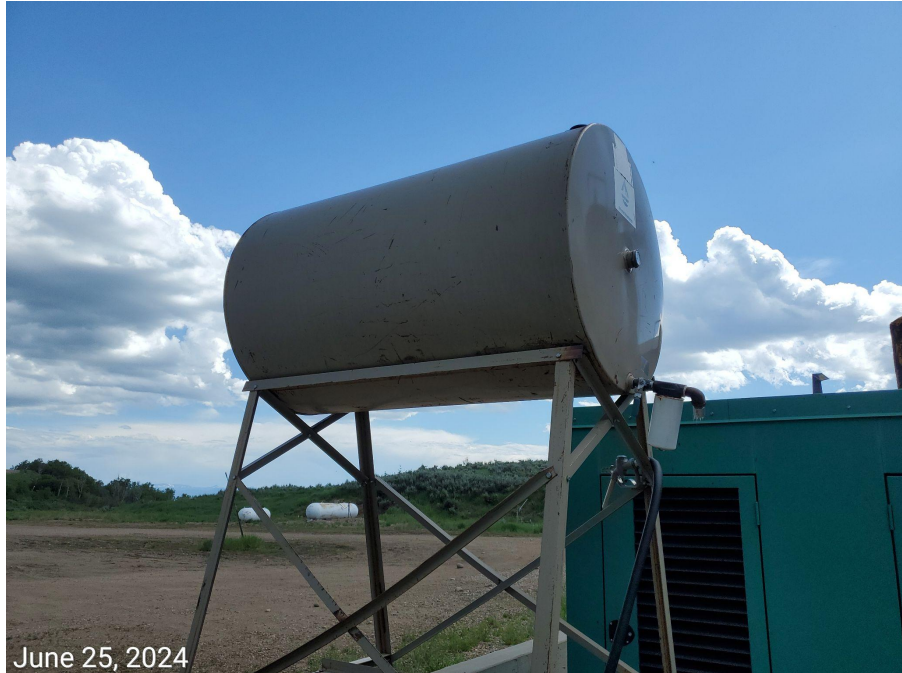
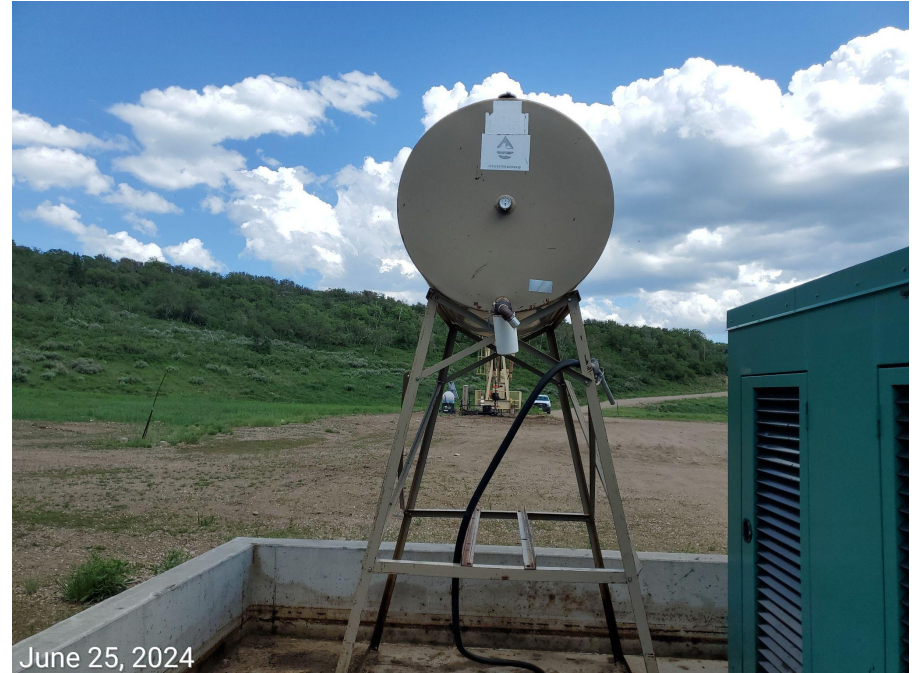
Photo 16: Labels at container no longer legible.

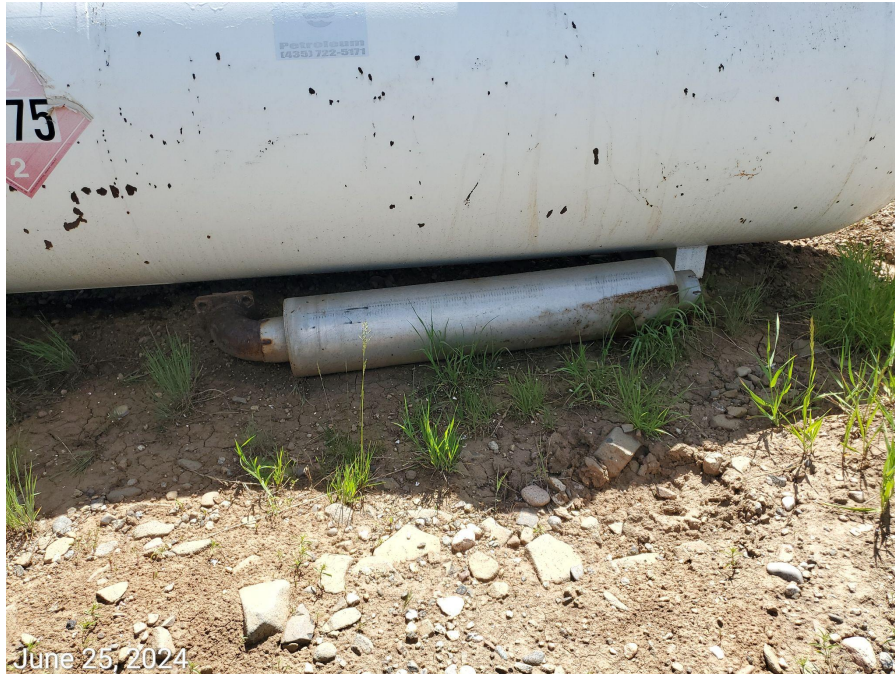
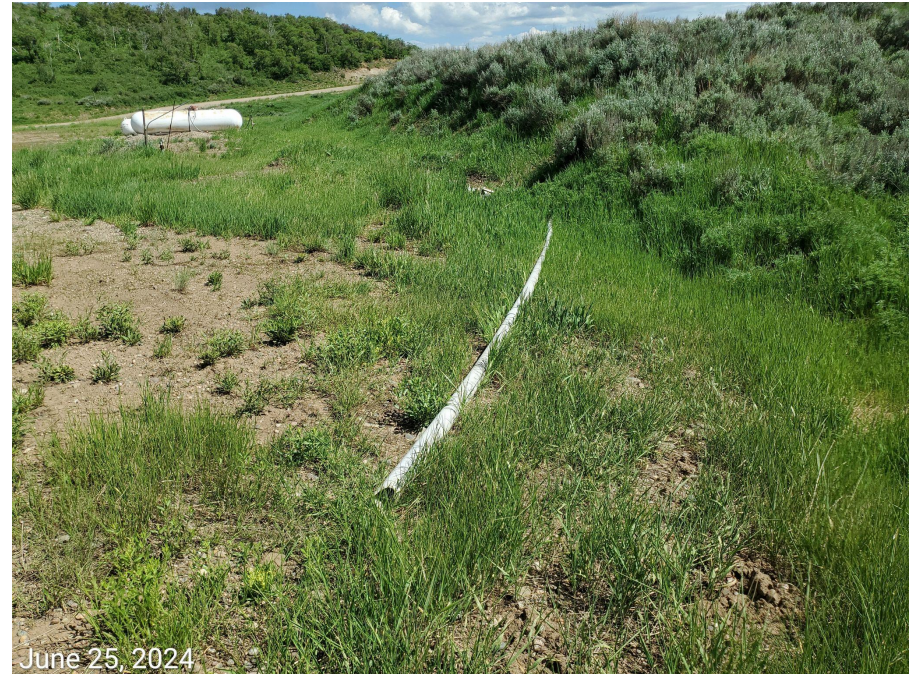
Photo 17: Photos 17-20 provide examples showing various trash, debris and/or unused equipment improperly stored on the Location. Photo left taken from the propane tank next to the wellhead. Photo right taken from the northwest end of the Location, facing southeast.

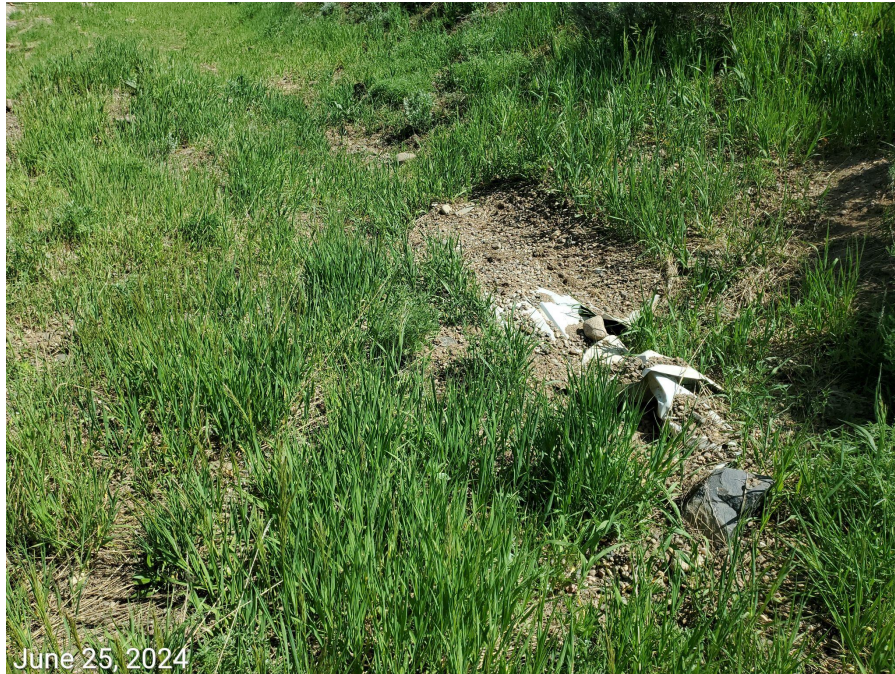
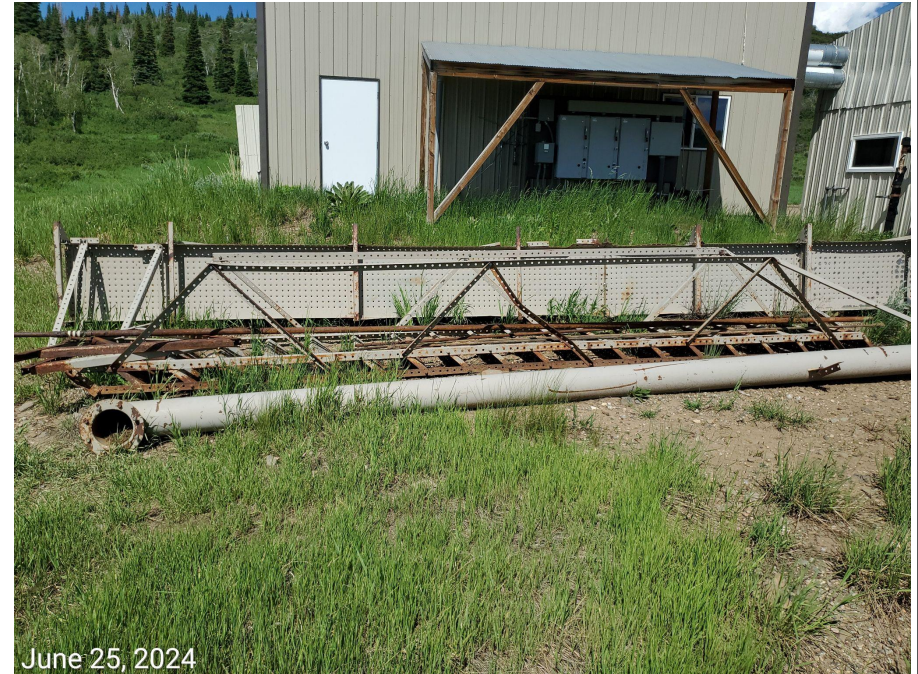
Photo 18: See comments under photo 17. Photos taken from the northwest end of the Location.
