Inspection Photos

06/25/2024

Operator: ENERGY INVESTMENTS INC - 10469

Location ID: 316782

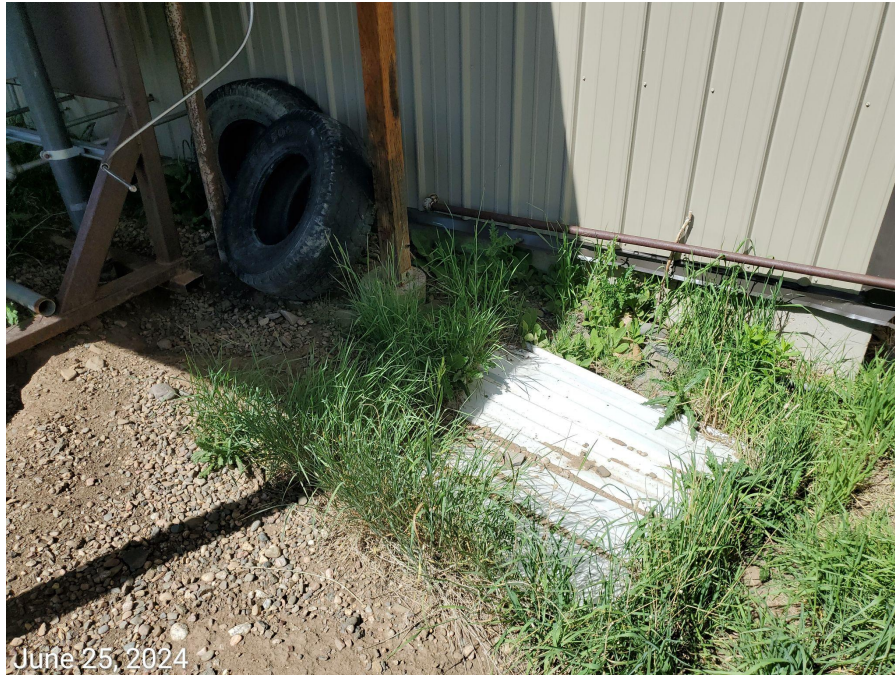
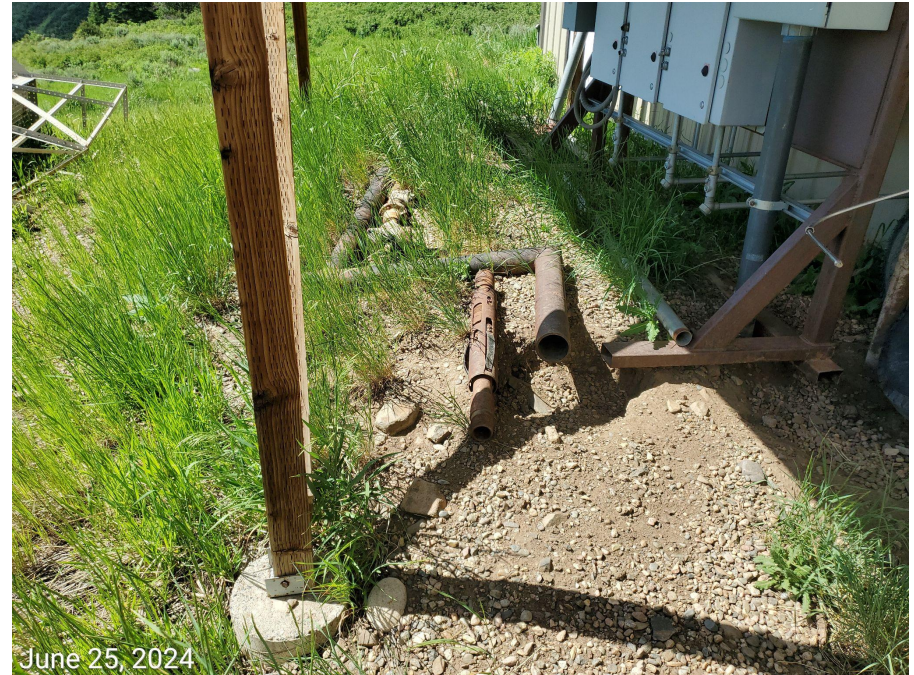
Photo 17: Photos 17-20 provide examples showing various trash, debris and/or unused equipment improperly stored on the Location. Photo left taken from the propane tank next to the wellhead. Photo right taken from the northwest end of the Location, facing southeast.

Photo 19: See comments under photo 17. Photos taken from behind the housing unit on the northwest end of the Location.

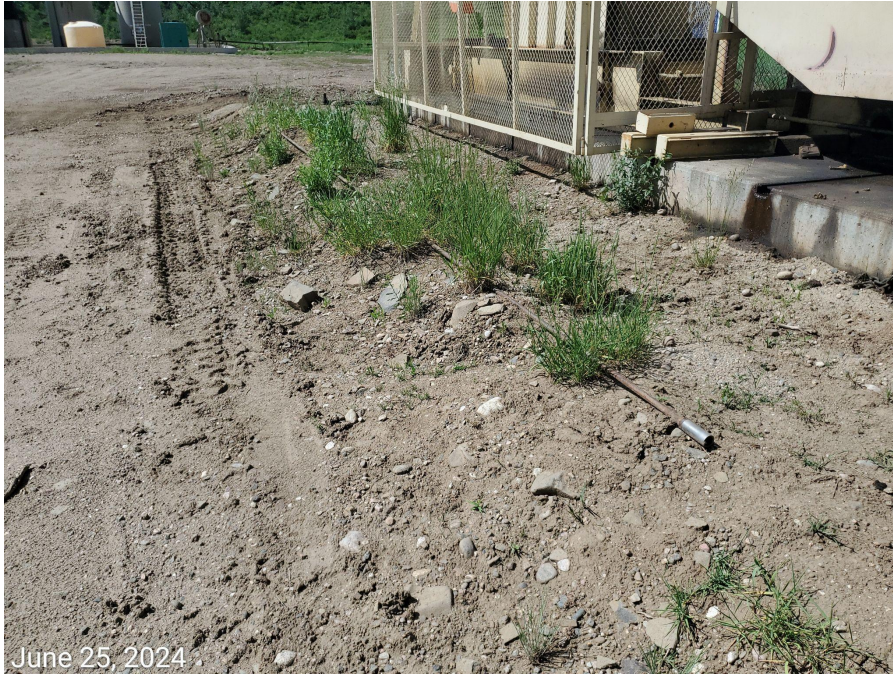
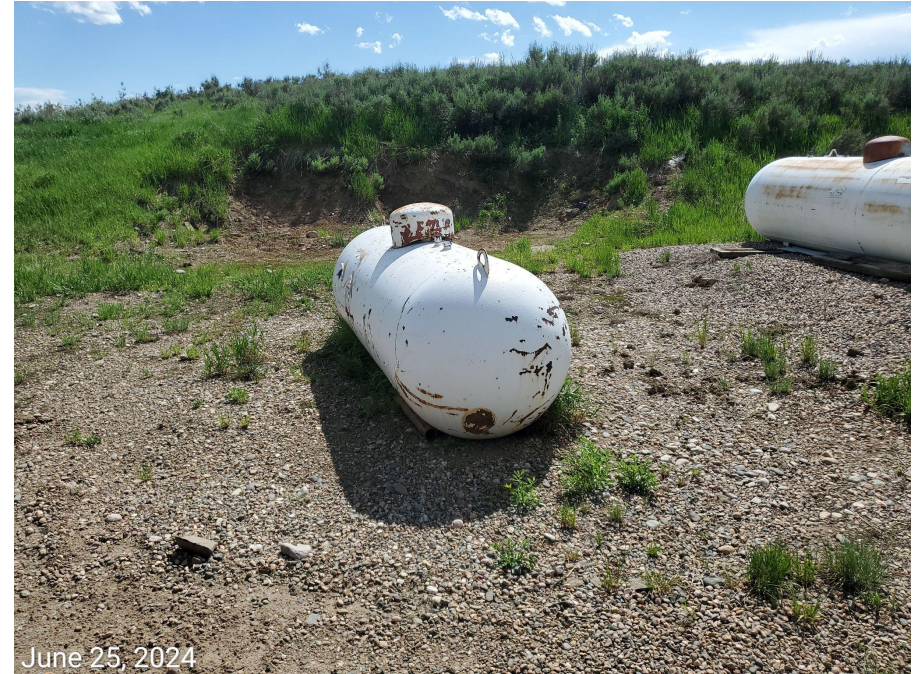
Photo 20: See comments under photo 17. Photo left taken from next to wellhead. Photo right shows unused propane tank stored on the southwest end of the Location.

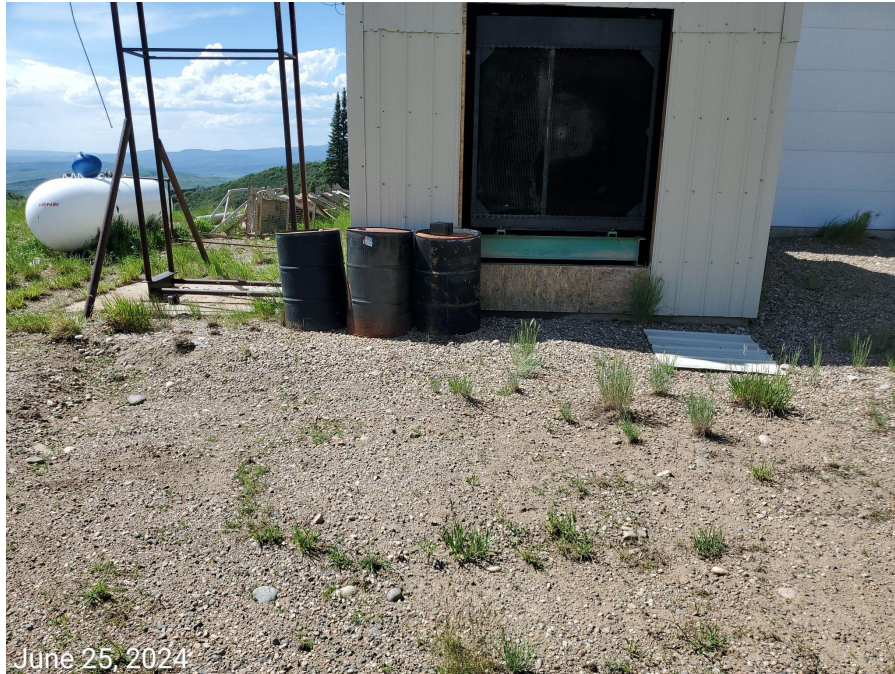
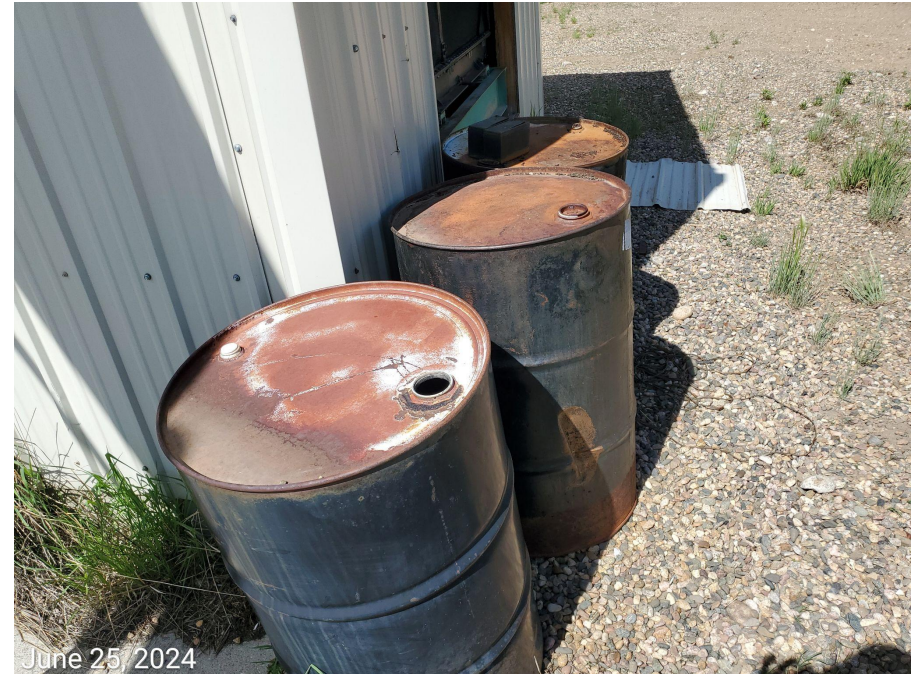
Photo 21: Photos show unlabeled barrels improperly stored on the Location. BMPs to prevent and/or to contain a spill or release are missing or insufficient.

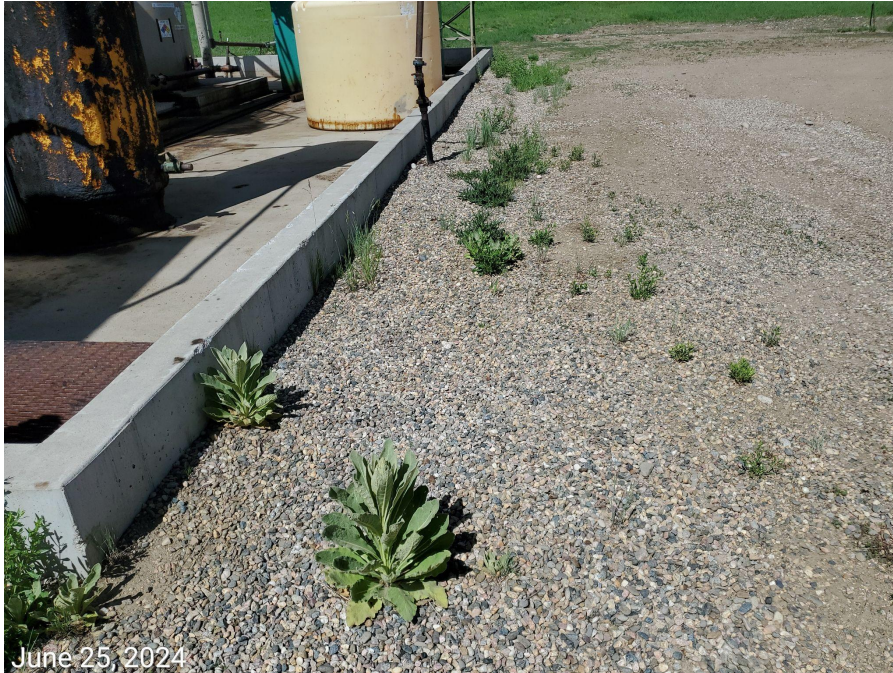
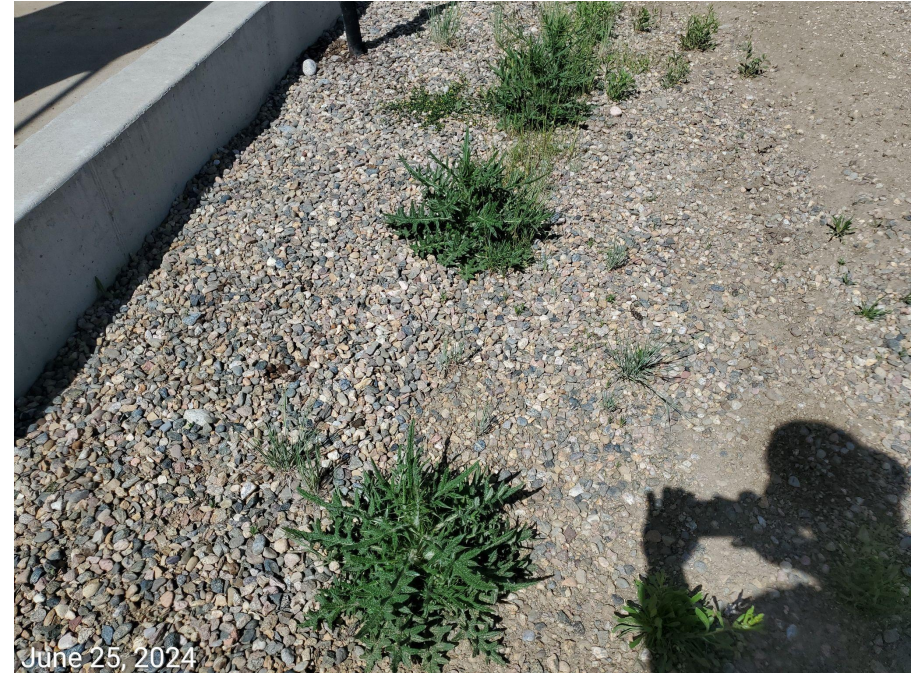
Photo 22: Photos examples of Noxious Weeds (Bull thistle, Houndstongue) observed on the production and interim areas of the Location.

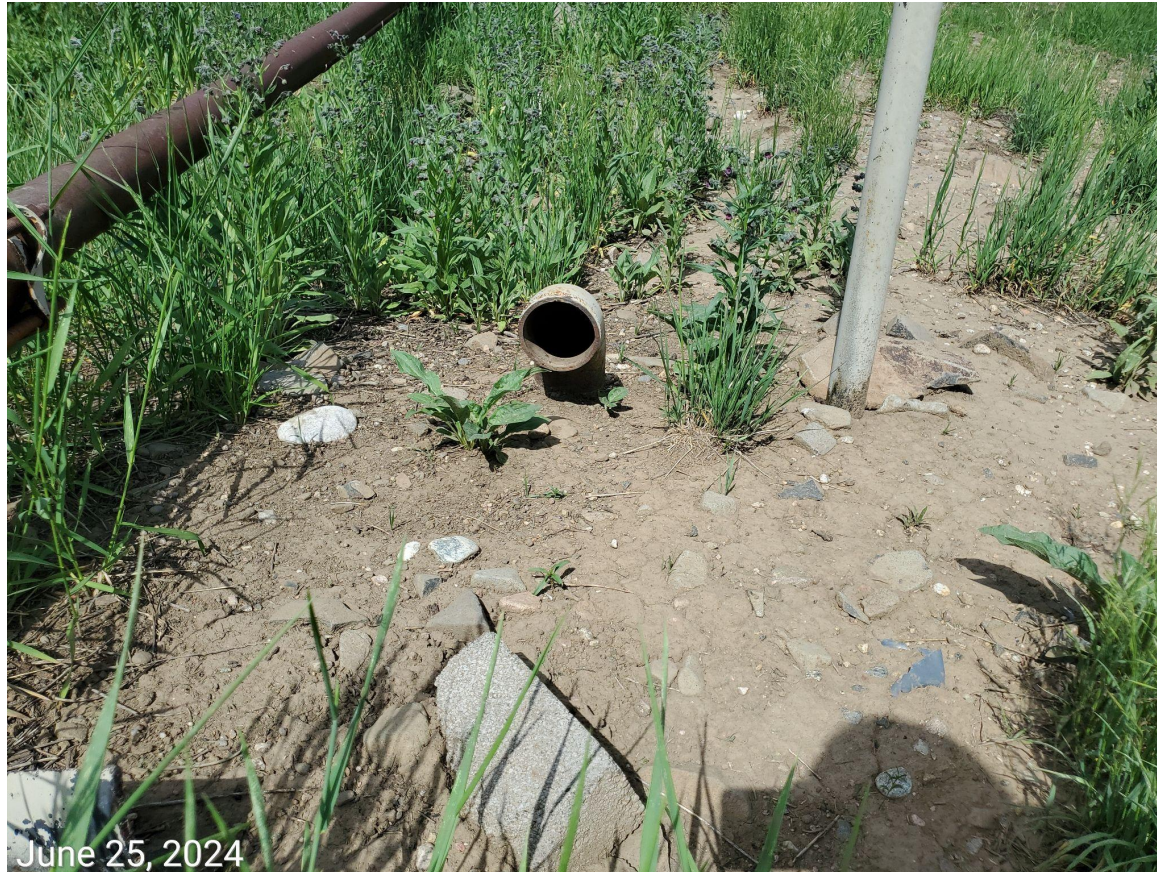
Photo 23: Photos taken from the north and of the Location, east of the battery. Photo shows open pipe. BMPs to prevent wildlife access missing.

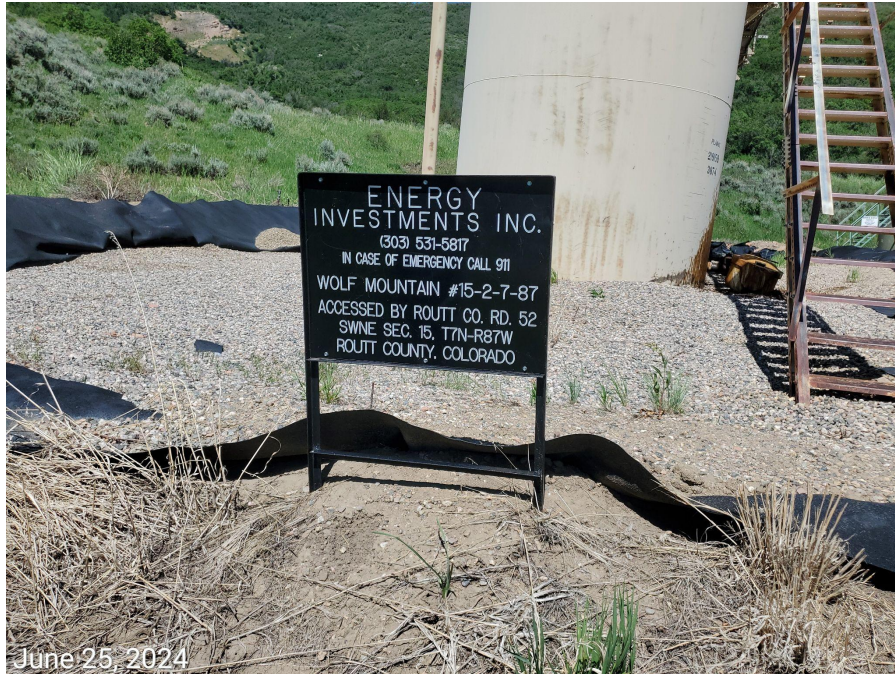
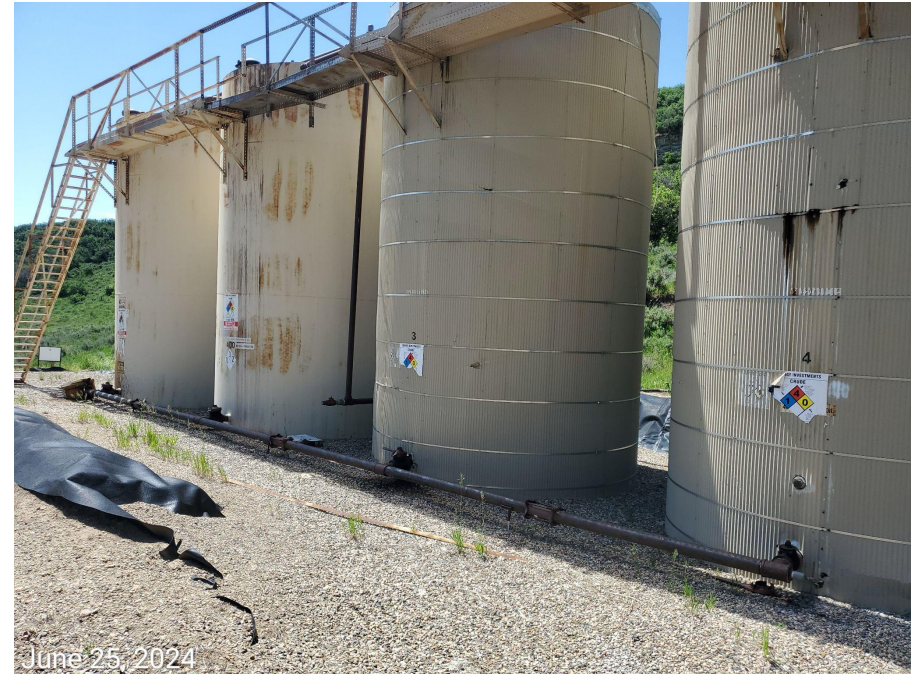
Photo 24: Photos 24-29 taken from the “Wolf Mountain Tank Battery Facility (#449642)”, Located on the north end of Beeman O&G’s Routt Bonanza-67N87W/22SENE Location (#316756). Photo left shows API information remains missing at the battery signage. Photo right shows tanks at the facility.

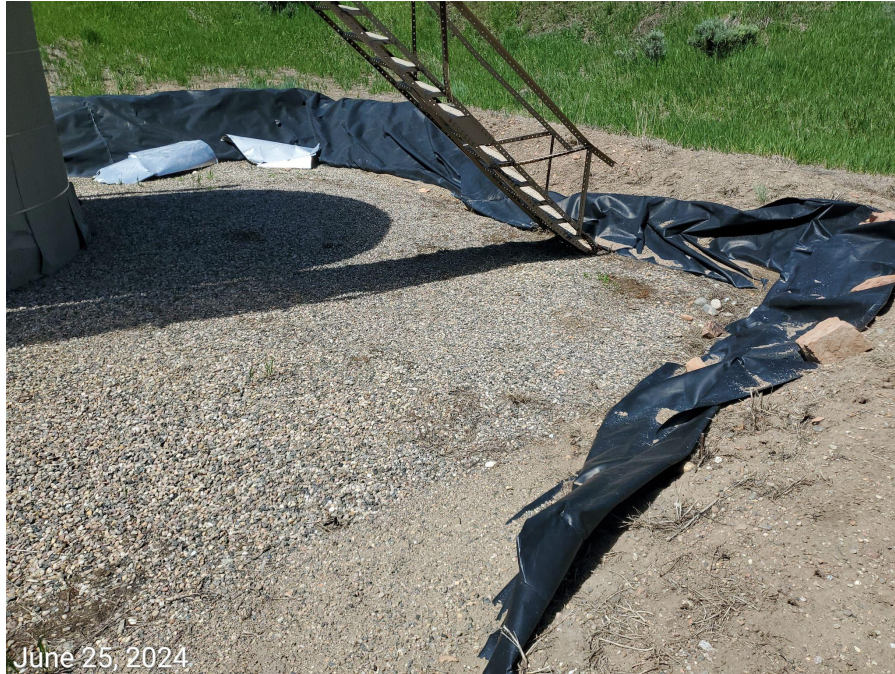
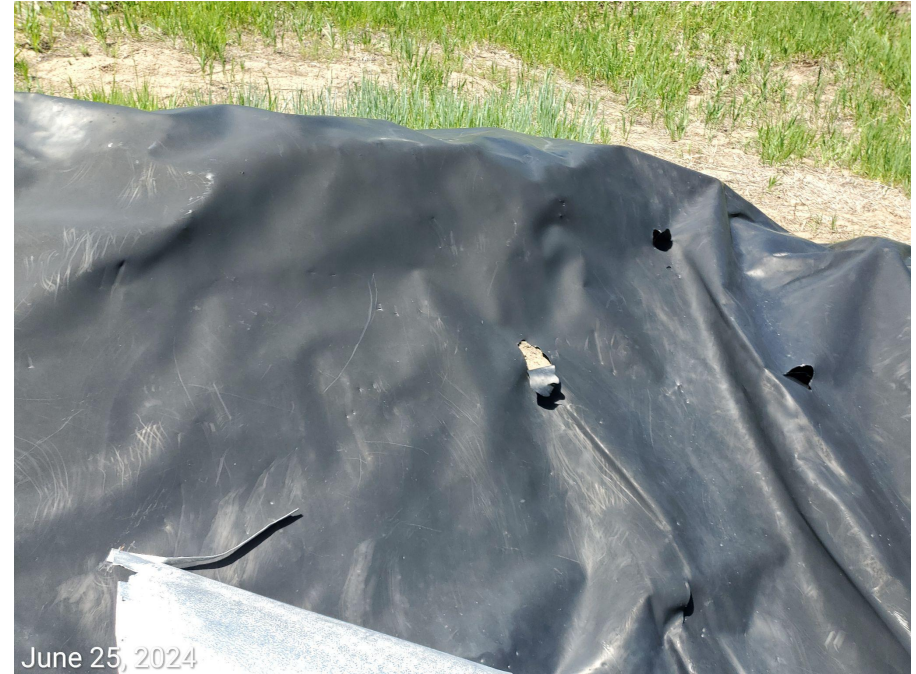
Photo 25: Photos shows that secondary containment measure remains in disrepair- containment is not impervious to contain a spill or release.

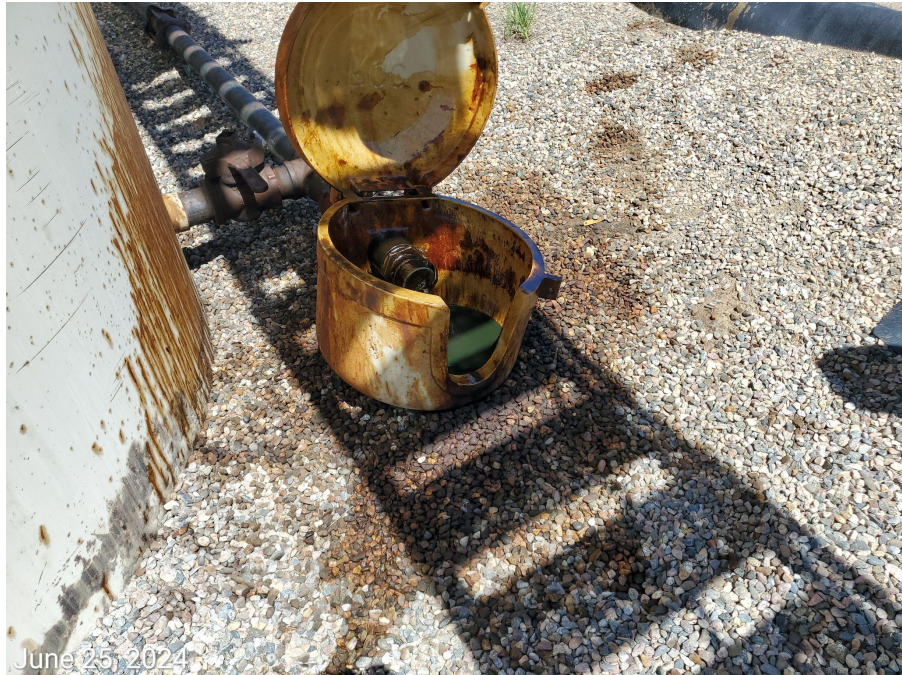
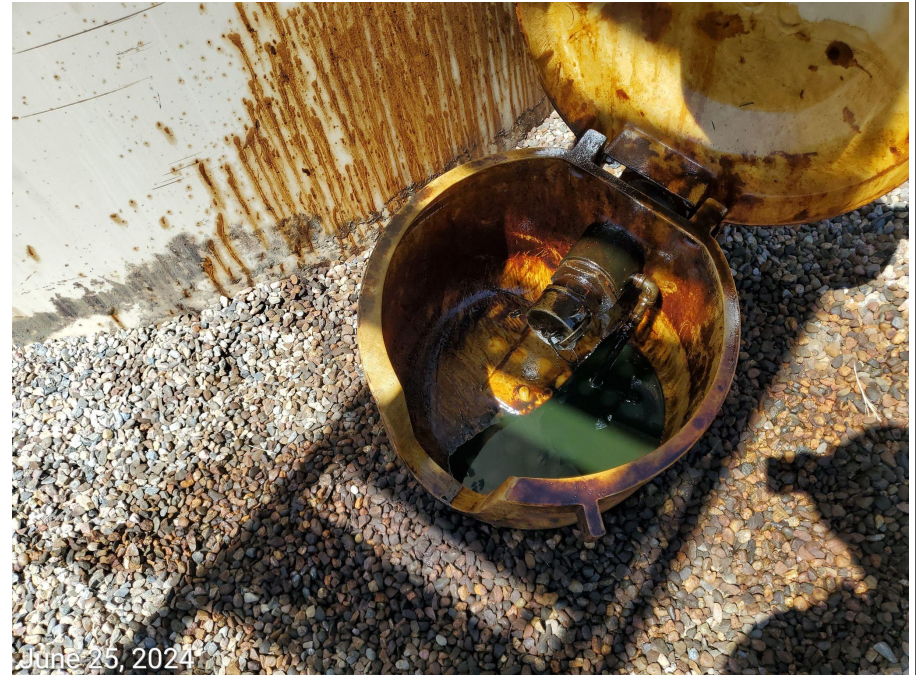
Photo 26: Photos show fluids remain in the honeypot. Photo also shows spills remaining around the loadline.

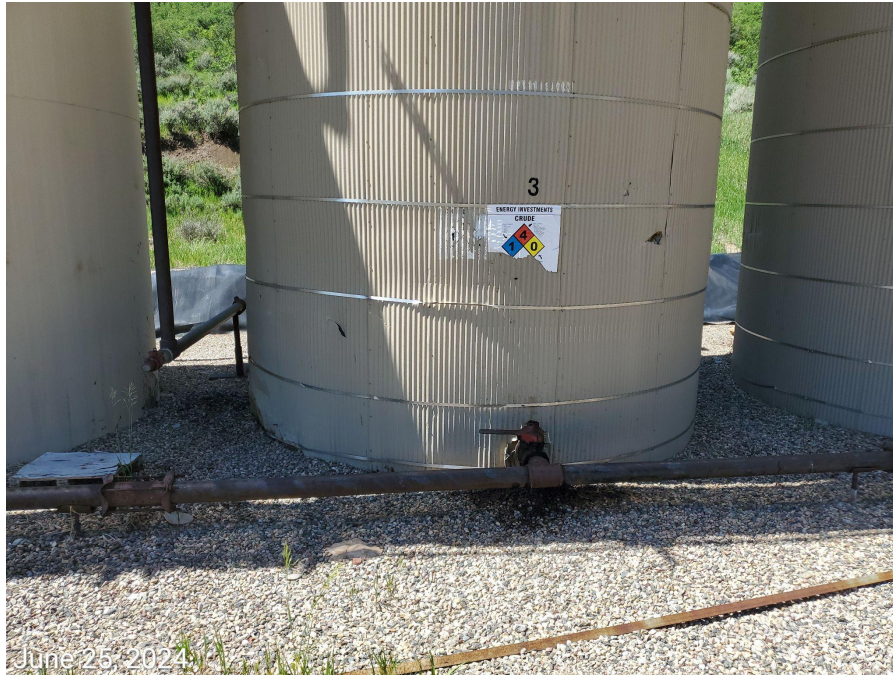
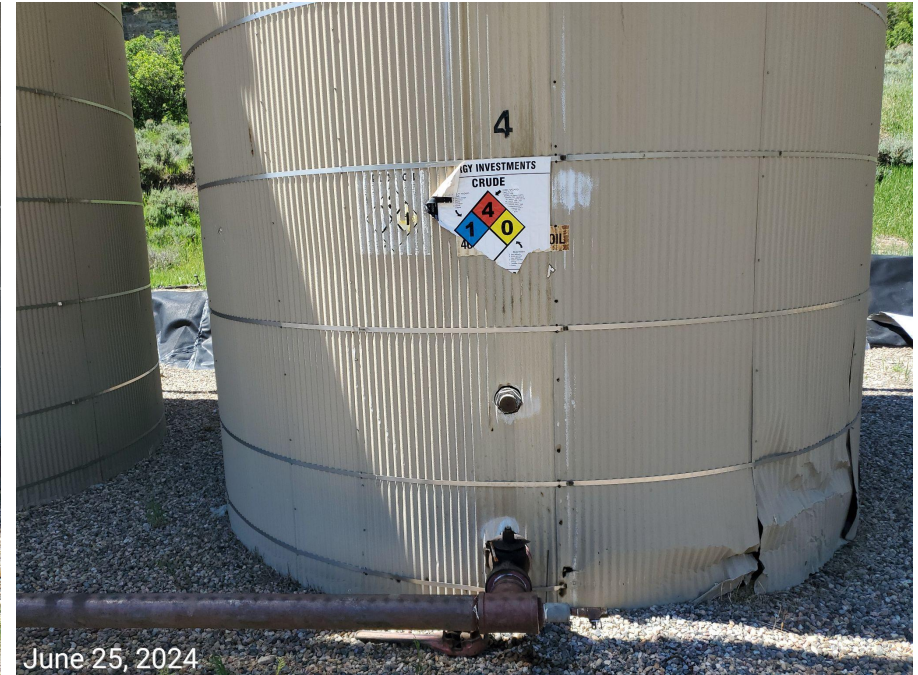
Photo 27: Photos show signage at the tank do not comport with 605 requirements.

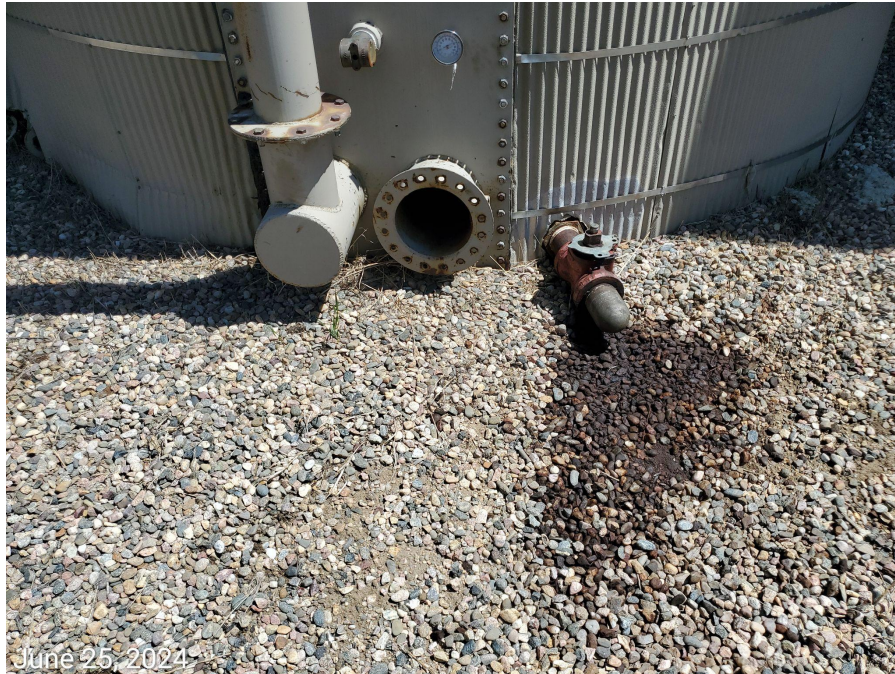
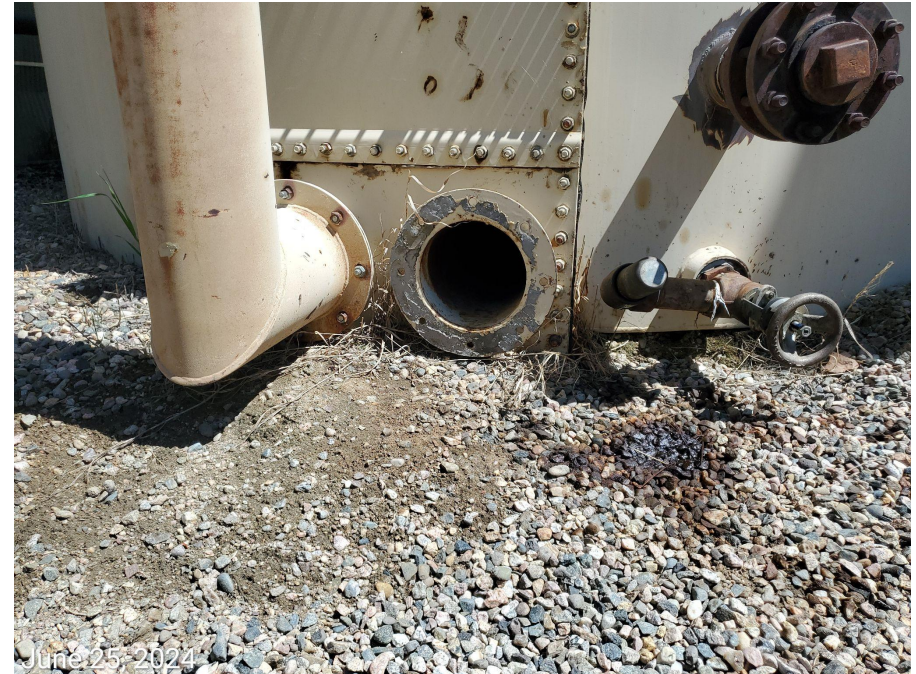
Photo 28: Photos examples showing covers at 3 of the 4 tanks on the Location have not been replaced. Photos also show stained soils due to spills at the battery facility have not been cleaned.

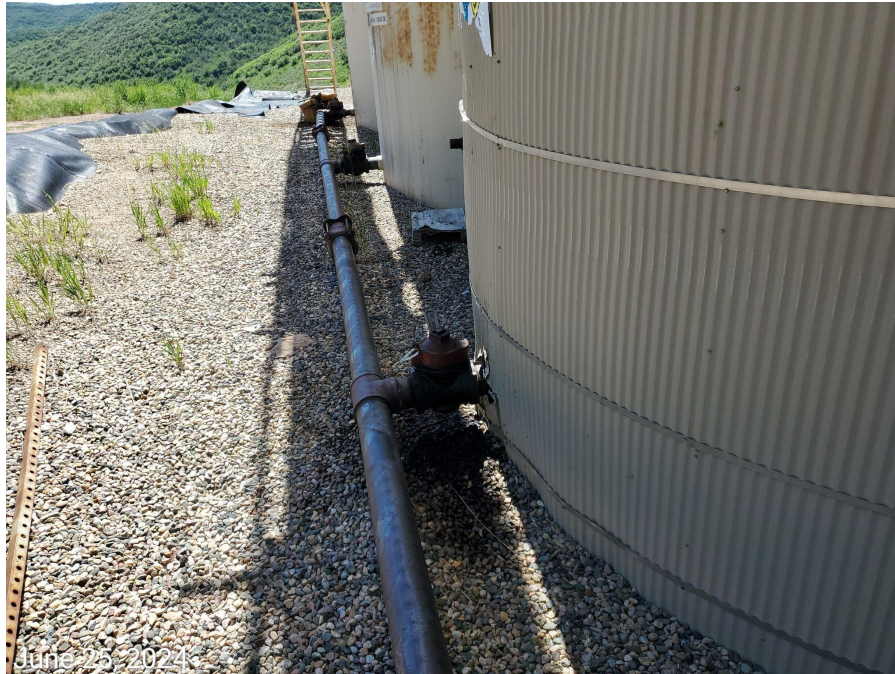
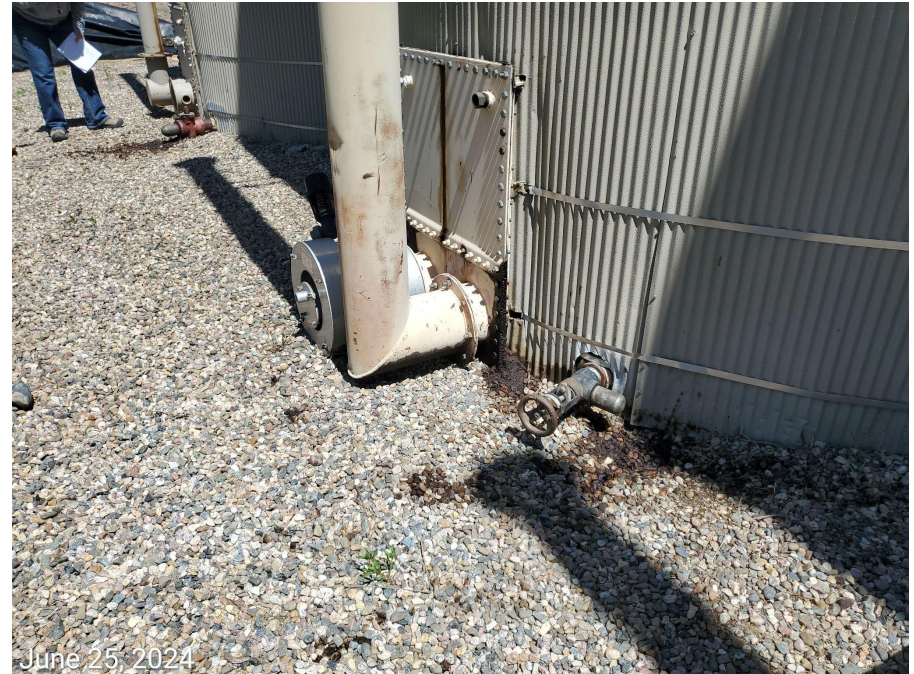
Photo 30: Photos examples show additional spills/stained soils that have not been cleaned/removed at the battery facility.
