Inspection Photos

Location Name: TEP Rocky Mountain LLC BRYNILDSON 14C-20-692 Pad

Location # 335300

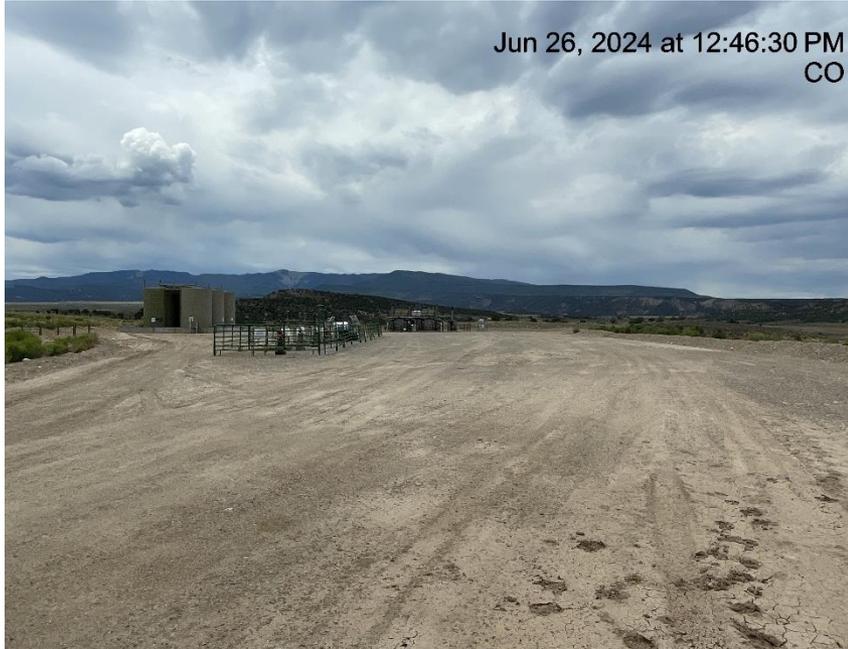
Photo # 1699 From entrance to location

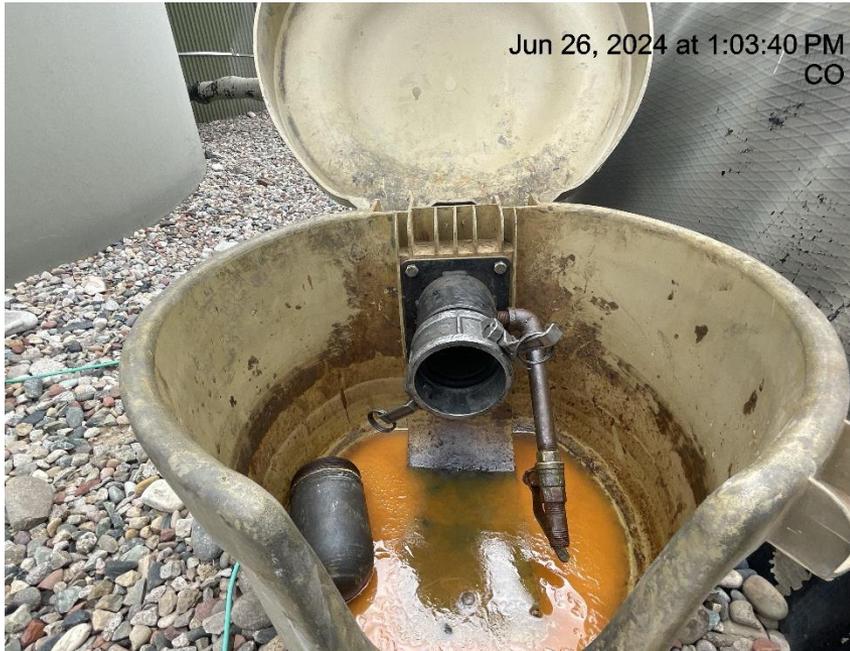
Photo # 1705 Open ended load line

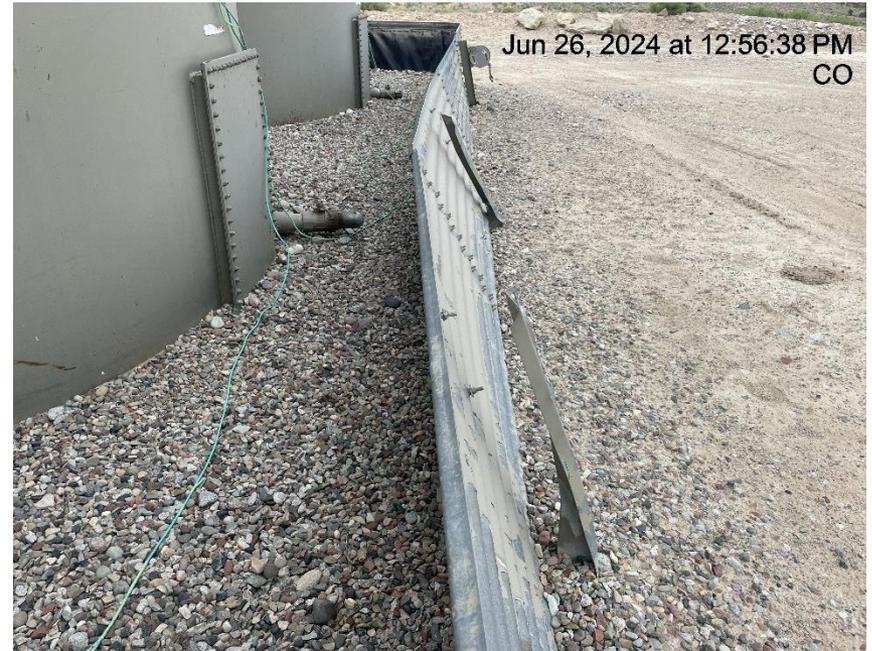
Photo # 1706 Tank containment damaged/buckling

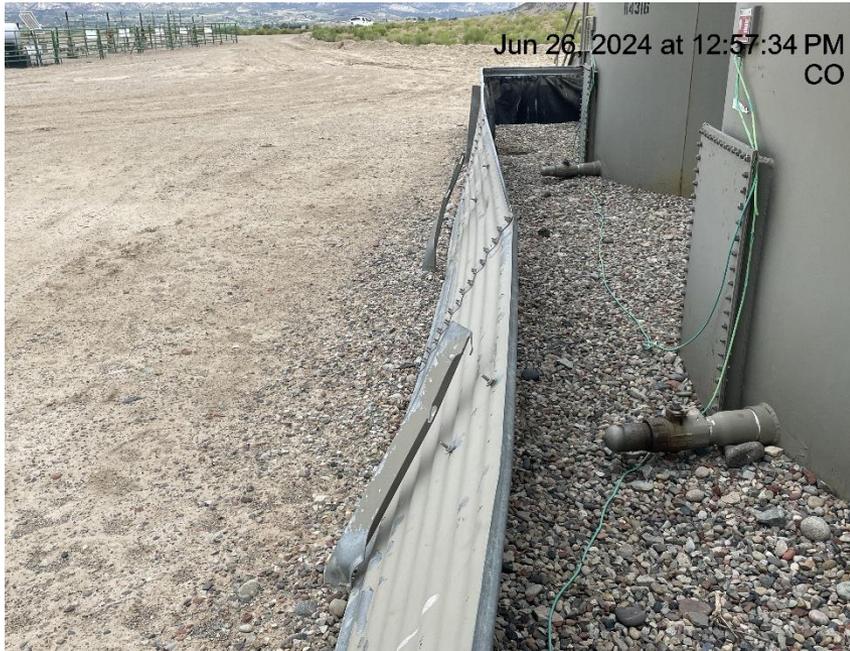
Photo # 1707 Tank containment damaged/buckling

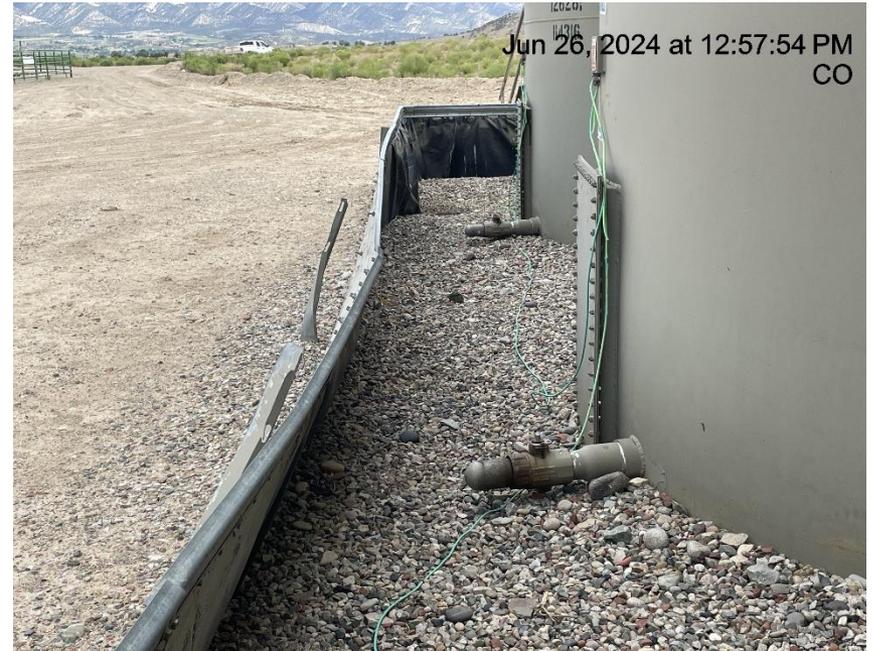
Photo # 1708 Tank containment damaged/buckling

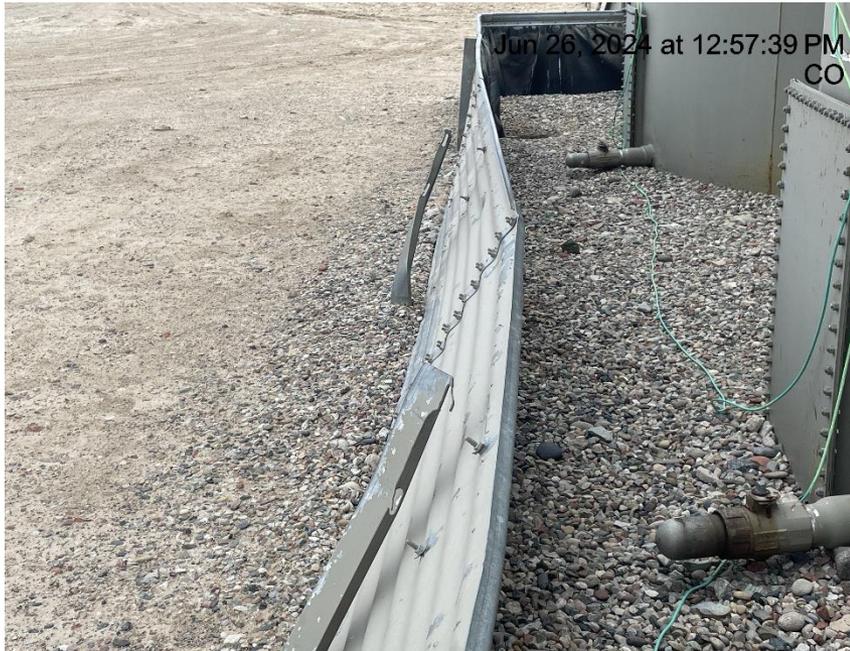
Photo # 1709 Tank containment damaged/buckling
