Interim Reclamation and Stormwater Inspection

Operator: GULF EXPLORATION LLC - #10728

Location ID: 456859

Inspection Photos
Location Name: Little Black Powder #2
Location ID: 456859

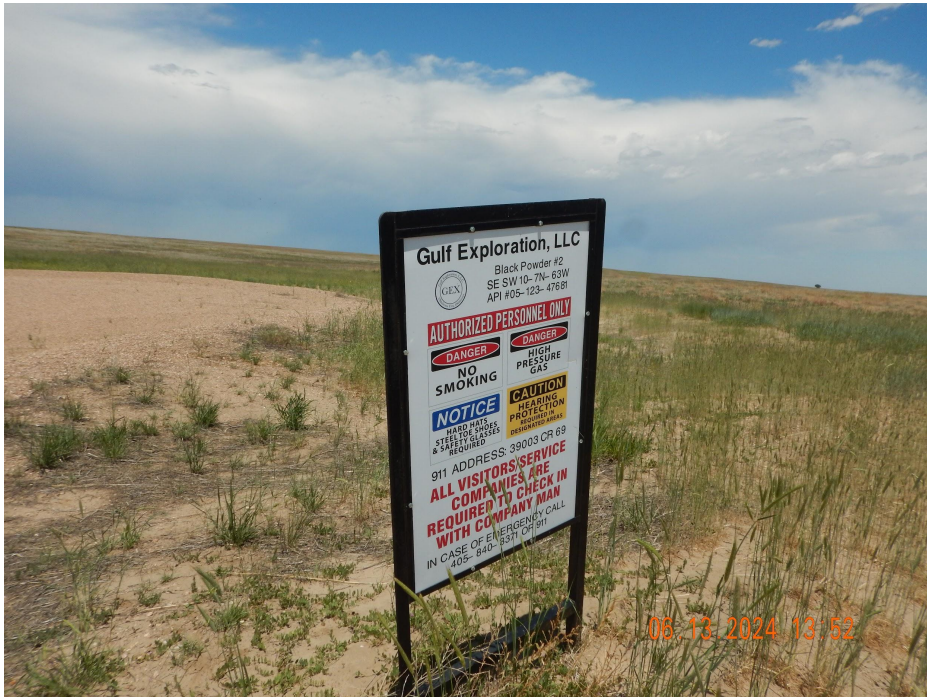
Photo 1. Photo taken from the location illustrating the Operator signage.

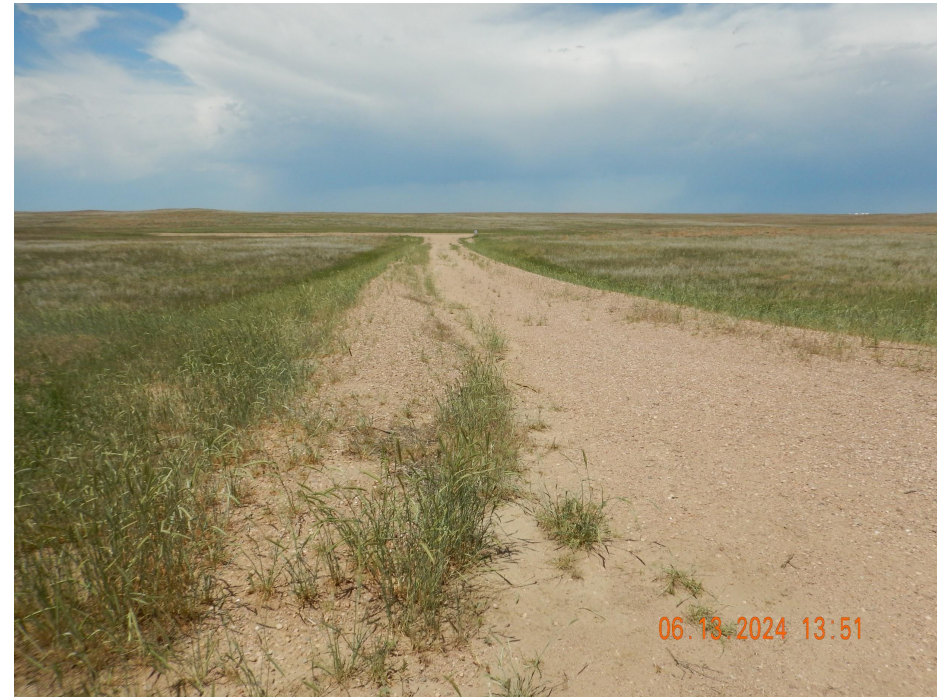
Photo 2. Photo taken from the entrance of location, facing North. Photo illustrates the access road that remains, which has an approved Commission variance.

Note- much of the vegetation growing along the access road BMP area and interim area is Cereal rye, which is not reflective of reference area vegetative conditions.

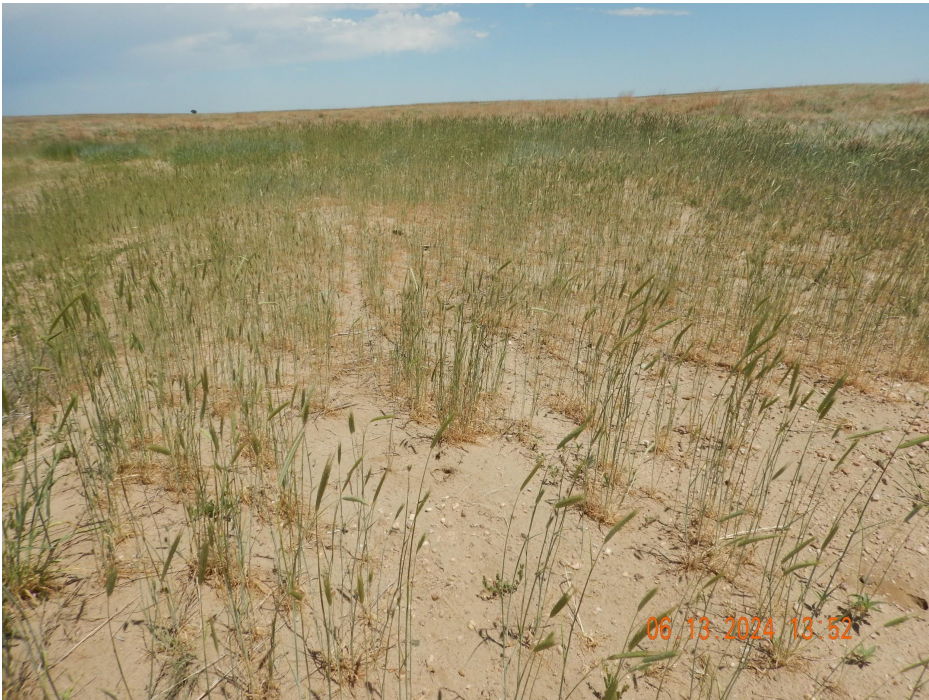
Photo 3. Photo taken from the eastern interim area, facing East. Photo illustrates the interim area is dominated by Cereal rye, which is not reflective of reference area vegetative conditions.

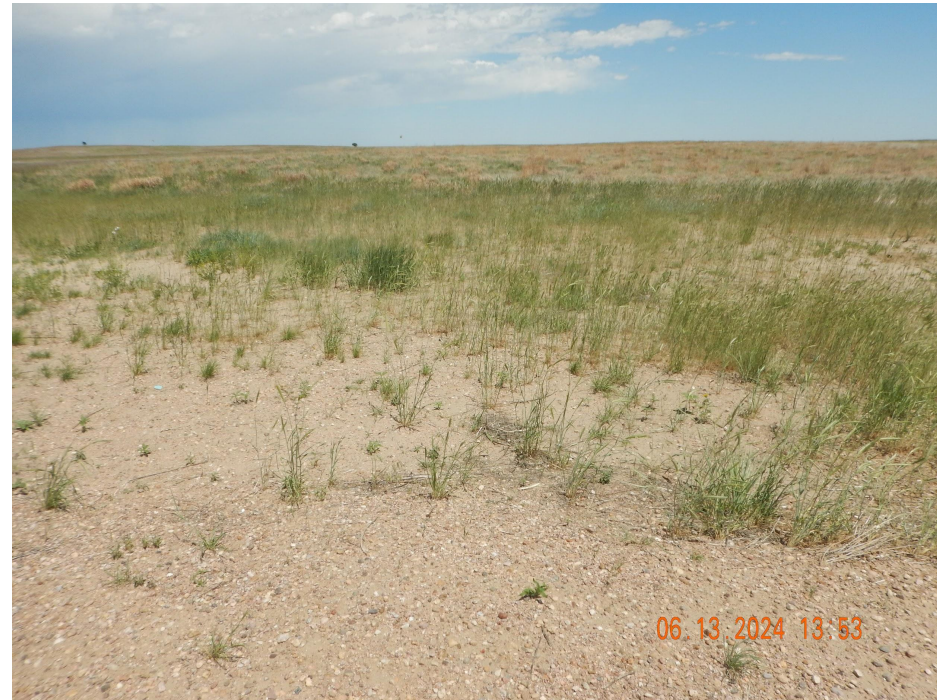
Photo 4. Photo taken from the eastern interim area, facing North. See comments under Photo 3.

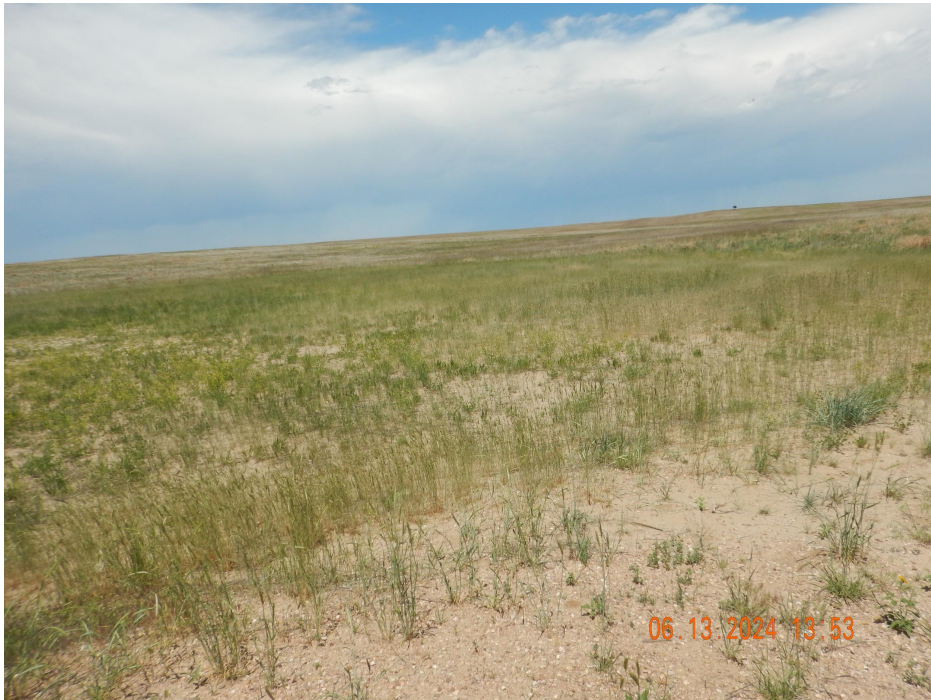
Photo 5. Photo taken from the northeastern interim area, facing Northeast. See comments under Photo 3.

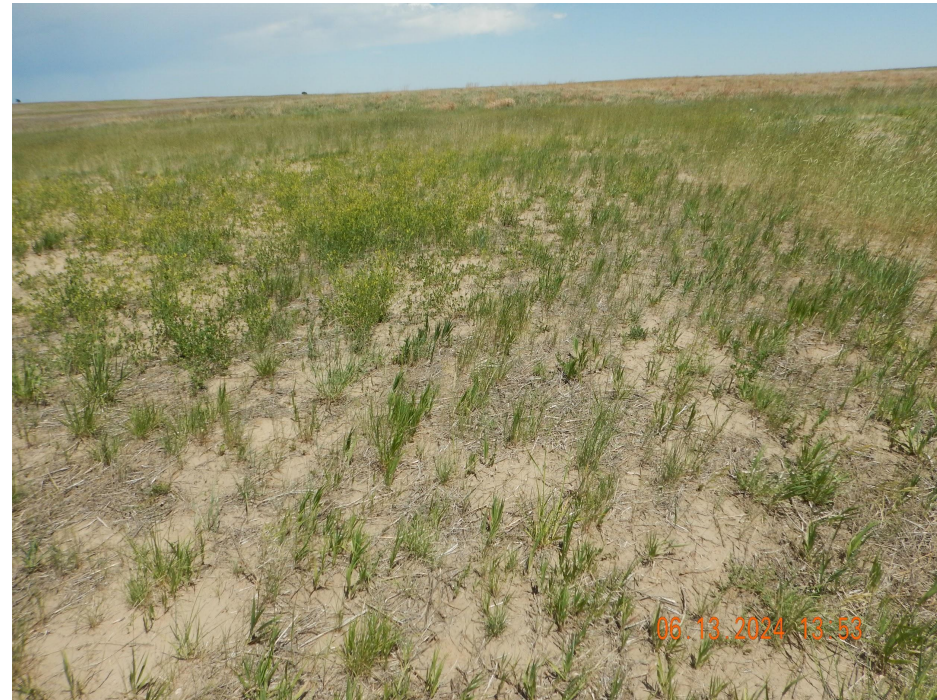
Photo 6. Photo taken from the northern interim area, facing East. See comments under Photo 5.

Note- there are other grass species observed within portions of the northern interim area but are introduced plant species like Smooth brome.

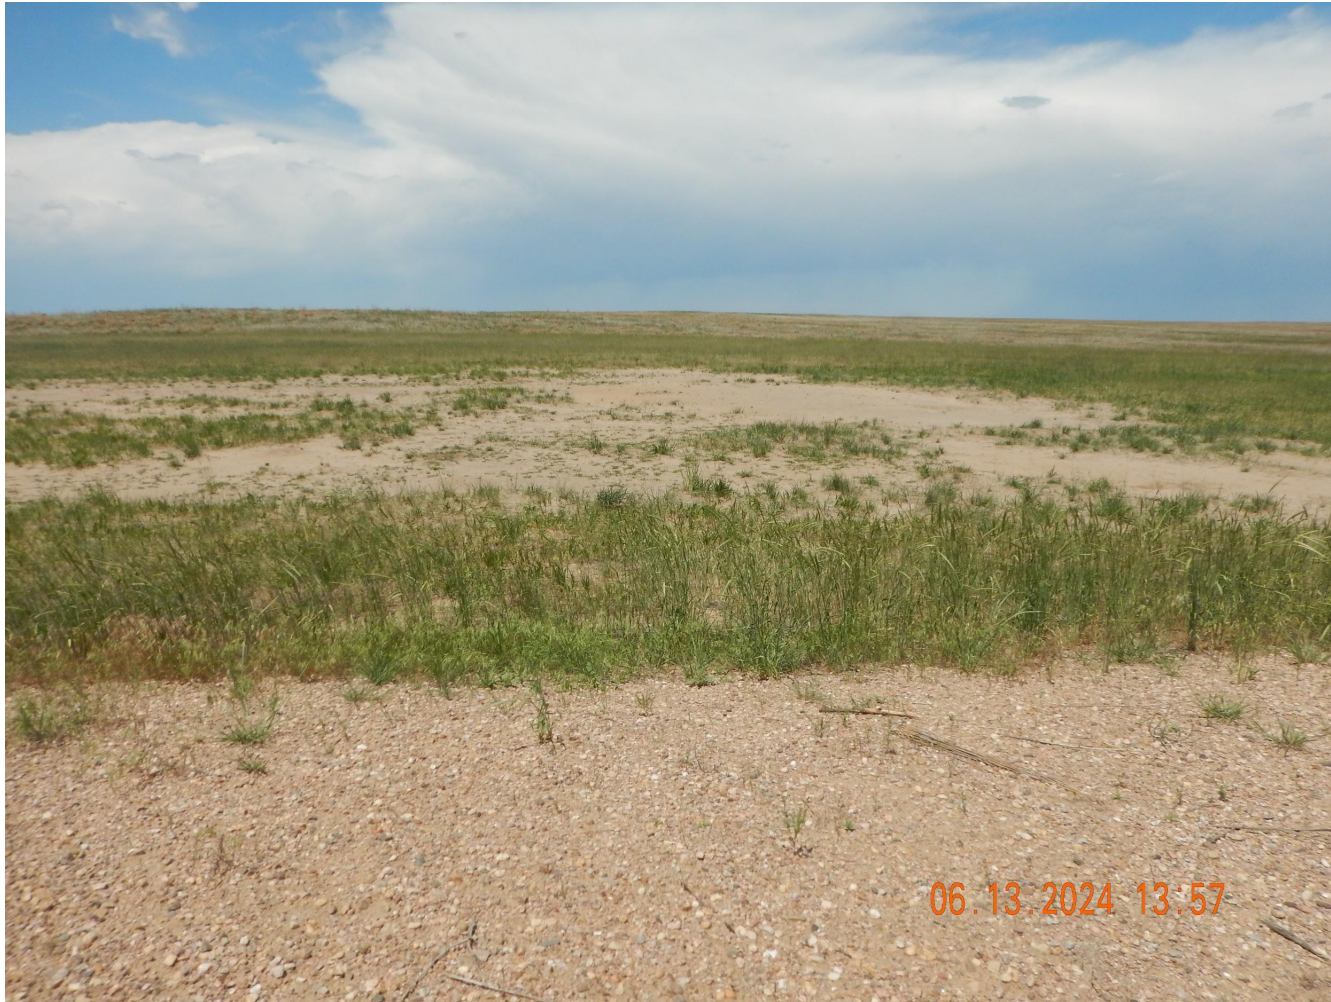
Photo 7. Photo taken from the northern interim area, facing North. Photo illustrates bare patches with no vegetation establishment.

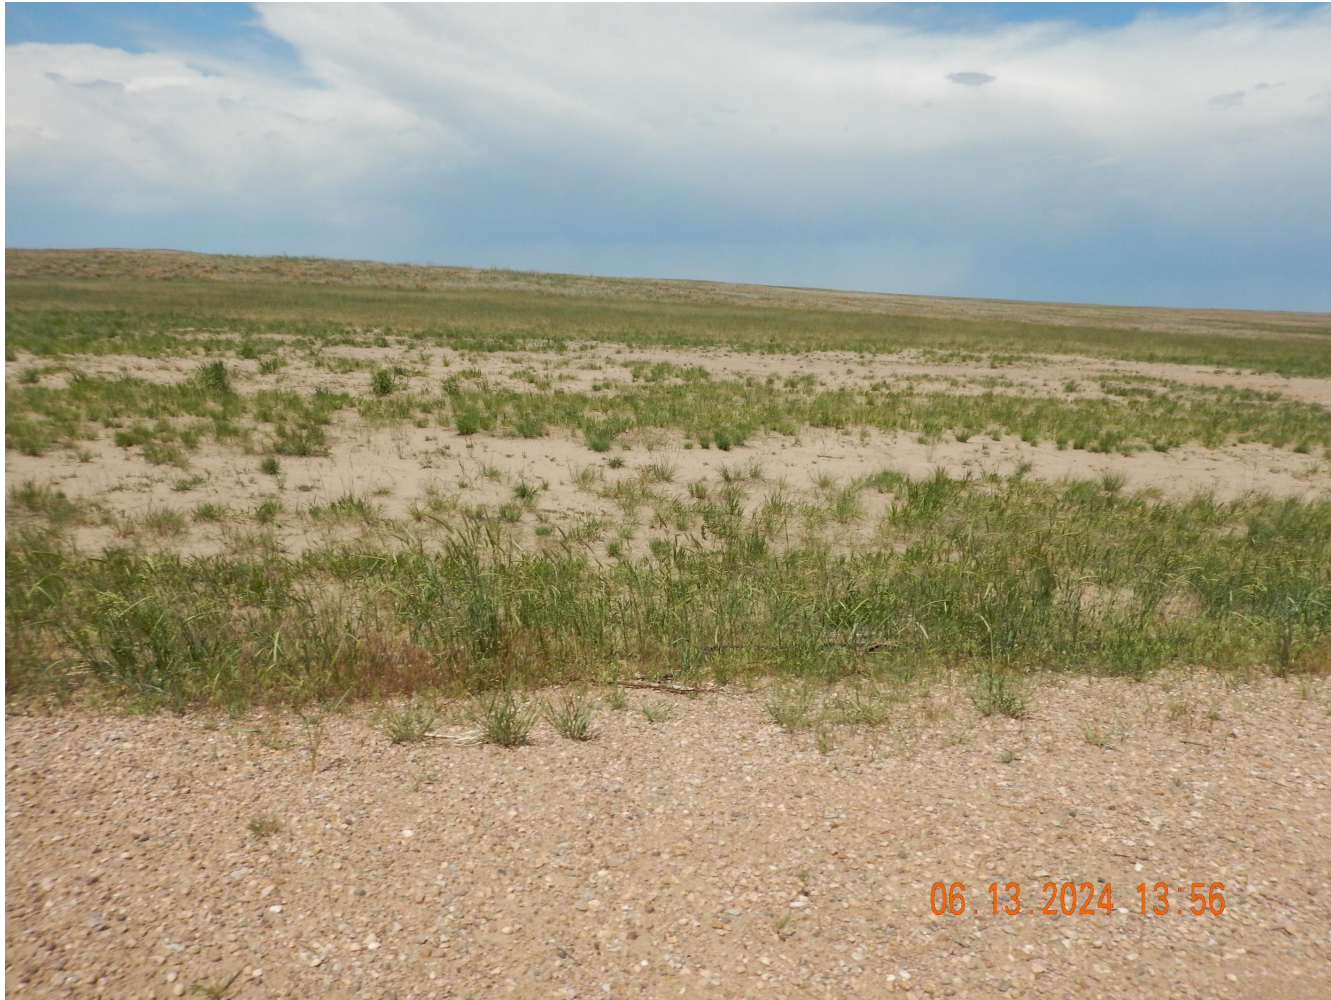
Photo 8. Photo taken from another portion of the northern interim area, facing North. See comments under Photo 7.
