# Inspection Photos

**Operator:** PETROLEUM RESOURCE  
MANAGEMENT CORP - 10421

**Location ID:** 485573

**Inspection Doc:** 696205931

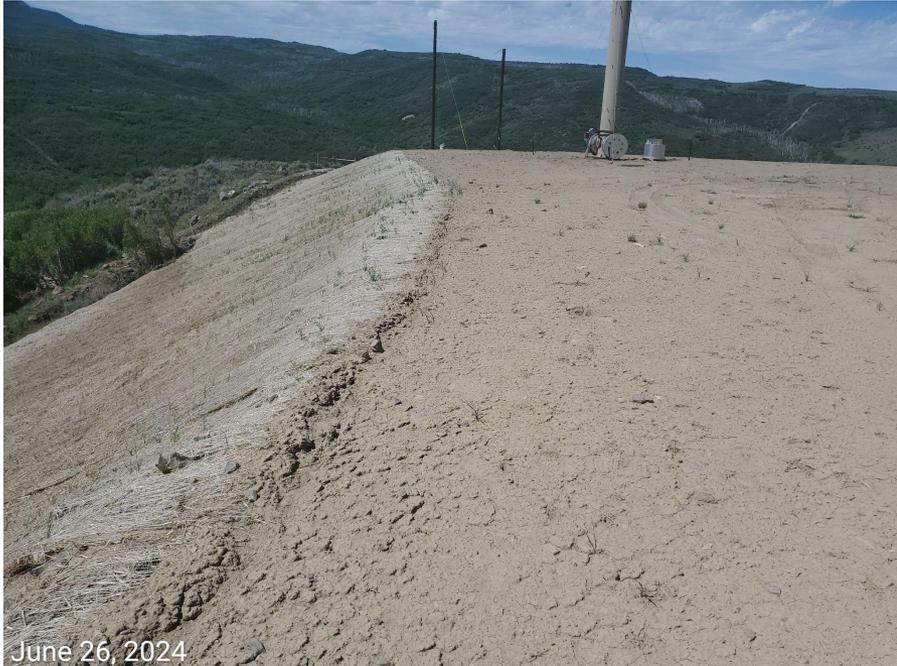
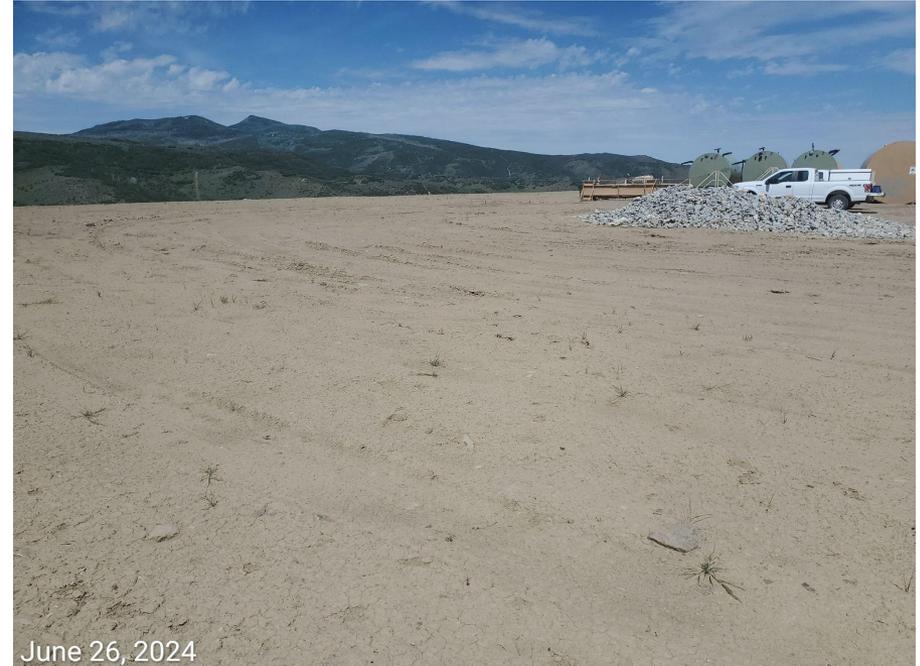
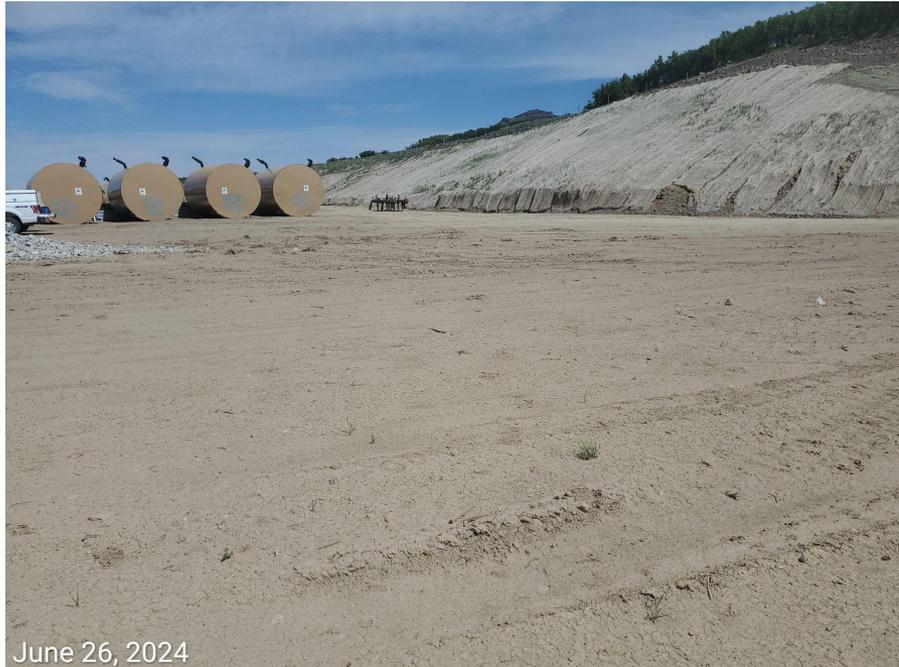
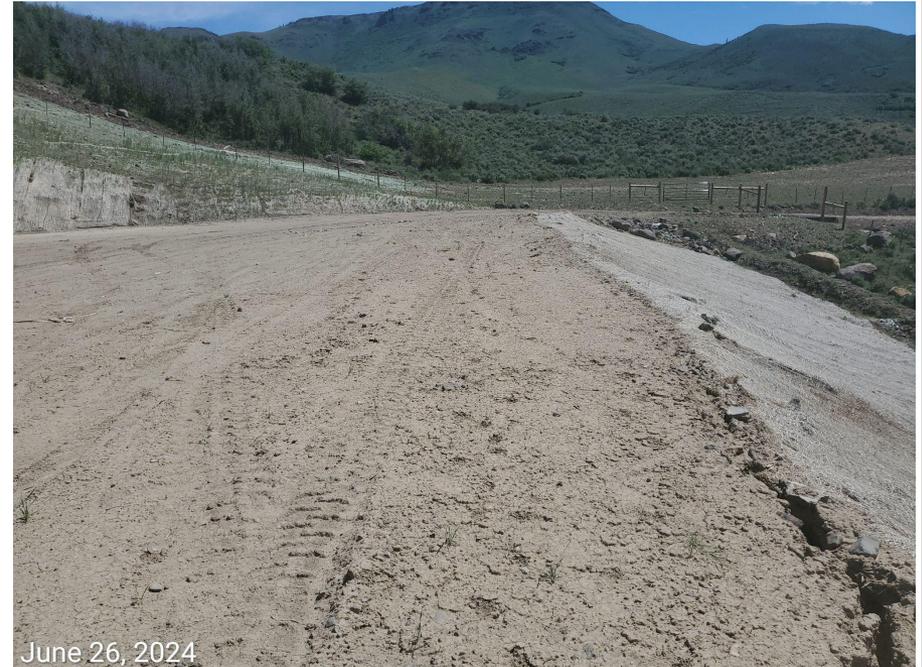
**Photo 1:** Photos 1-2 taken from the southeastern end of the Location's working pad surface west end of the Location. Photos provide an overview of the Location from southwest, northwest, north to northeast.

**Photo 2:** See comments under photo 1.

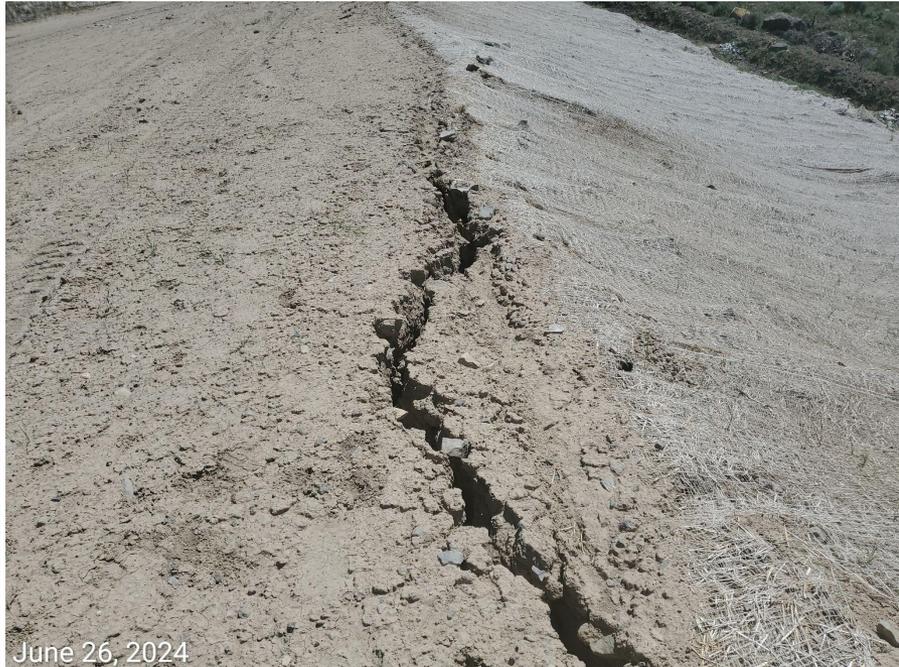
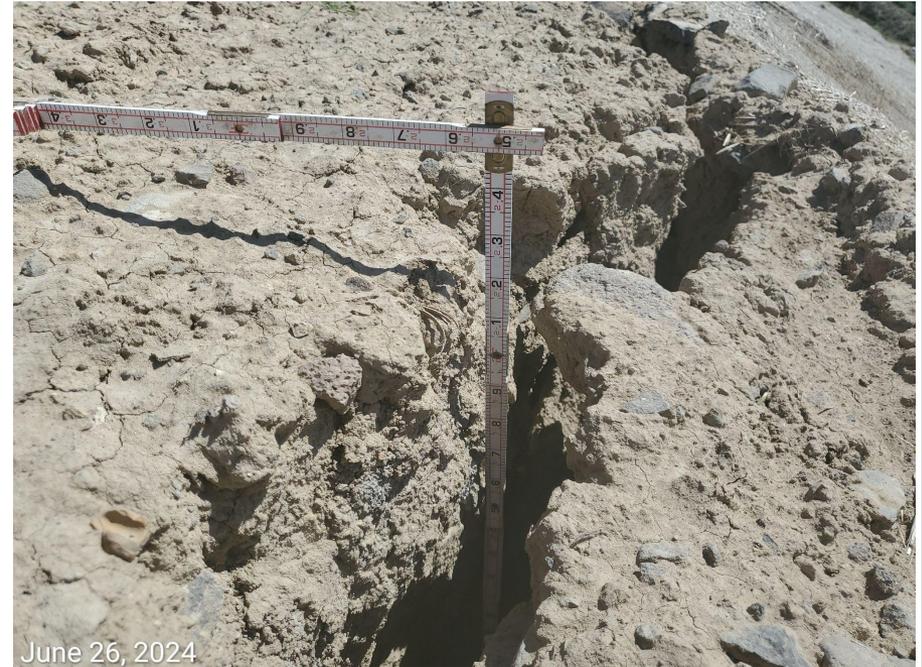
**Photo 3:** Photos taken from the southeastern edge of the working pad surface. Photo shows ~2 foot deep cracks forming on the Location.

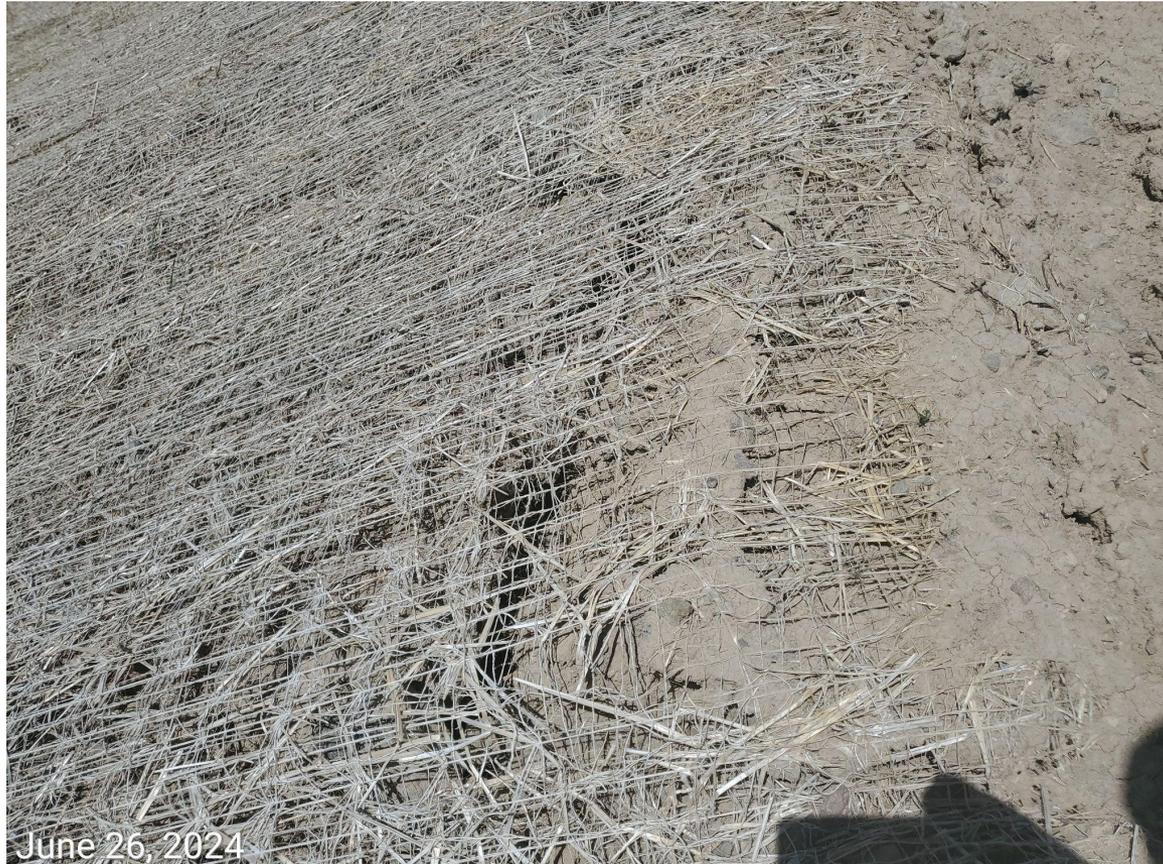
**Photo 4:** Continued from photo 3. Cracks also evident within the fill slopes. Soil migration and stabilization concerns exist.

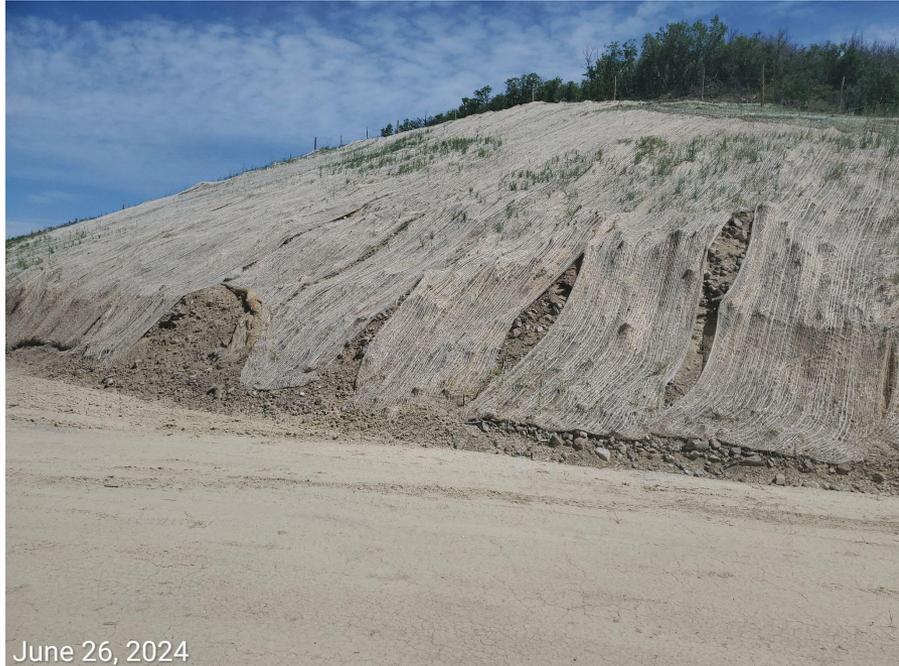
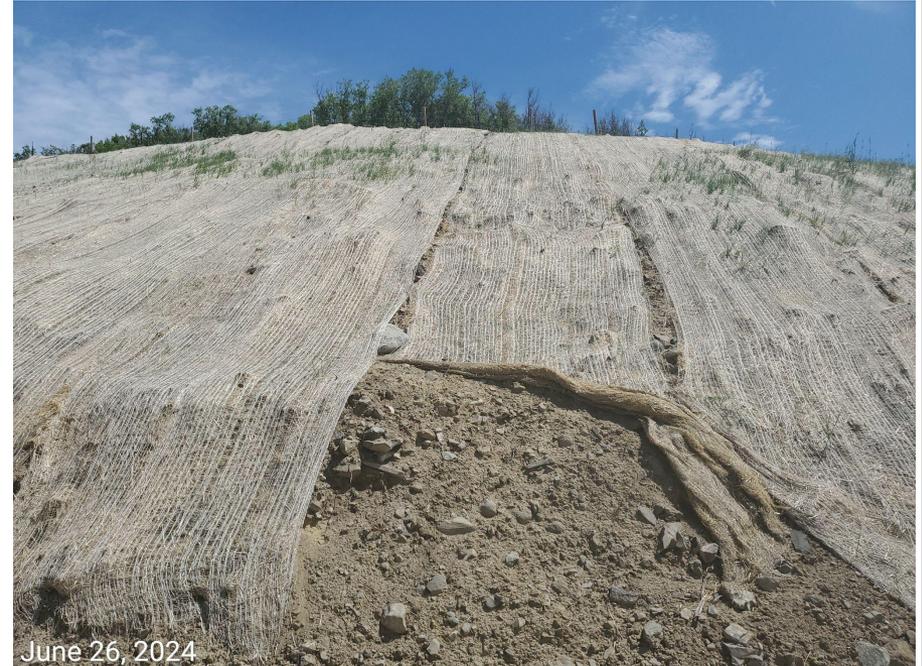
**Photo 5:** Photos taken from the cut slopes on the east end of the Location. Operator has implemented erosion blankets on the cut and fill slopes of the Location; blankets have not been installed or maintained in proper functioning condition; blankets have not been properly overlapped, have been secured with metal stakes rather than wooden or biodegradable stakes, and are not in full contact with the soil; erosion, degradation and sediment transport observed.

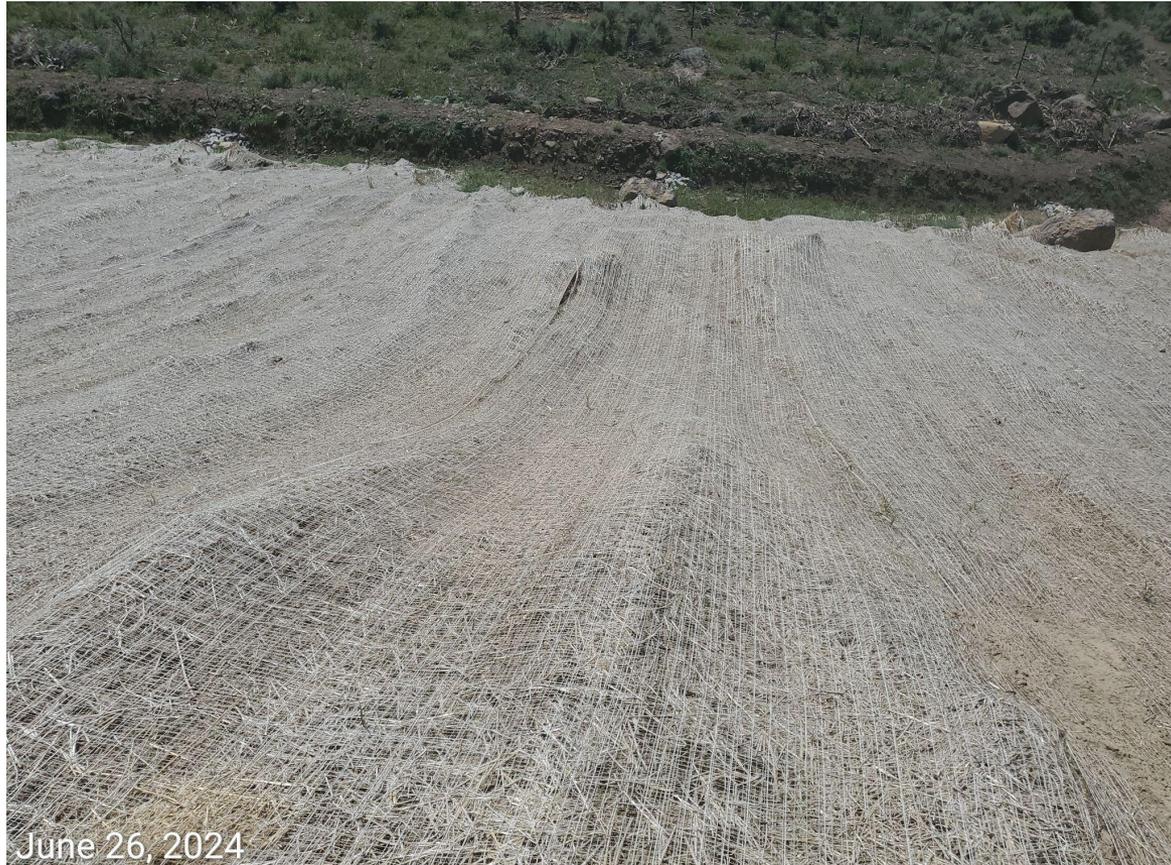
**Photo 6:** See comments under photo 5. Erosion blankets on the cut and fill slopes are not in full contact with the soil; erosion, degradation and sediment transport observed.

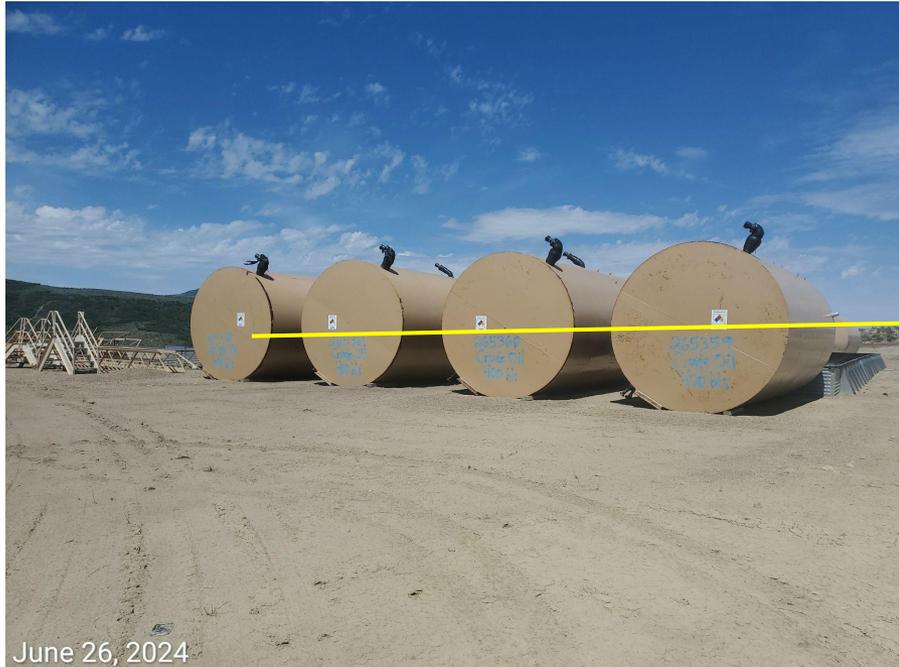
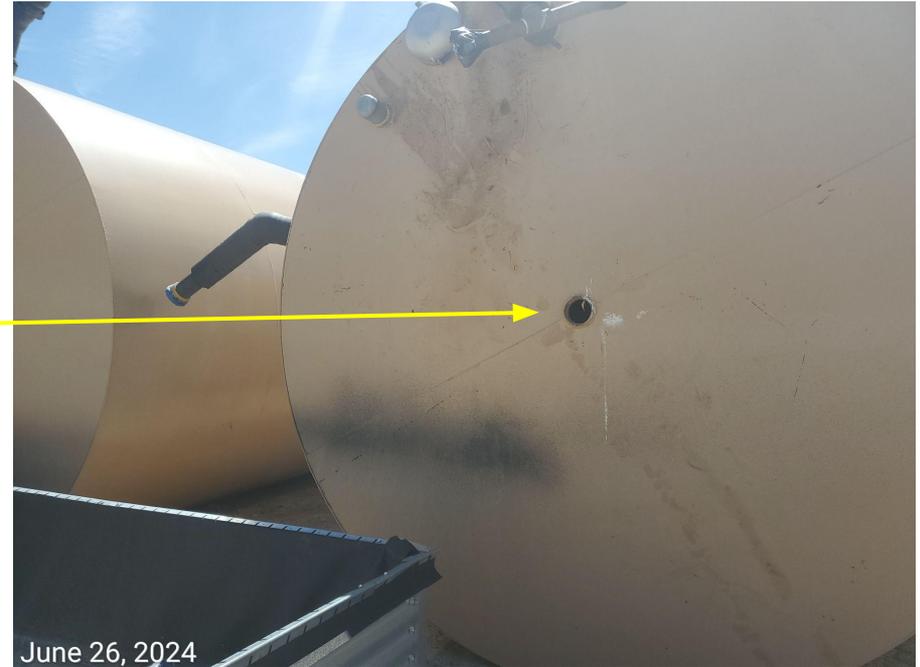
**Photo 7:** Photo right shows tank on Location missing proper covering, or other BMPs to prevent access by wildlife, including birds and bats.

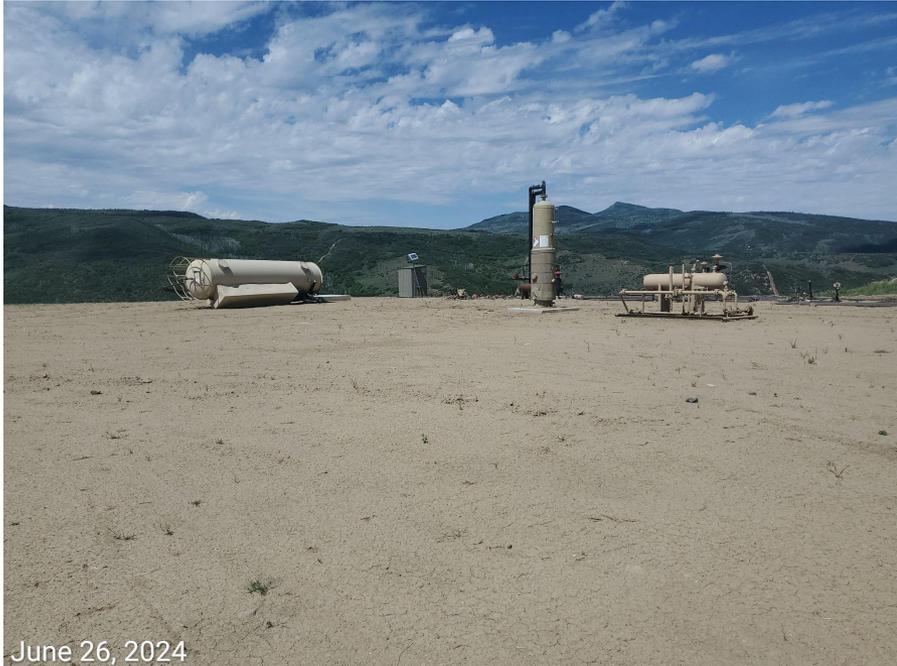
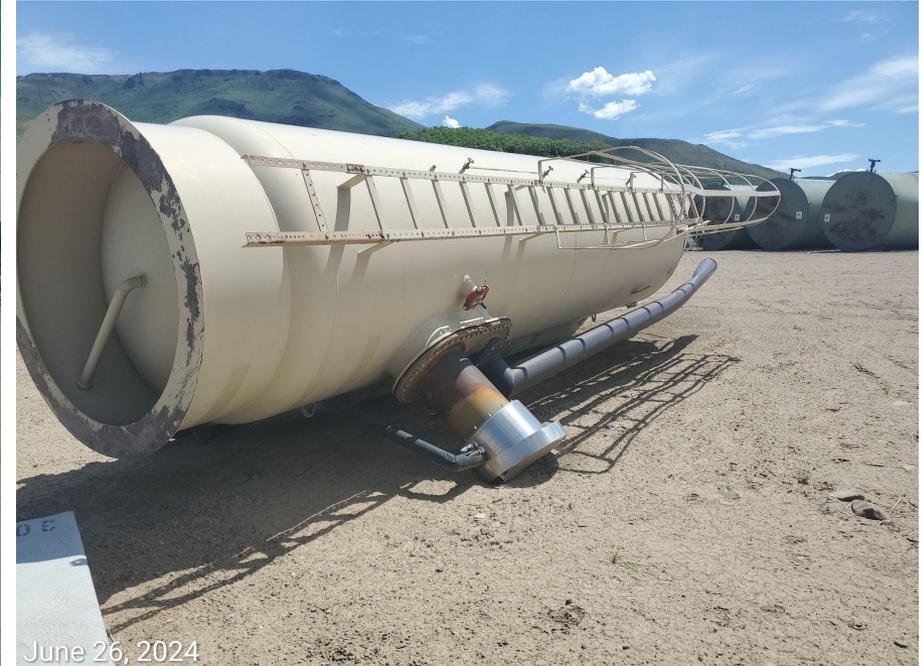
**Photo 8:** Photos taken from the west end of the Location. Photo shows vertical heater treater that was not properly secured down, and has since been “blown over”. Damage to the equipment evident.

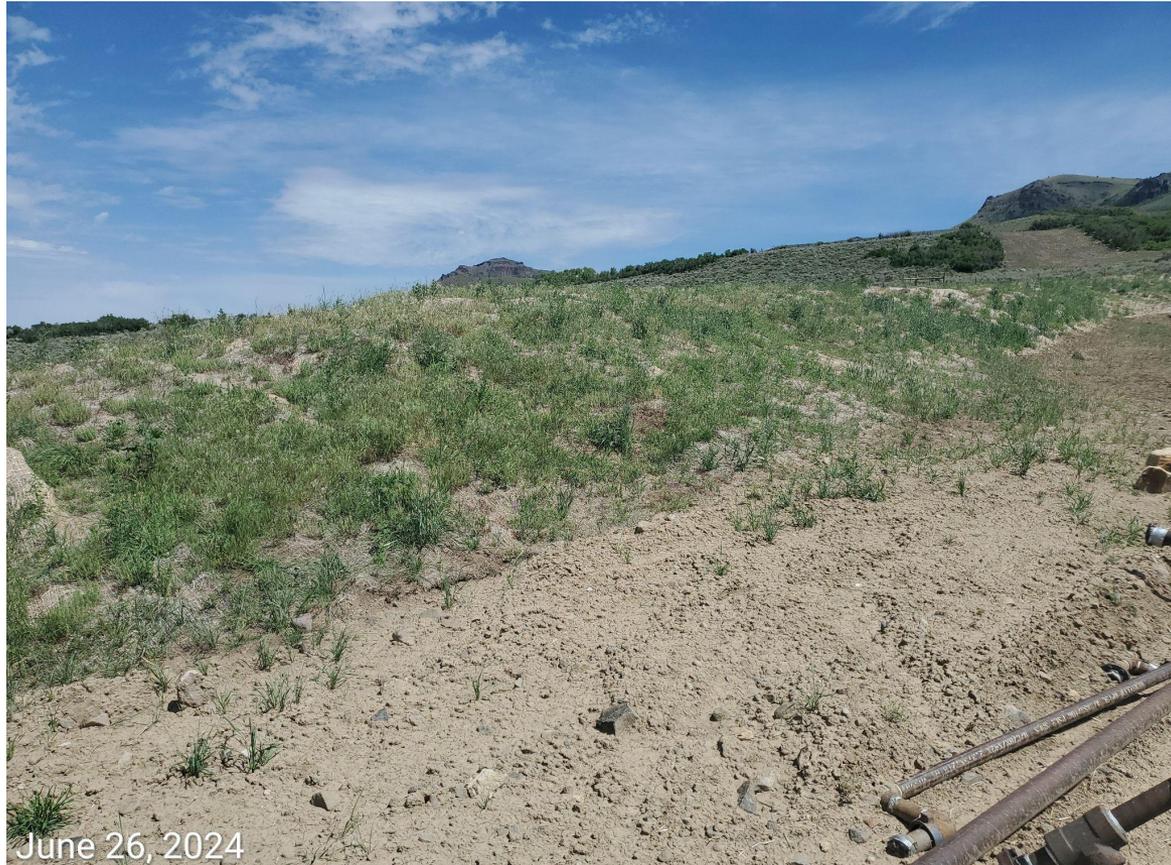
**Photo 9:** Photos taken from the topsoil stockpile on the north end of the Location. Weed establishment (Cheatgrass) observed.

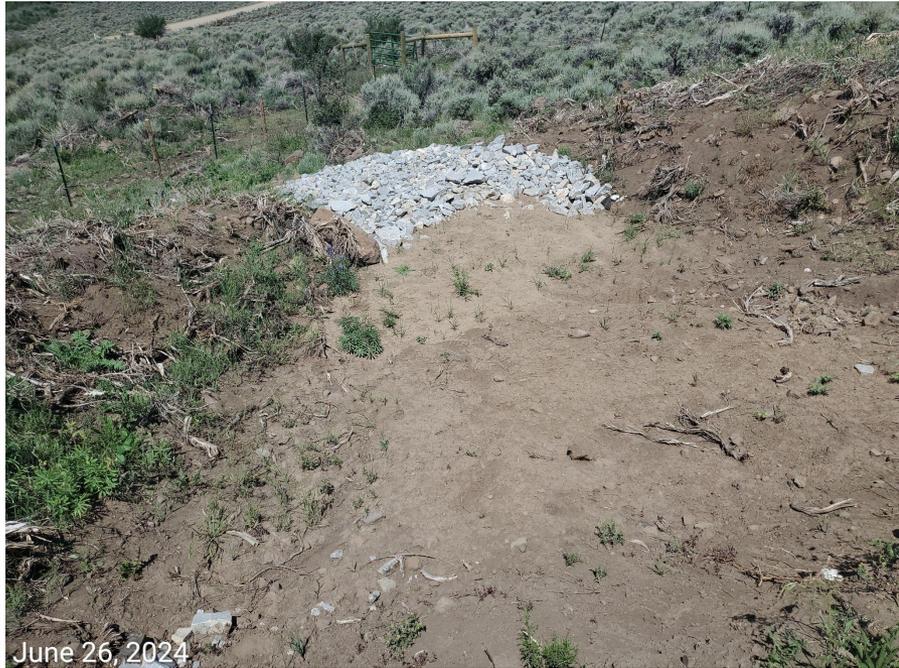
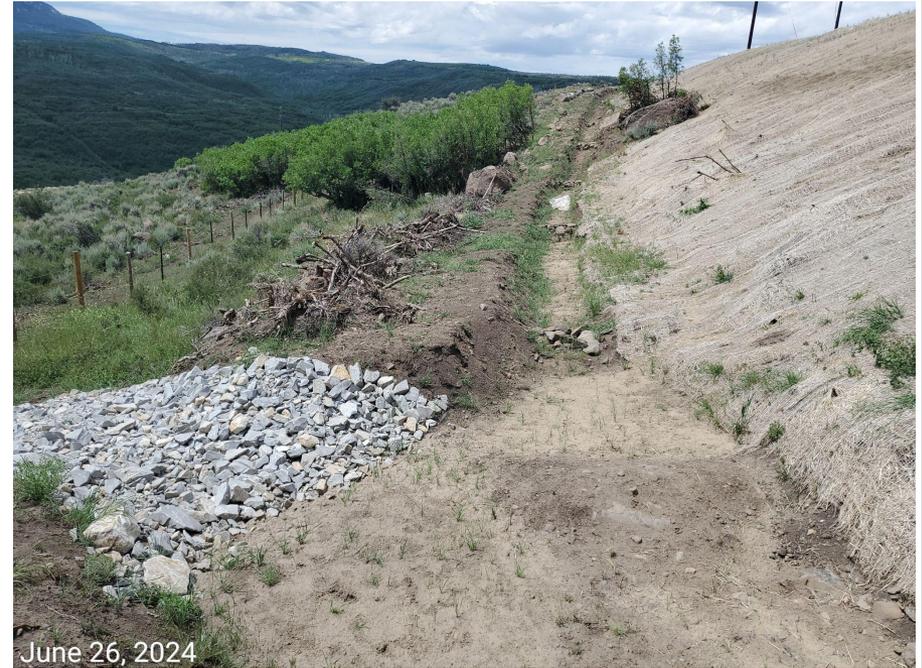
**Photo 10:** Photos show the 2 outlets from the stormwater diversion ditch on the northwestern and southeastern ends of the Location. BMPs have not been constructed in conjunction with sediment traps to allow for sediment drop out prior to stormwater discharging from the Location. Photos also shows the BMPs (Including the ditch/berm) have been constructed with topsoil material. Sediment (lighter soils) due to erosion from the fill slopes observed comingling with the topsoil.

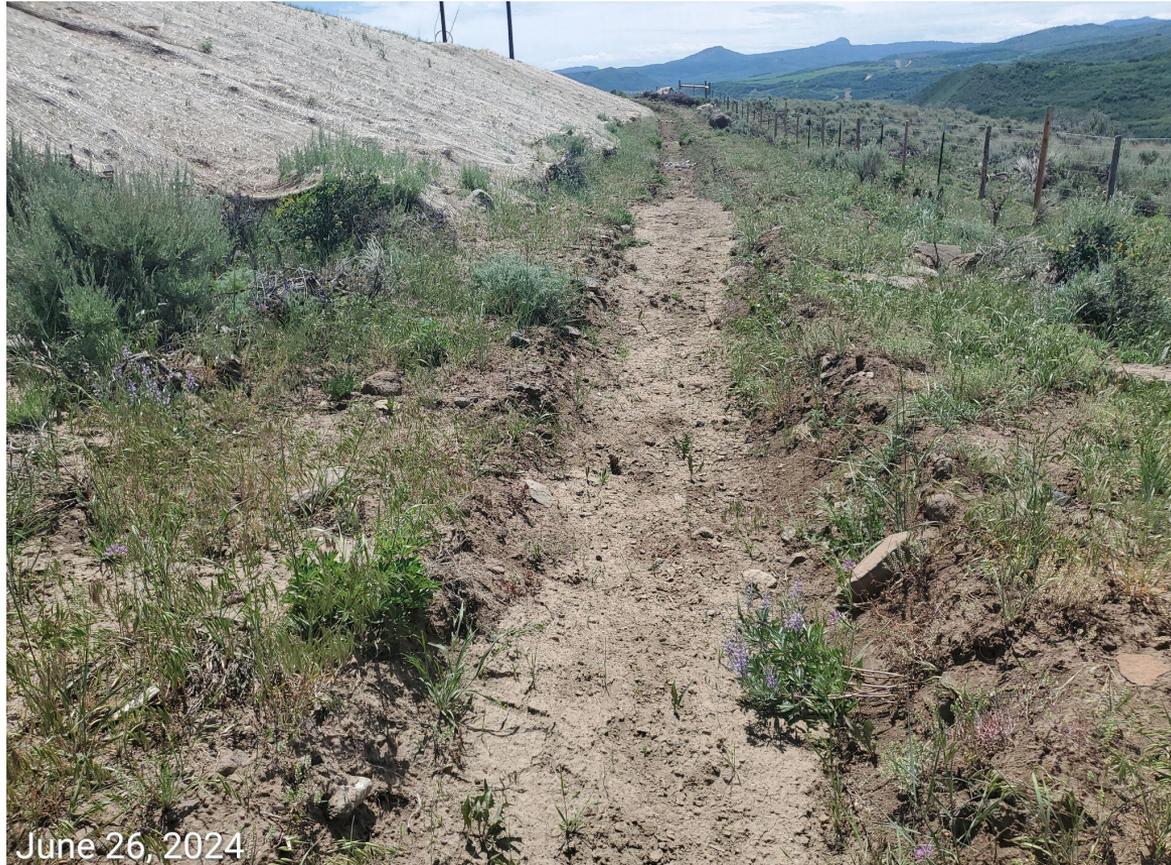
**Photo 11:** Photos taken from the stormwater diversion ditch on the west end of the Location. Photo shows sediment due to erosion from the fill slopes have filled the ditch.

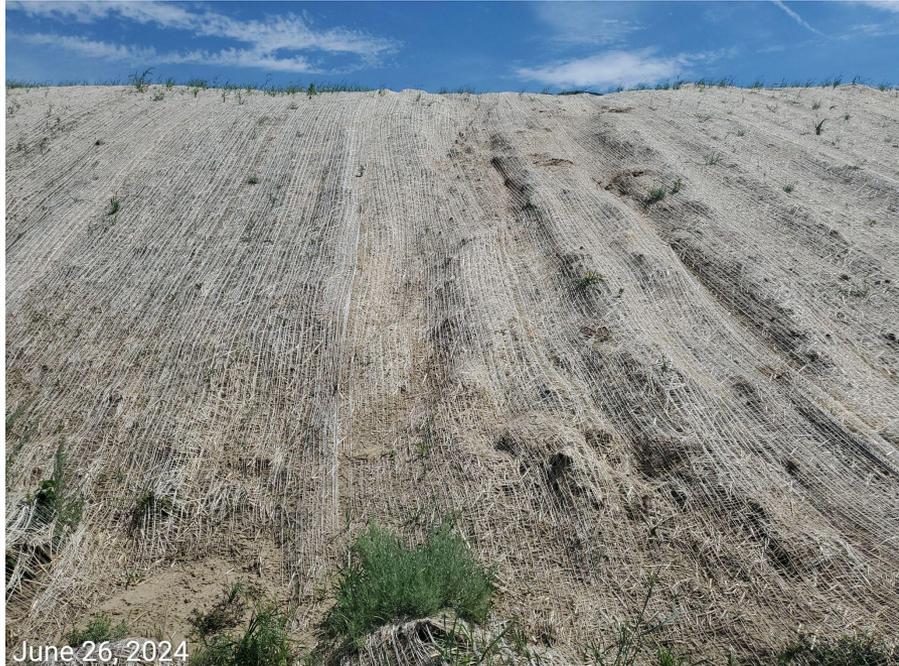
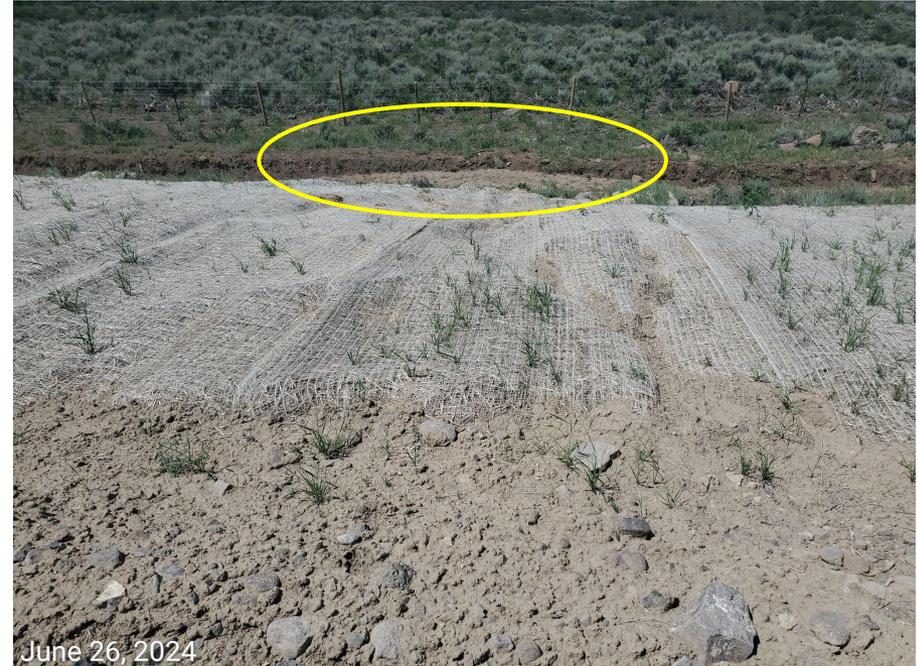
**Photo 12:** Photos examples showing erosion degradation occurring at the fill slopes of the Location. Lighter soil (circle) is sediment deposition due to erosion (see photo 11)

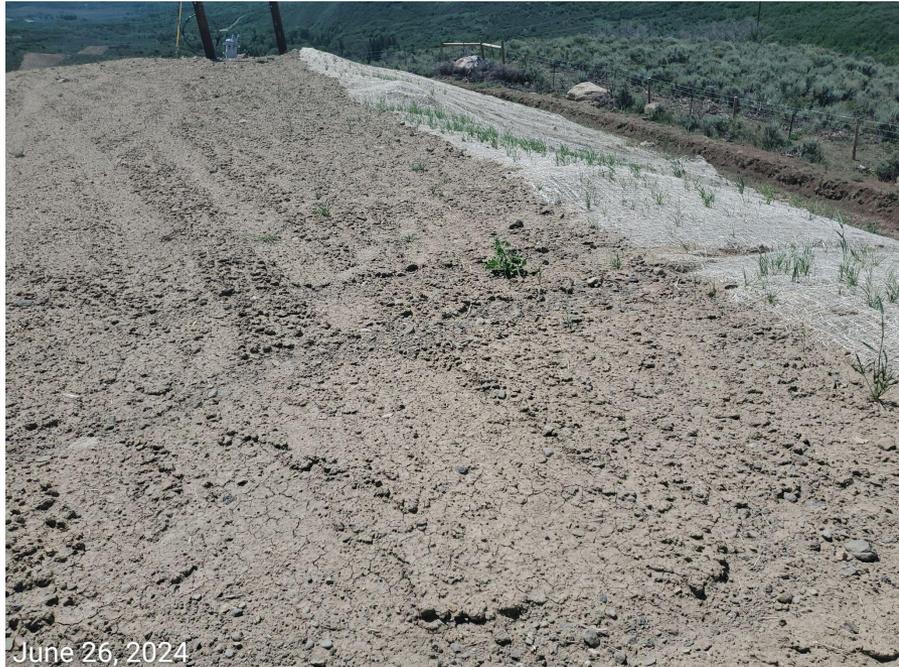
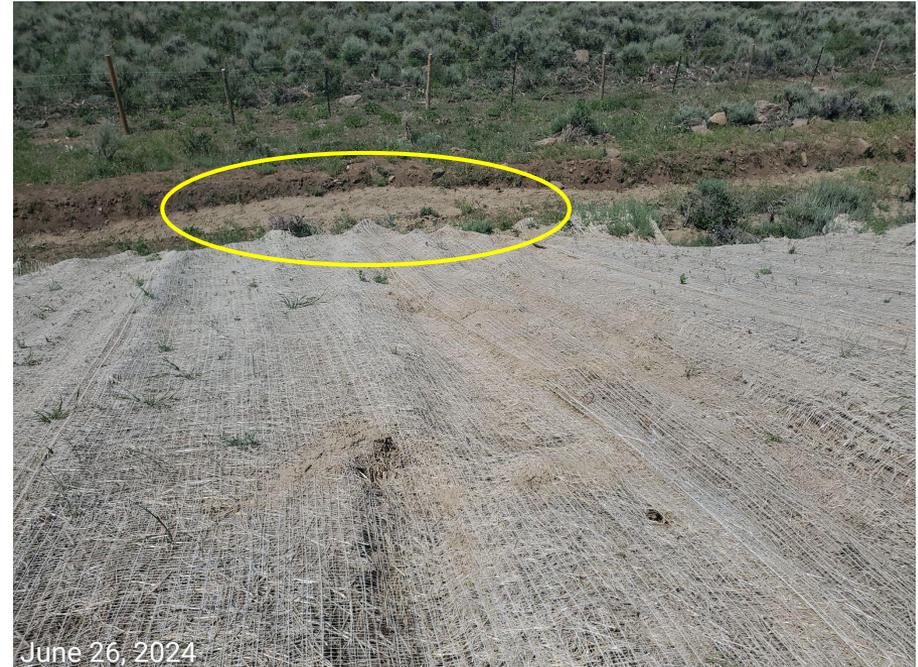
**Photo 13:** Photos examples showing erosion degradation occurring at the fill slopes of the Location; BMPs to manage runoff from the pad missing or insufficient. Lighter soils (circle) is sediment deposition due to erosion.

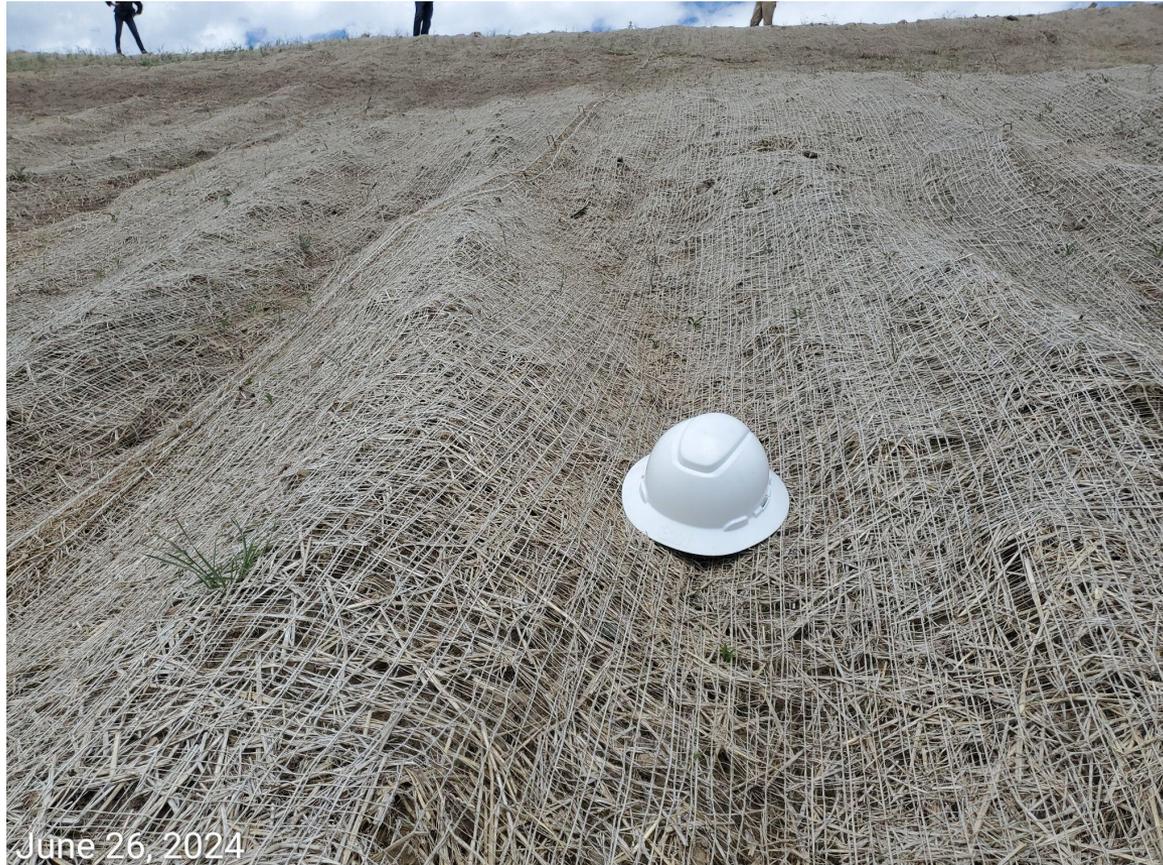
**Photo 14:** Photo example show what appear to be gullies beneath the erosion blankets. Hard-hat for reference.

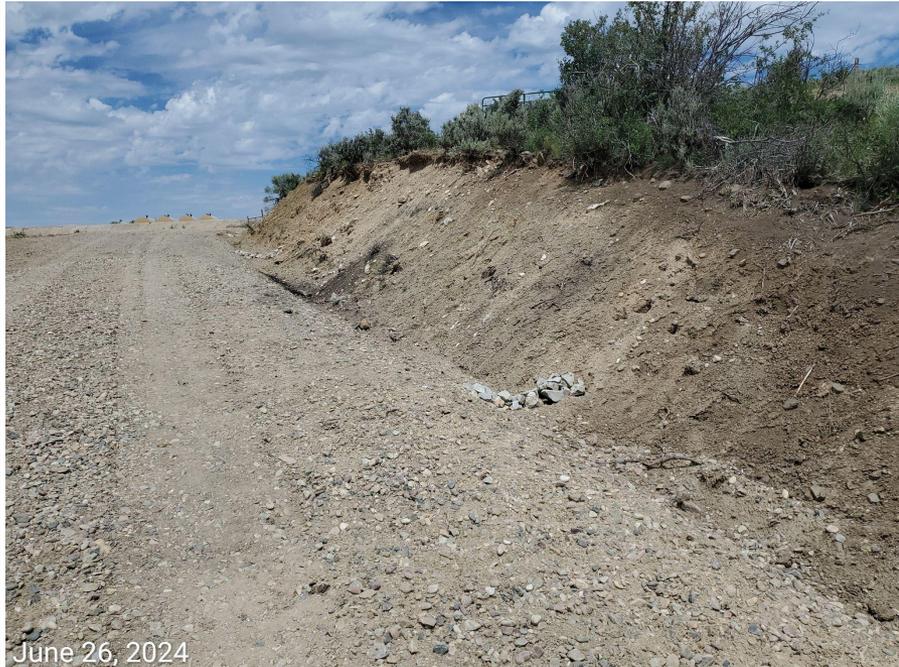
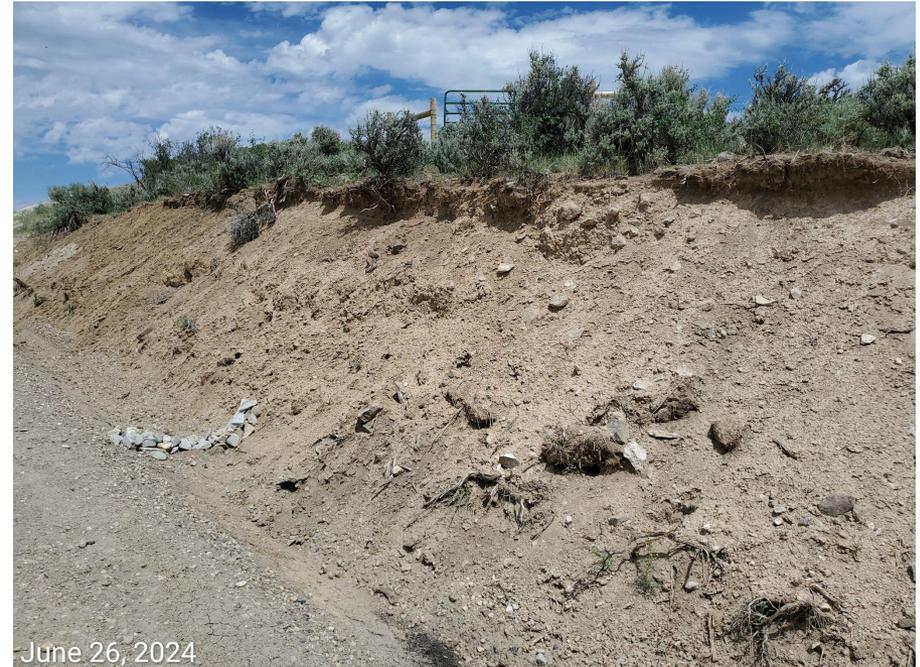
**Photo 15:** Photos taken from the access road. BMPs to minimize erosion, degradation and sediment transport missing or insufficient along slopes of the access road.

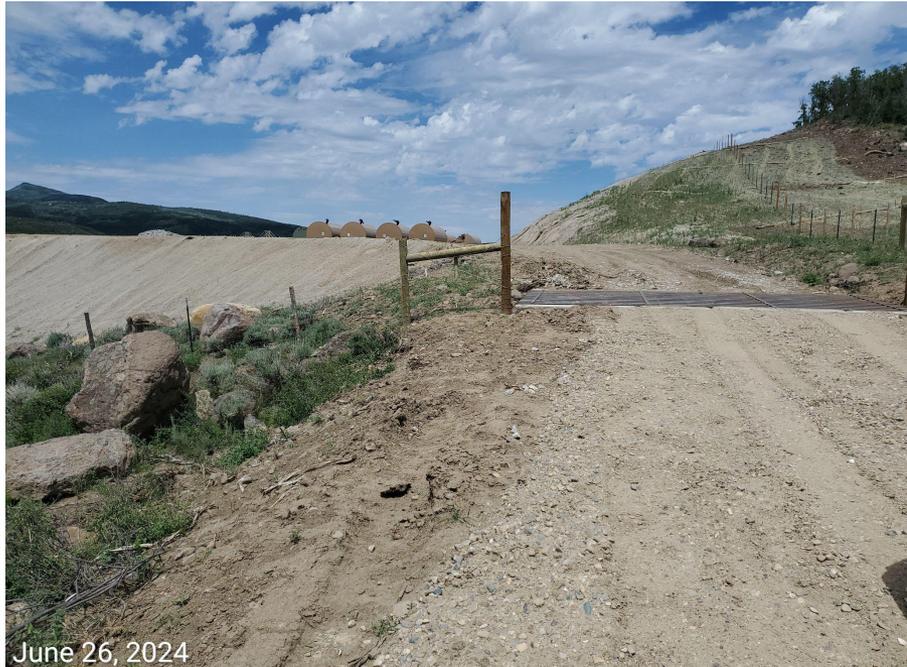
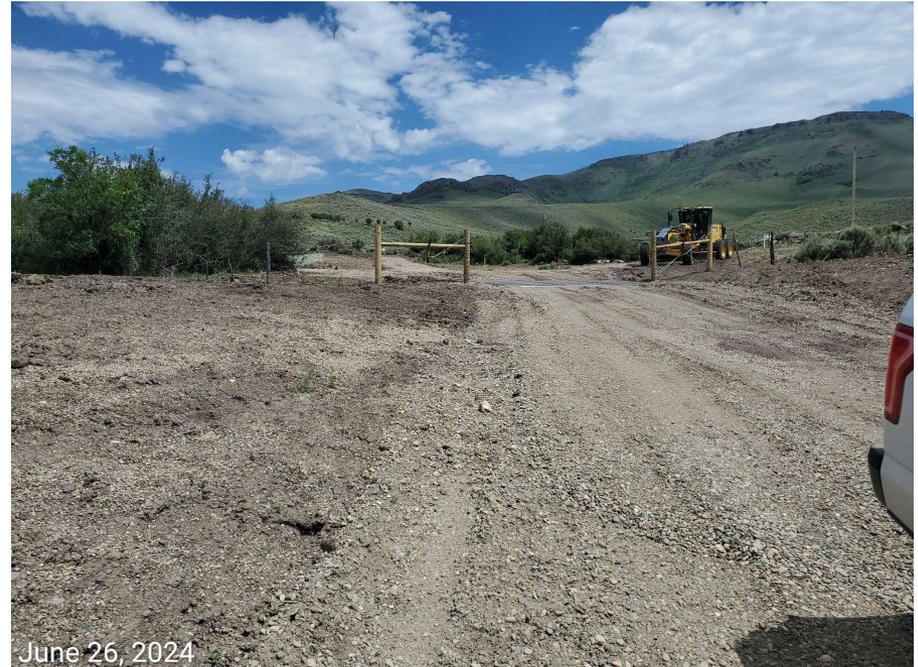
**Photo 16:** Photos show signage missing from the Location entrance and access road.

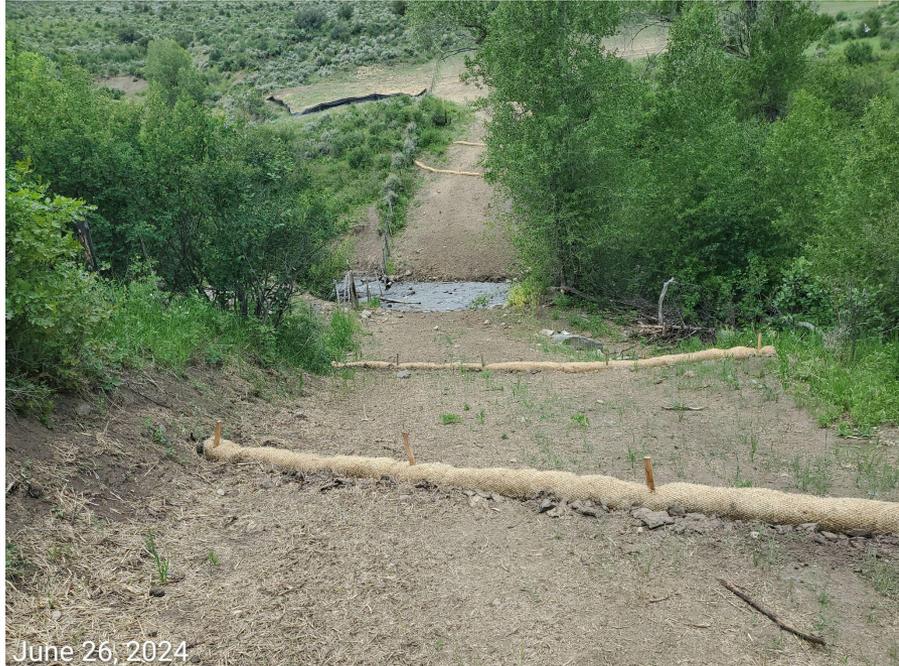
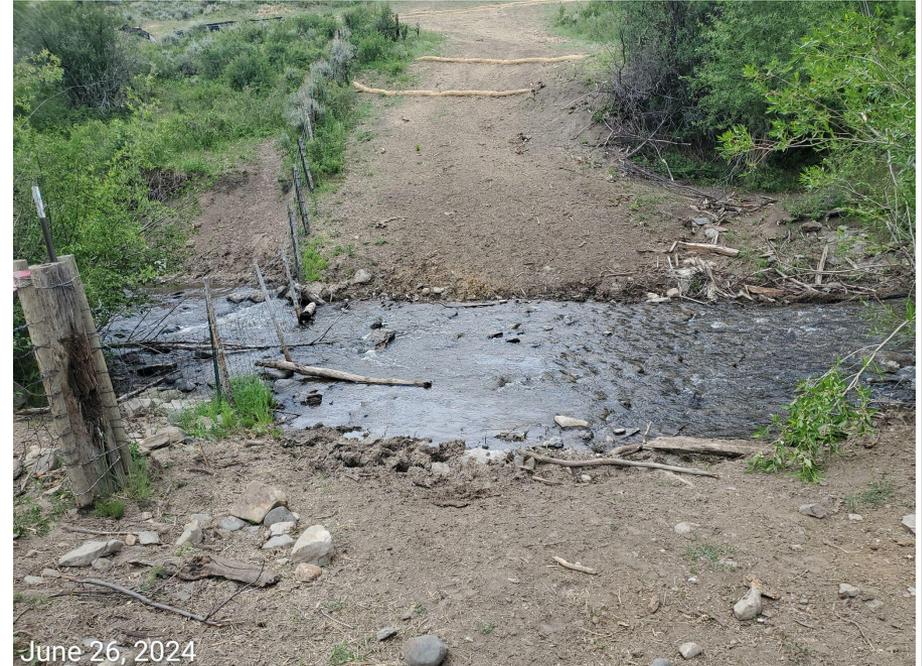
**Photo 17:** Photos taken from the access road and stream crossing associated with the Flowline System construction. Previous inspection identified stream as “Slater Creek”; CORRECTION-this crossing is located ad “Beaver Creek”, approximately ¼ mile upstream from Slater Creek. Photos show road has not been constructed with a properly engineered stream cross.

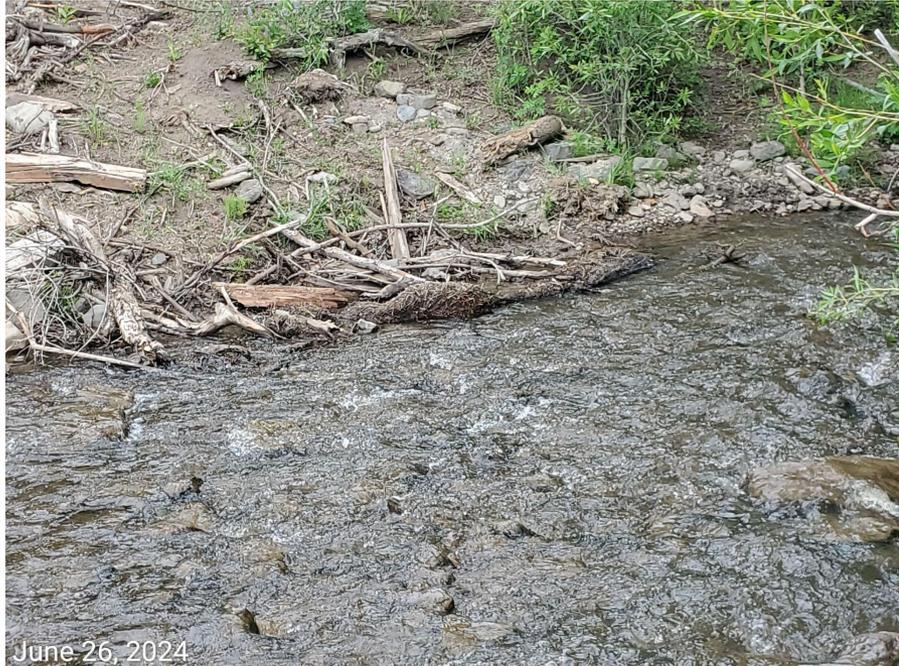
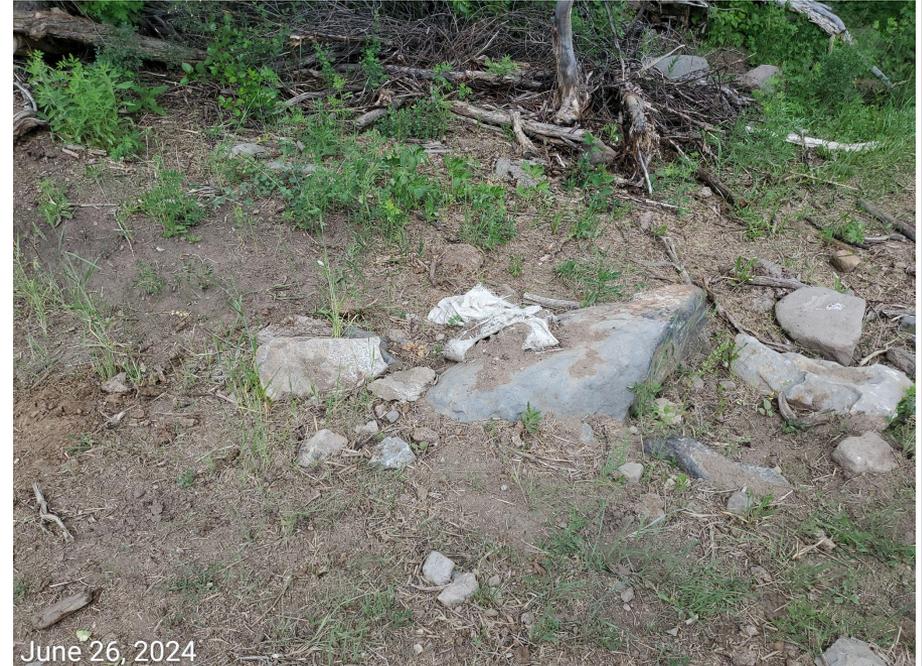
**Photo 18:** Photos show trash/debris along the access road, including a degraded erosion log within the stream.

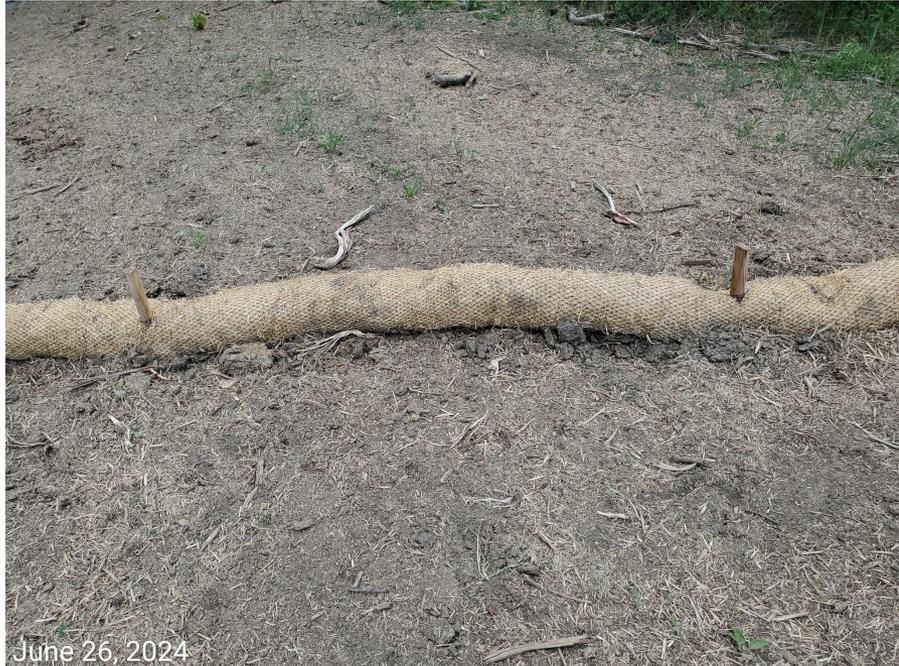
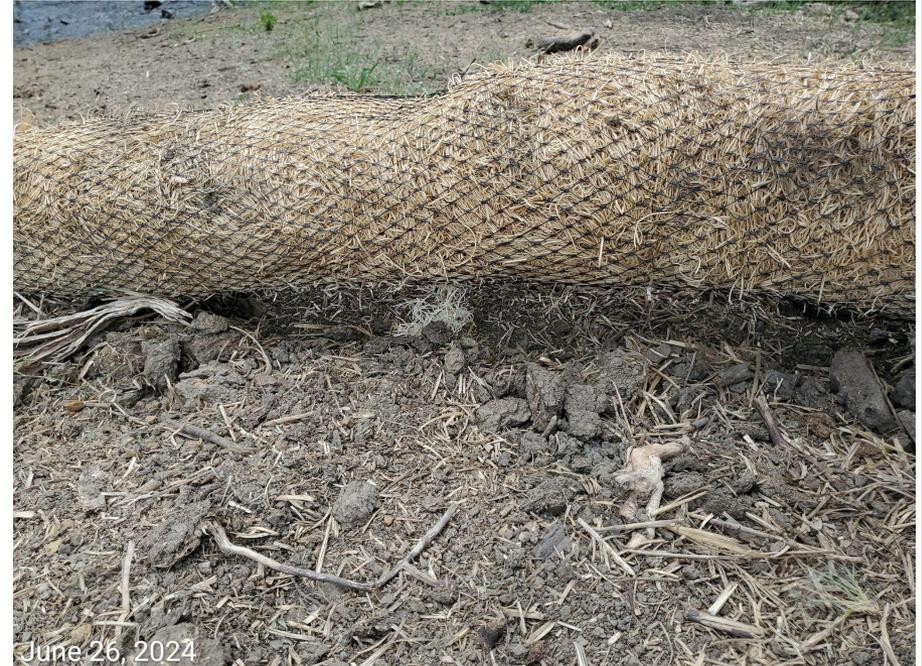
**Photo 19:** See comments under photo 17. Photos example showing erosion logs that have not been installed or maintained in accordance with good engineering practice.
