# Inspection Photos

**Operator:** PETROLEUM RESOURCE  
MANAGEMENT CORP - 10421

**Location ID:** 485573

**Inspection Doc:** 696205931

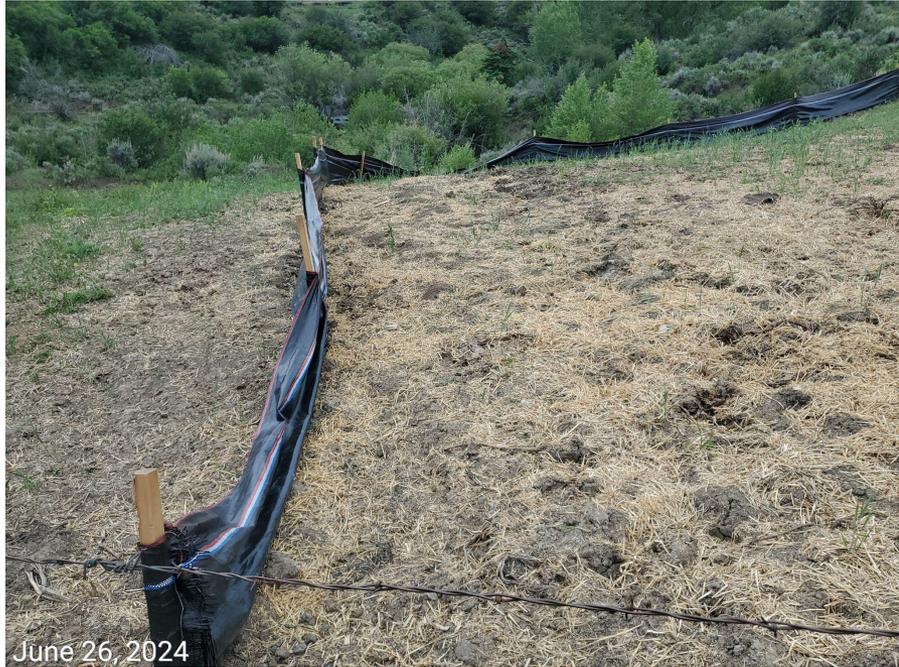
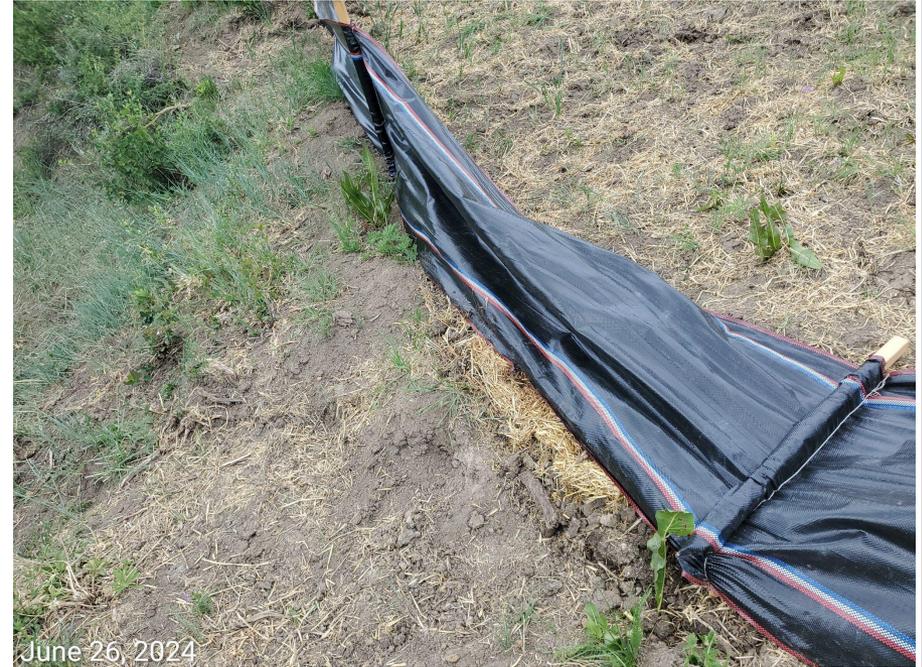
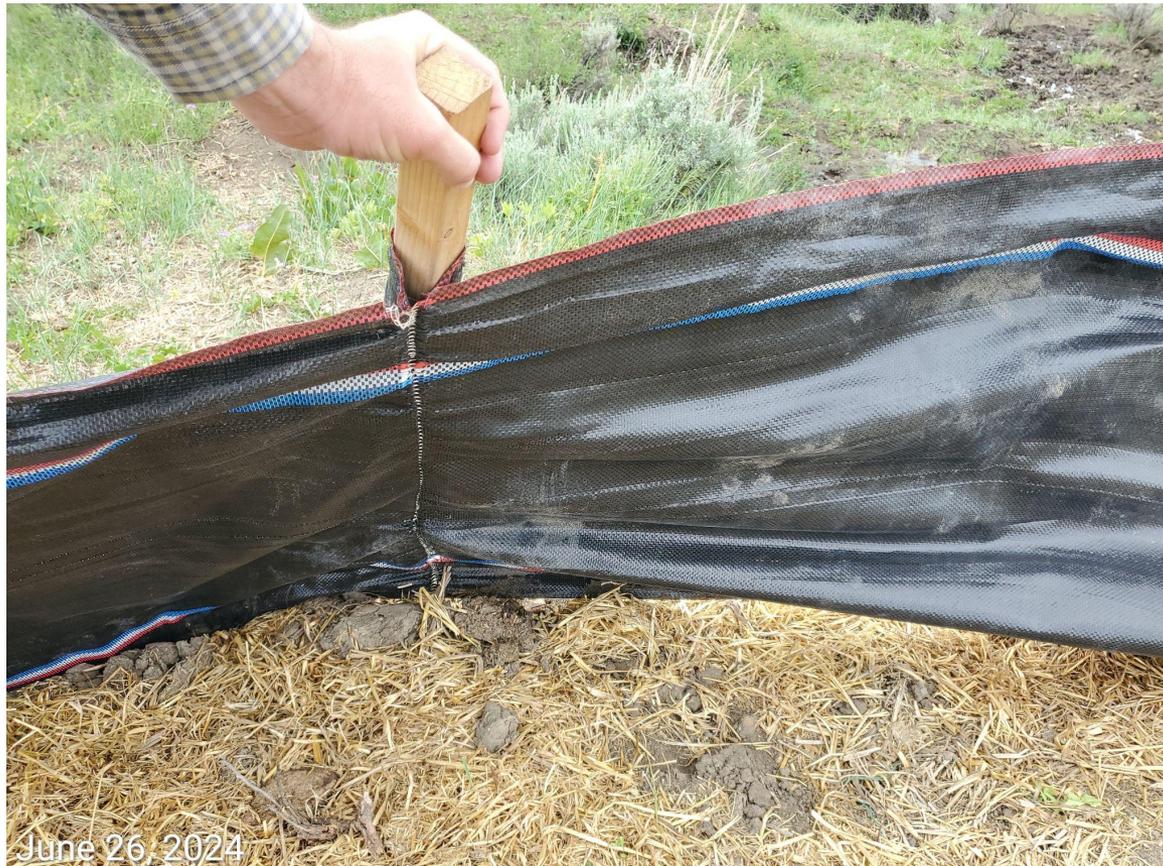
**Photo 20:** Photos taken from the Flowline System disturbance. Operator had installed silt fence along the toe of the slopes adjacent to the pipeline stream crossings. Work to repair the BMP is evident, however control has not been re-installed per good engineering practices and/or has not been maintained per good engineering practice.

**Photo 21:** See comments under photo 20.

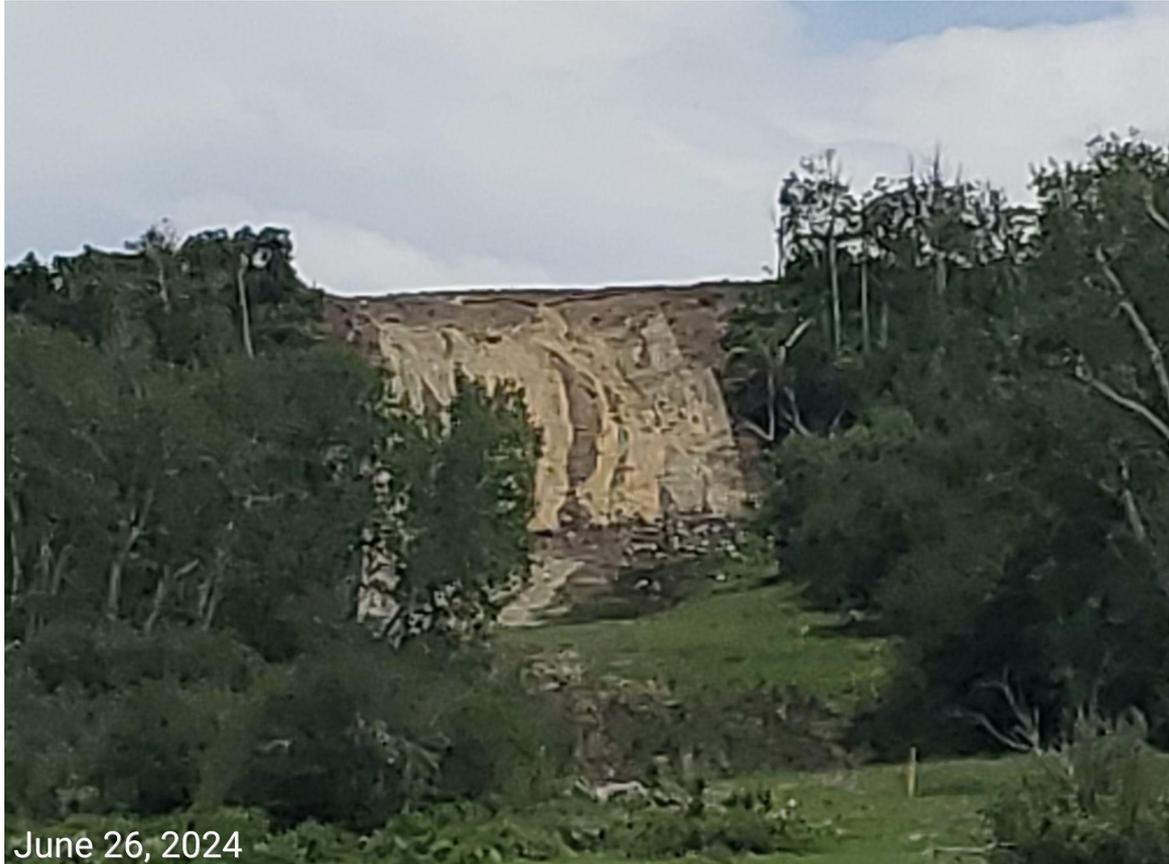
**Photo 22:** Photos example showing BMPs implemented at the Flowline System disturbance; controls include mulch, erosion blankets, silt fence and erosion logs. Photo examples showing erosion blankets have not been installed or maintained per good engineering practice.

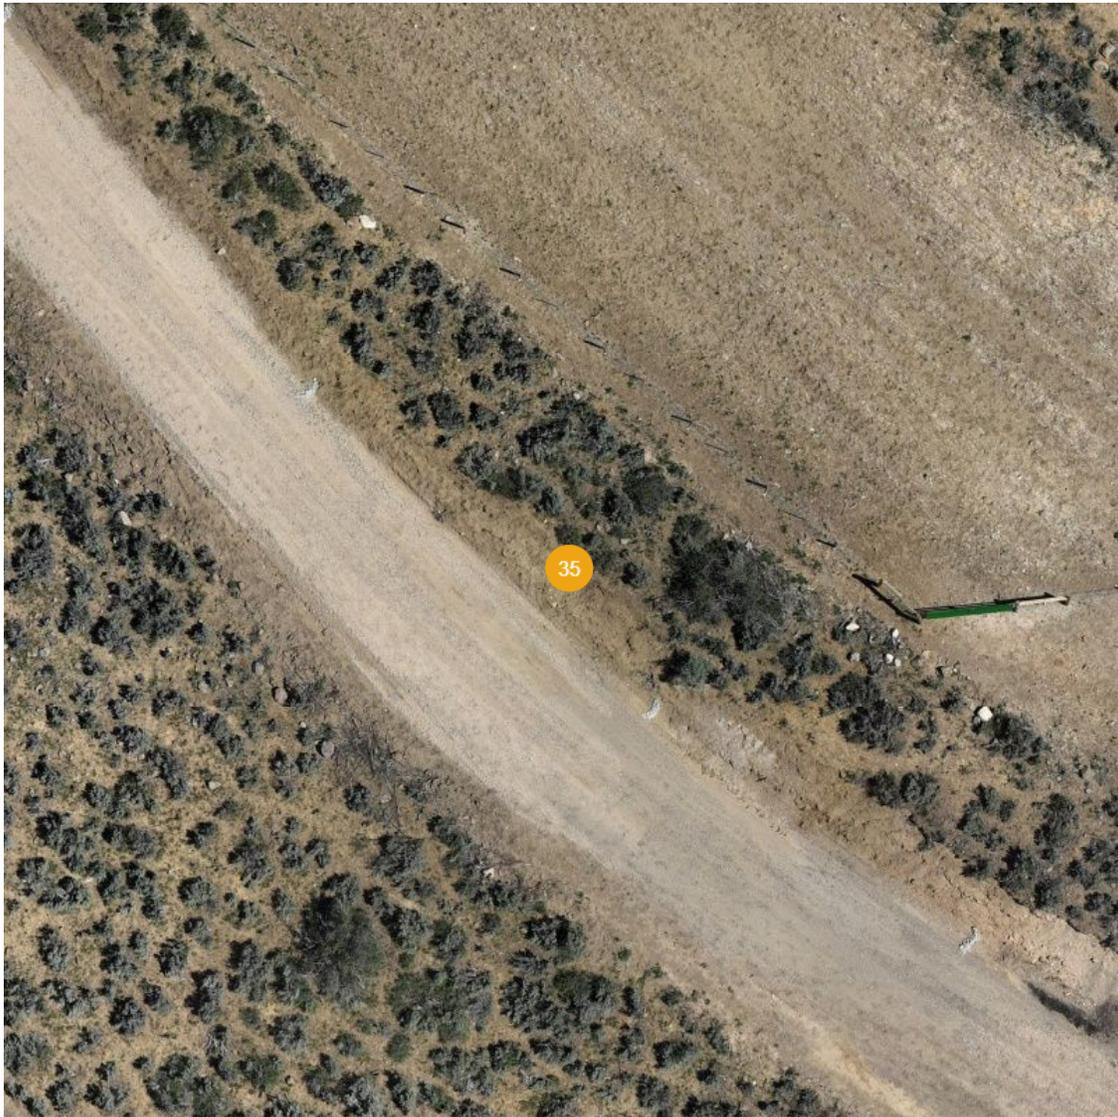
**35 - Observation**

Summary:	BMPs to minimize erosion, degradation and sediment transport missing or insufficient at slopes.
Created:	Jul 1, 2024, 2:48pm by Aaron Trujillo
Cost of Repair:	—
Lat/Long:	40.9116204, -107.3501987
Northing:	1580290.1 US ft
Easting:	2488626.7 US ft
Elevation:	7172.24 US ft

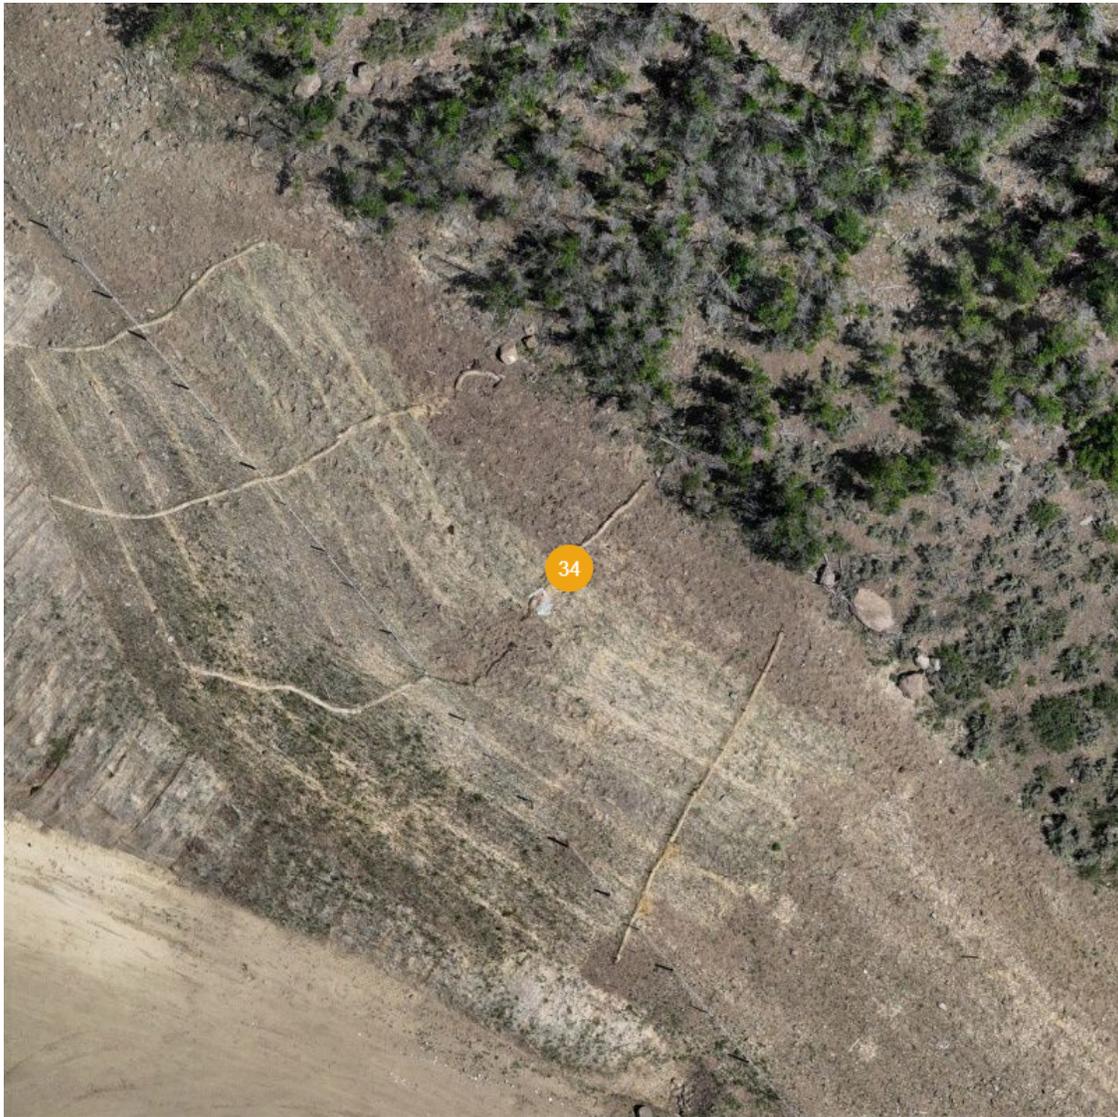
**34 - Observation**

Erosion log in disrepair  
Jul 1, 2024, 2:47pm by Aaron Trujillo

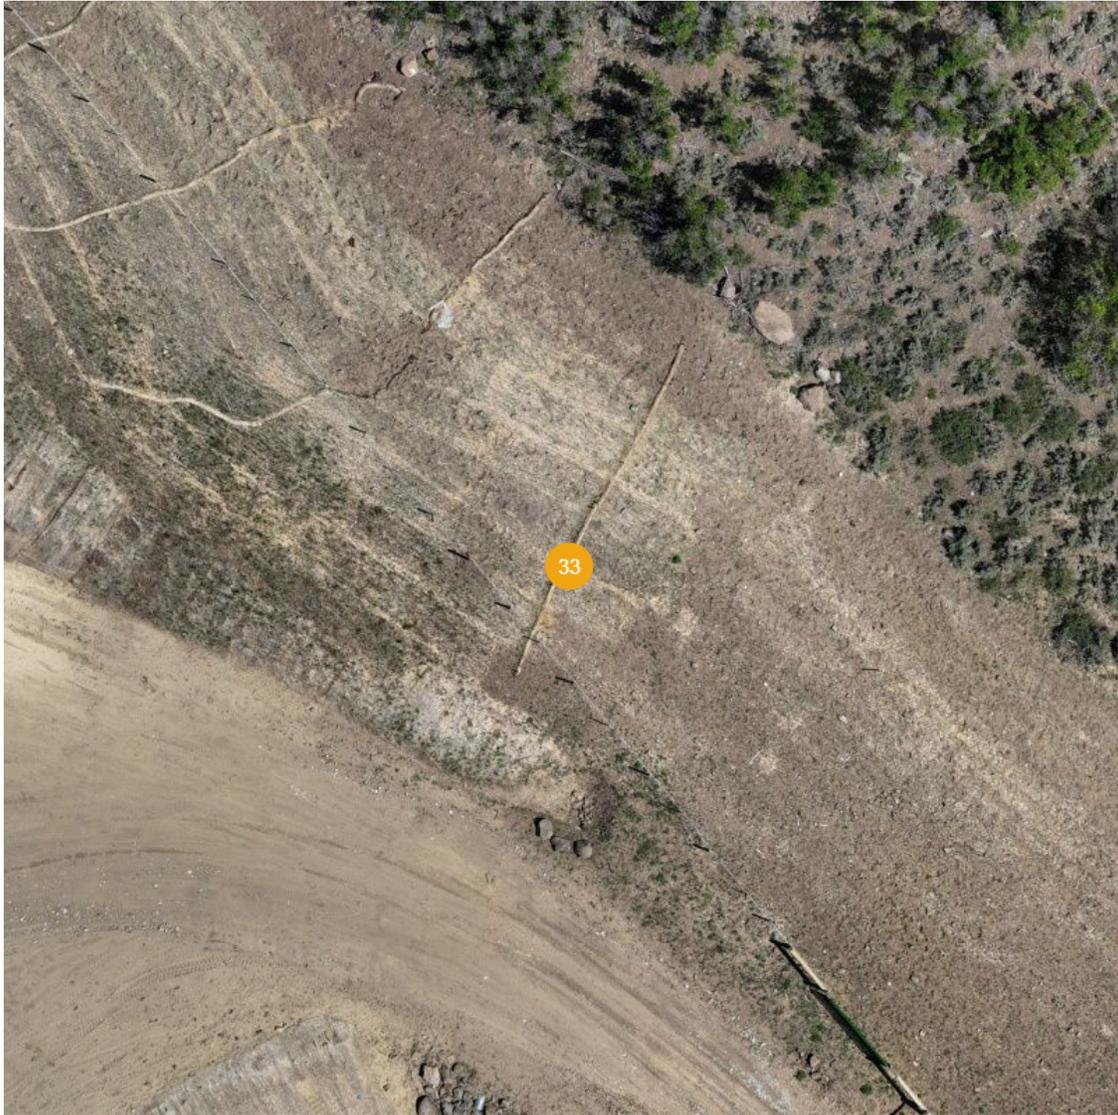
**33 - Observation**

Summary:	Erosion log in disrepair
Created:	Jul 1, 2024, 2:46pm by Aaron Trujillo
Cost of Repair:	—
Lat/Long:	40.9122265, -107.3508570
Northing:	1580514.7 US ft
Easting:	2488449.4 US ft
Elevation:	7186.89 US ft
NAD83(2011) / Colorado North (ftUS) (US survey foot)

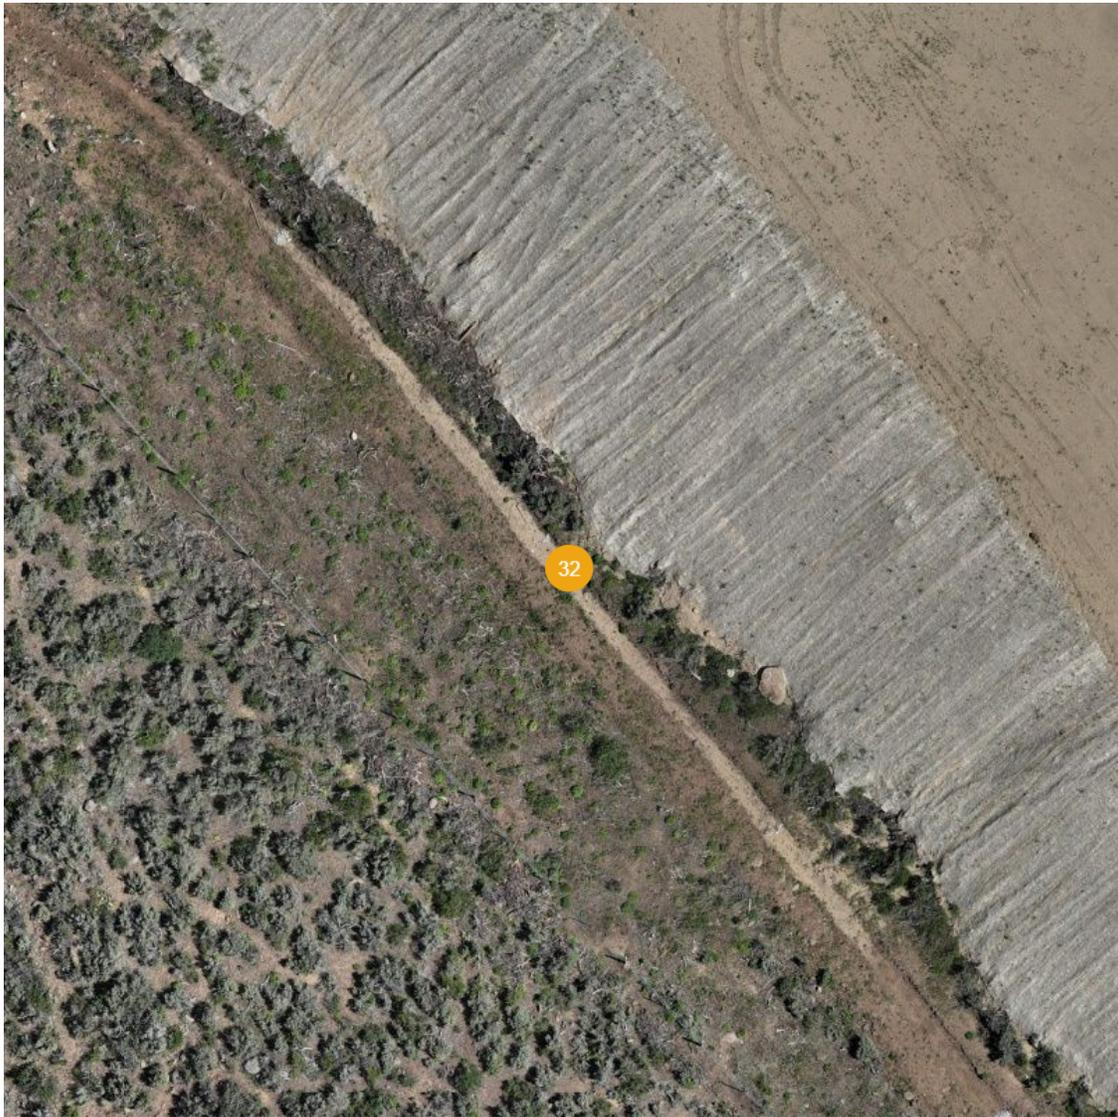
**32 - Observation**

Summary: Lighter soils observed is sediment due to stormwater runoff and erosion degradation occurring at the fill slopes. Stormwater diversion ditch has filled with sediment.

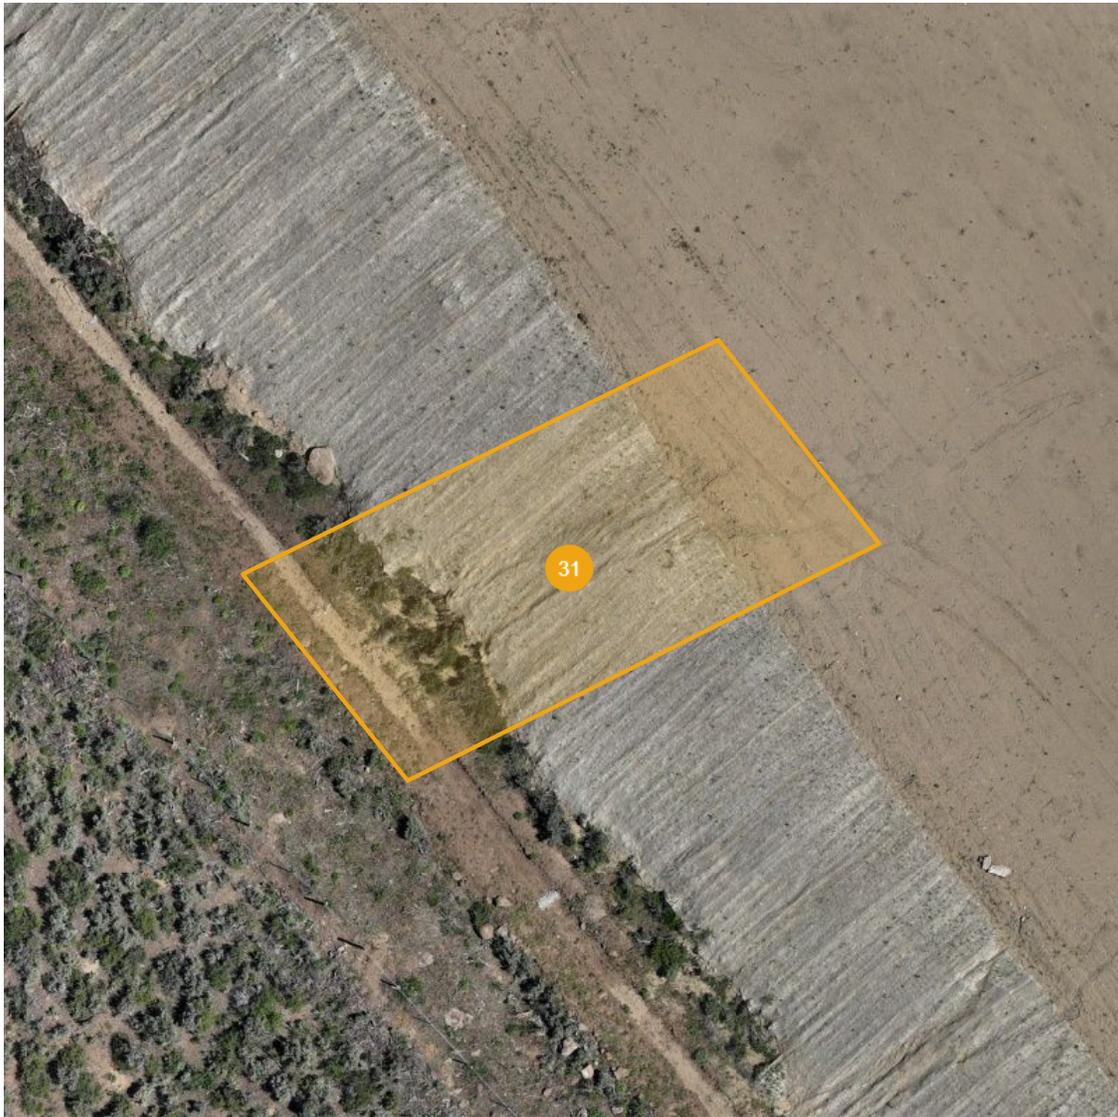
**31 - Observation**

Summary:	BMPs to manage runoff from the Pad missing or insufficient, resulting in erosion degradation and sediment transport.
Created:	Jul 1, 2024, 2:45pm by Aaron Trujillo
Cost of Repair:	—
Lat/Long:	40.91208, -107.35246
Area:	2417.22 ft <sup>2</sup>
Surface area:	2597.82 ft <sup>2</sup>

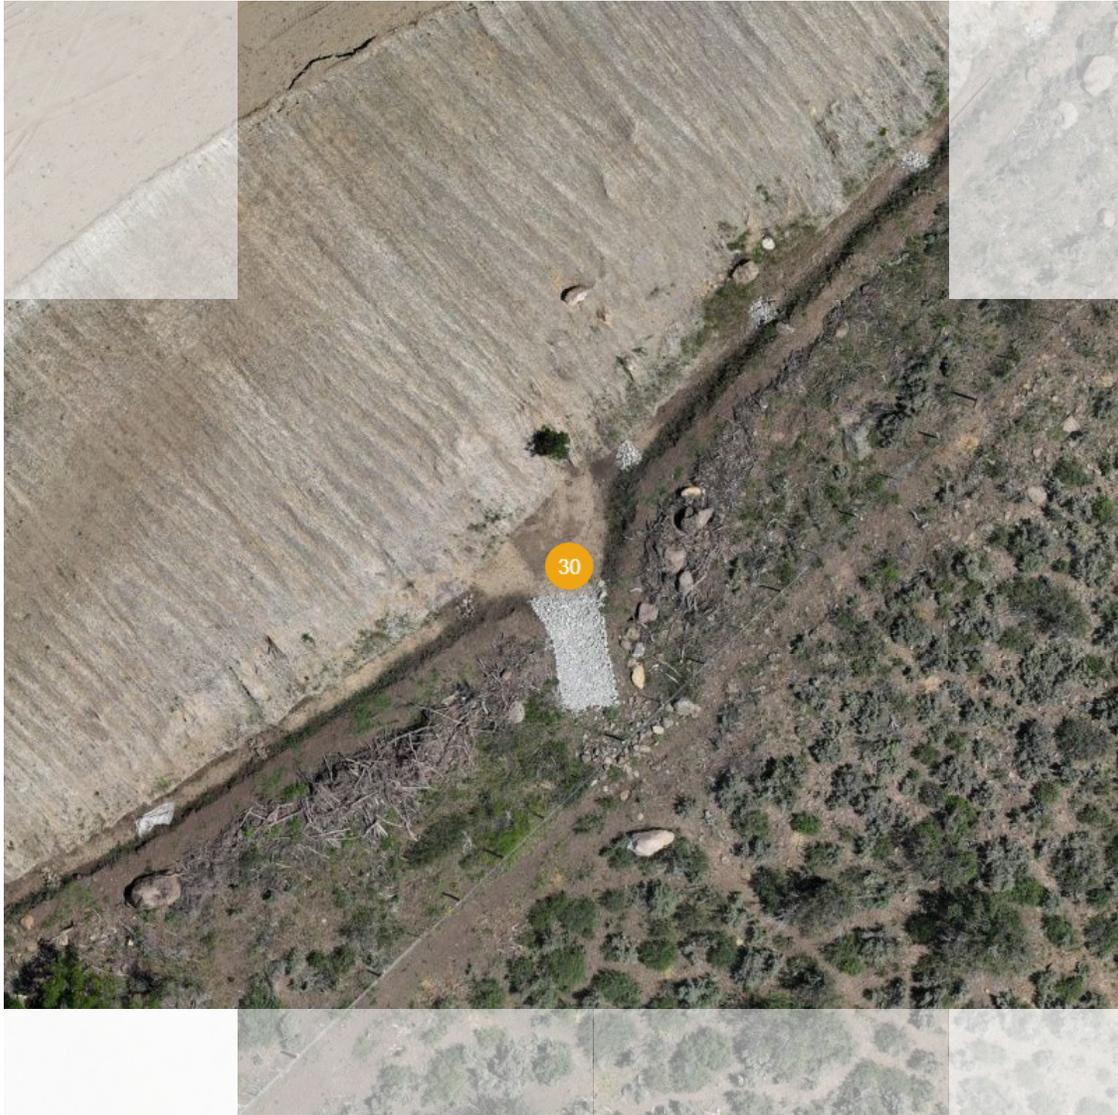
**30 - Observation**

Summary:	BMP not constructed in conjunction with a sediment trap. BMPs also constructed with use of topsoil material.
Created:	Jul 1, 2024, 2:44pm by Aaron Trujillo
Cost of Repair:	—
Lat/Long:	40.9117316, -107.3512040
Northing:	1580336.4 US ft
Easting:	2488349.8 US ft
Elevation:	7148.58 US ft

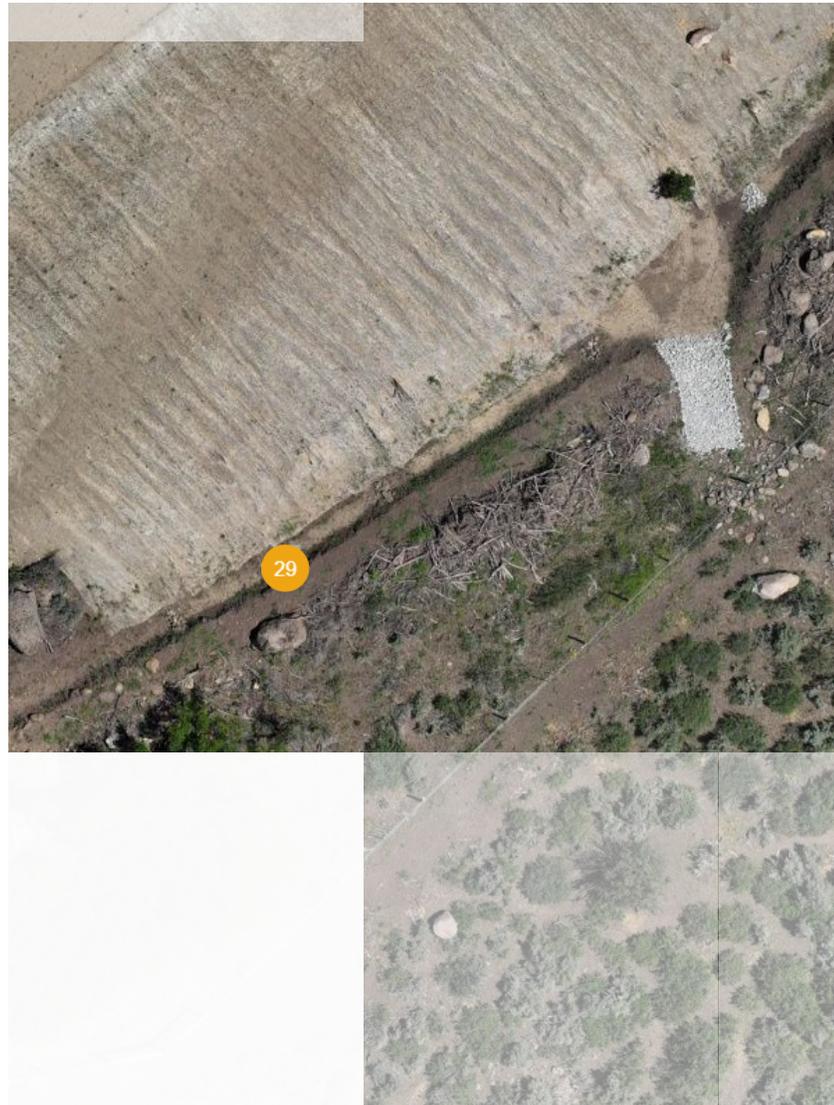
29 - Observation

Summary:	Trash debris observed within the stormwater diversion ditch.
Created:	Jun 28, 2024, 10:24am by Aaron Trujillo
Cost of Repair:	—
Lat/Long:	40.9116366, -107.3514019
Northing:	1580303.0 US ft
Easting:	2488294.3 US ft
Elevation:	7149.98 US ft
	NAD83(2011) / Colorado North (ftUS) (US survey foot)

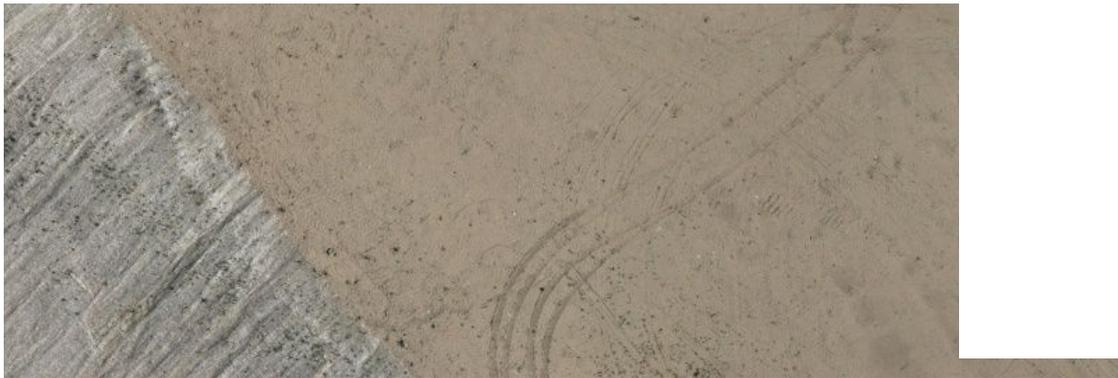
**23 - Observation**

Summary: **Improperly anchored equipment blown over by wind. Damage evident. Operator was directed to secure all equipment on the Location.**

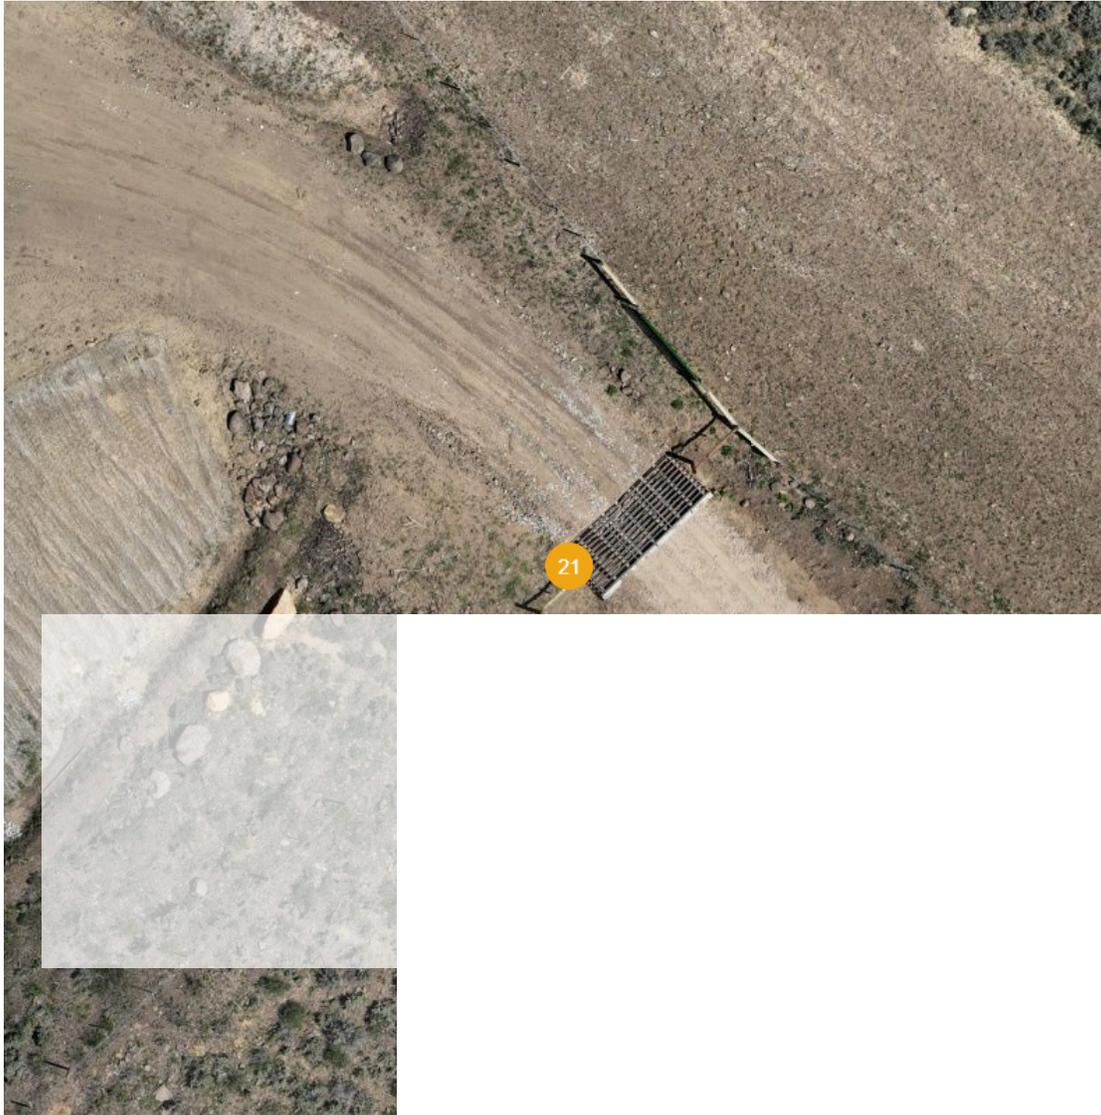
21 - Observation

Signage at Location entrance not posted.

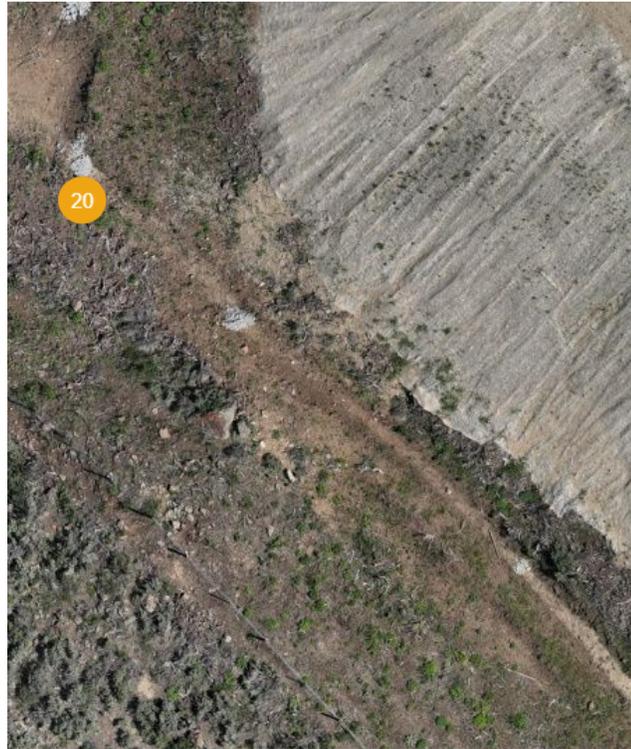
**20 - Observation**

Summary:	BMP not constructed in conjunction with a sediment trap. BMPs also constructed with use of topsoil material.
Created:	Jun 28, 2024, 9:55am by Aaron Trujillo
Cost of Repair:	—
Lat/Long:	40.9124053, -107.3530447
Northing:	1580592.5 US ft
Easting:	2487846.2 US ft
Elevation:	7151.24 US ft

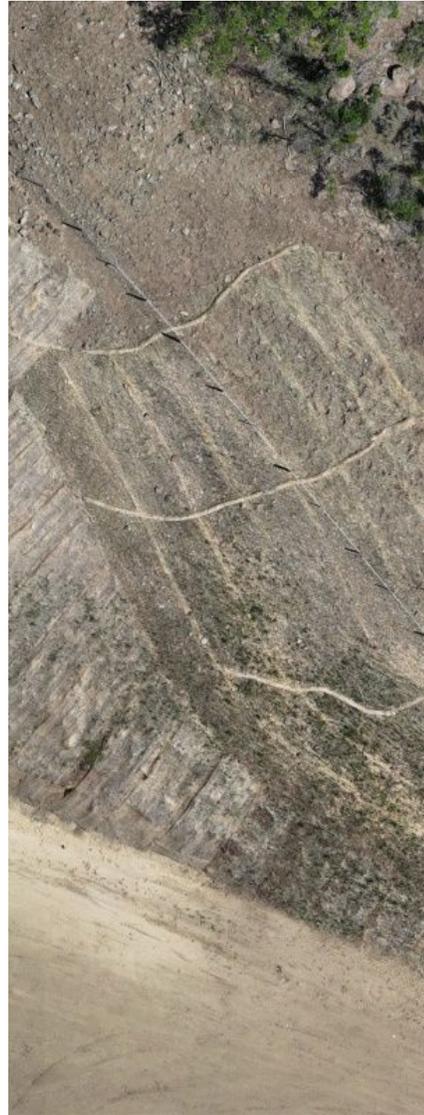
19 - Observation

Summary: BMPs to minimize erosion, degradation and sediment transport at the slopes of the Location remain missing or insufficient: Erosion blankets have not been installed or maintained per good engineering practices, resulting in erosion degradation at slopes.

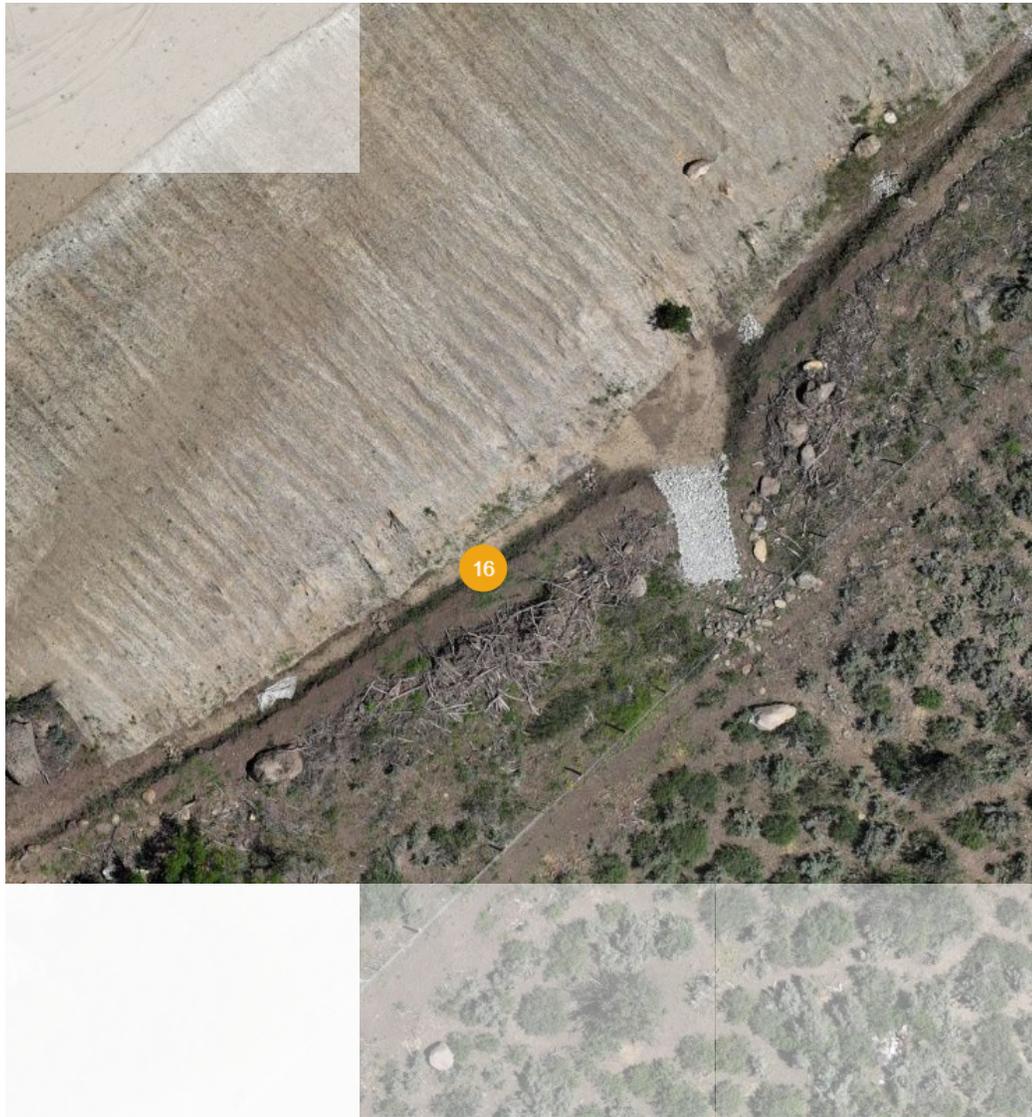
16 - Observation

Summary:	Lighter soils observed is sediment due to stormwater runoff and erosion degradation occurring at the fill slopes
Created:	Jun 28, 2024, 9:49am by Aaron Trujillo
Cost of Repair:	—
Lat/Long:	40.9116850, -107.3513047
Northing:	1580320.0 US ft
Easting:	2488321.6 US ft
Elevation:	7149.22 US ft

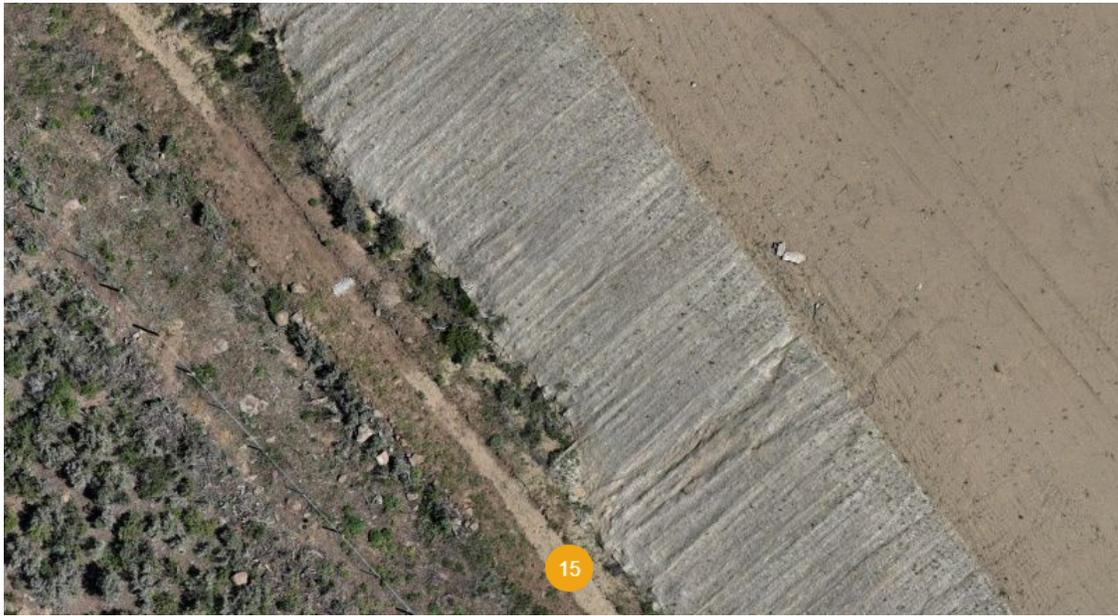
15 - Observation

Summary: Lighter soils observed is sediment due to stormwater runoff and erosion degradation occurring at the fill slopes. Stormwater diversion ditch has filled with sediment.

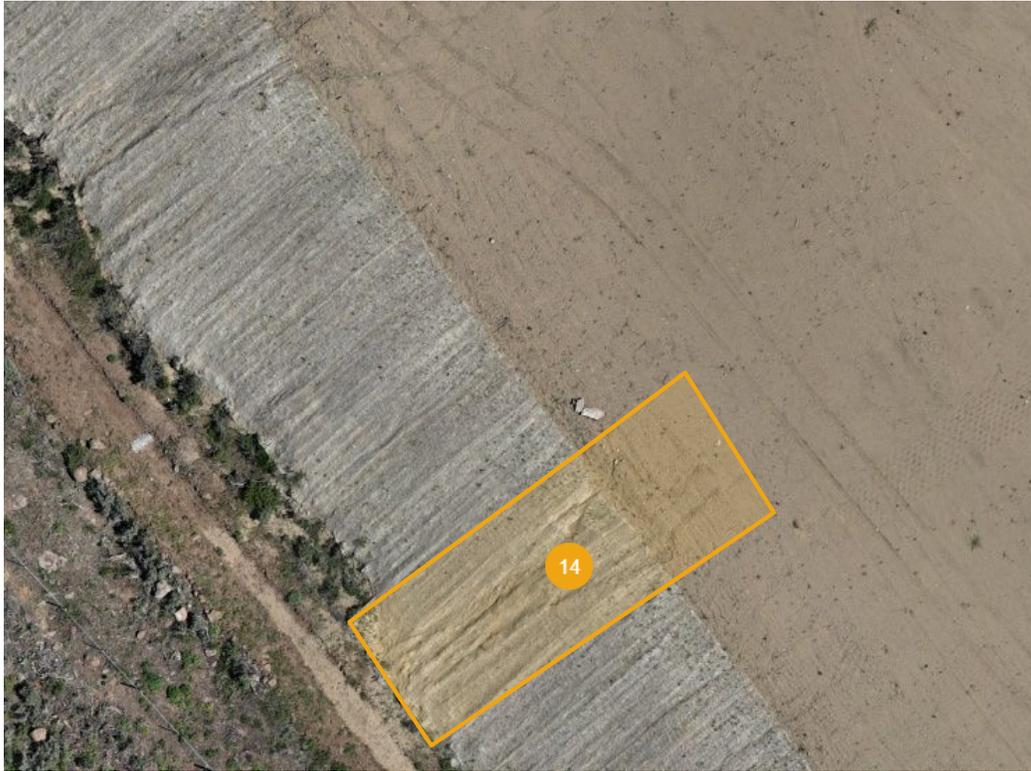
14 - Observation

Summary:	BMPs to manage runoff from the Pad missing or insufficient, resulting in erosion degradation and sediment transport.
Created:	Jun 28, 2024, 9:12am by Aaron Trujillo
Cost of Repair:	—
Lat/Long:	40.91191, -107.35228
Area:	1162.56 ft <sup>2</sup>
Surface area:	1223.17 ft <sup>2</sup>

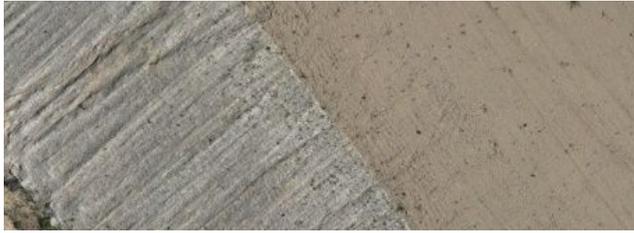
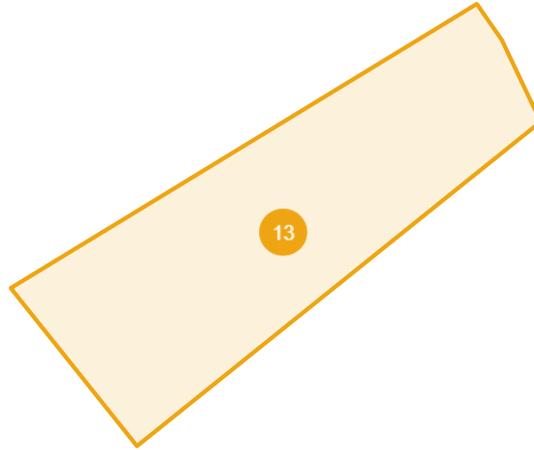
**13 - Observation**

Summary:	BMPs to manage runoff from the Pad missing or insufficient, resulting in erosion degradation and sediment transport.
Created:	Jun 28, 2024, 9:11am by Aaron Trujillo
Cost of Repair:	—
Lat/Long:	40.91172, -107.35206
Area:	1590.83 ft <sup>2</sup>
Surface area:	1686.82 ft <sup>2</sup>
