Inspection Photos

Operator: Arkoma Operations LLC - 10766

Location ID: 325118

Inspection Photos
Location Name: Crigler MVRD Unit 1
Location ID: 325118

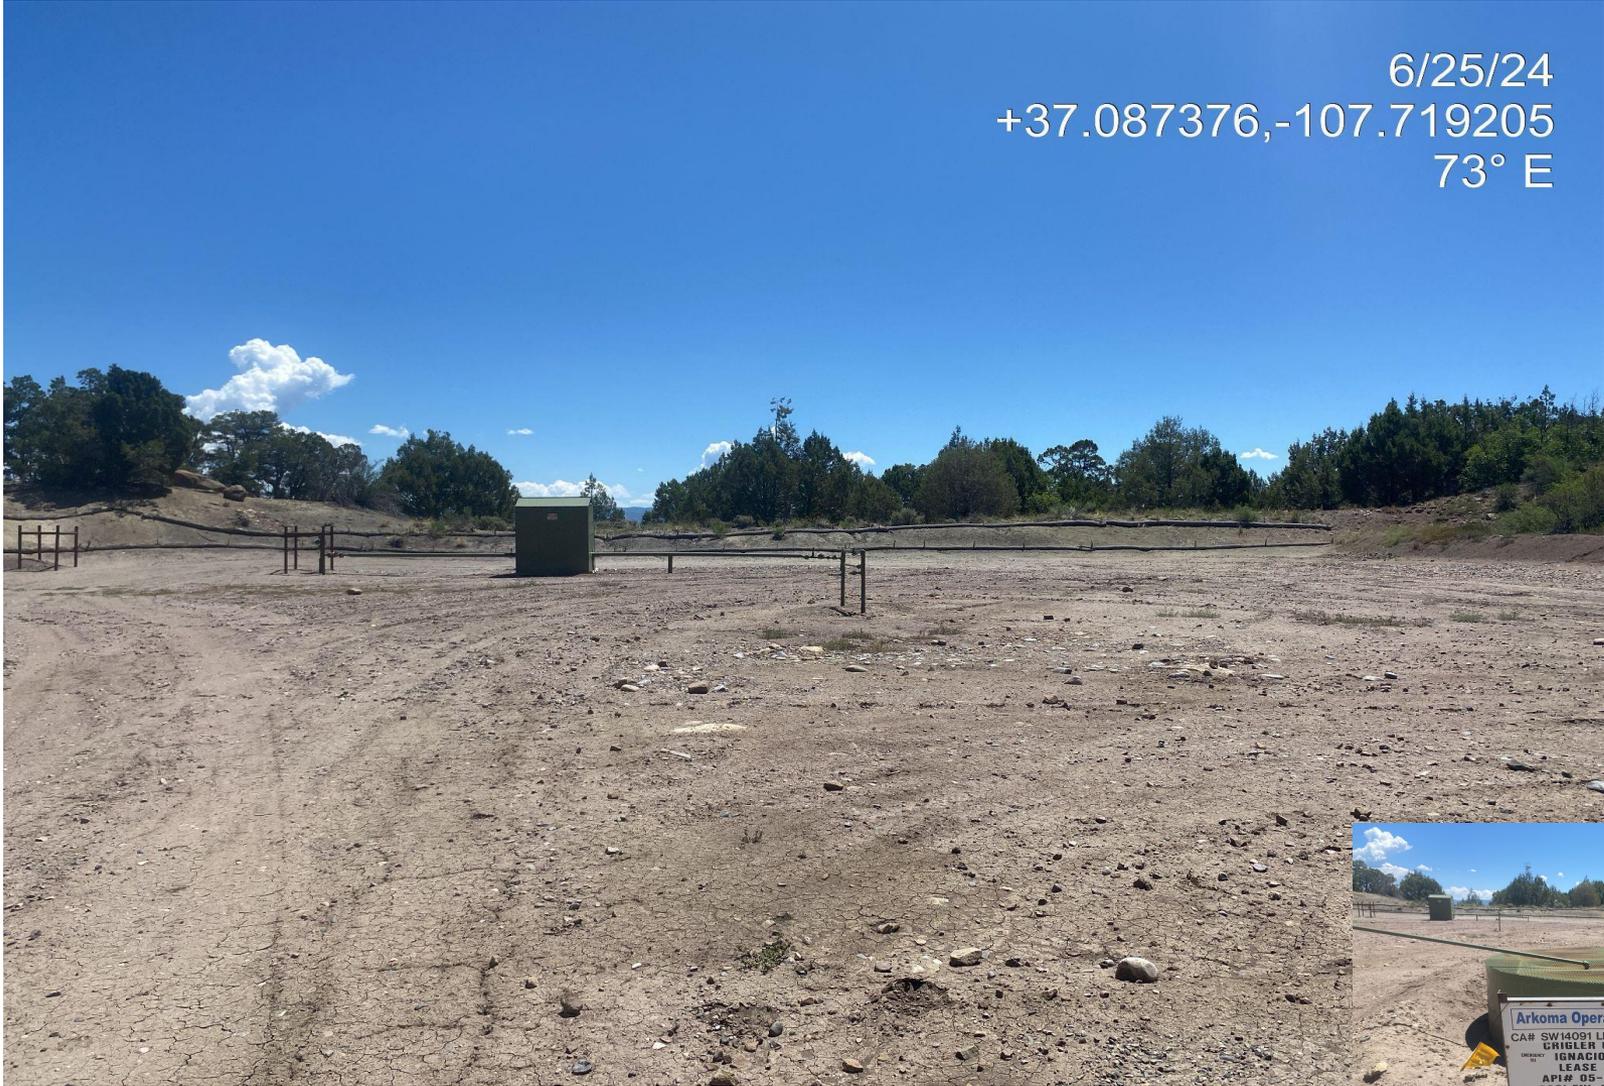
Photo 1. View of the well disturbance taken from the access point facing center.

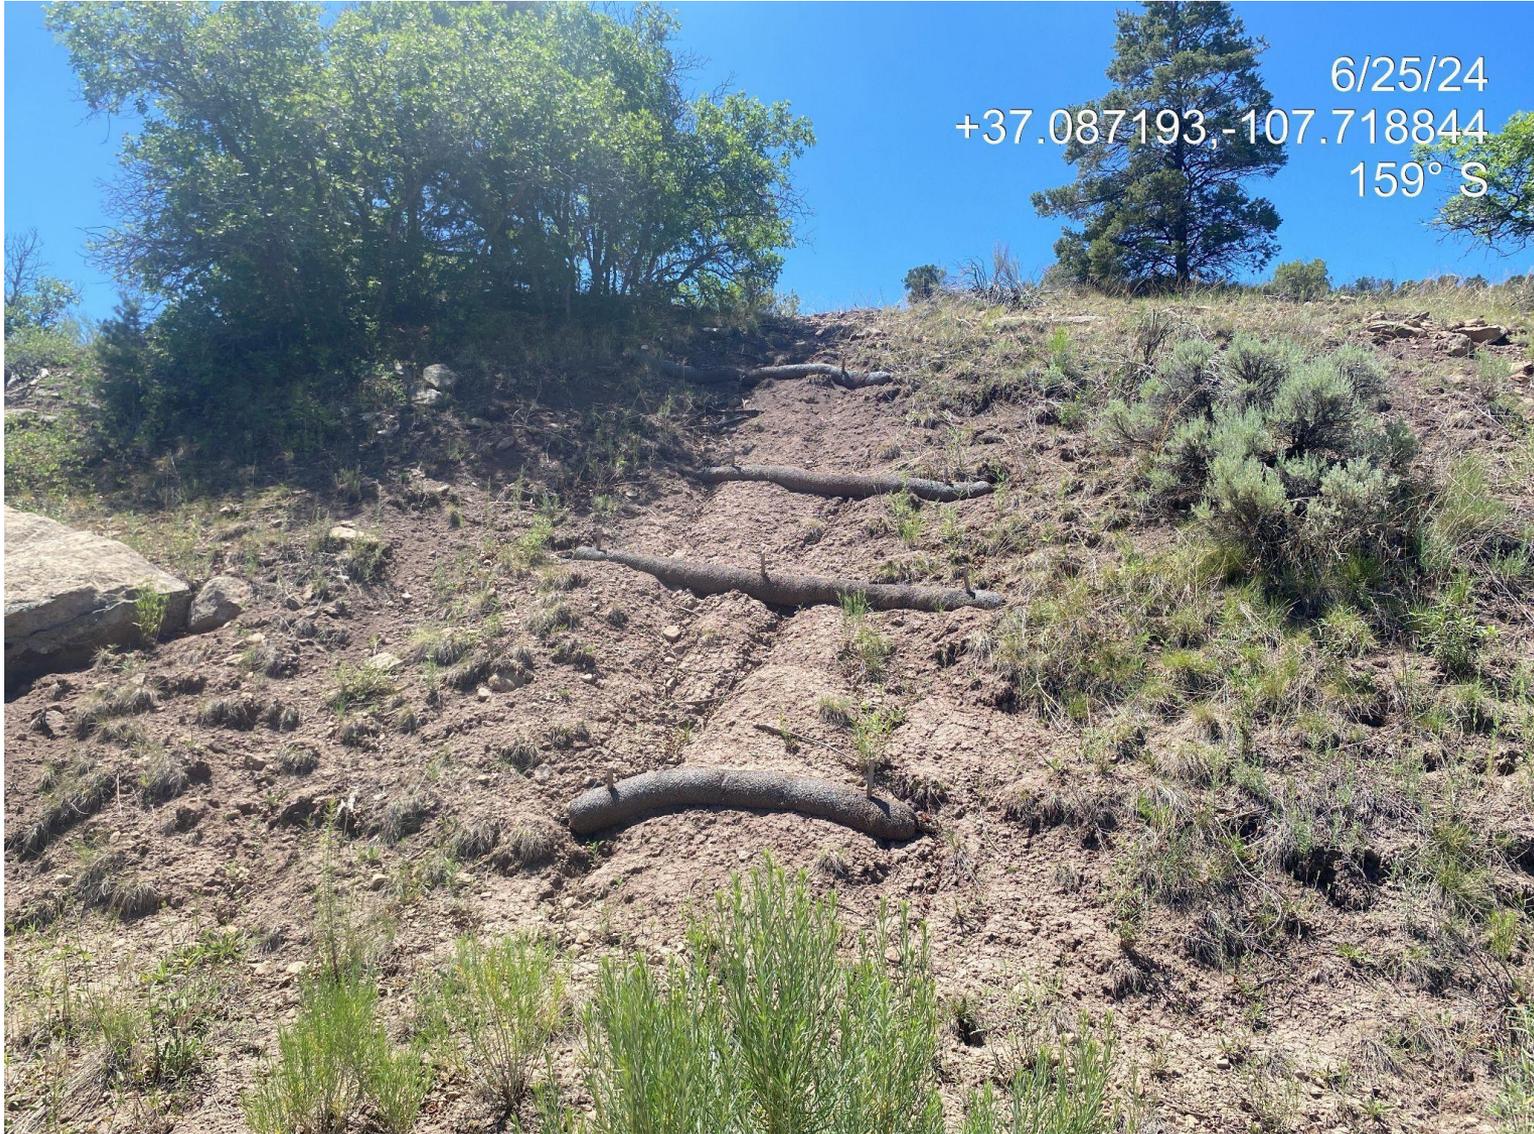
Photo 2. Erosion issues persist in the southern cut slope area. Storm water BMP wattles needs maintenance.

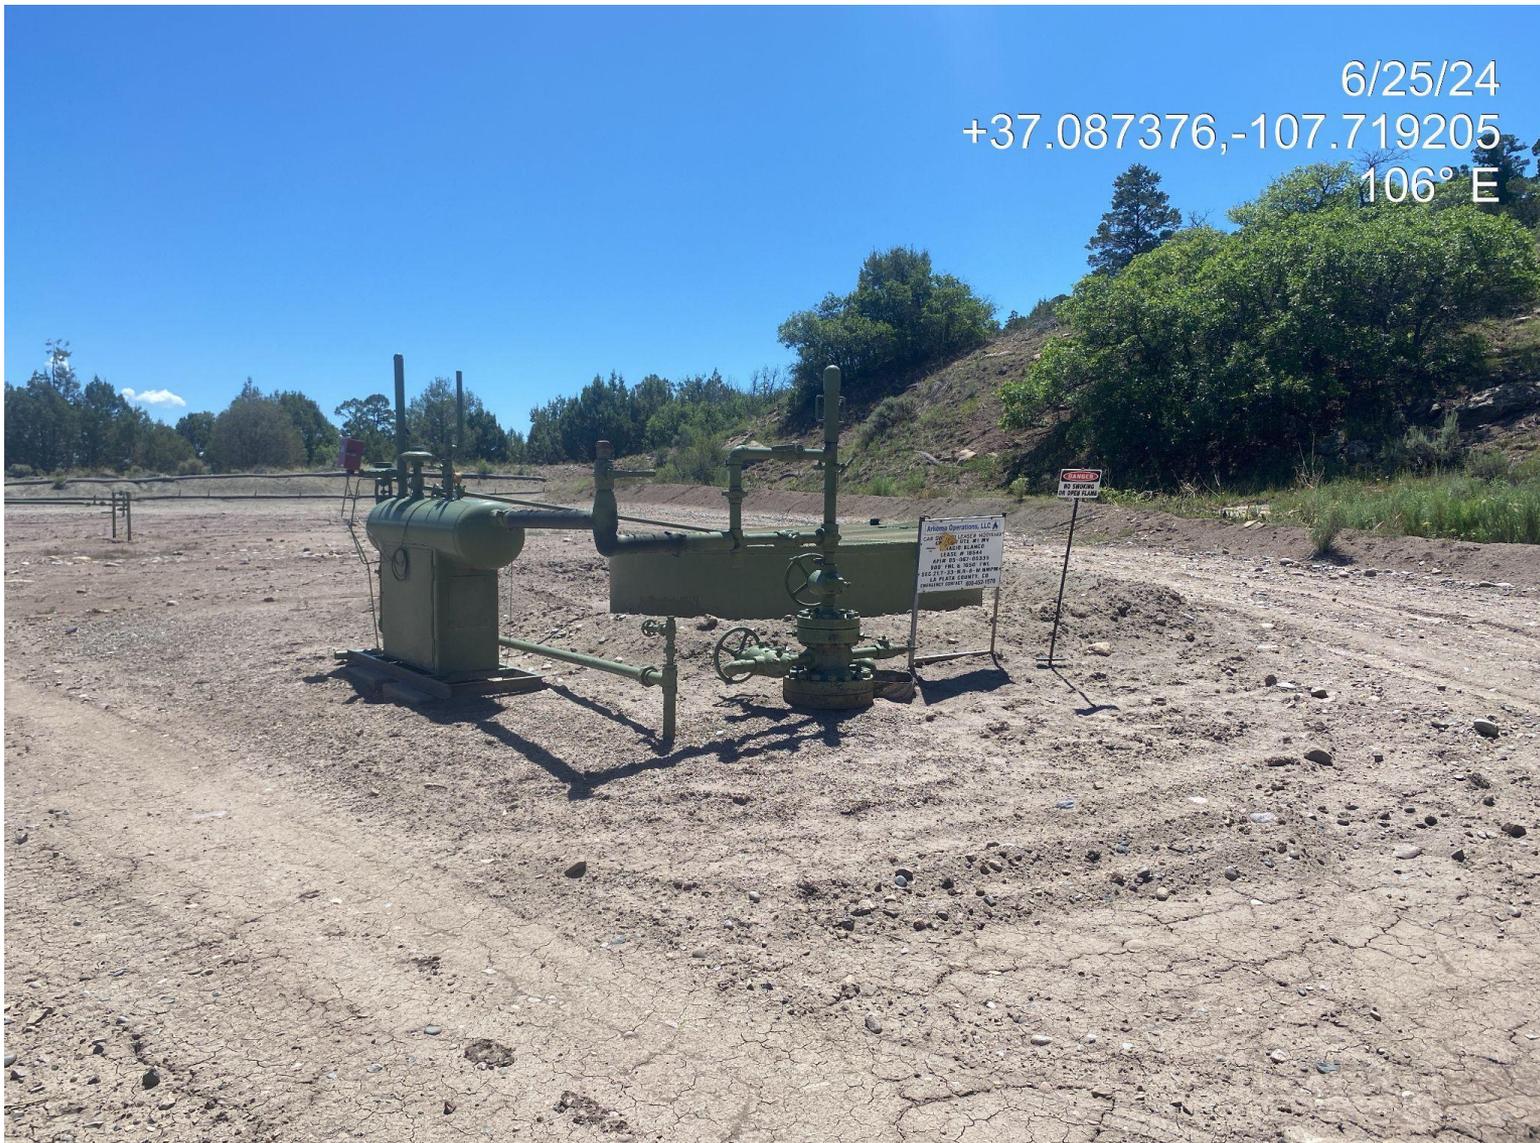
Photo 3. Berm/secondary containment corrective action identified in the previous inspection doc #693903535 has been addressed/resolved.

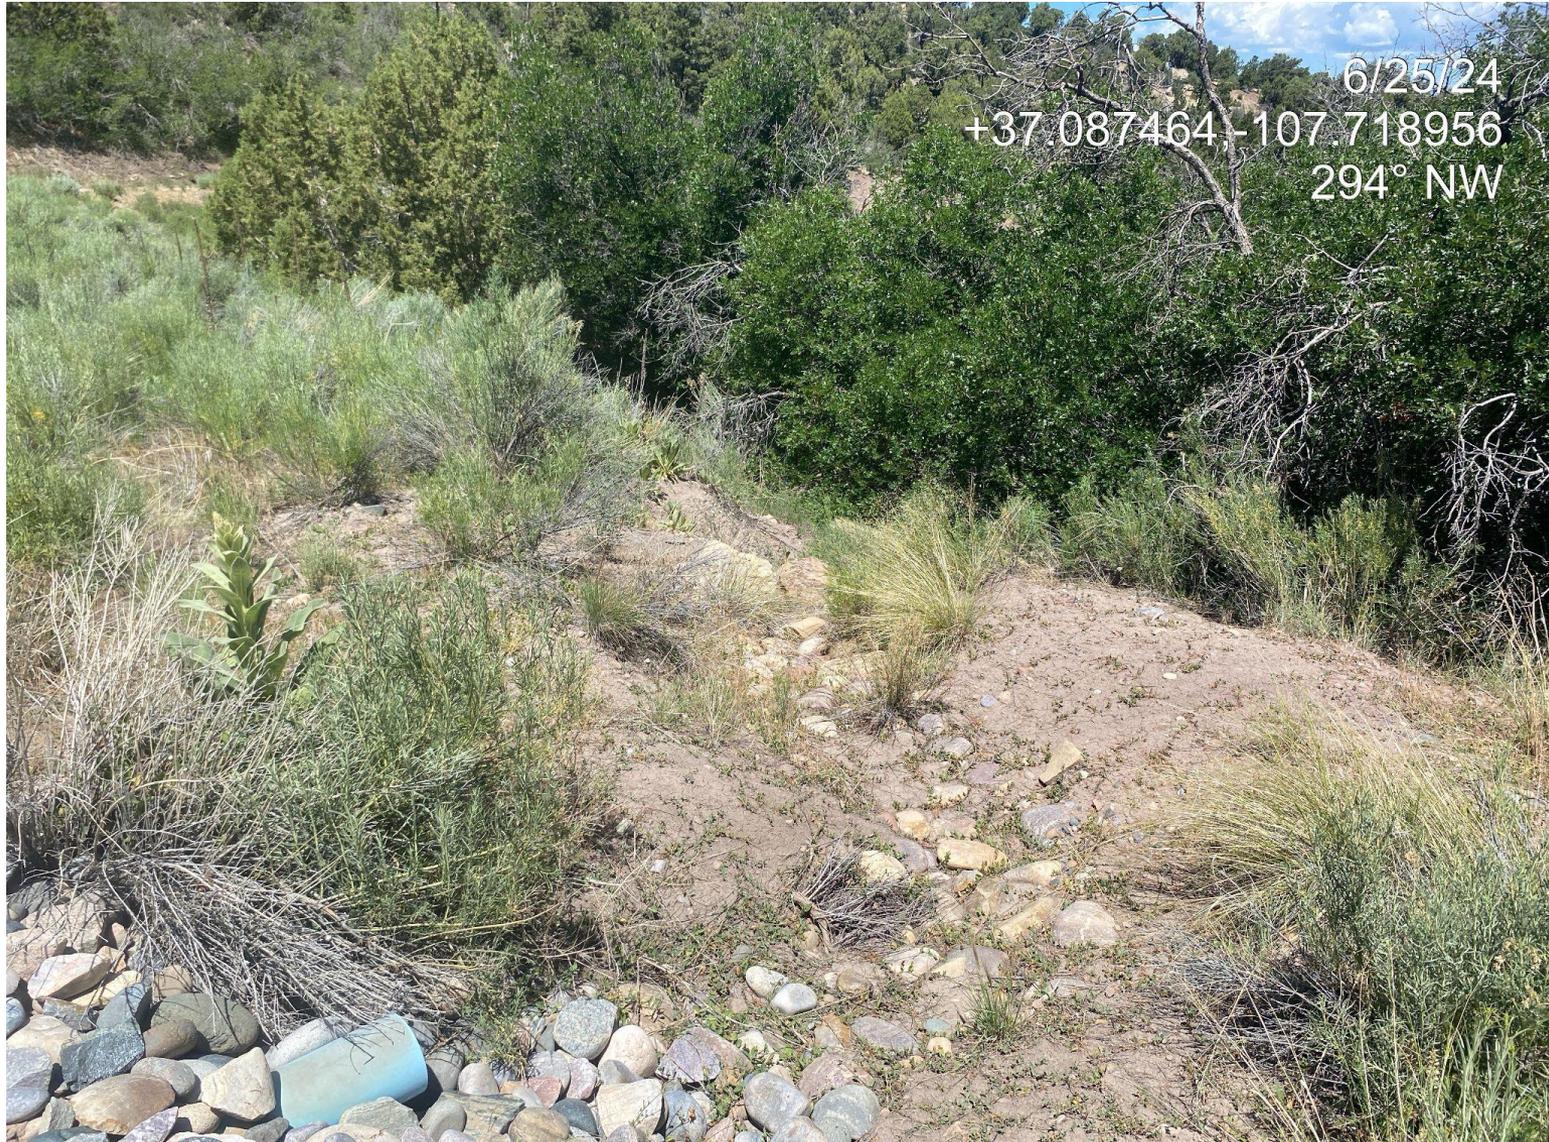
Photo 4. View of storm water BMPs that remain functional in the northern interim reclamation area.

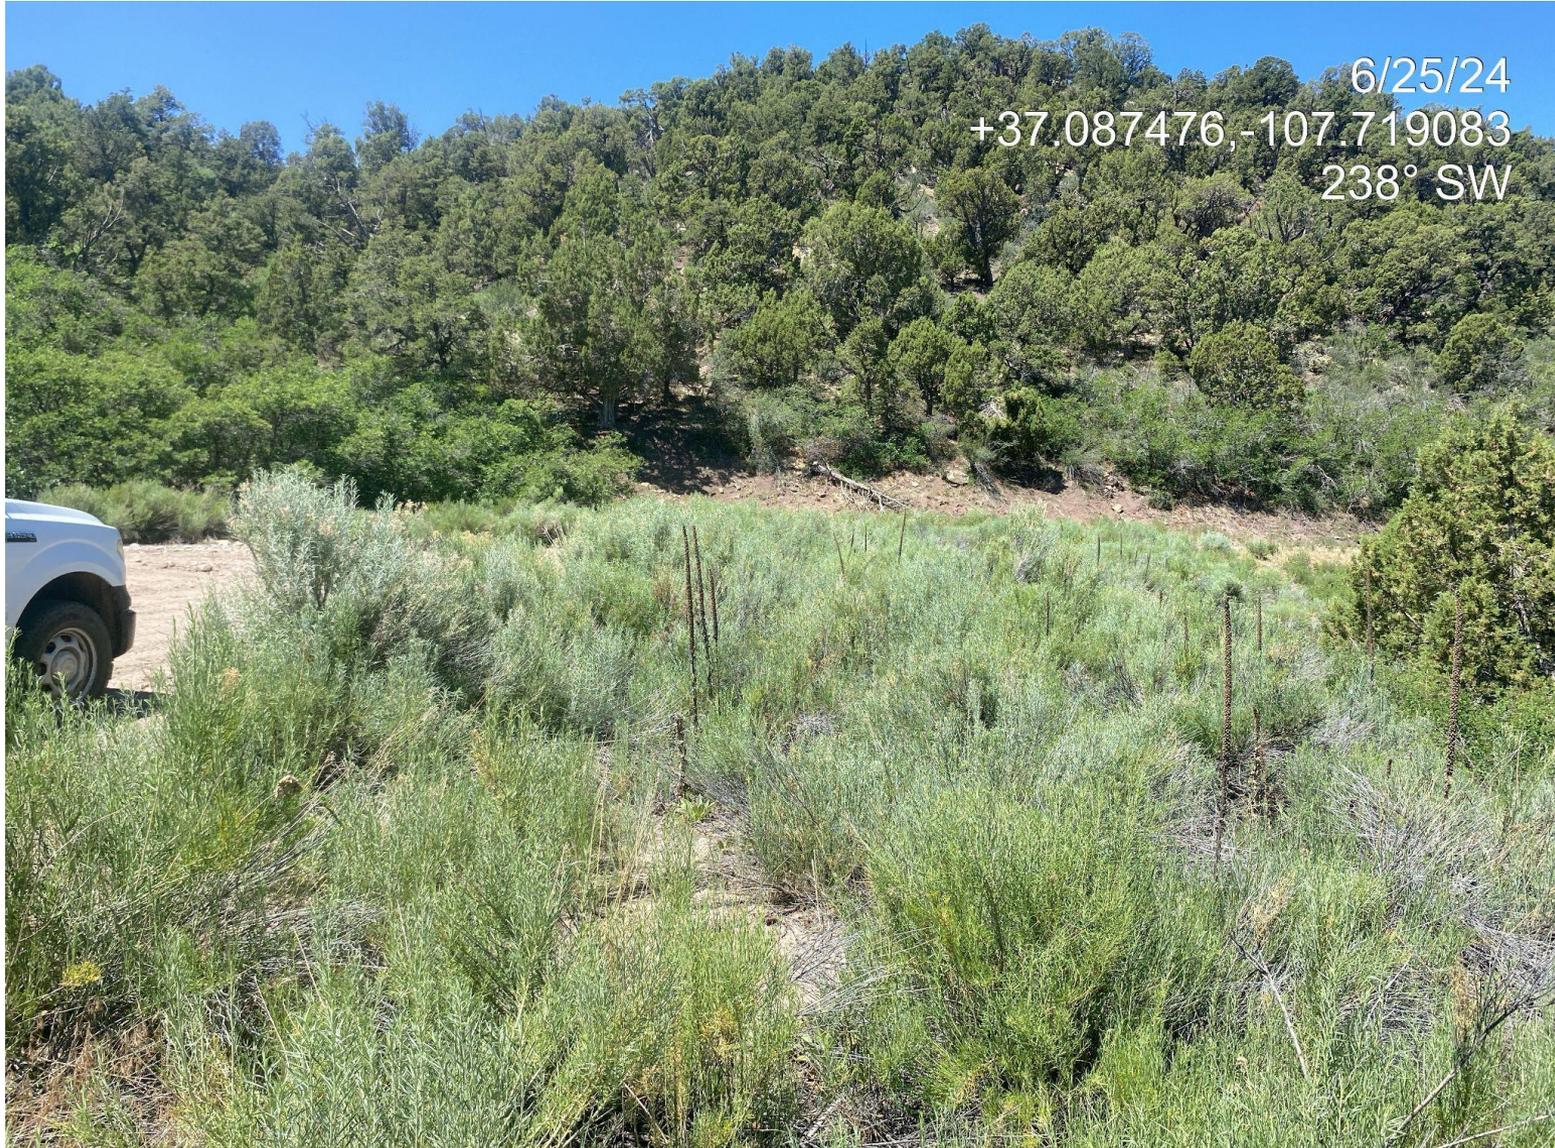
Photo 5. View of the western interim reclamation area facing southwest.

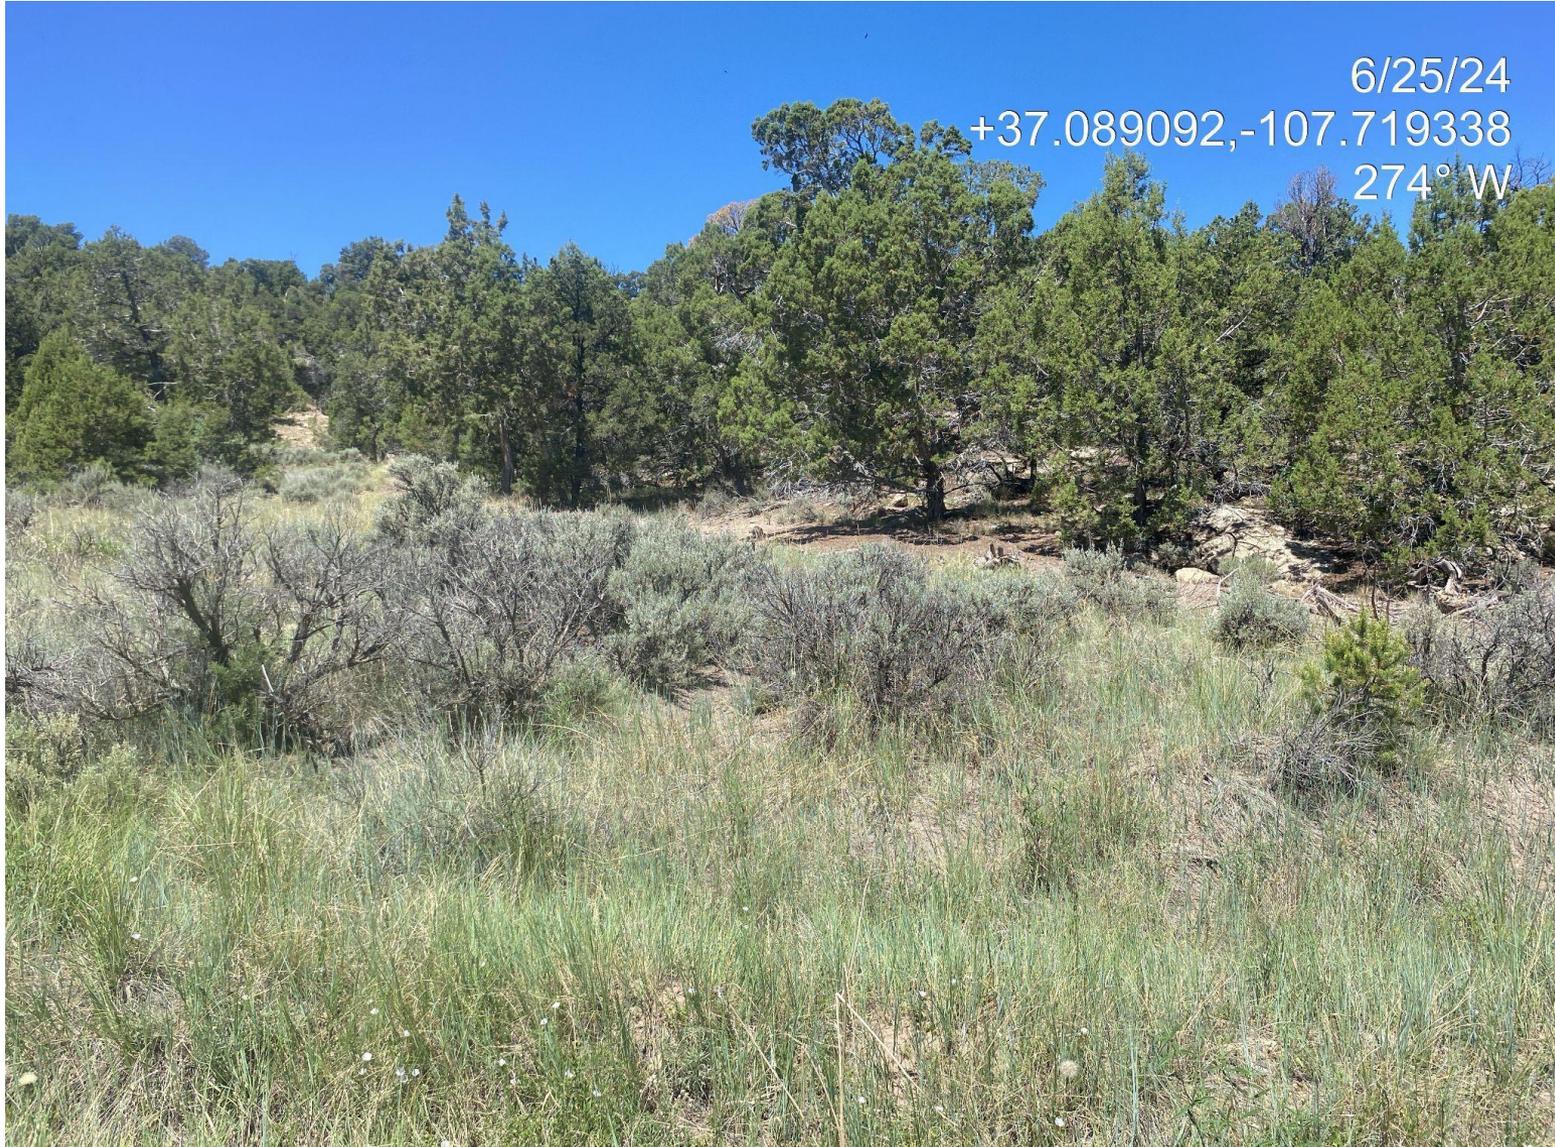
Photo 6. View of the reference are comprised of smooth brome, sage brush and juniper.
