Interim Reclamation and Stormwater Inspection

Date: 06/21/2024

Operator: DENOVA SEQUESTRATION LLC - 10790

Inspection Document #: 708201343

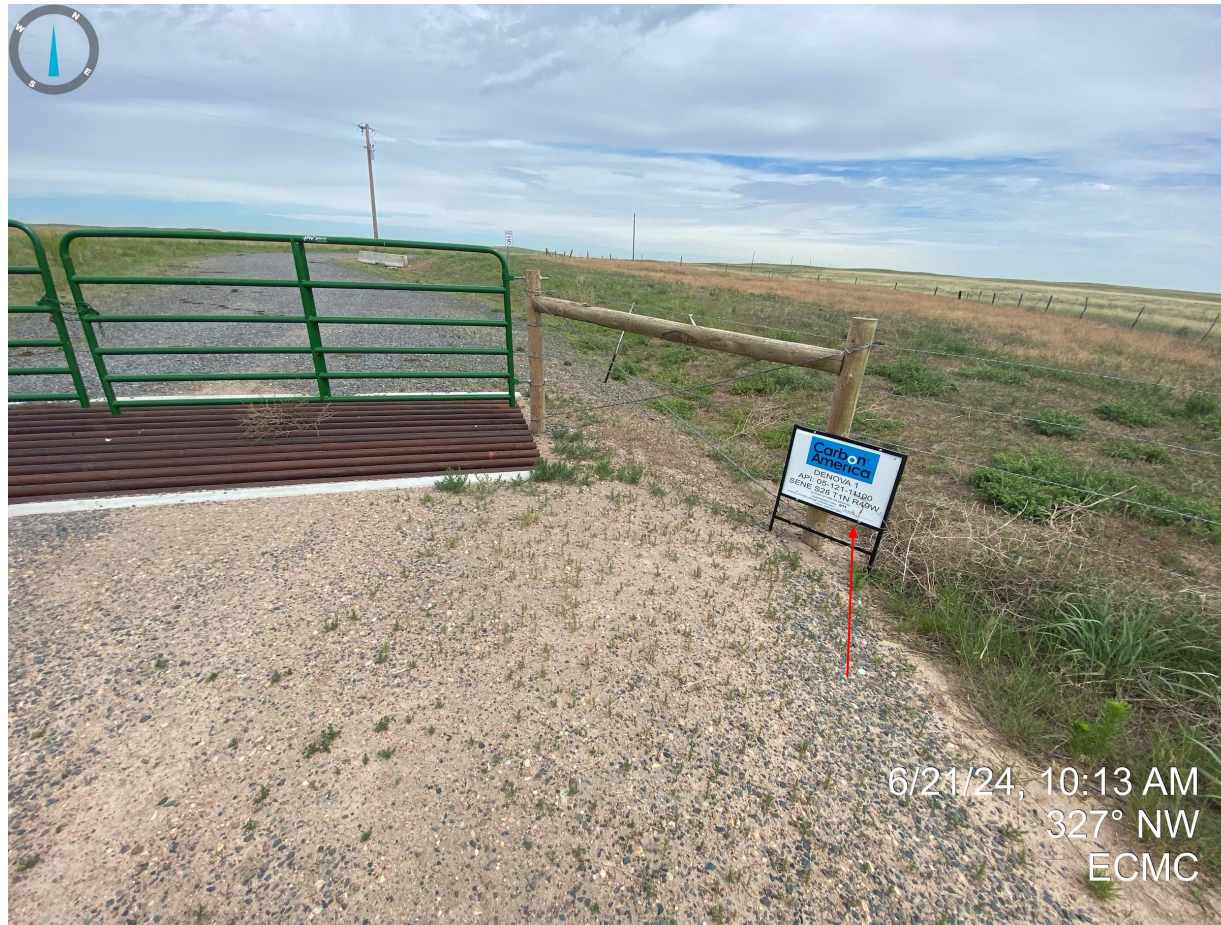
Photo 1. Emergency Contact number not legible from a distance.

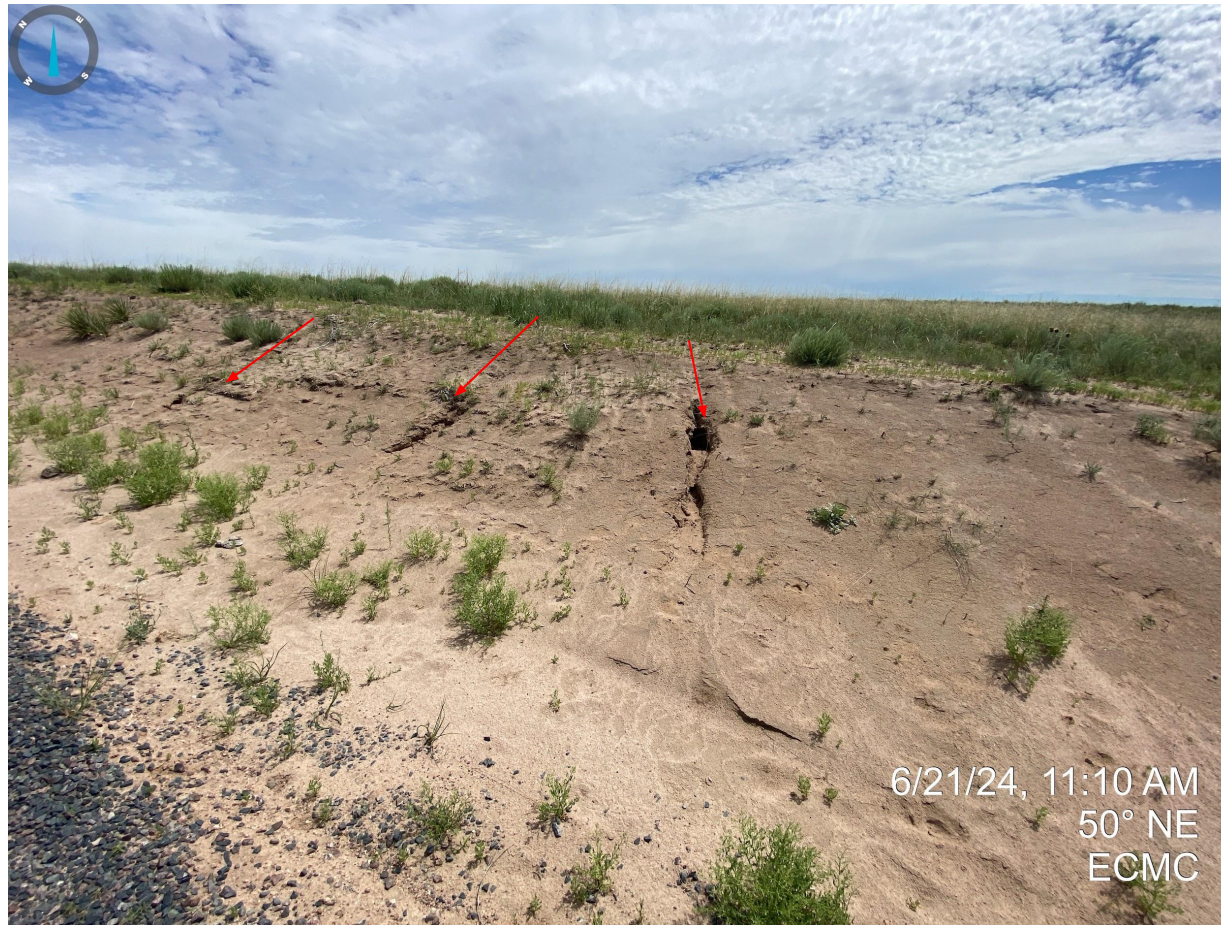
Photo 2. Erosion degradation (riling) occurring along the access roads and unstabilized slopes. It does not appear that any repairs have been made or any additional BMPs have been installed since the previous inspection.

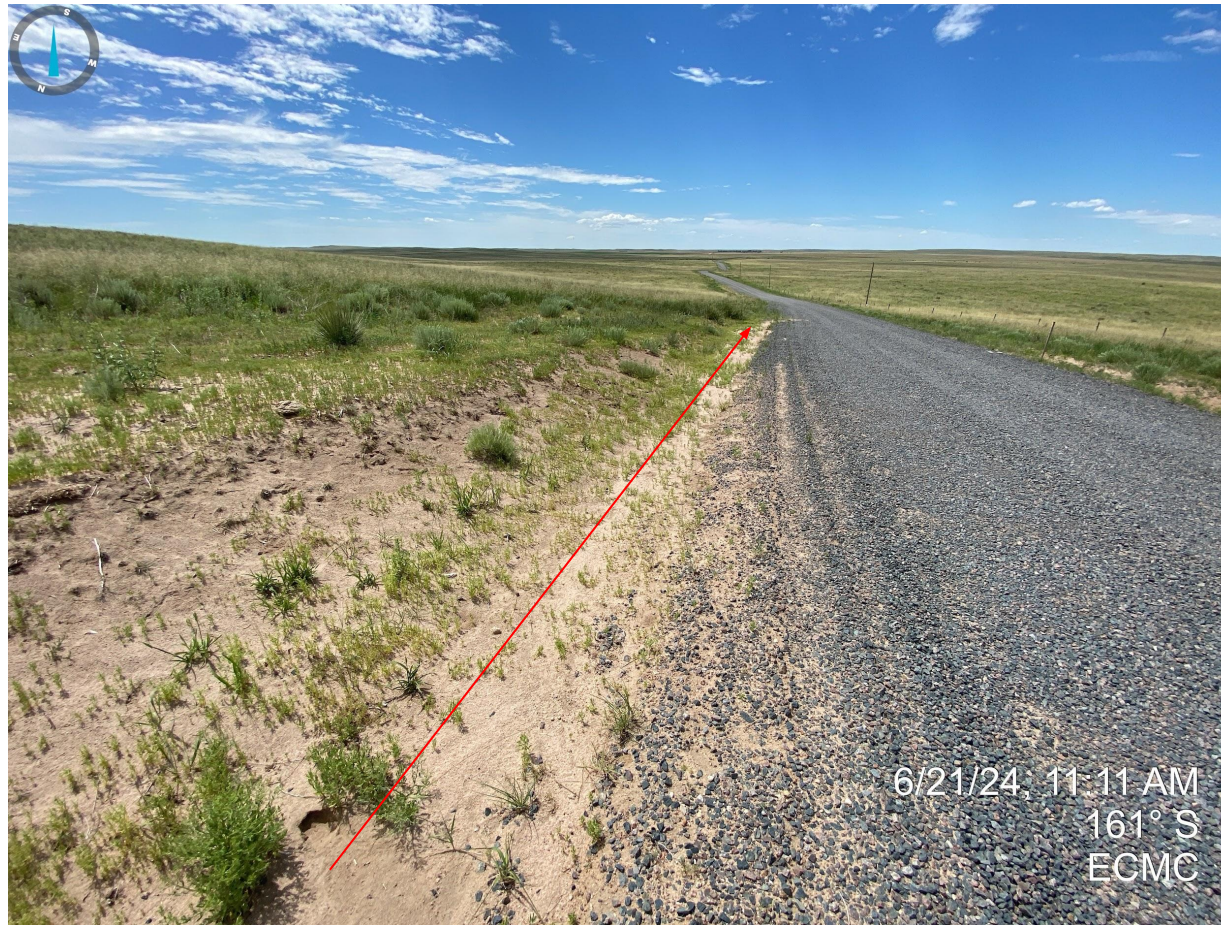
Photo 3. Evidence of sediment deposition along the eastern side of the access road. It does not appear that any repairs have been made or any additional BMPs have been installed since the previous inspection.

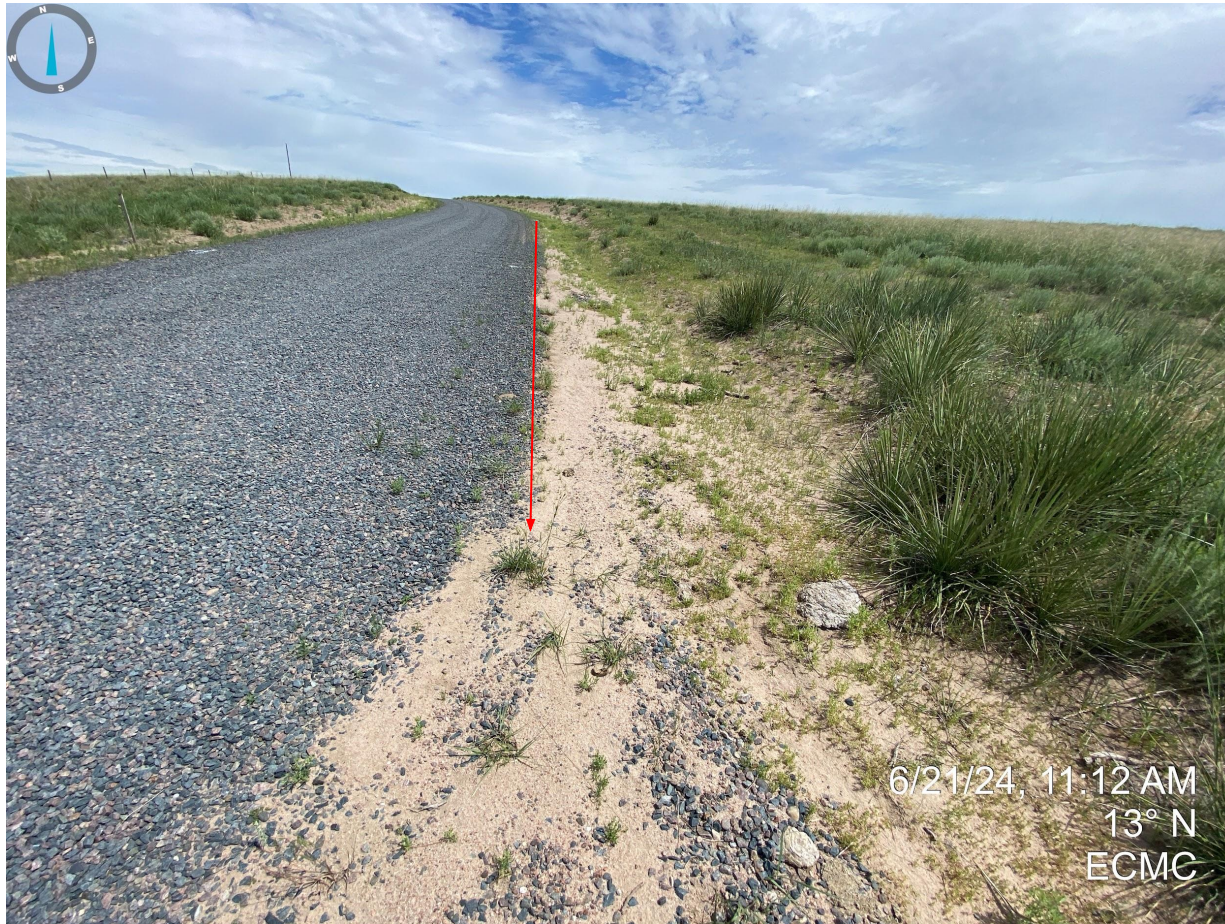
Photo 4. Facing north; see comments in Photo 3.

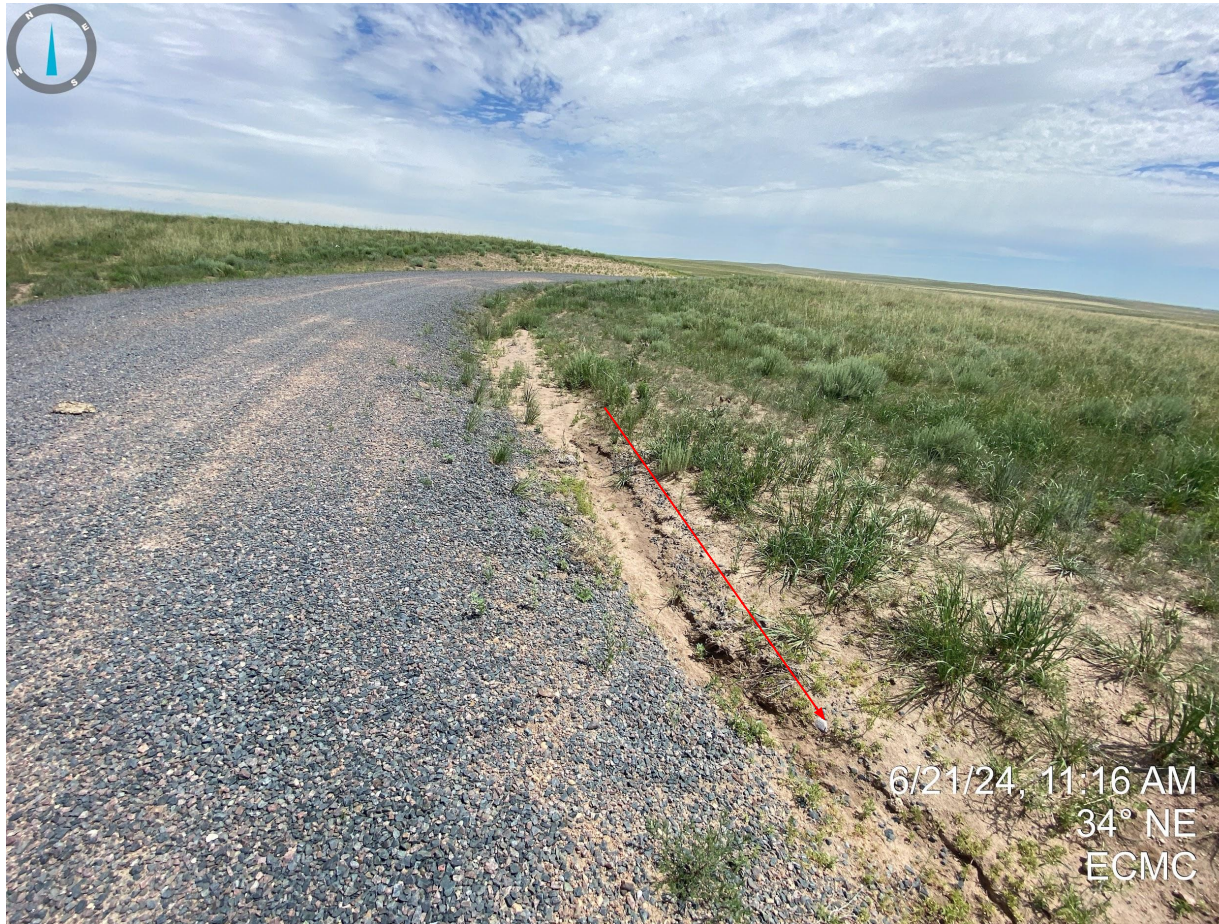
Photo 5. Erosion degradation observed along the access road. It does not appear that any repairs have been made or any additional BMPs have been installed since the previous inspection.

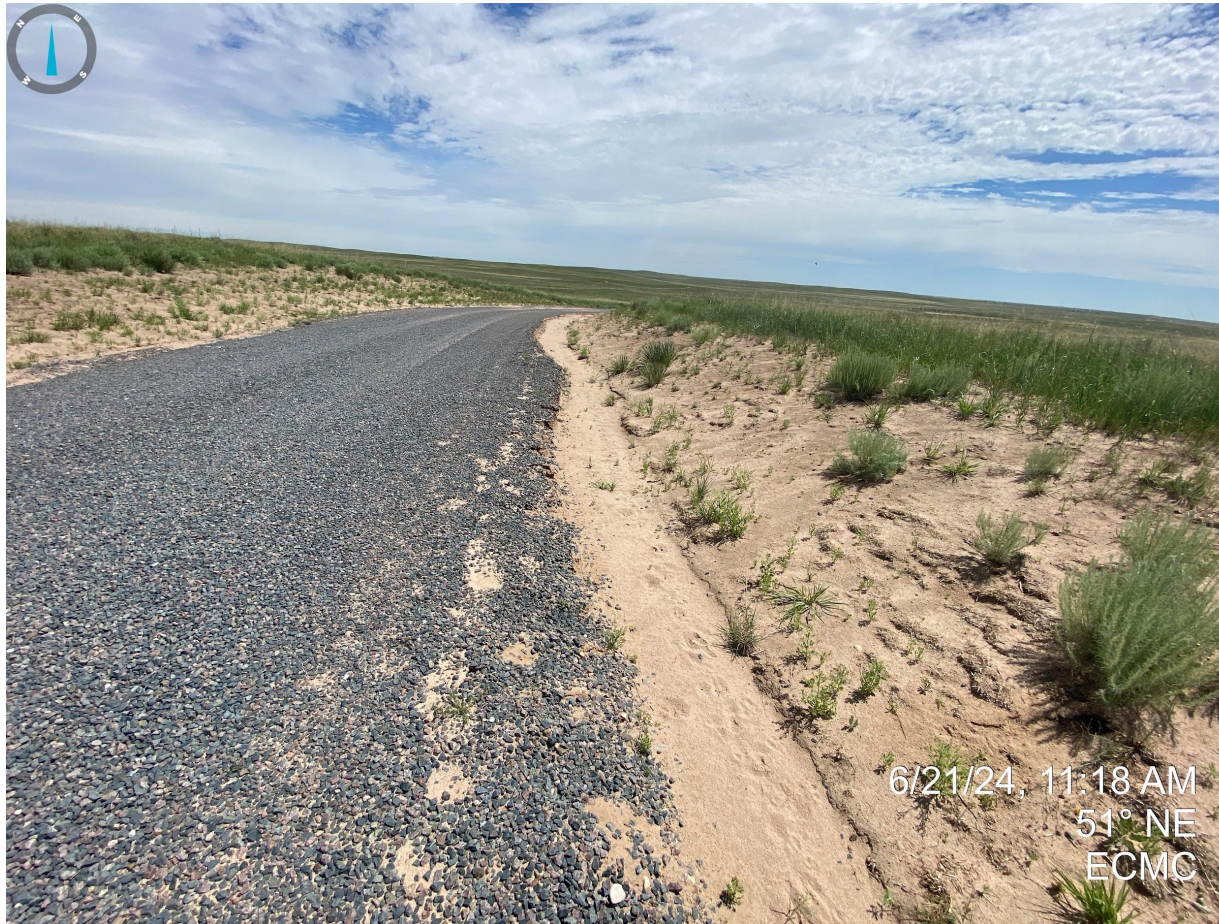
Photo 6. Erosion degradation observed along the access road and unstabilized slopes. It does not appear that any repairs have been made or any additional BMPs have been installed since the previous inspection.

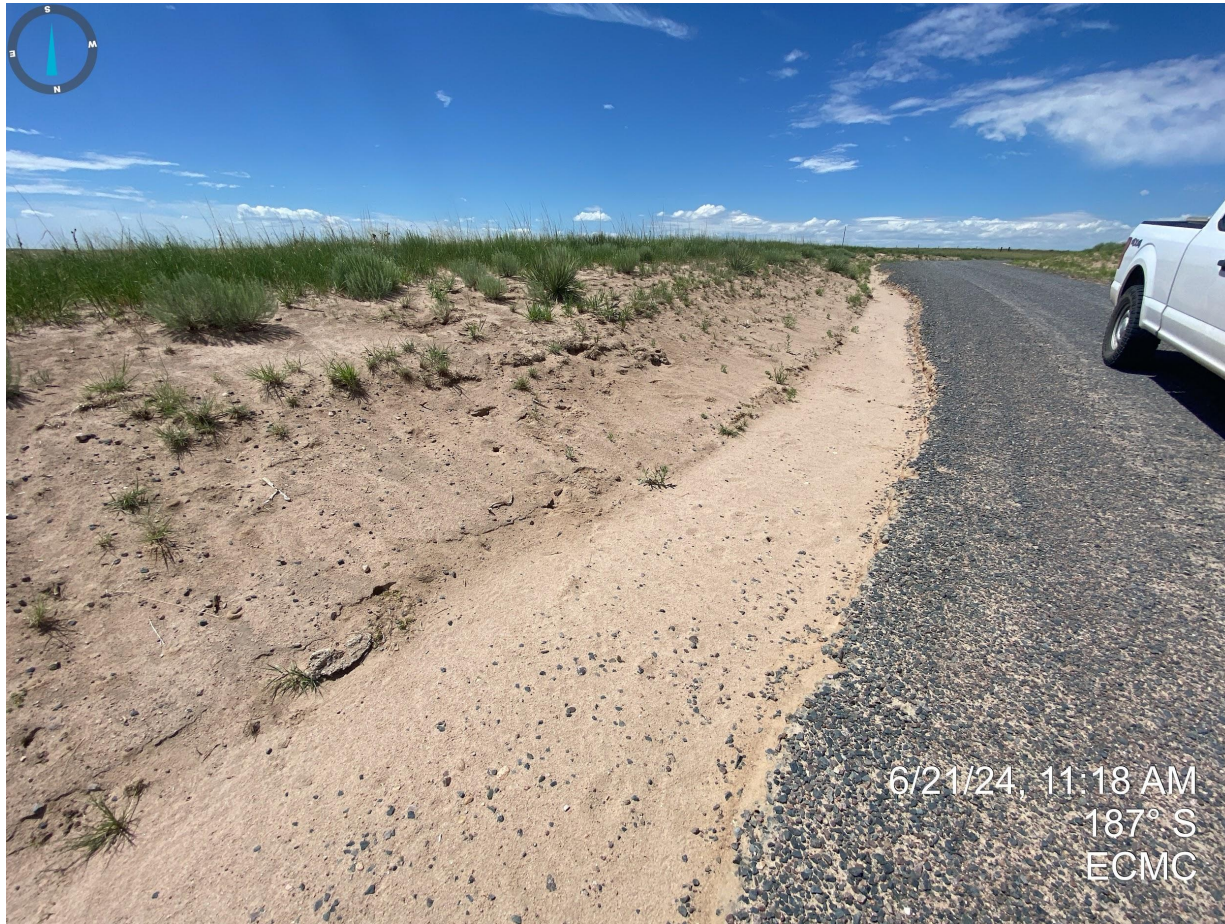
Photo 7. Continued from Photo 6, facing south.

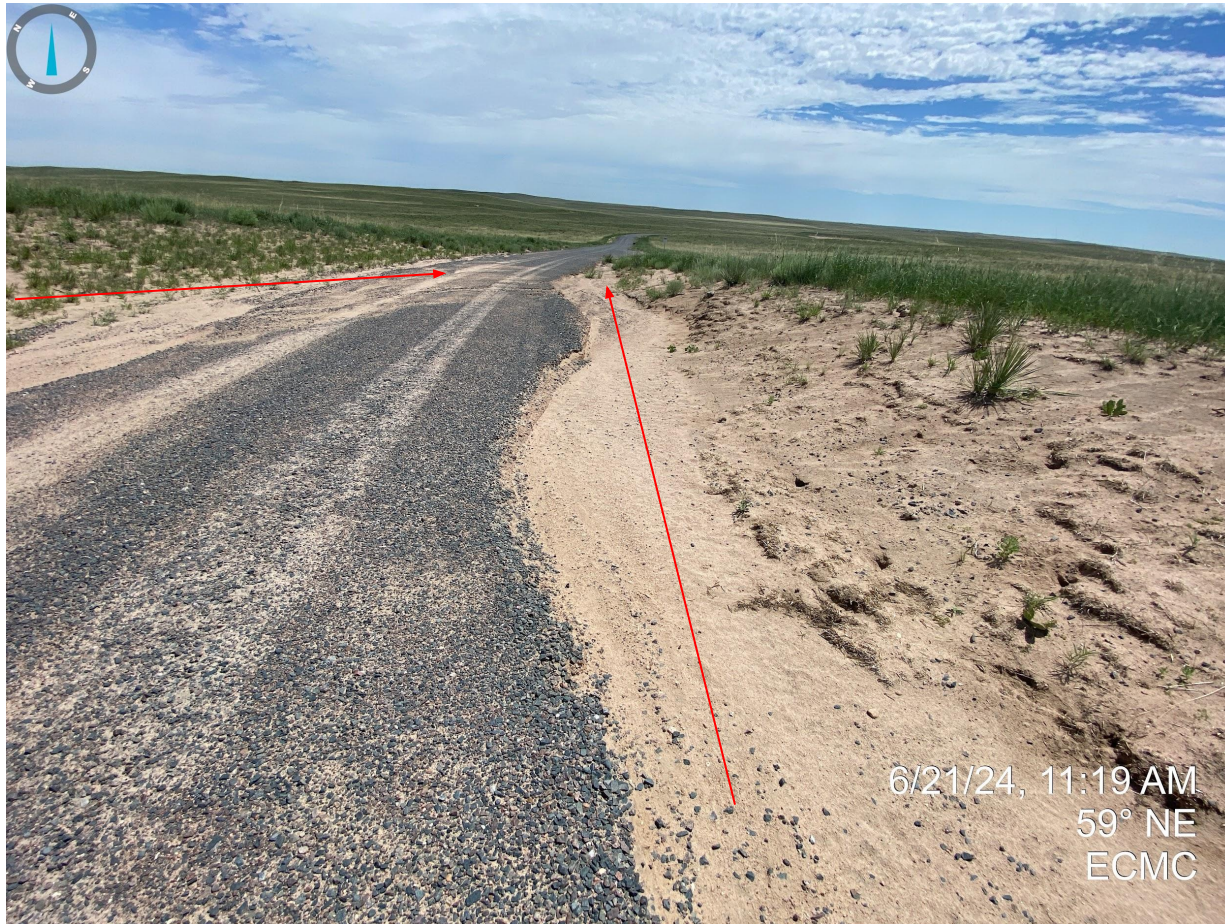
Photo 8. Continued from Photos 6 & 7; facing northeast towards the location.

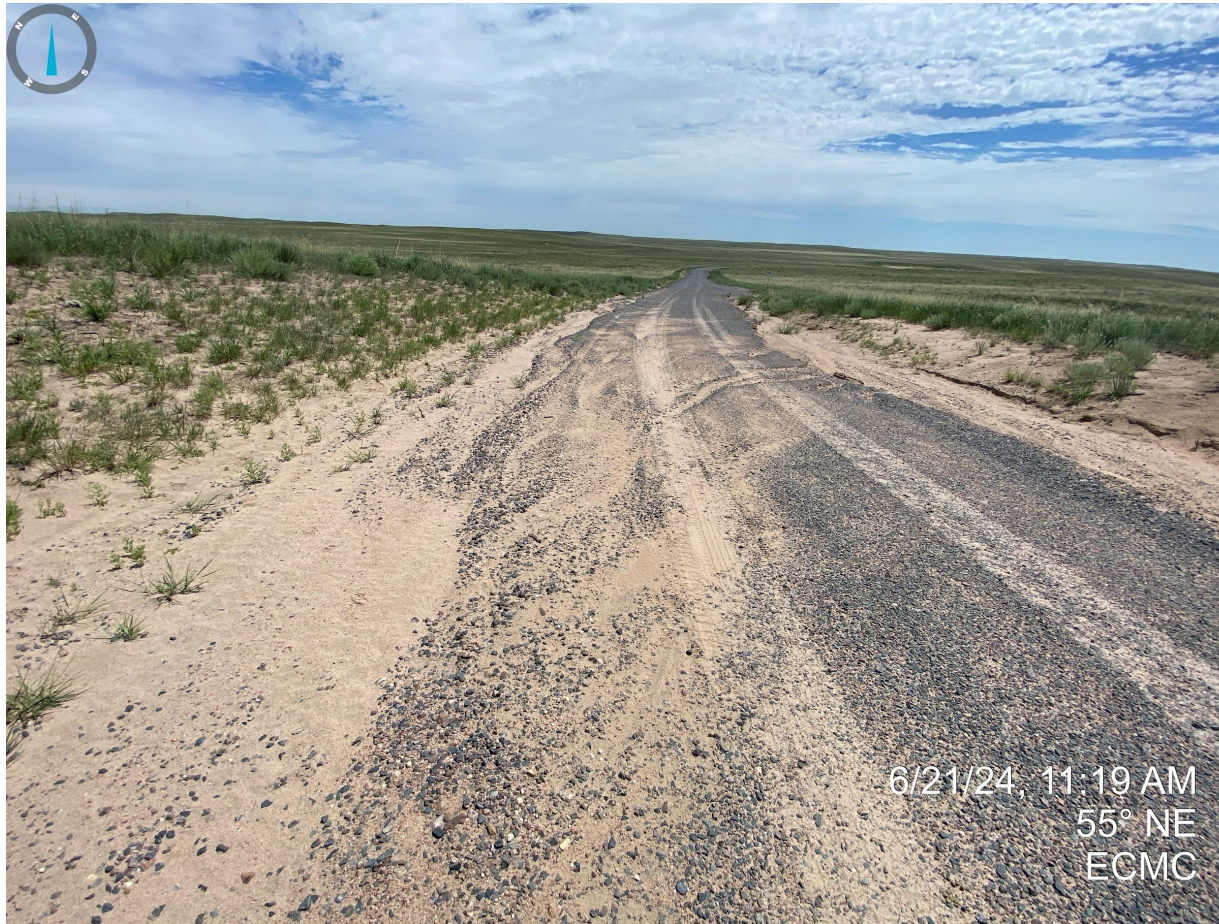
Photo 9. Continued from Photo 8; facing northeast. Sediment deposition from unstabilized soils observed on the access road. It does not appear that any repairs have been made or any additional BMPs have been installed since the previous inspection.

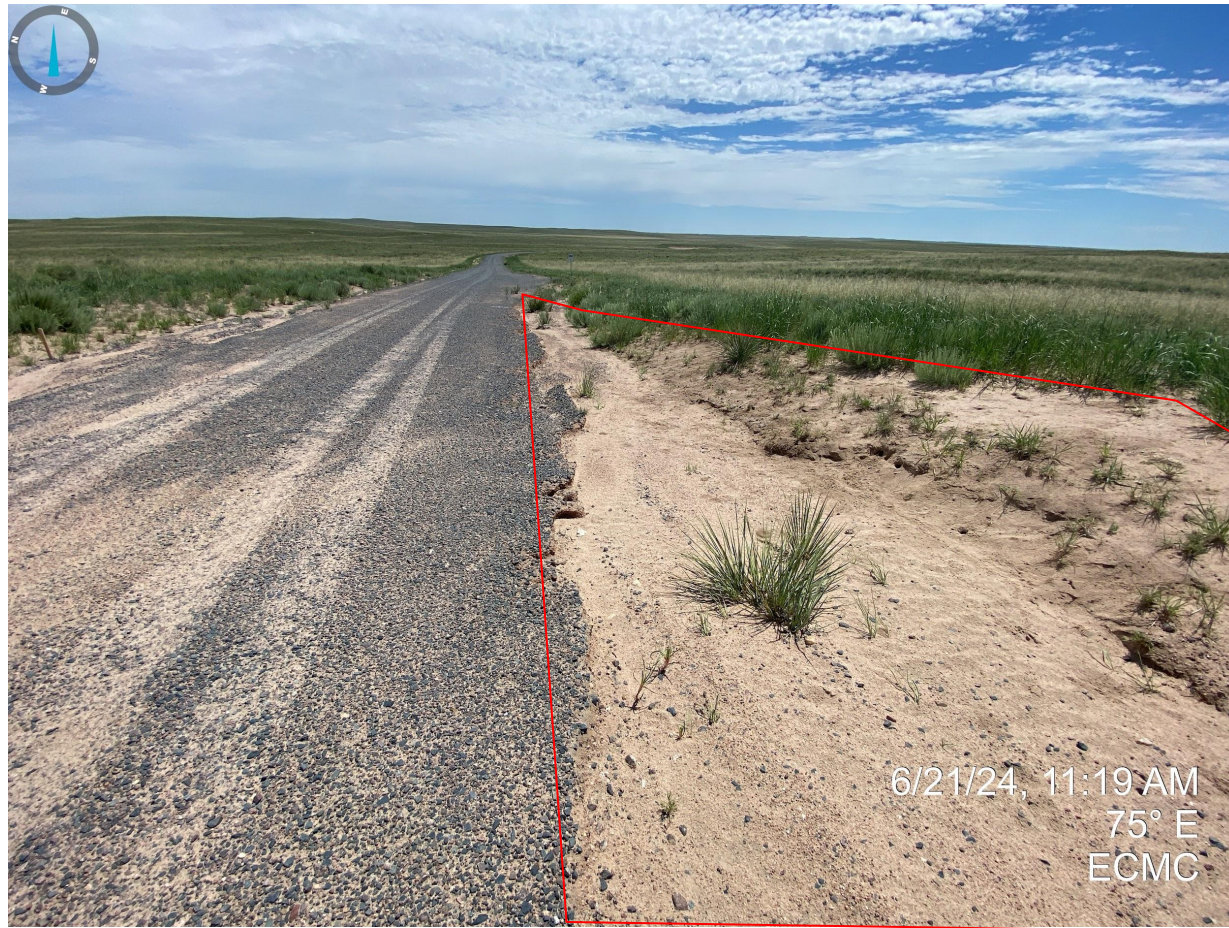
Photo 10. Erosion degradation observed along the access road and unstabilized slopes. It does not appear that any repairs have been made or any additional BMPs have been installed since the previous inspection.

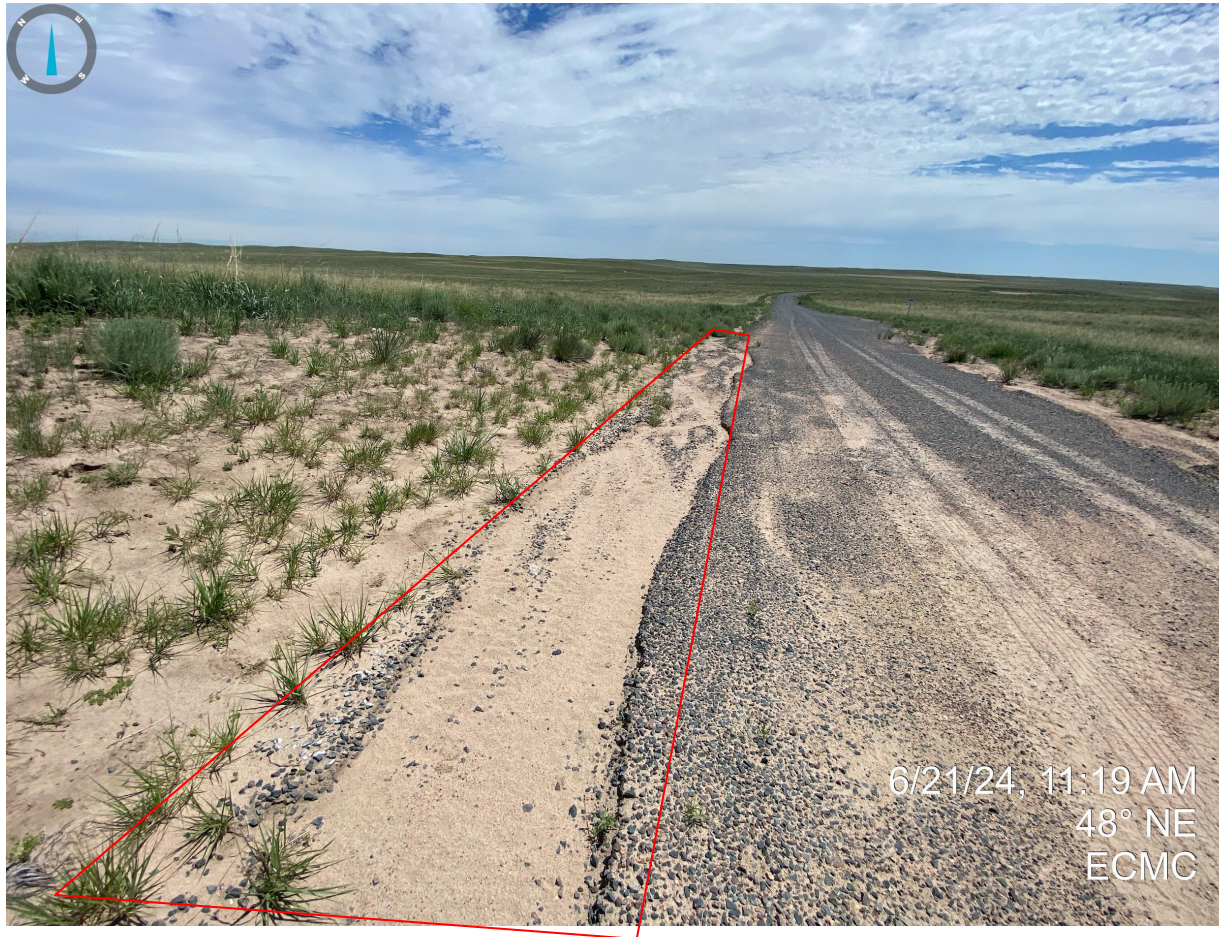
Photo 11. Erosion degradation observed along the access road and unstabilized slopes. It does not appear that any repairs have been made or any additional BMPs have been installed since the previous inspection.

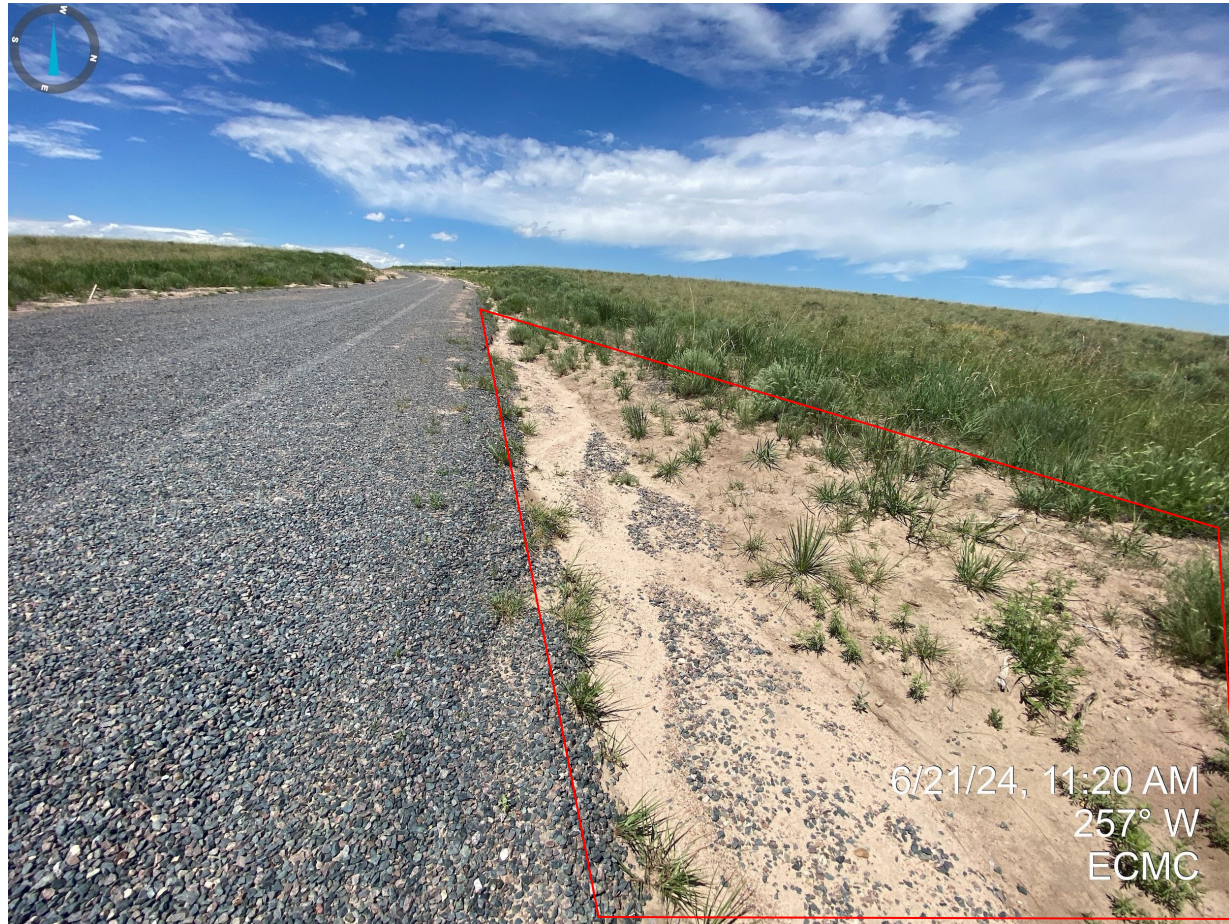
Photo 12. Continued from Photo 11; facing west.

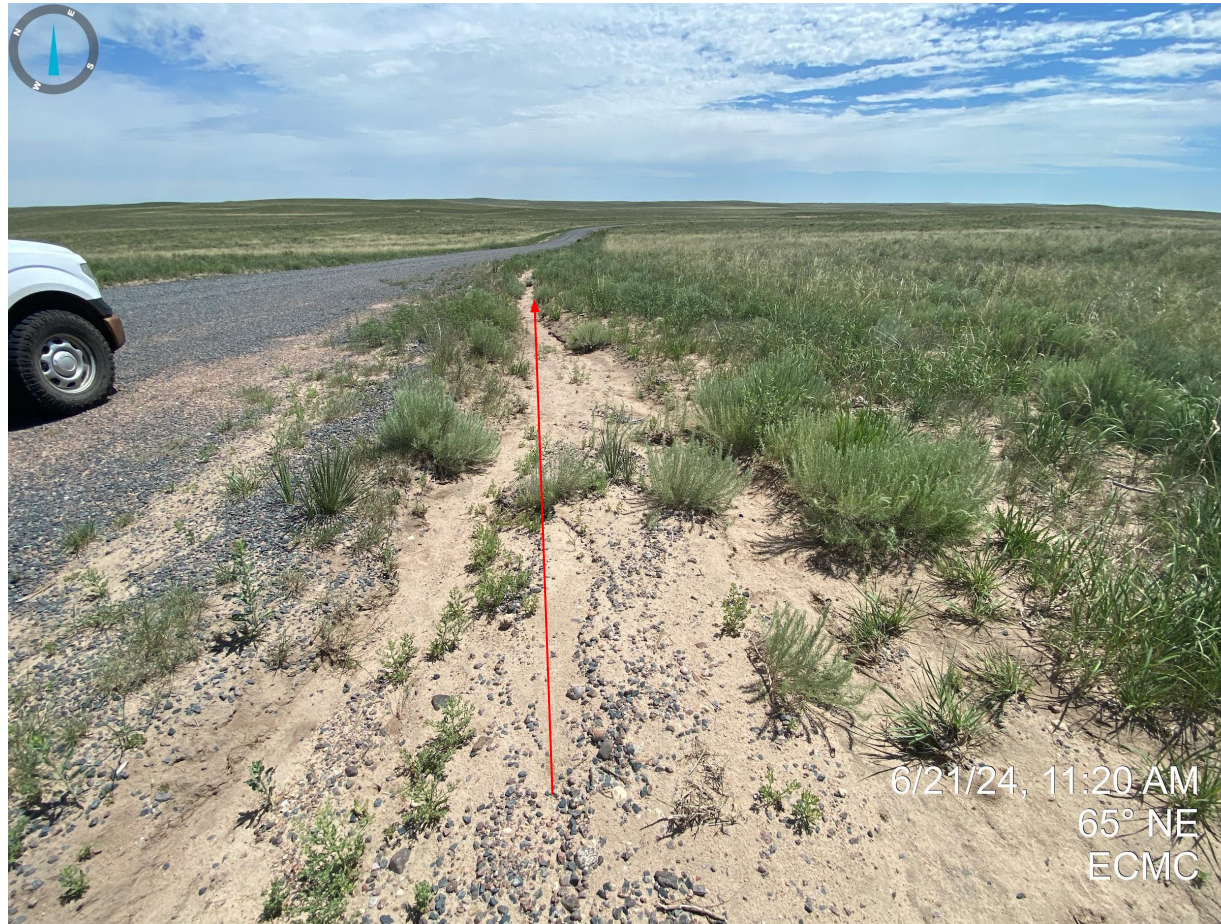
Photo 13. Erosion degradation observed along the access road. It does not appear that any repairs have been made or any additional BMPs have been installed since the previous inspection.

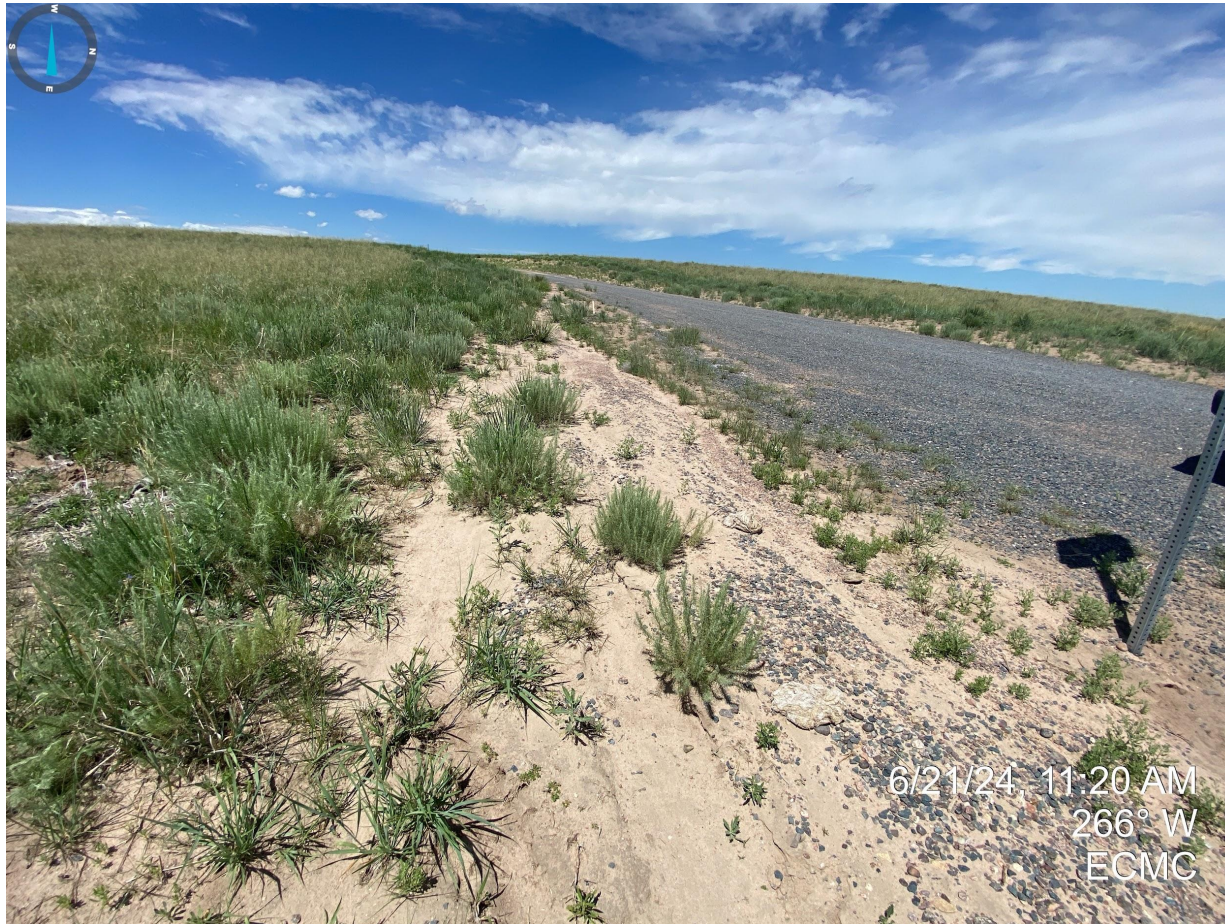
Photo 14. Continued from Photo 13; facing west.

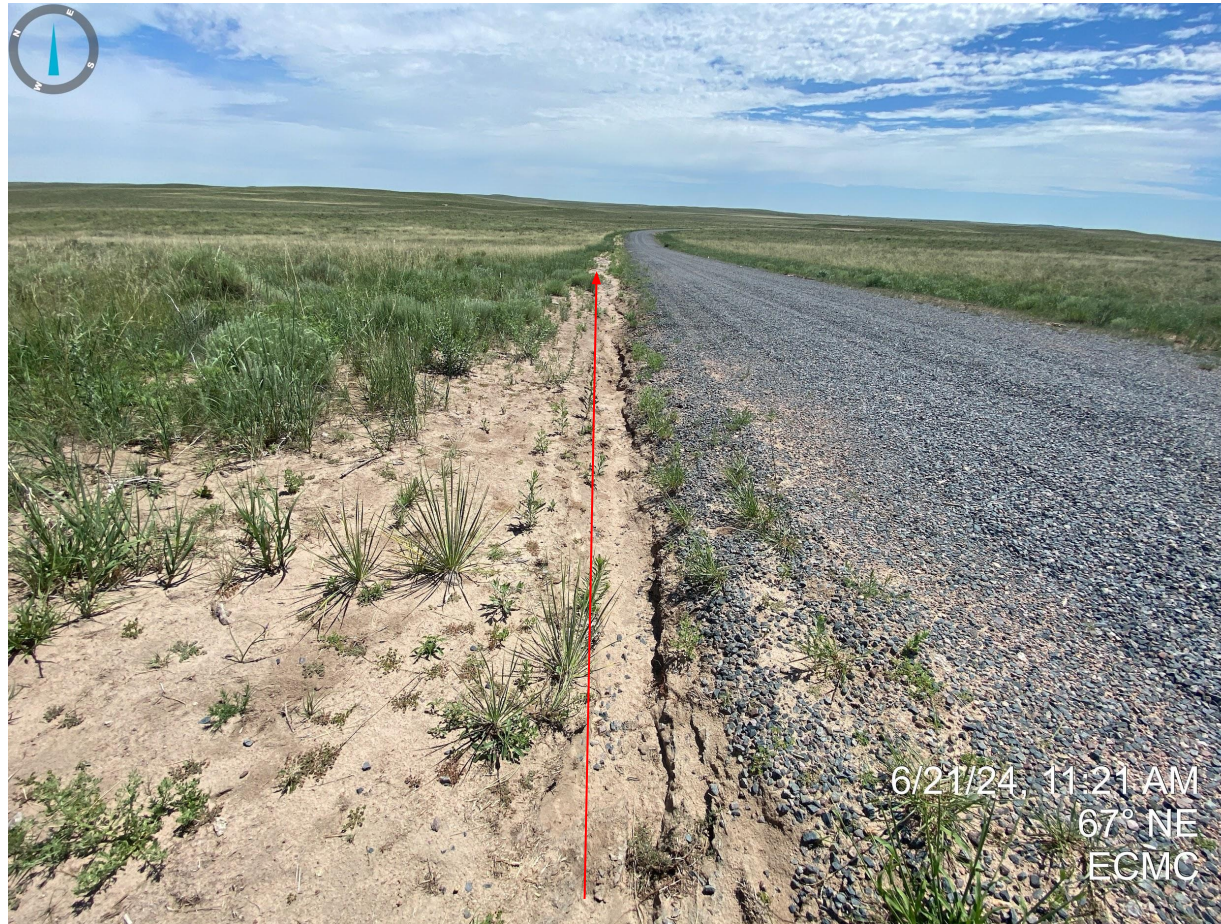
Photo 15. Erosion degradation observed along the access road. It does not appear that any repairs have been made or any additional BMPs have been installed since the previous inspection.

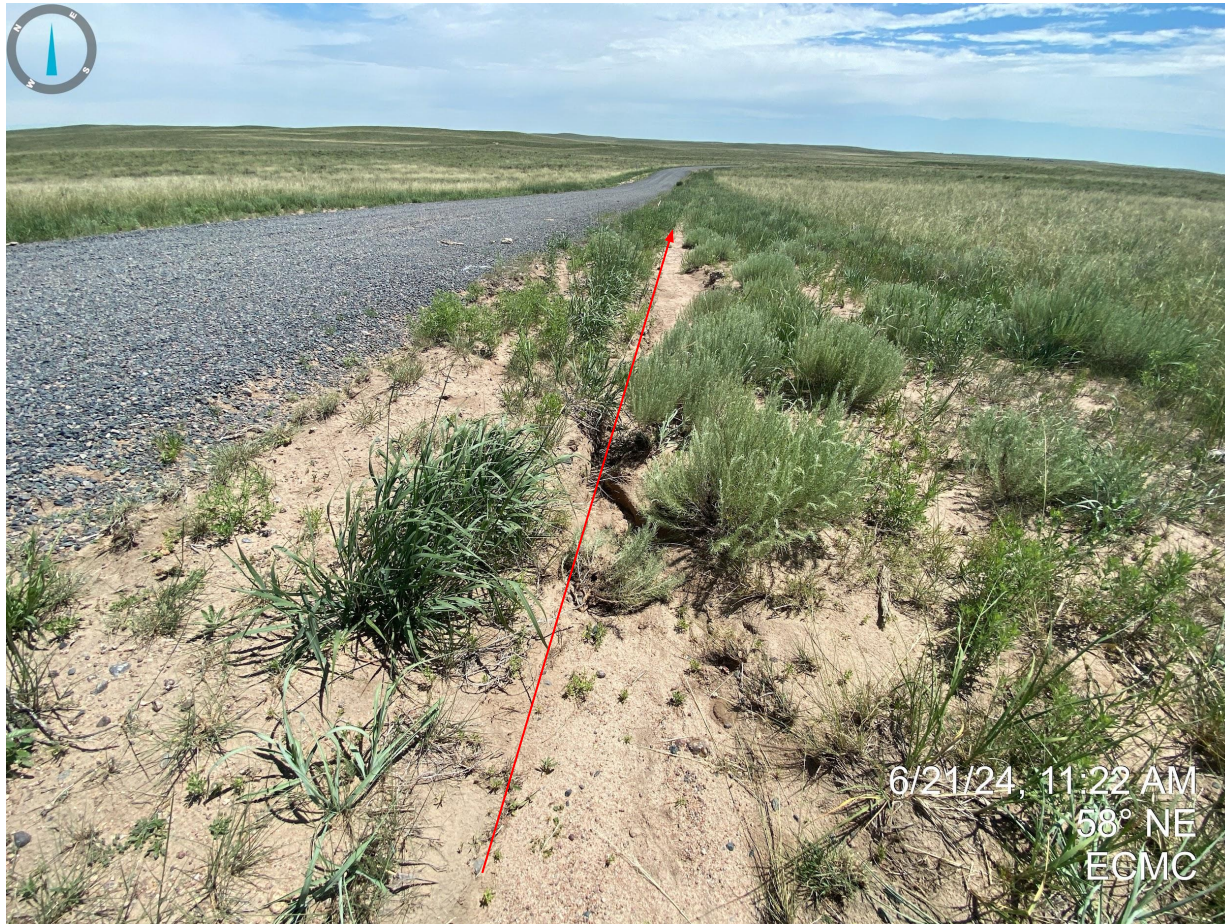
Photo 16. Erosion degradation observed along the access road. It does not appear that any repairs have been made or any additional BMPs have been installed since the previous inspection.

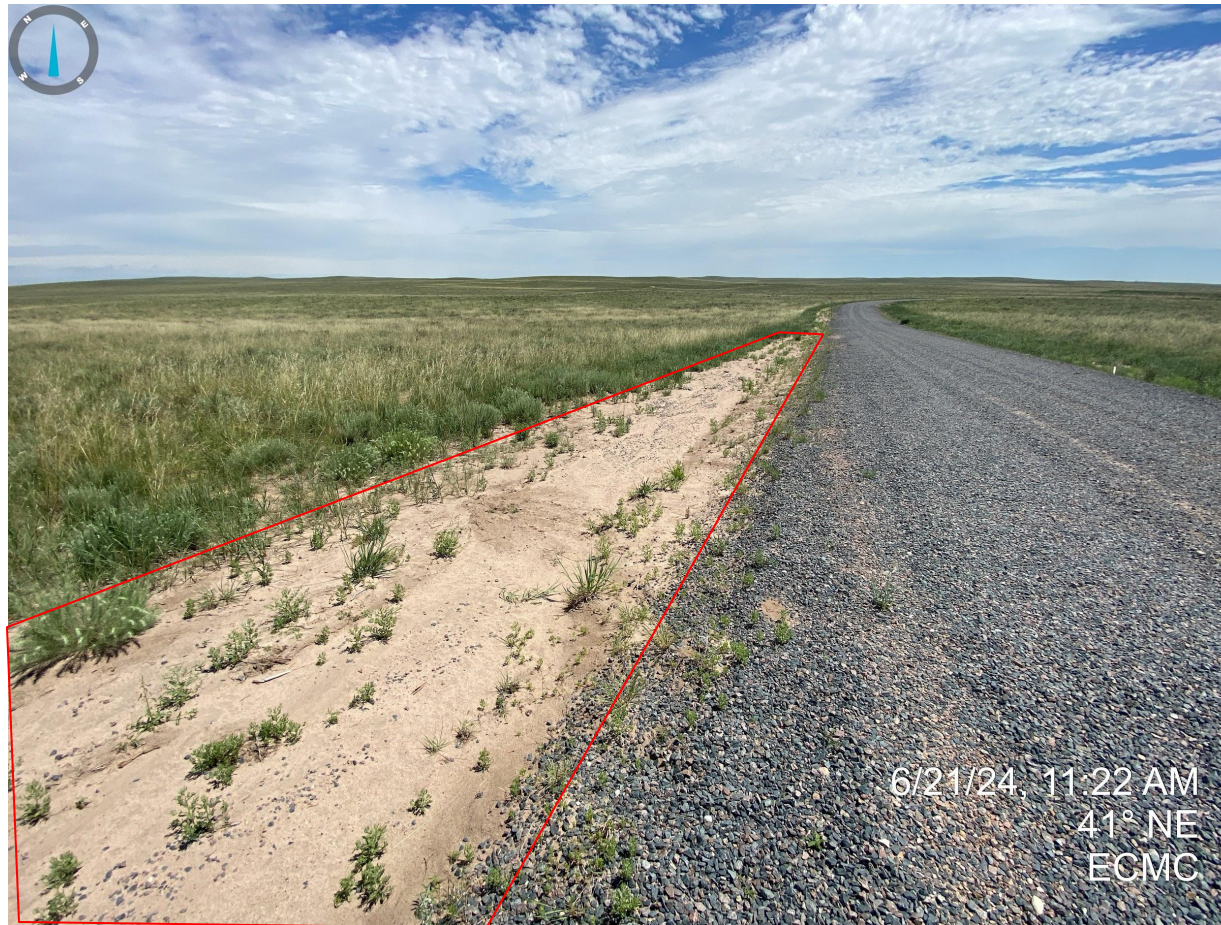
Photo 17. Erosion degradation and sediment transport observed along the access road. It does not appear that any repairs have been made or any additional BMPs have been installed since the previous inspection.

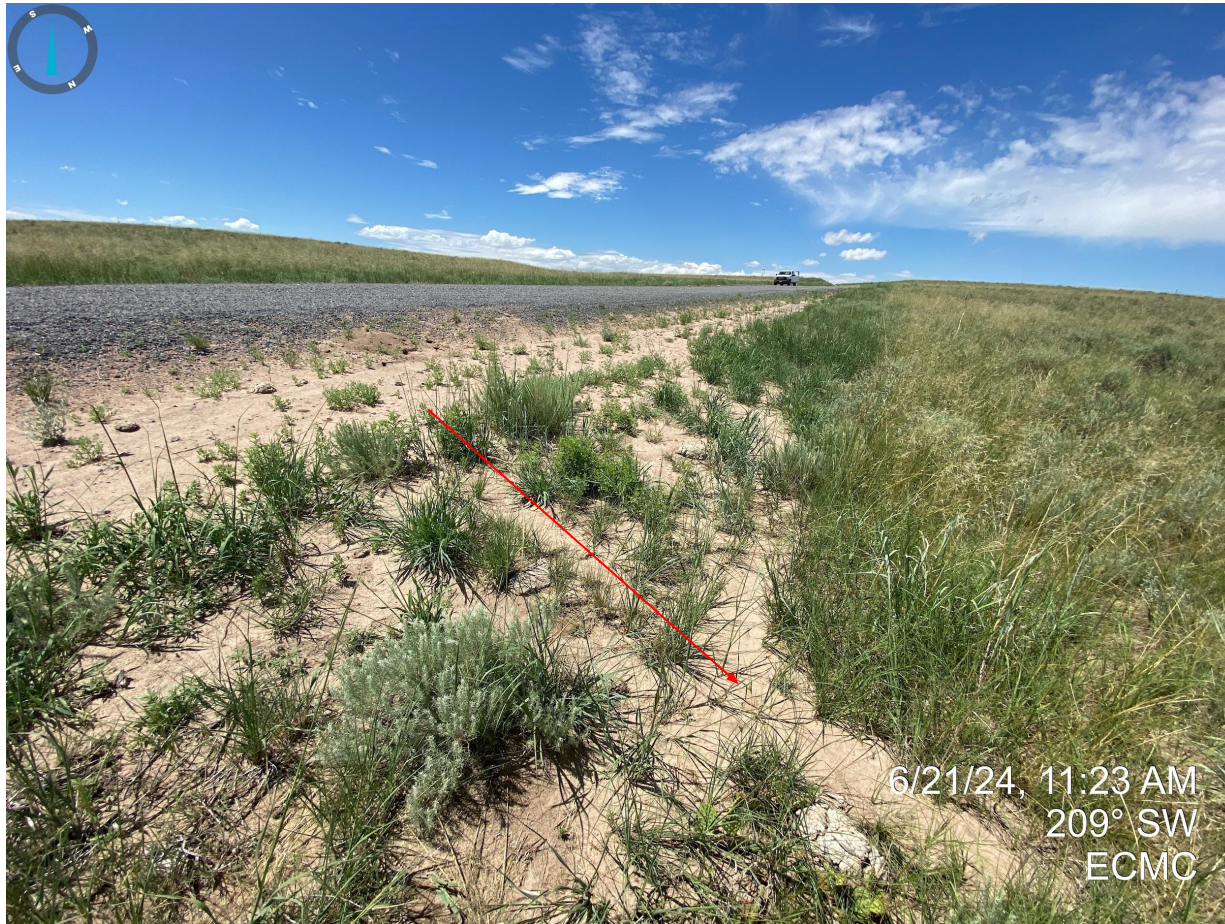
Photo 18. Continued from Photo 17; facing southwest. Photo illustrates off-location sediment deposition.

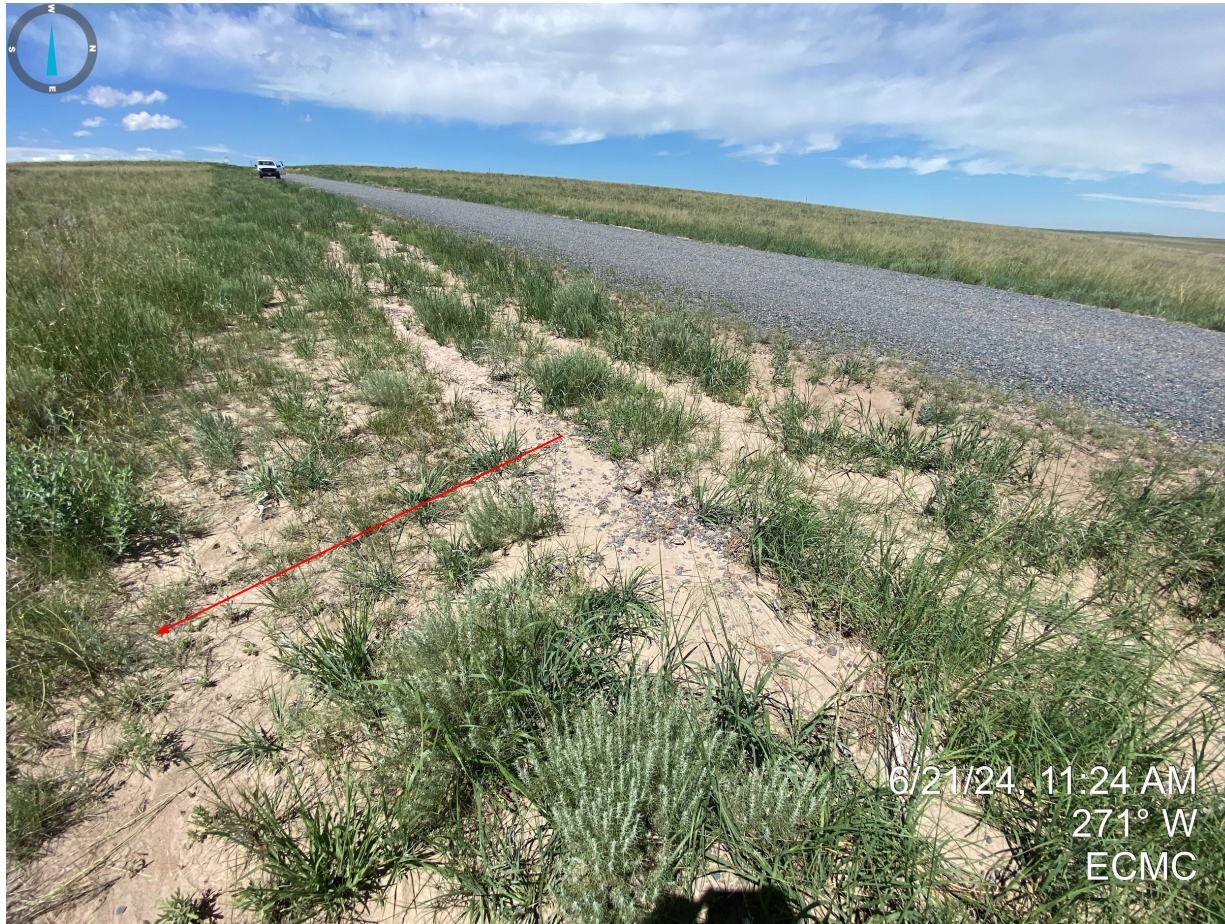
Photo 19. Continued from Photo 18; south side of the road, facing west.
