Interim Reclamation and Stormwater Inspection

Date: 06/21/2024

Operator: DENOVA SEQUESTRATION LLC - 10790

Inspection Document #: 708201343

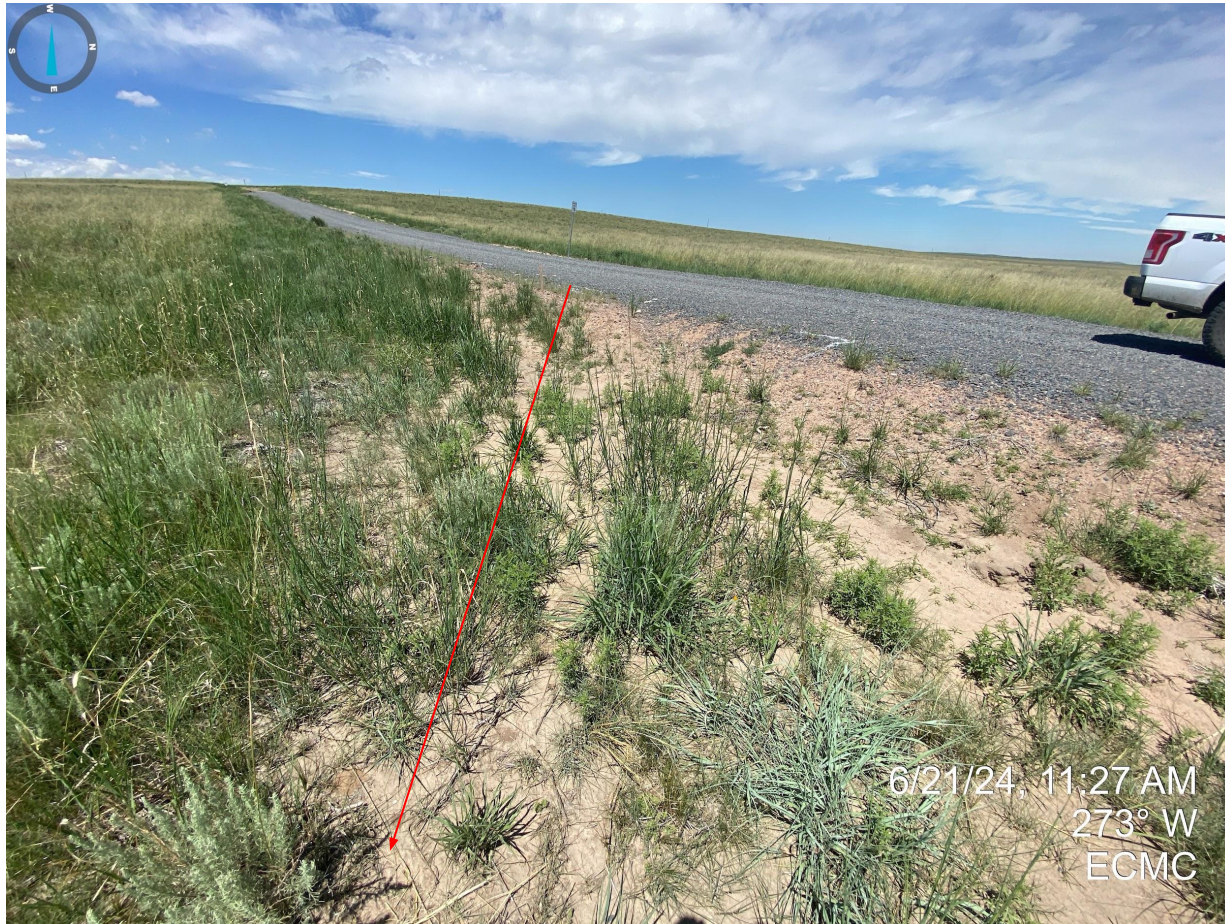
Photo 20. Erosion degradation and sediment transport observed along the access road. It does not appear that any repairs have been made or any additional BMPs have been installed since the previous inspection.

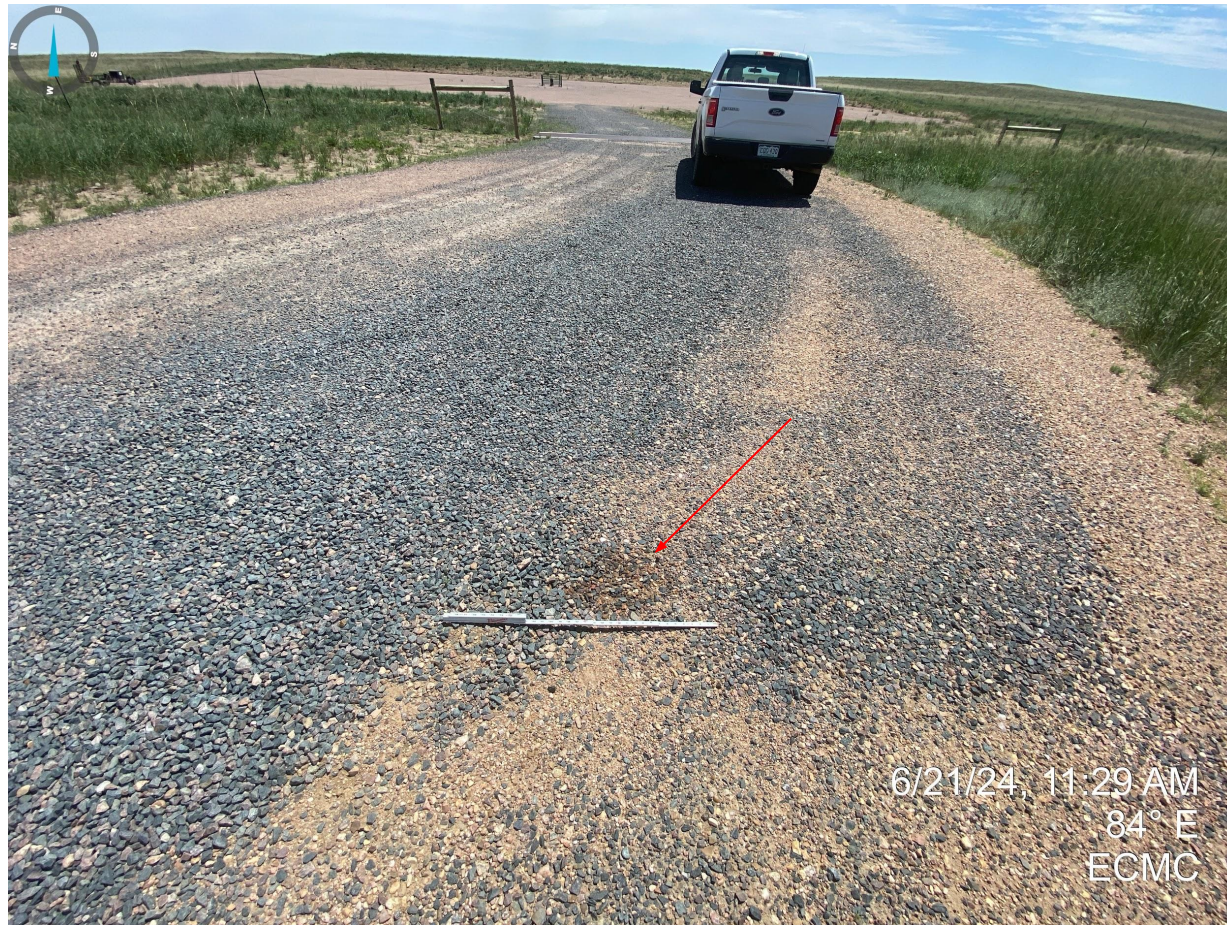
Photo 21. Stained soil observed near the drilling pad entrance.

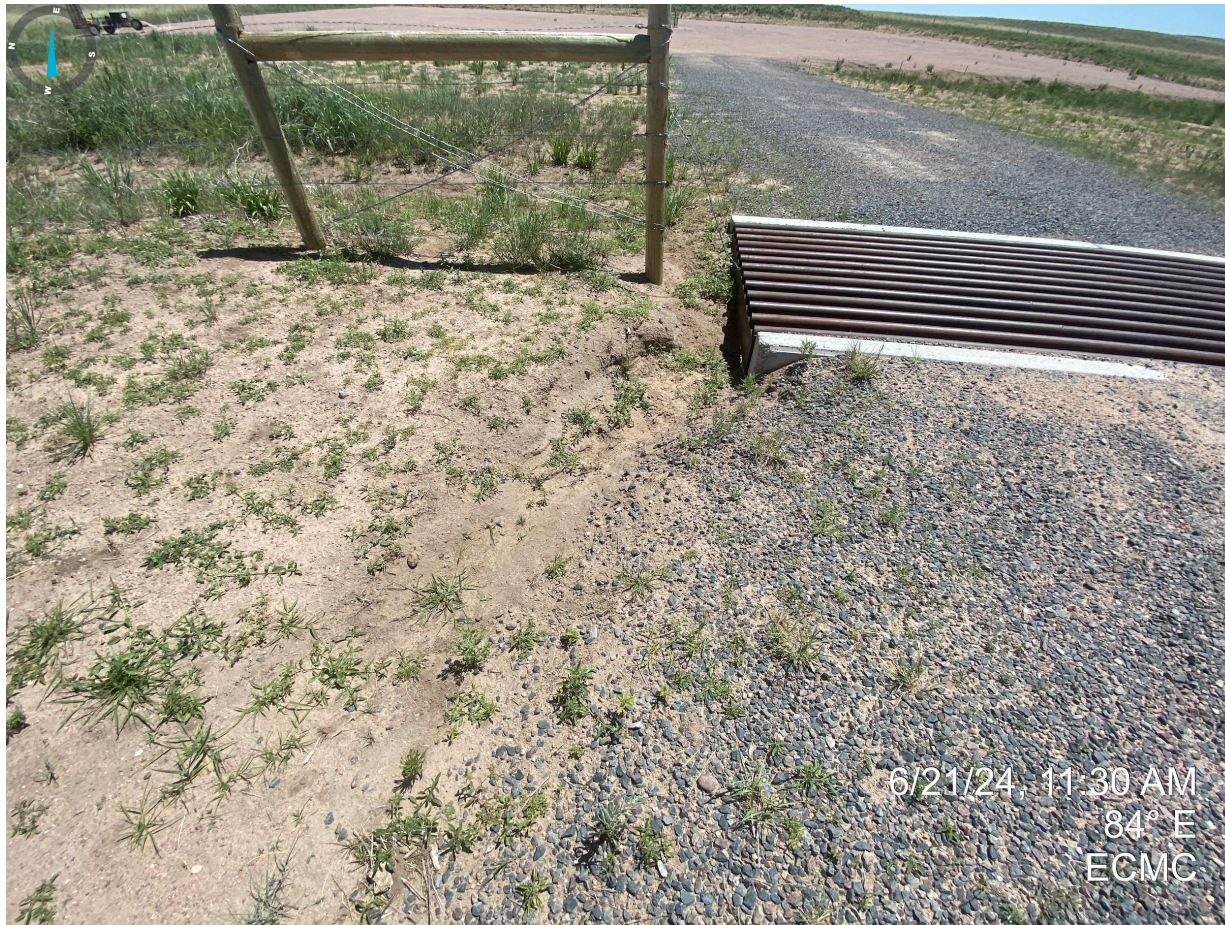
Photo 22. Erosion degradation observed near the cattle guard. It does not appear that any repairs have been made or any additional BMPs have been installed since the previous inspection.

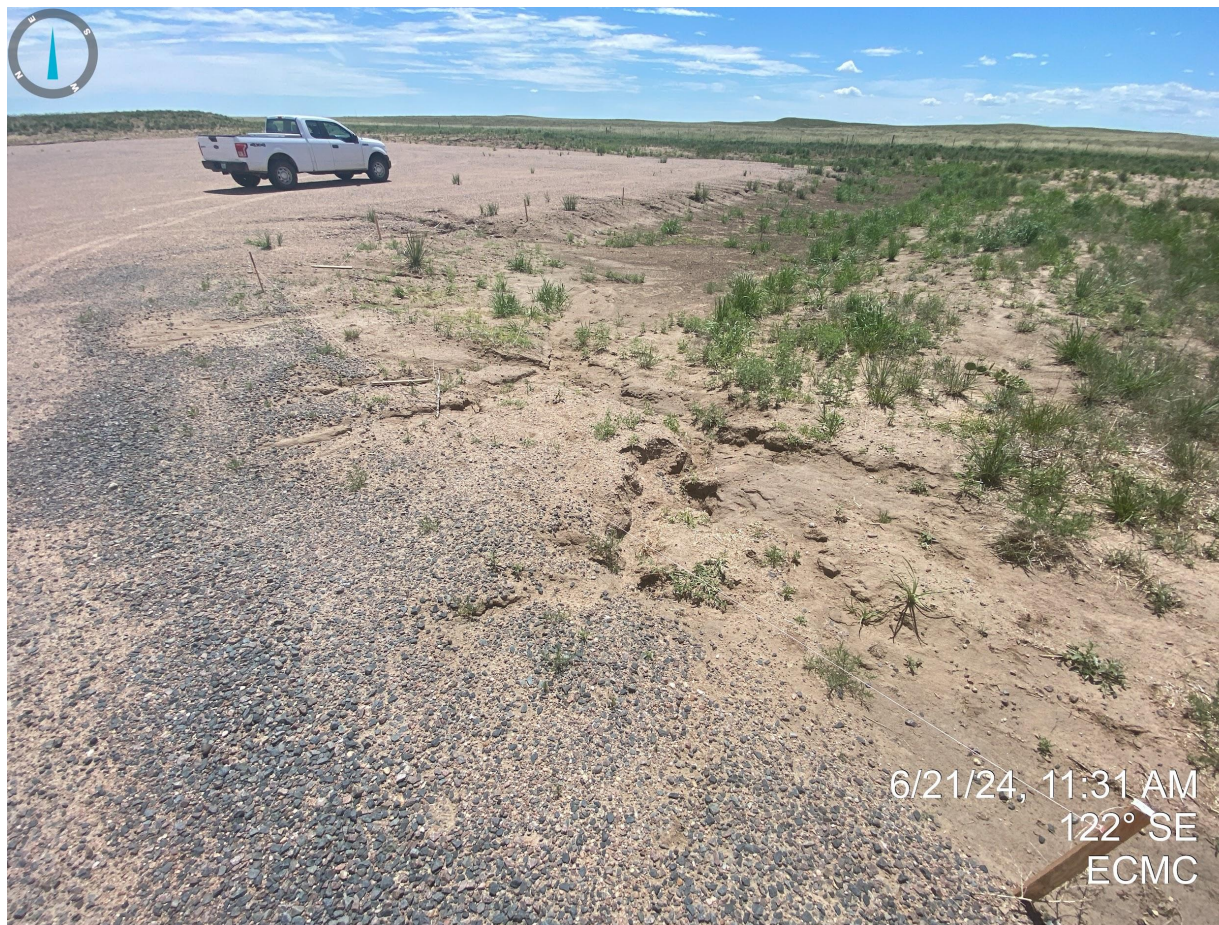
Photo 23. Erosion degradation originating from the drilling pad. It does not appear that any repairs have been made or any additional BMPs have been installed since the previous inspection.

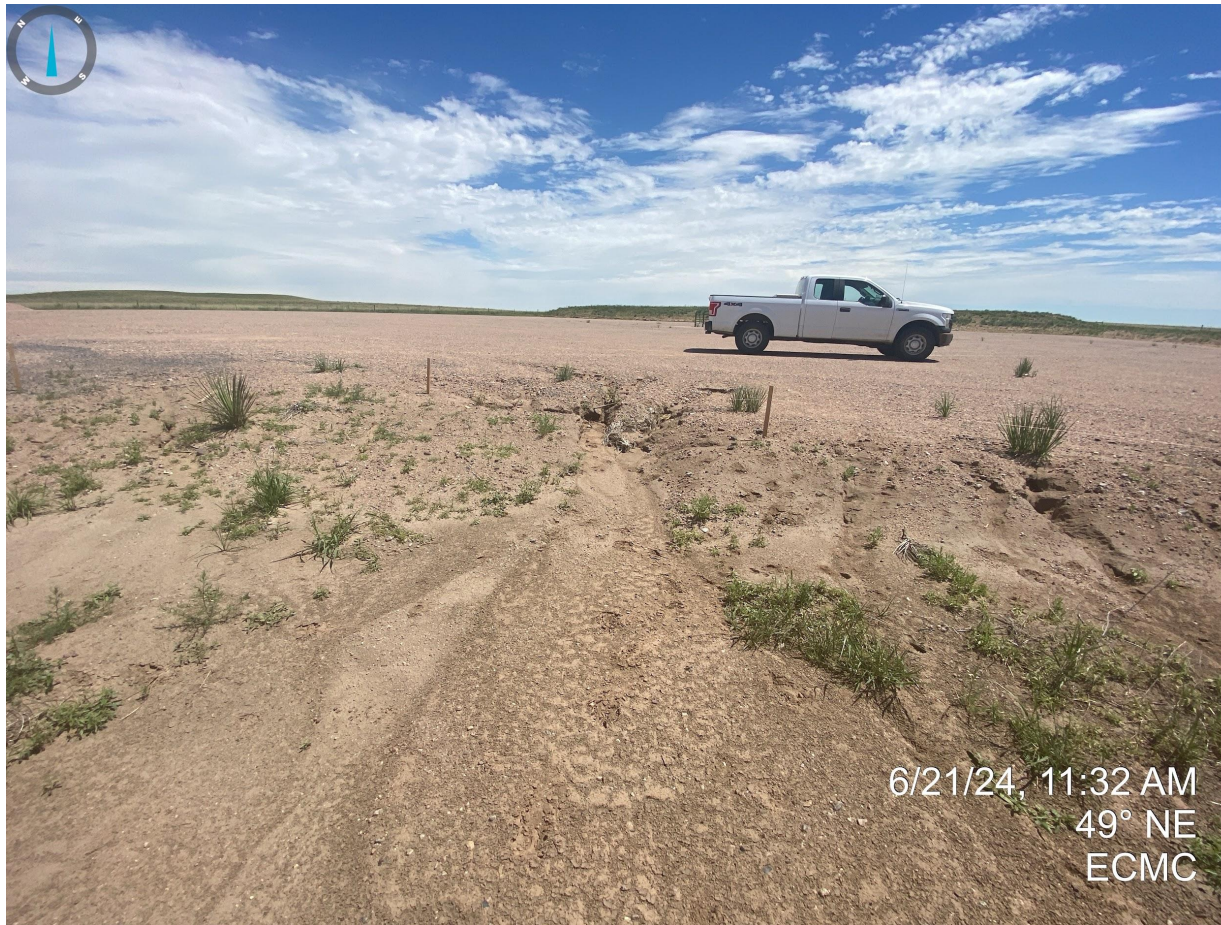
Photo 24. Erosion degradation originating from the drilling pad. It does not appear that any repairs have been made or any additional BMPs have been installed since the previous inspection.

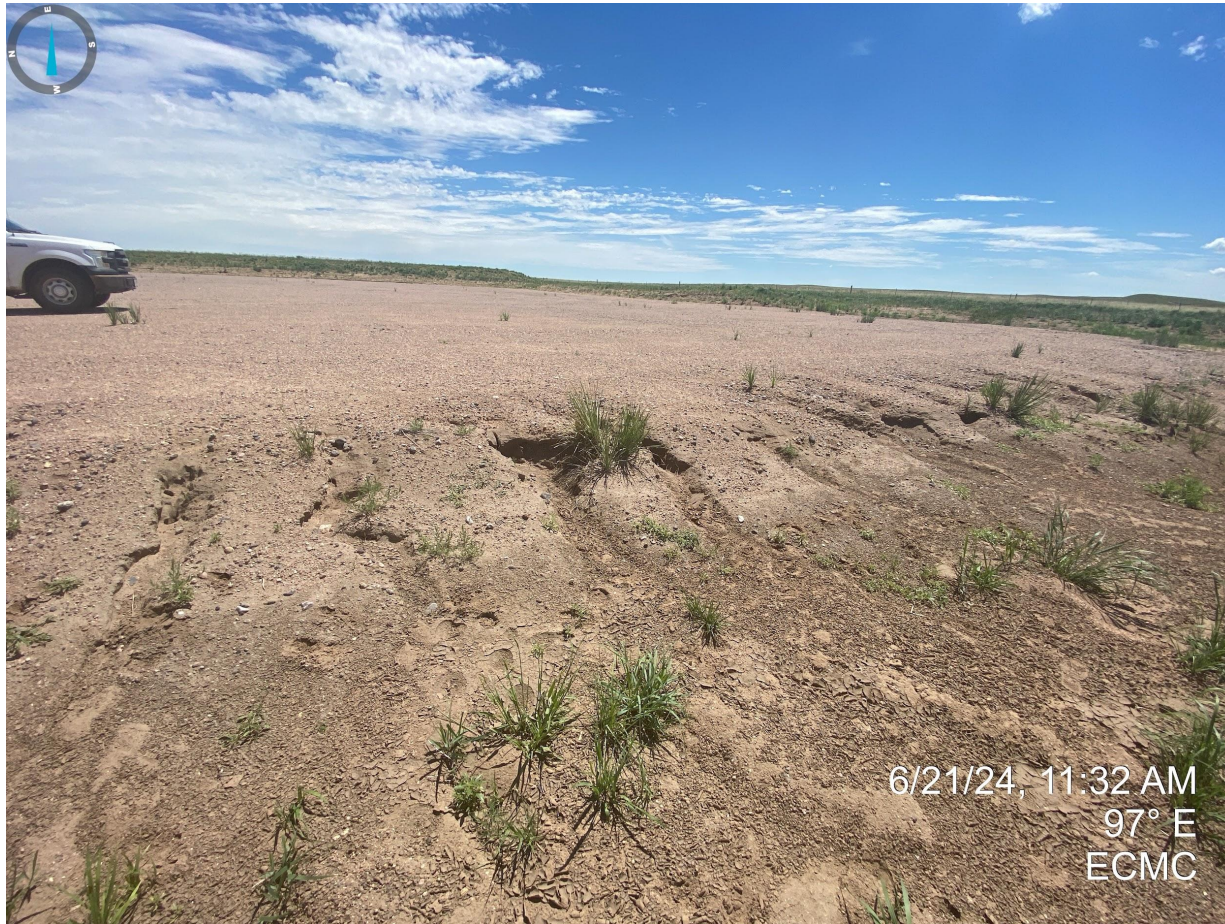
Photo 25. Erosion degradation originating from the drilling pad. It does not appear that any repairs have been made or any additional BMPs have been installed since the previous inspection.

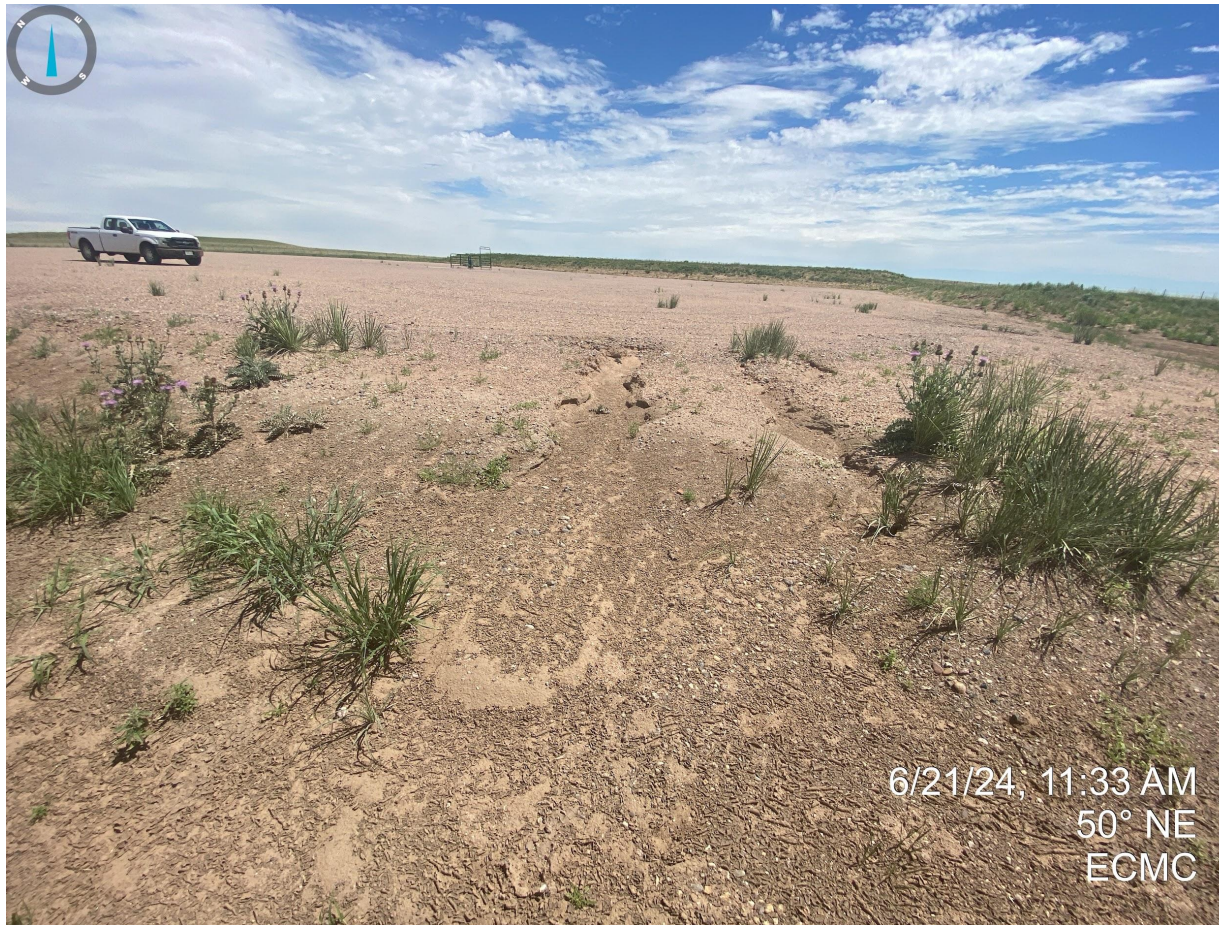
Photo 26. Erosion degradation originating from the drilling pad. It does not appear that any repairs have been made or any additional BMPs have been installed since the previous inspection.

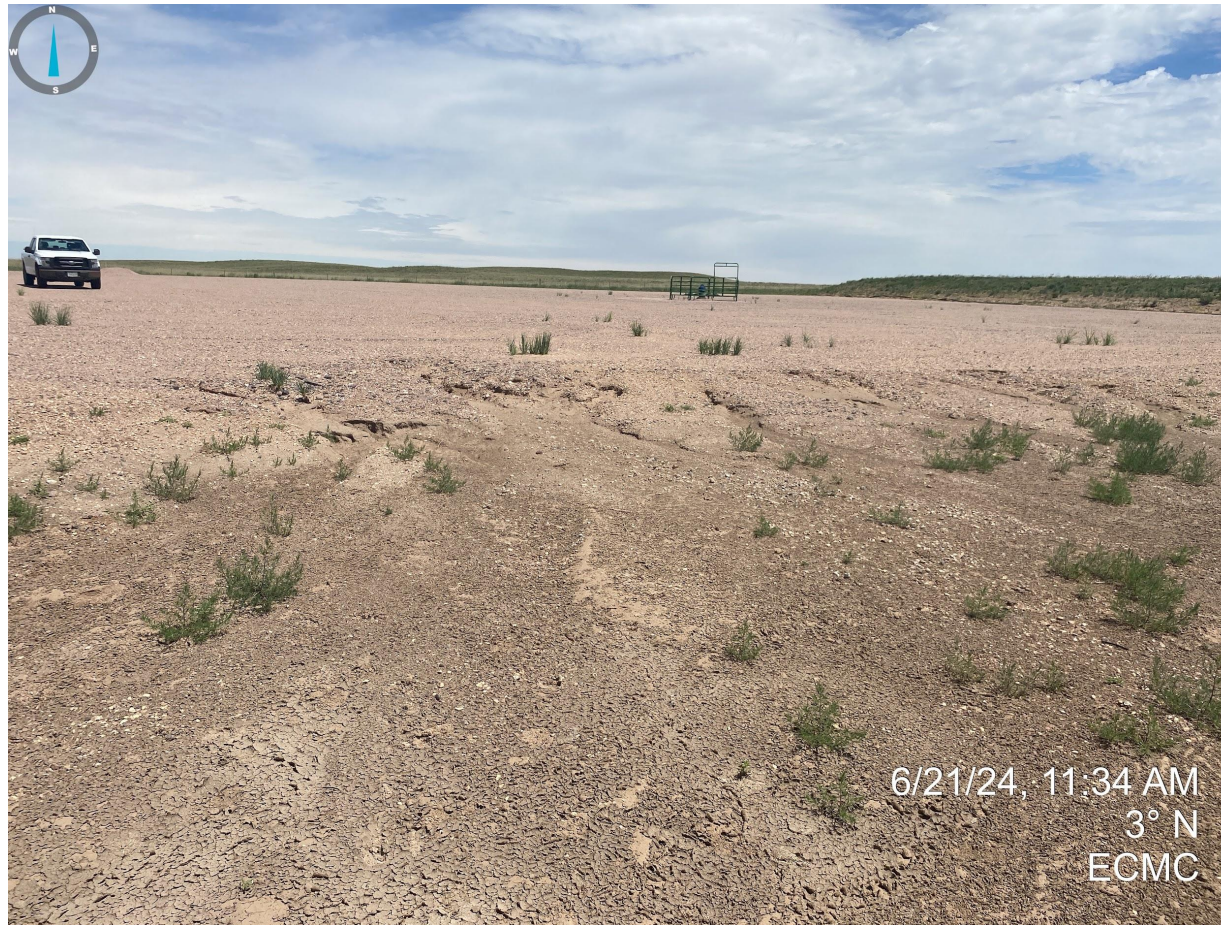
Photo 27. Erosion degradation originating from the drilling pad. It does not appear that any repairs have been made or any additional BMPs have been installed since the previous inspection.

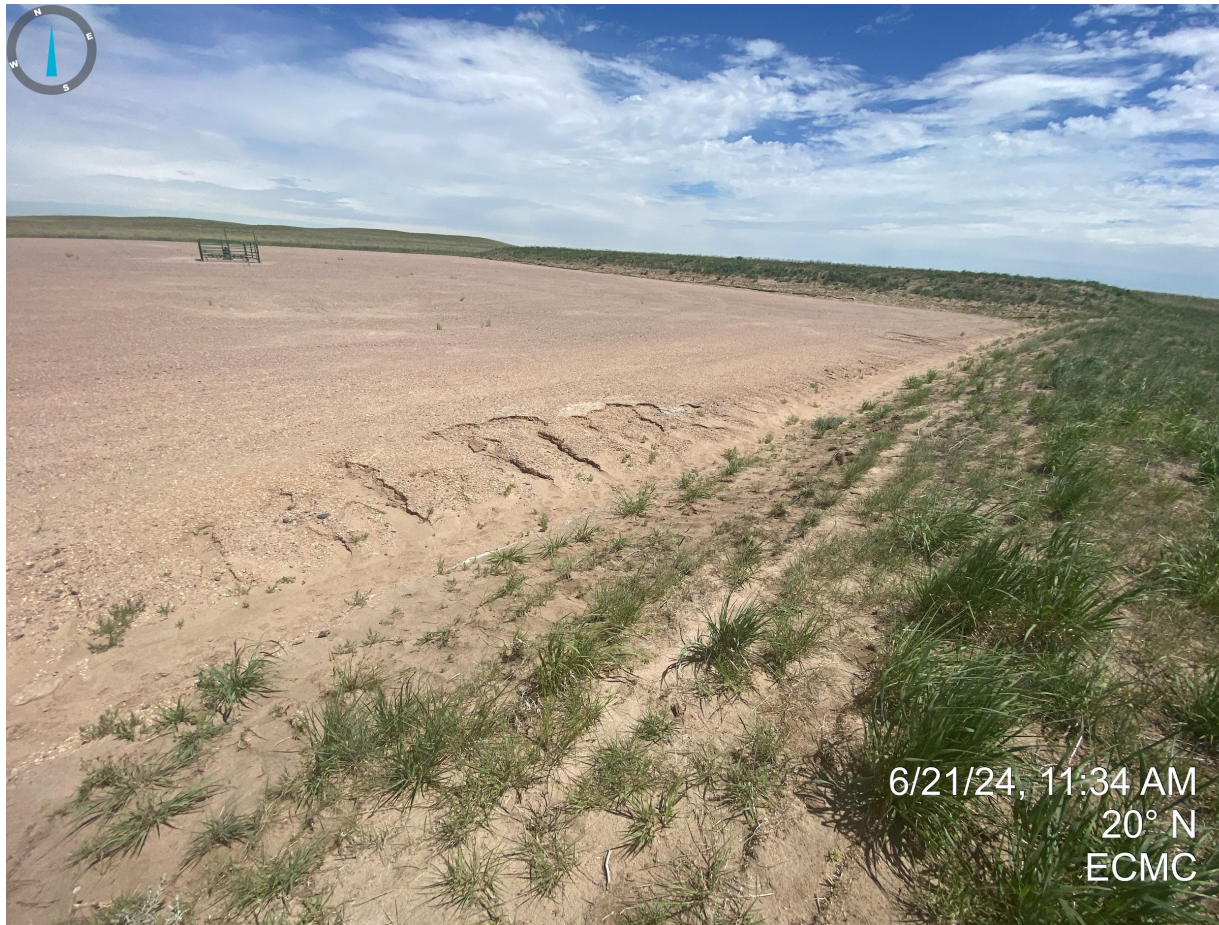
Photo 28. Erosion degradation originating from the drilling pad. It does not appear that any repairs have been made or any additional BMPs have been installed since the previous inspection.

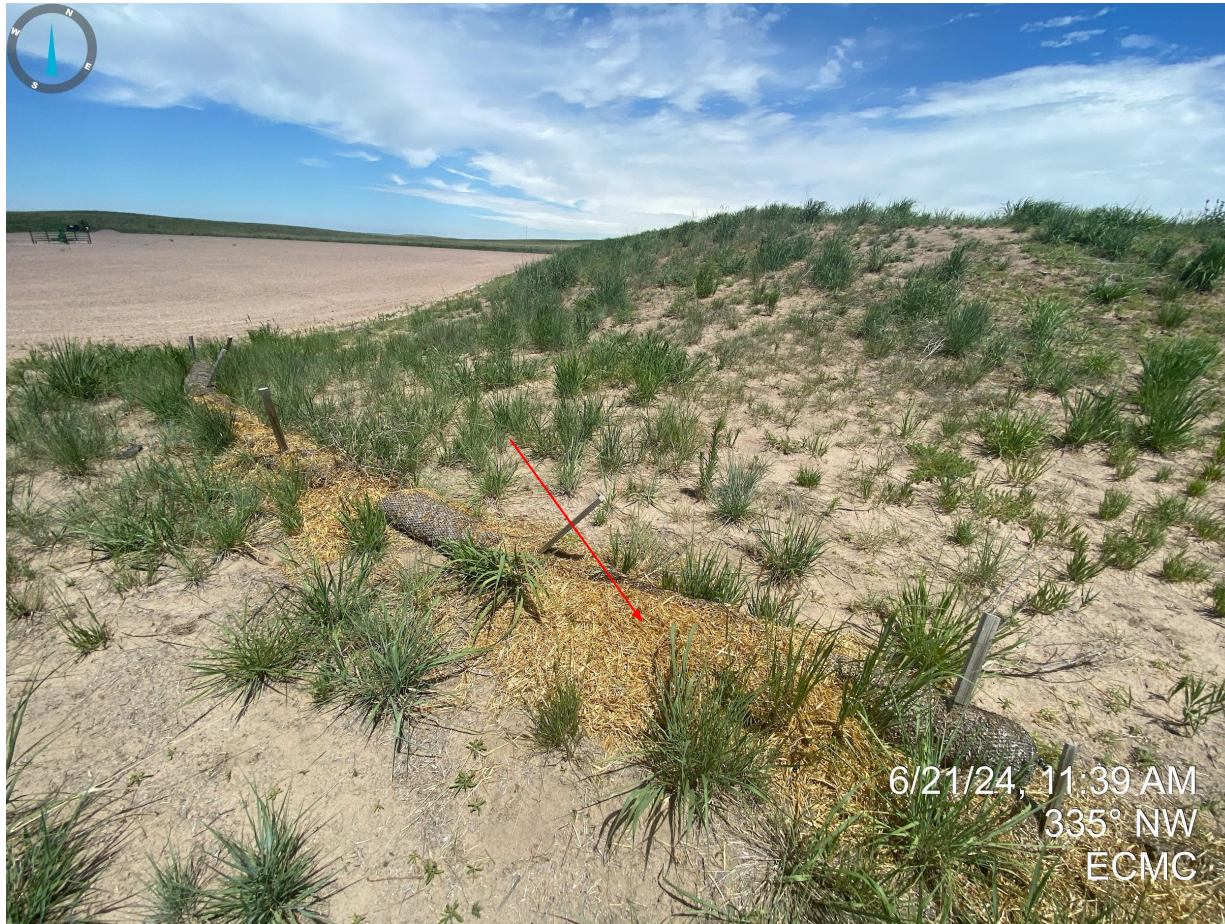
Photo 29. Stormwater control measures/BMPs are inadequate around the topsoil stockpile.

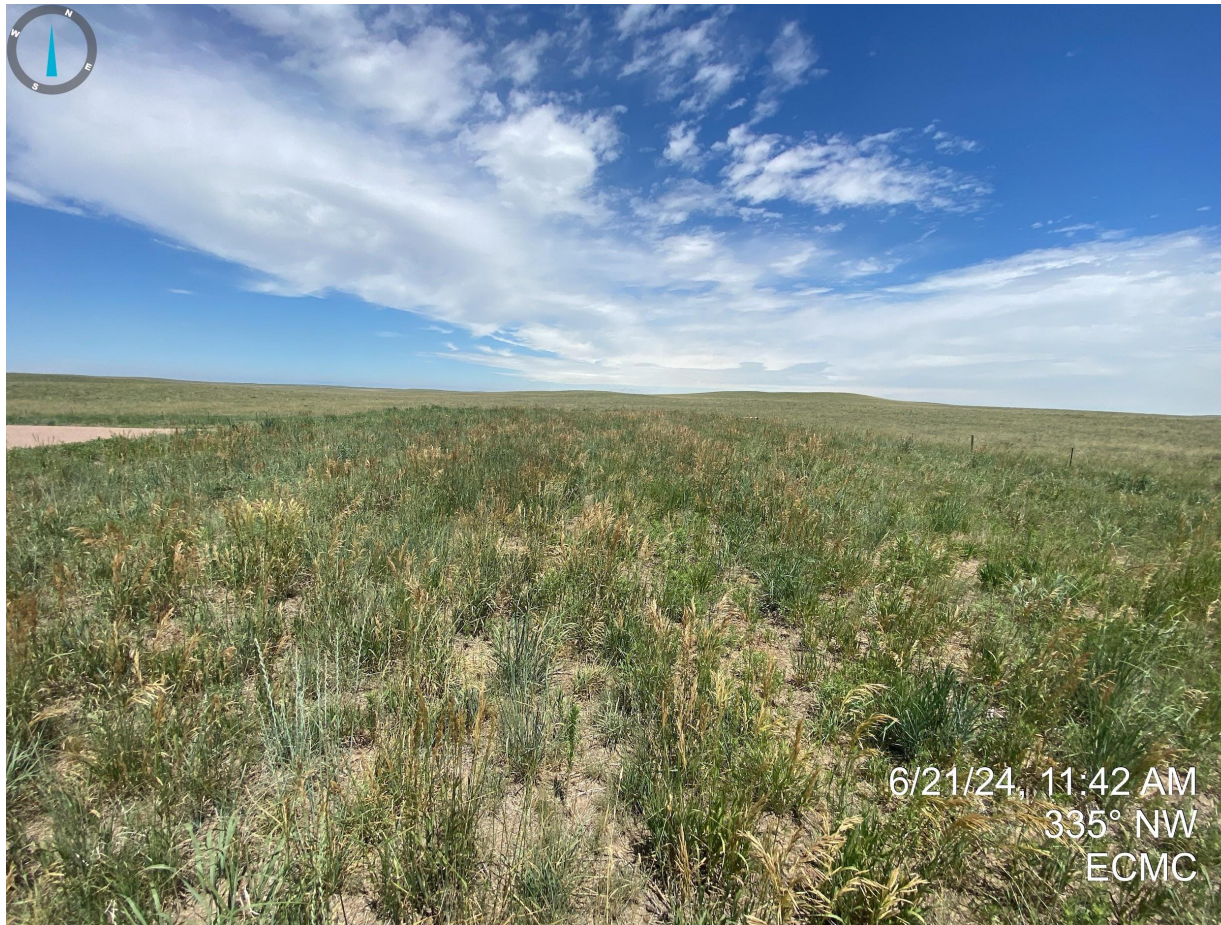
Photo 31. Top/center portion of the topsoil stockpile, facing northwest. The stockpile pile has evidence of desirable vegetation establishment with western wheatgrass, prairie sandreed, yucca, sand sage, etc observed. However, there was also a large establishment of smooth brome, an introduced species, that was identified throughout the stockpiled topsoil.

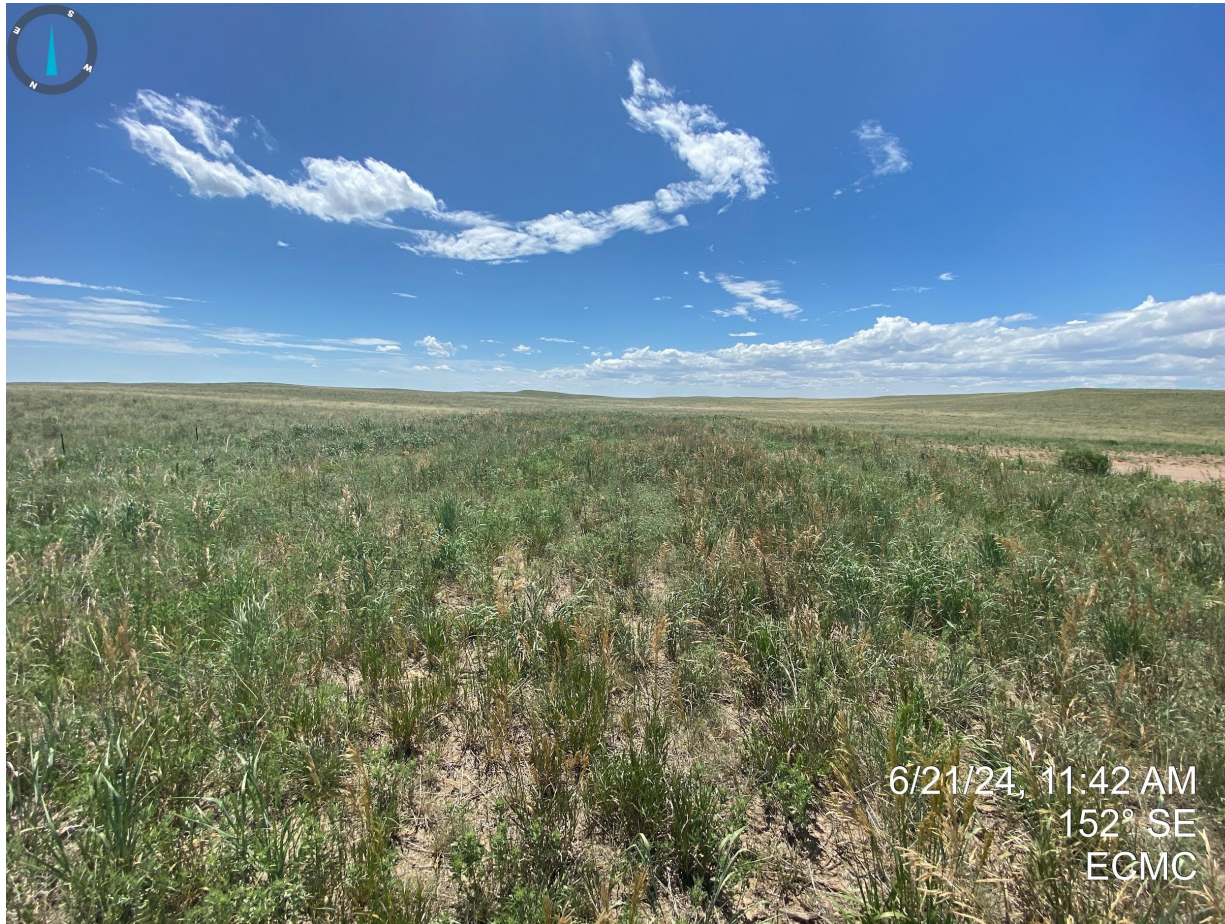
Photo 32. Top/center portion of the topsoil stockpile, facing southeast. See comments in Photo 31.

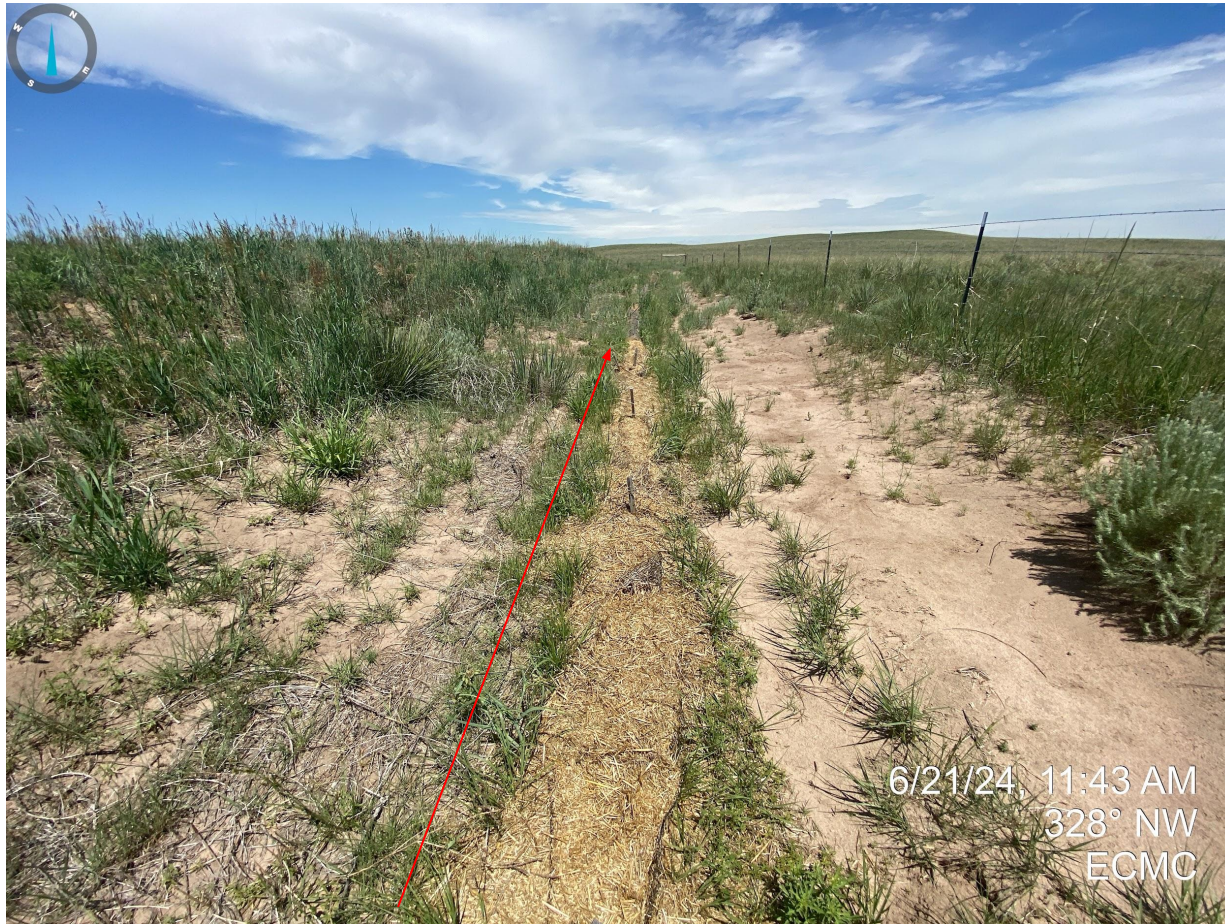
Photo 33. Stormwater control measures/BMPs are inadequate around the topsoil stockpile.

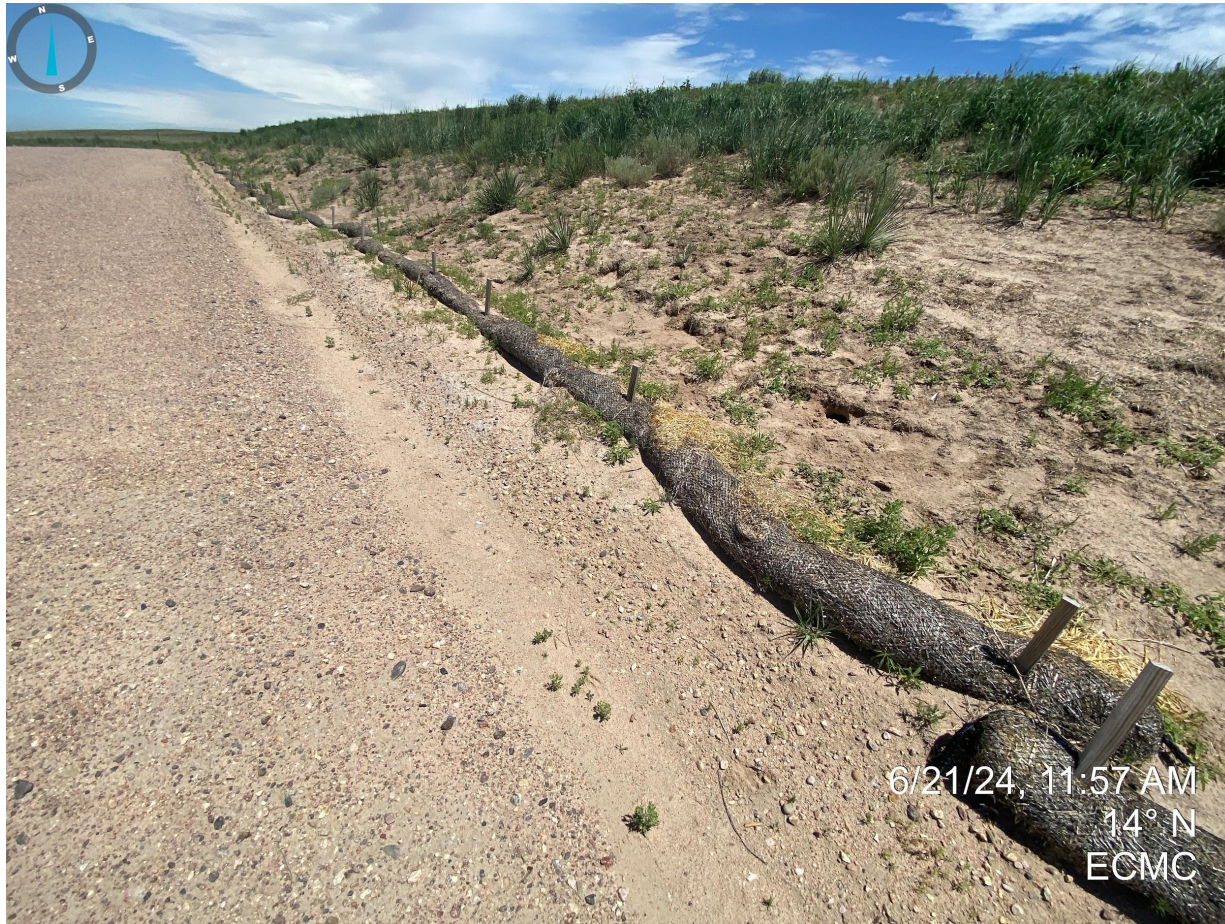
Photo 35. Stormwater control measures/BMPs are inadequate around the topsoil stockpile.

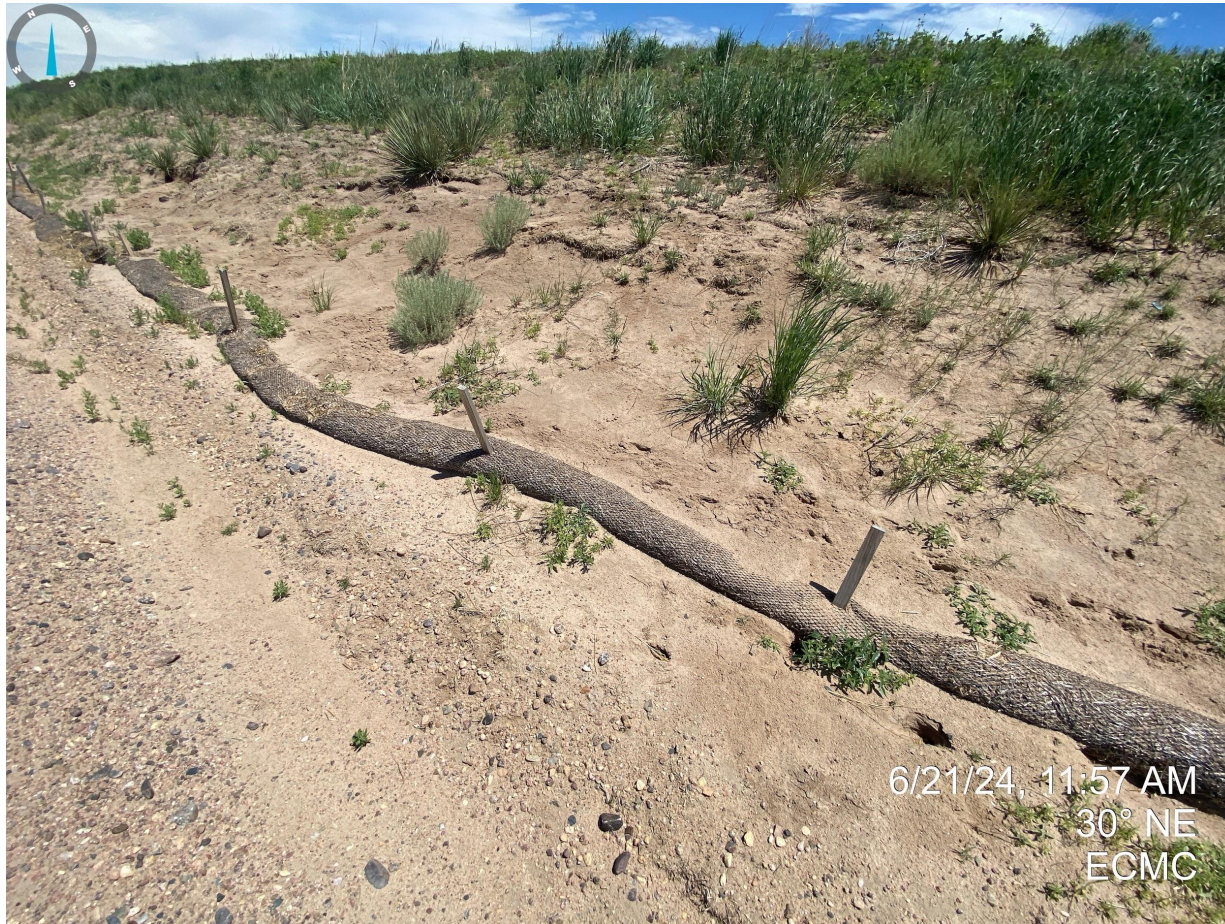
Photo 36. Stormwater control measures/BMPs are inadequate around the topsoil stockpile.

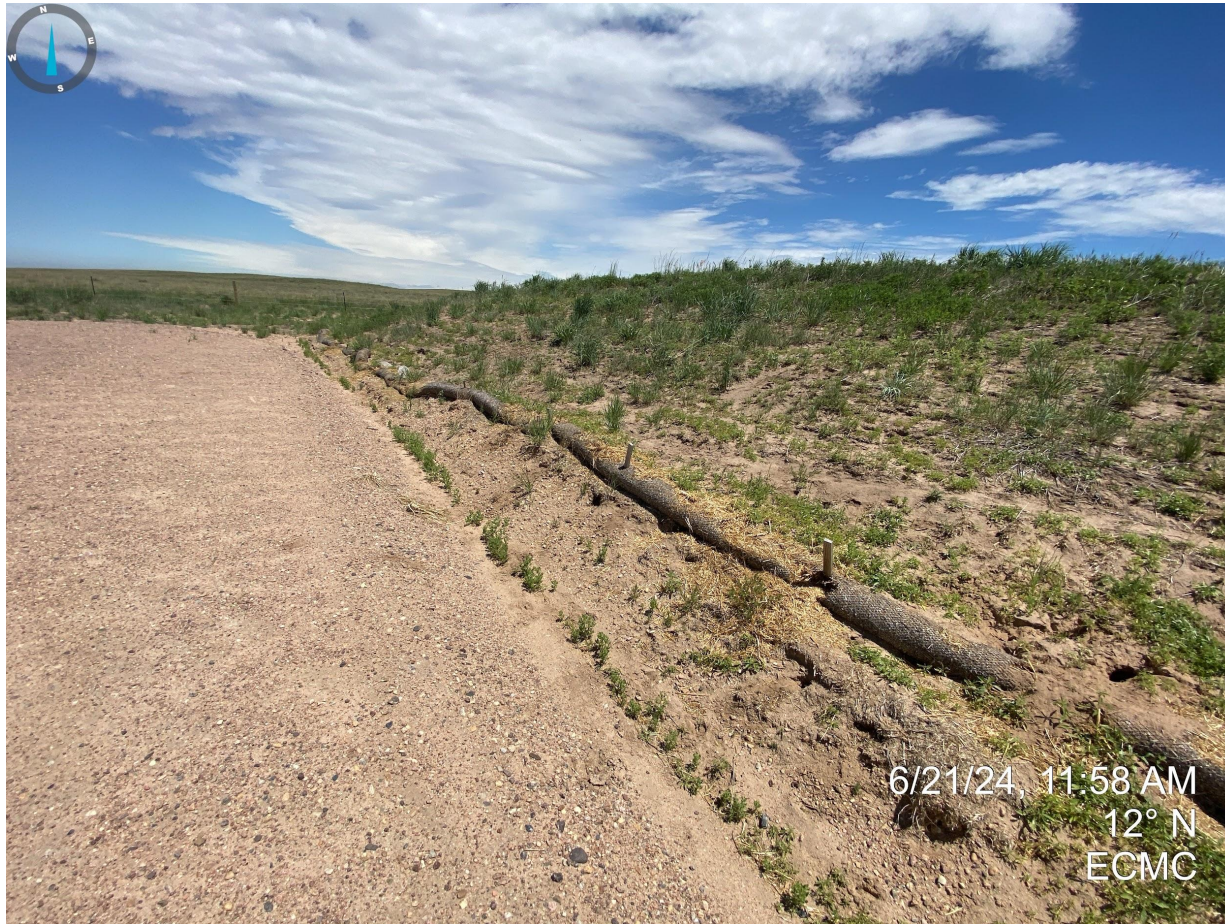
Photo 37. Stormwater control measures/BMPs are inadequate around the topsoil stockpile.

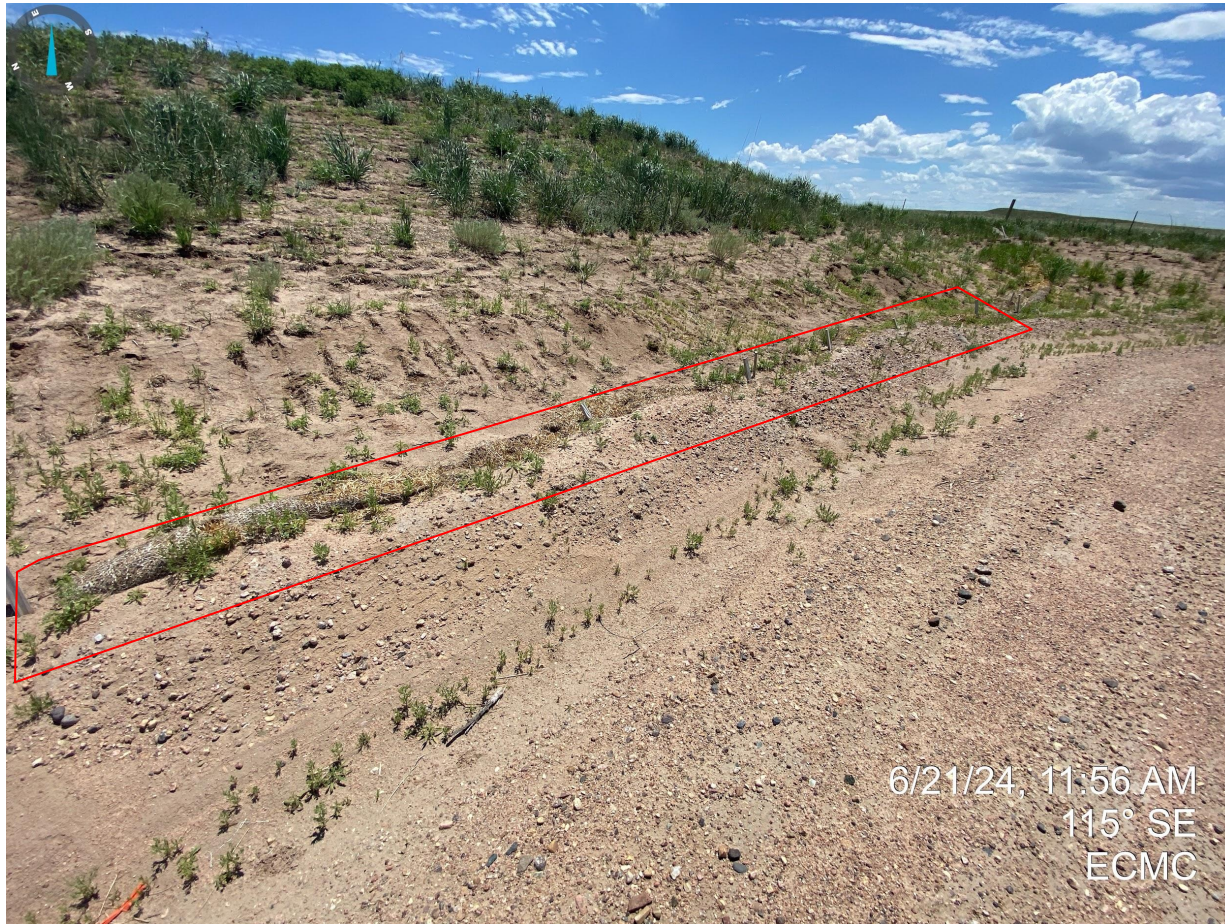
Photo 38. Stormwater control measures/BMPs are inadequate around the topsoil stockpile.

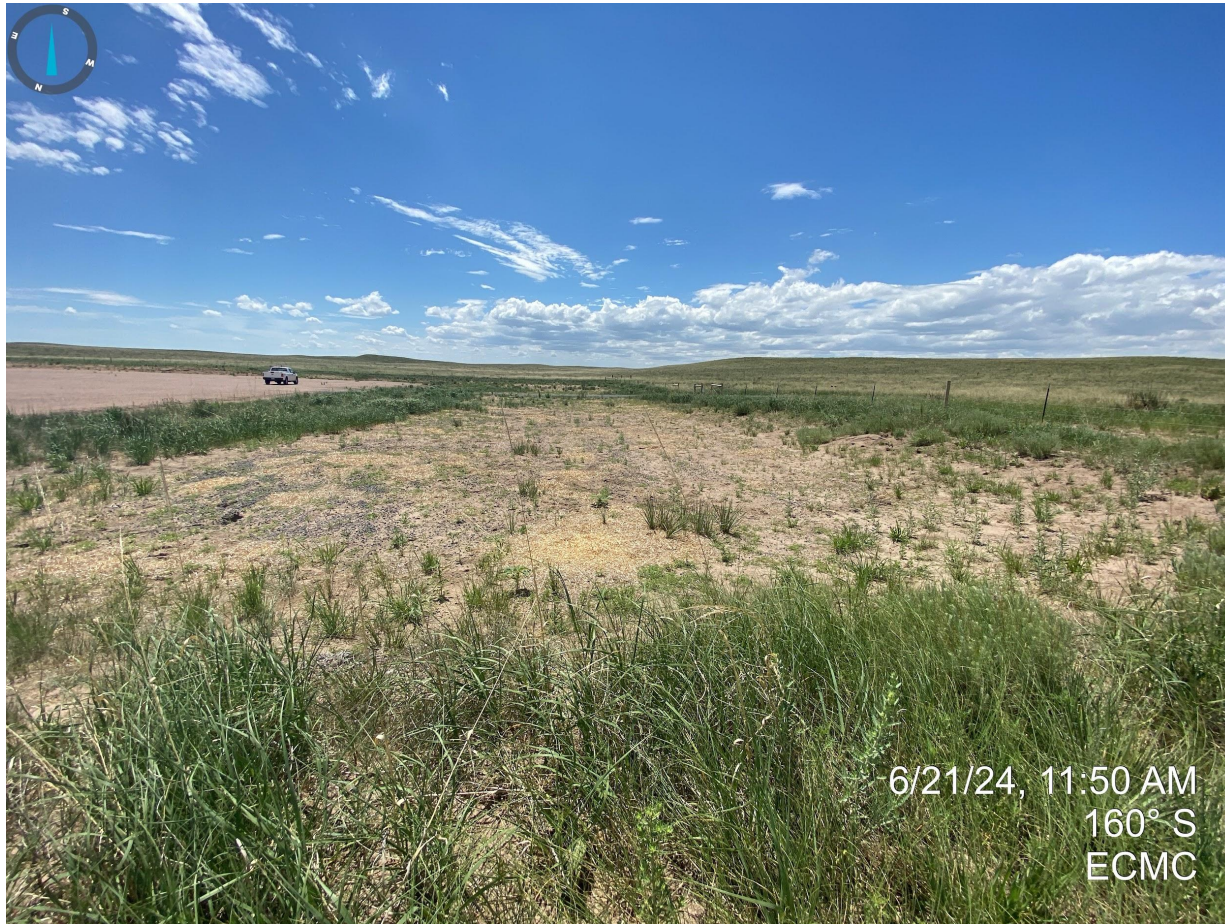
Photo 39. North Parking area has not been properly reclaimed per the 1000 series rules- gravel remains and the area does not have a uniform vegetative cover to help stabilize the soils.

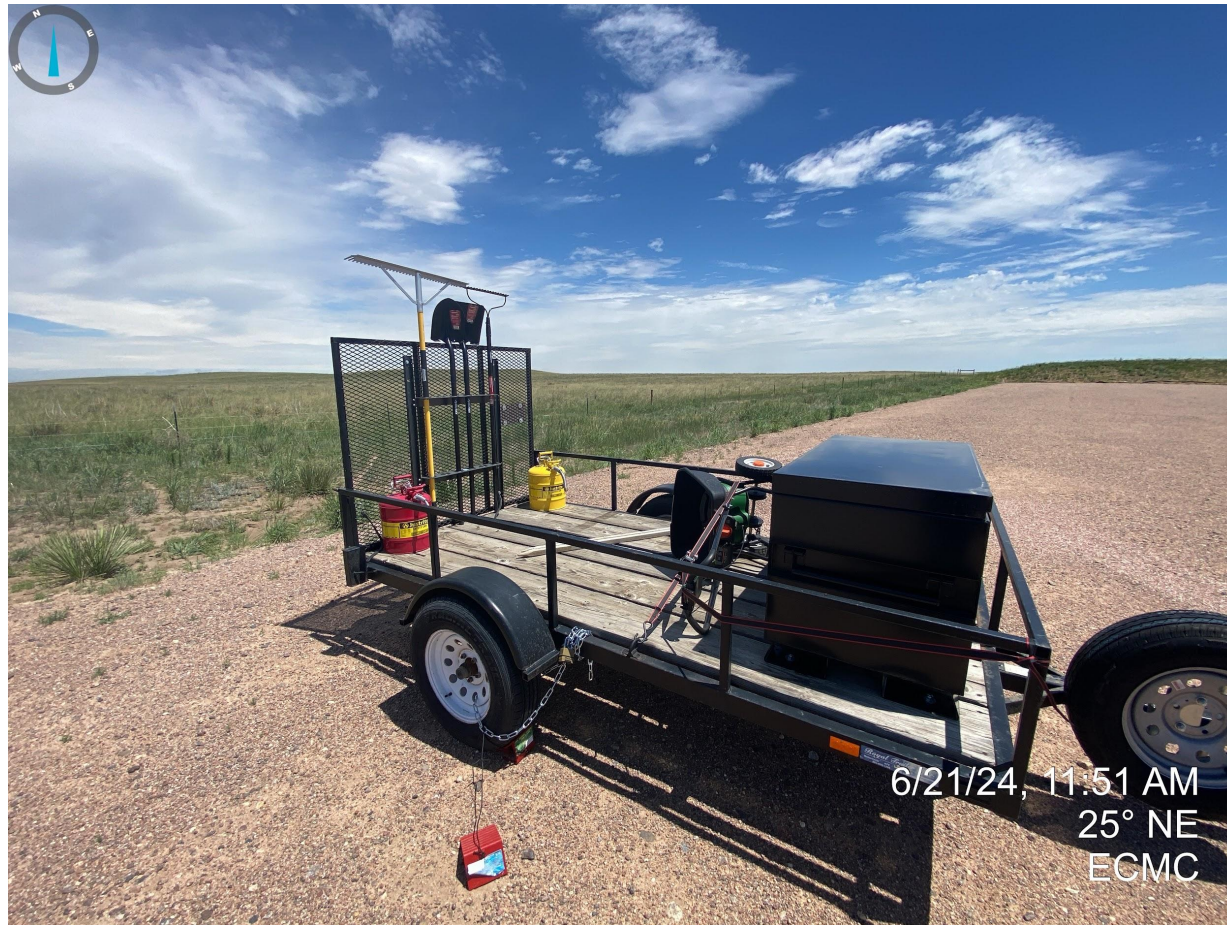
Photo 40. Storage of equipment not necessary for production is prohibited on location.
