Interim Reclamation and Stormwater Inspection

Date: 06/21/2024

Operator: DENOVA SEQUESTRATION LLC - 10790

Inspection Document #: 708201343

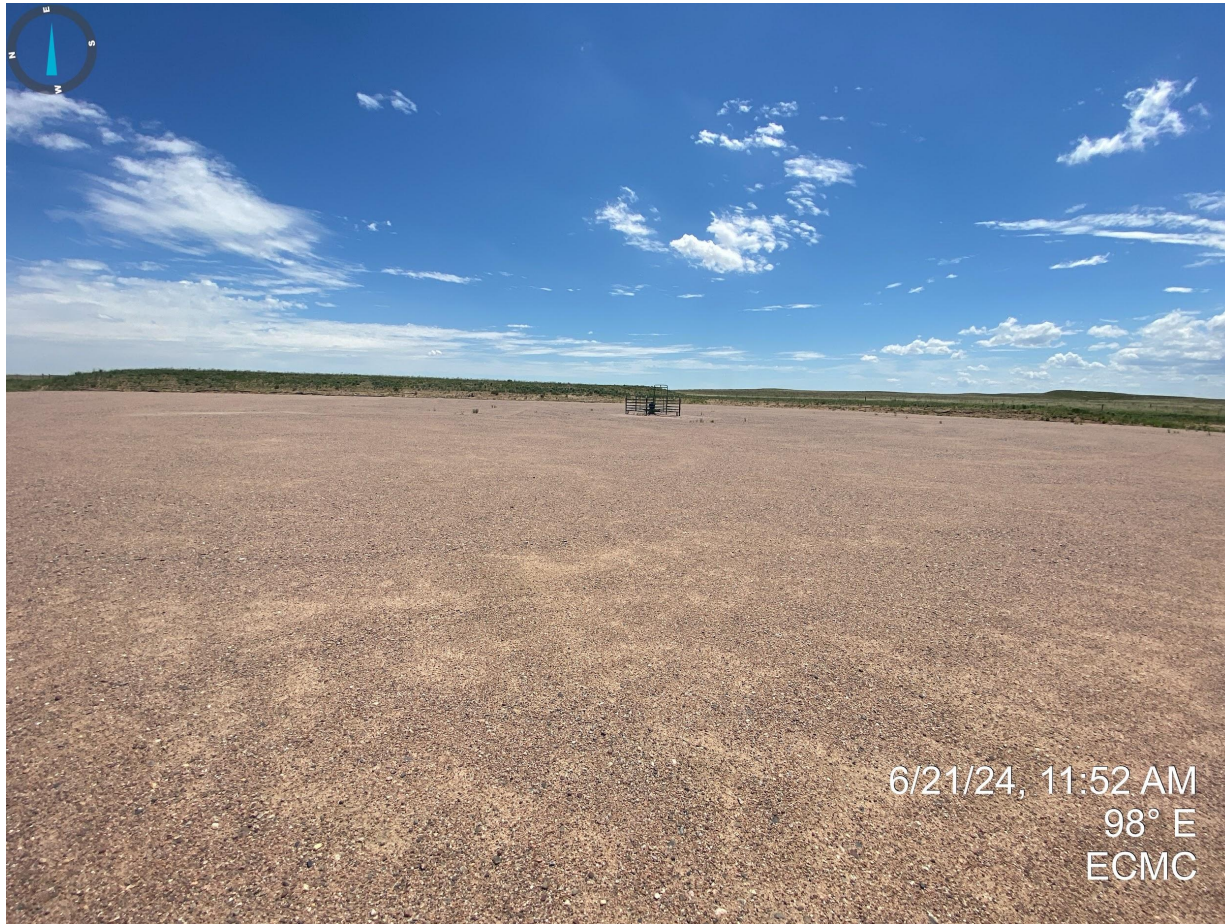
Photo 41. Taken from the northwestern portion of the drilling pad. Photo illustrates that the location does not appear to have been reclaimed per the 1000 series rules.

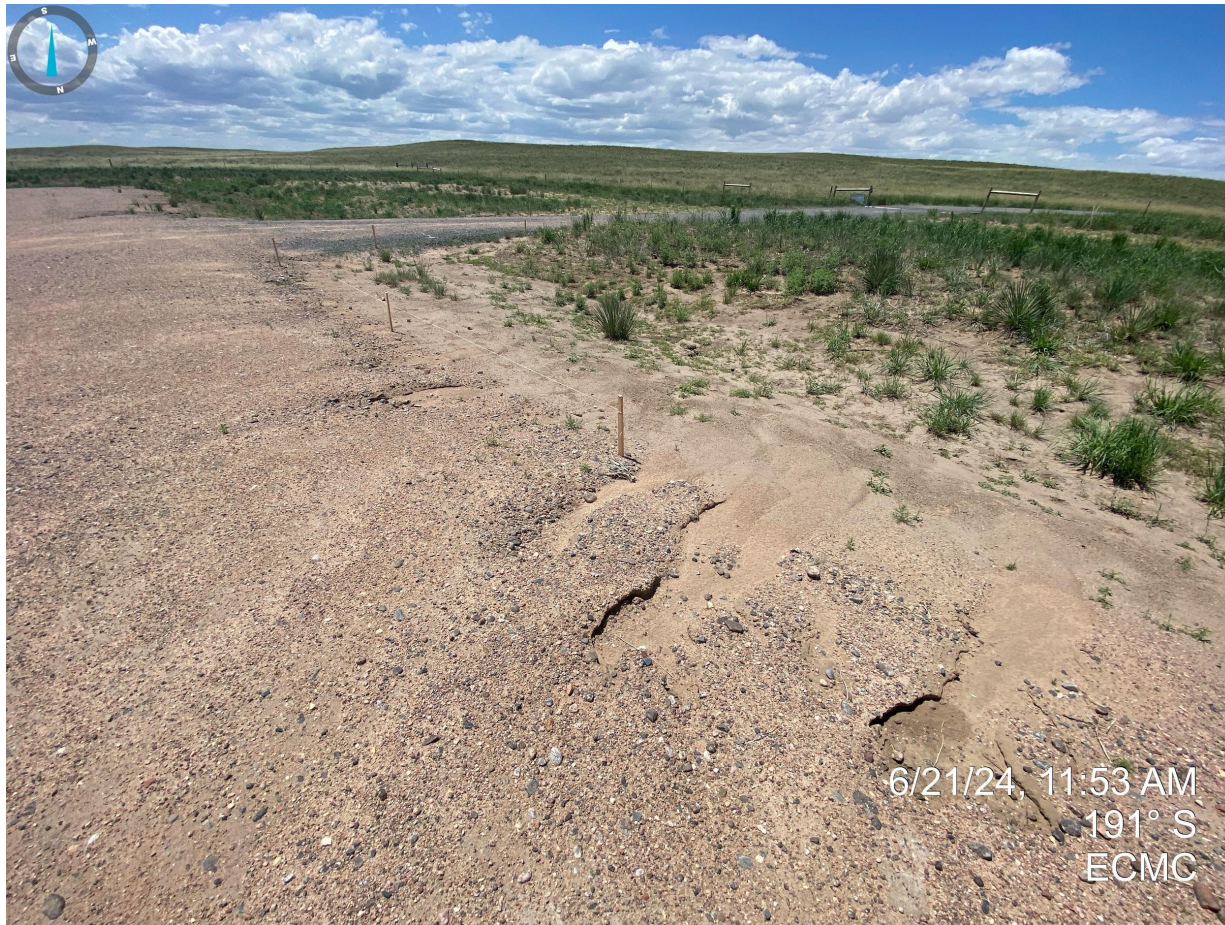
Photo 42. Erosion degradation originating from the drilling pad. It does not appear that any repairs have been made or any additional BMPs have been installed since the previous inspection.

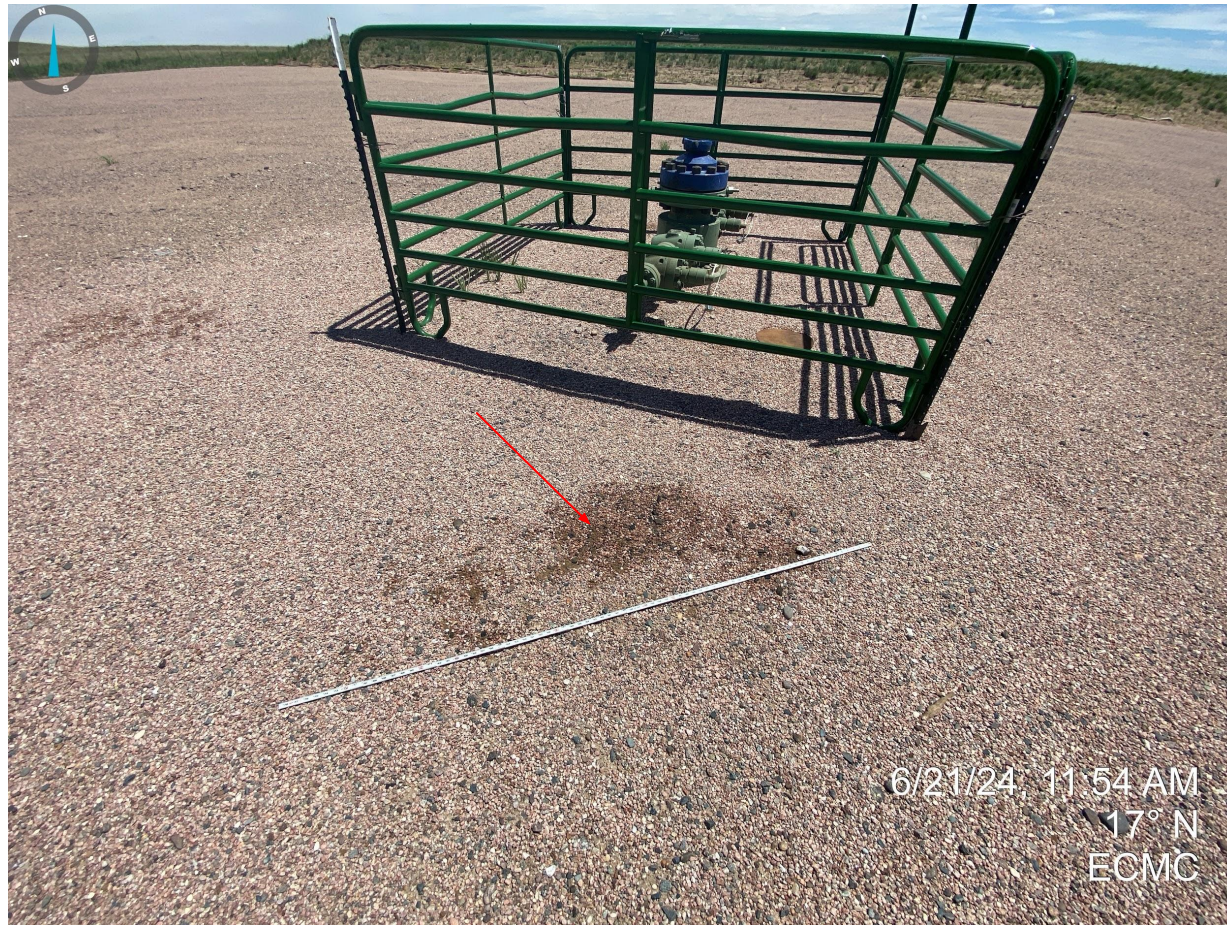
Photo 43. Stained soil observed around the wellhead.

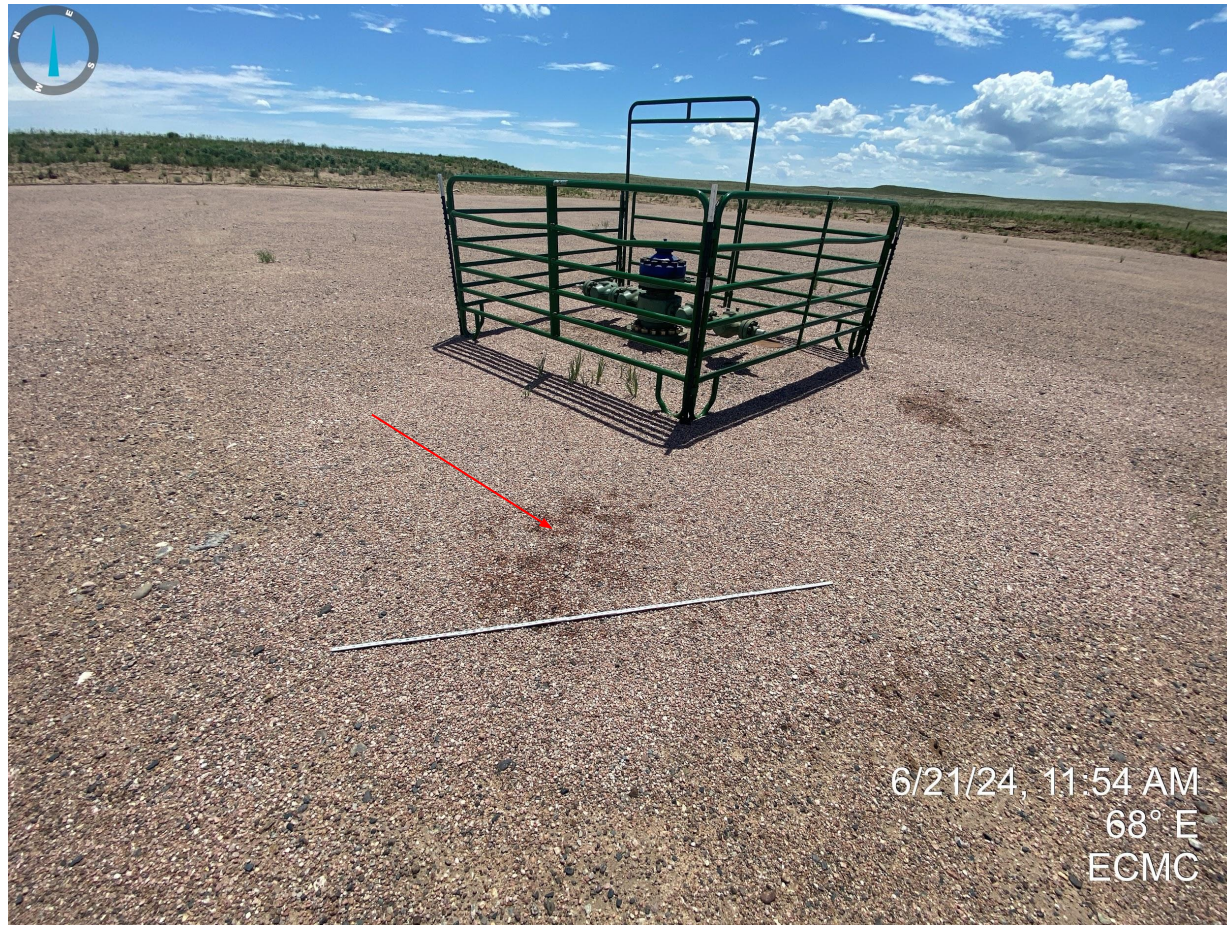
Photo 44. Stained soil observed around the wellhead.

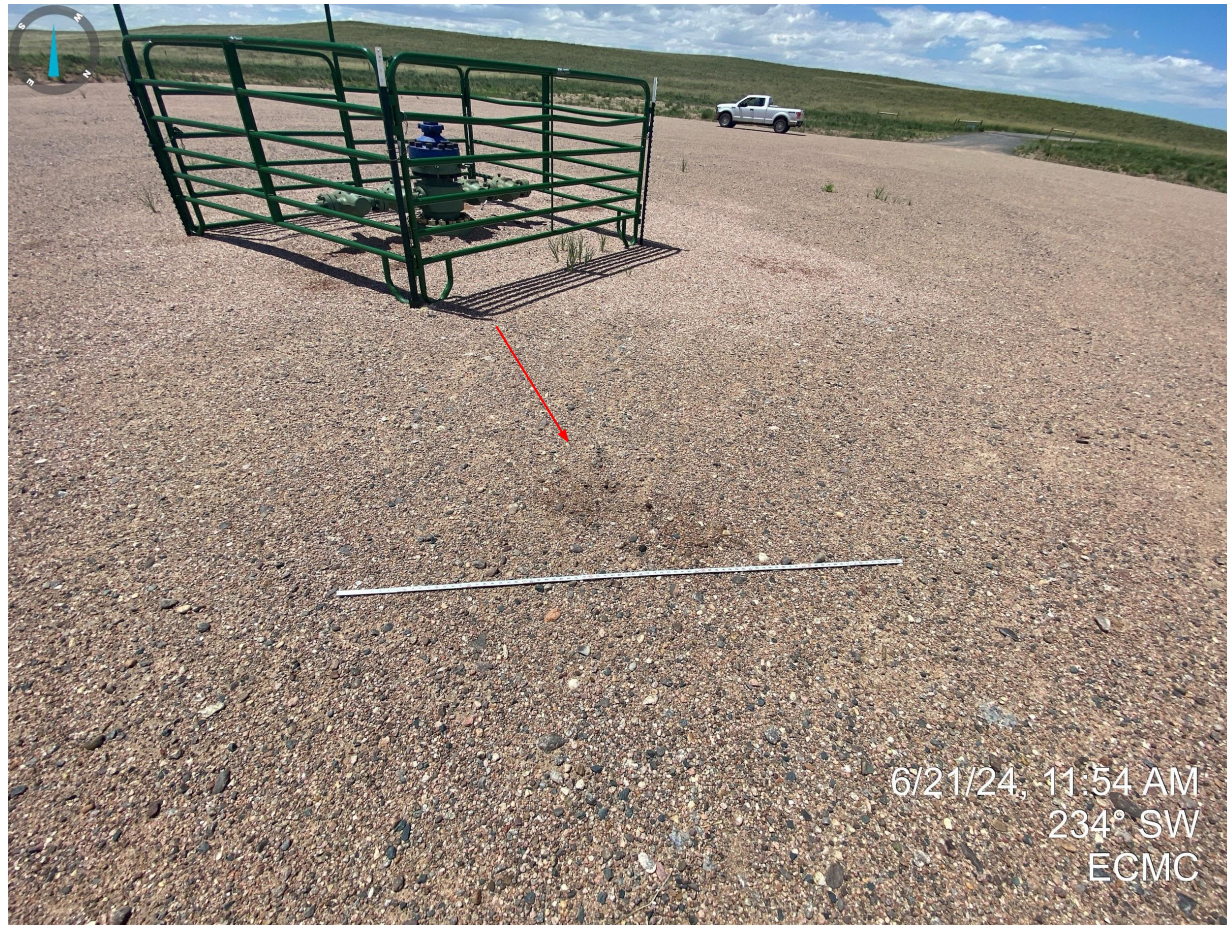
Photo 45. Stained soil observed around the wellhead.

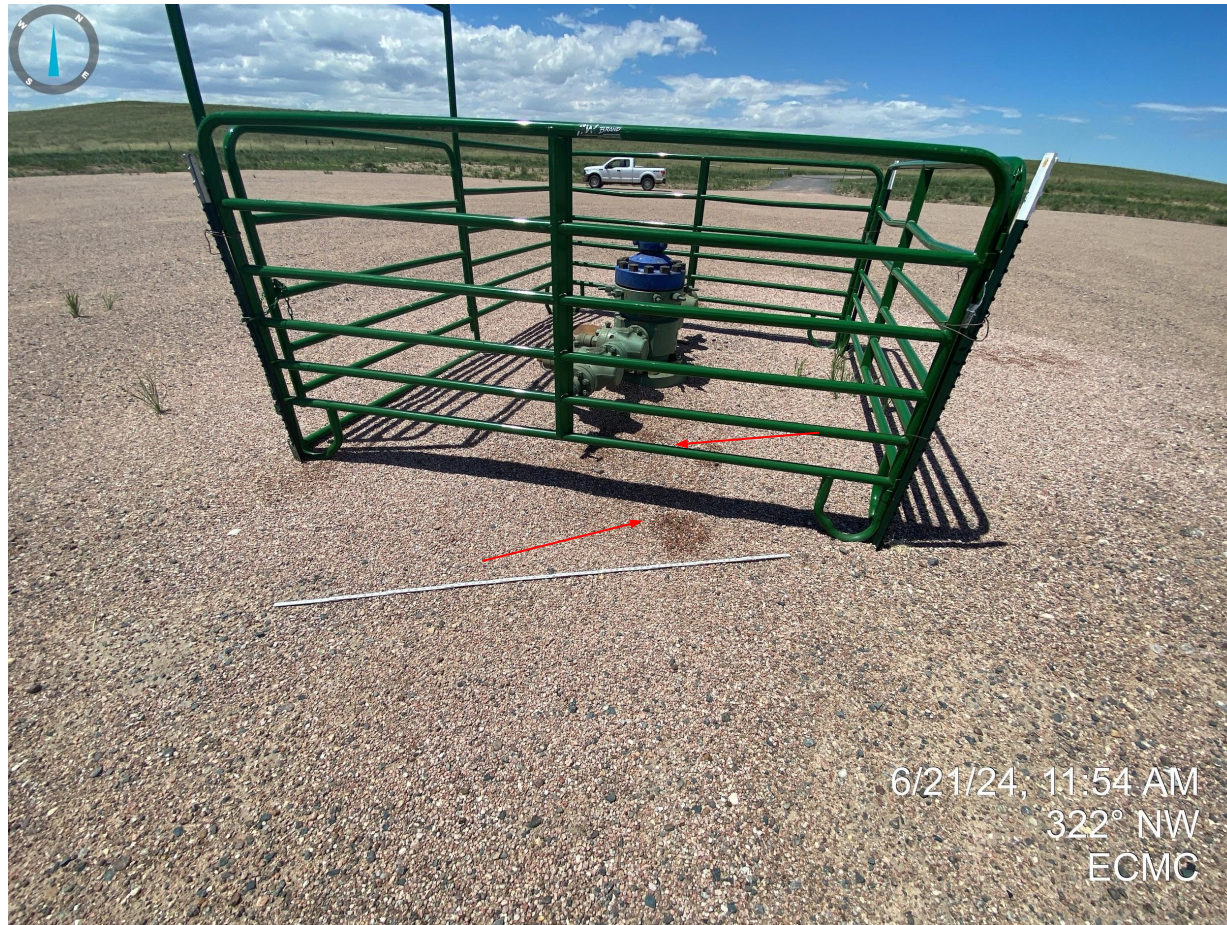
Photo 46. Stained soil observed around the wellhead.

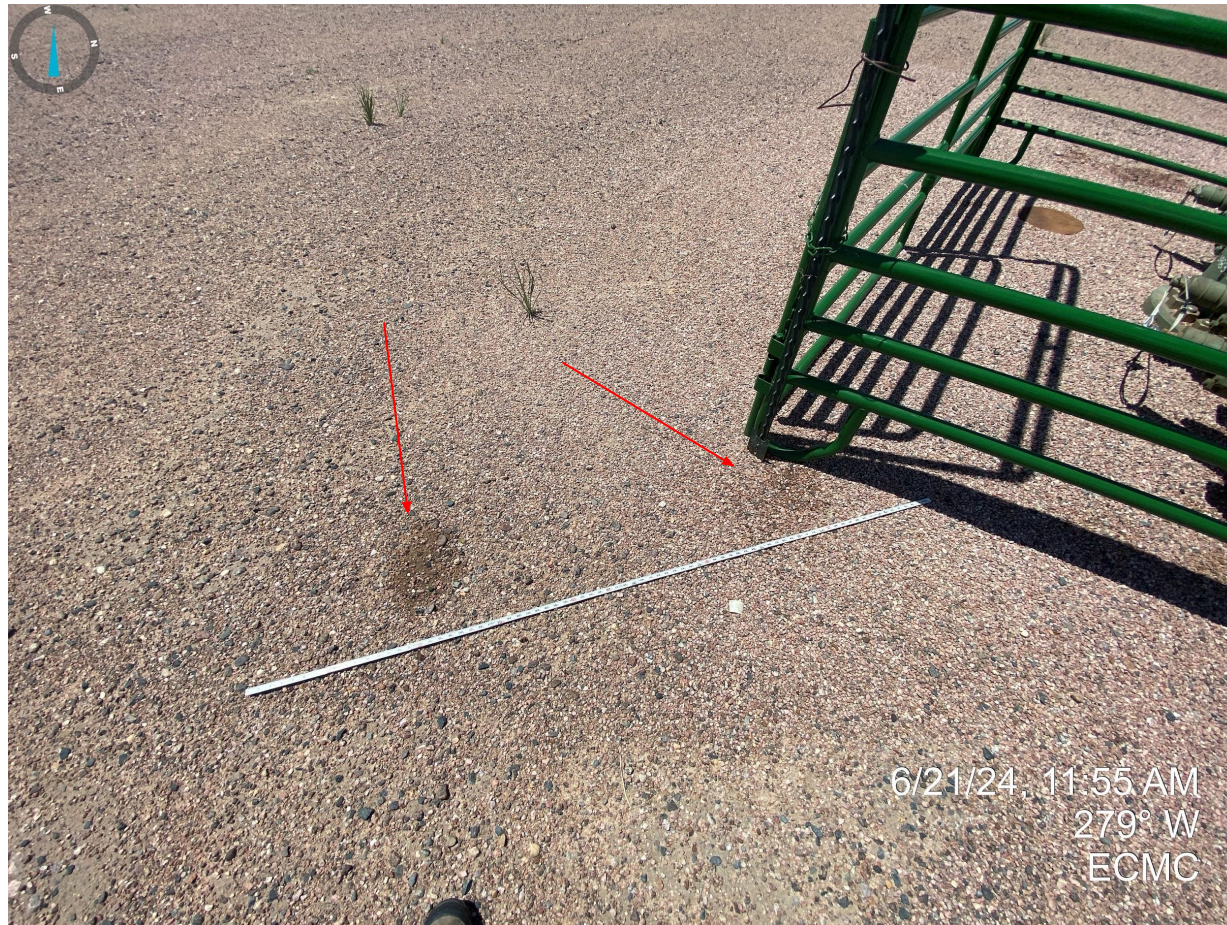
Photo 47. Stained soil observed around the wellhead.

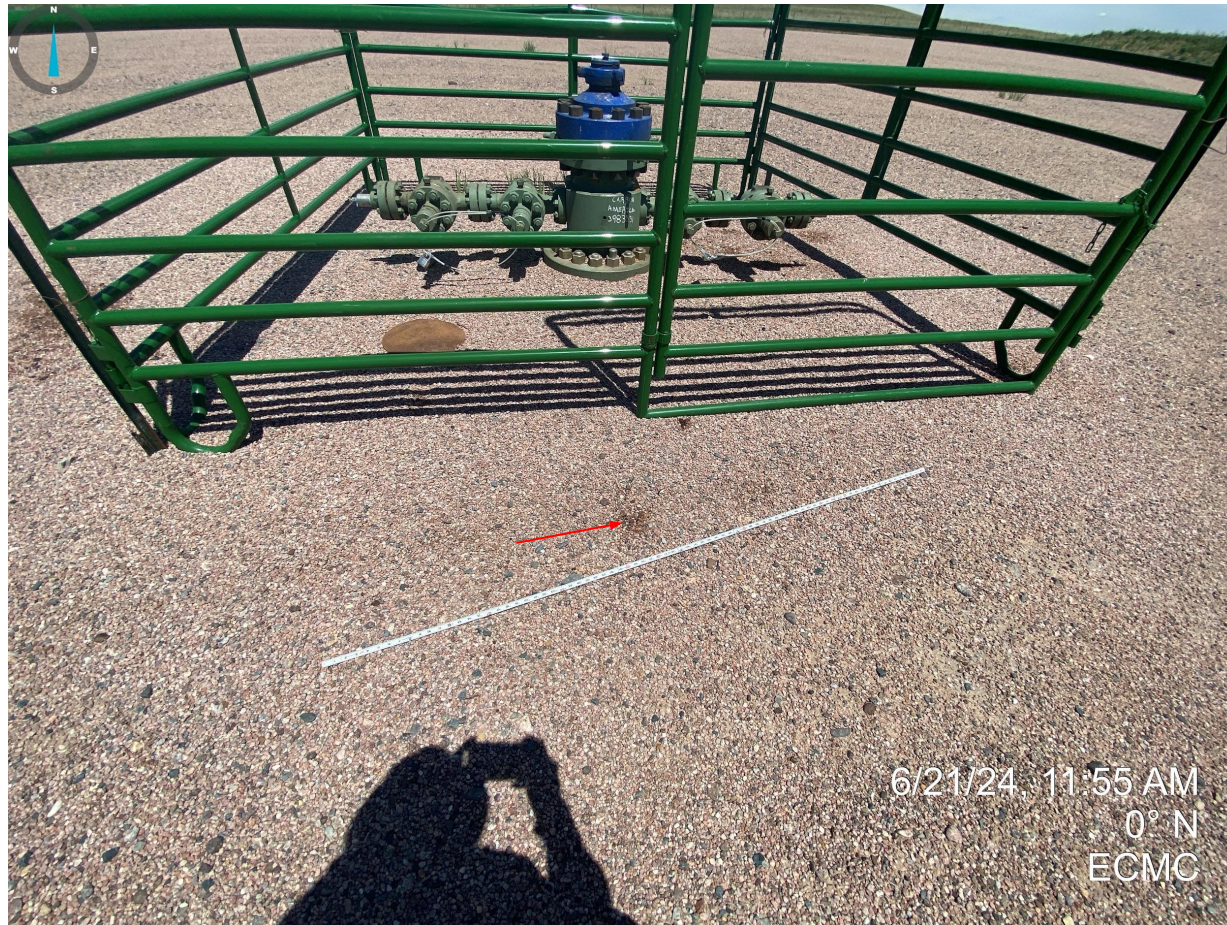
Photo 48. Stained soil observed around the wellhead.

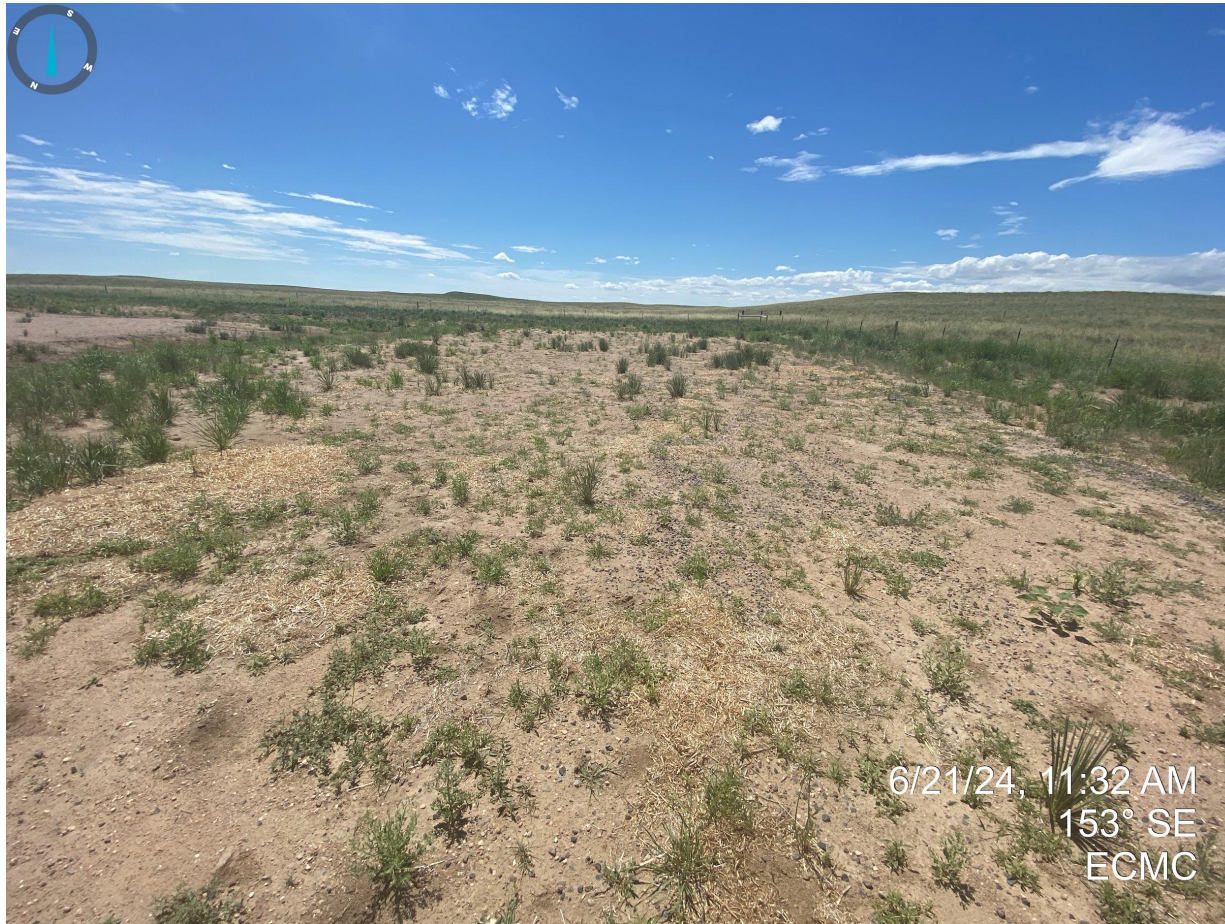
Photo 49. South Parking area has not been properly reclaimed per the 1000 series rules- gravel remains and the area does not have a uniform vegetative cover to help stabilize the soils.
