Inspection Photos
Location Name: Mailander SWD 16B-34-6-45
API Number: 095-06149

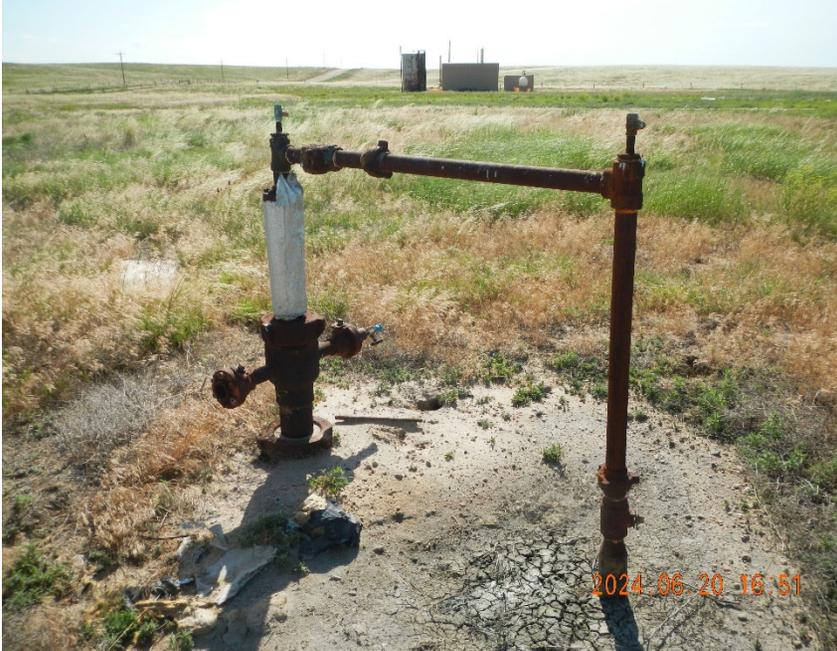
1. View of wellhead. Note vegetation growing across location.

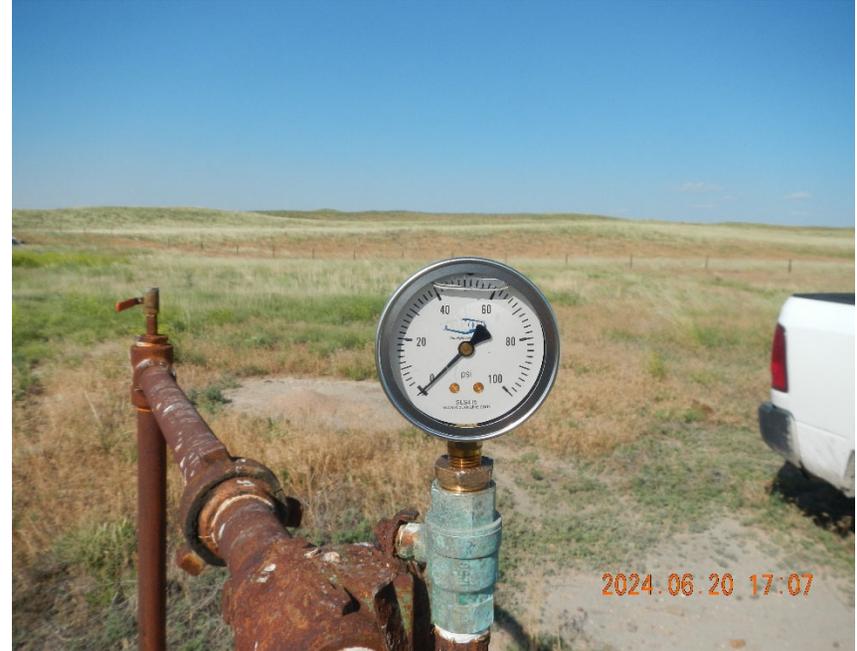
2. Tubing pressure at time of inspection.

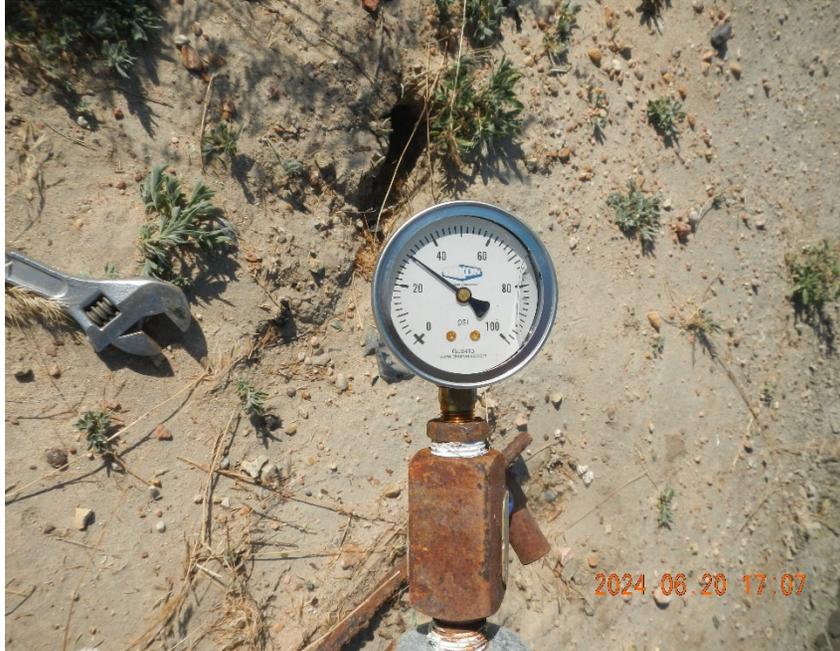
3. Casing pressure at time of inspection.

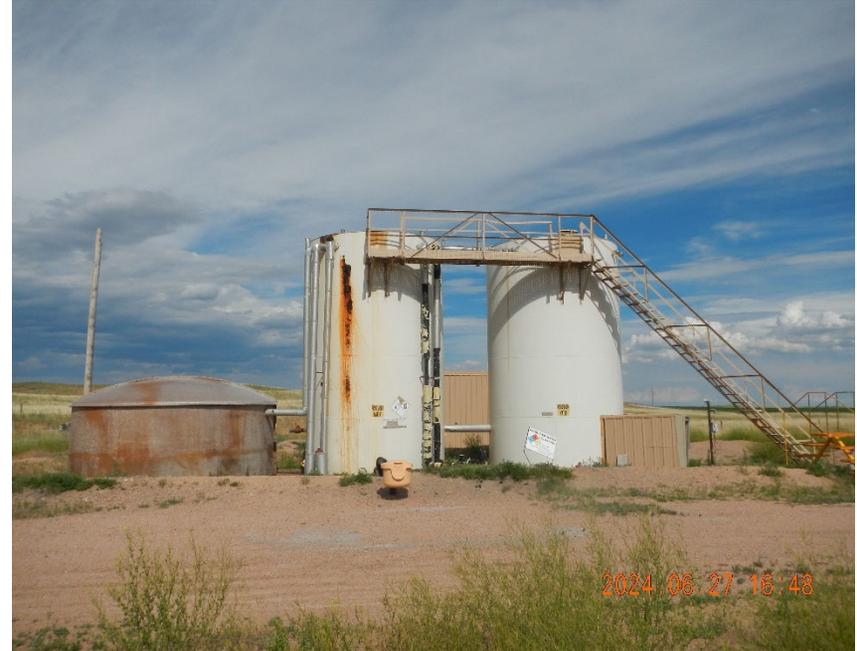
4. View of Tank Battery. Note rust streak down tank on the left.

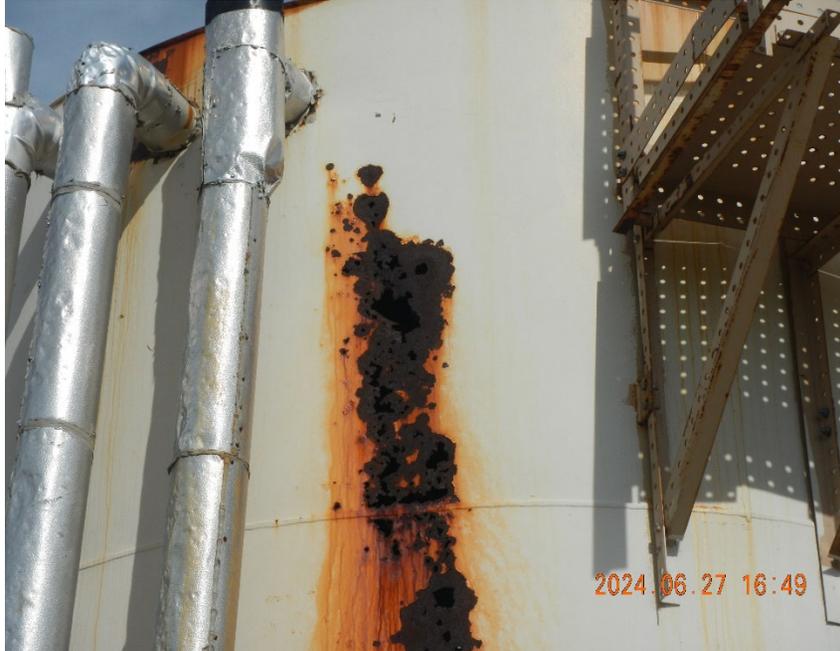
5. Close up of hole in wall of left side 400 BBL tank.

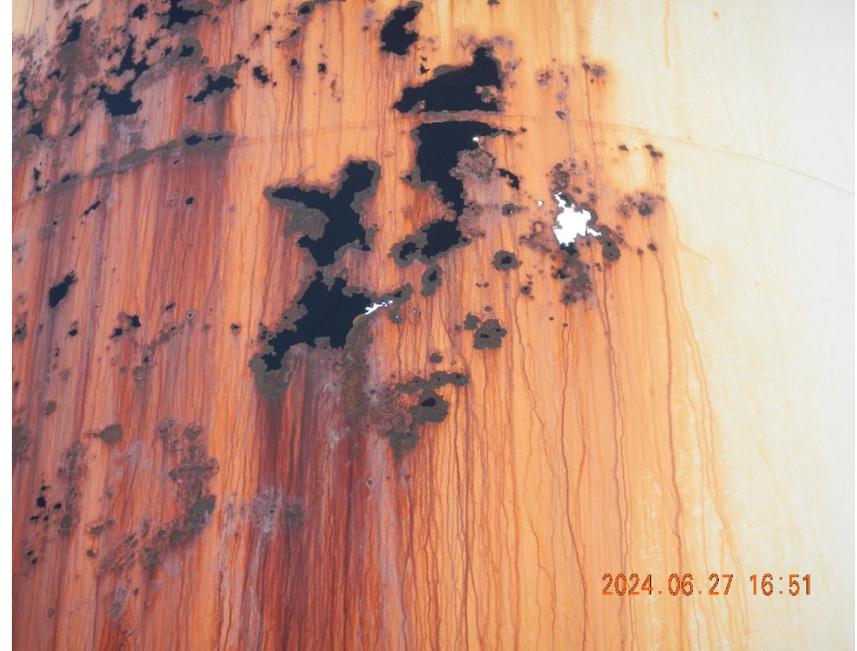
6. Additional view of rusting, holes, and pitting on the backside of the left tanks wall.

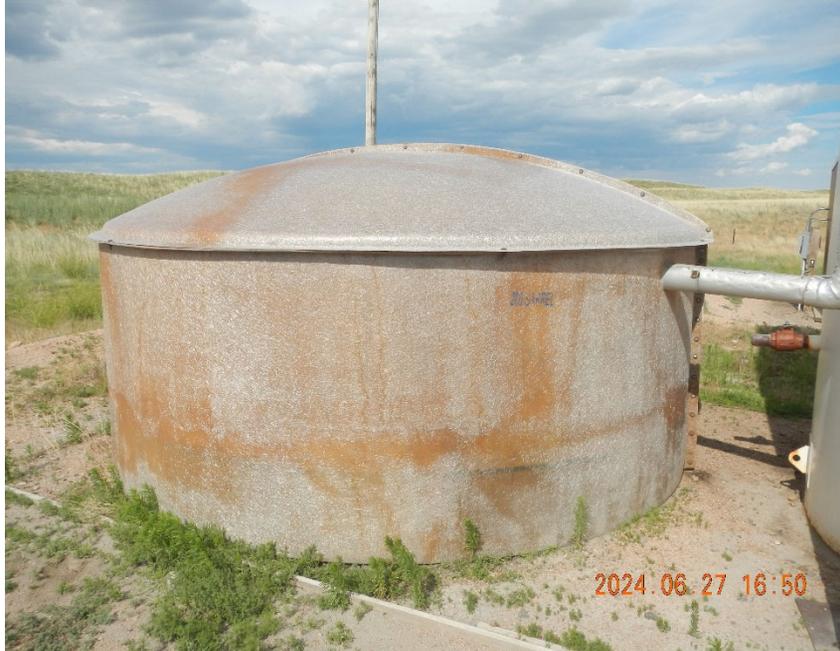
7. View of 200 BBL Tank. No Content/Quantity/Hazard lable on tank. Note vegetation.

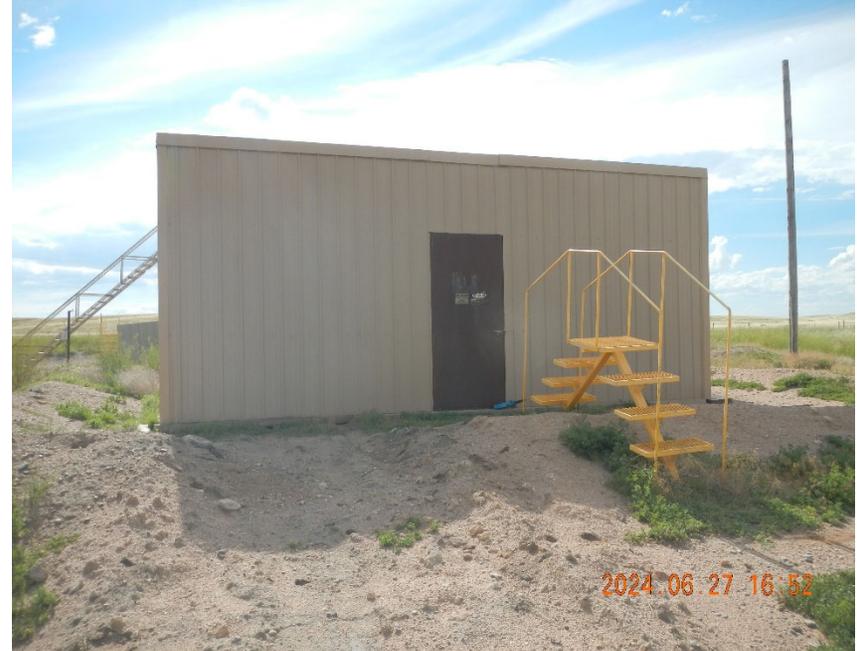
8. Steel Injection Pump and Equipment Building. Note berm has been opened up on left side front of building.

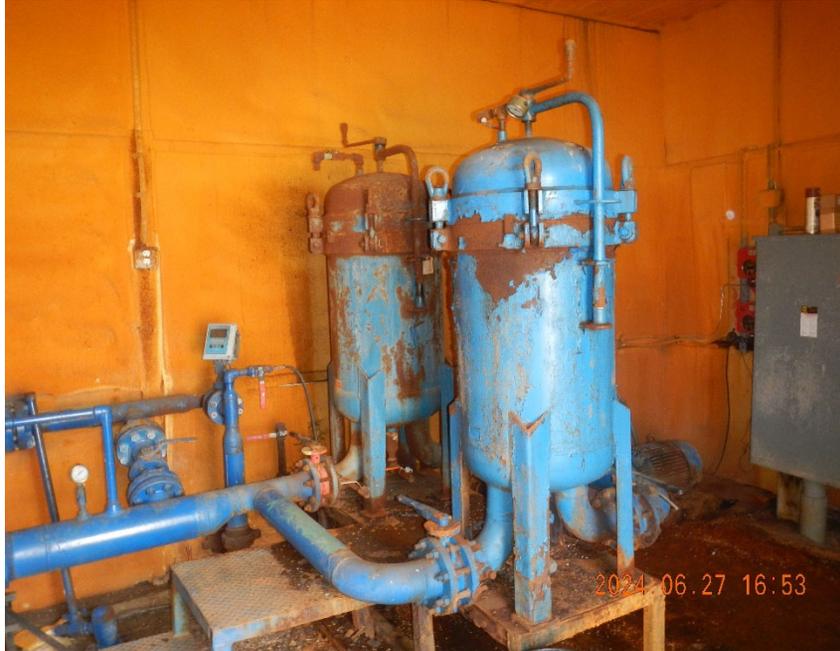
9. View of Filter Pots inside building.

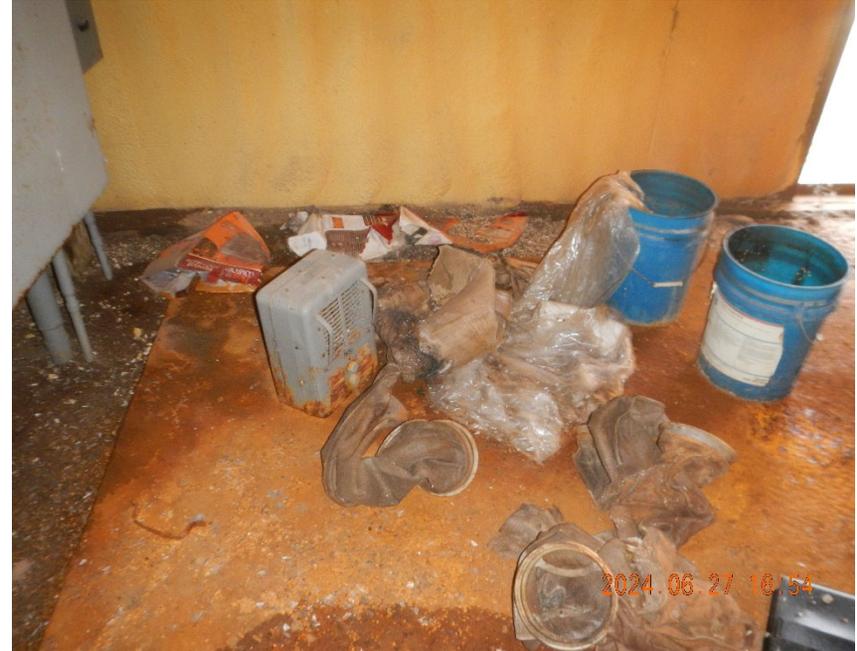
10. Equipment, debris, and trash inside pump building.

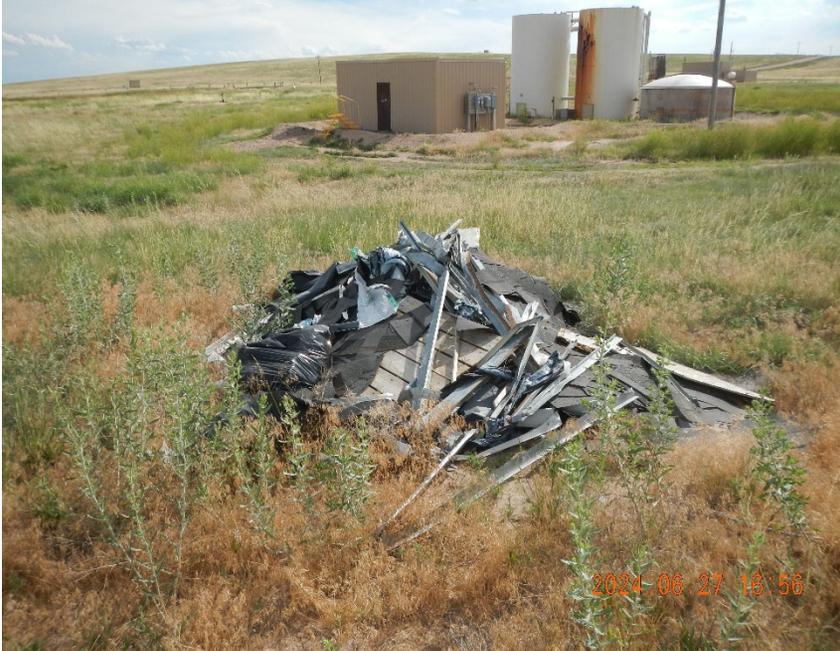
11. Dumped trash pile on location.

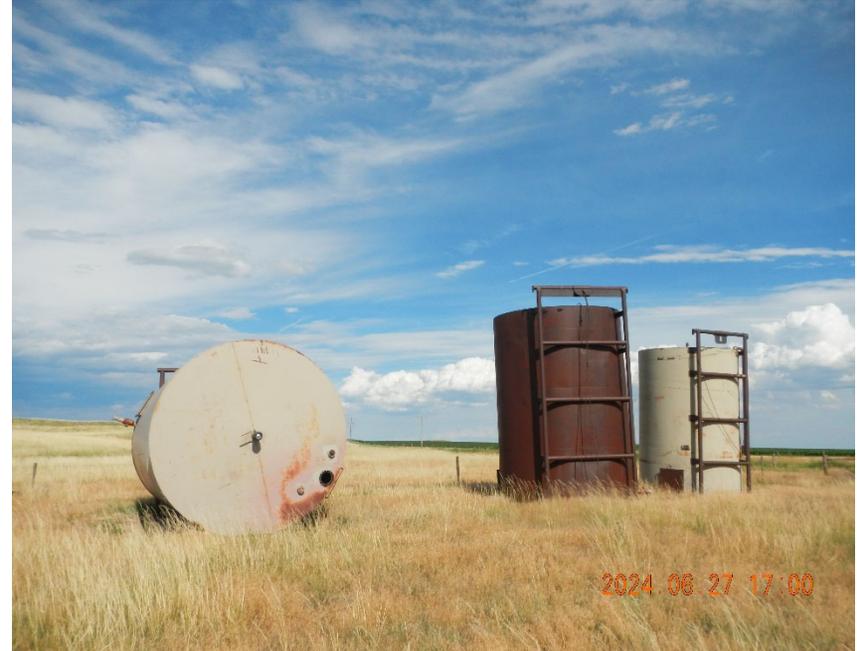
12. Unused Tanks on location.

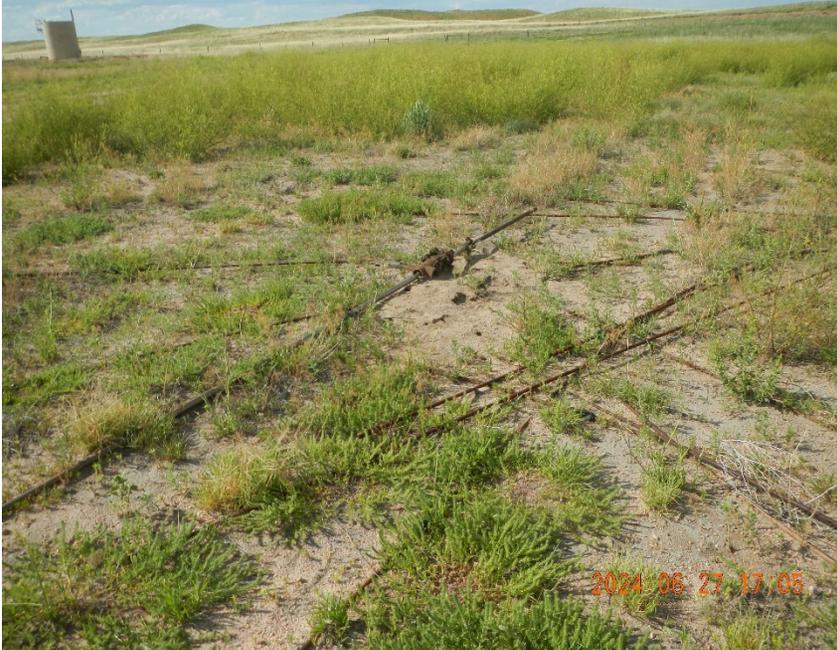
13. Rods and polish rod dumped on location.

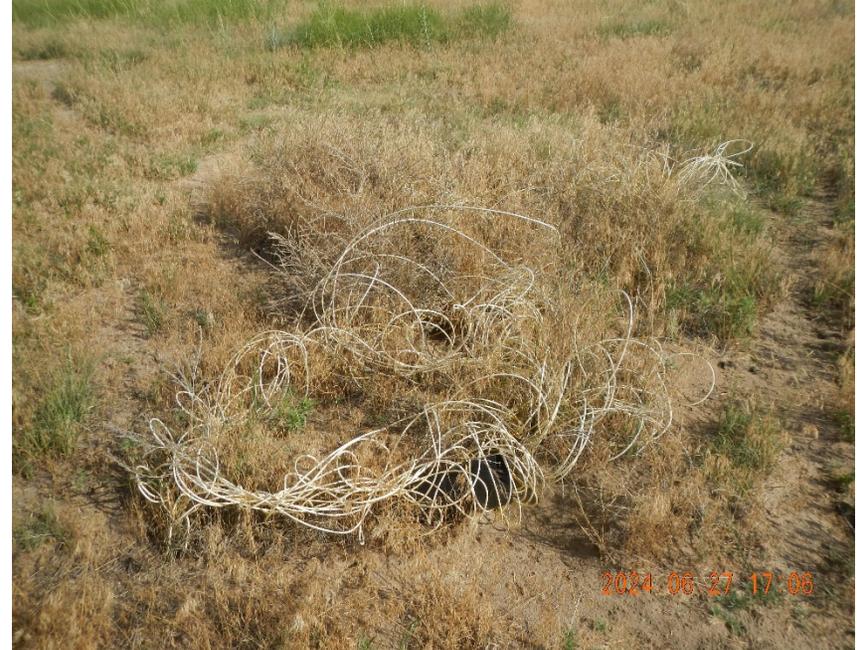
14. Loose wire on location. Creates a wildlife and live stock hazard.

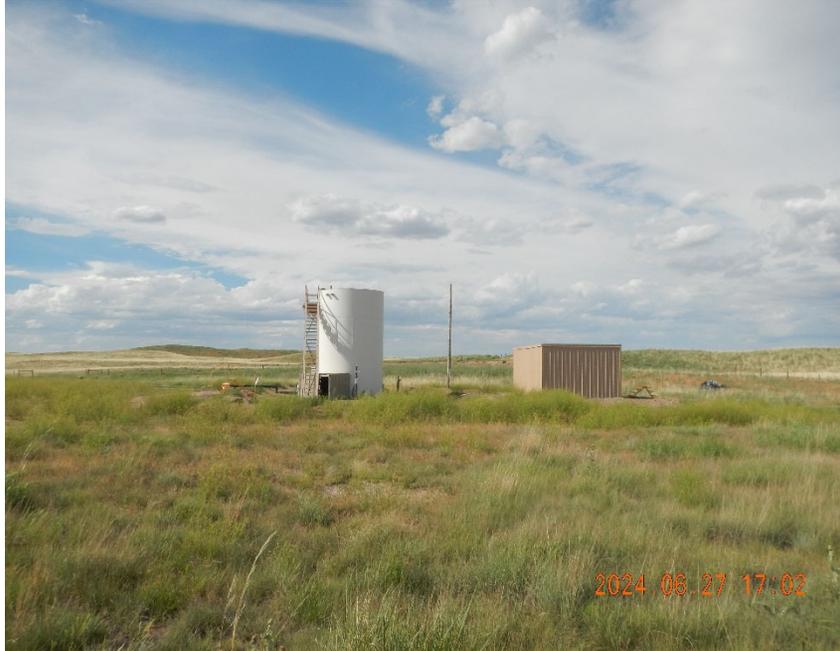
15. Location overview from wellhead looking towards Tank Battery. Note vegetation.

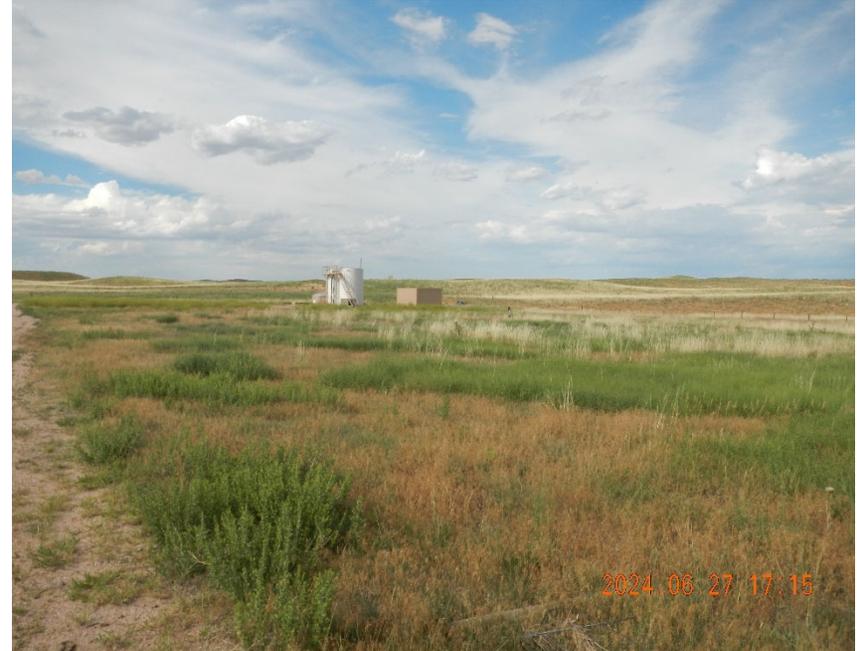
16. Location overview from entry point looking towards Tank Battery.
