Inspection Photos

Location Name: TEP ROCKY MOUNTAIN LLC SAVAGE RWF 32-26 Pad

Location ID: 335490

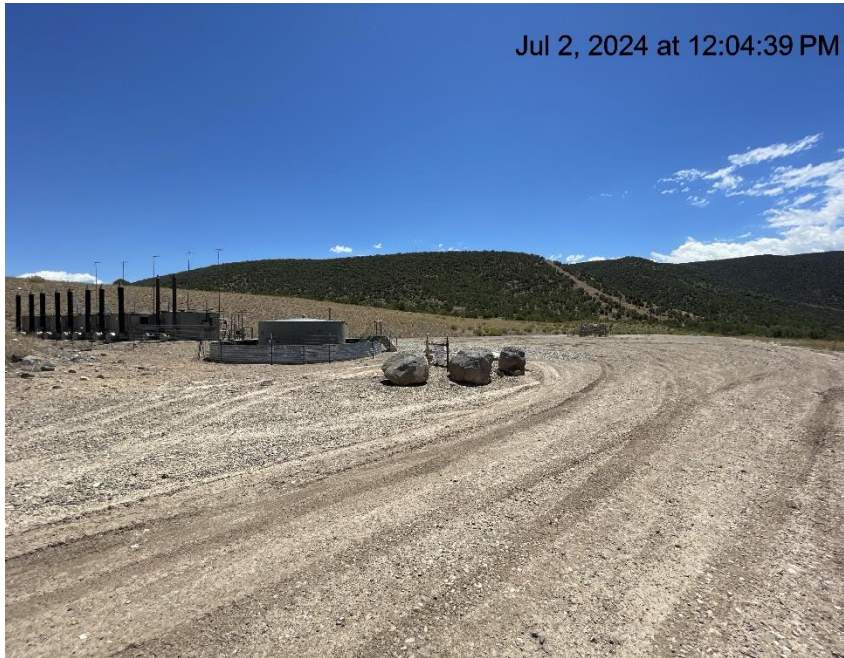
Photo # 2209 From entrance to location

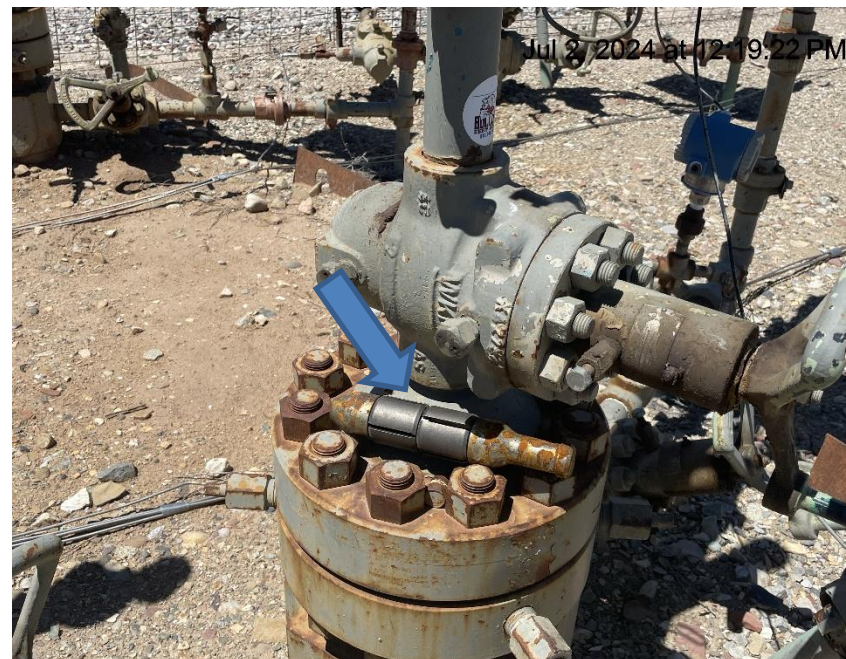
Photo # 2218 Debris

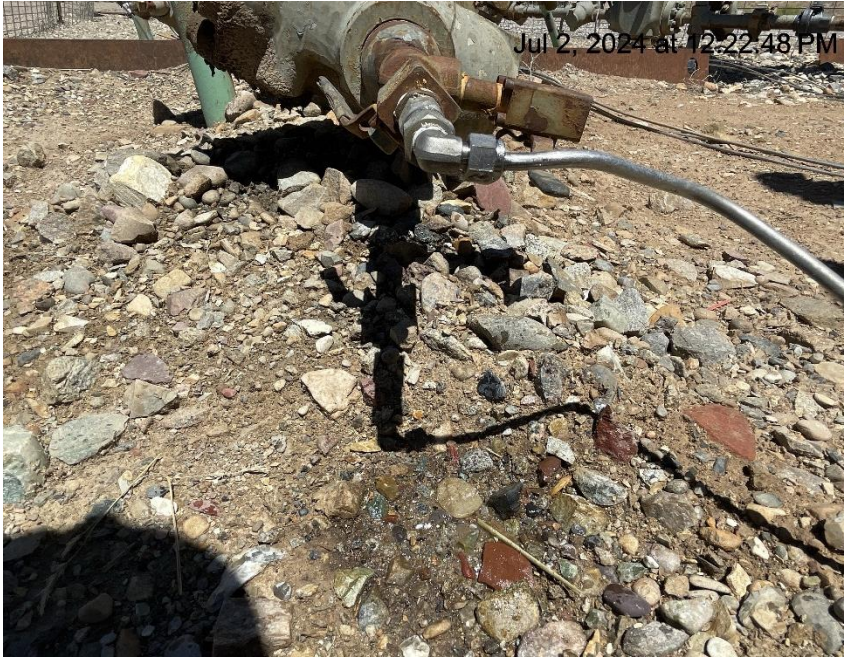
Photo # 2219 Mechanical Condition – possible leak on chemical line connected to RWF 432-26 well casing valve

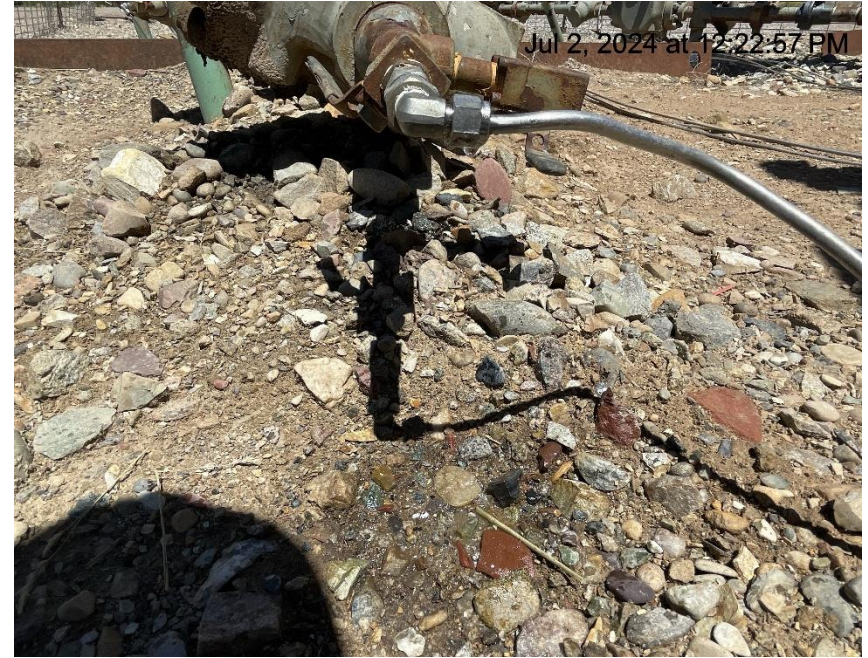
Photo # 2220 Mechanical Condition – possible leak on chemical line connected to RWF 432-26 well casing valve

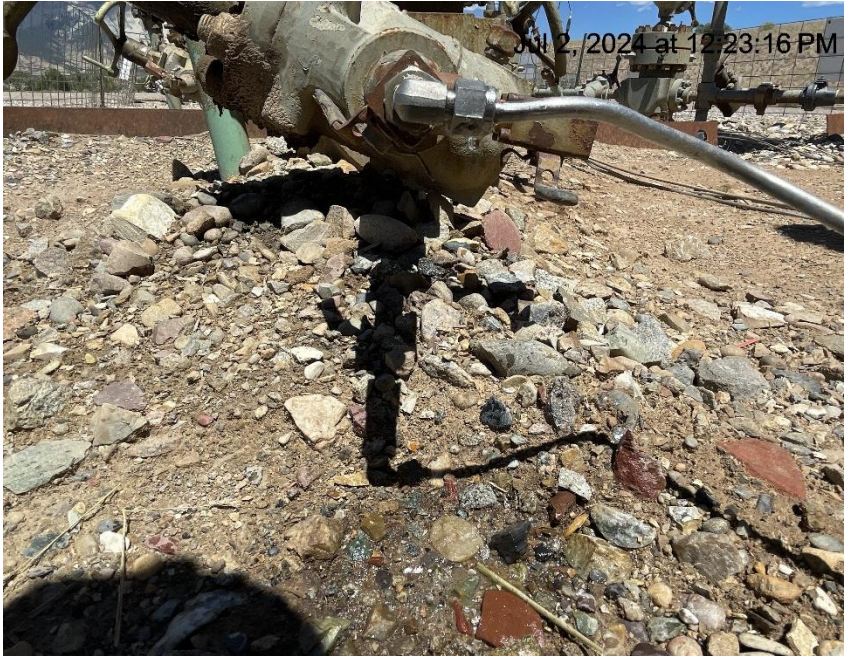
Photo # 2221 Mechanical Condition – possible leak on chemical line connected to RWF 432-26 well casing valve

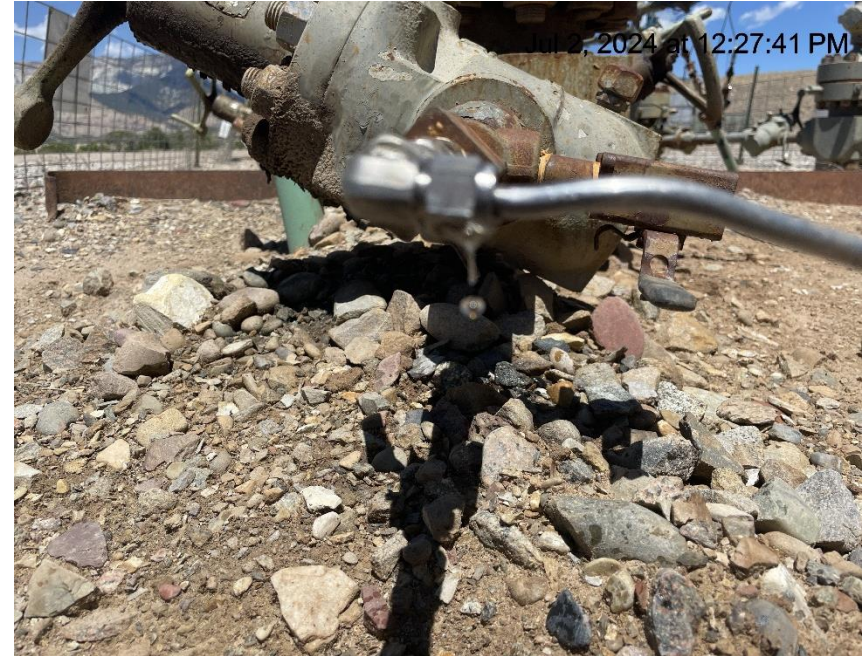
Photo # 2222 Mechanical Condition – possible leak on chemical line connected to RWF 432-26 well casing valve

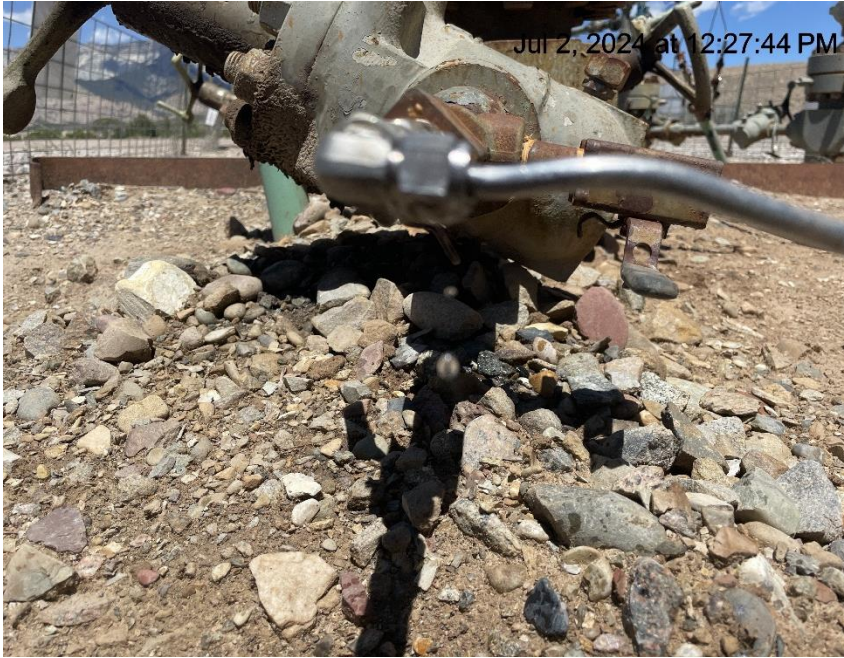
Photo # 2223 Mechanical Condition – possible leak on chemical line connected to RWF 432-26 well casing valve

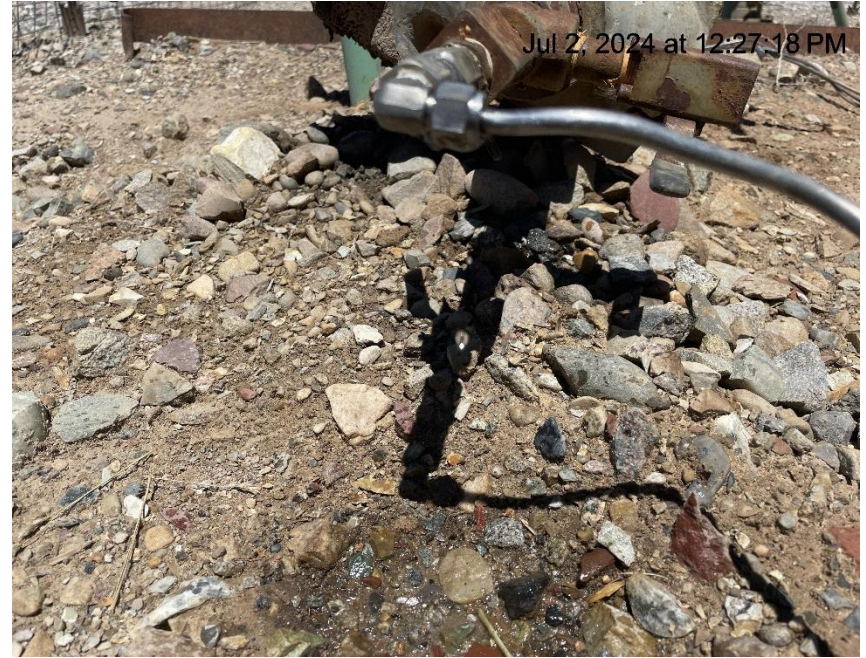
Photo # 2224 Mechanical Condition – possible leak on chemical line connected to RWF 432-26 well casing valve

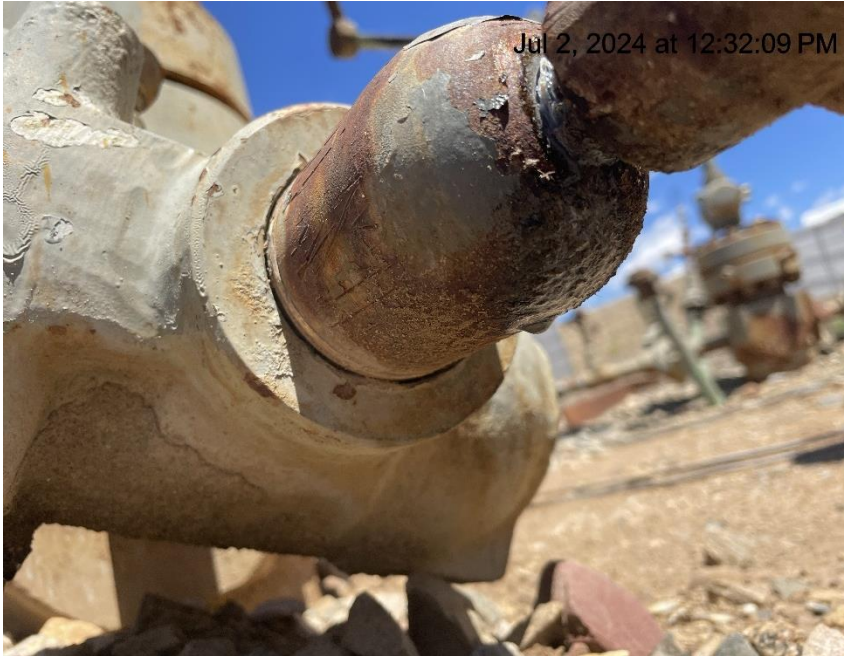
Photo # 2225 Mechanical Condition – possible leak on bullplug connected to RWF 432-26 well casing valve

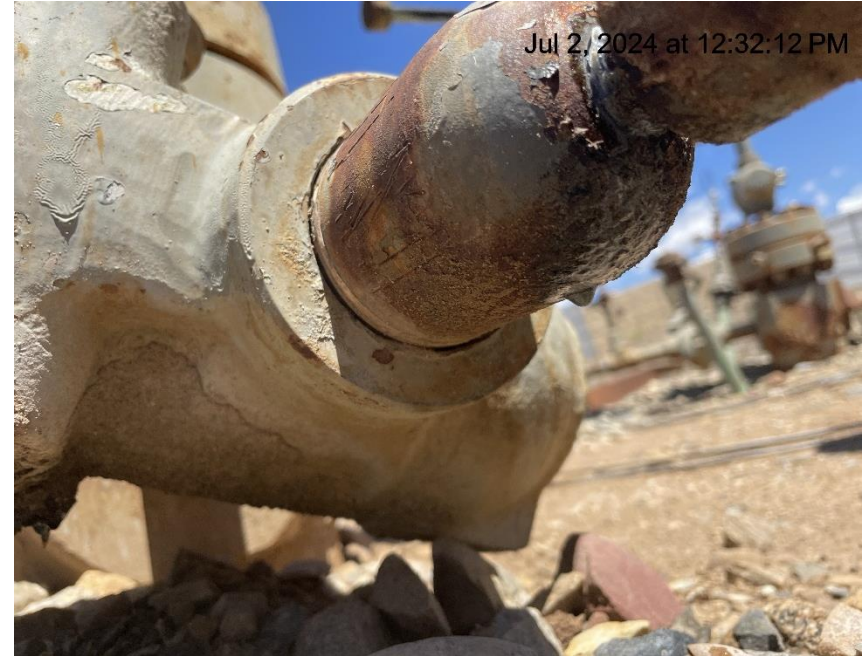
Photo # 2226 Mechanical Condition – possible leak on bullplug connected to RWF 432-26 well casing valve

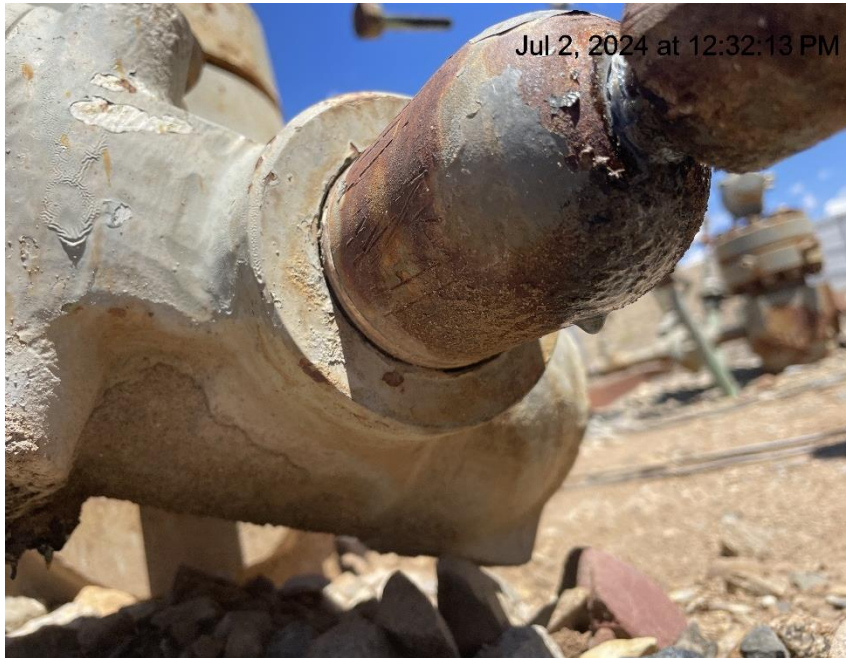
Photo # 2227 Mechanical Condition – possible leak on bullplug connected to RWF 432-26 well casing valve

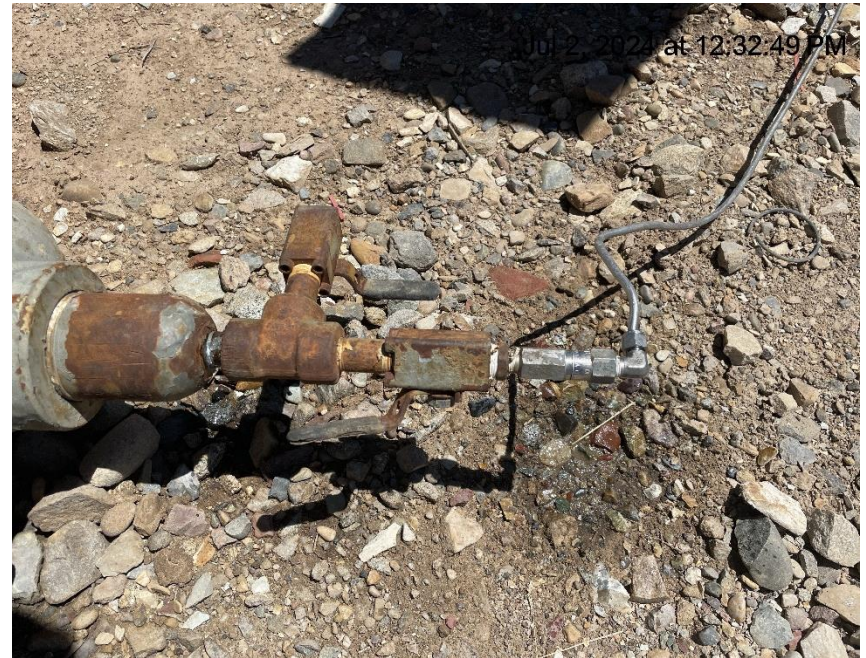
Photo # 2228 Mechanical Condition – possible leaks on chemical line & bullplug connected to RWF 432-26 well casing valve
