Inspection Photos

Location Name: TEP ROCKY MOUNTAIN LLC, AP-66S95W/18NENW

Location ID: 335996

Date: 6/27/2024

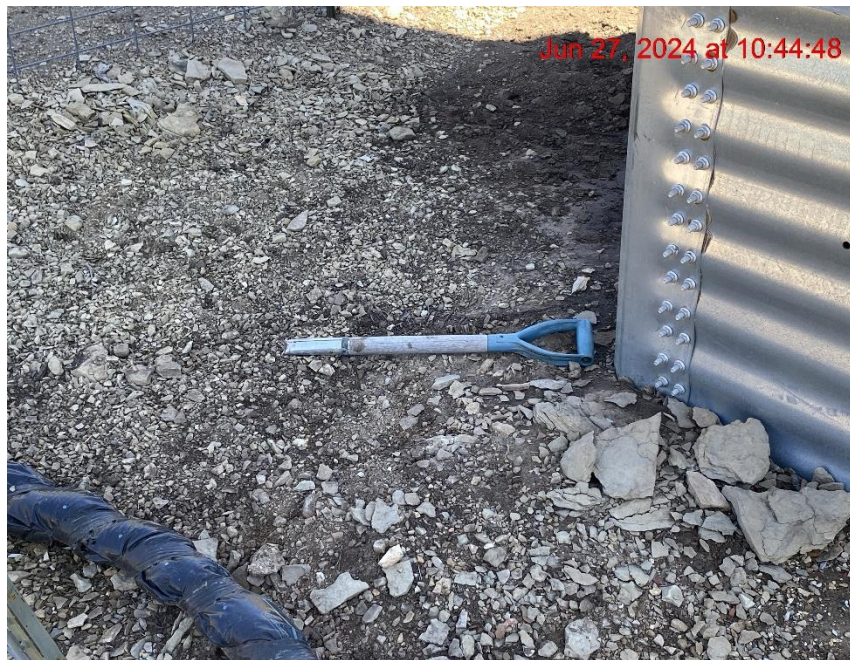
Housekeeping/Debris – Photo #01920

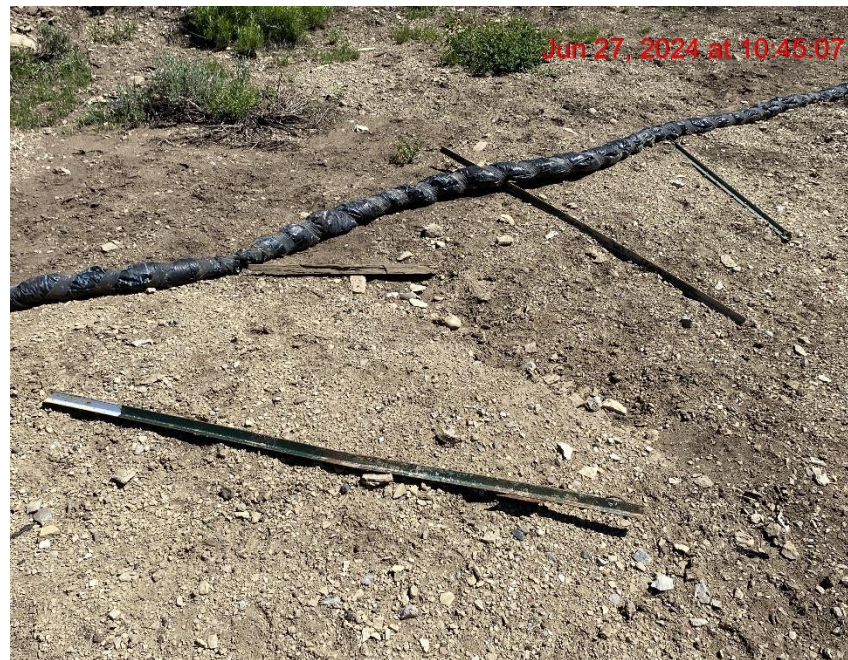
Housekeeping/Debris – Photo #01921

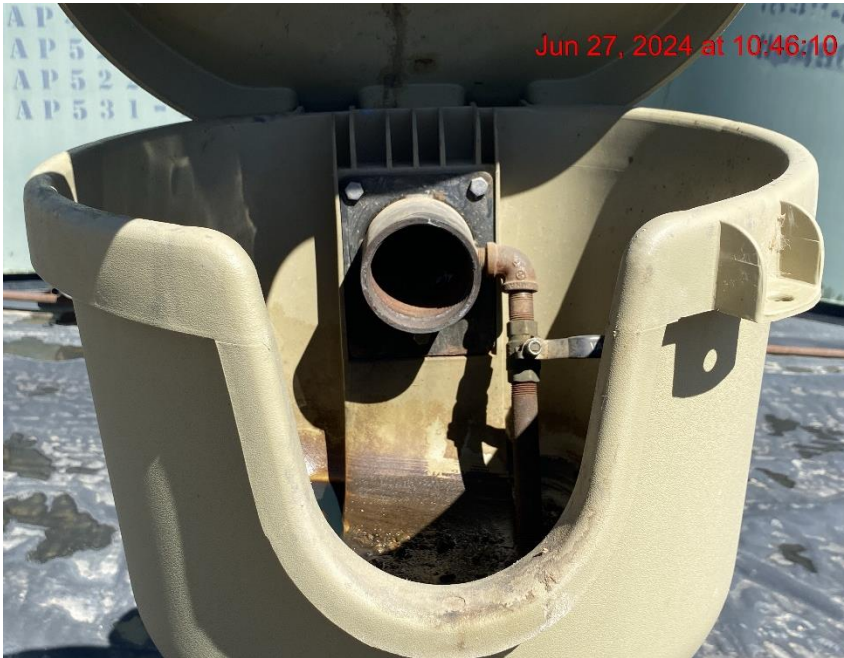
Open-Ended Load Line – Photo #01925

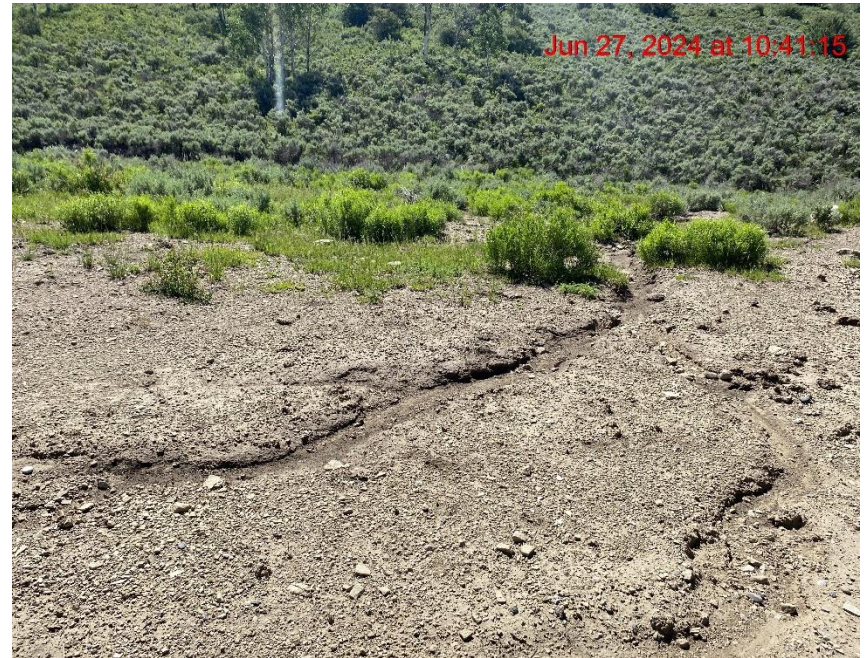
Sediment Run-Off from Location – Photo #01913

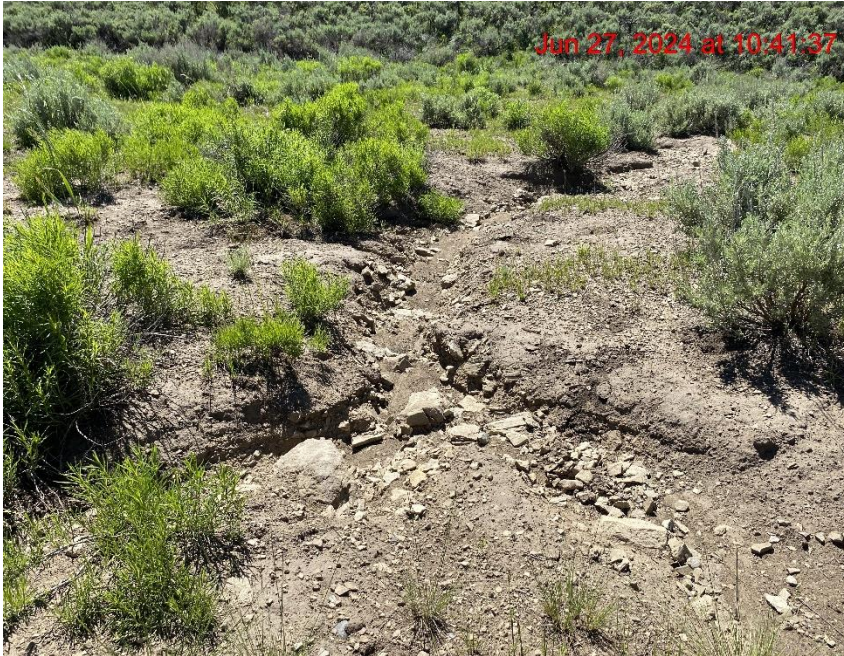
Sediment Run-Off from Location – Photo #01914

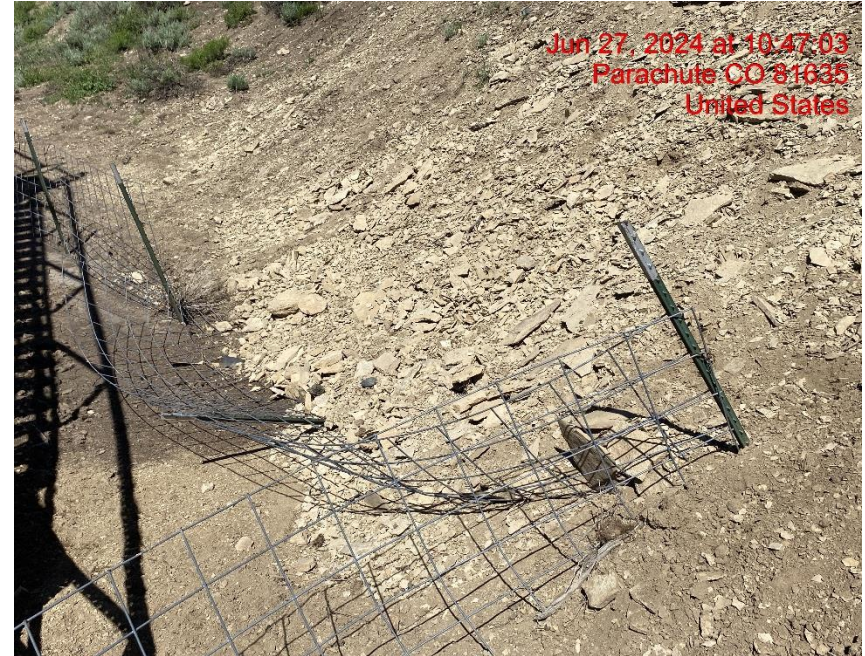
Insufficient Erosion Control/Site Degradation – Photo #01928

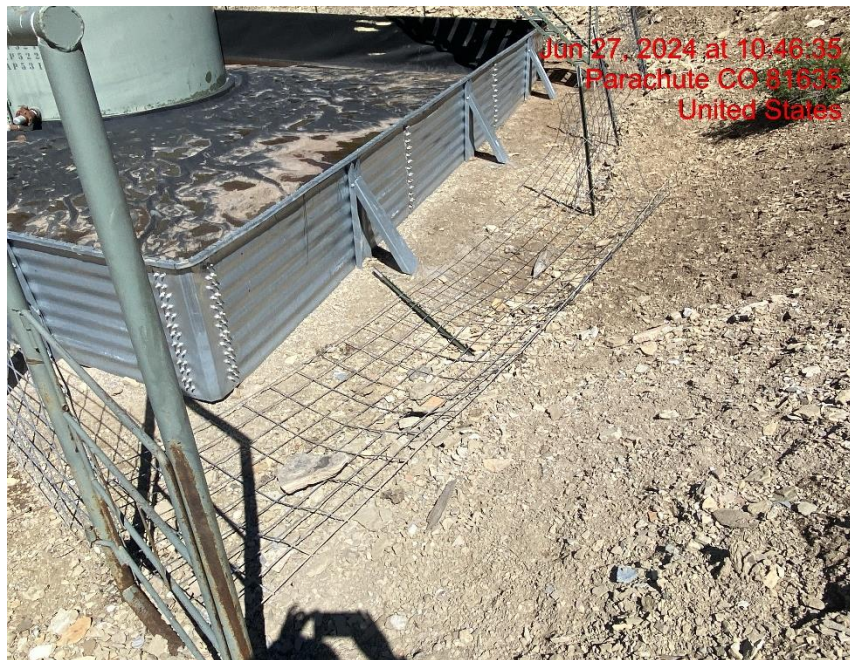
Insufficient Erosion Control/Site Degradation – Photo #01926

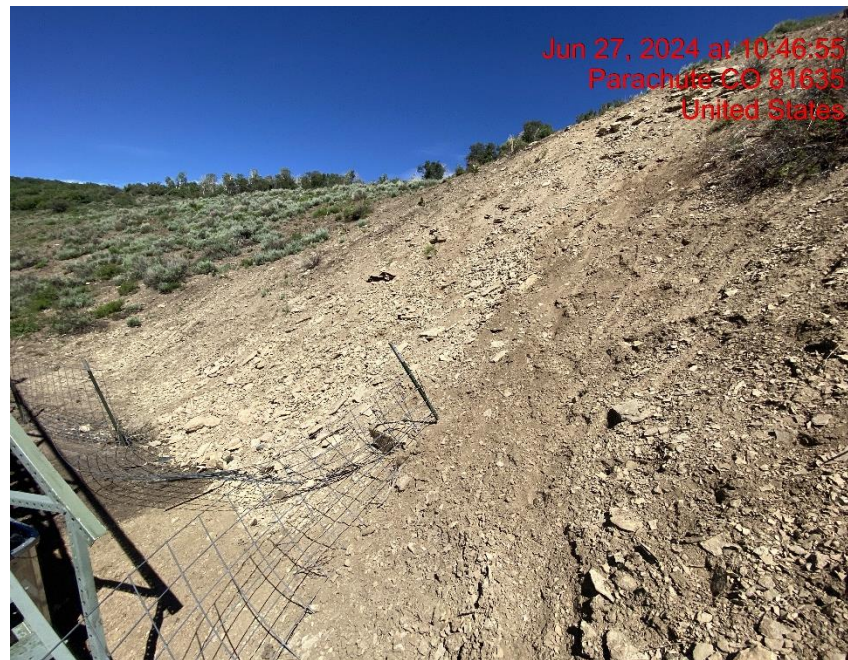
Insufficient Erosion Control/Site Degradation – Photo #01927

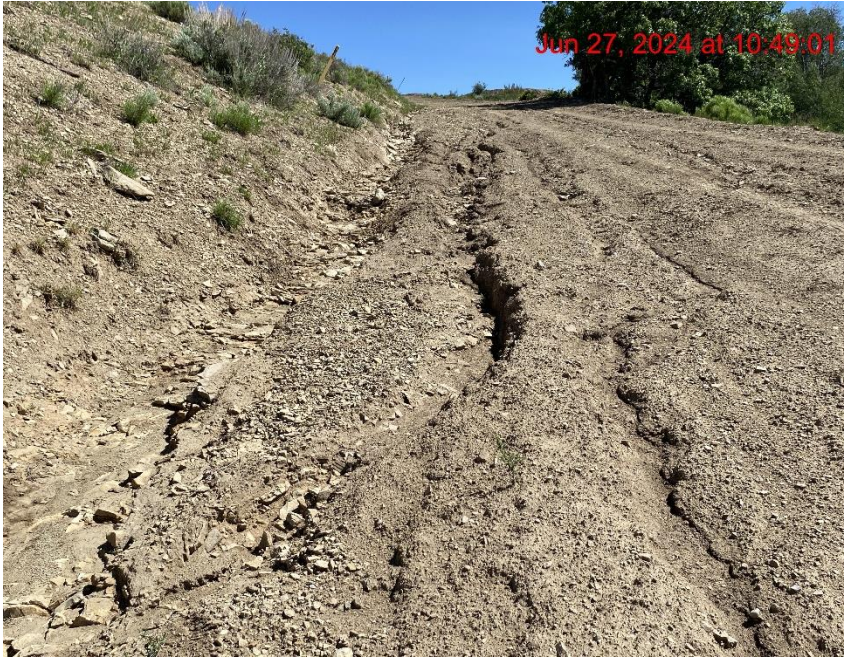
**Insufficient Erosion Control/Rill Erosion Bypassing Ditch
BMP on Access Road – Photo #01929**

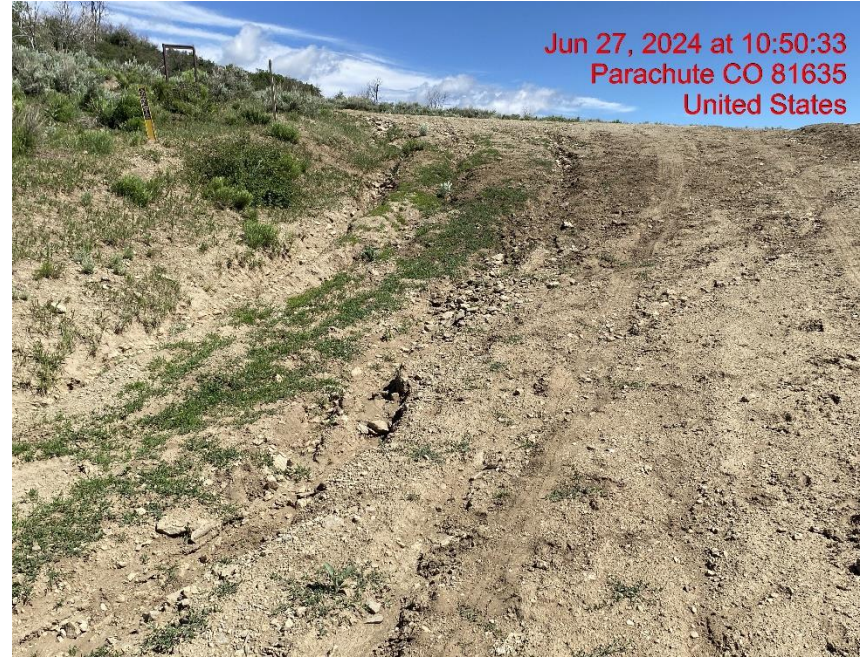
**Insufficient Erosion Control/Rill Erosion Bypassing Ditch
BMP on Access Road – Photo #01931**
