Inspection Photos

Location Name: CAERUS PICEANCE LLC EM 30-7 (B30NE) Pad

Location #: 335454

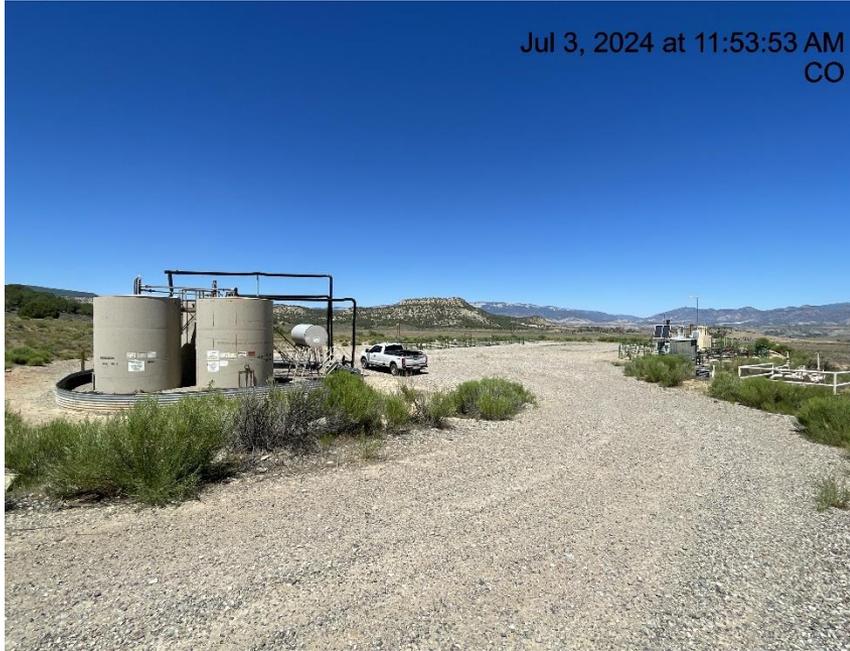
Photo # 2487 From entrance to location

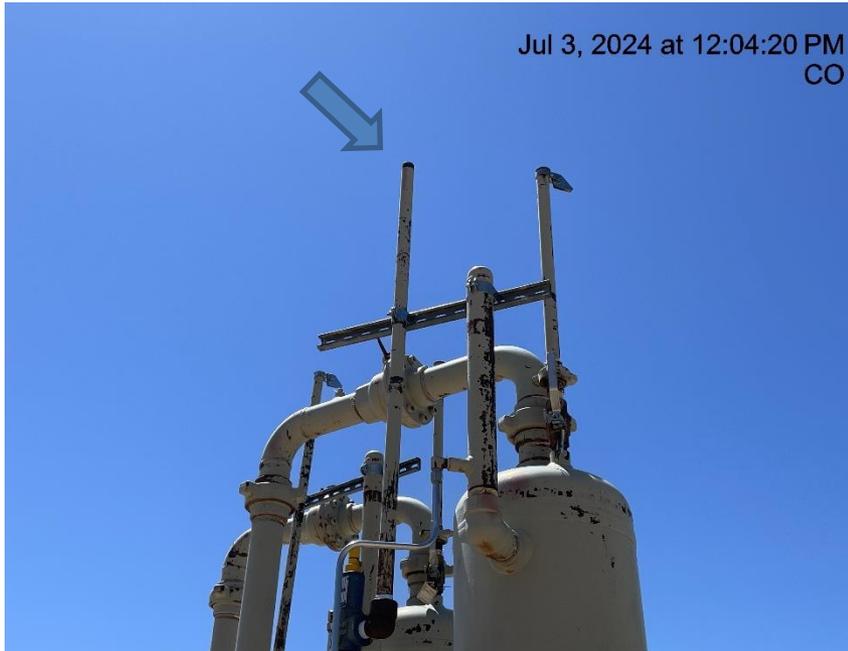
Photo # 2497 PRV vent line does not comply with CECMC pressure safety device rules

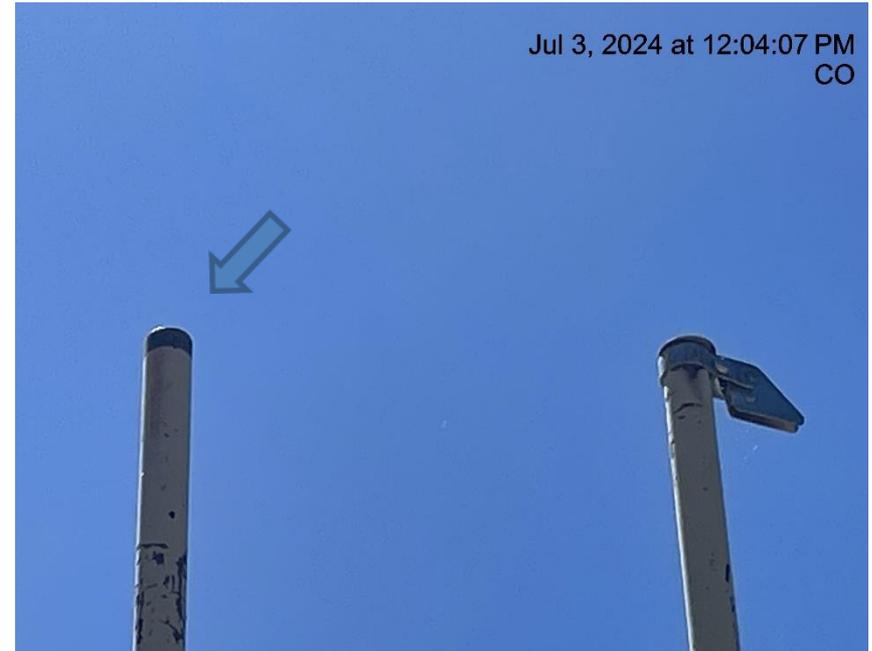
Photo # 2498 PRV vent line does not comply with CECMC pressure safety device rules

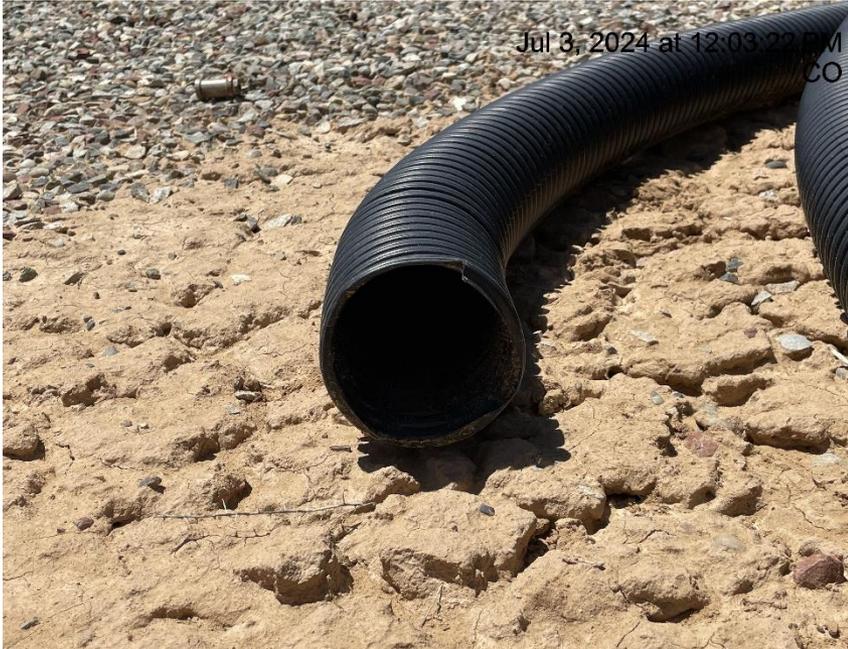
**Photo # 2499 Flowline heating insulation open ended
/wildlife hazard/available for entry by wildlife**

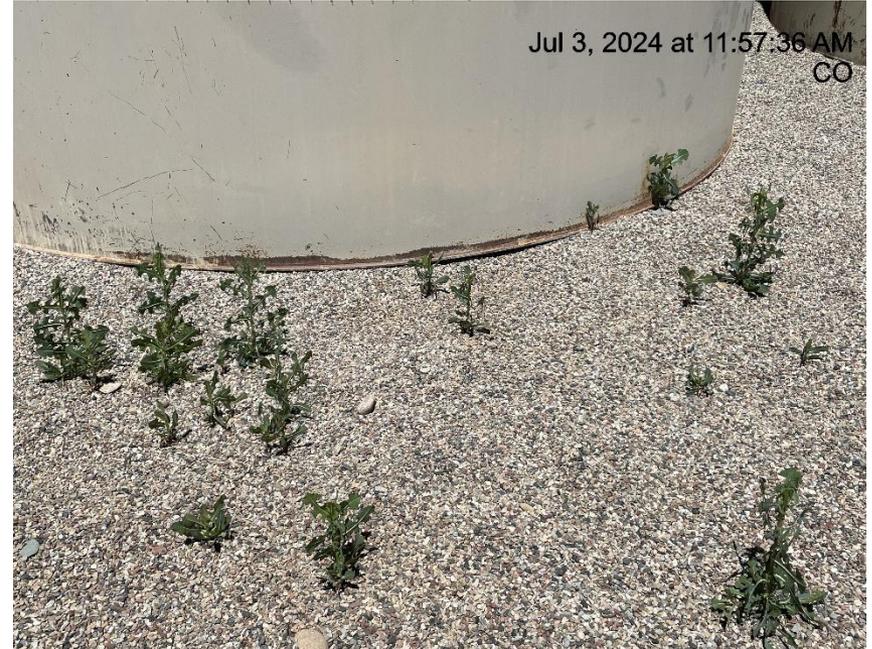
Photo # 2500 Weeds in secondary containment

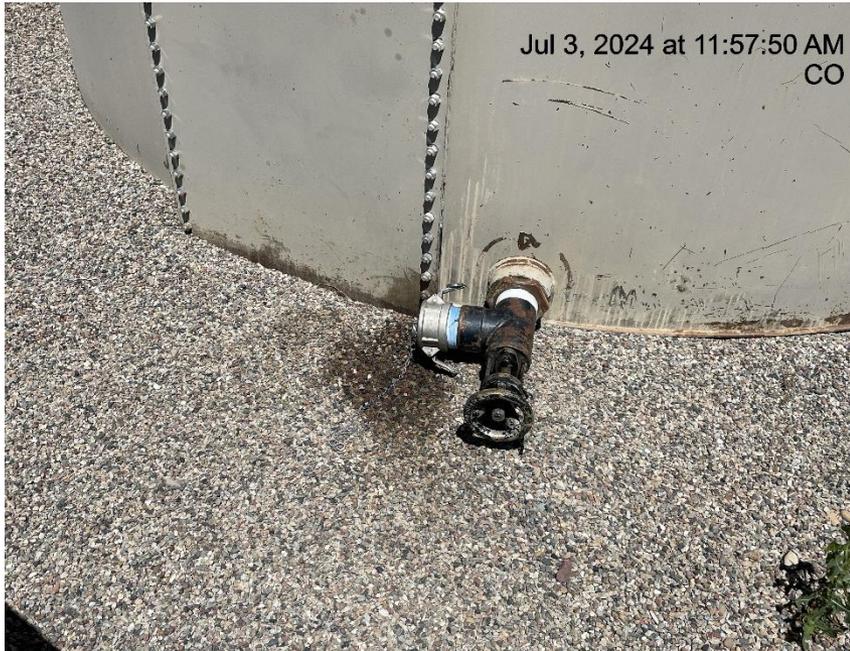
Photo # 2501 Staining in secondary containment near frost free valve

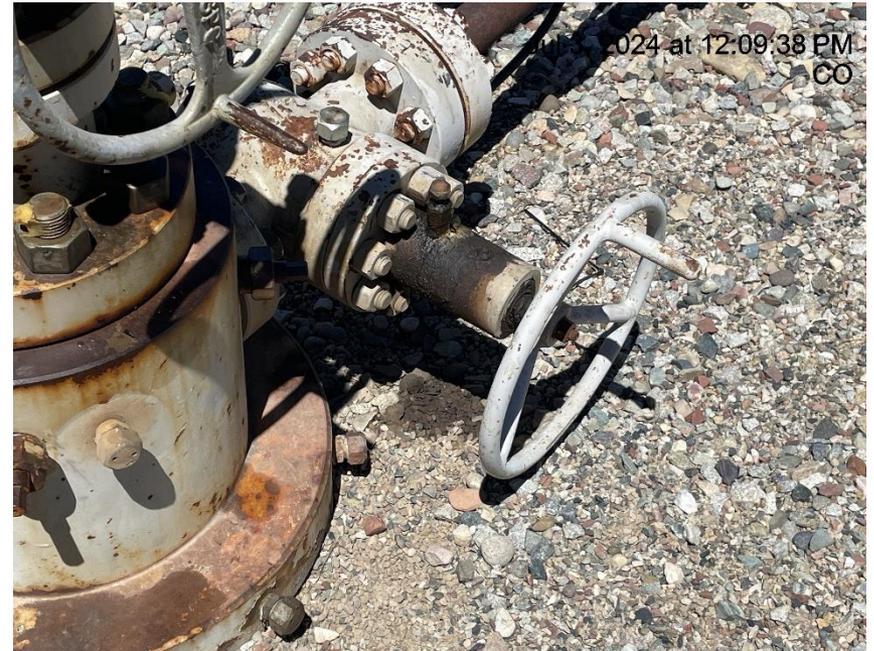
Photo # 2502 Staining near wellhead

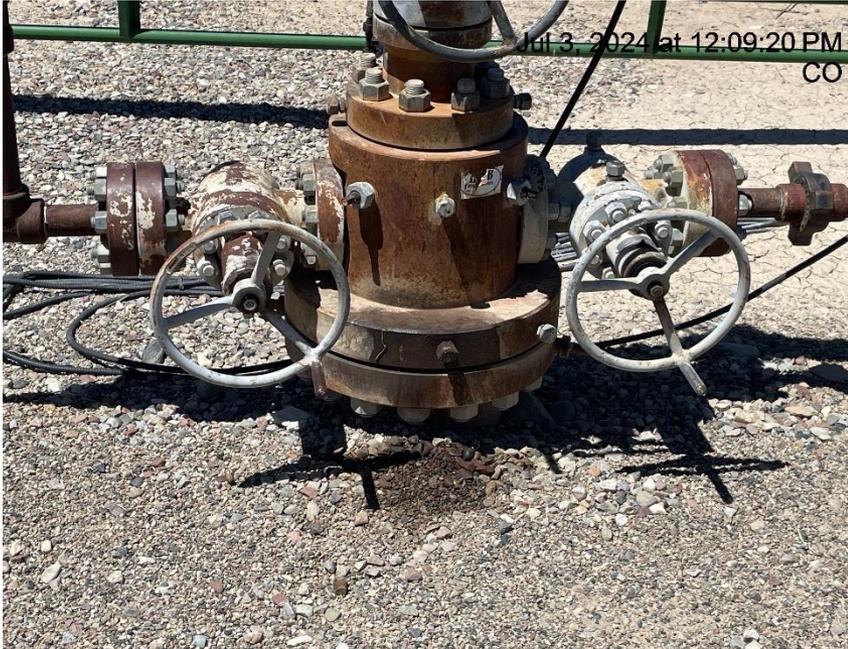
Photo # 2503 Staining near wellhead
