Subject: RE: ARGENTA 34-10-33 3 - INC - 714000826

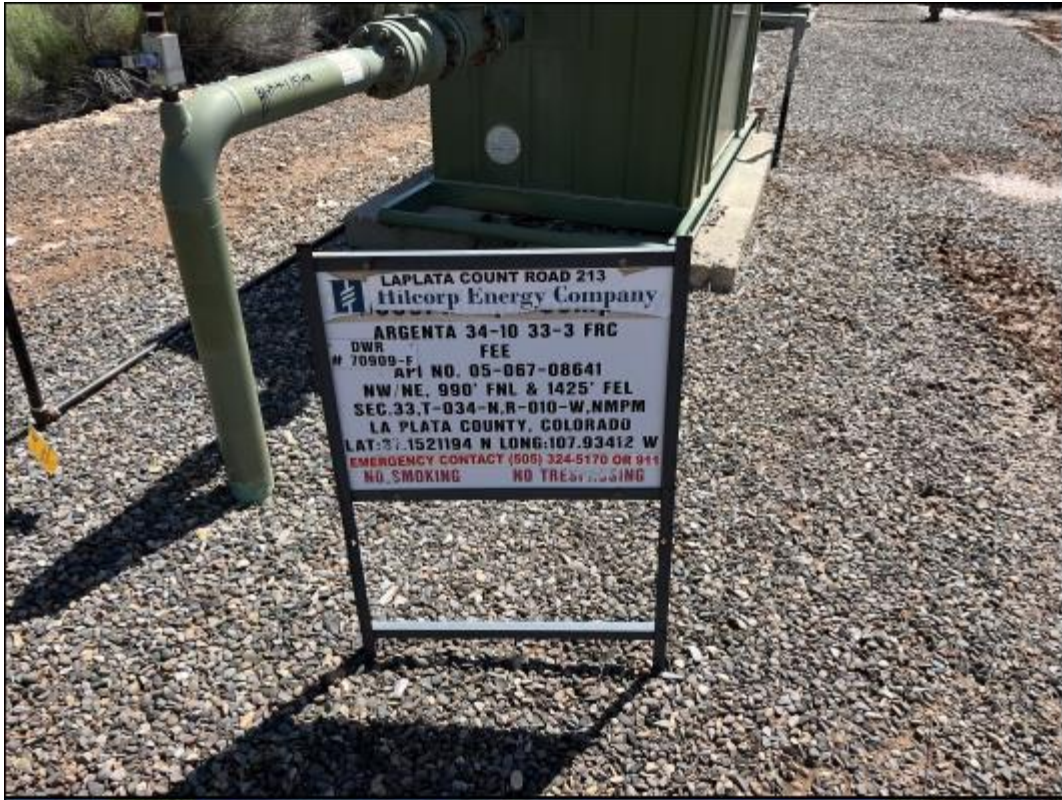
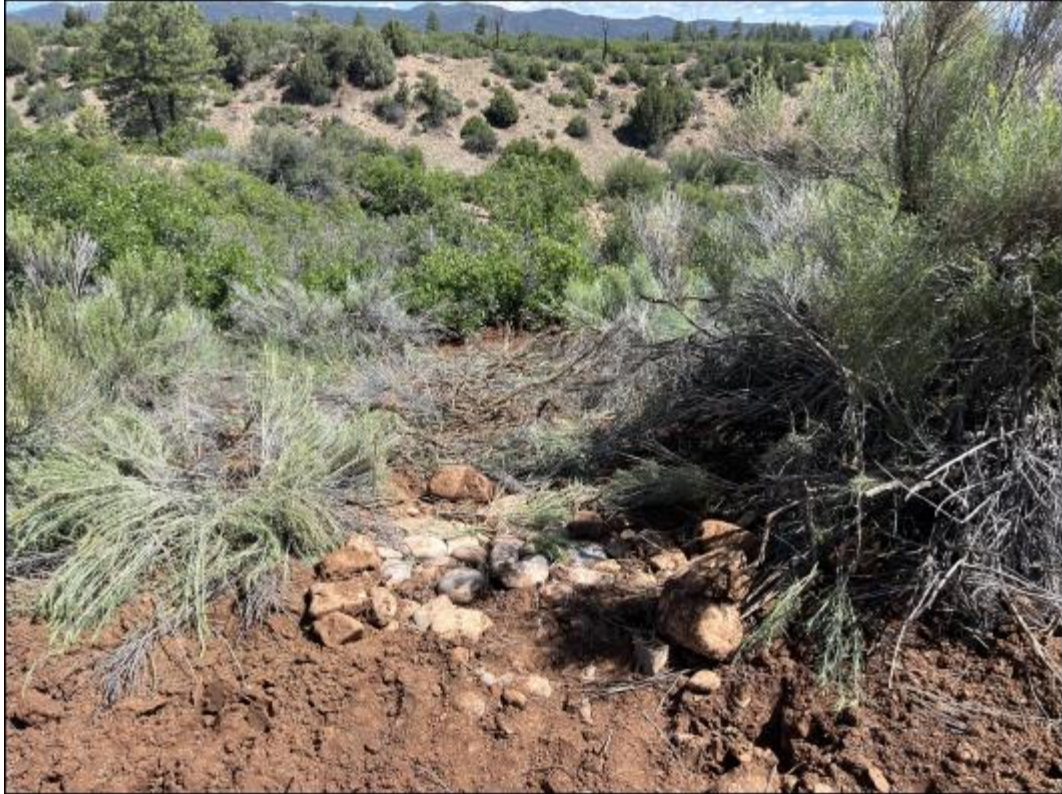
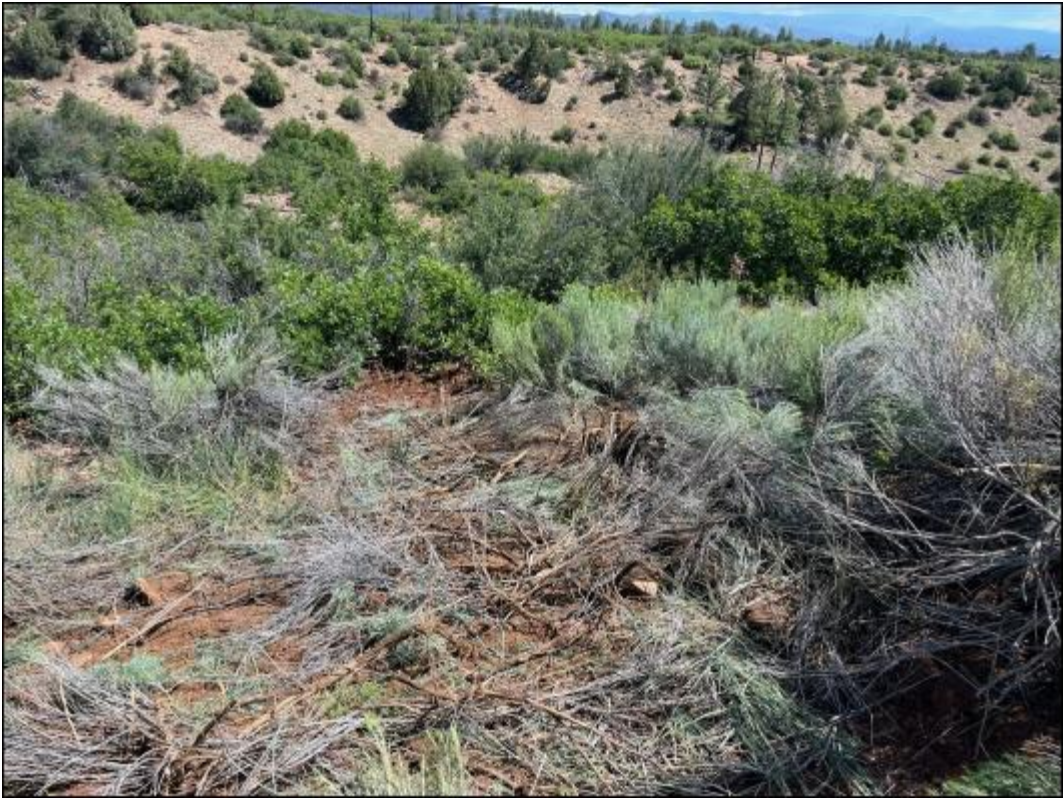
Storm water: Inspection doc #693904585 observed storm water issues in the northern portion of the disturbance and required compliance by 7/16/2022. It was observed in this inspection that storm water issues are persisting with gully erosion forming down slope of round river rock check dam, current storm water BMPs appear inadequate. Original CA has not been addressed. Original CA and date remains applicable. No CA date is being provided as this location is out of compliance for the same Rule.

Storm water issues have been addressed.

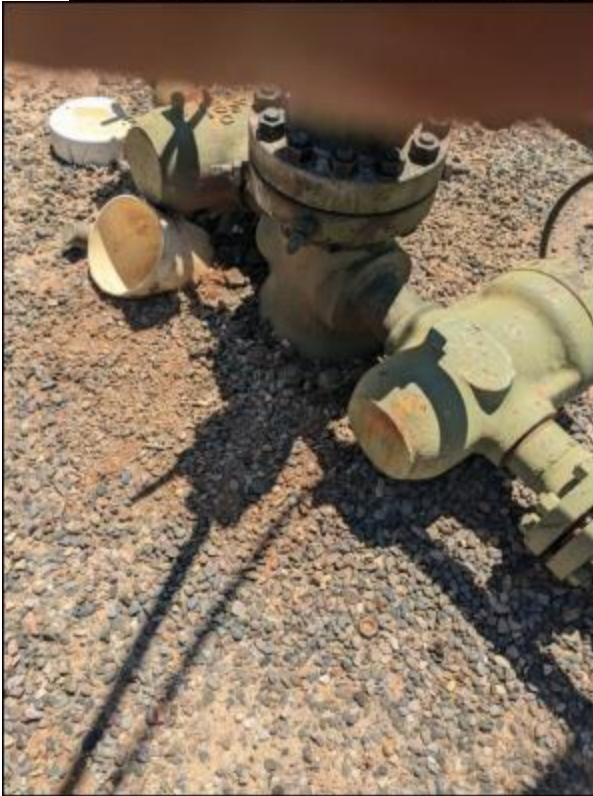
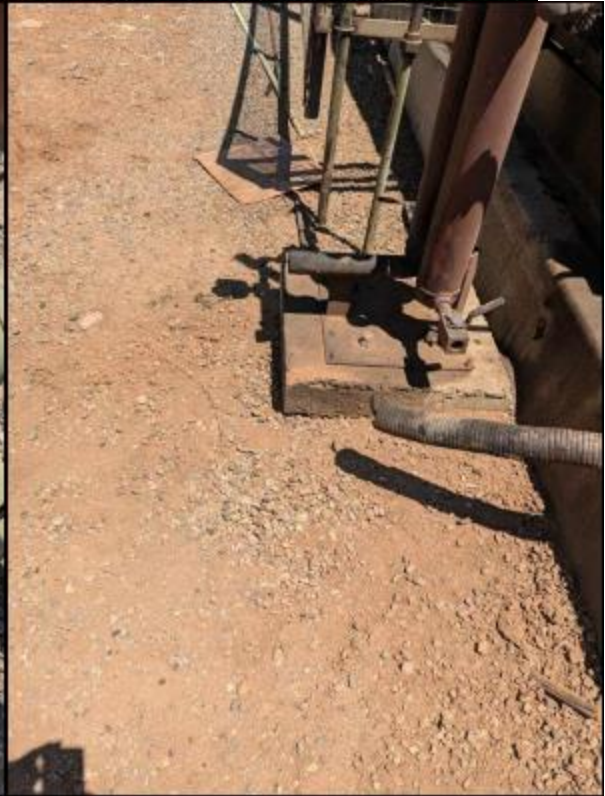
Impacted Surface Material: Impacted surface material observed at the pump jack and well head.

Impacted soil has been removed and disposed of properly.

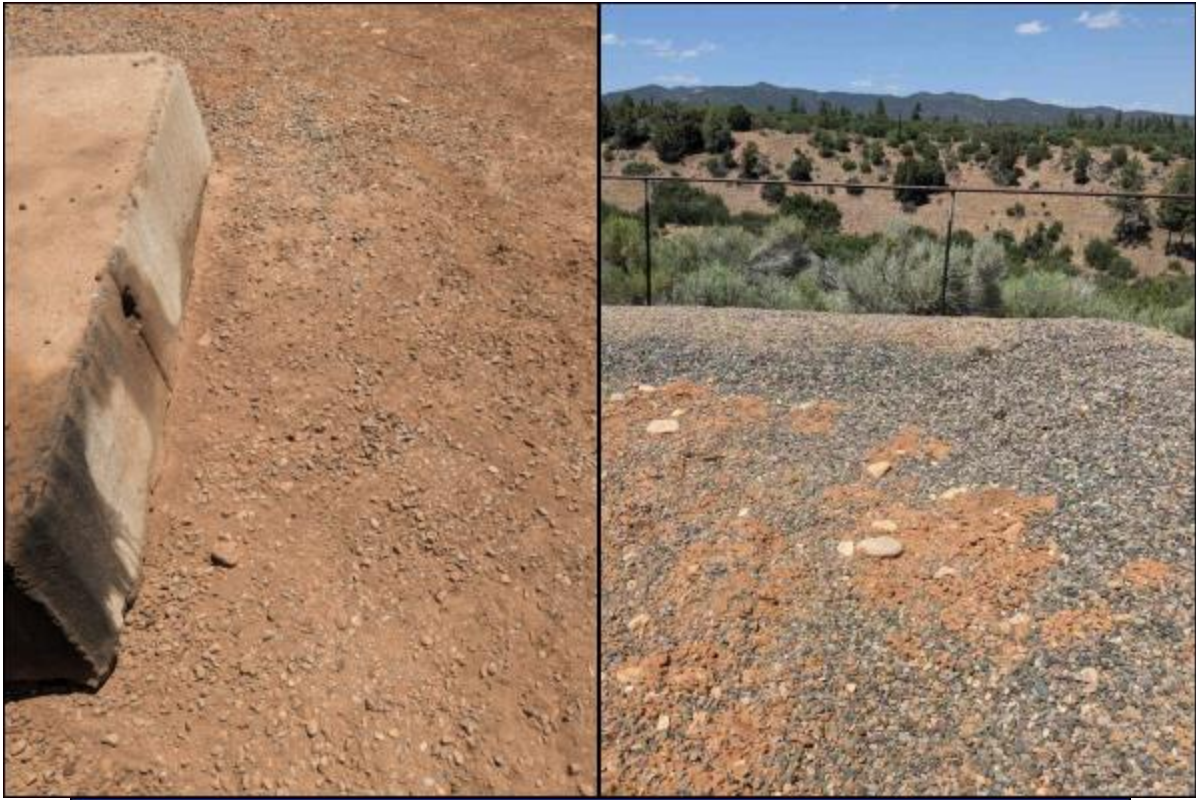
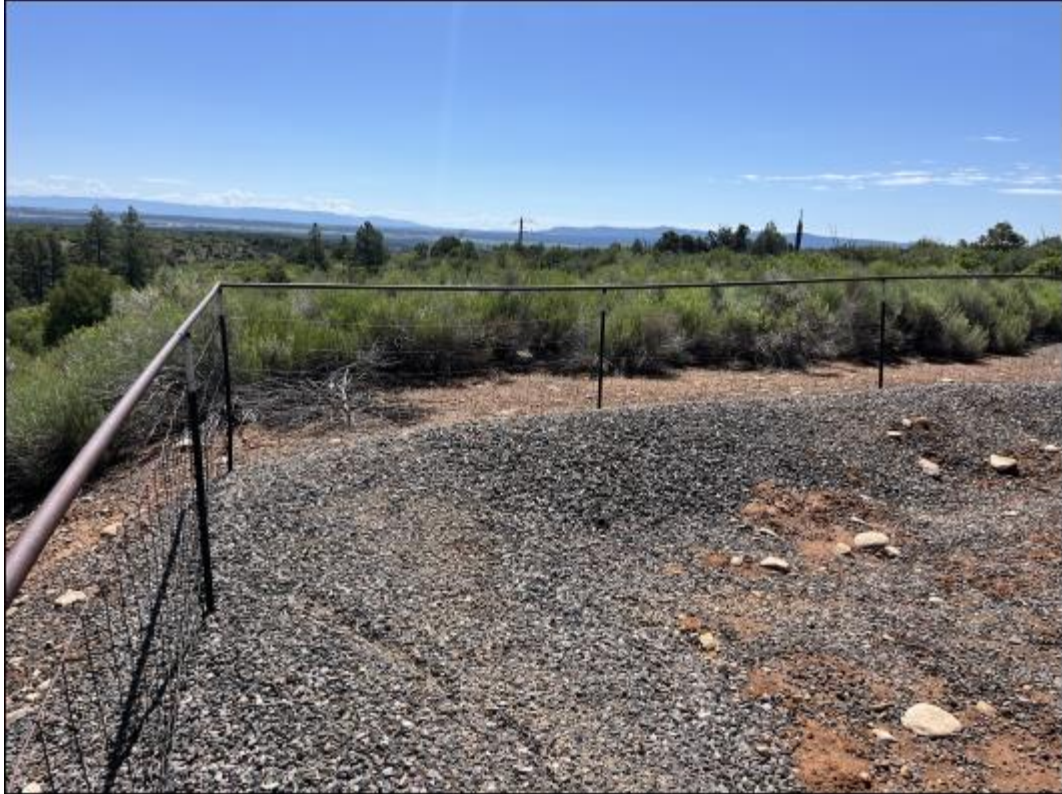
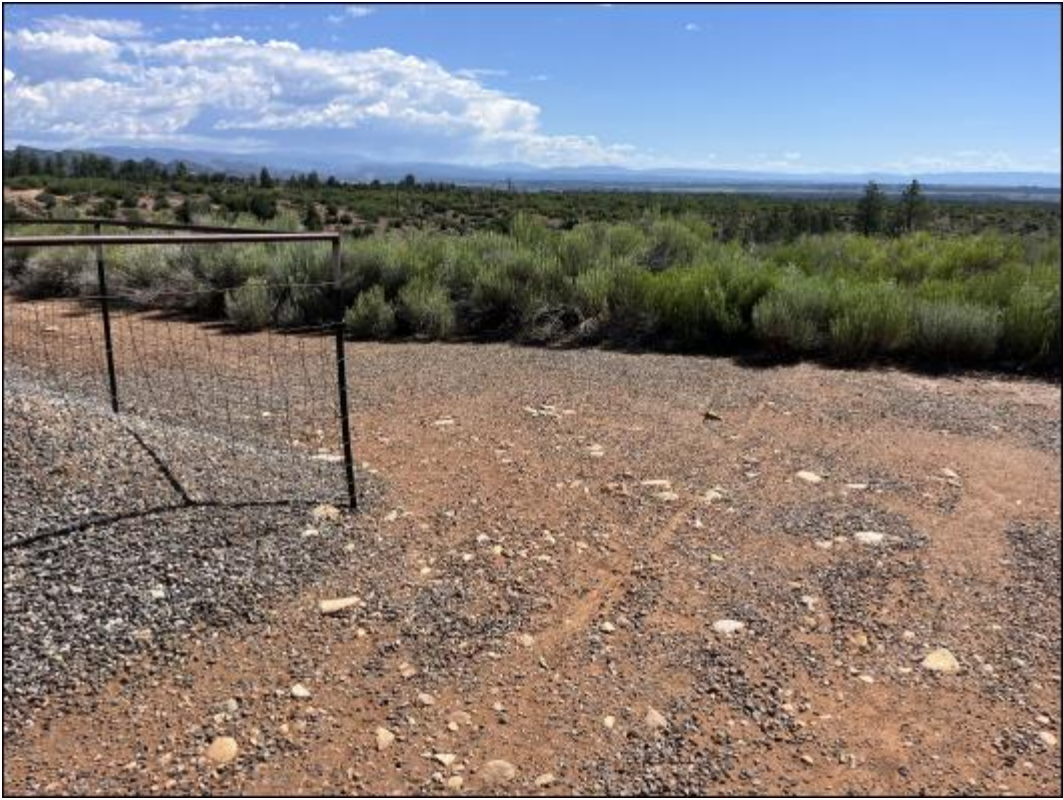
Unused Equipment/Debris: Unused oil and gas piping and metal panels/debris observed on location.

Unused equipment and debris have been removed and disposed of properly.
