Construction and Stormwater Inspection

Date: 06/25/2024

Operator: PDC ENERGY INC - 69175

Inspection Photos
Location Name: Edmundson #30
Location ID: 453934

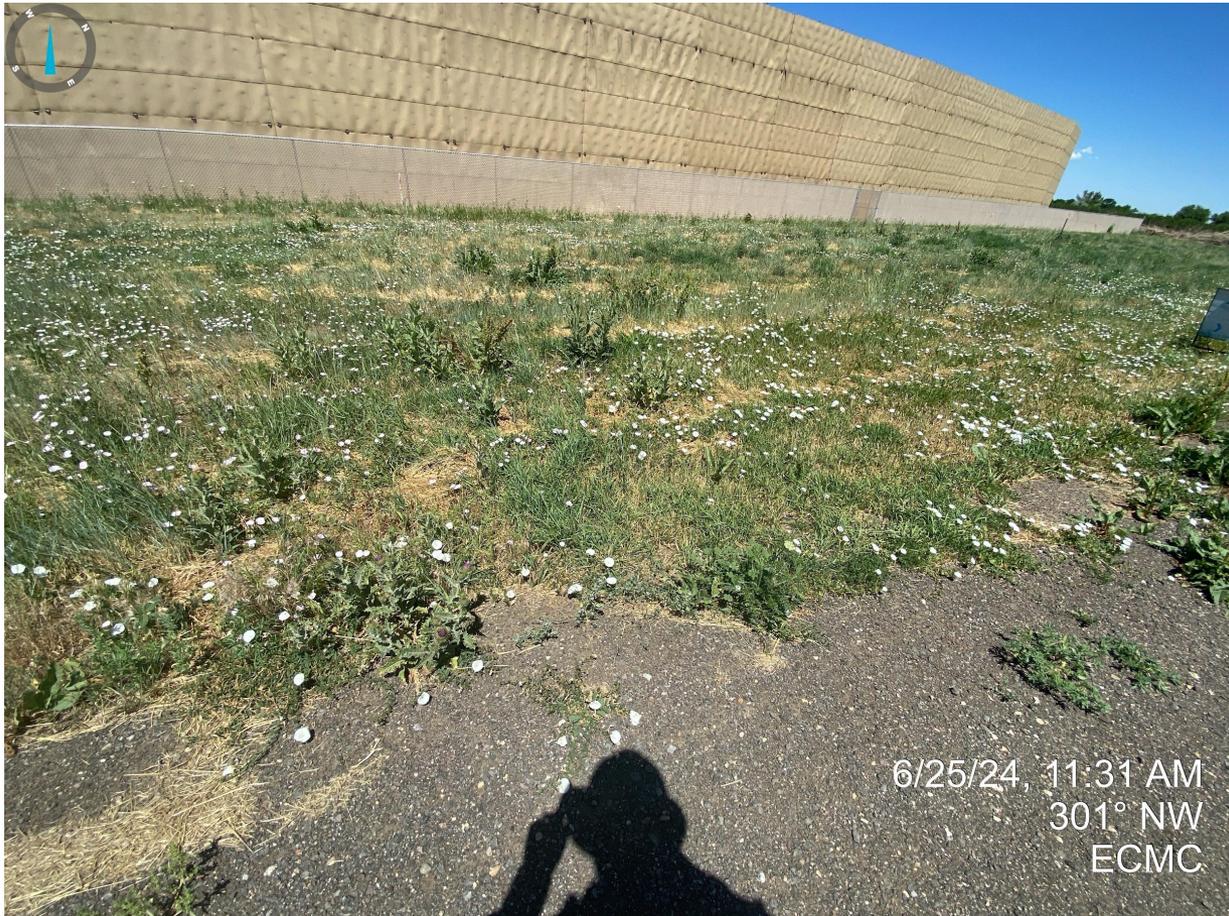
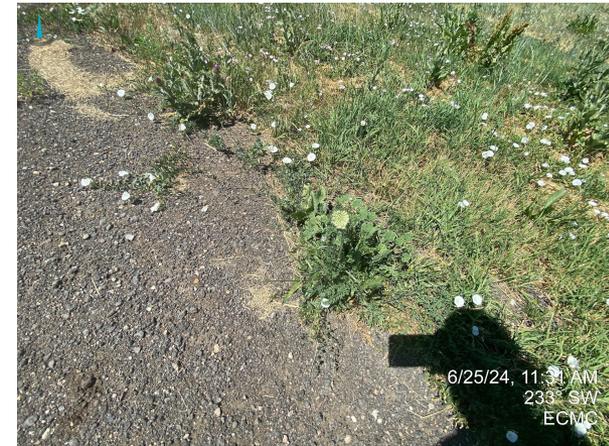
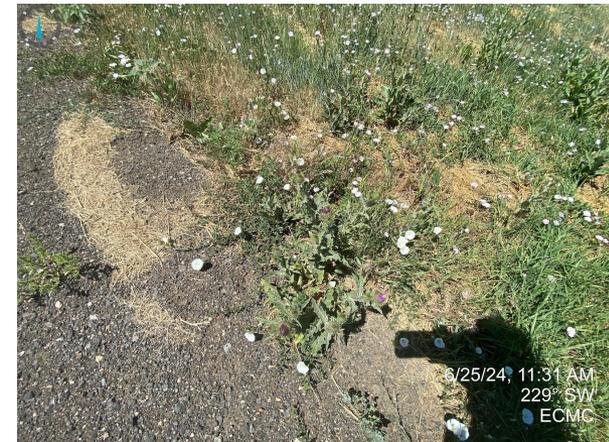
Photo 1. Taken near the location entrance. Undesirable vegetation (e.g. field bindweed, poison hemlock, scotch thistle, smooth broome, curly dock, cheatgrass, etc) observed.

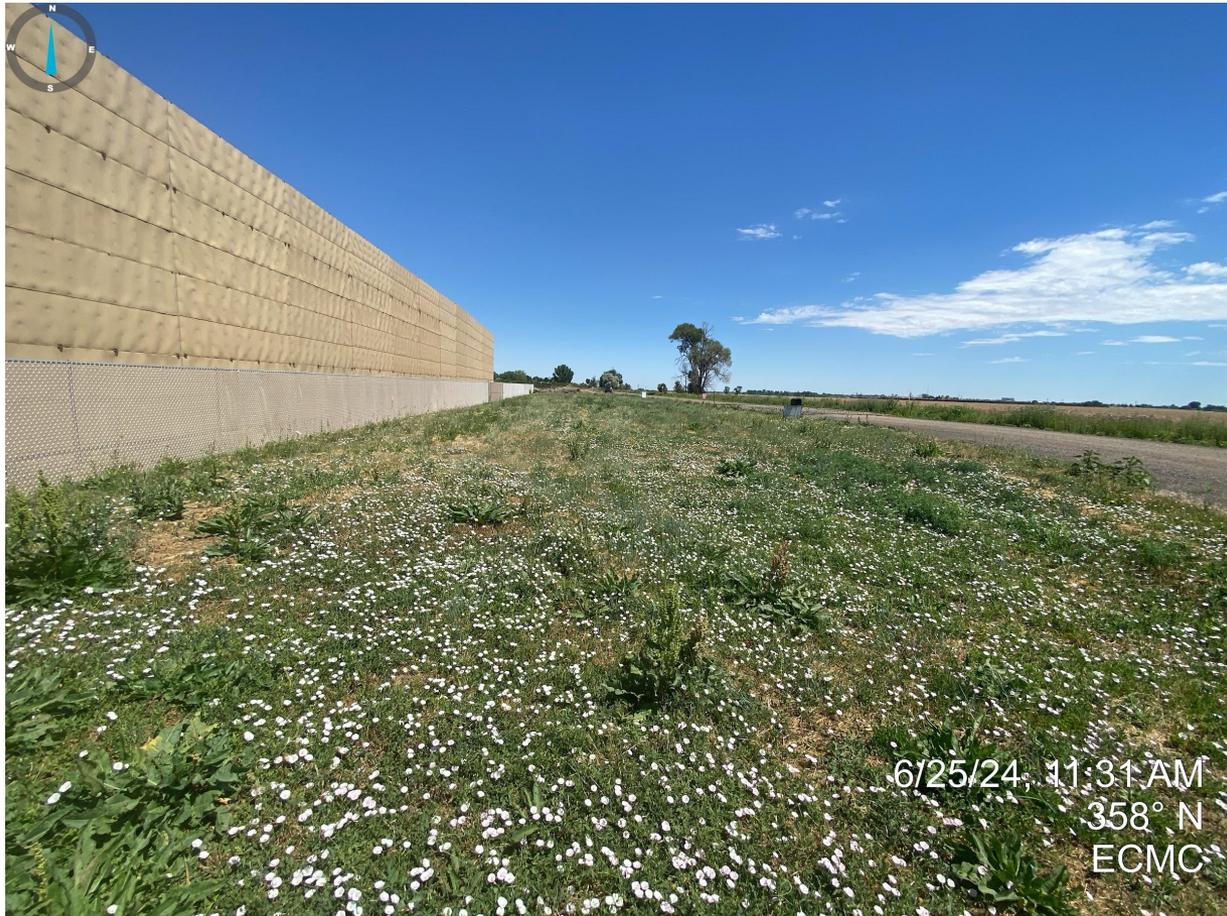
Photo 2. Continued from Photo 1, facing north.

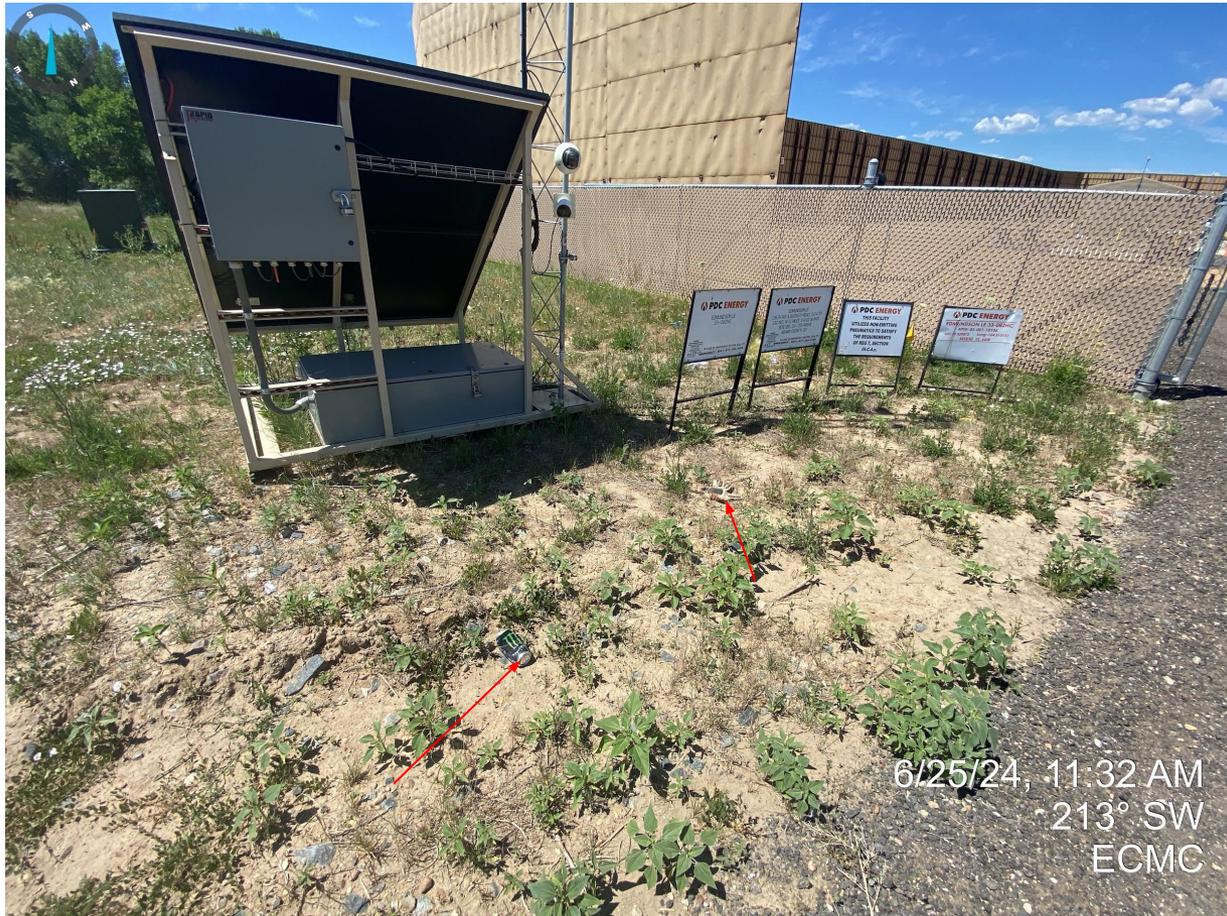
Photo 3. Trash and debris observed near the location entrance.

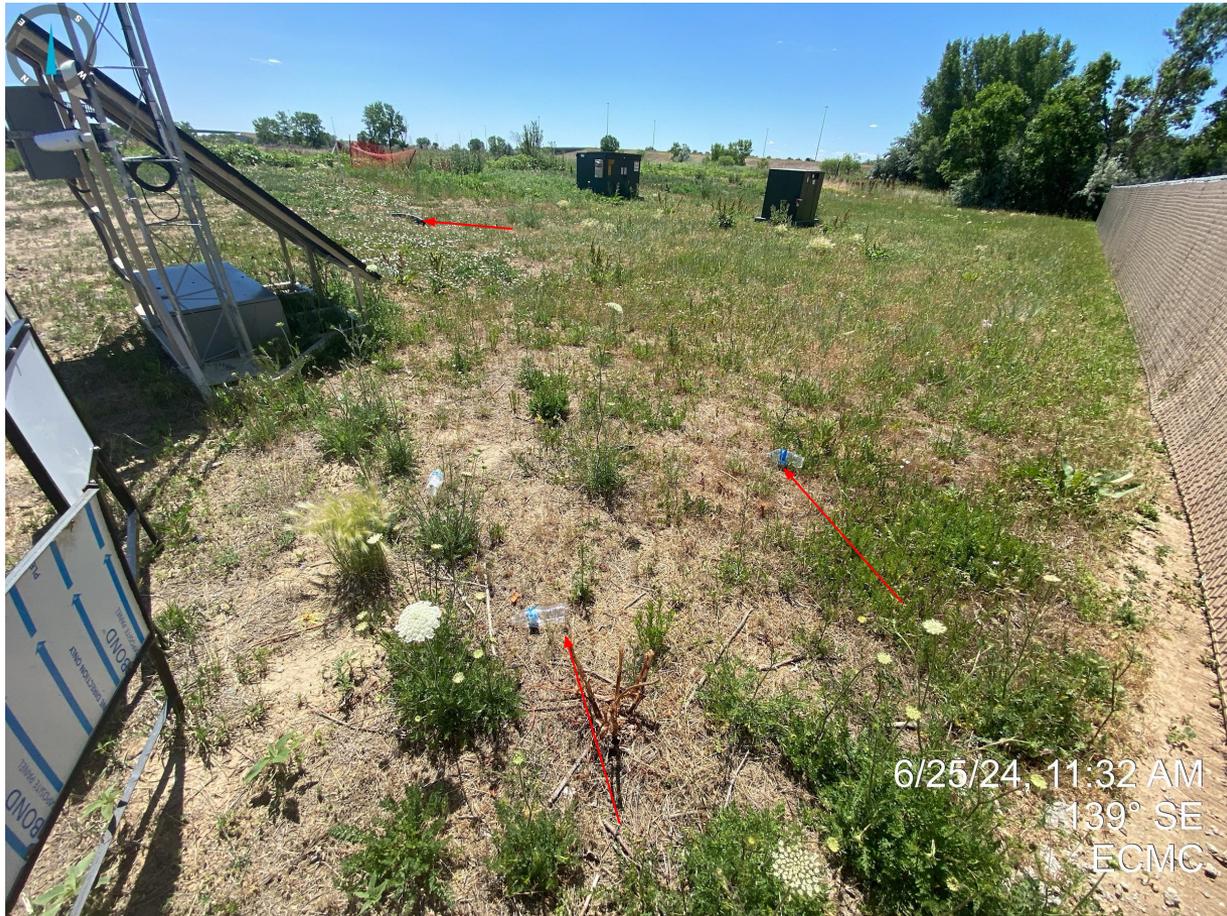
Photo 4. Continued from Photo 3.

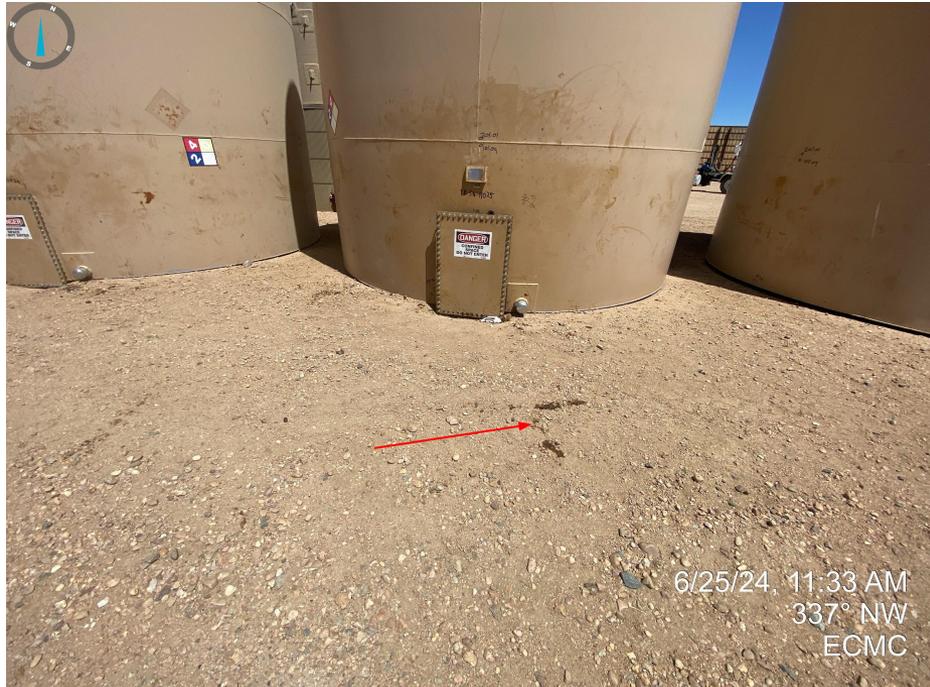
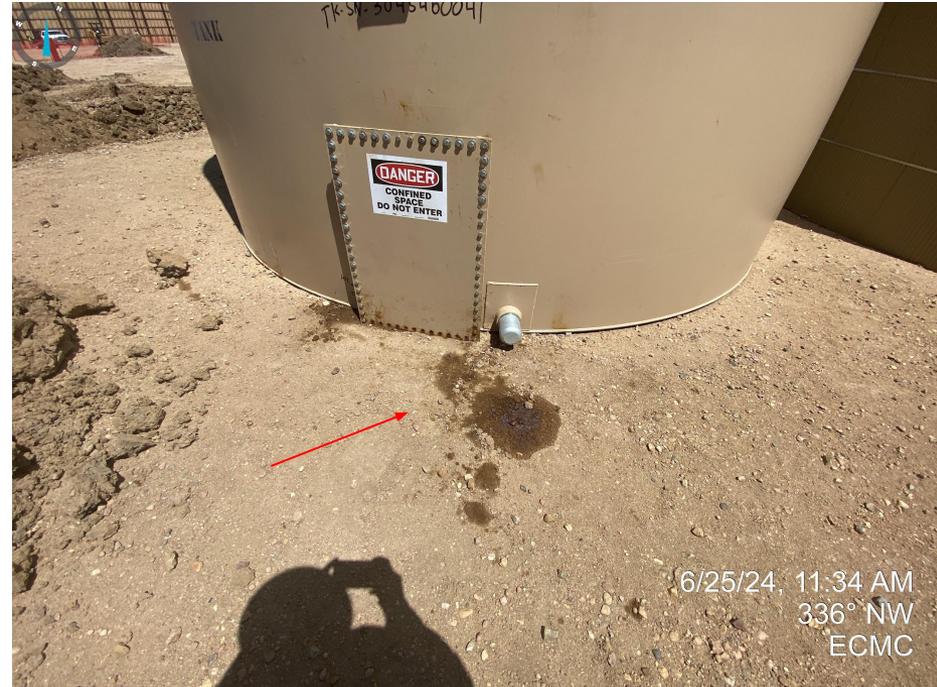
Photo 5. Stained soil observed at AST.

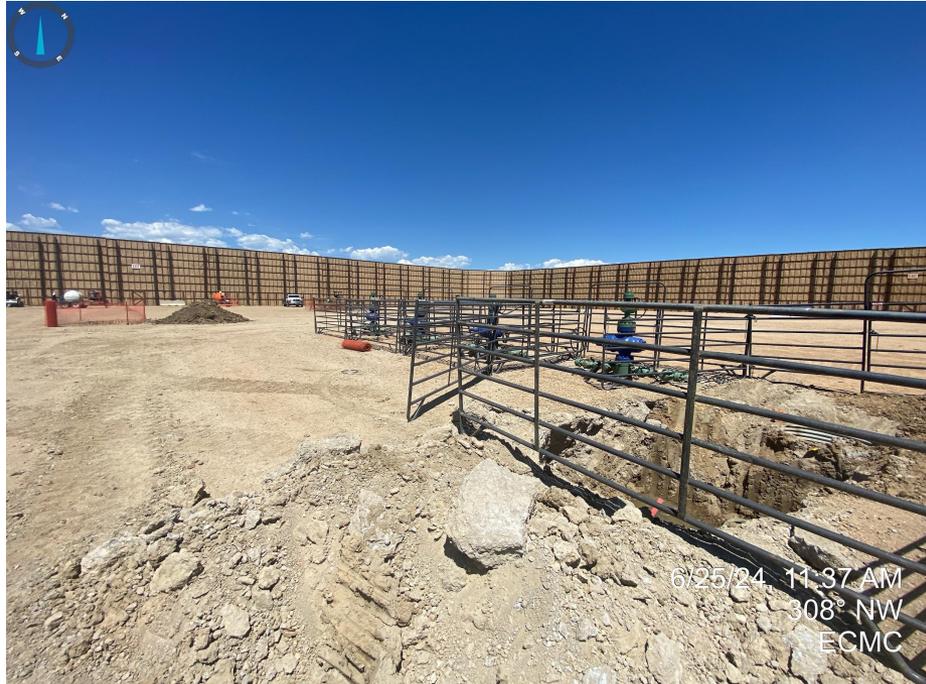
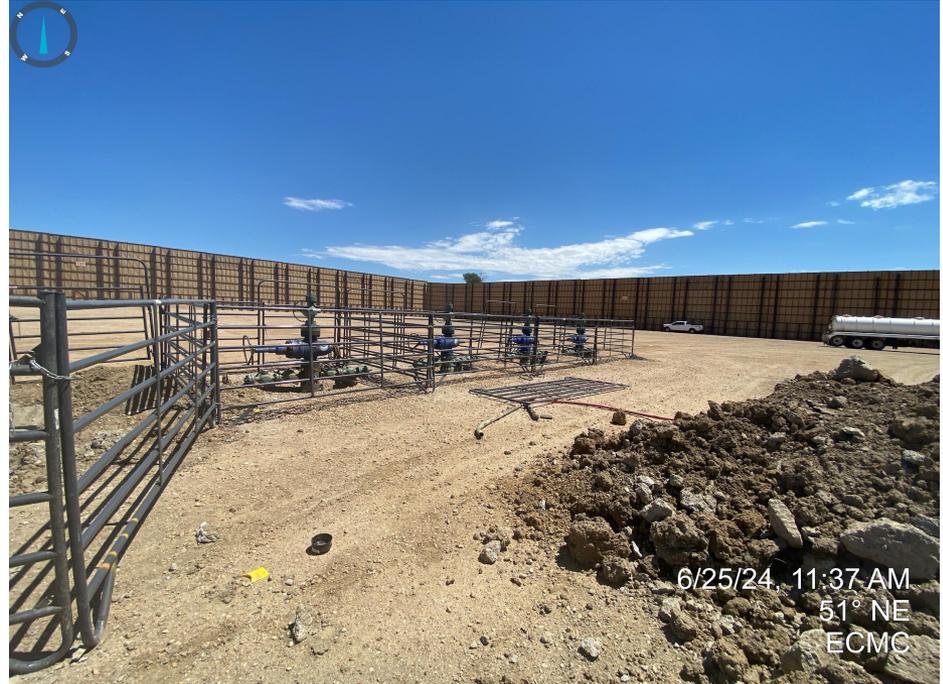
Photo 6. Eight (8) additional wells have been drilled at the location.

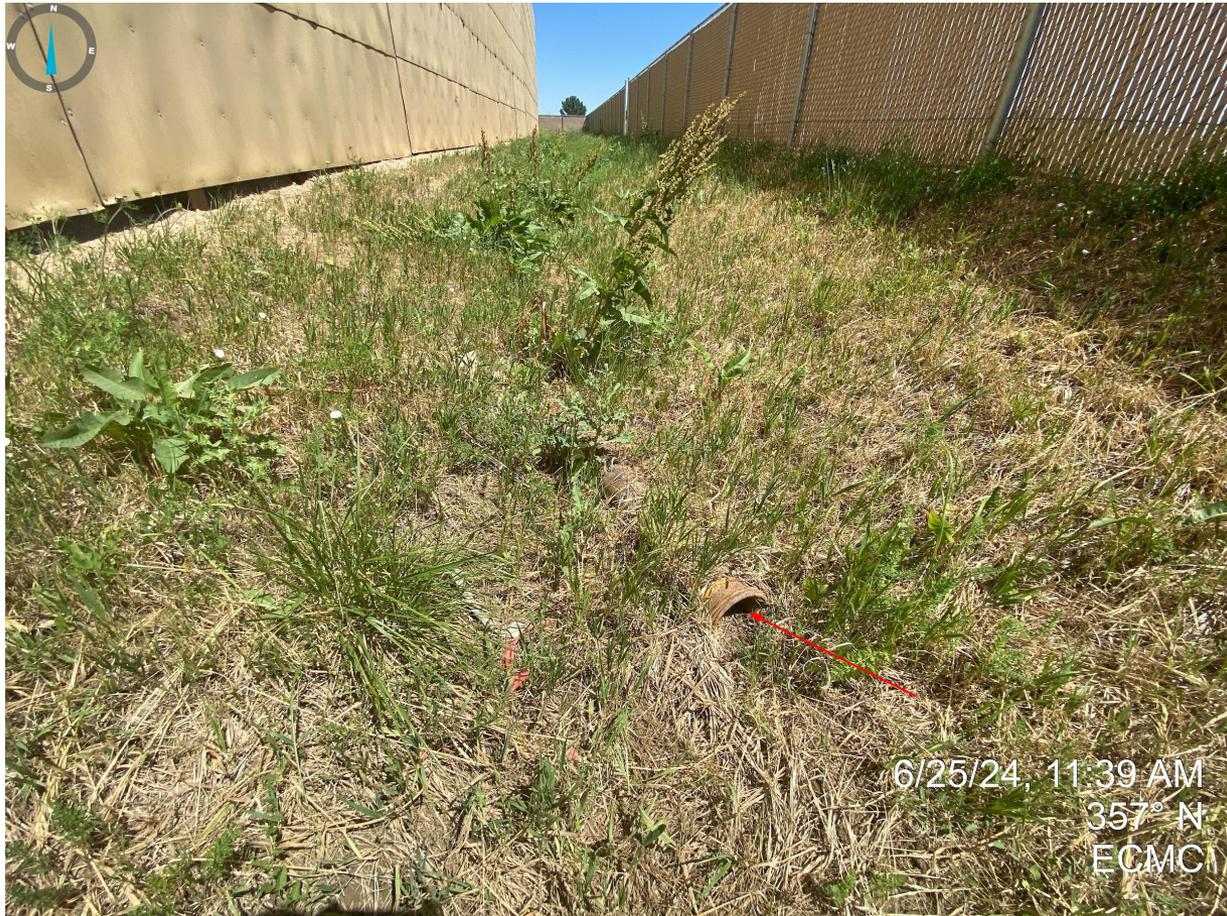
Photo 7. East side of location. Undesirable vegetation and trash/debris observed throughout the perimeter of the location. Red arrow indicating buried pipe.

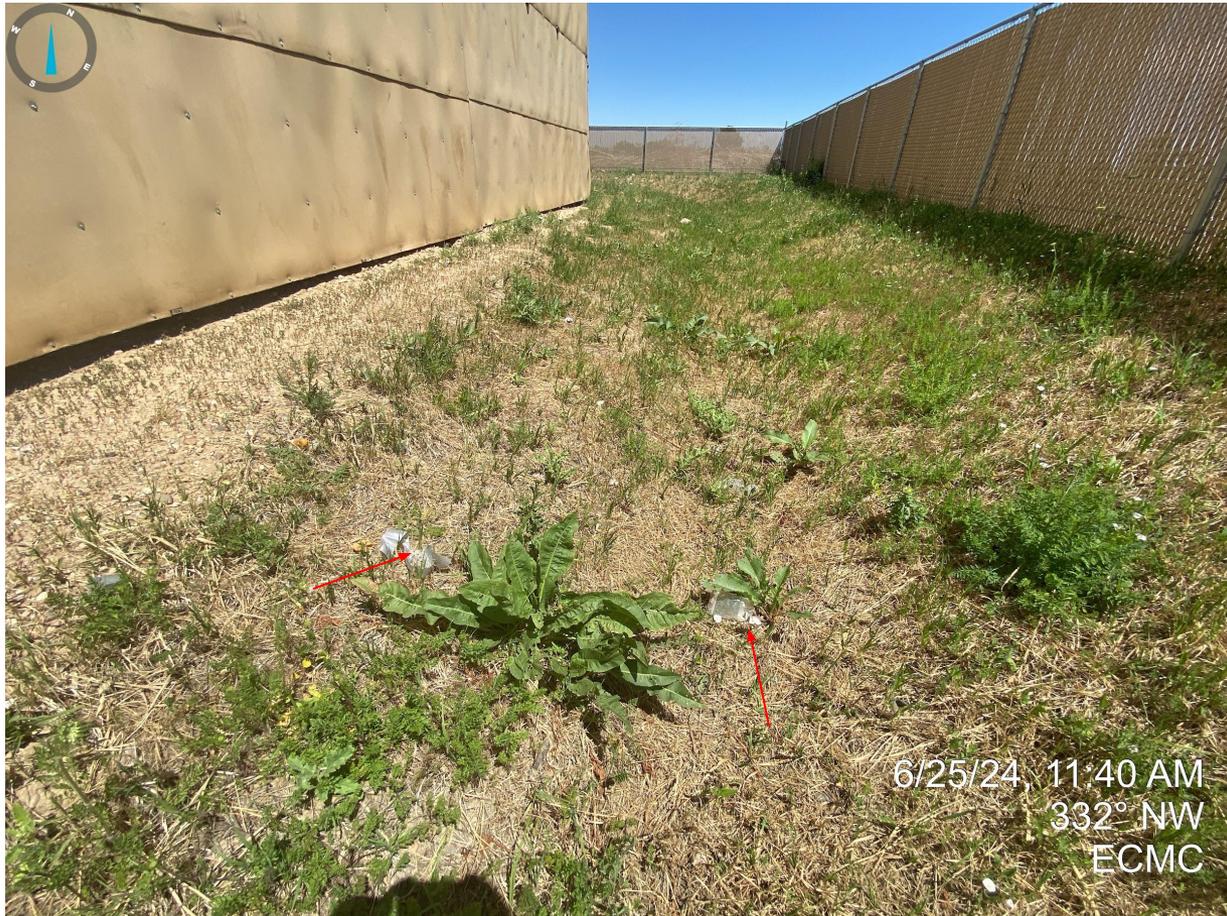
Photo 8. East side of location; see comments in Photo 7.

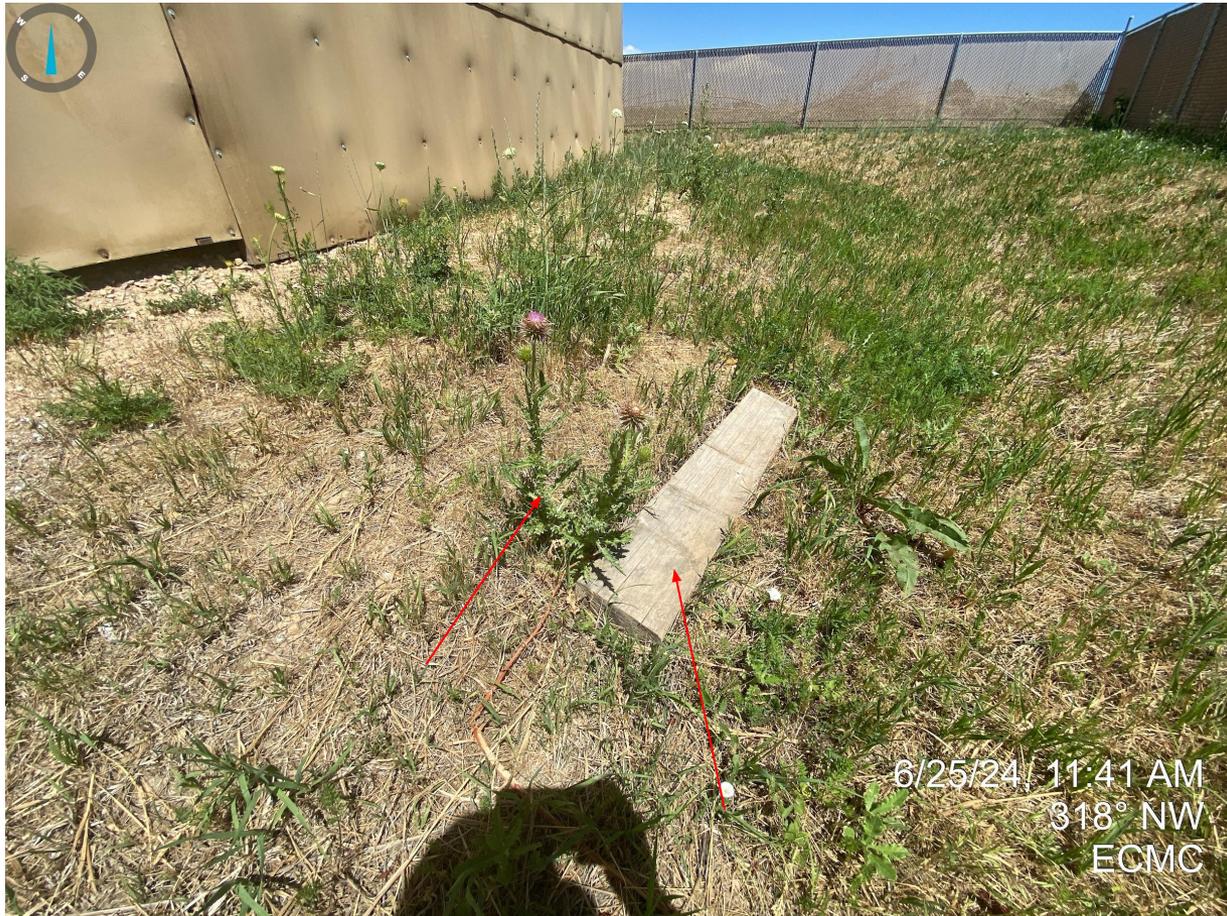
Photo 9. East side of location; see comments in Photo 7.

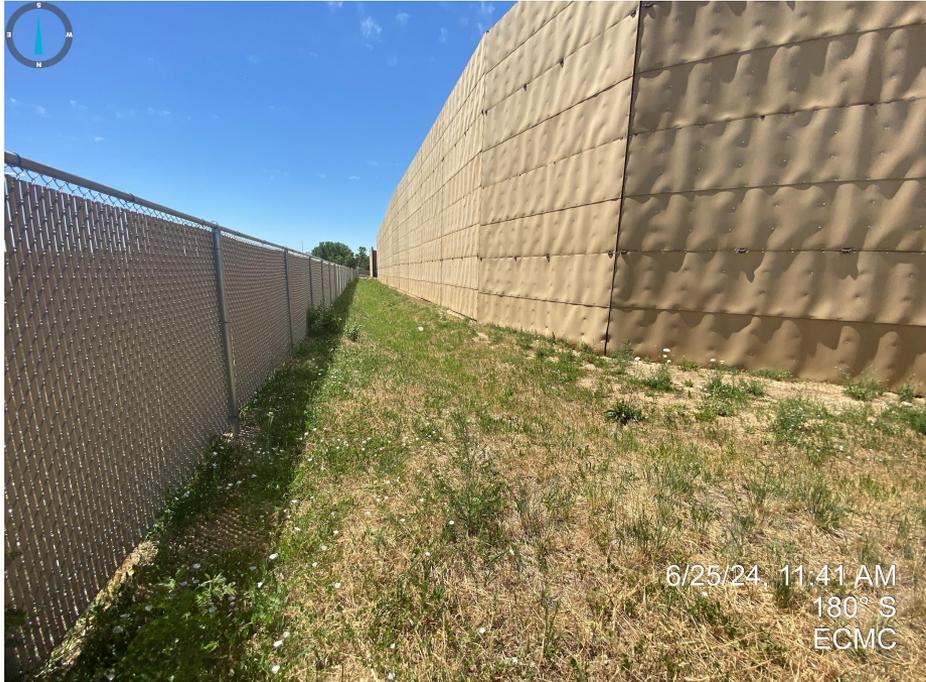
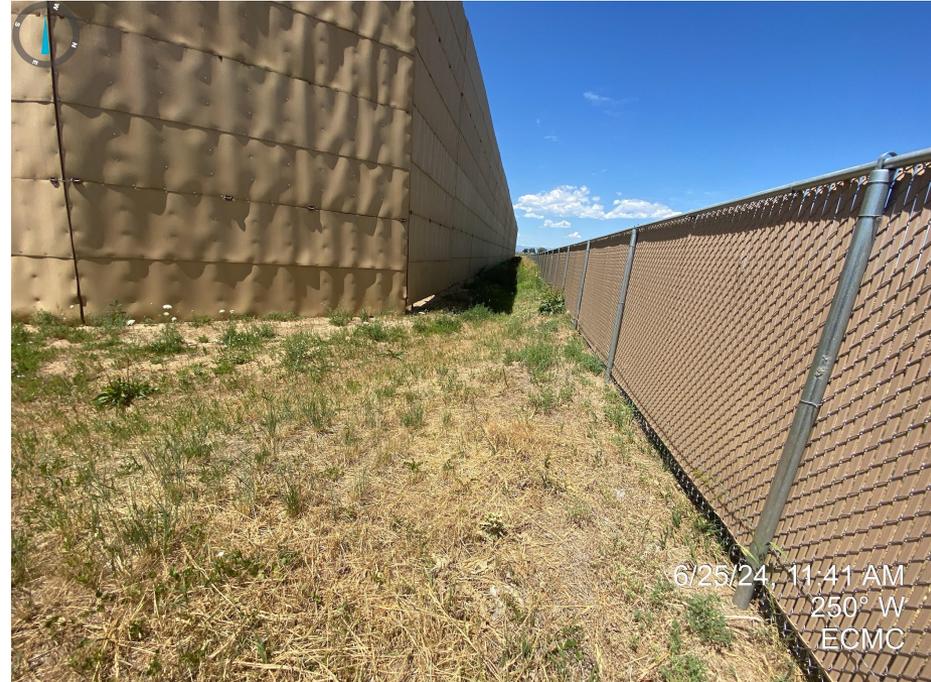
Photo 10. Northeast corner of location; see comments in Photo 7.

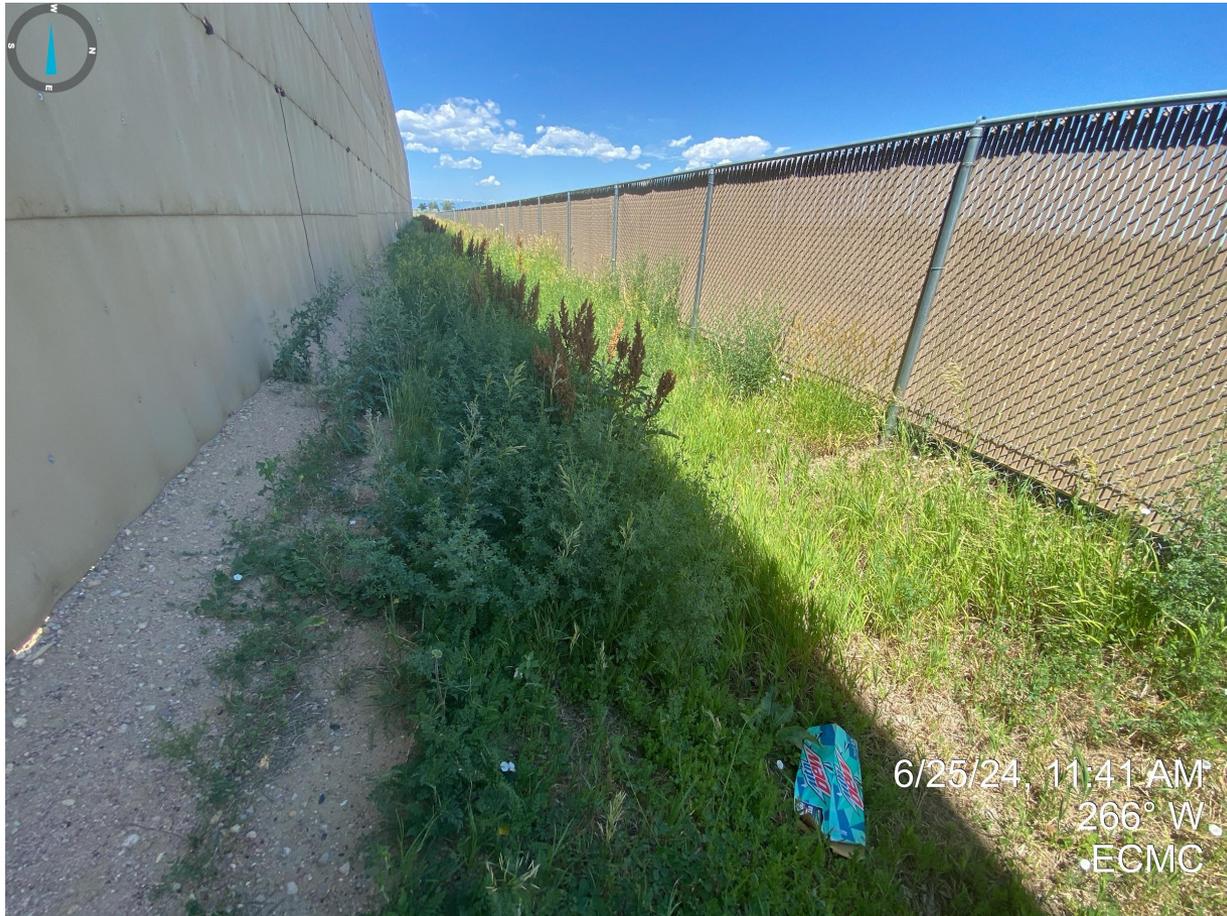
Photo 11. North side of location; see comments in Photo 7.

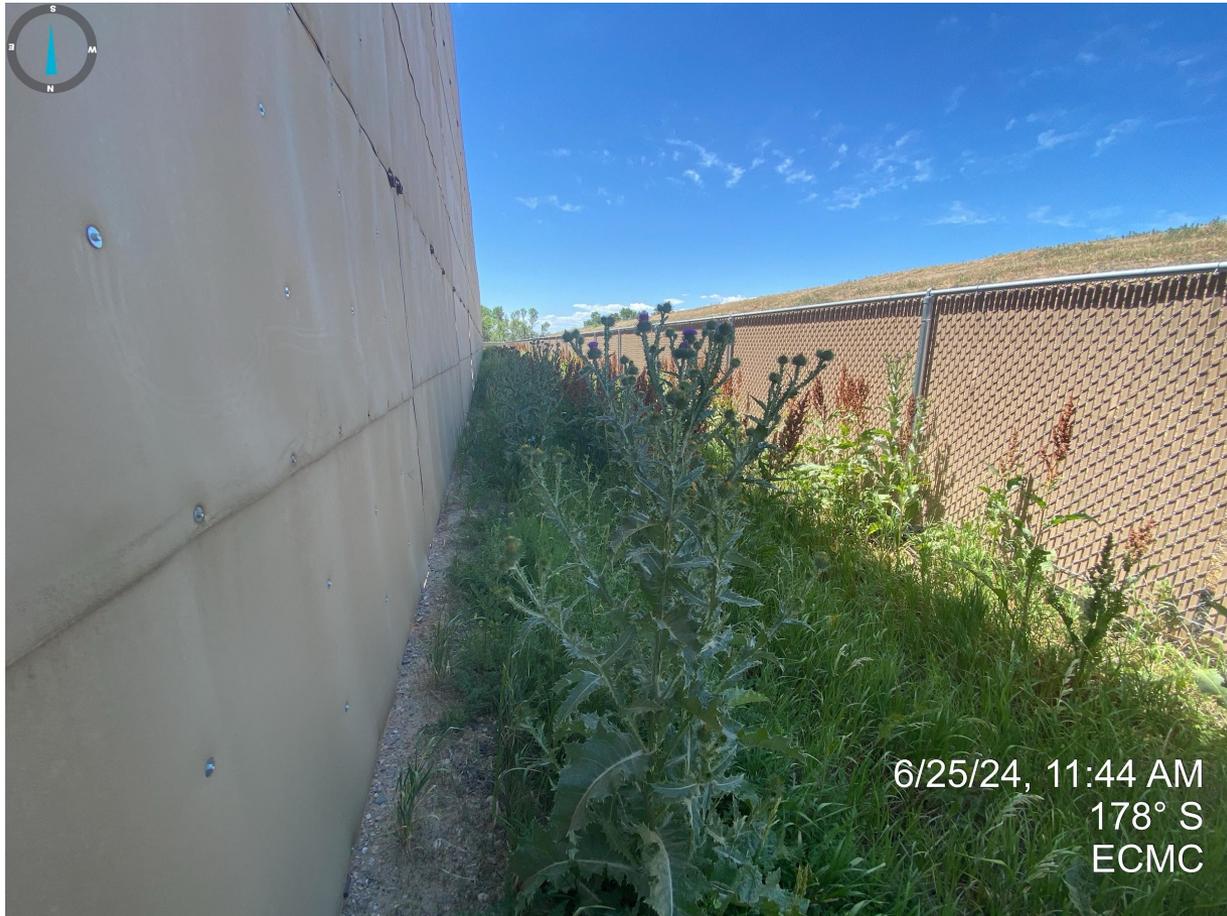
Photo 12. West side of location; see comments in Photo 7.

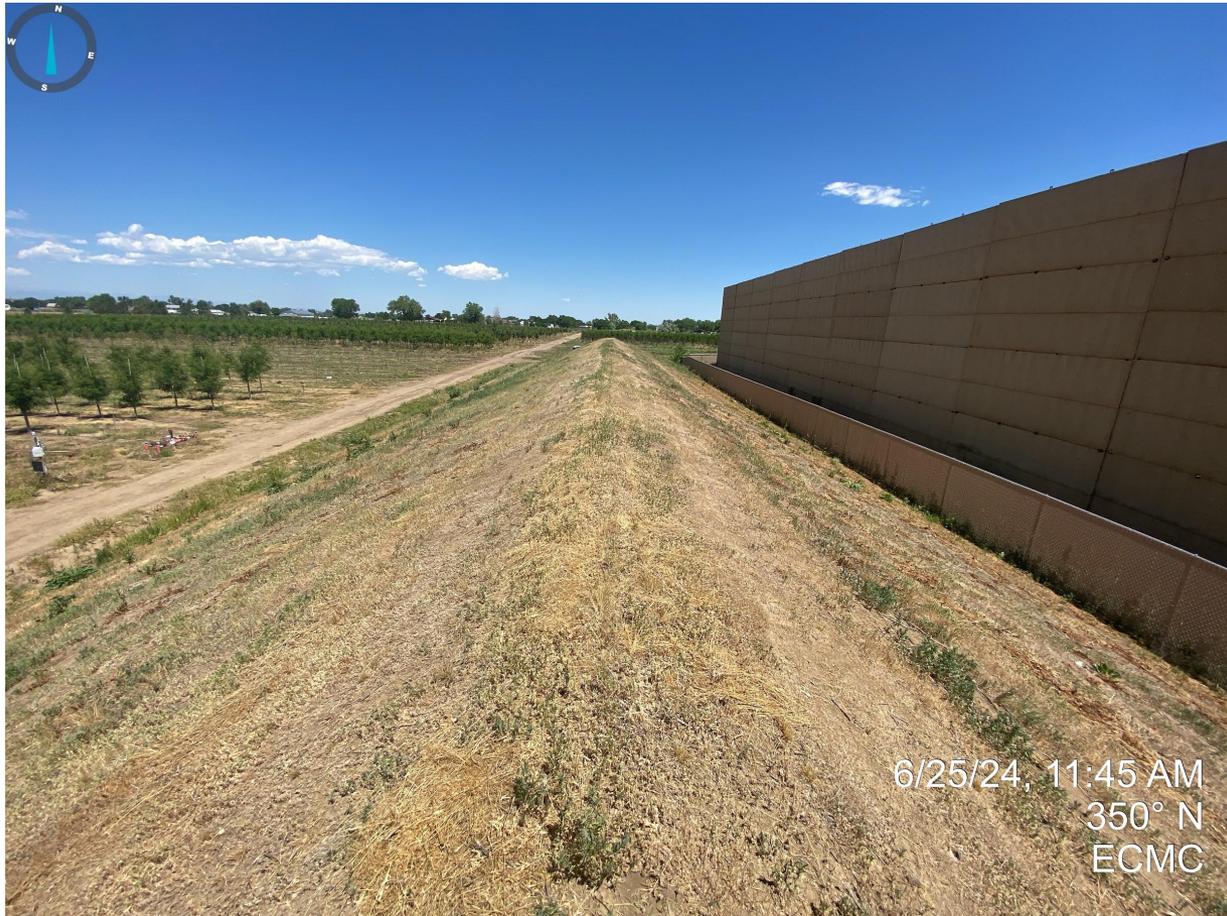
Photo 13. Topsoil stockpile appears to have been recently mowed. However, the predominant vegetation cover appears to be kochia and curly dock. Additional revegetation activities are required to comply with Rule 1002.c.

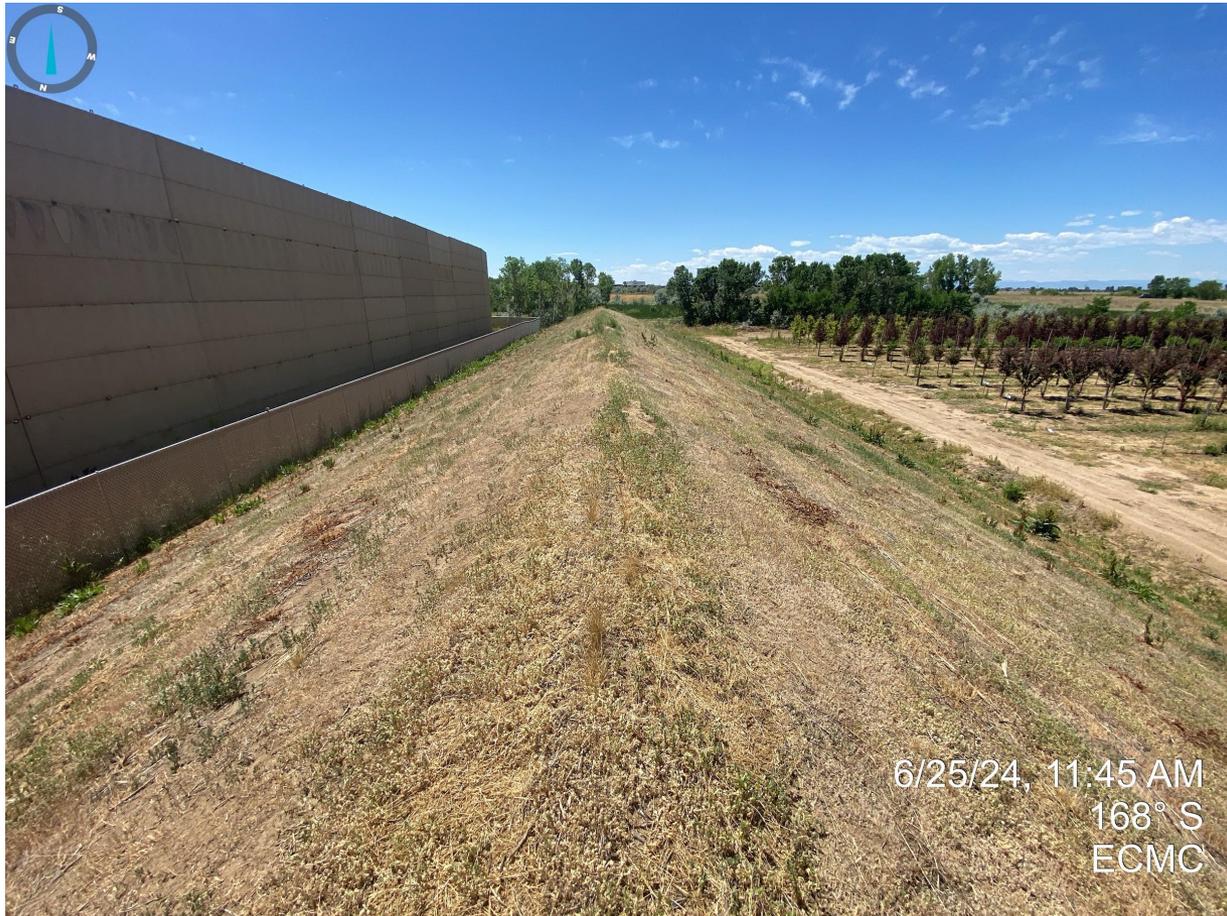
Photo 14. Facing south; see comments in Photo 13.

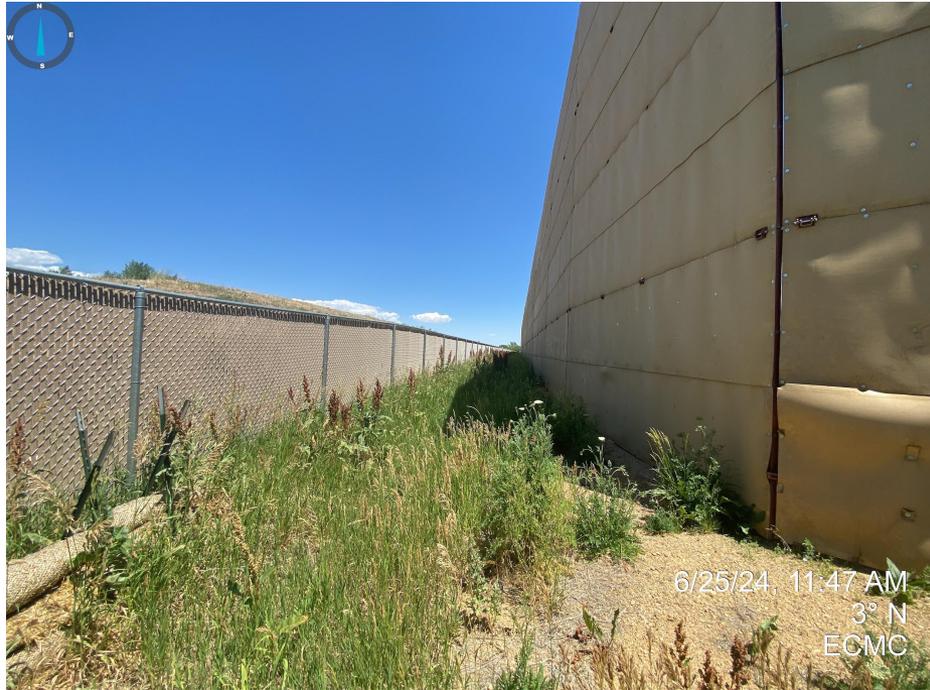
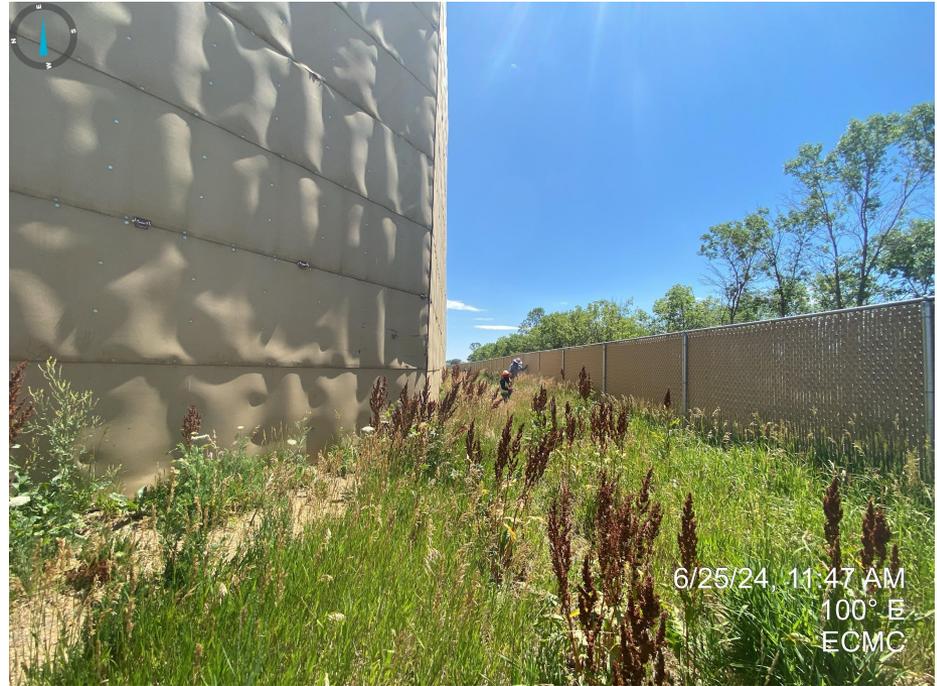
Photo 15. Southwest corner of the location; see comments in Photo 7.

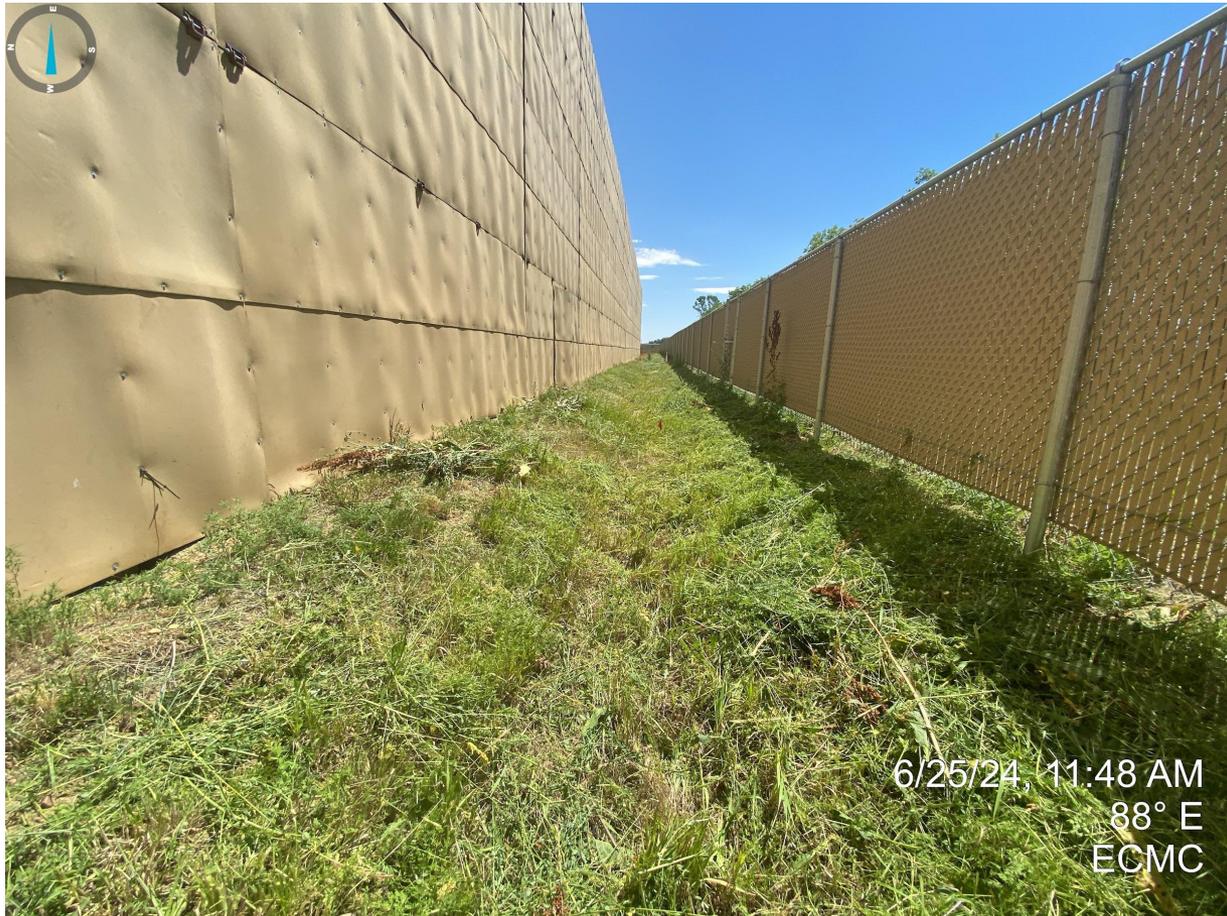
Photo 16. South side of location. Crews were actively managing the undesirable vegetation at the time of this inspection.

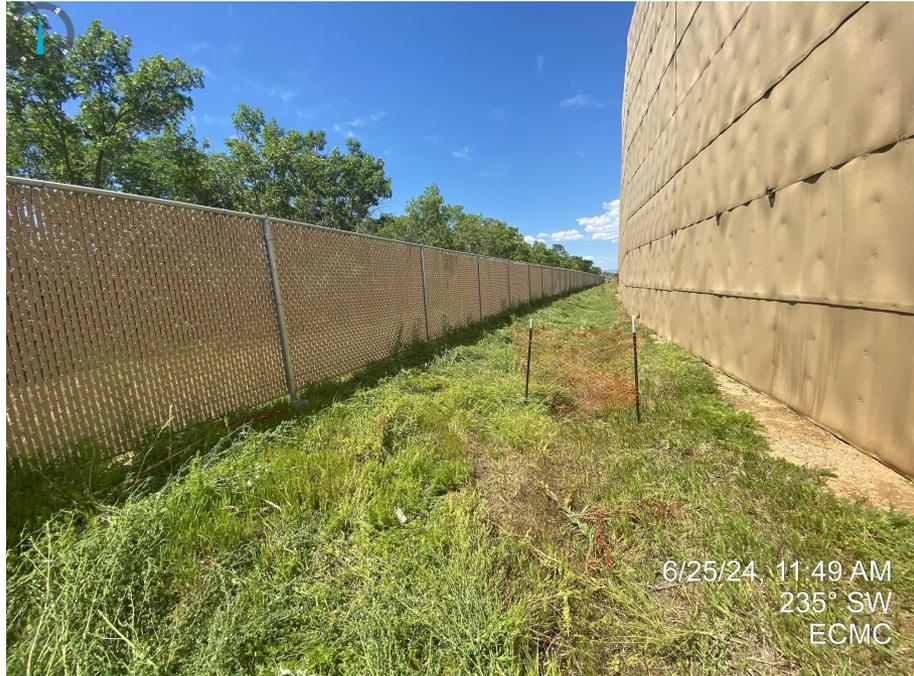
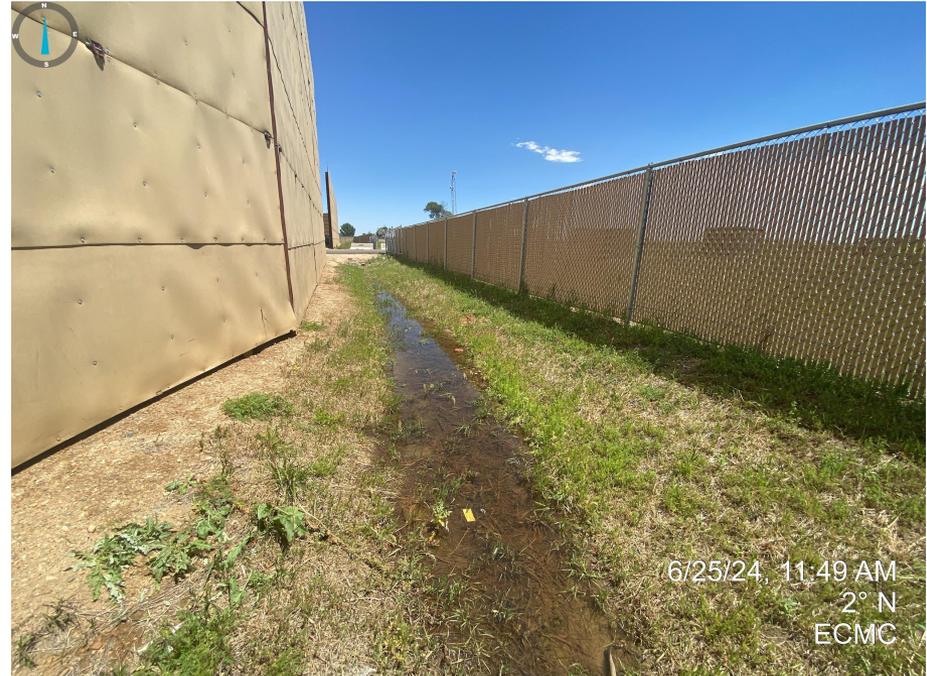
Photo 17. Southeast corner of the location; see comments in Photo 16.
