# Inspection Photos

**Operator:** CHEVRON USA INC #16700

**Location ID:** 316610

**Inspection Doc:** 696205961

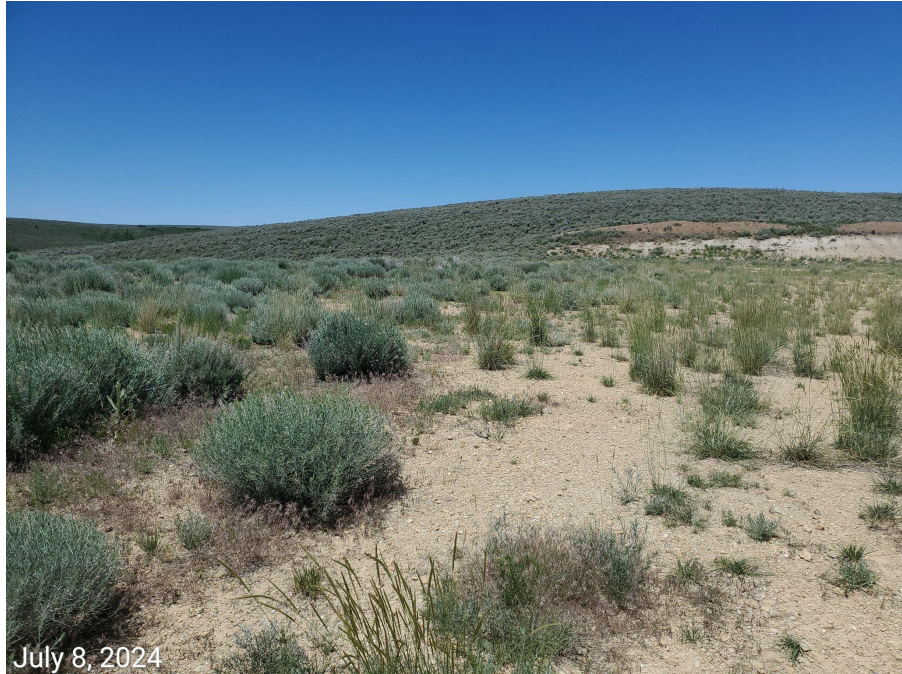
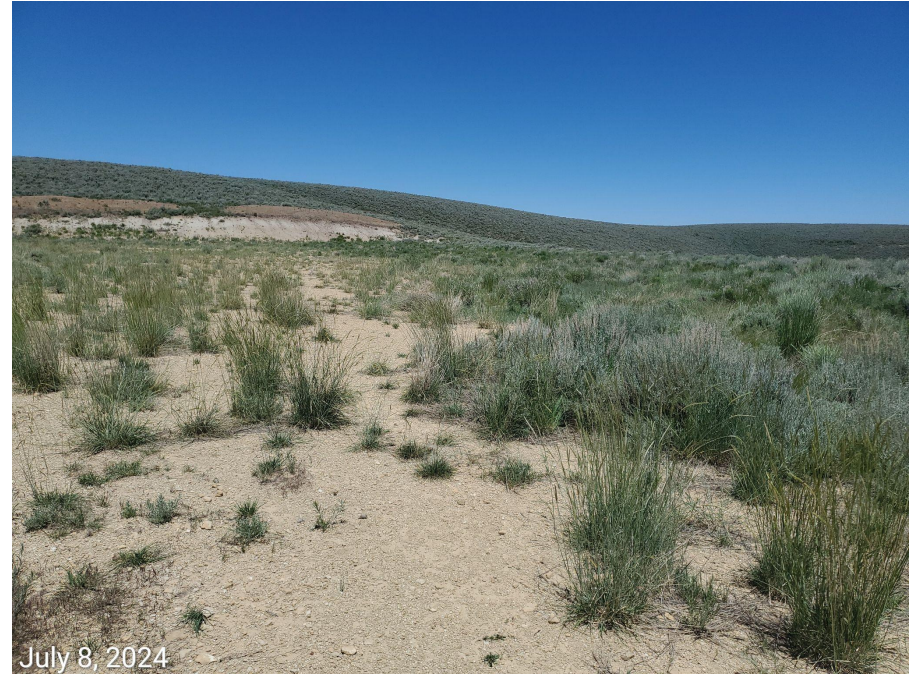
**Photo 1:** Photos taken from the south end of the Location, facing northwest and northeast. Photos provide an overview of the Location; work pursuant to 1004.a including, but not limited to, recontouring/regrading, compaction alleviation, replacement of topsoil and reclamation has not been performed on the Location.

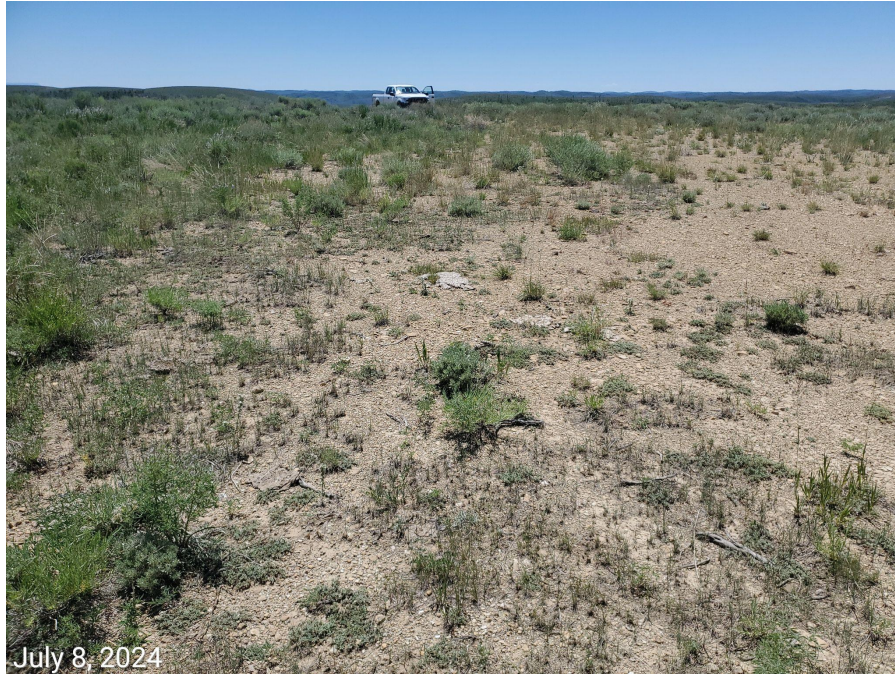
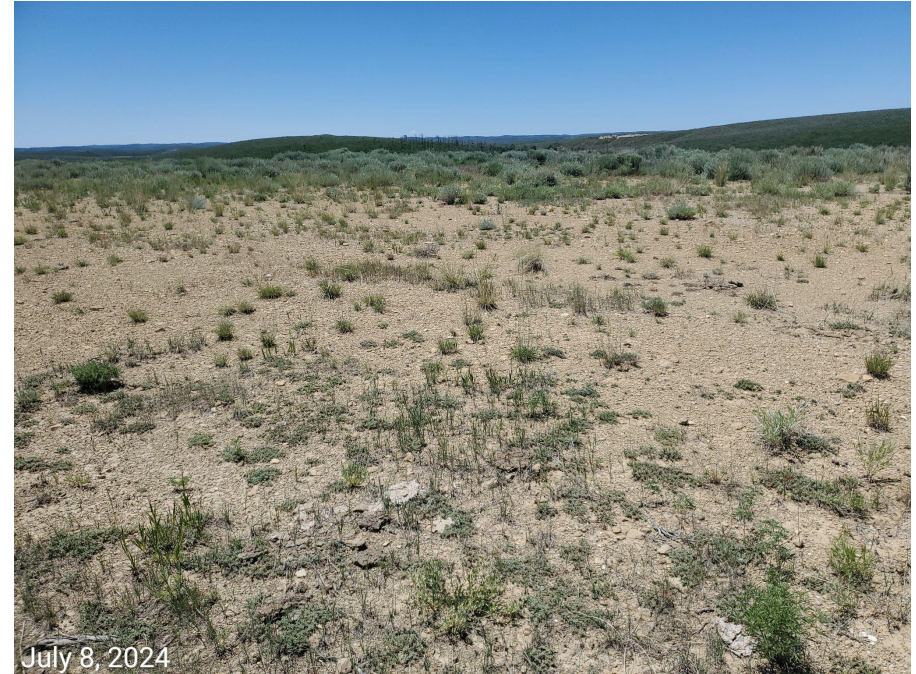
**Photo 2:** Photos 2-3 taken from the east end of the Location. Photos provide an overview from south, southwest, northwest to north. See comments under photo 1.

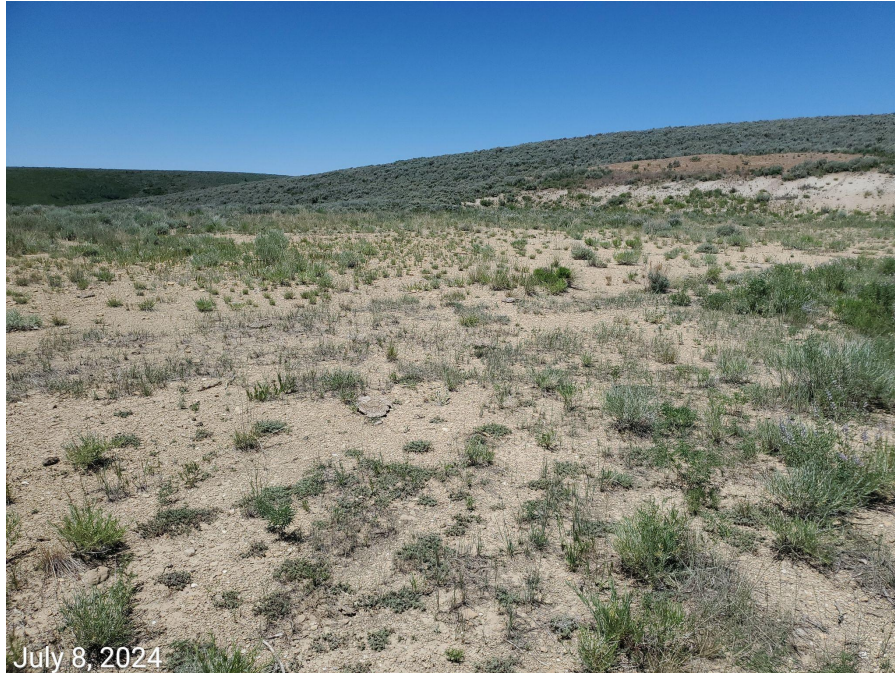
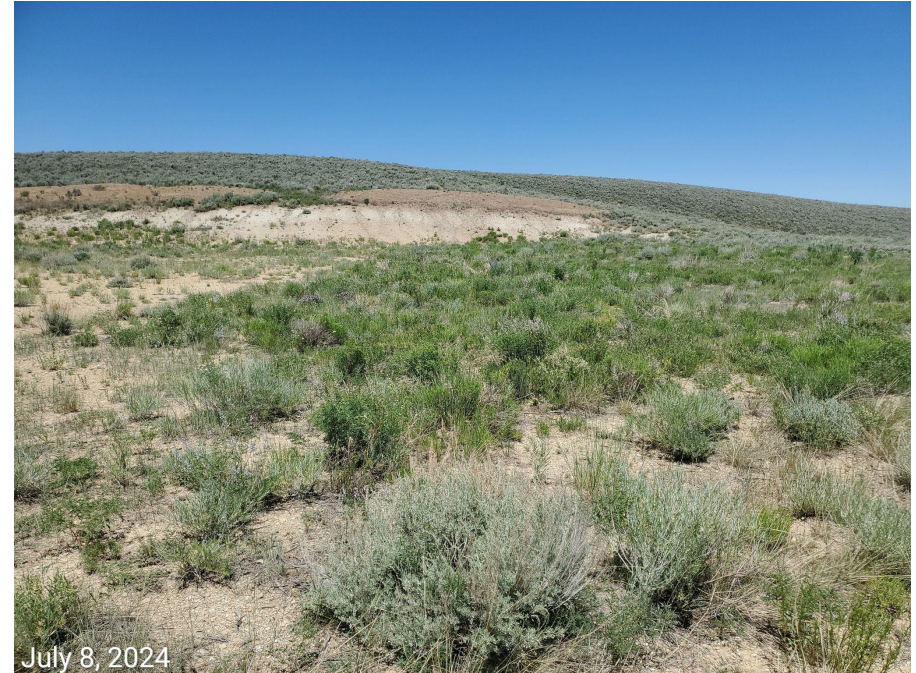
**Photo 3:** See comments under photo 2.

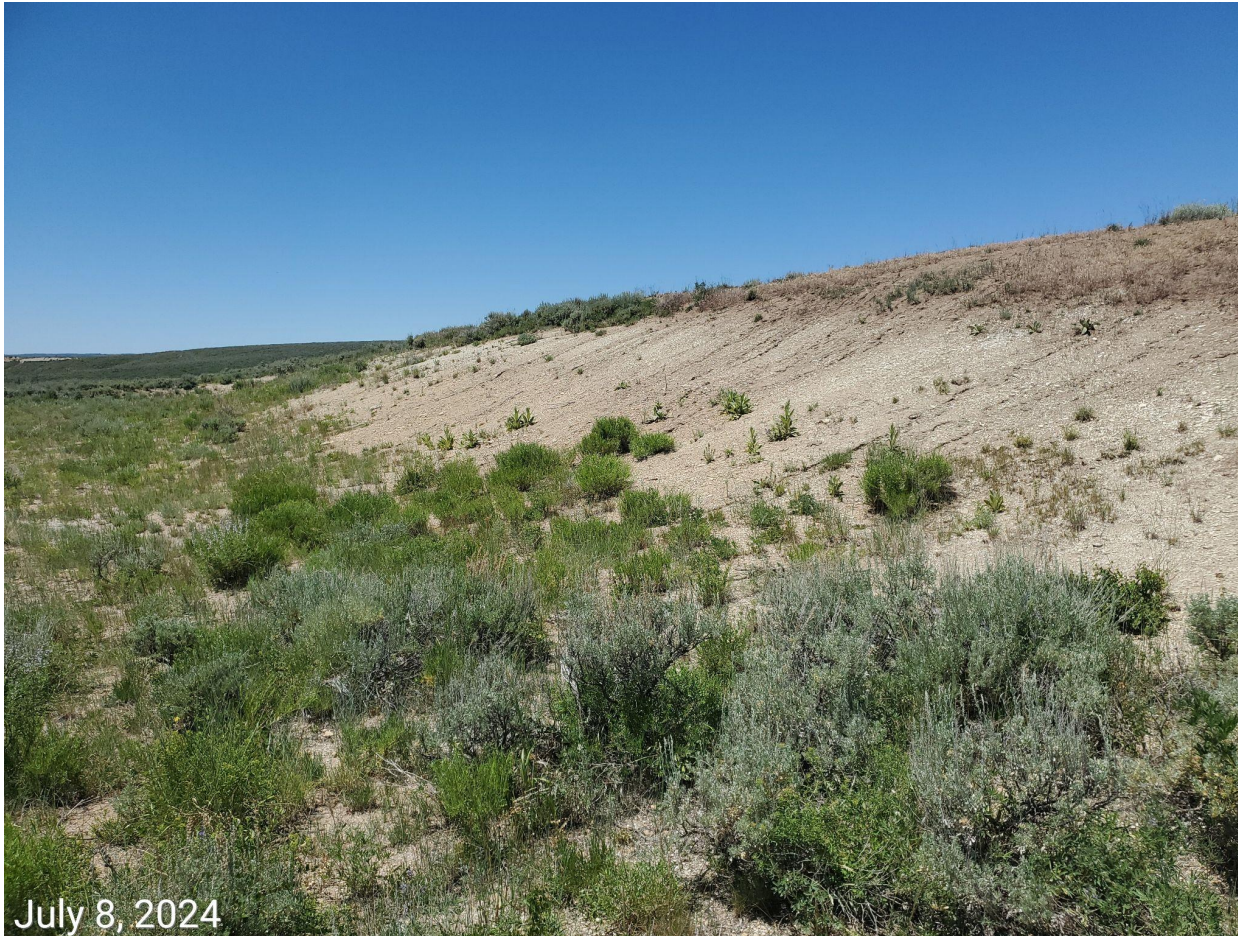
**Photo 4:** Photo taken from the northeast end of the Location, facing west. Photo shows cut slopes remaining on the Location. Slopes are bare and erosion degradation is evident.

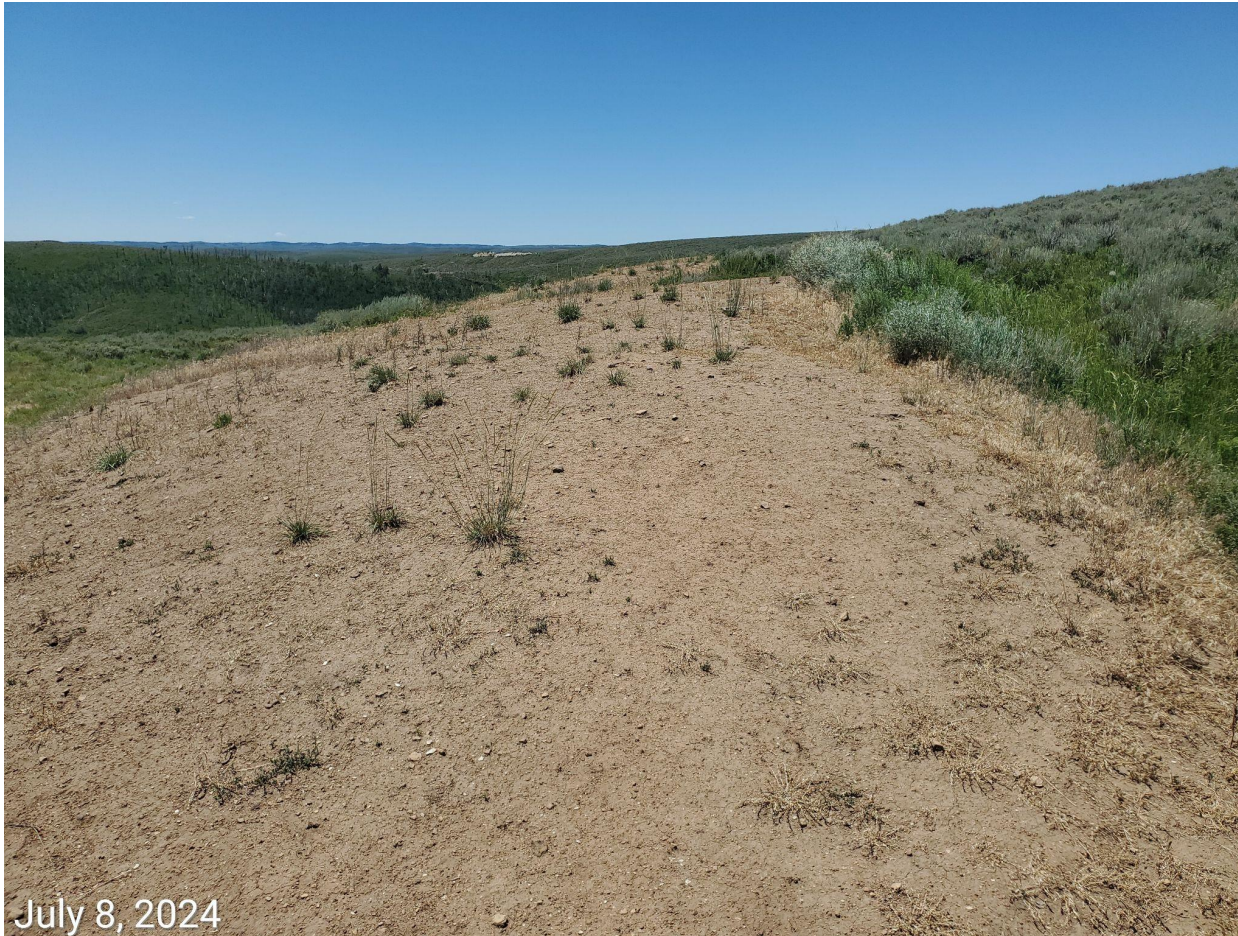
**Photo 5:** Photo taken from the north end of the Location, facing west. Photo shows what appears to be topsoil stockpiled above the cutslope. Topsoil on Location has not been replaced, is predominantly bare, and has not been protected pursuant to Rule 1002.c.

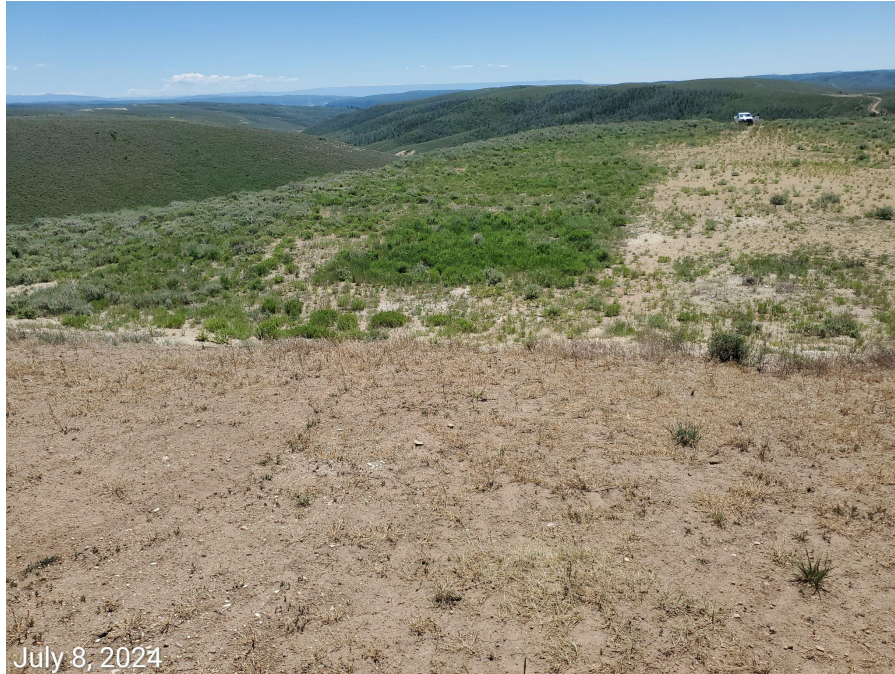
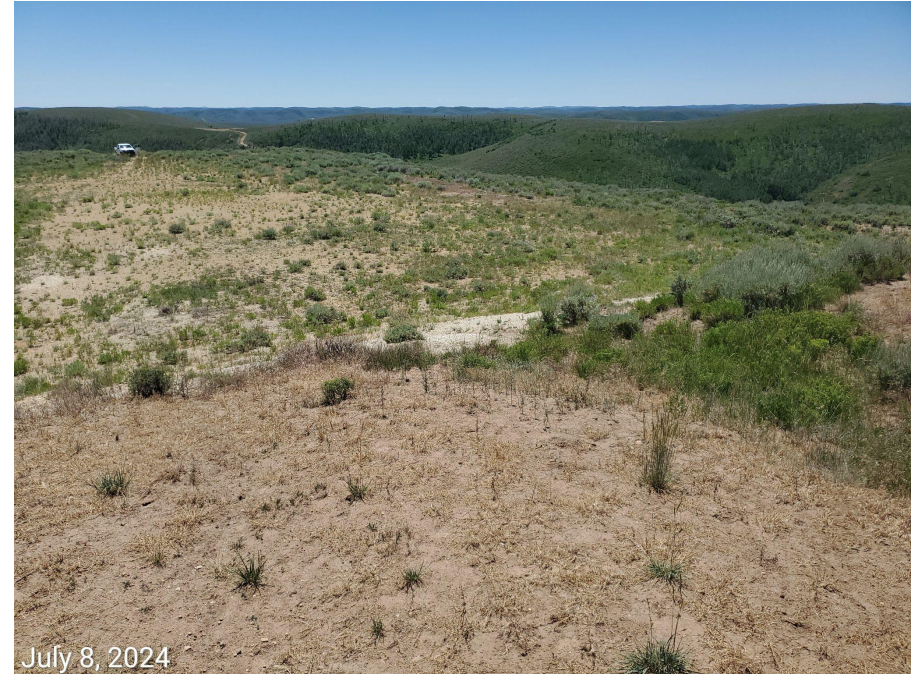
**Photo 6:** Photos taken from the north end of the Location, facing southeast and southwest. See comments under photo 1

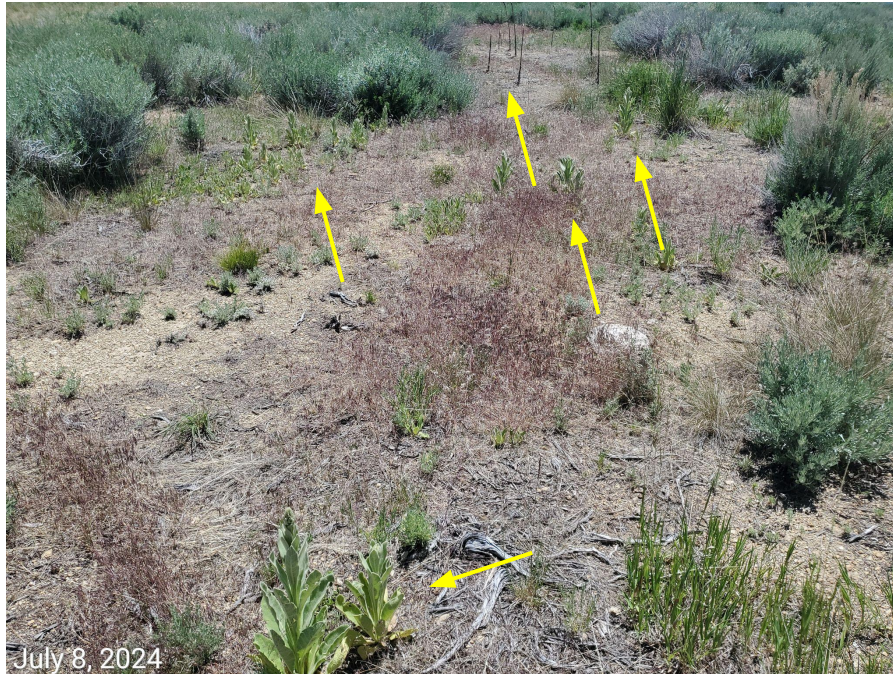
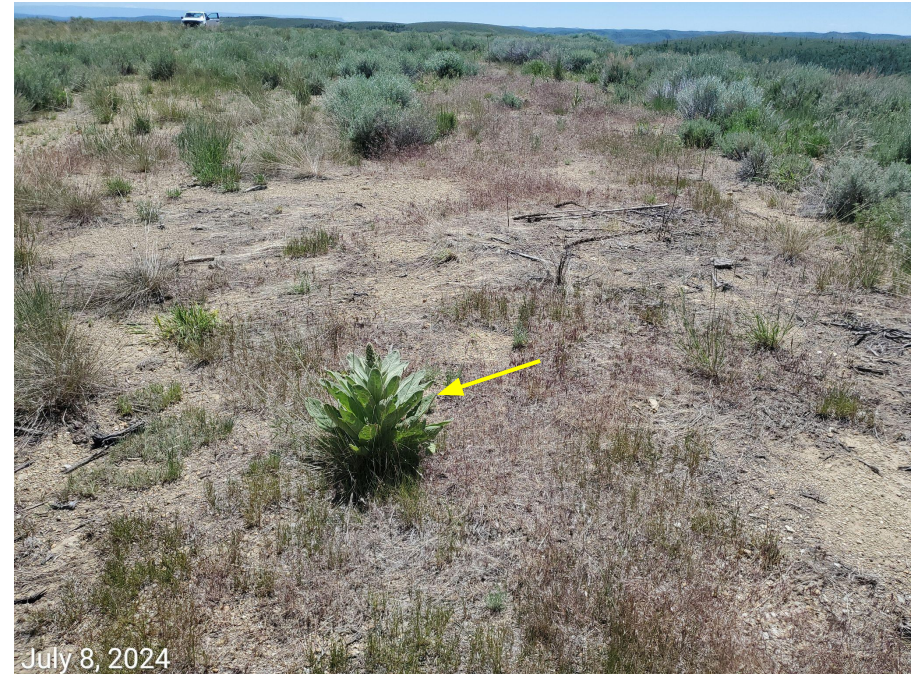
**Photo 7:** Photos examples showing Undesirable Plant Species (Mullein) have continued to spread and establish on the Location and access road.

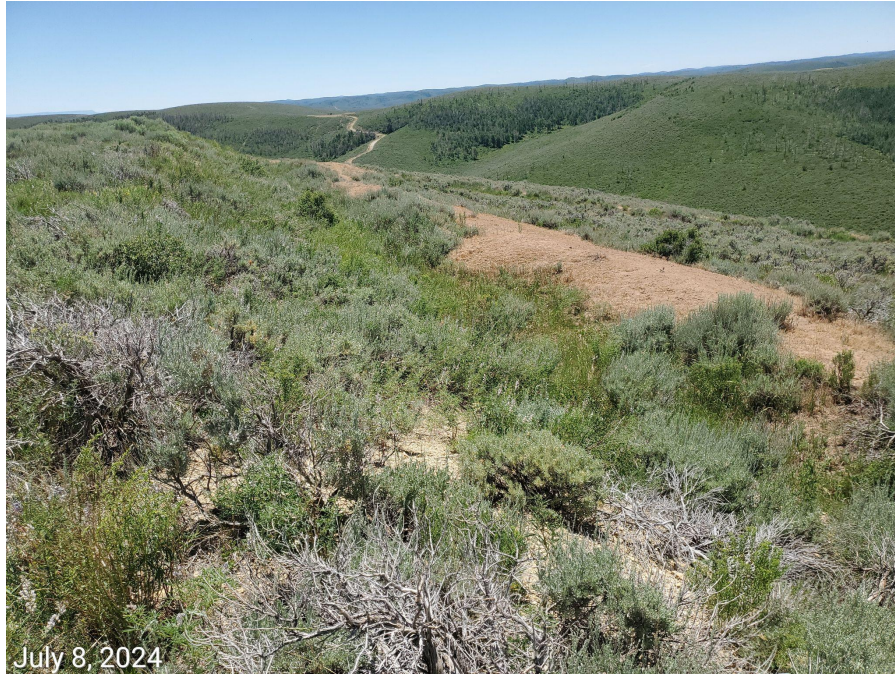
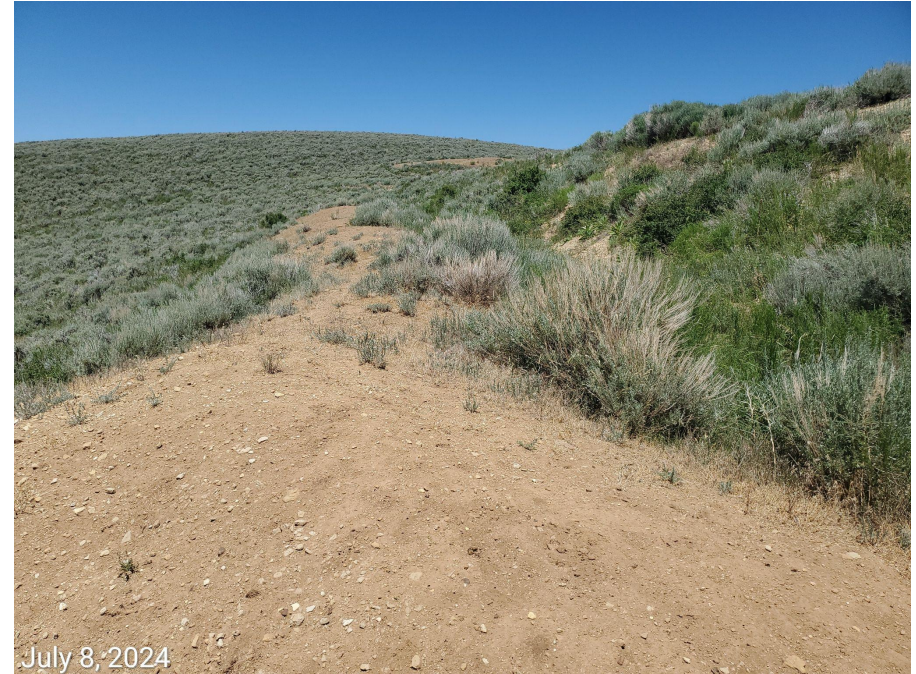
**Photo 8:** Photos taken from the west end of the Location. Photos examples showing bare topsoil stockpiles on the Location. Photo also example showing location has not been recontoured/regraded and reclaimed in accordance with 1004 Rules.

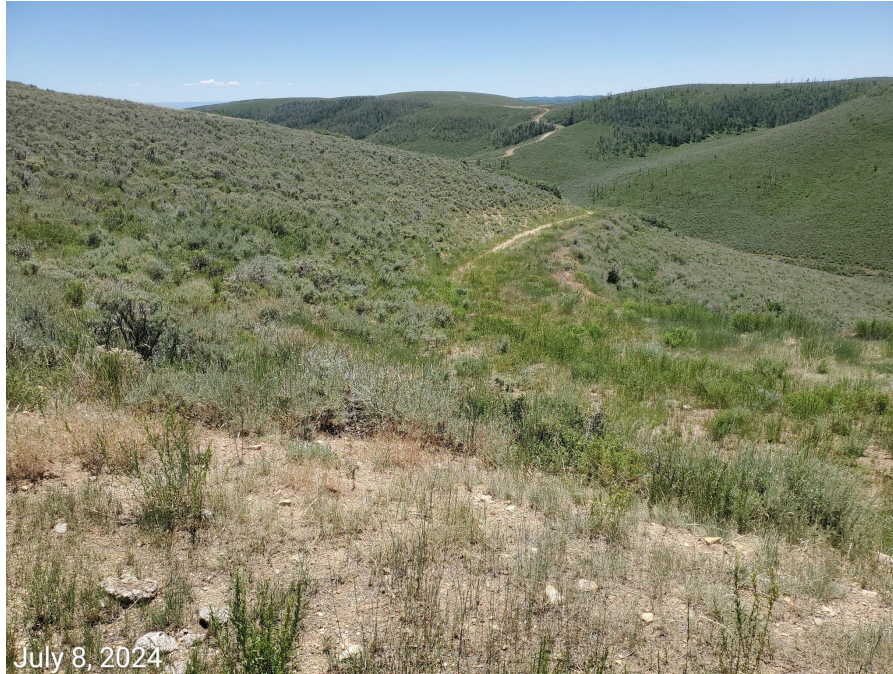
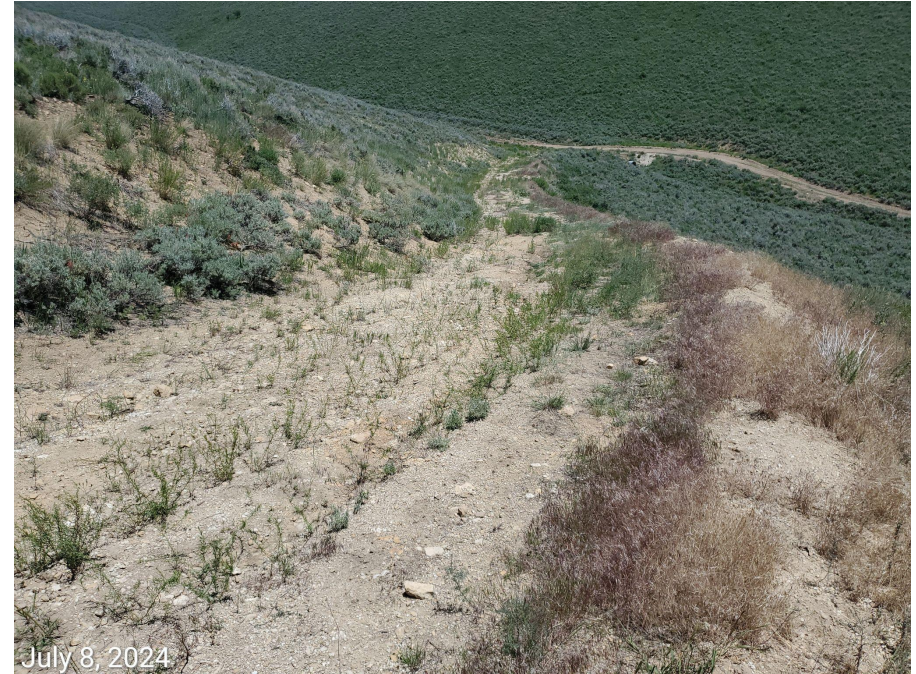
**Photo 9:** Photos examples showing the access road has not been recontoured/regraded and reclaimed in accordance with Rule 1004.a.
