Inspection Photos on July 9th, 2024
Operator: Strachan Exploration
Location Name: Frazee-Bolyard 1-35
API: 05-061-06202

Inspection #715200487

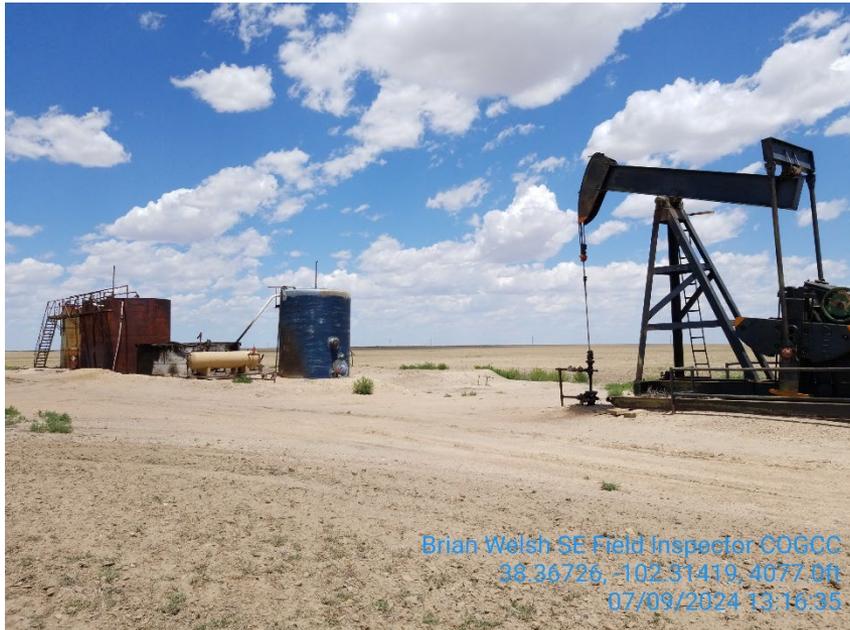
1. Overview of location

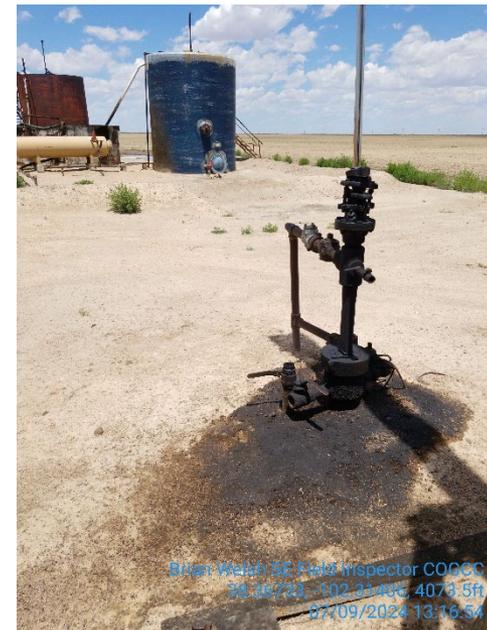
2. Stained soil at the wellhead
needs removed

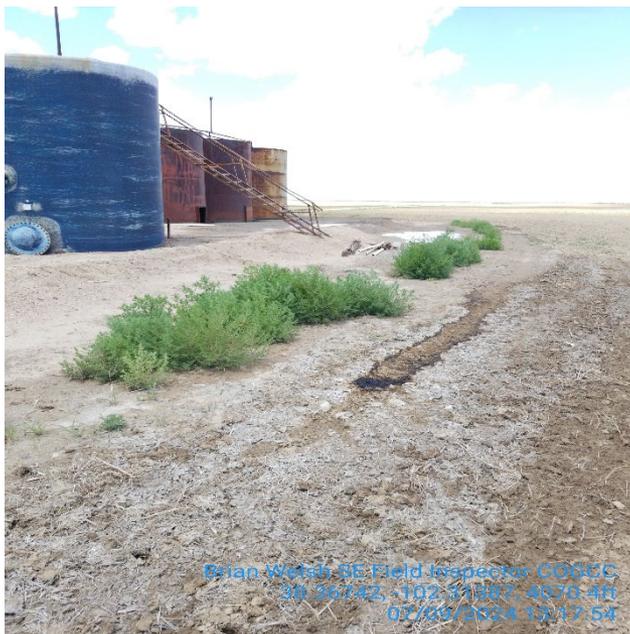
3. Southeast corner of tank battery looking north at spill outside of berms. There is some crude oil from the spill that traveled south in the adjacent cropland

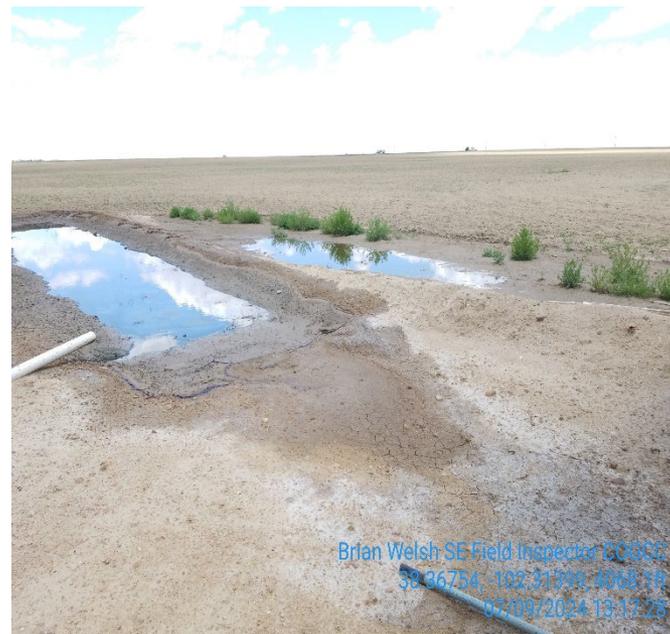
4. Standing inside the berms looking north. Spill had breached the berms and went outside of containment

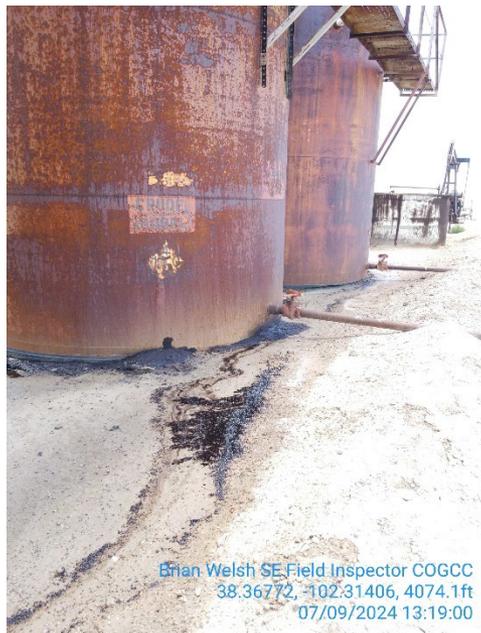
5. There is a skim of oil from the mess being somewhat cleaned up by a vac truck

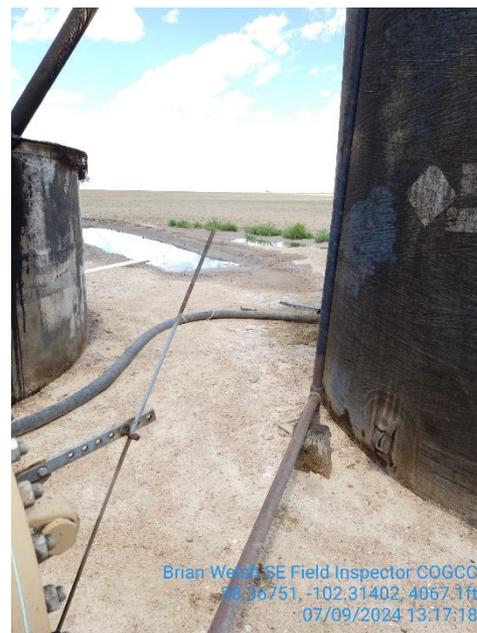
6. The spill appears to be from the overflow tank exceeding its capacity and spilling into the berms
