**KT Resources LLC  
Ant Hill Unit 19-44  
Location ID: 316310**

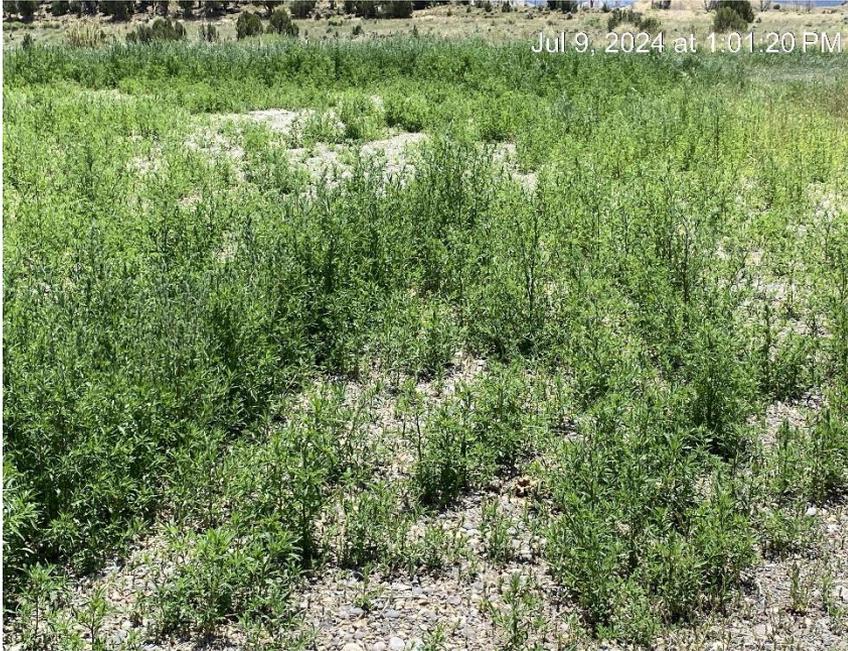
**Weeds**

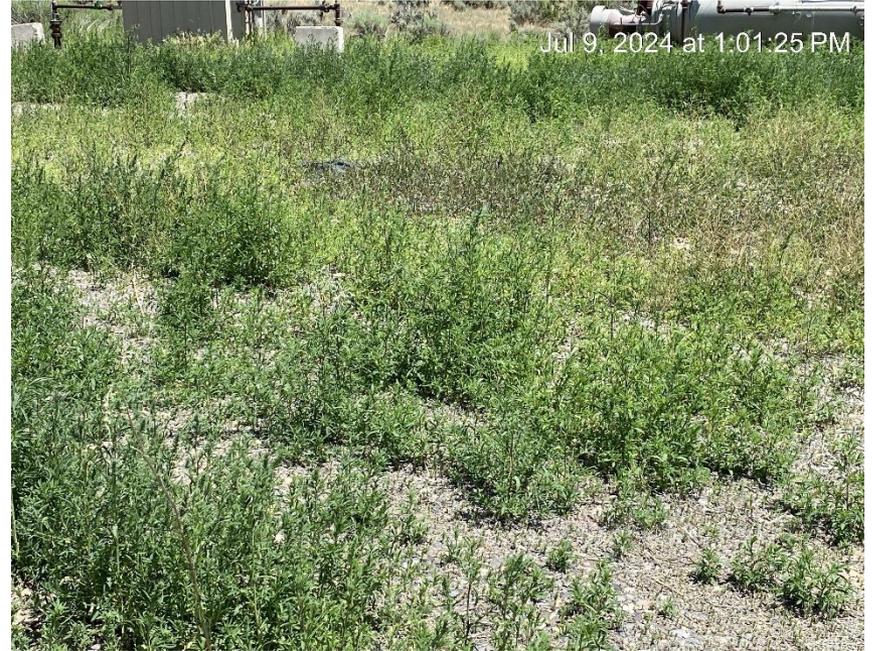
**Weeds**

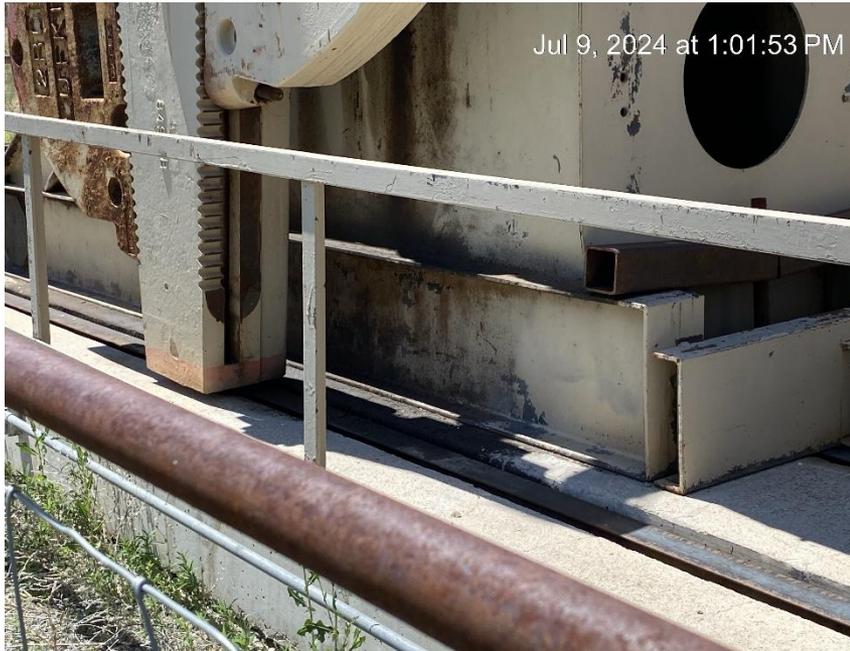
**Oily waste from equipment leak**

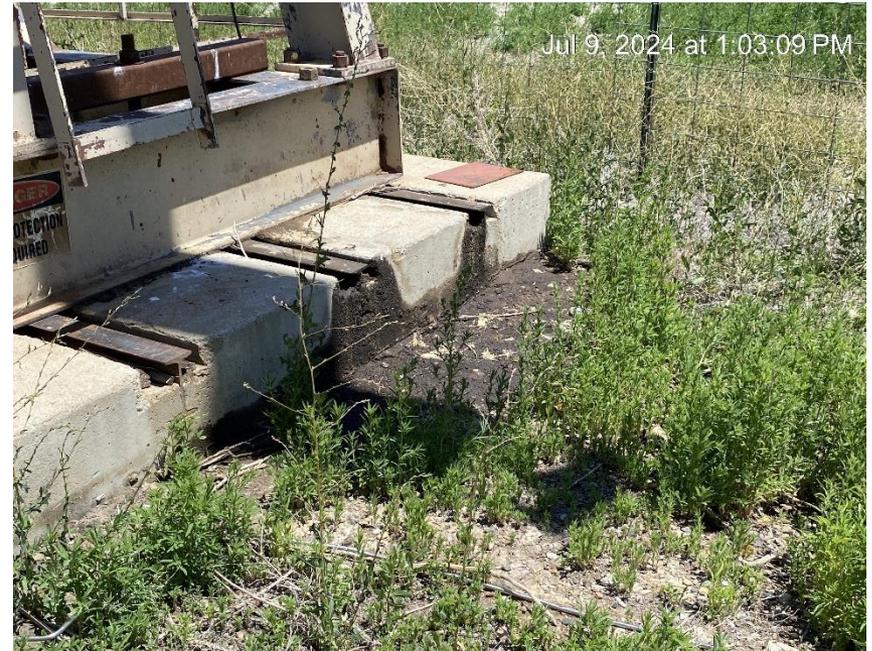
**Stained soil**

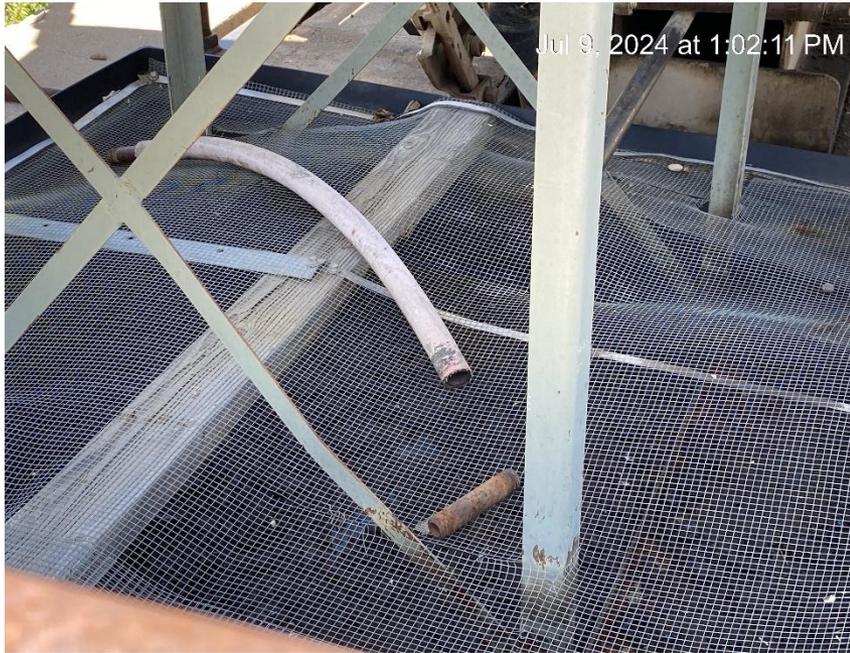
Debris

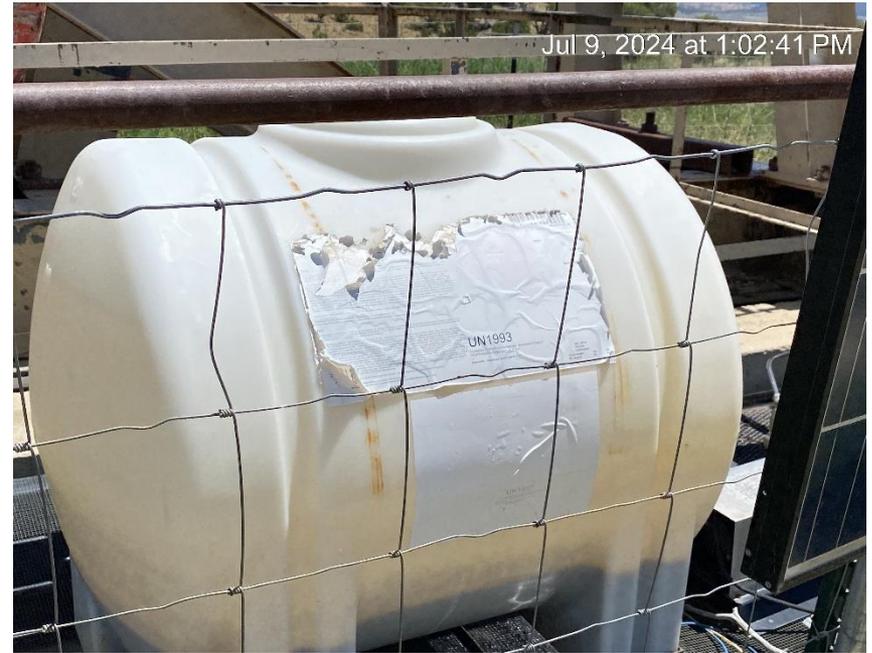
Illegible label

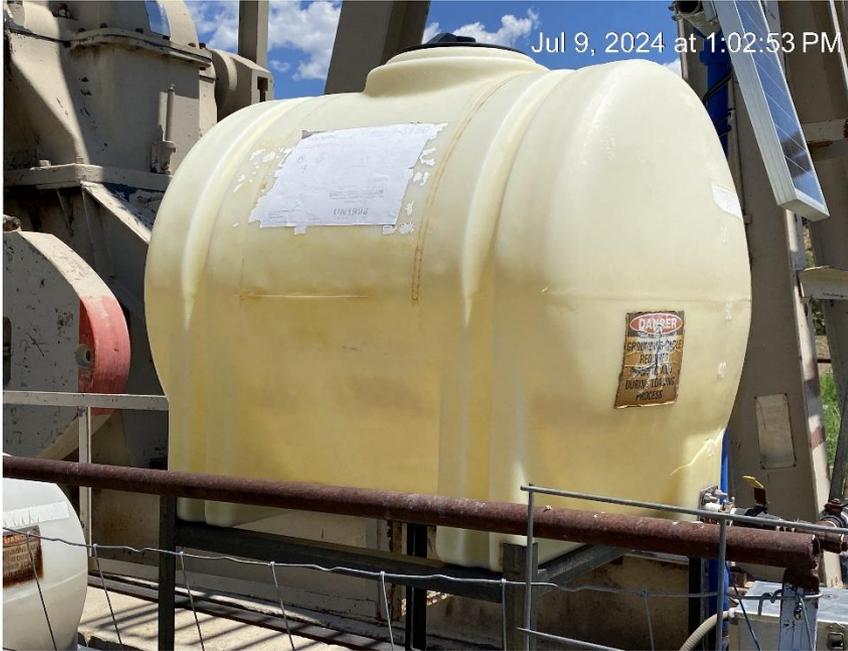
**Illegible label. Broken equipment.**

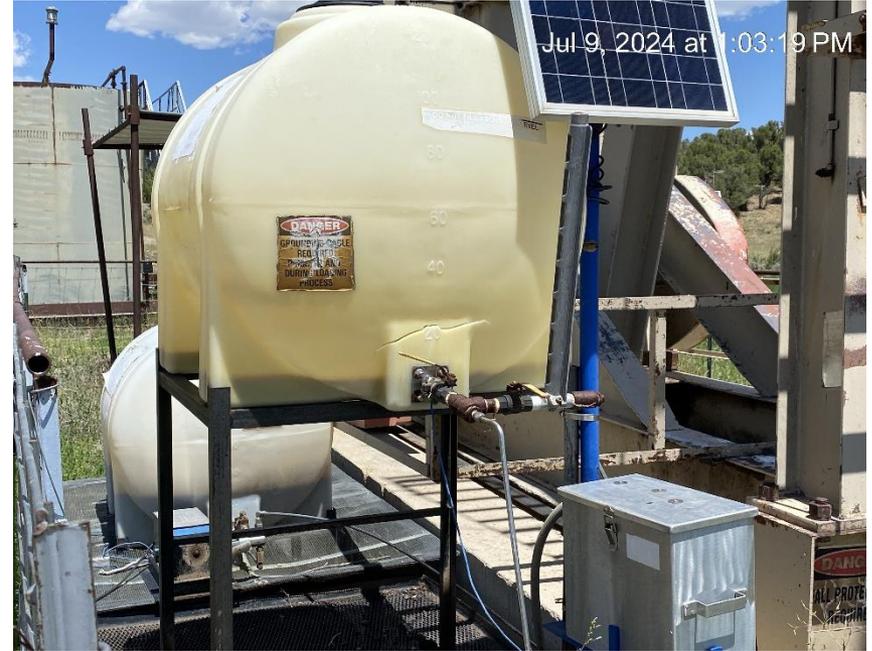
**Tank cracked**

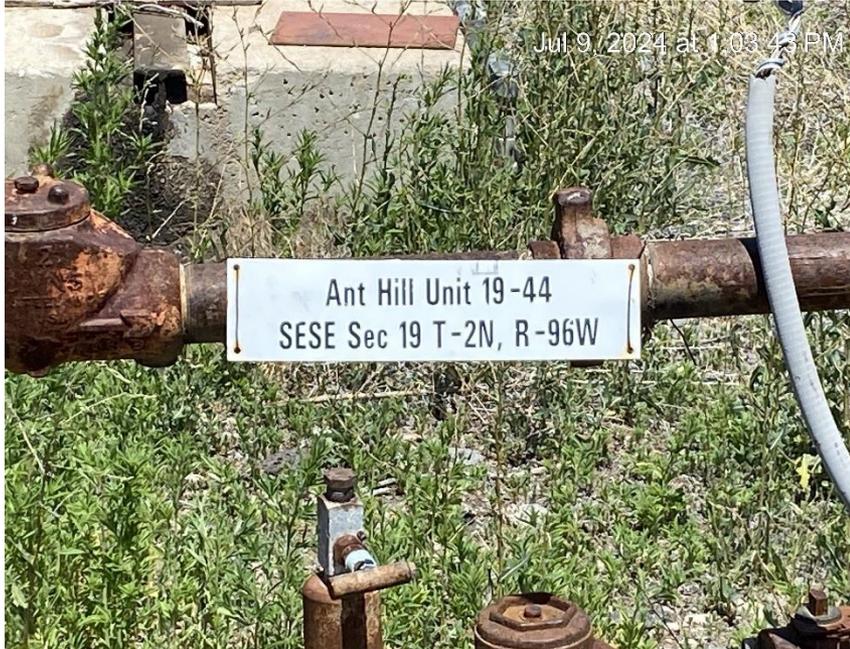
**When replaced additional information is required**

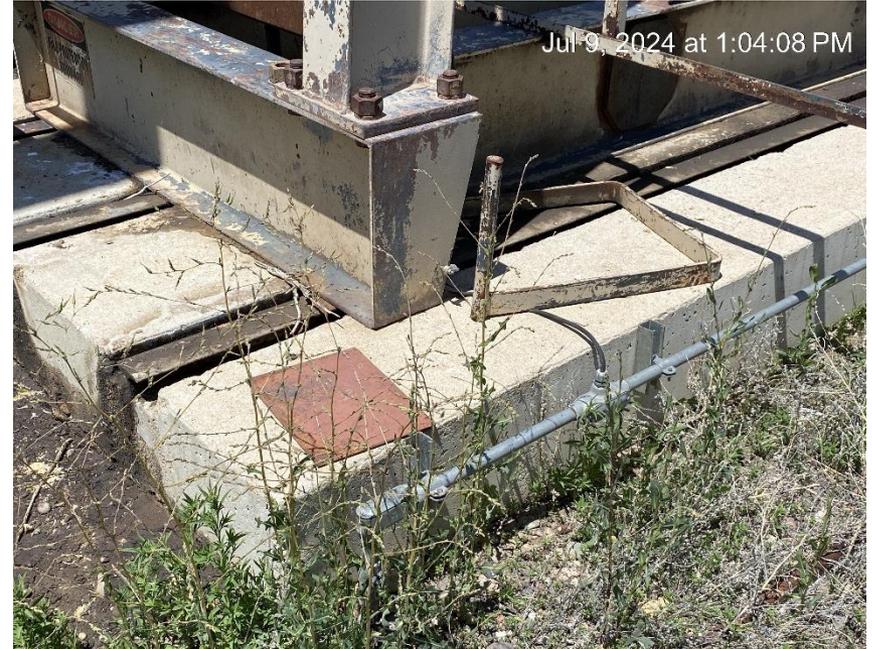
**Debris**

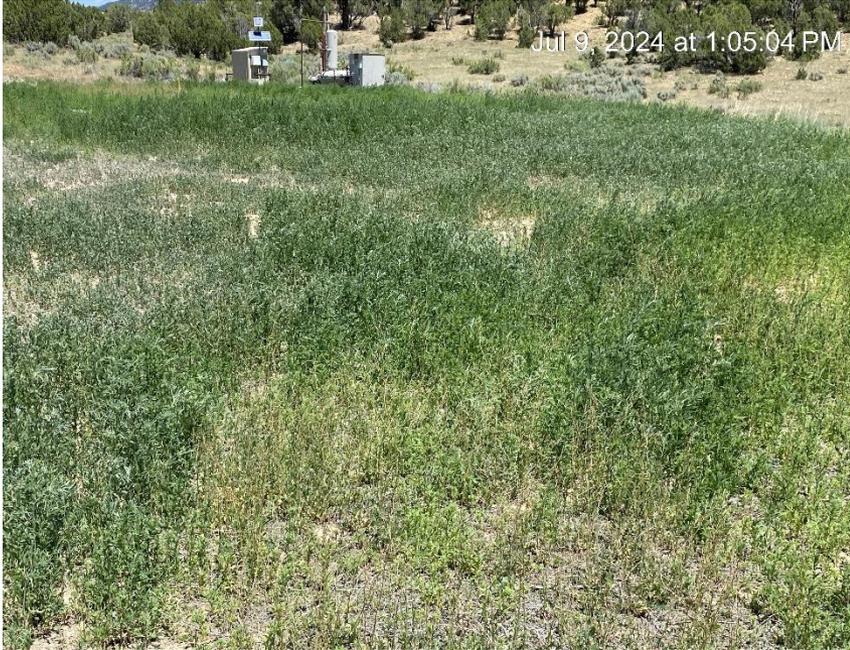
**Weeds**

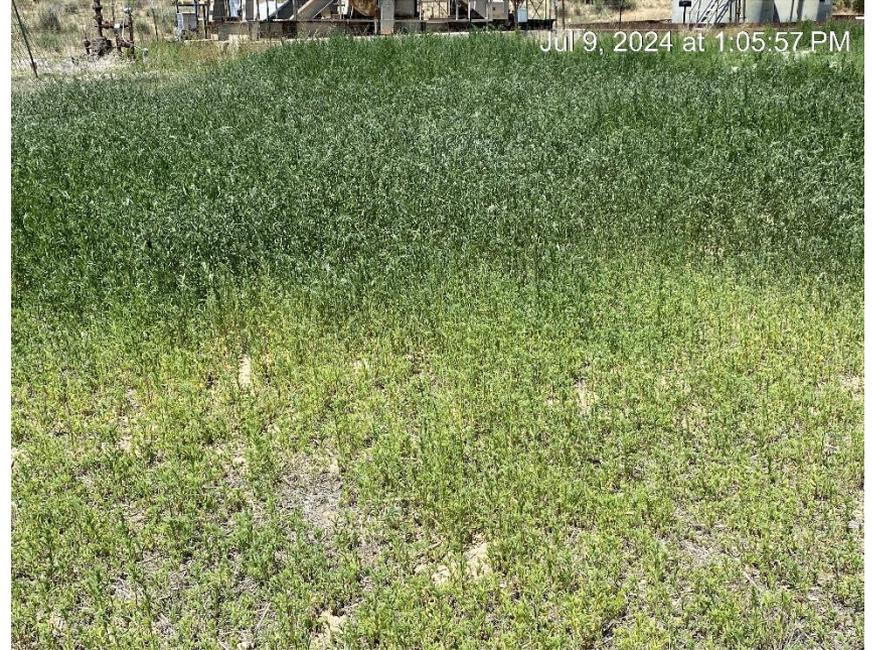
**Weeds**

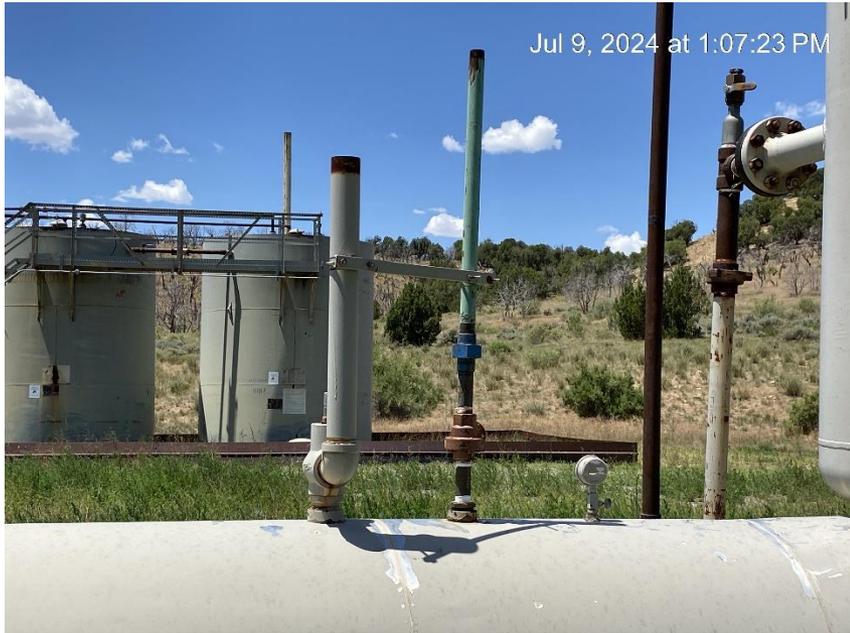
**Relief risers missing protective covers**

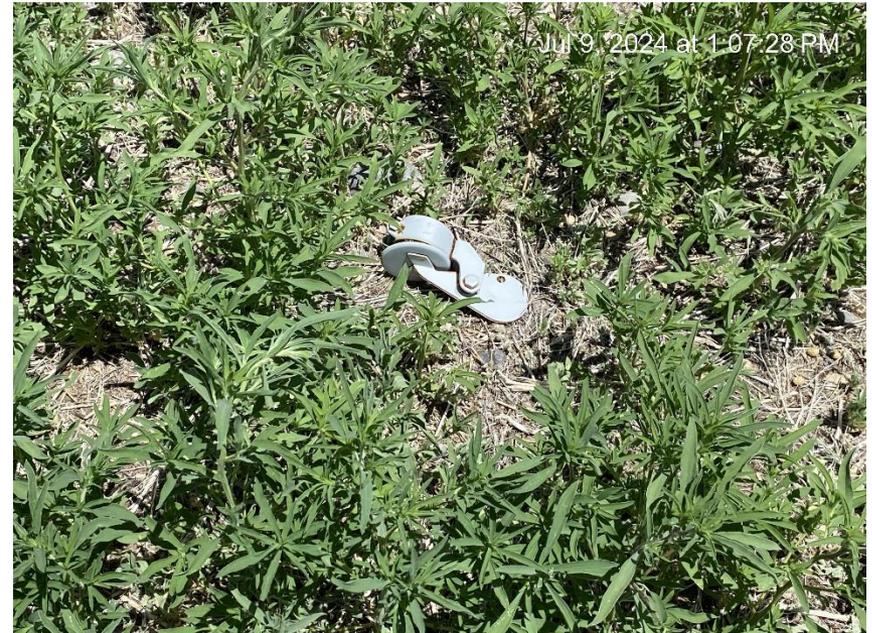
**Rain cap**

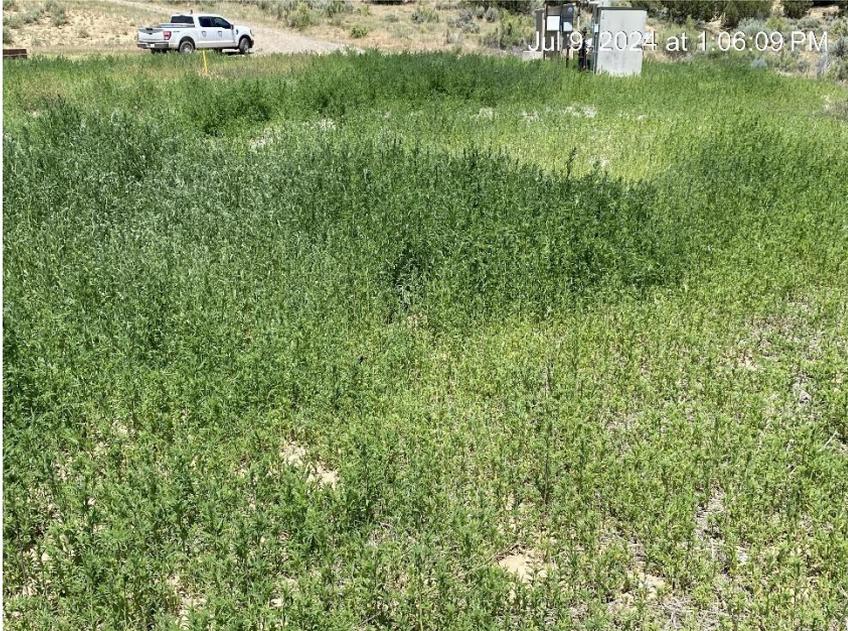
Weeds

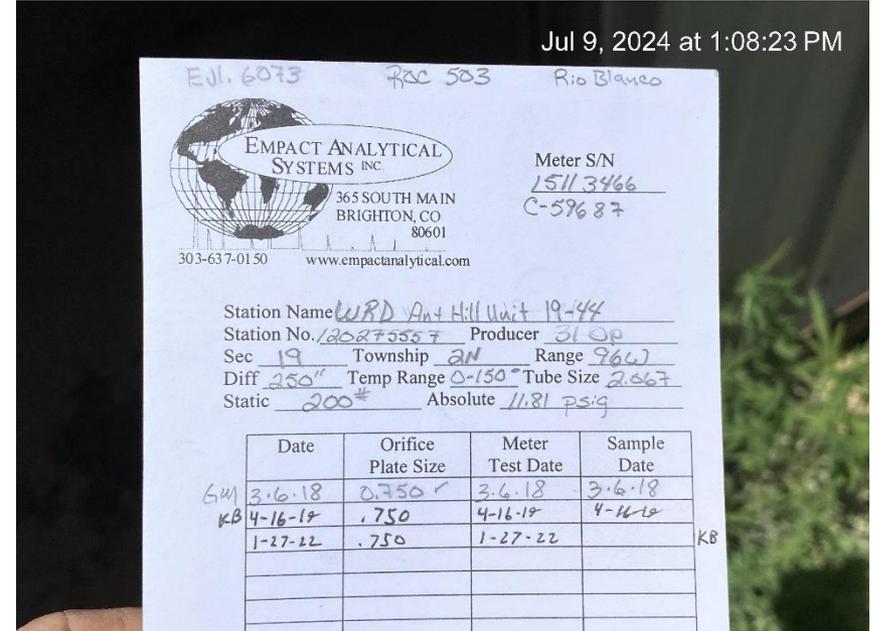
Calibration overdue
