# Interim Reclamation and Stormwater Inspection

Operator: MDS ENERGY DEVELOPMENT LLC - 10814

Location ID: 471039

Inspection Document #: 708201402

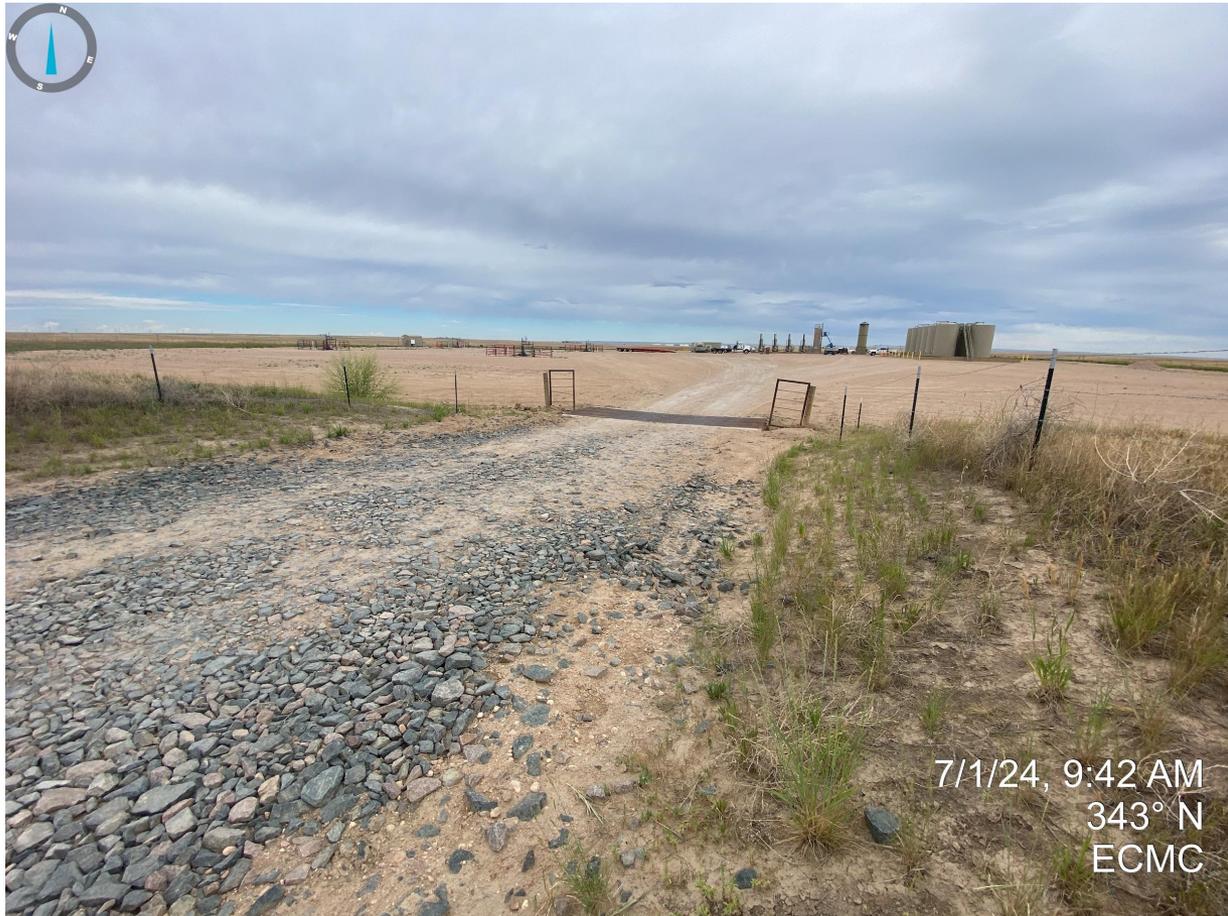
**Photo 1.** Track out pad is beginning to fill with sediment and requires maintenance.

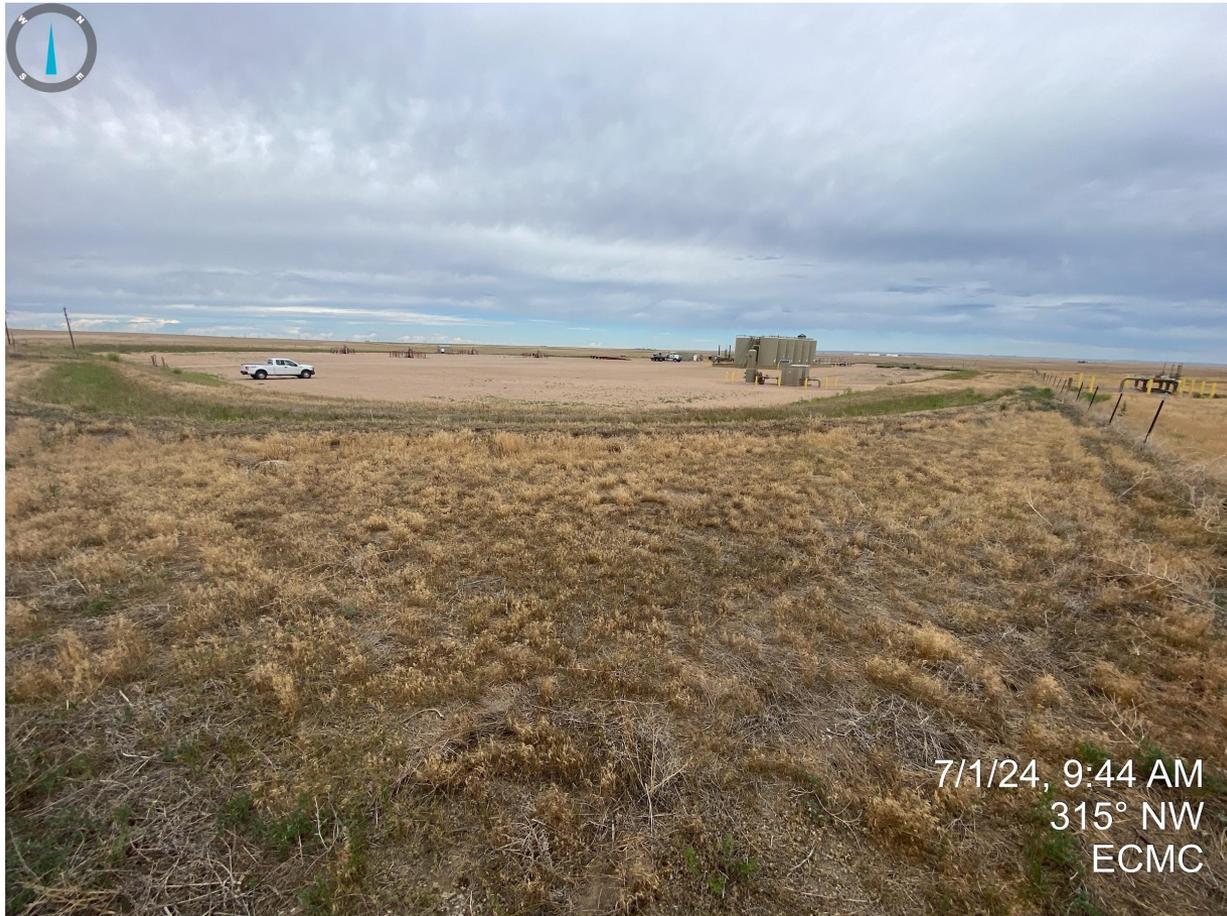
**Photo 2.** Southeast corner of the location. Interim reclamation activities had not commenced at the time of this inspection. Also pictured in foreground , cheatgrass (CO List C Noxious Weed) observed throughout the location.

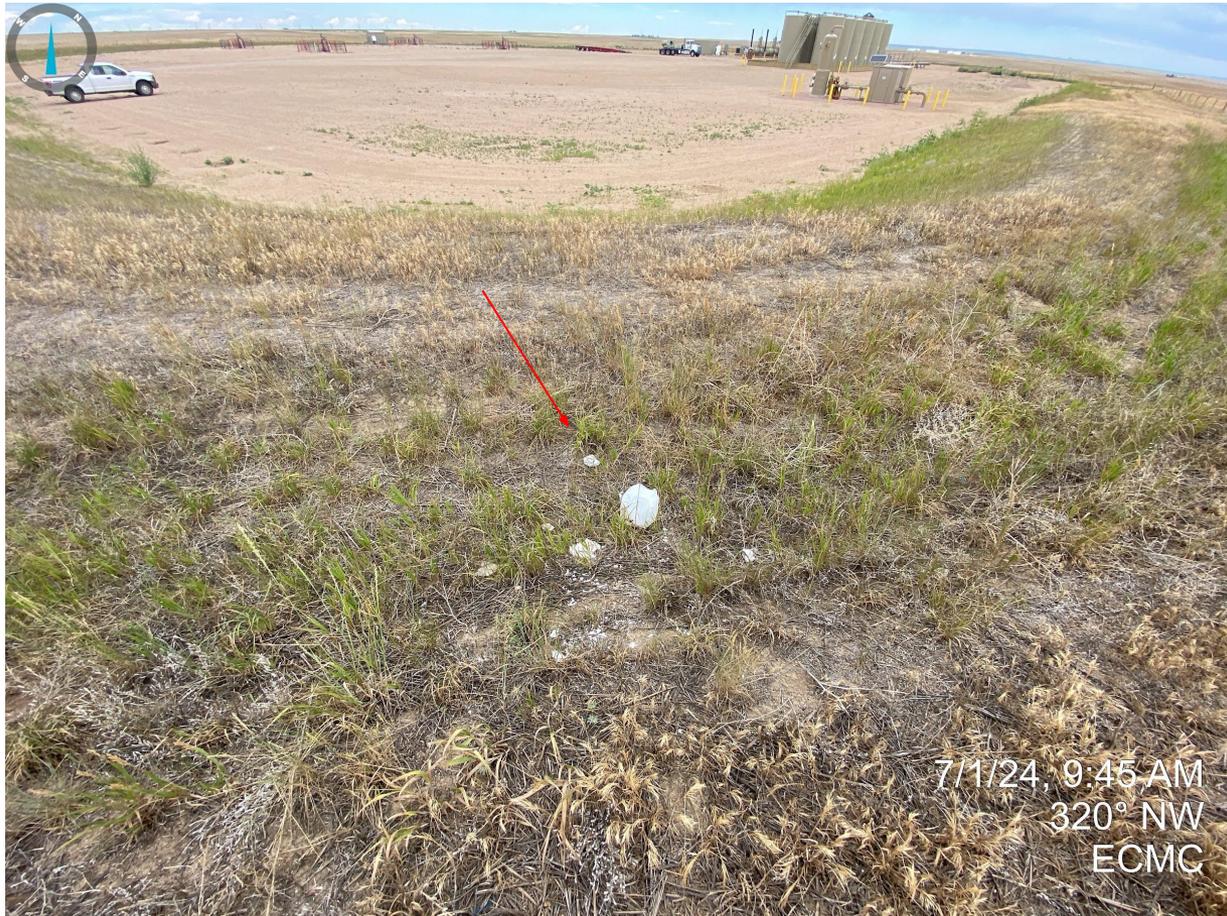
**Photo 3.** Trash observed in the southeast portion of the location. The Operator shall self-inspect the entire location to identify and dispose of any trash/debris.

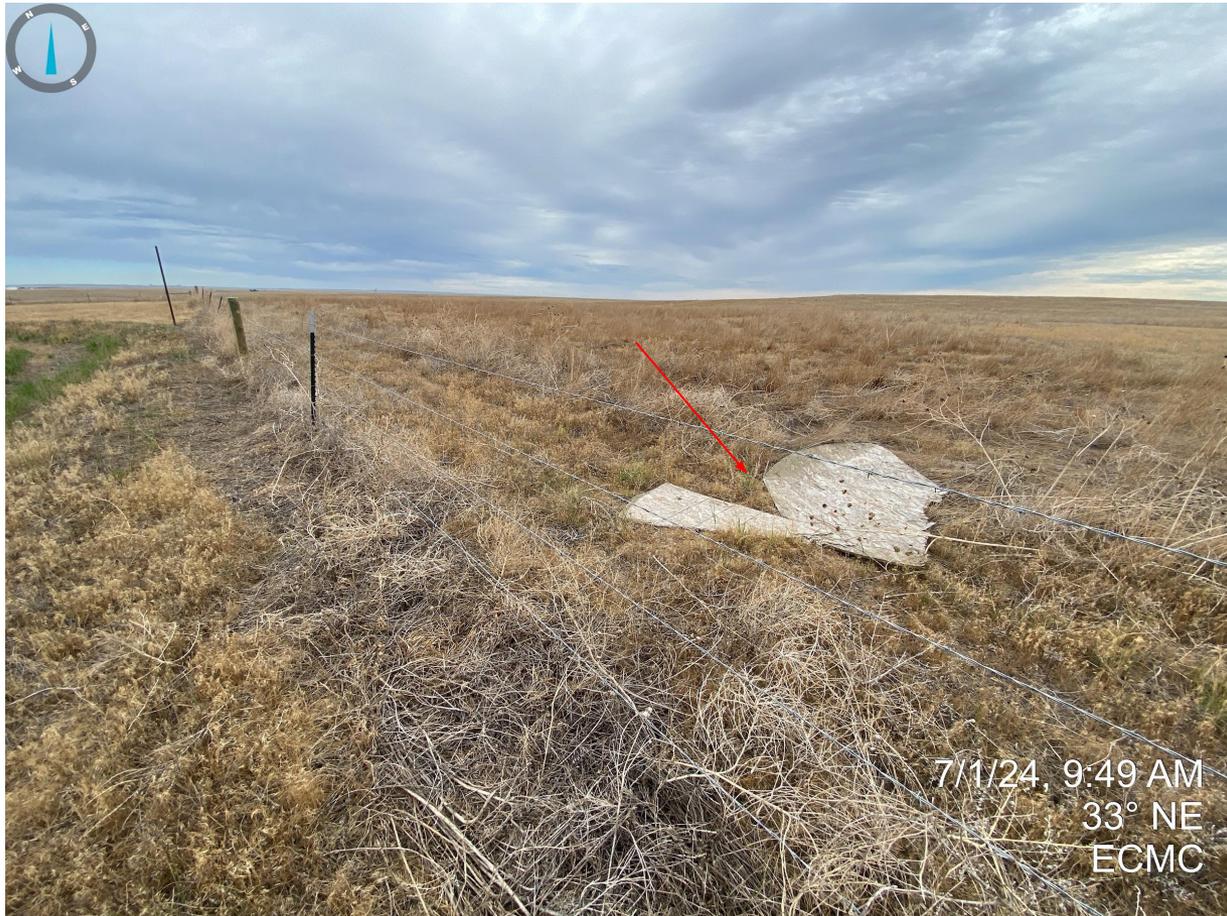
**Photo 4.** Trash observed in the northeast portion of the location. The Operator shall self-inspect the entire location to identify and dispose of any trash/debris.

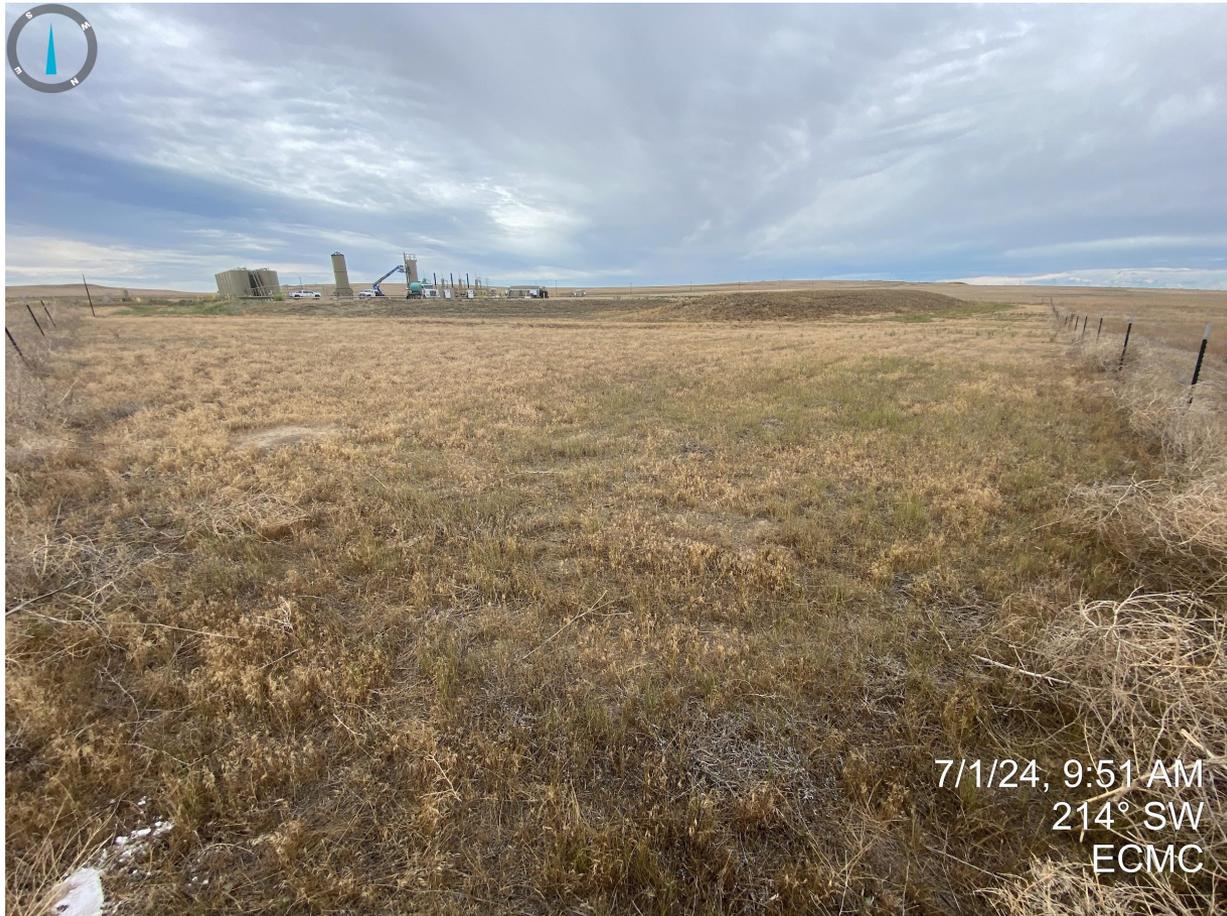
**Photo 5.** Northeast corner of the location; see comments in Photo 2.

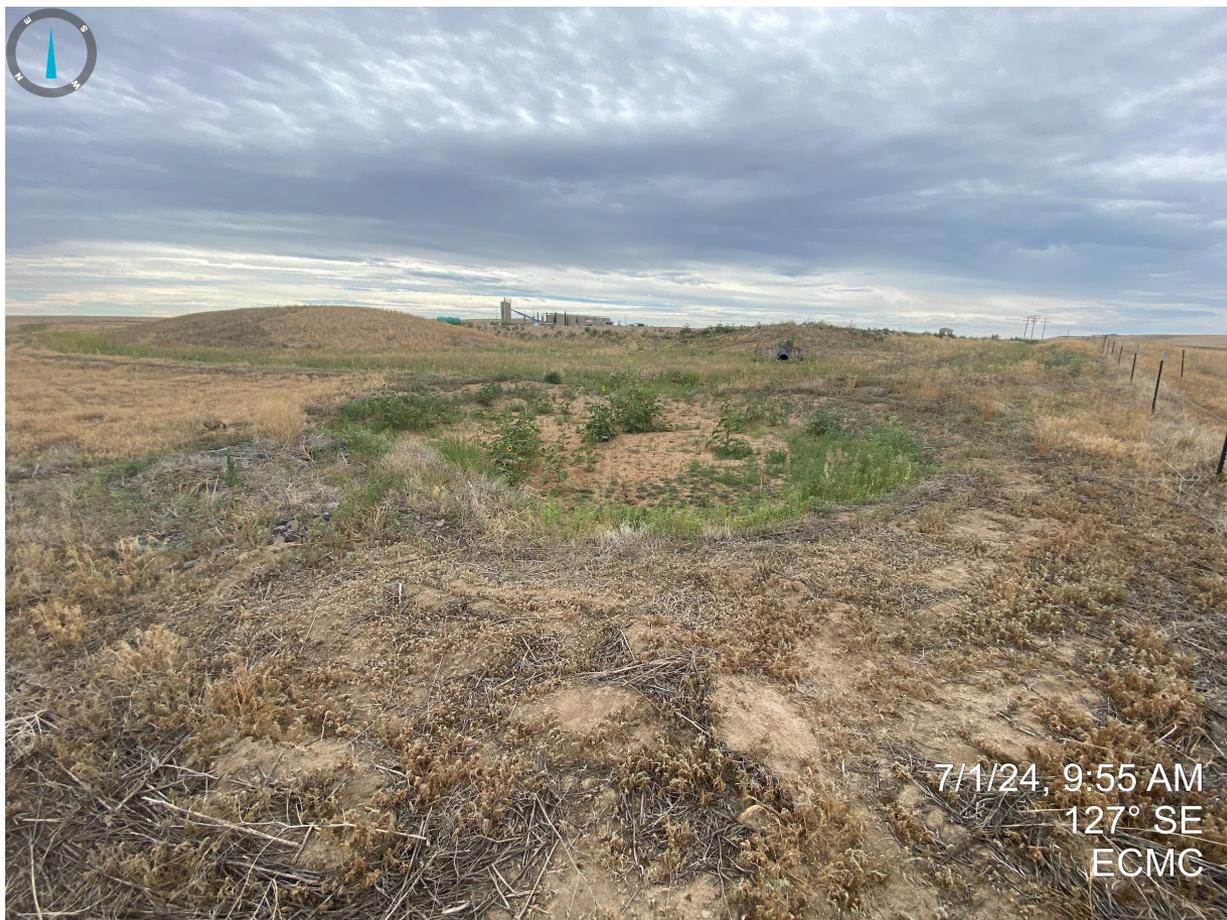
**Photo 6.** Northwest corner of the location; see comments in Photo 2.

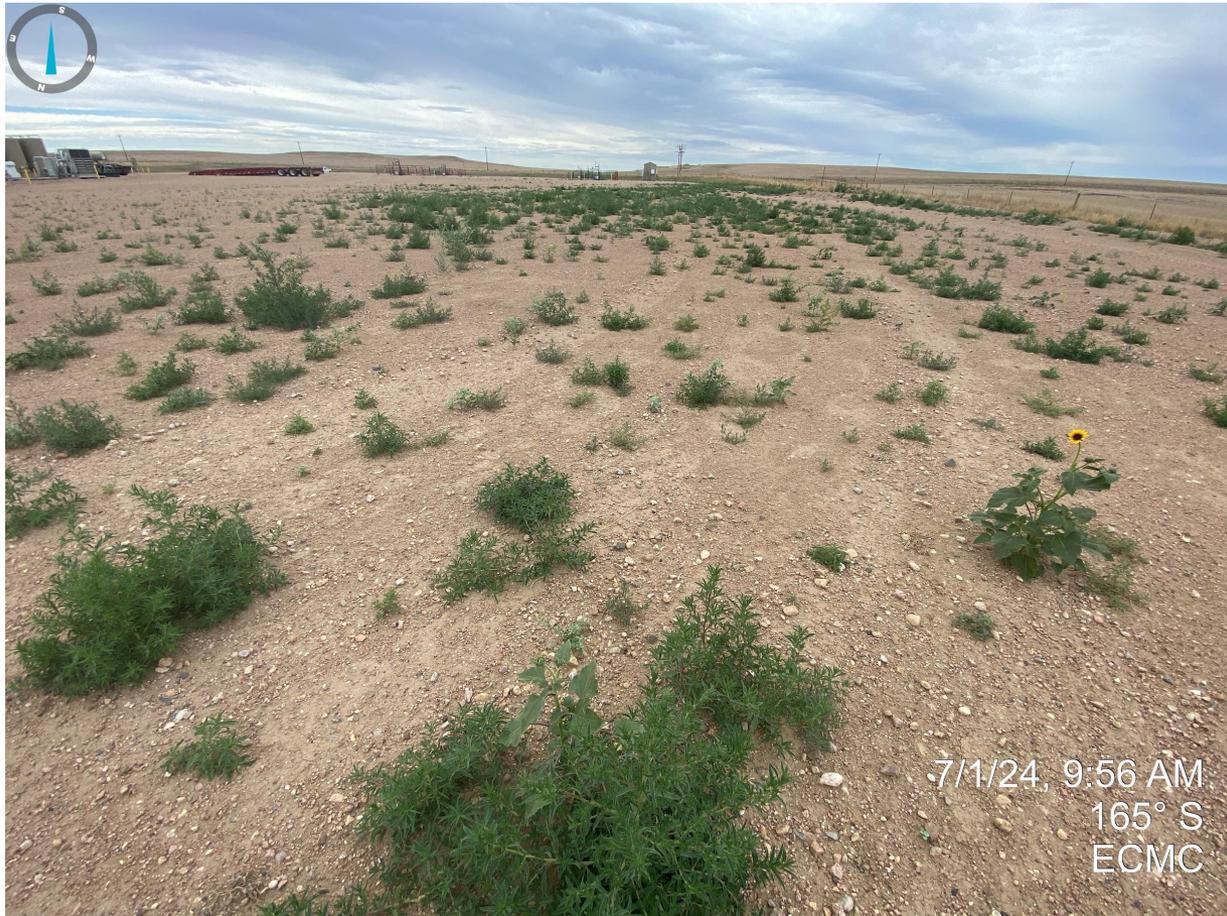
**Photo 7.** Undesirable vegetation (e.g. kochia and russian thistle) observed on the drilling pad area. Photo taken from the northern portion of the drilling pad.

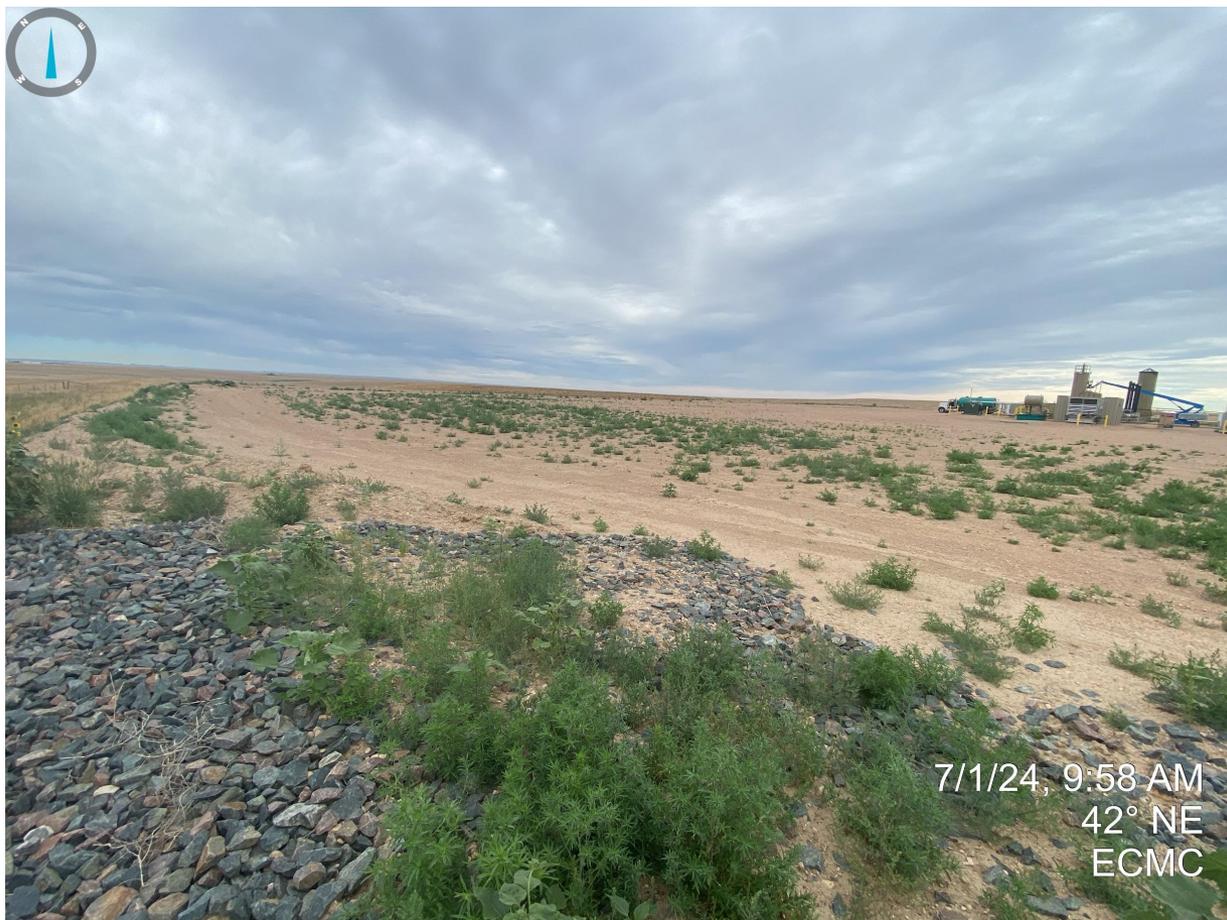
**Photo 8.** Taken from the western/center portion of the drilling pad, facing northeast. See comments in Photo 7.

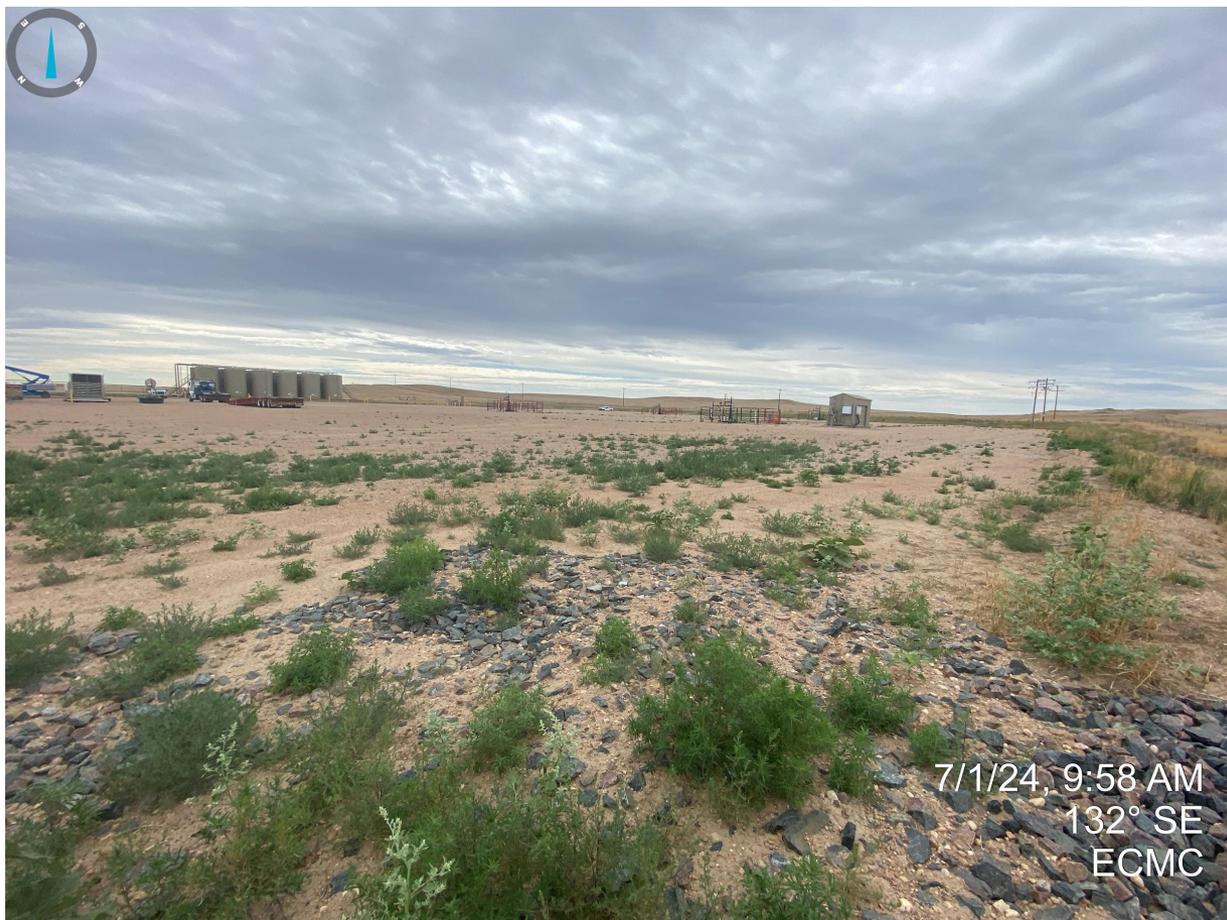
**Photo 9.** Taken from the western/center portion of the drilling pad, facing southeast. See comments in Photo 7.

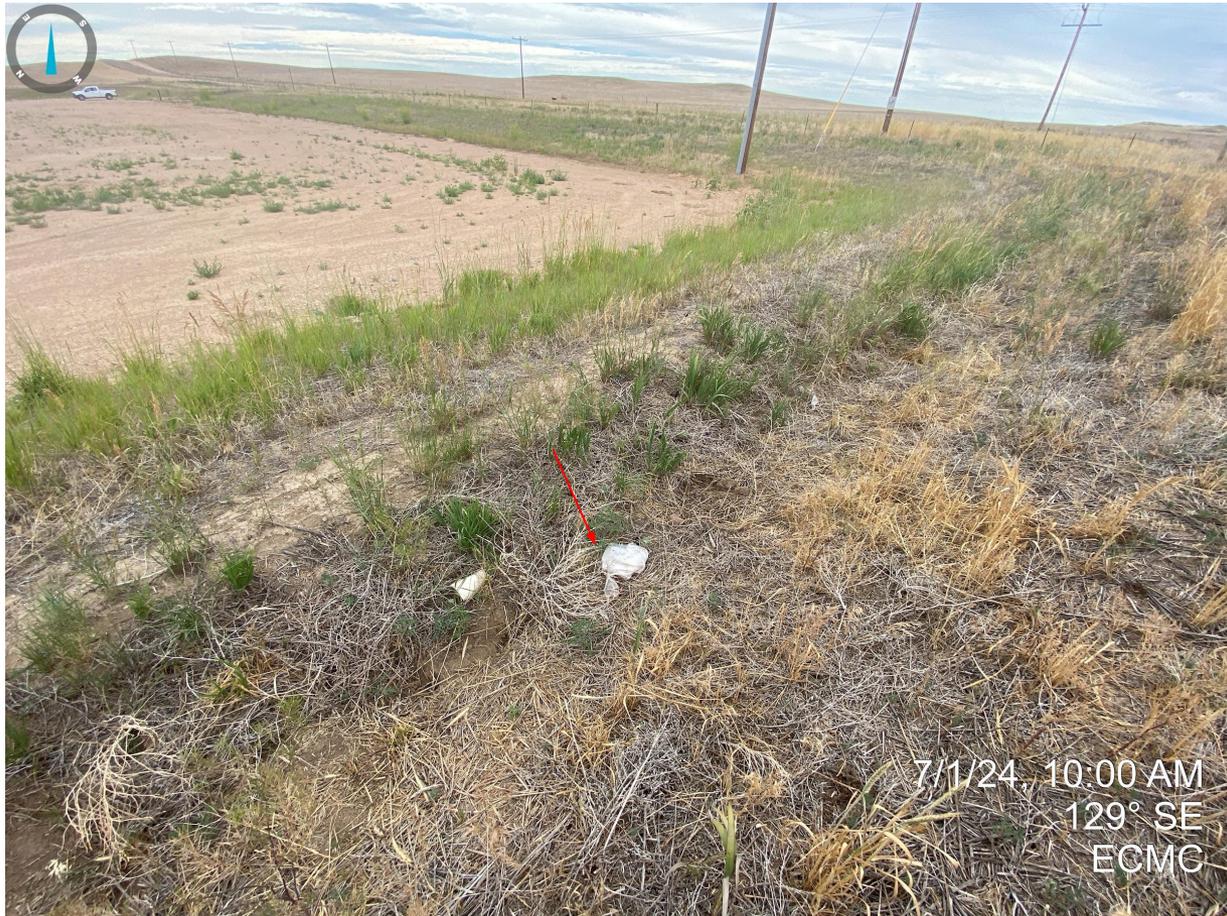
**Photo 10.** Example of trash/debris observed near the southwest corner of the location. The Operator shall self-inspect the entire location to identify and dispose of any trash/debris.

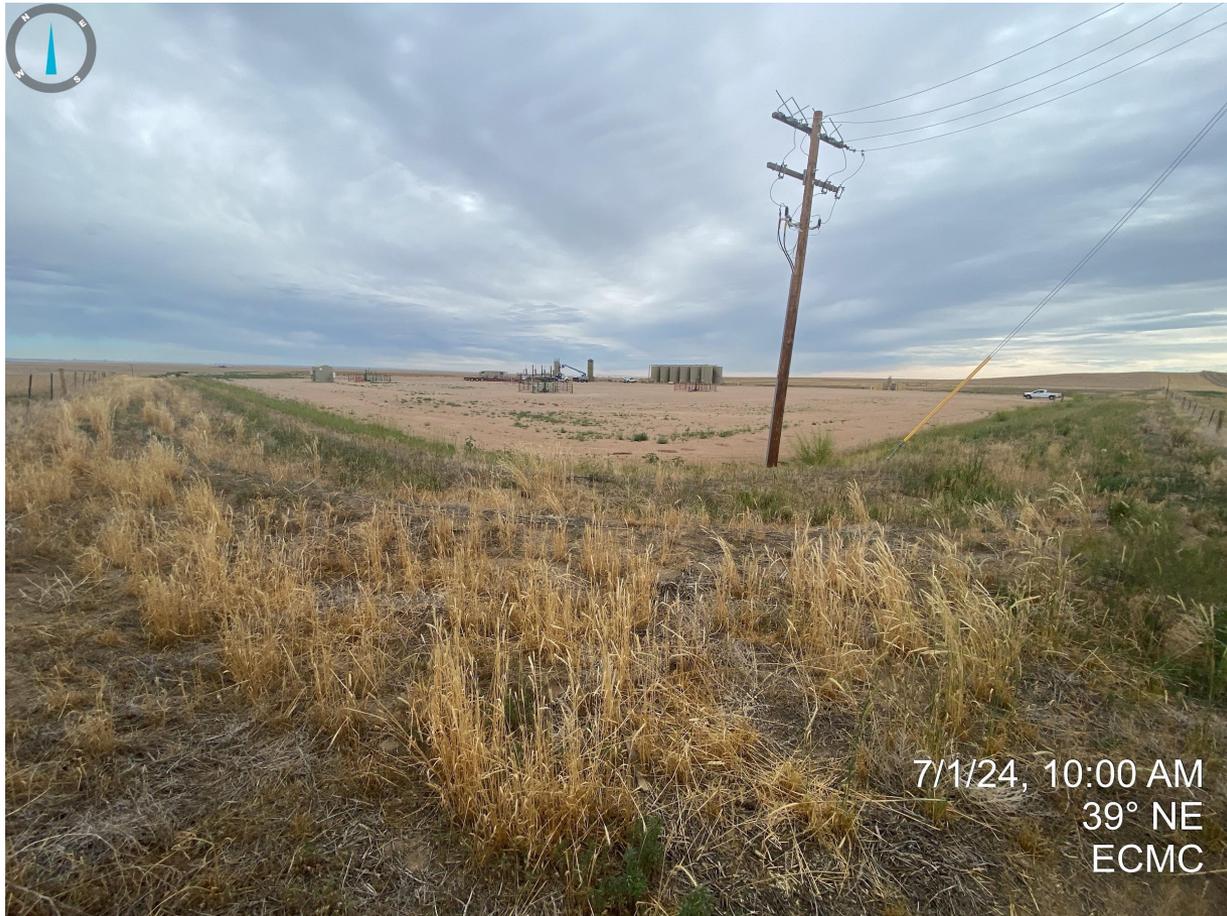
**Photo 11.** Southwest corner of the location; see comments in Photo 2.

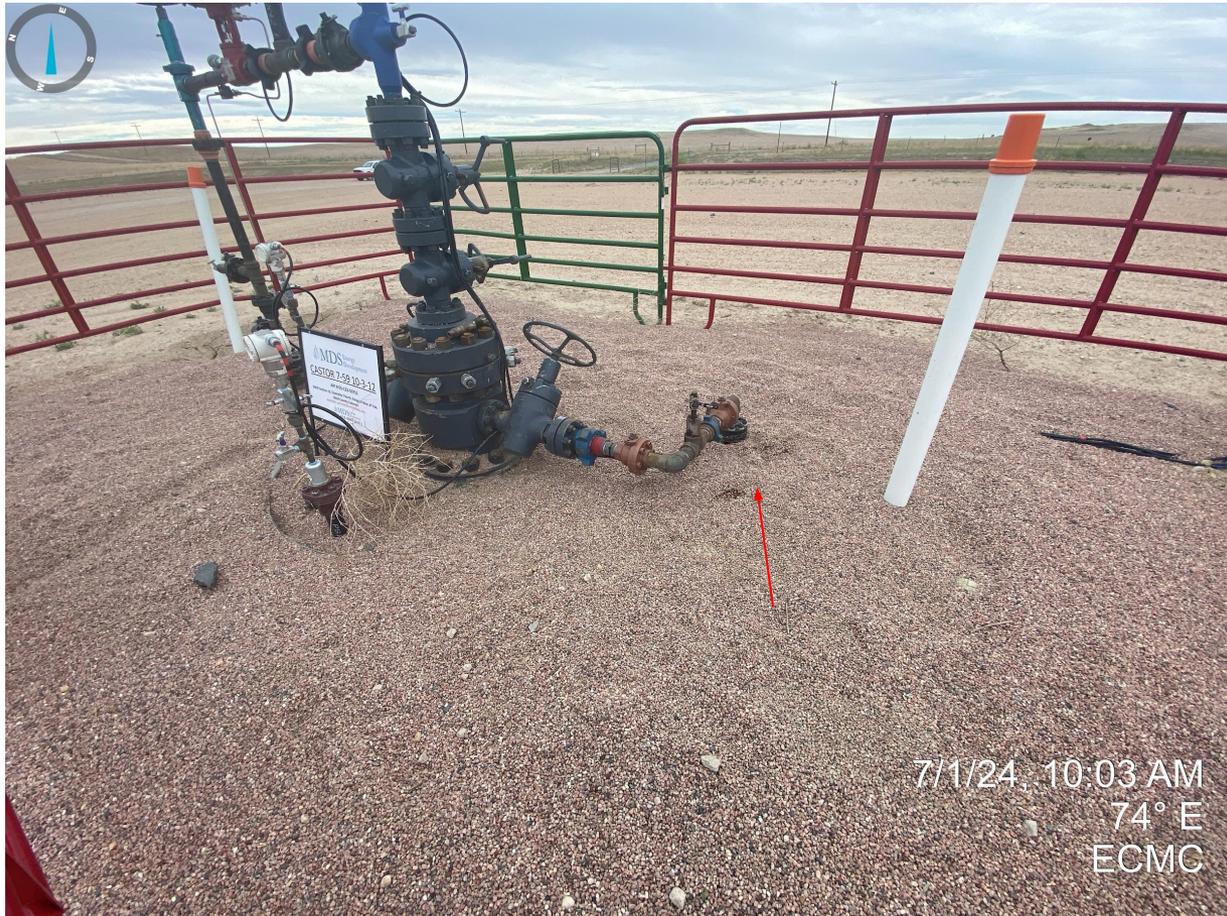
Photo 12. Stained soil observed near wellhead.

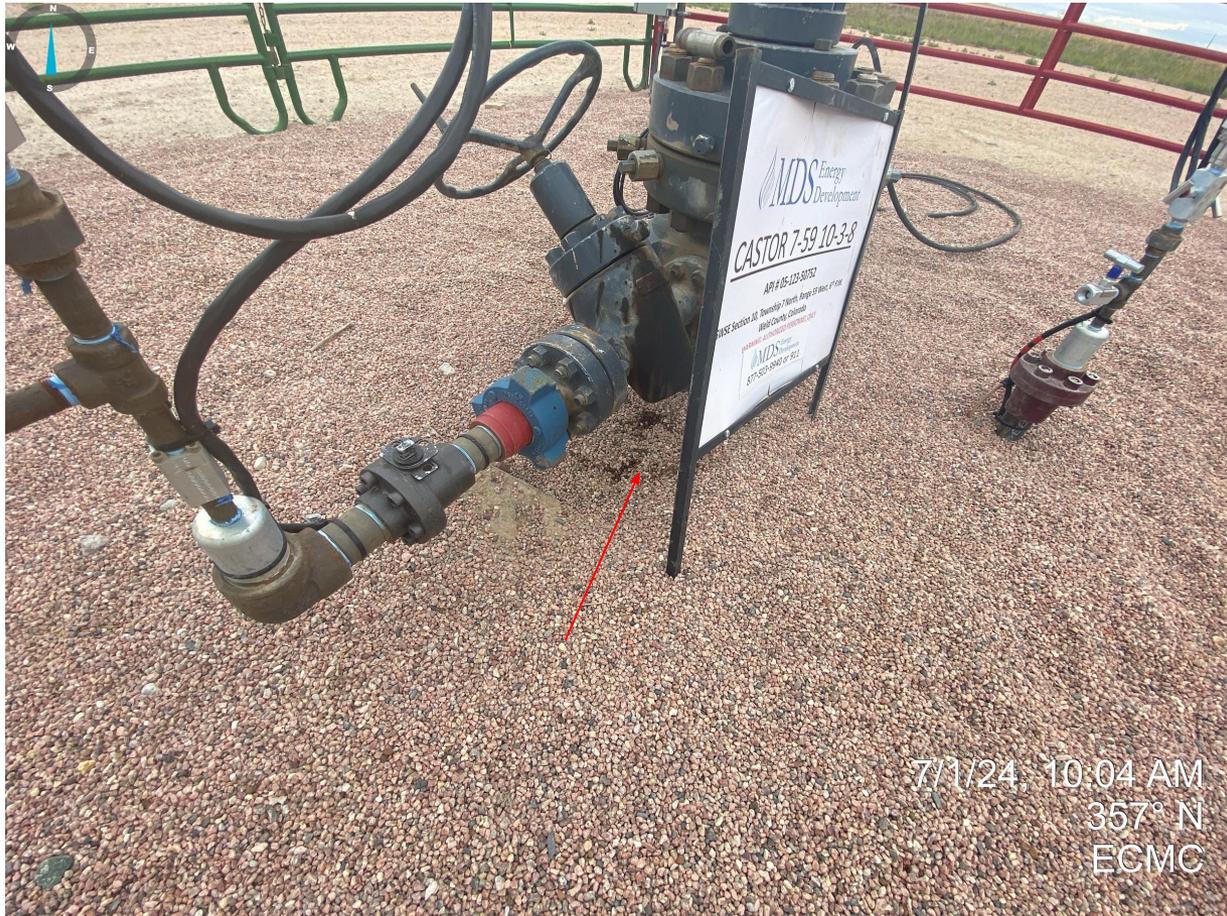
Photo 13. Stained soil observed near wellhead.

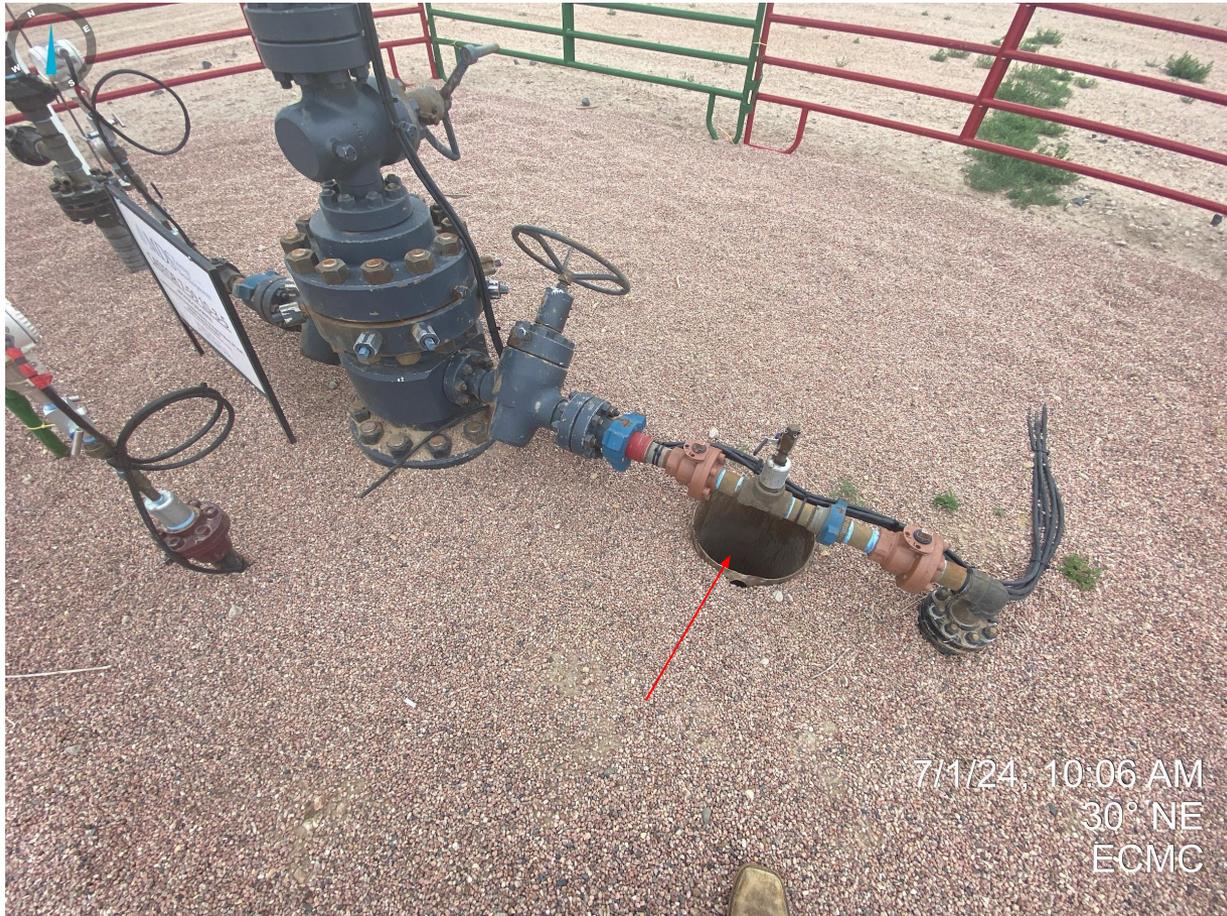
**Photo 14.** No cover or wildlife protection equipment observed near wellhead rat/mouse hole.

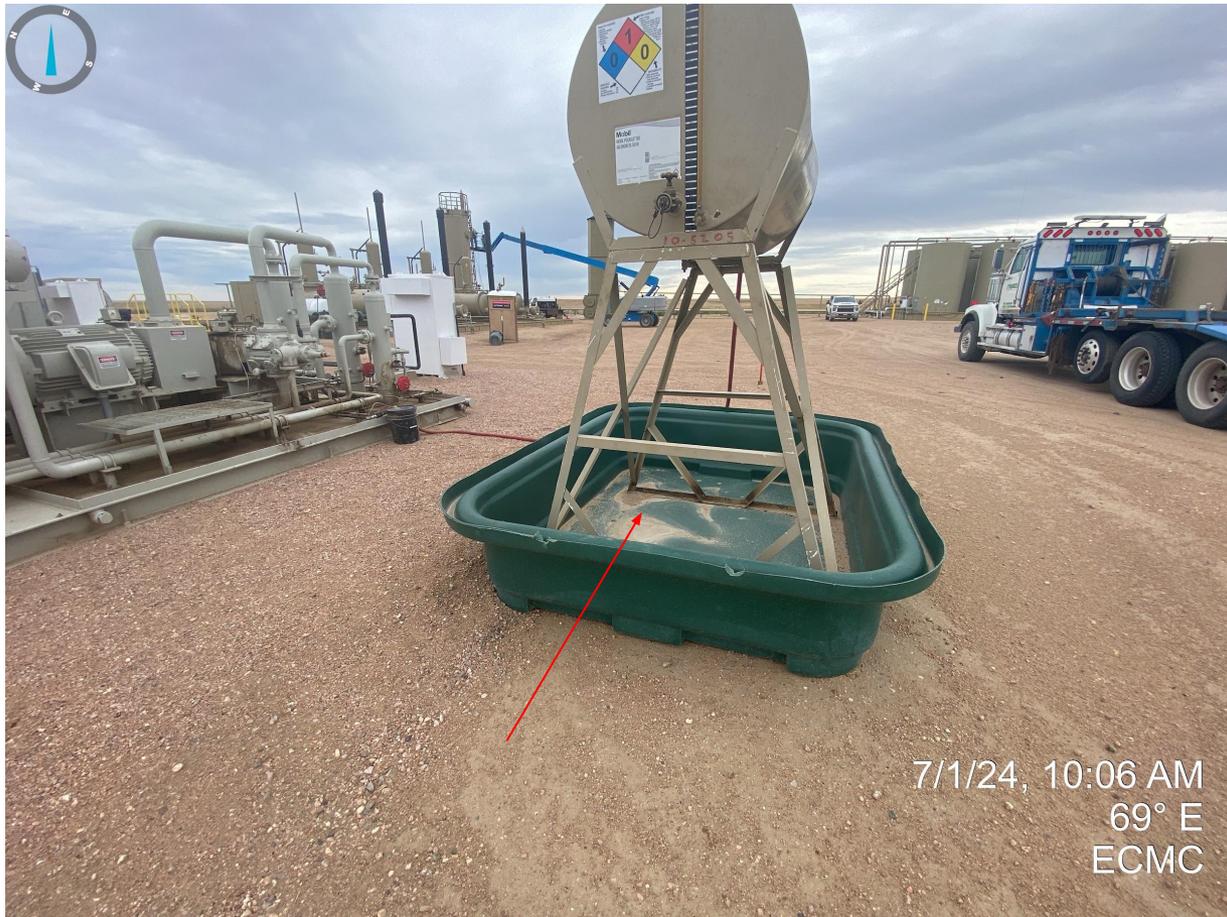
**Photo 15.** No wildlife netting observed at secondary containment.

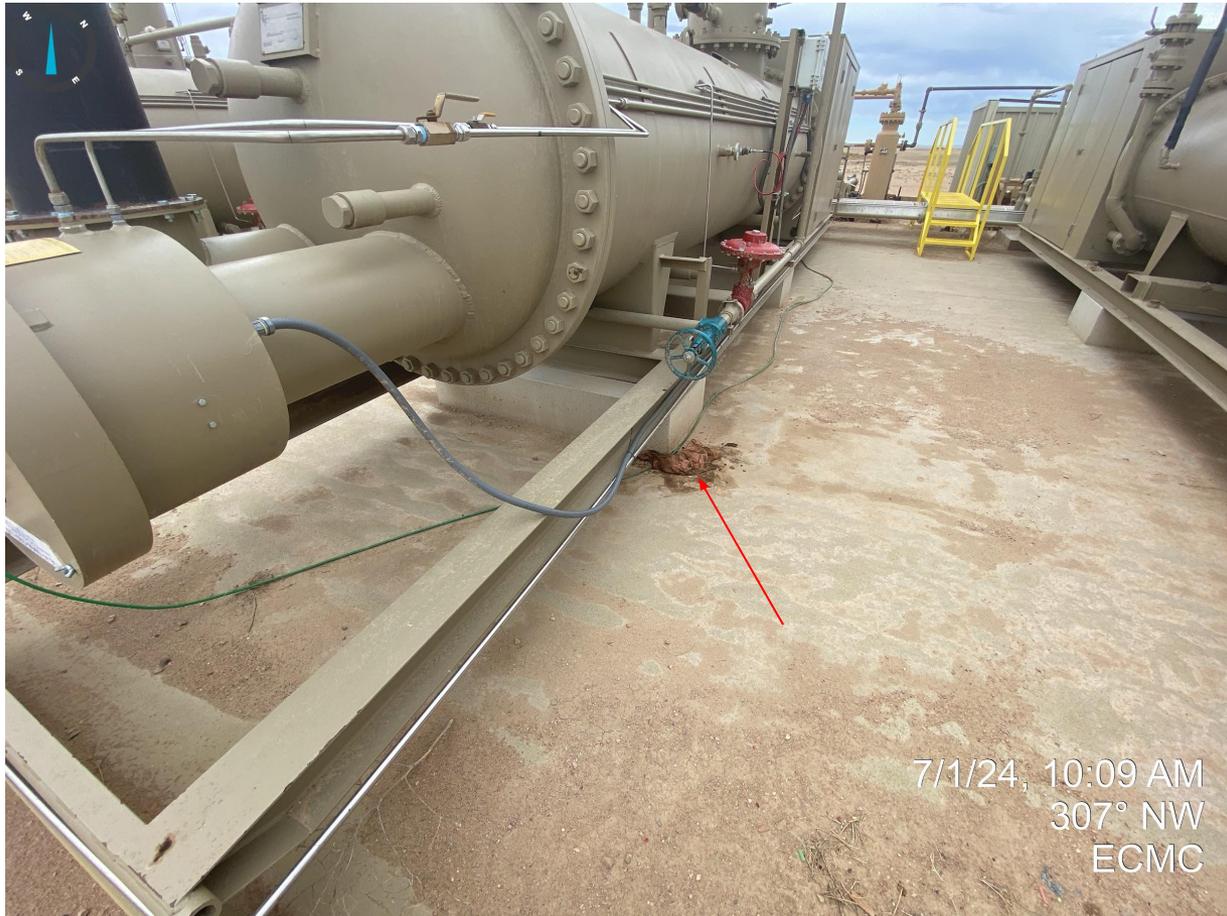
**Photo 16.** Staining and debris observed within secondary containment at separator.

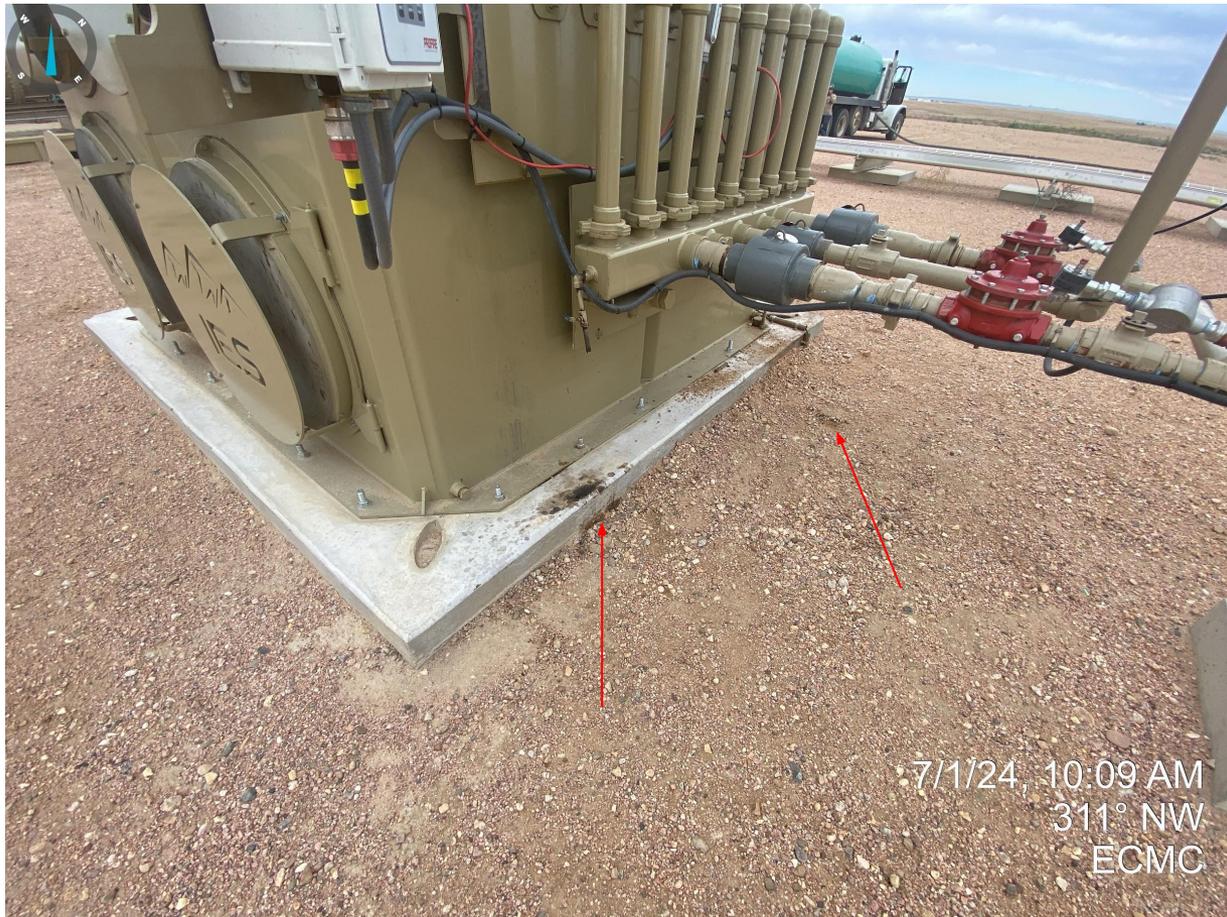
**Photo 17.** Staining at equipment.

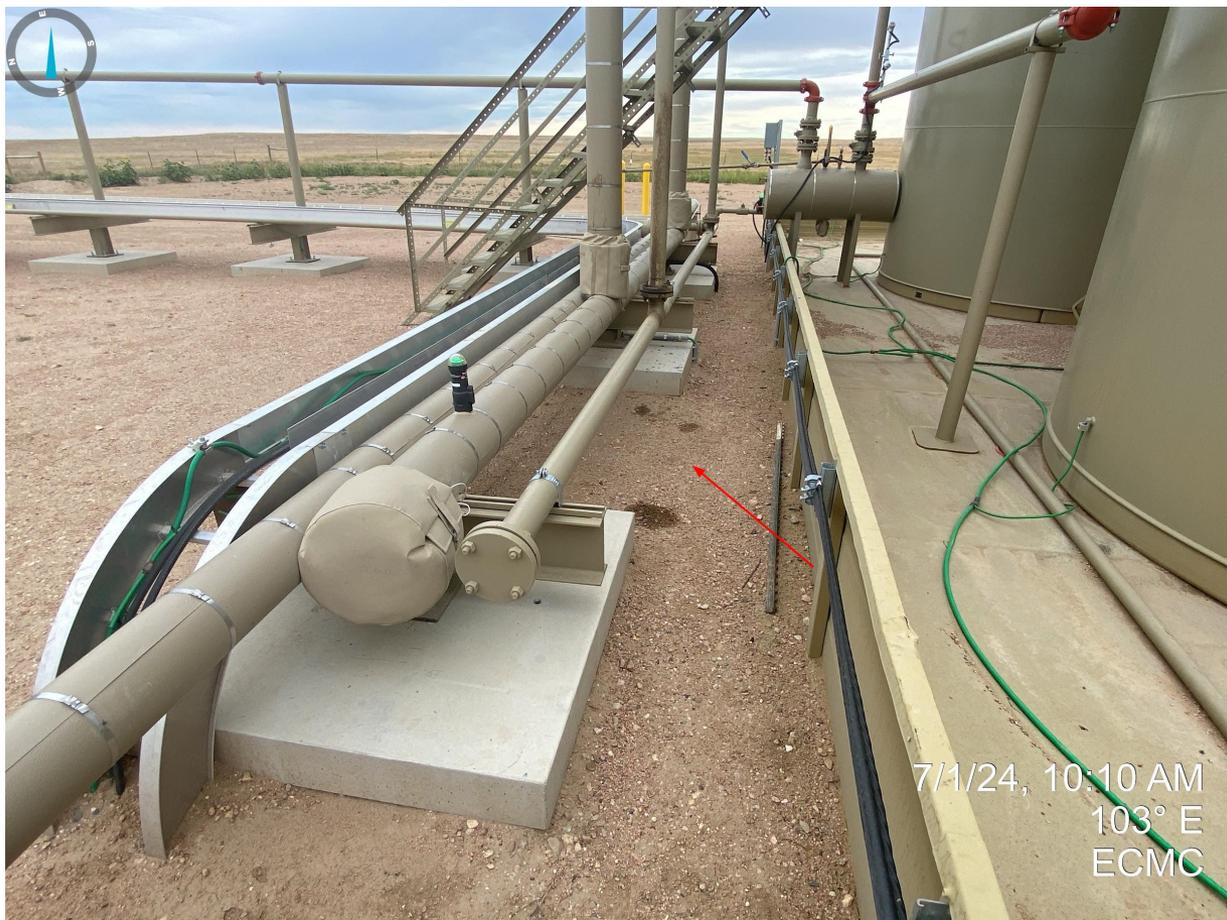
**Photo 18.** Stained soils observed on north end of tank battery.

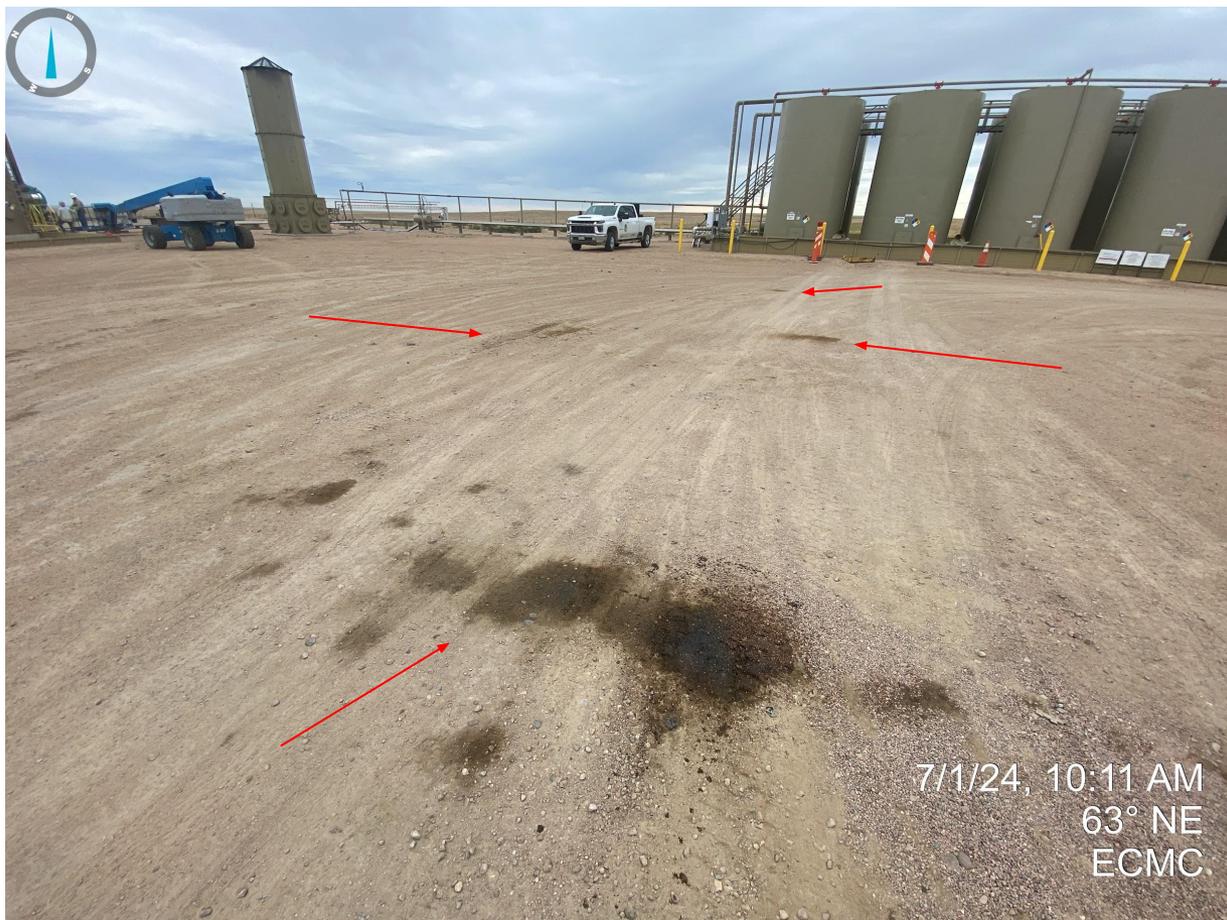
**Photo 19.** Stained soils observed west of tank battery.

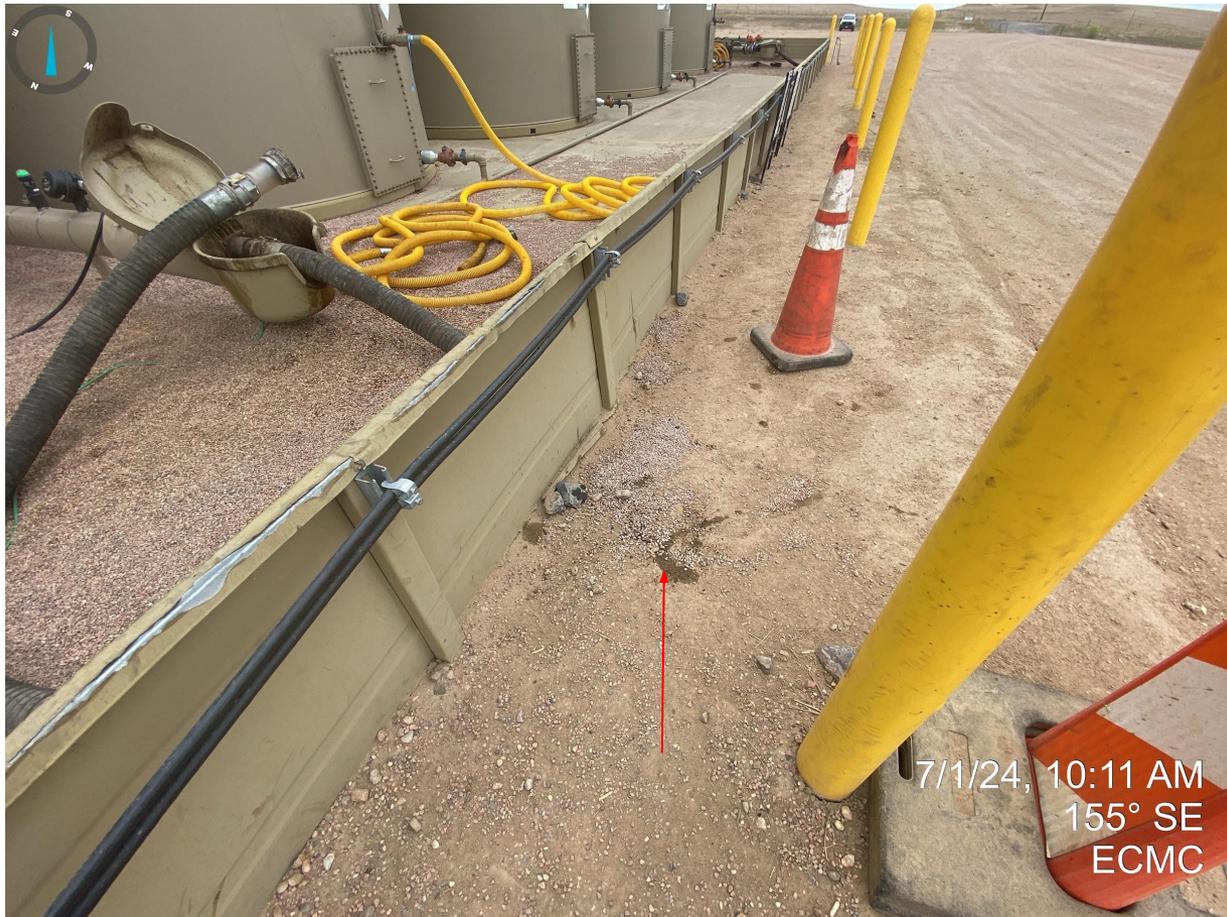
**Photo 20.** Stained soil observed on west side of tank battery.
