# Interim Reclamation and Stormwater Inspection

Operator: MDS ENERGY DEVELOPMENT LLC - 10814

Location ID: 471039

Inspection Document #: 708201402

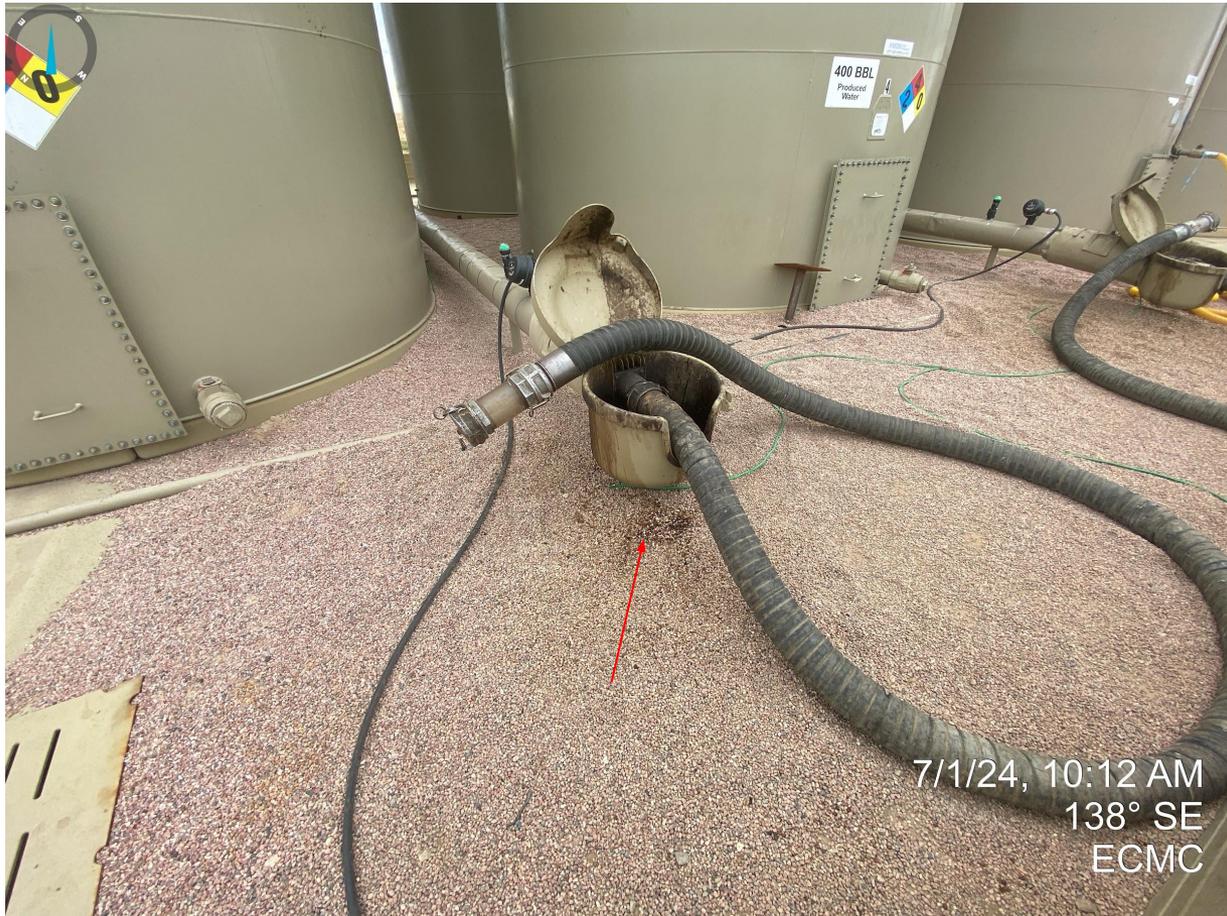
**Photo 21.** Stained soil within tank battery secondary containment.

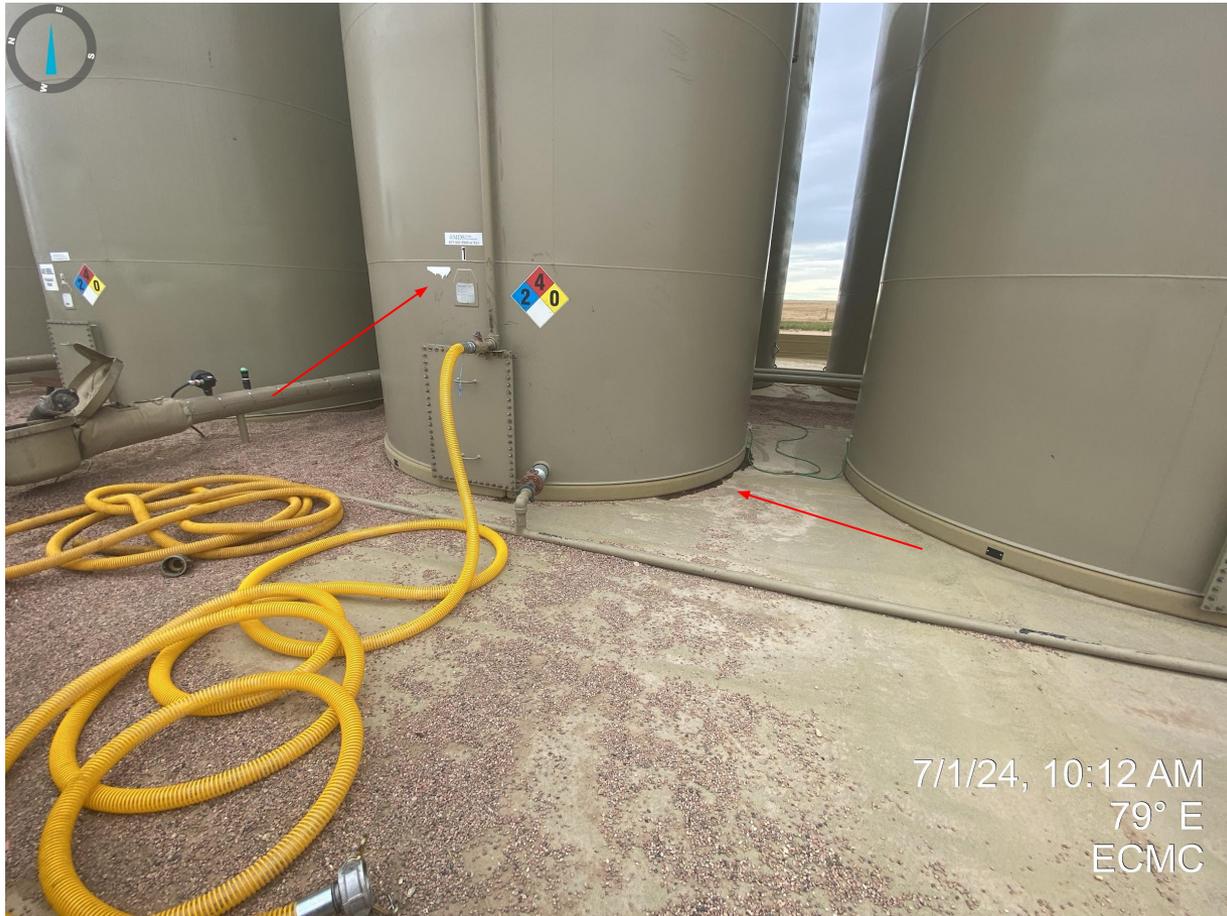
**Photo 22.** Tank content label missing. Also pictured, staining underneath tank.

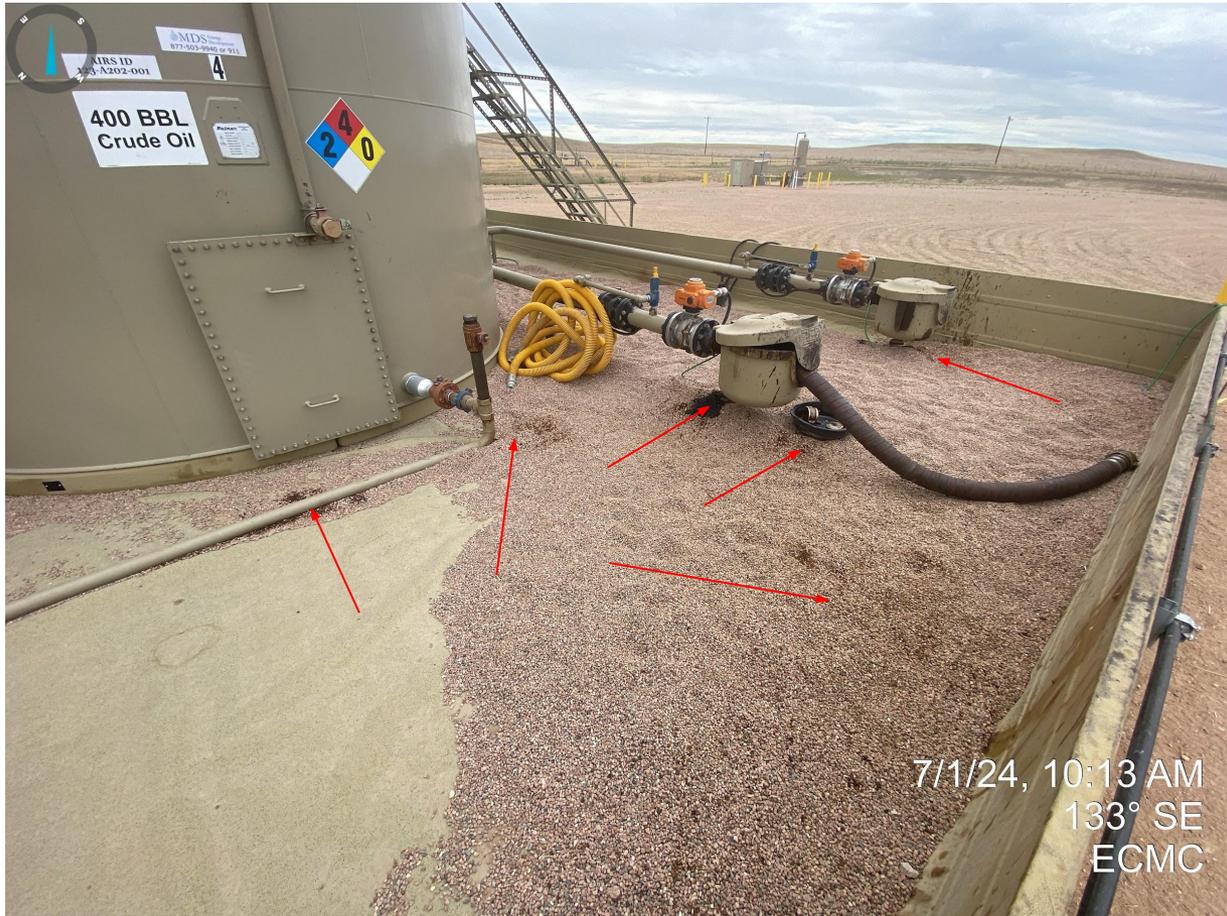
**Photo 23.** Stained soil within tank battery secondary containment.

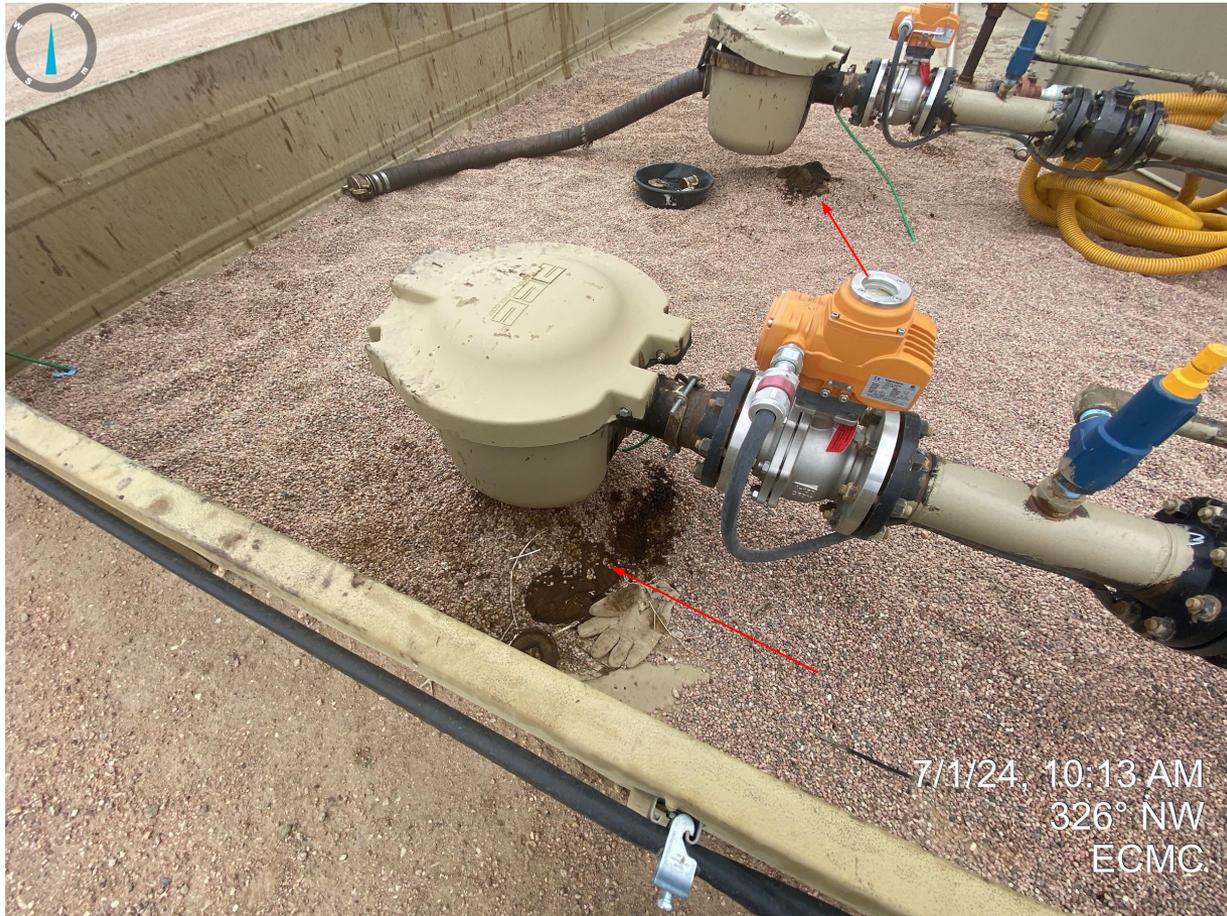
**Photo 24.** Stained soil within tank battery secondary containment.

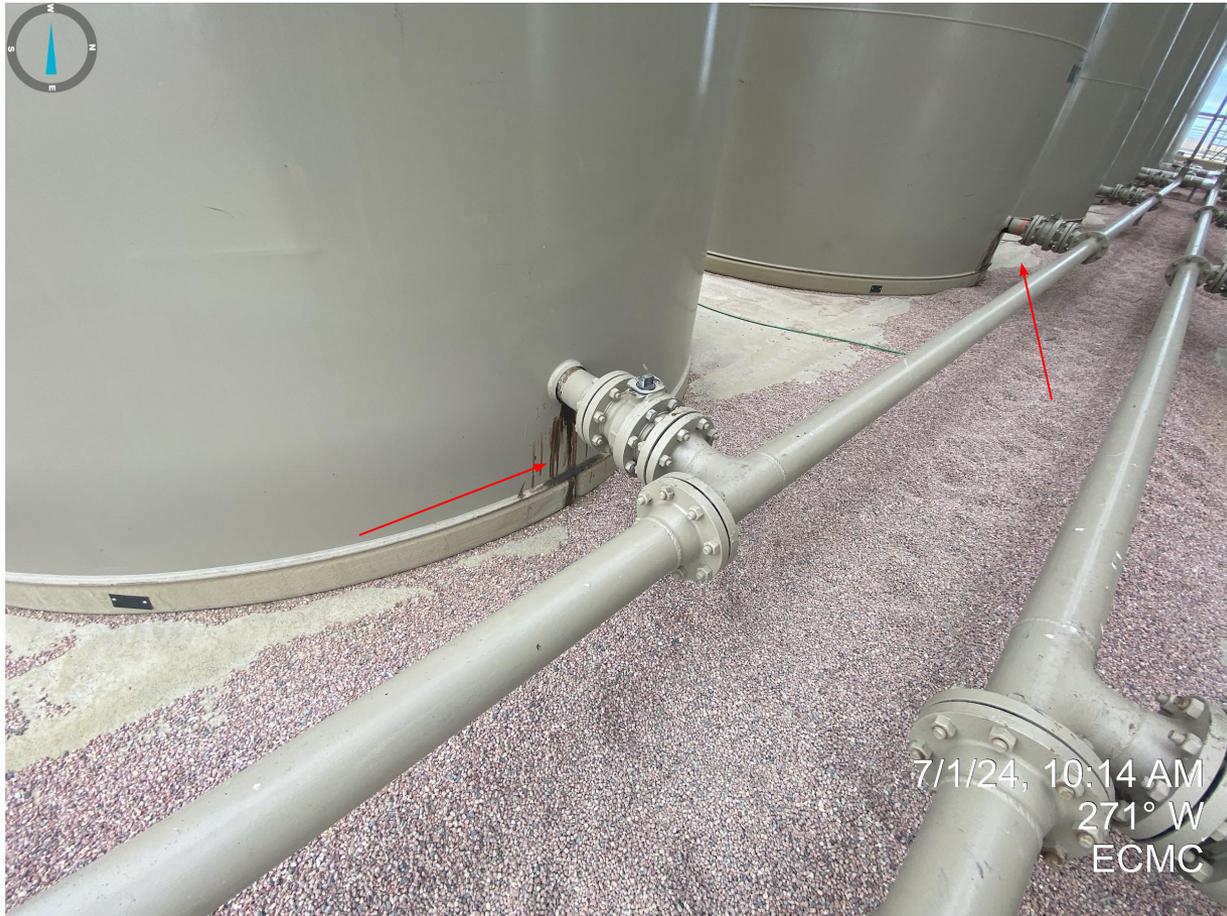
**Photo 25.** Leaking equipment requires maintenance.

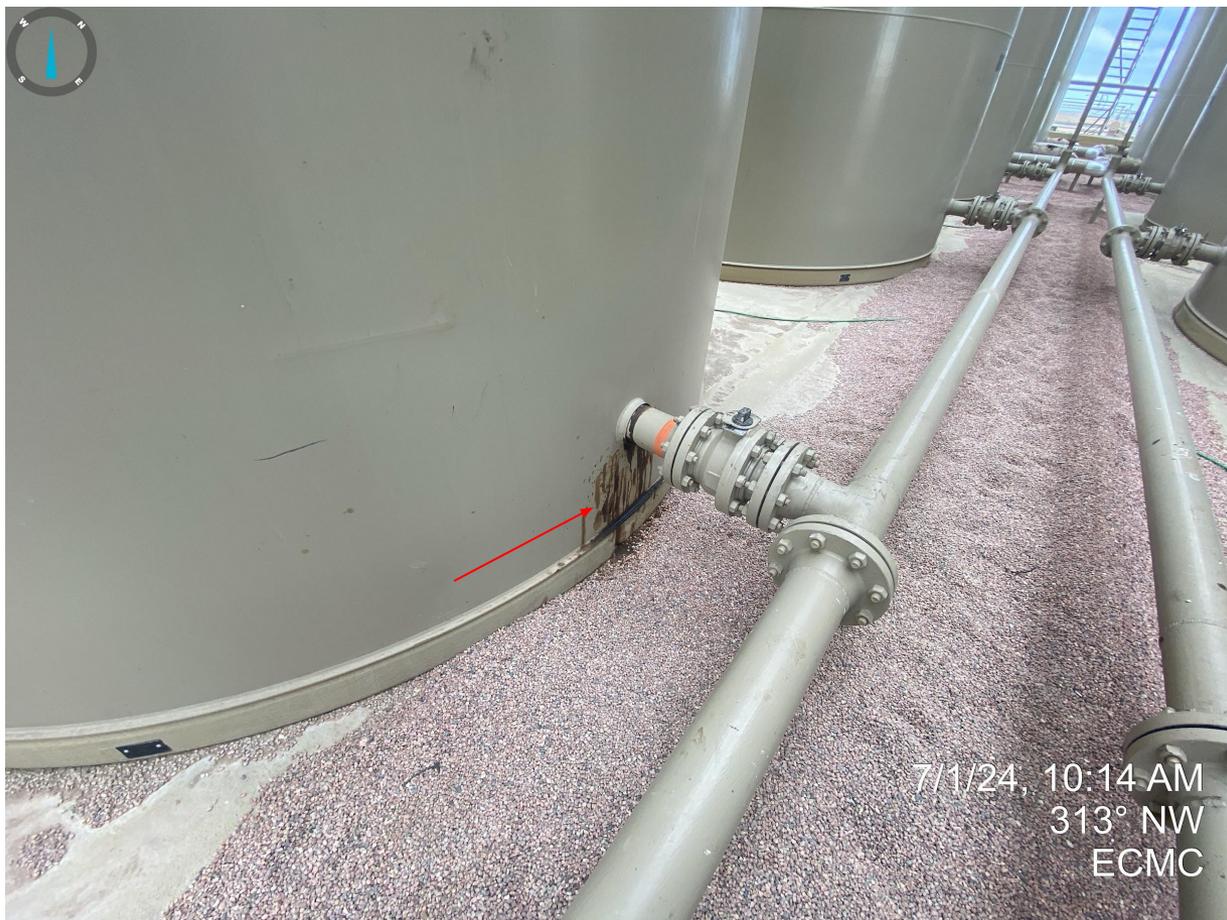
**Photo 26.** Continued from Photo 25, one tank to the north of previous photo.
