Inspection Photos
Location Name: UPRR 42 Pan Am D2
Location ID: 318931

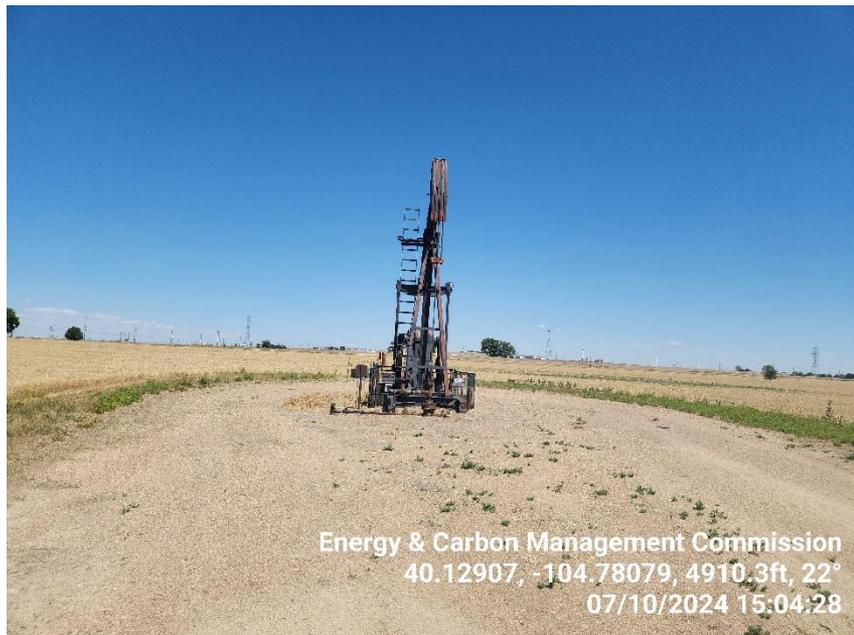
Photo 1 wellsite.

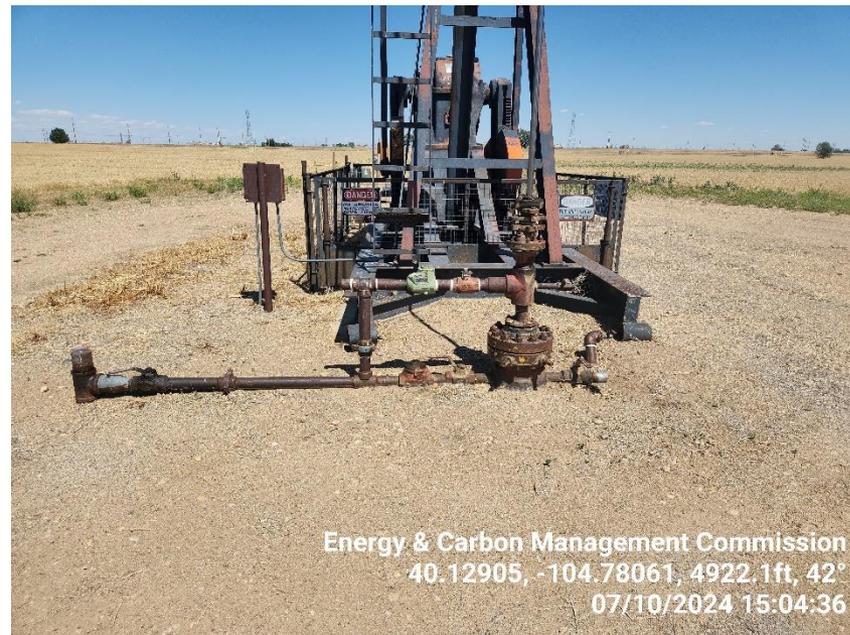
Photo 2 WH.

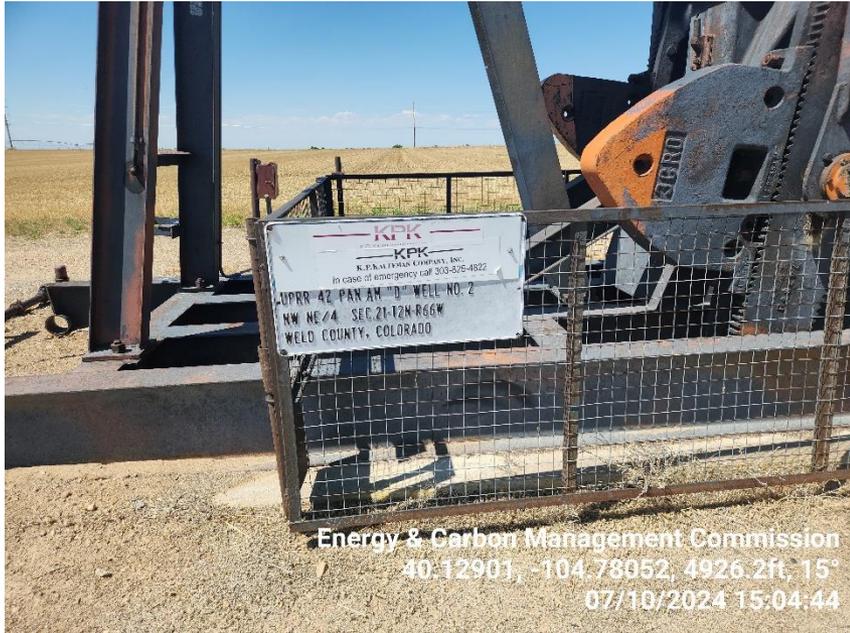
Photo 3 Sign.

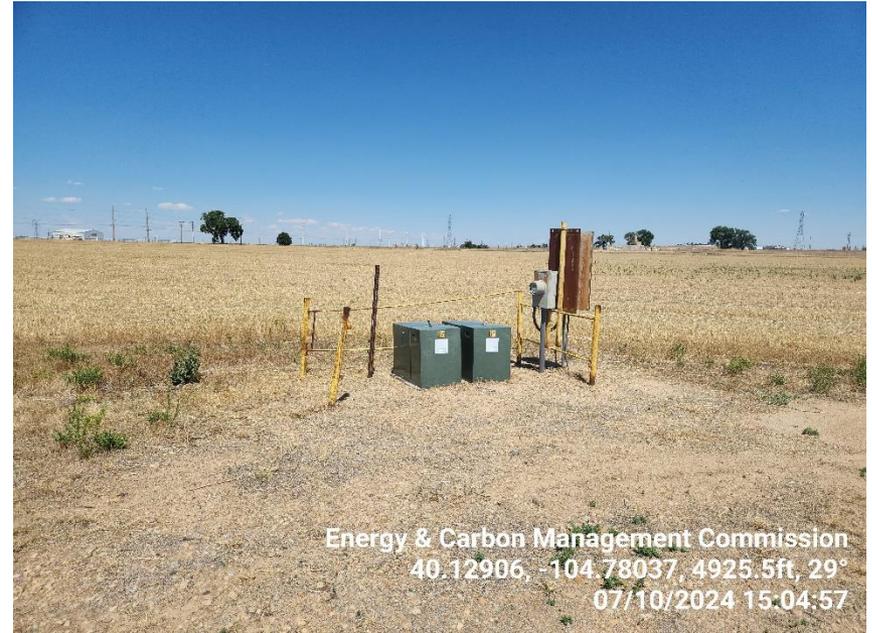
Photo 4 ancillary equip.

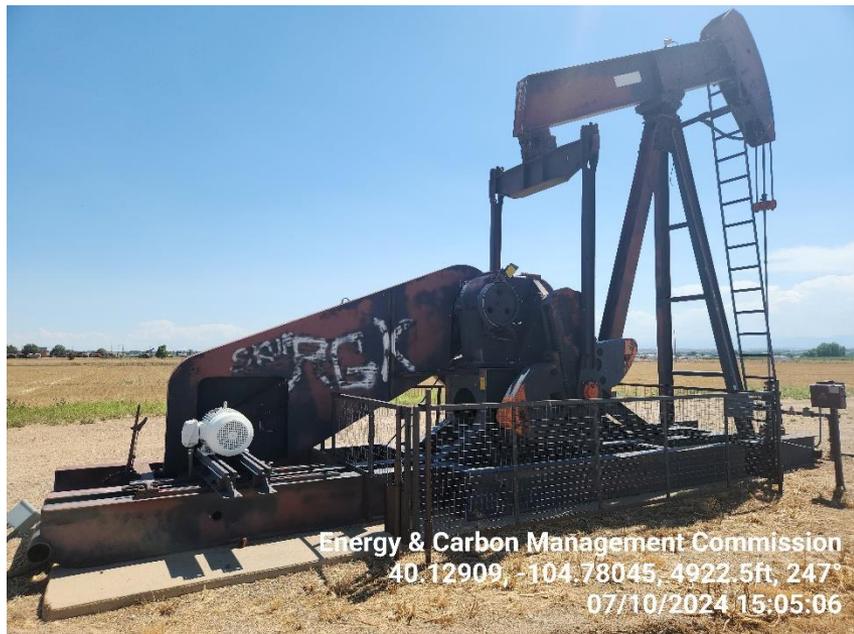
Photo 5 Pump jack.

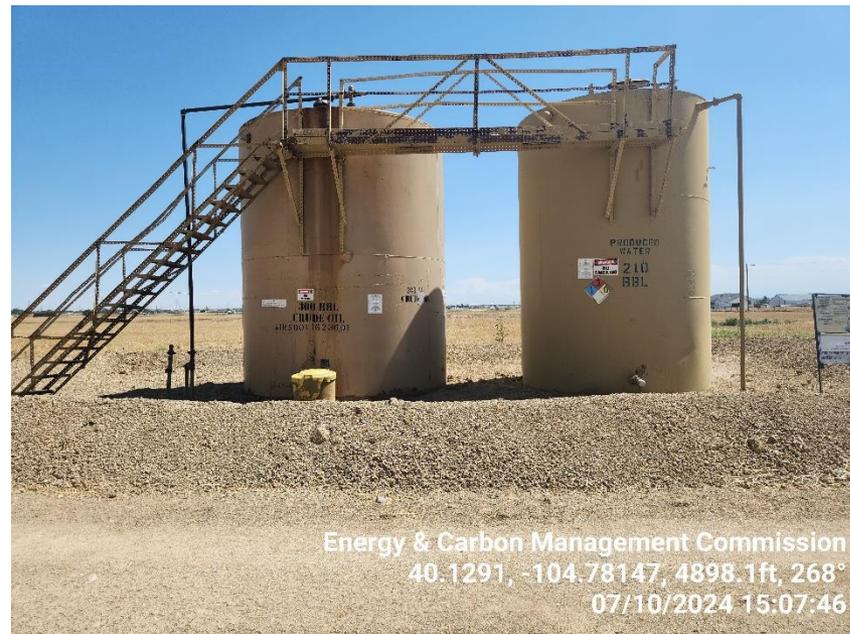
Photo 6 Tank Battery.

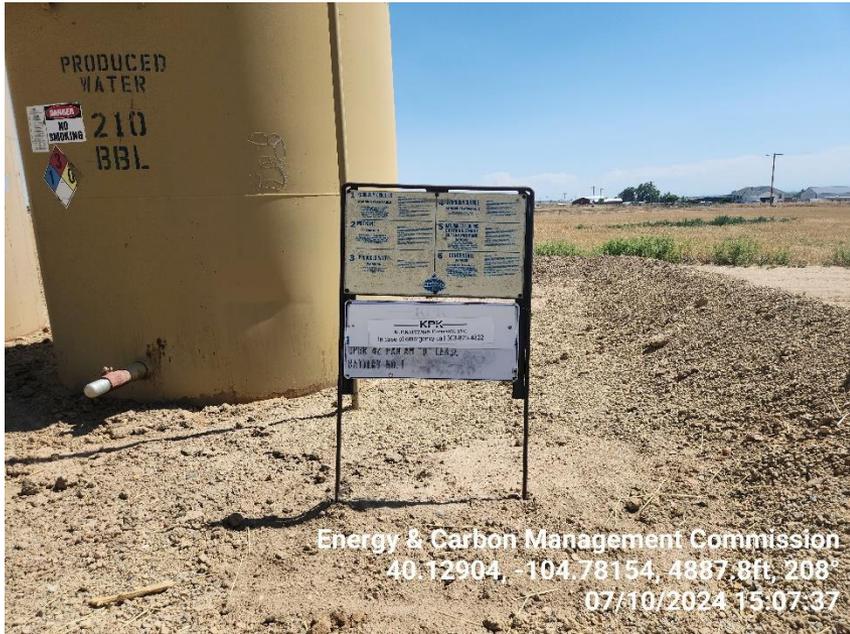
Photo 7 Tank Battery sign.

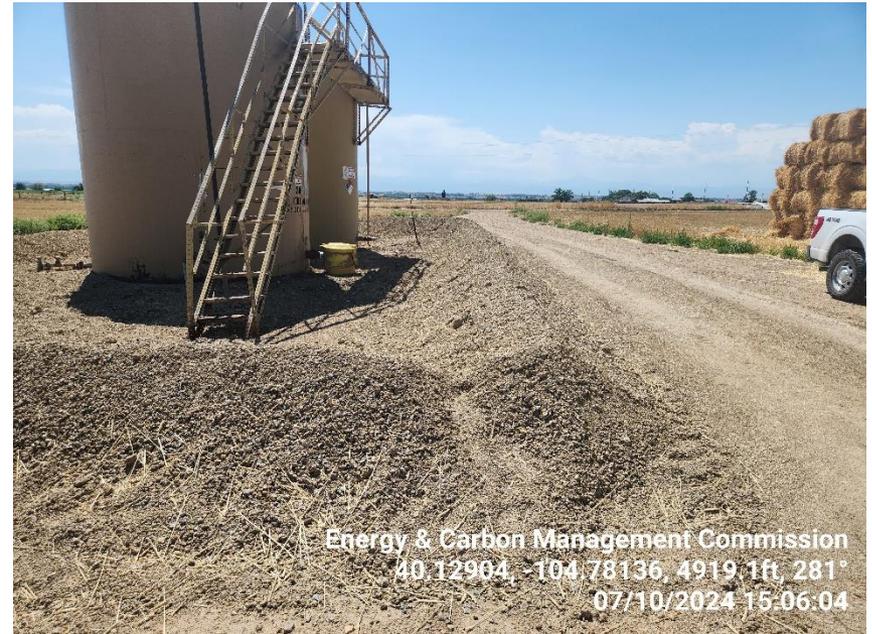
Photo 8 Unlined gravel berm around the tank battery not in compliance with Rule 603.o.

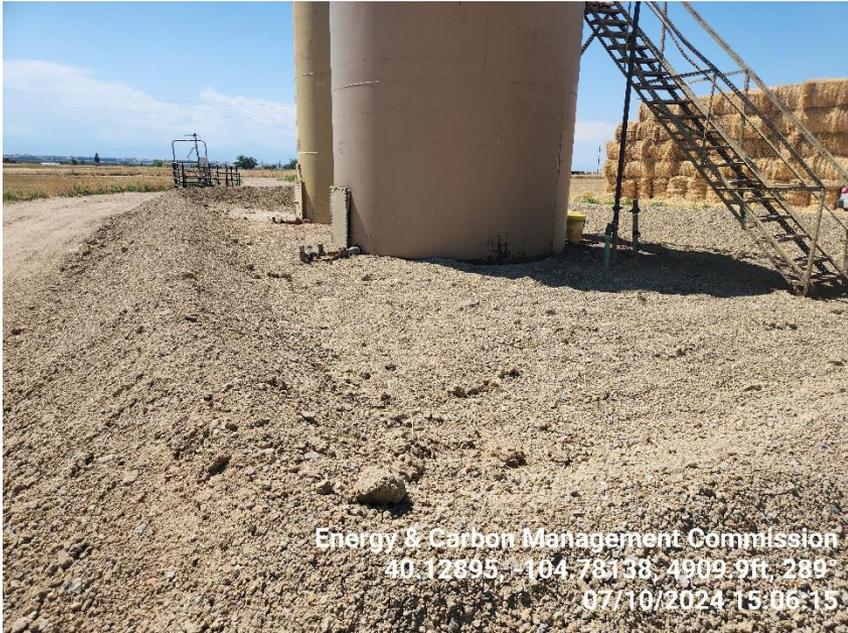
Photo 9 Unlined gravel berm around the tank battery not in compliance with Rule 603.o.

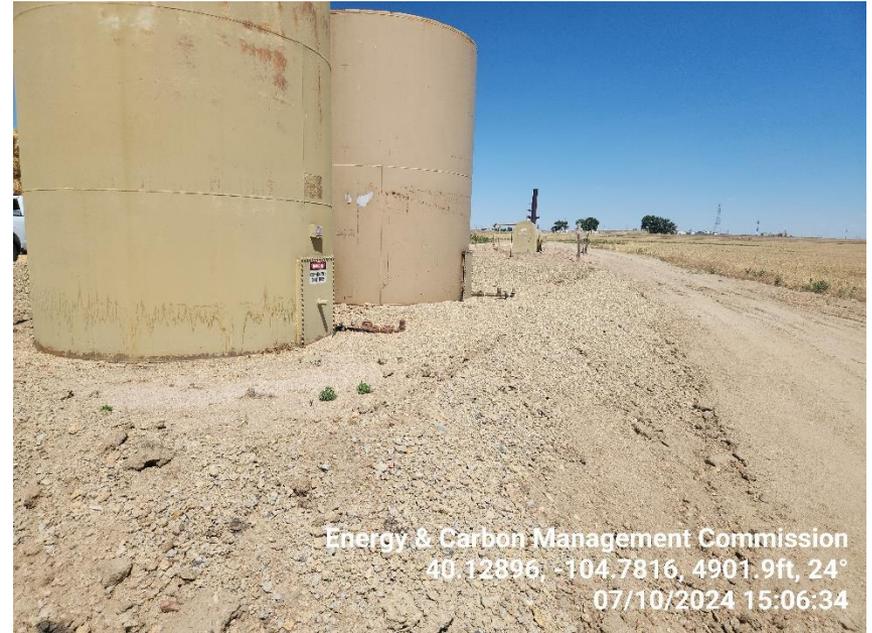
Photo 10 Unlined gravel berm around the tank battery not in compliance with Rule 603.o.

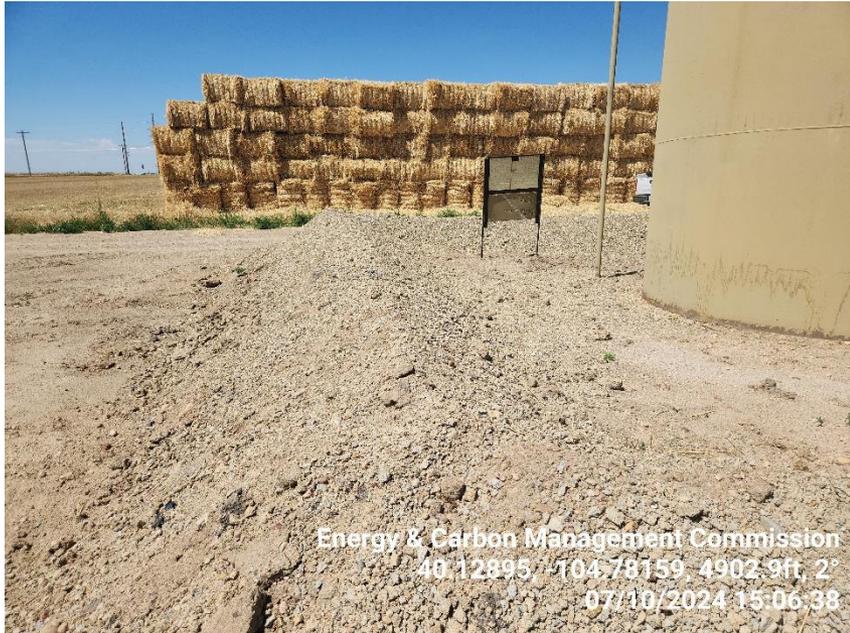
Photo 11 Unlined gravel berm around the tank battery not in compliance with Rule 603.o.

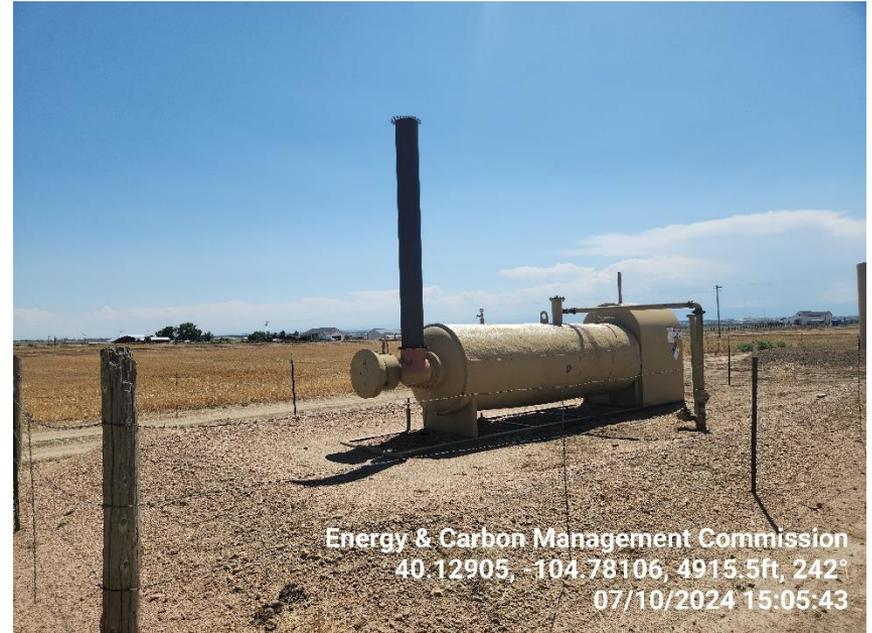
Photo 12 Horizontal heated separator.

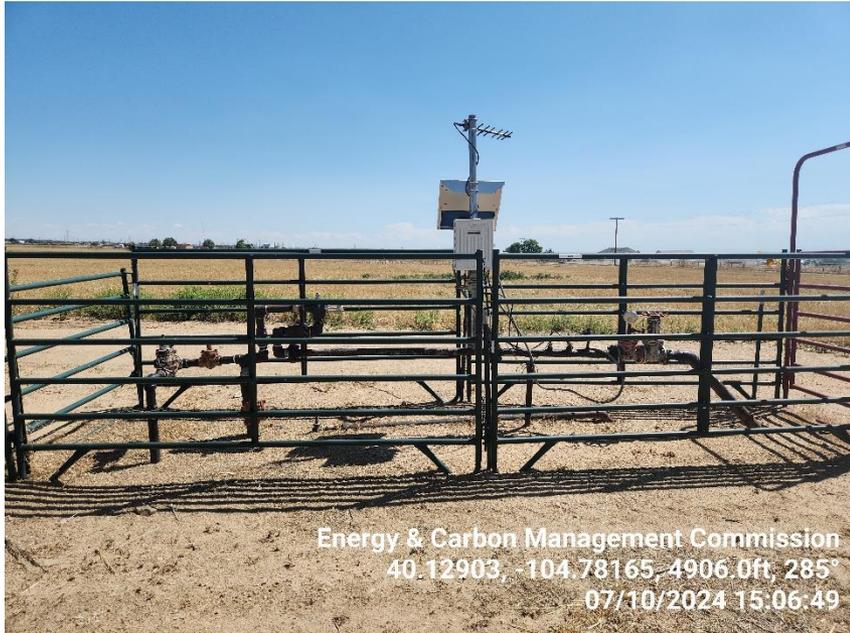
Photo 13 Gas Meter Run.
