Inspection Photos

Loc: 324494

Operator: **OXY USA INC**

Inspection Date: 7/9/2024

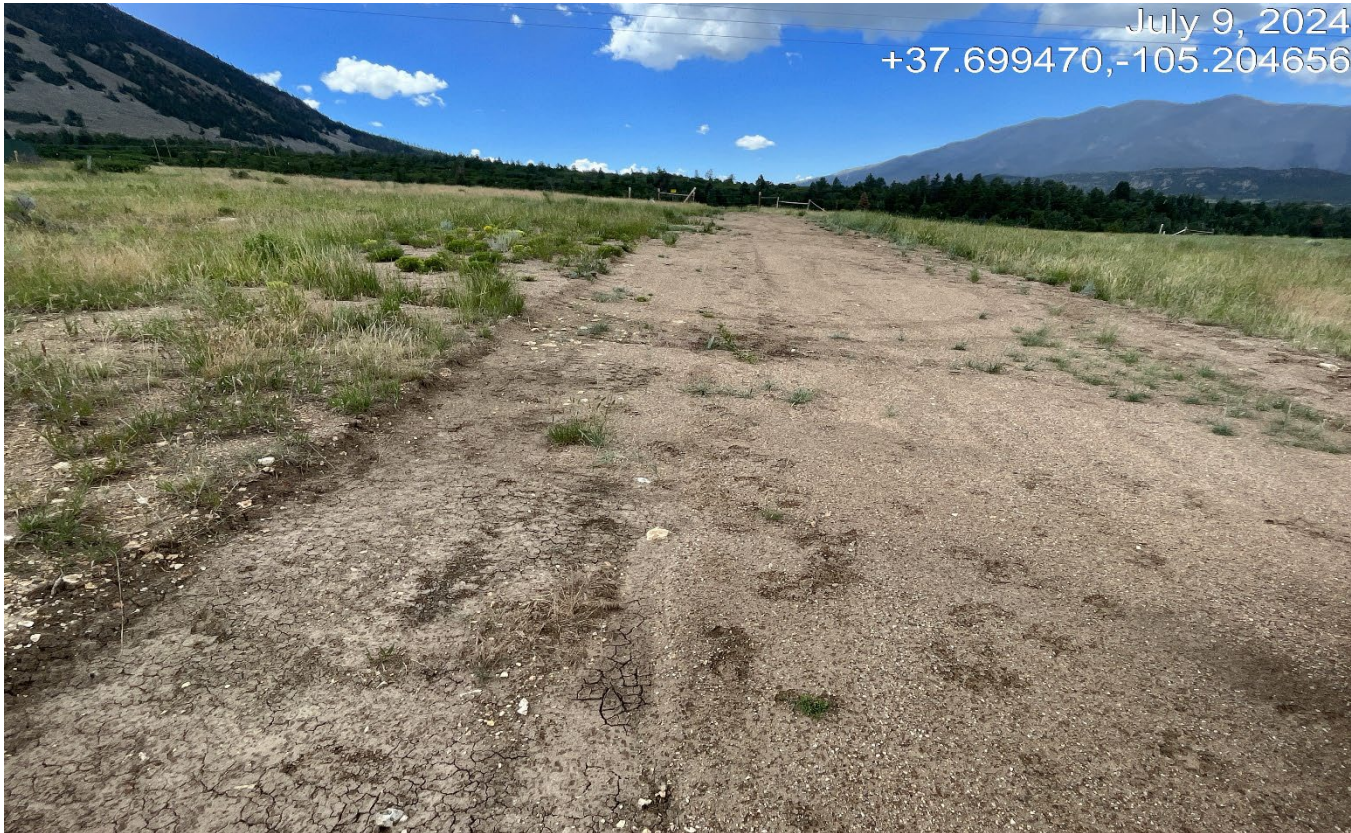
Photo 1. Facing south toward the access road.. The access road will need to be decompacted and reclaimed. Previous corrective action has not been completed.

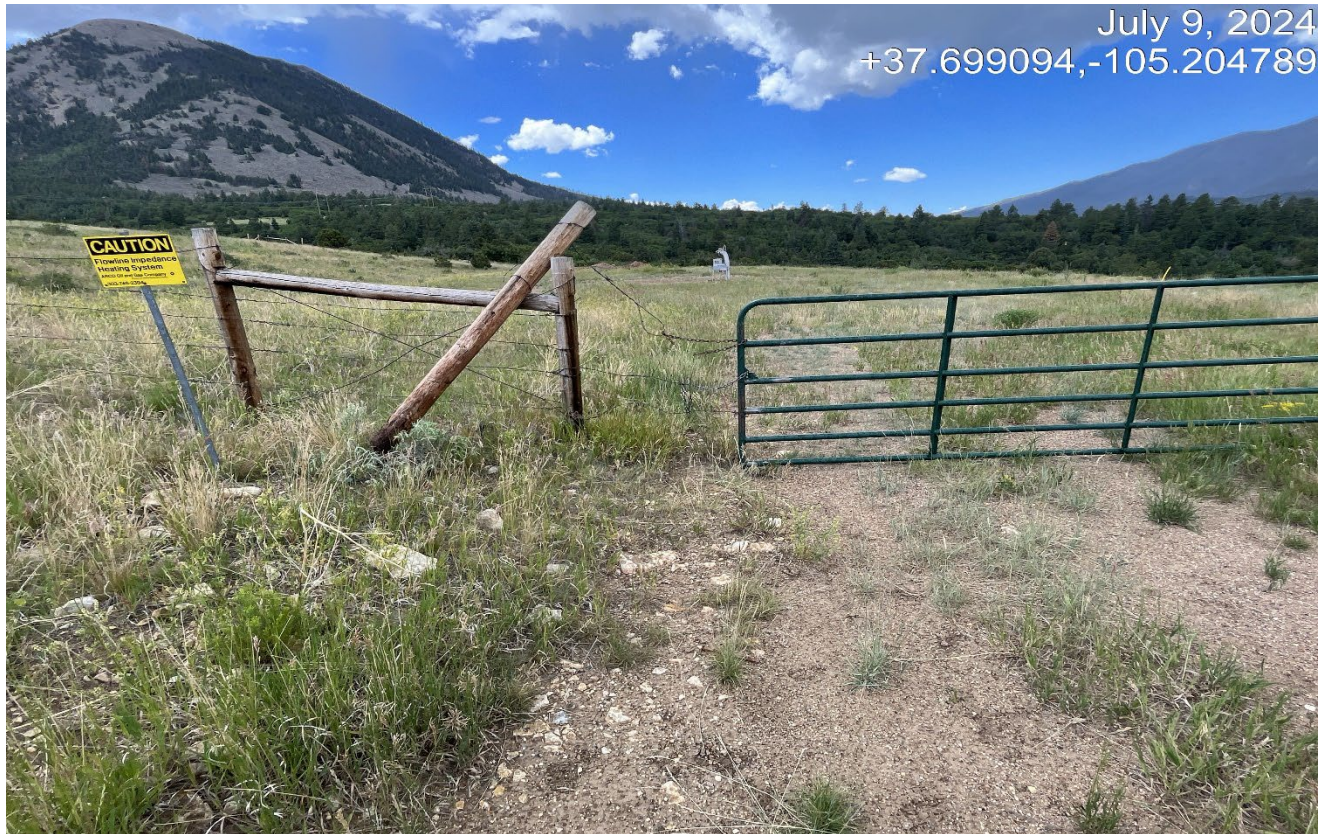
Photo 2. Facing south toward the location. The well has been plugged and abandoned . The location will must be reontoured back to the original contours and reclaimed. This gate does not prevent livestock entry.

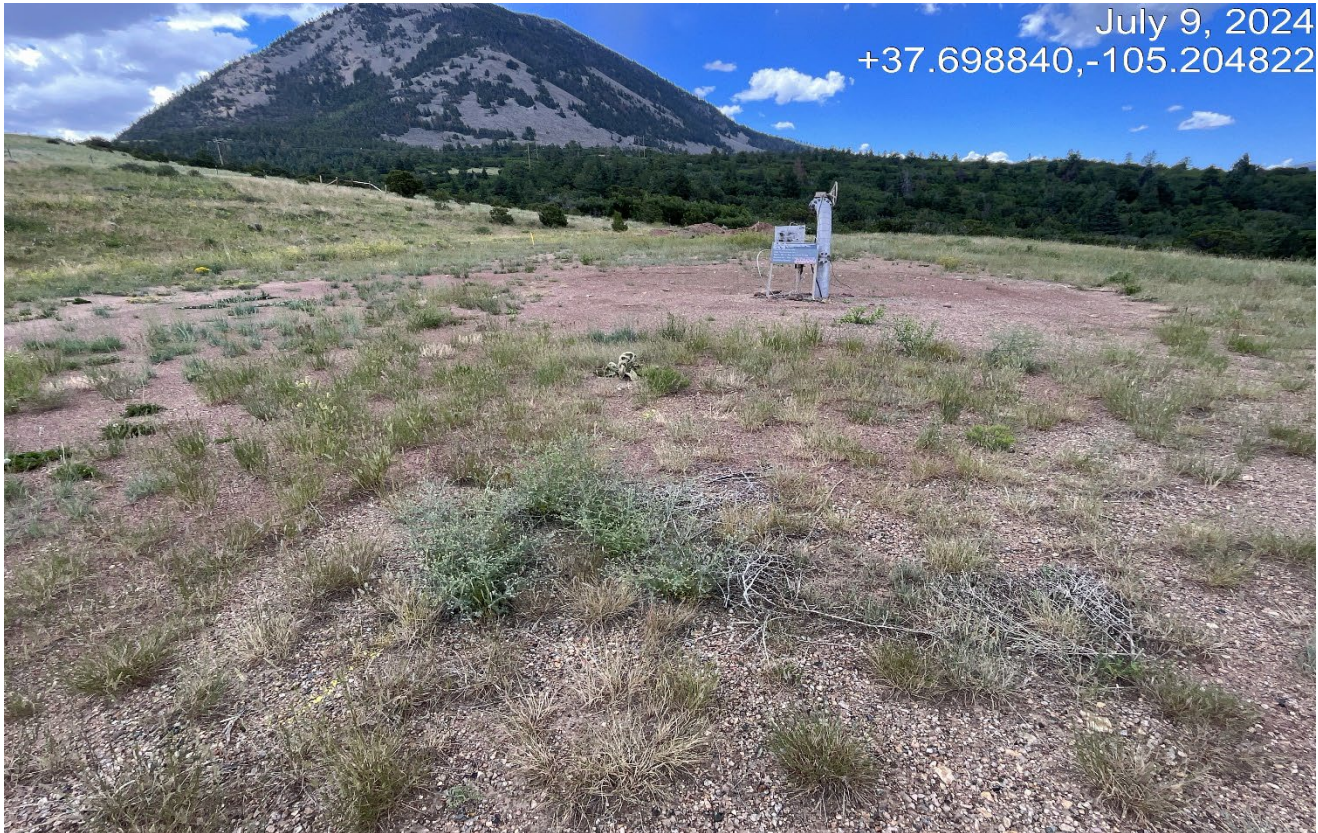
Photo 3. Facing toward the wellsite. There is pipe riser that still remains on the location that must be removed per 1004 Rules.

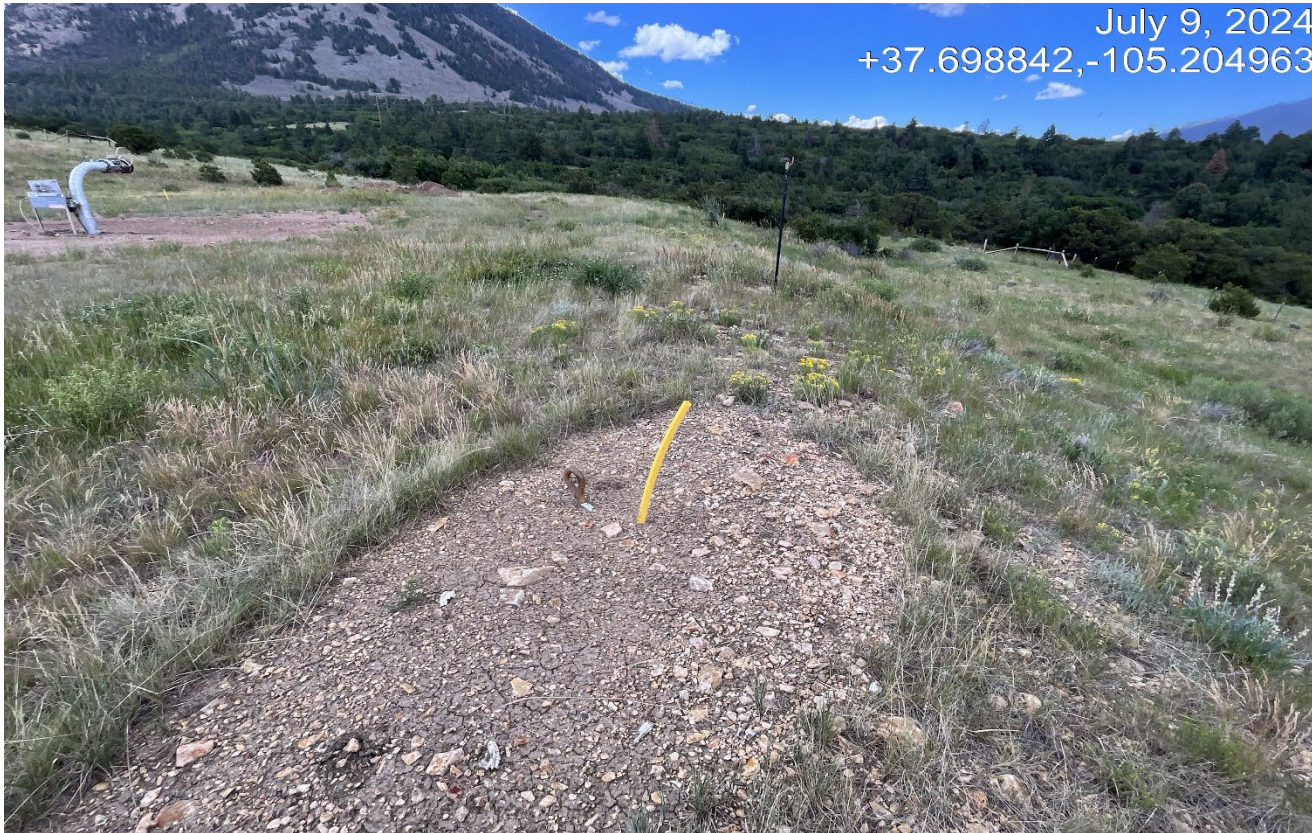
Photo 4. Facing south toward the fill slope which must be recontoured back to the original condition. The four guyline anchors need to be removed along with the pipe riser shown in this photo.

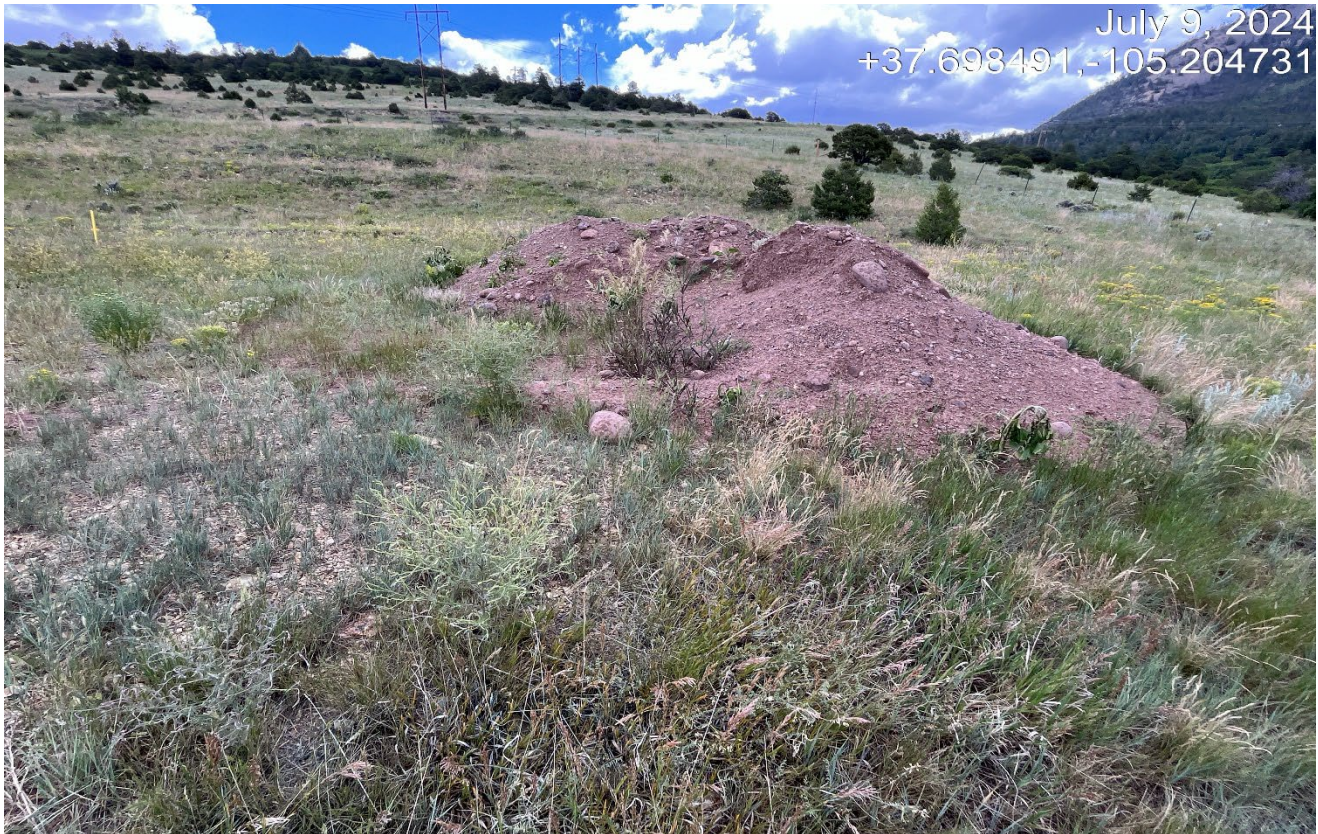
Photo 5. There is a pile of roadbase that remains at the south side of the location that must be removed.

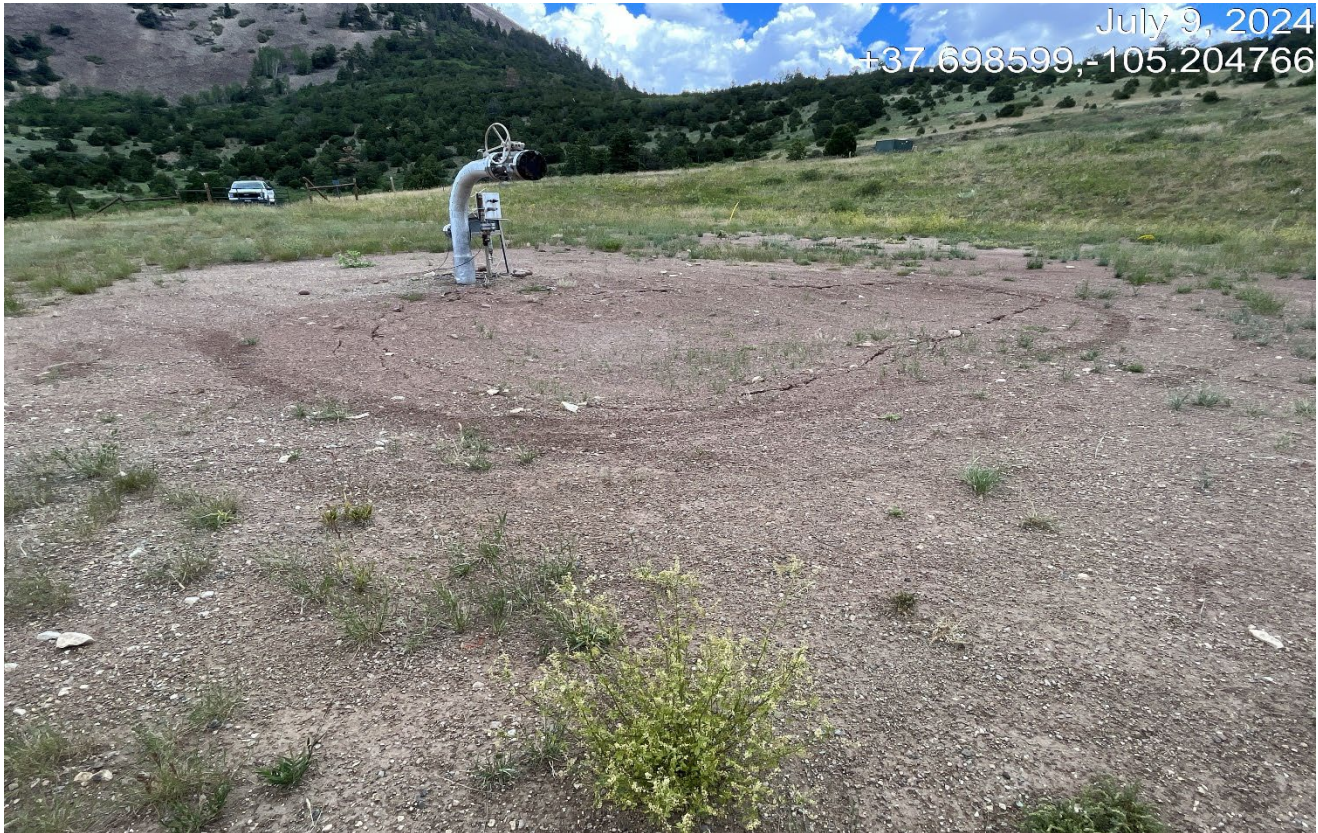
Photo 6. Facing toward the abandoned well which was cut and capped. The remaining pipe riser must be removed.
