# Inspection Photos

Loc: 334553

Operator: OXY USA INC

Inspection Date: 7/9/2024

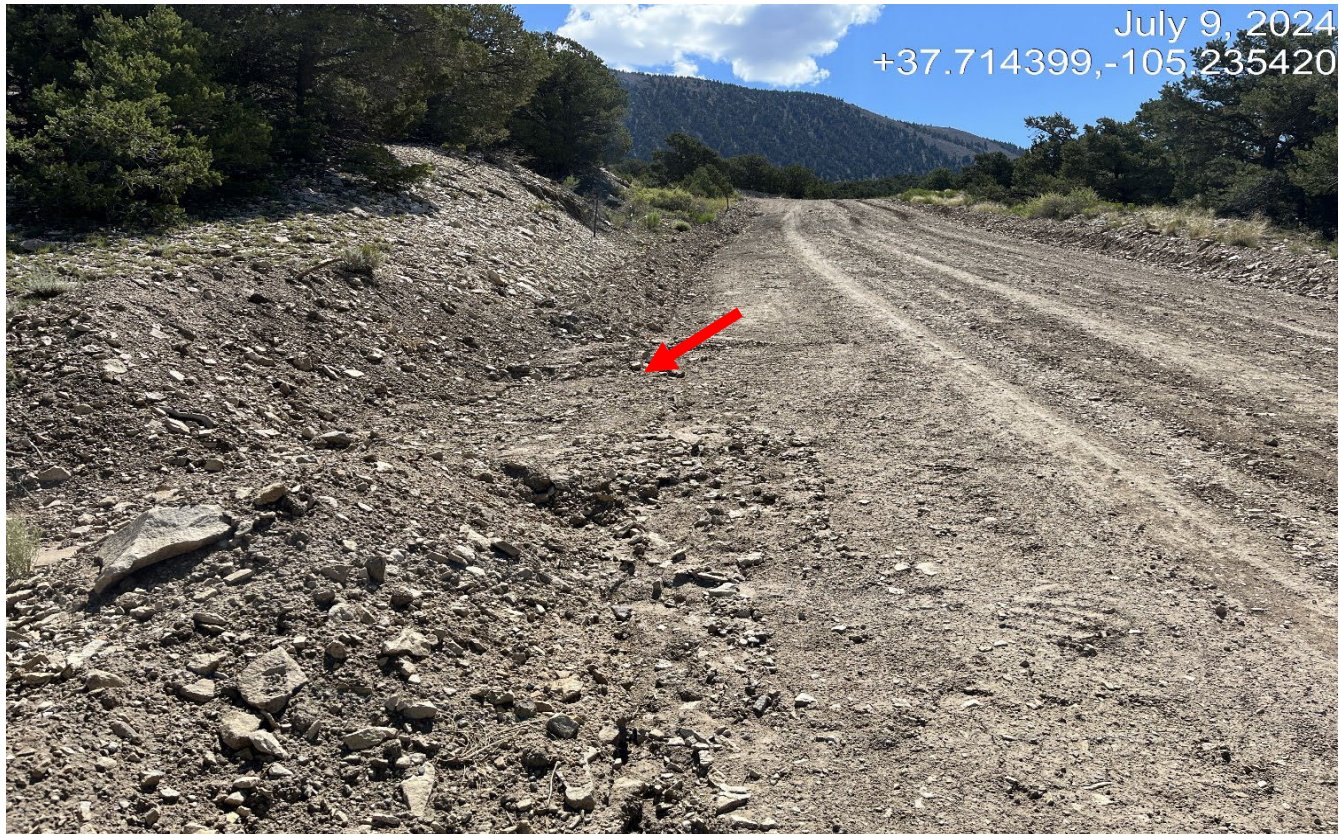
**Photo 1.** Facing east along the access road. Grading has been performed to allow drainage off the road.

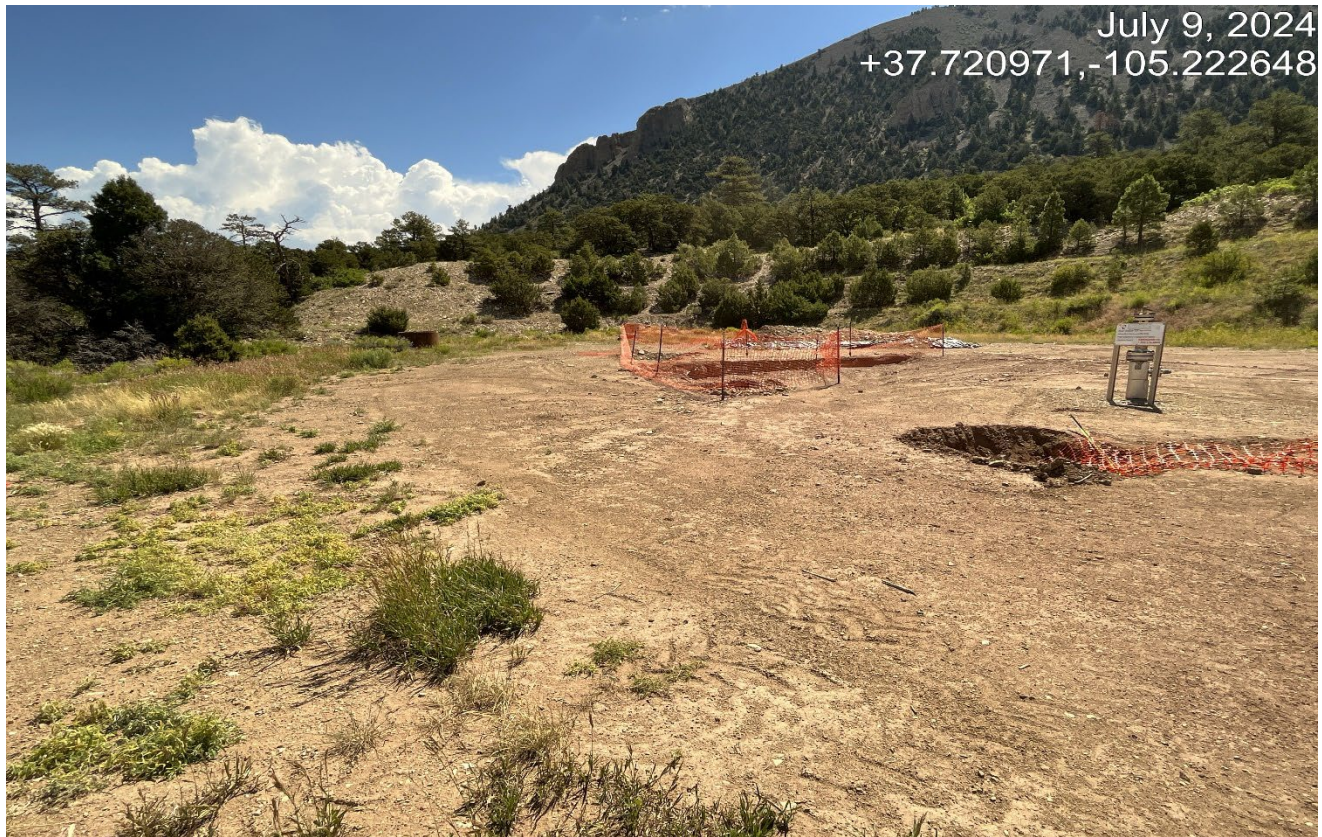
**Photo 2.** Facing northeast toward the wellsite.

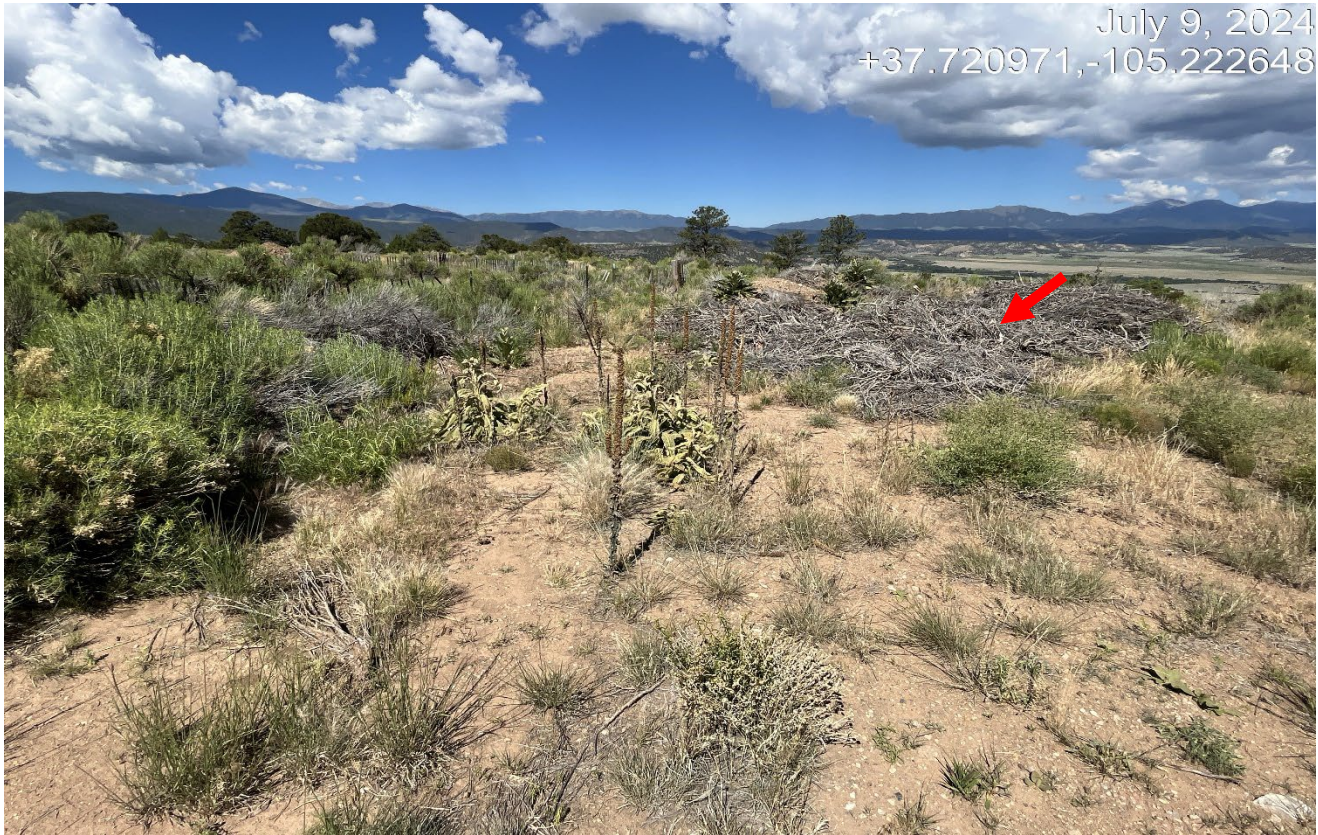
**Photo 3.** Facing northwest at the location. There is a pile of brush debris that was pushed to this area that must be removed. Previous corrective action was not completed.

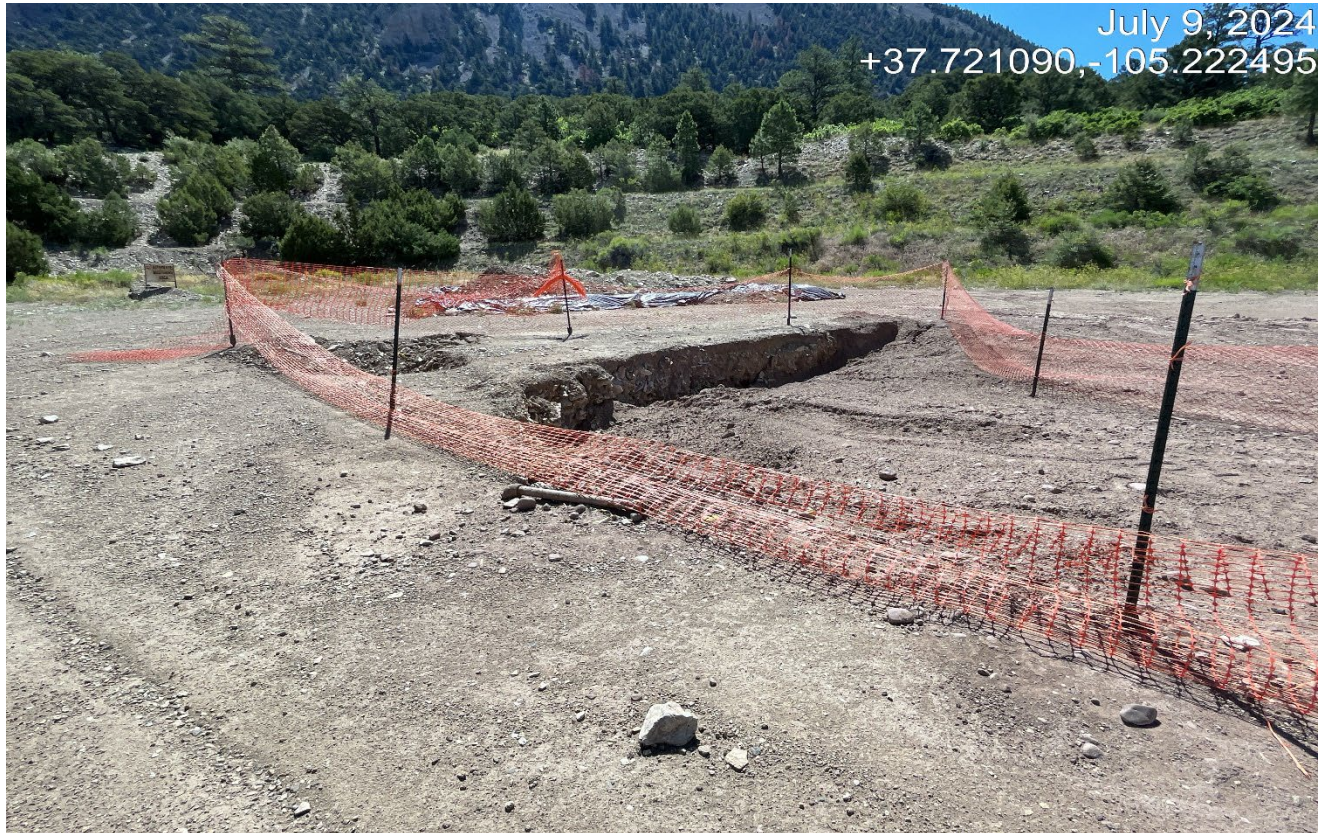
**Photo 4.** Facing toward the abandoned wellhead which has been backfilled with road base material.

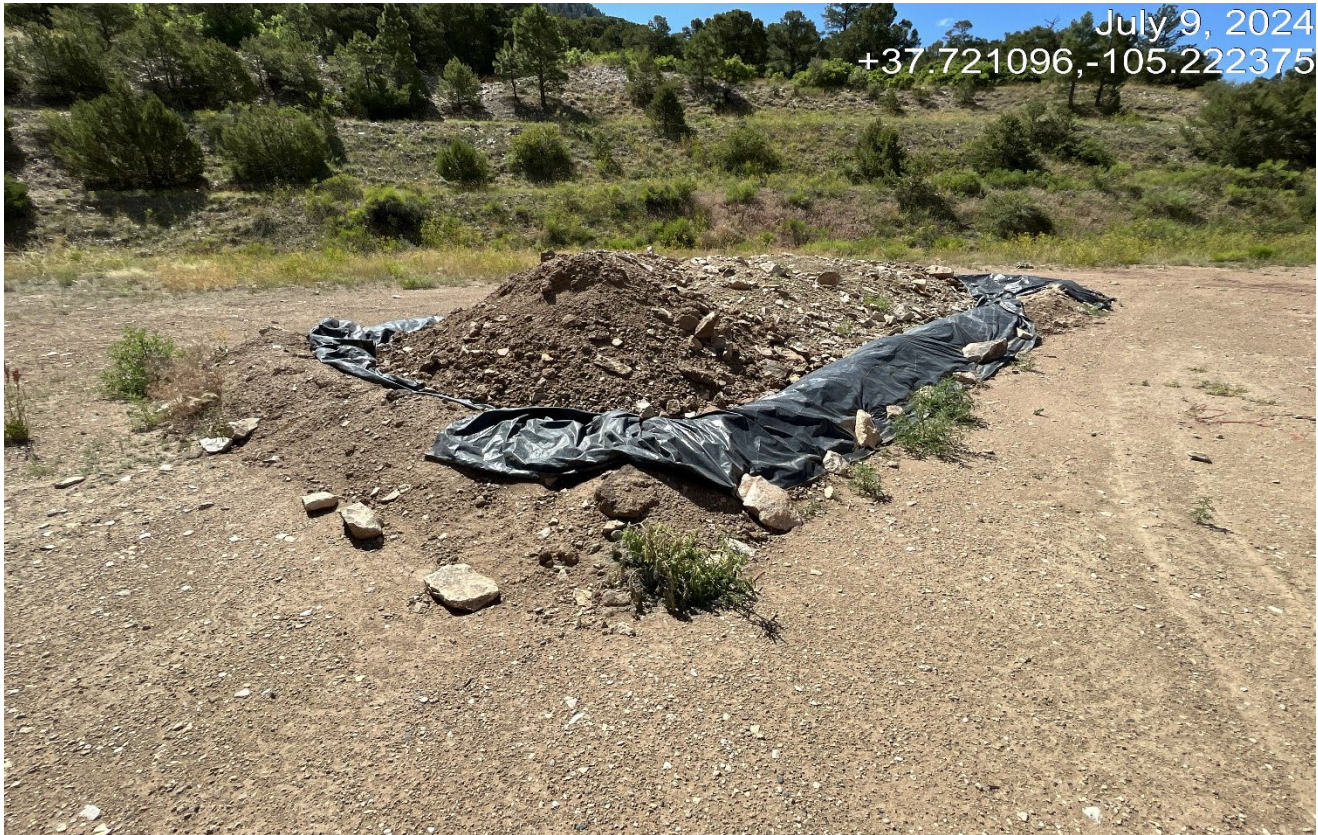
**Photo 5.** The plastic liner is compromised and impacted soil needs to be removed.
