Inspection Photos

API: 055-06037

Operator: OXY USA INC

Inspection Date: 7/9/2024

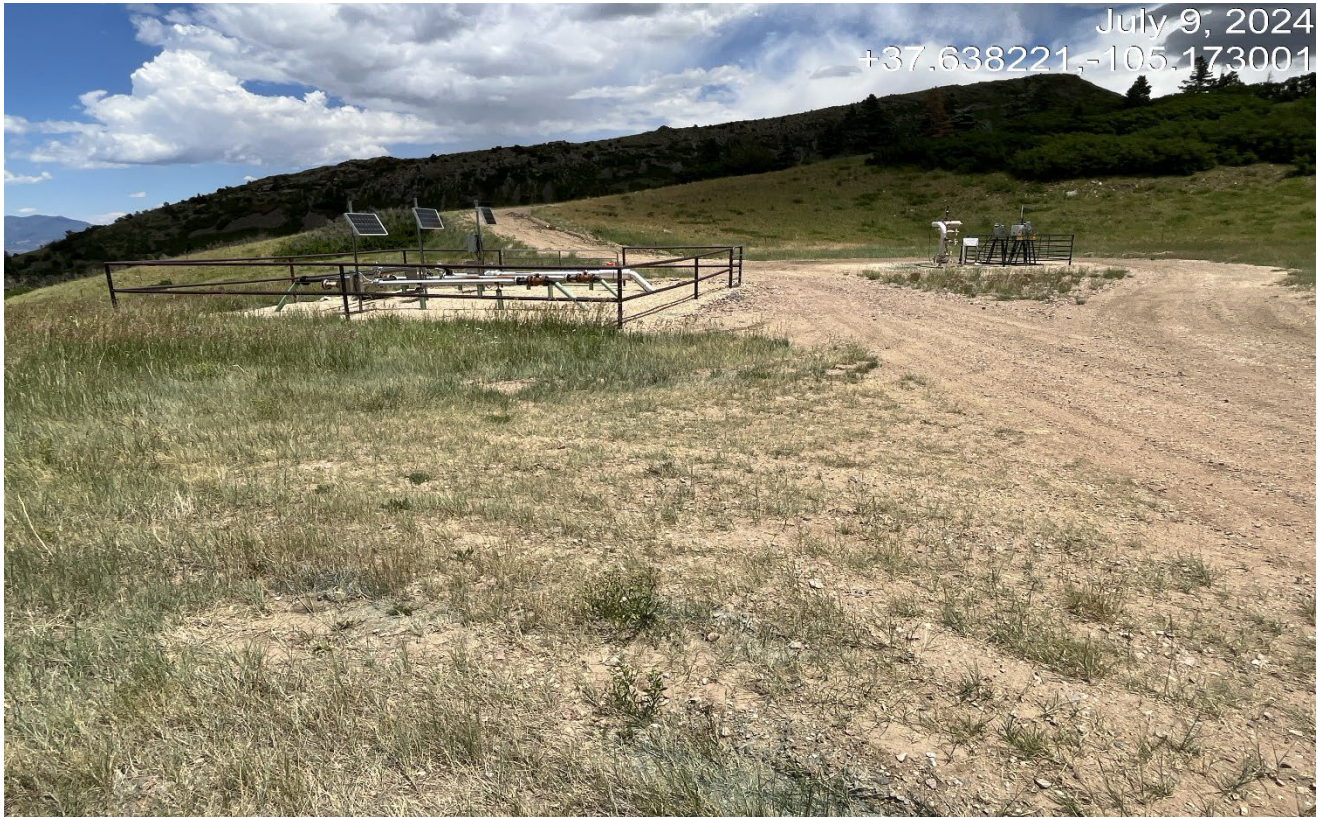
Photo 1. Facing east toward the wellsite.

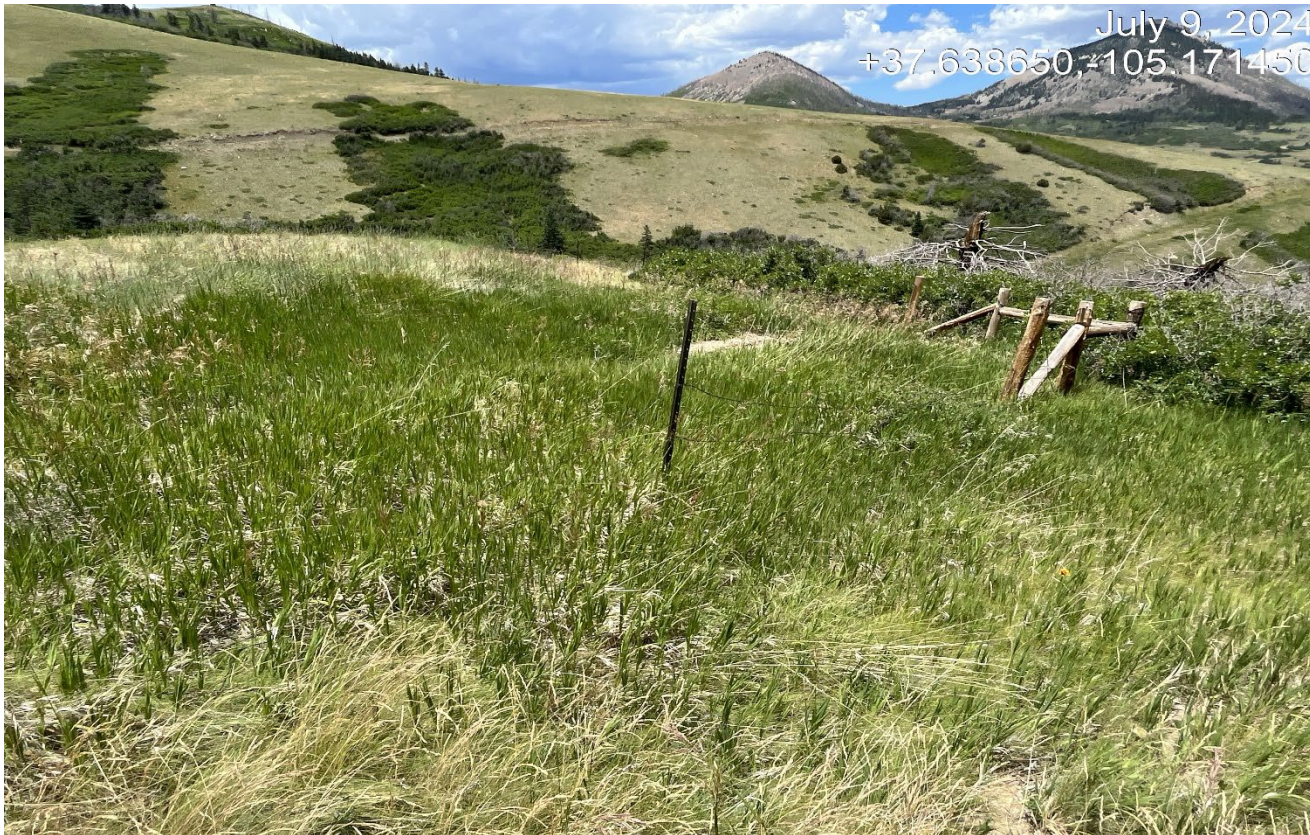
Photo 2. The perimeter fence around the location is not maintained and there is wire laying on the ground.

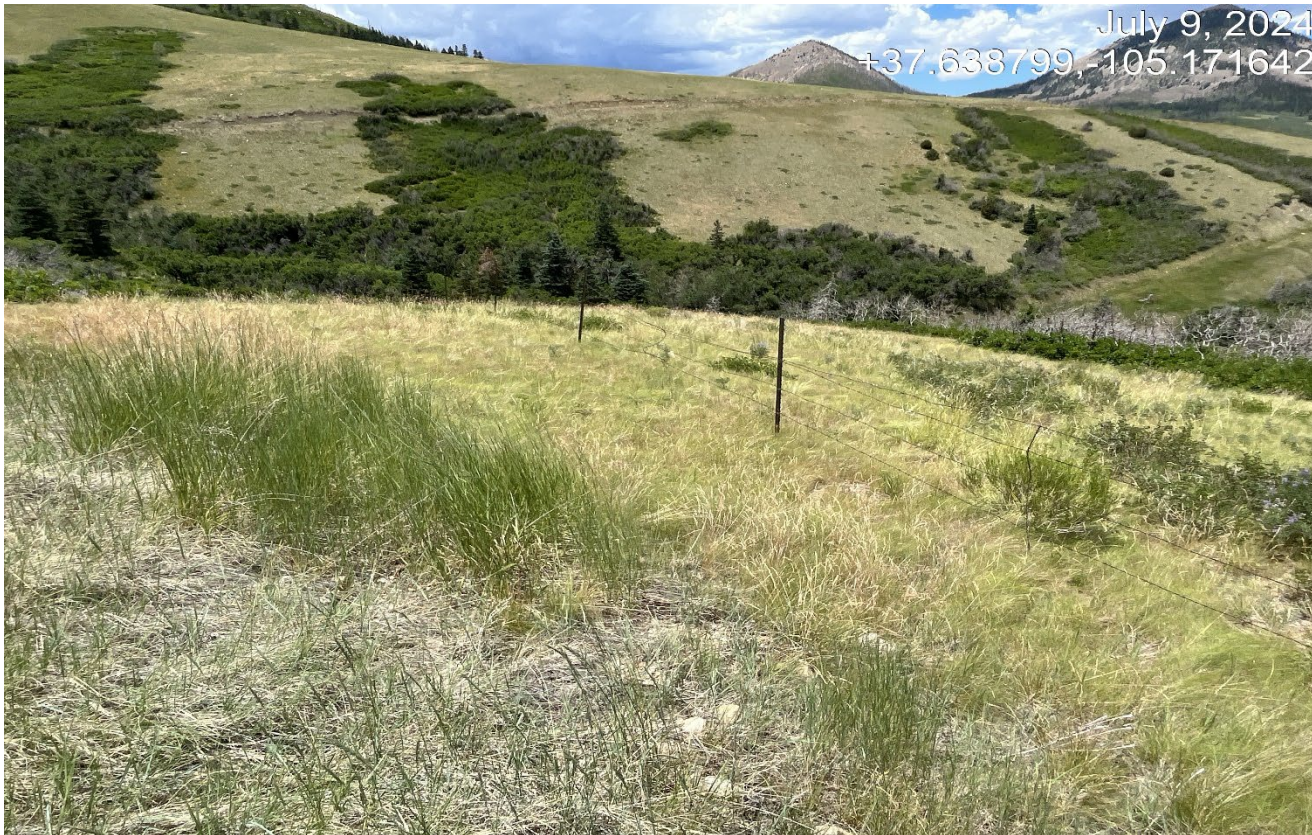
Photo 3. The perimeter fence around the location is not maintained. Previous corrective action was not completed.
