Inspection Photos

API: 055-06316

Operator: OXY USA INC

Inspection Date: 7/9/2024

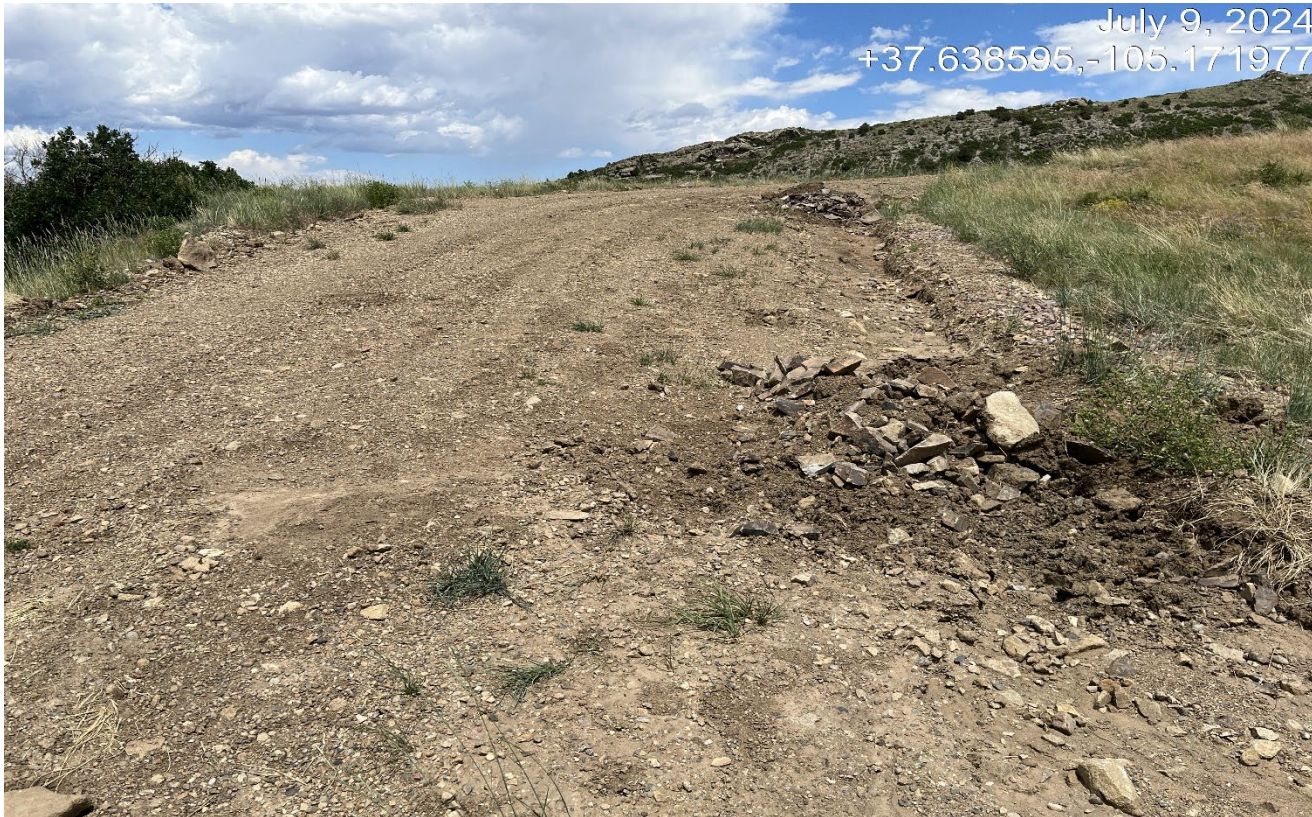
Photo 1. Facing east along the access road. There is rock and soil pushed up along the road side. This is not an adequate stormwater control.

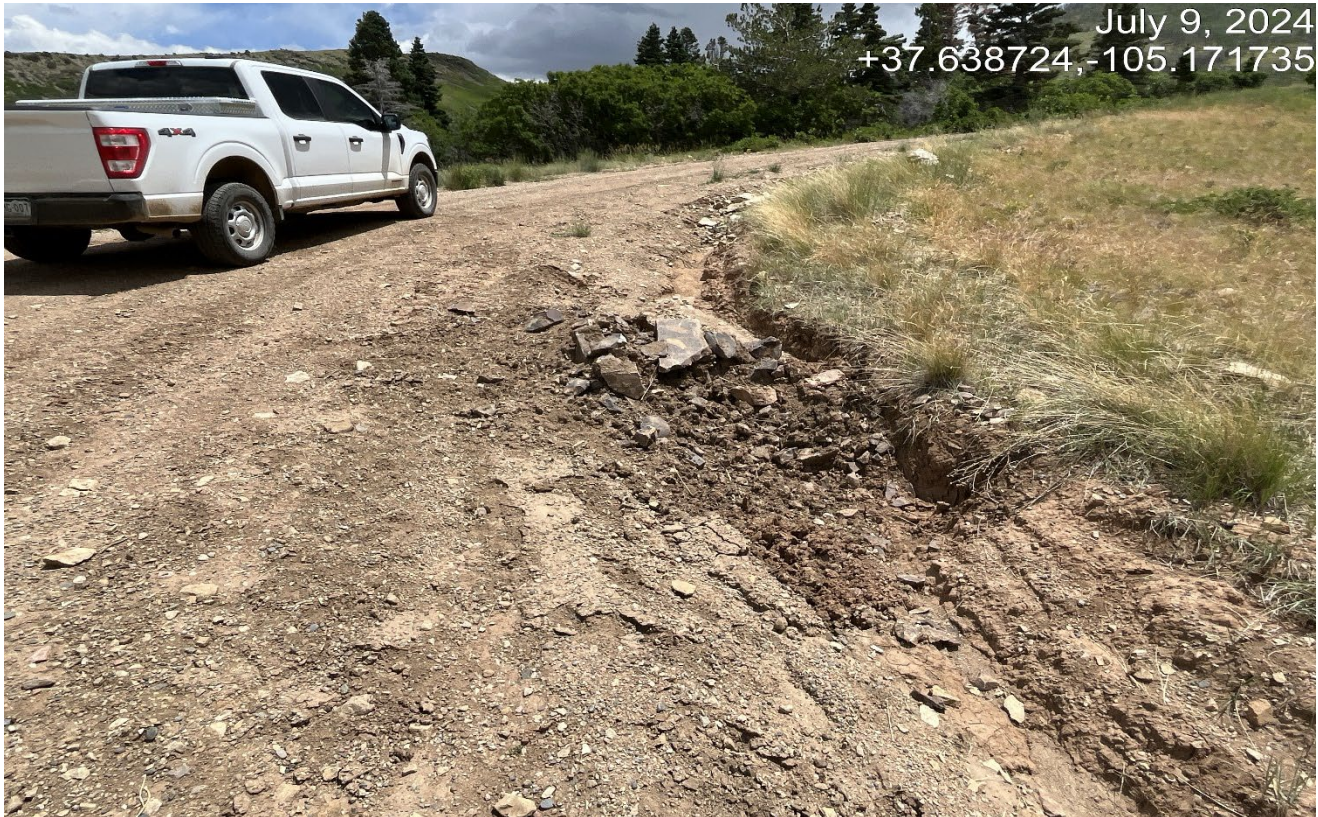
Photo 2. Facing southeast along the access road. There is rock and soil pushed up along the road side. This is not an adequate stormwater control.

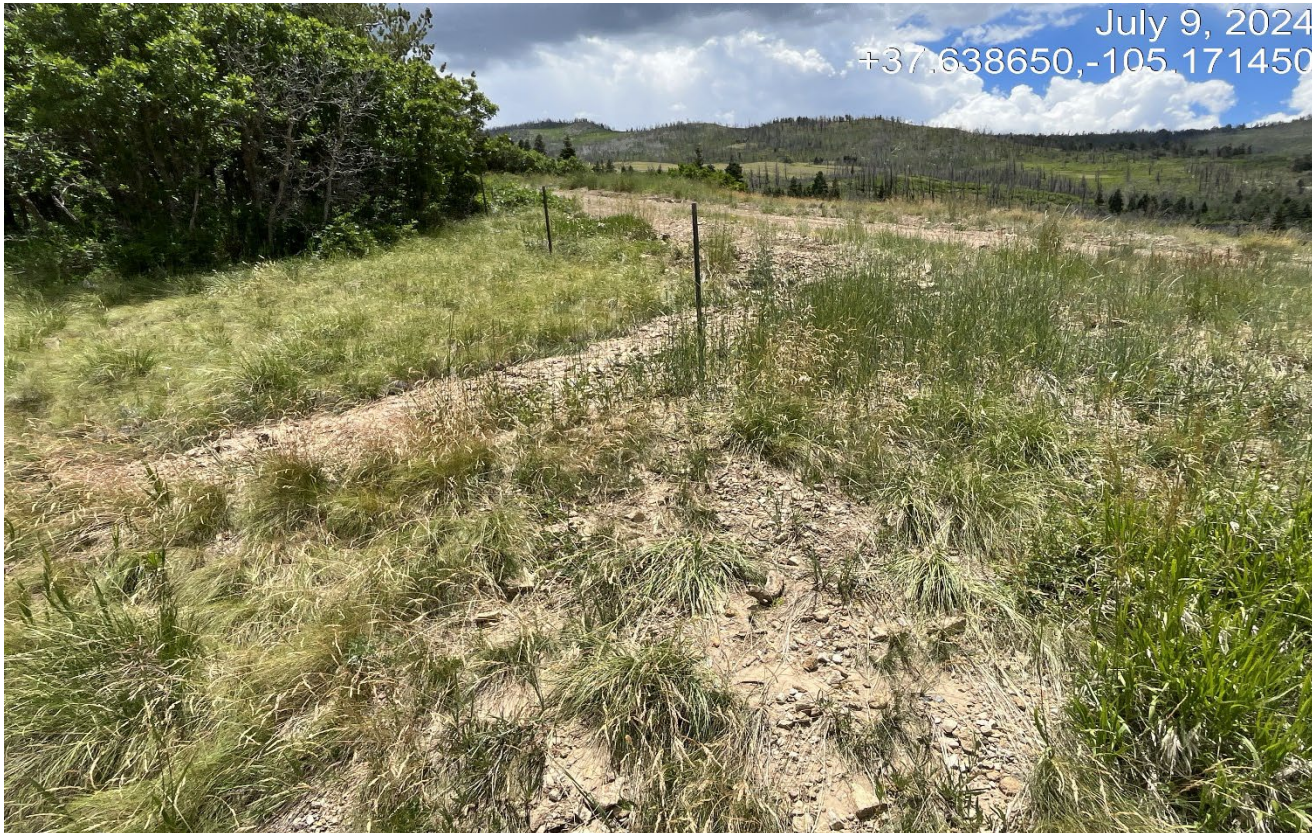
Photo 3. There is sediment that has been transported offsite along the road. A BMP such as a sediment trap should be installed to control erosion.

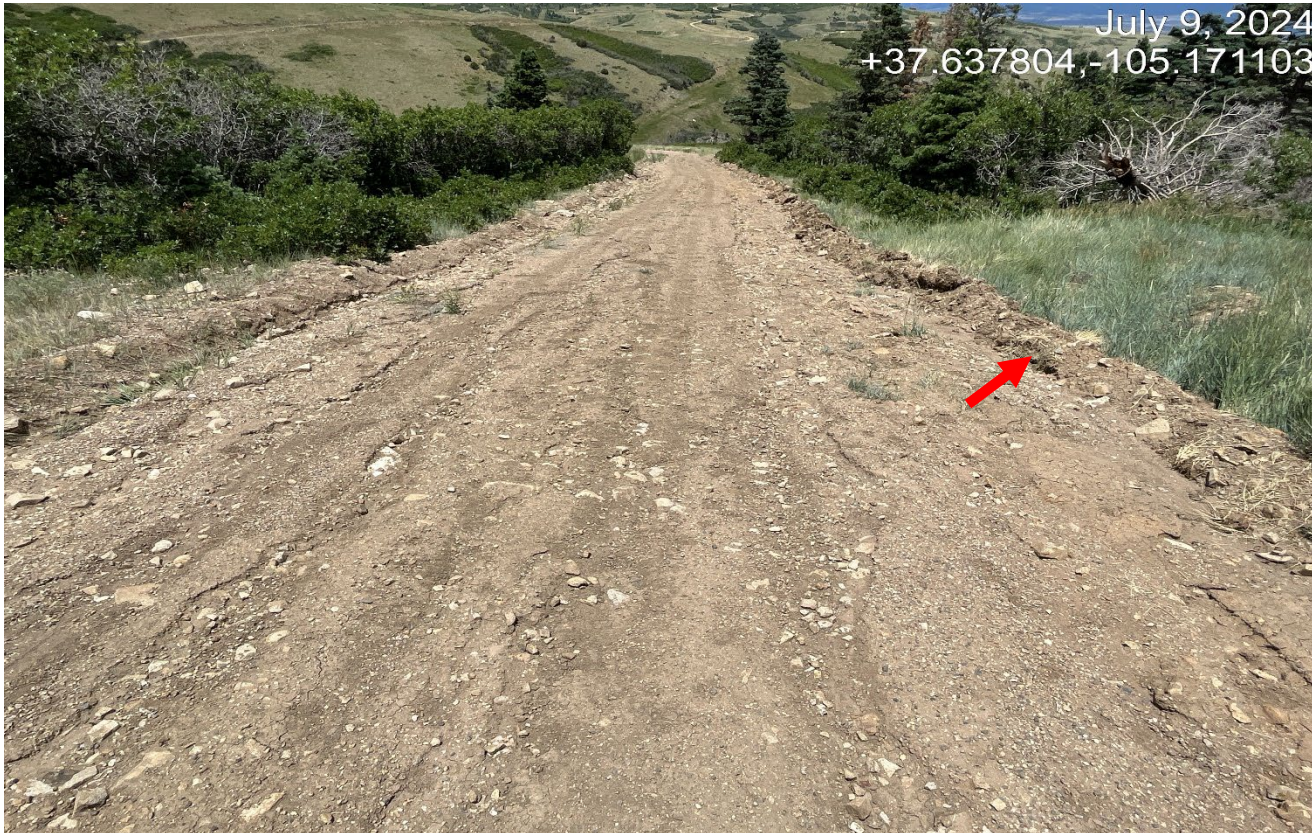
Photo 4. Facing back north the steep grade of access road. Stormwater is not being diverted off the road which is causing erosion of the road. Stormwater should be divert toward red arrow and into a sediment trap.

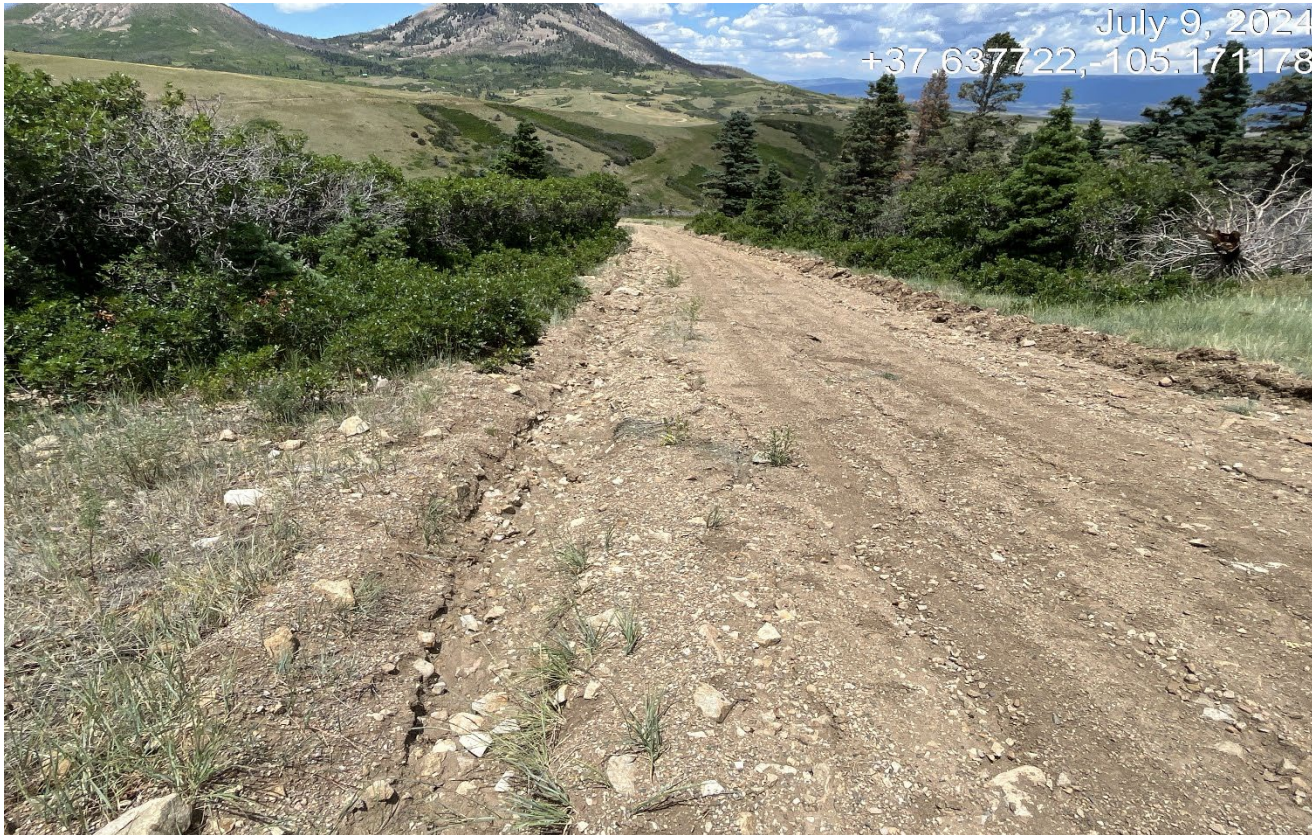
Photo 5. Facing north along the steep grade of access road. Stormwater is directed all the way down this road and there are no BMP's for sediment control.

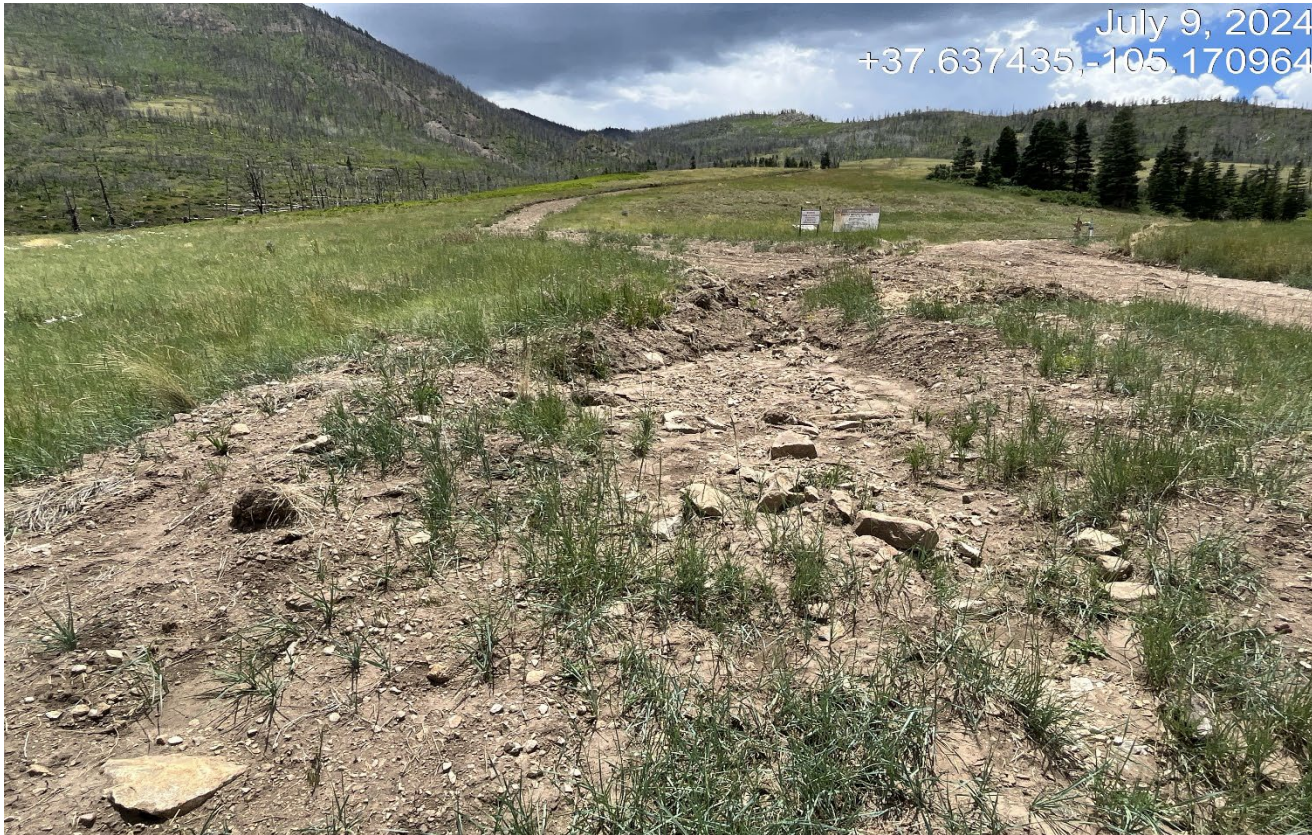
Photo 6. Facing southwest along the access road near the SMU #1-12-B . Sediment has been deposited and pushed off the road into this area creating additional disturbance.
