Inspection Photos
Location: State 3-8
Location ID: 314181
API # 05-099-06131

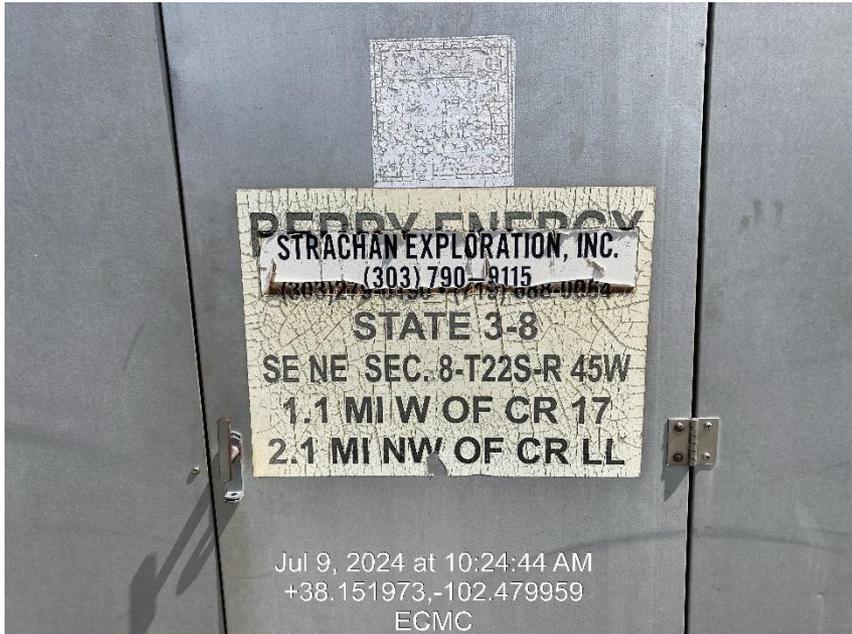
Photo 1 –Well Placard on meter house for State 3-8

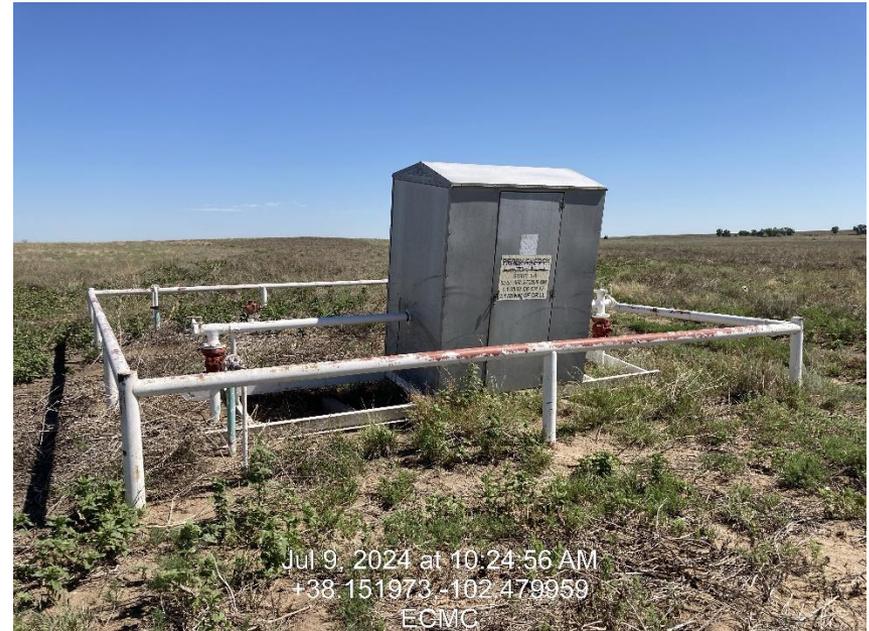
Photo 2 – Meter house for State 3-8

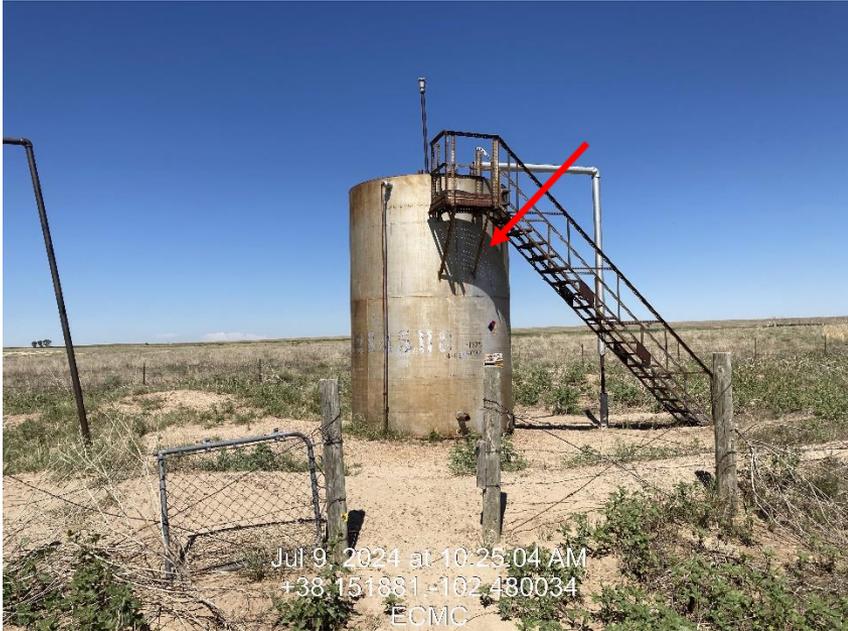
Photo 3 – Tank Battery

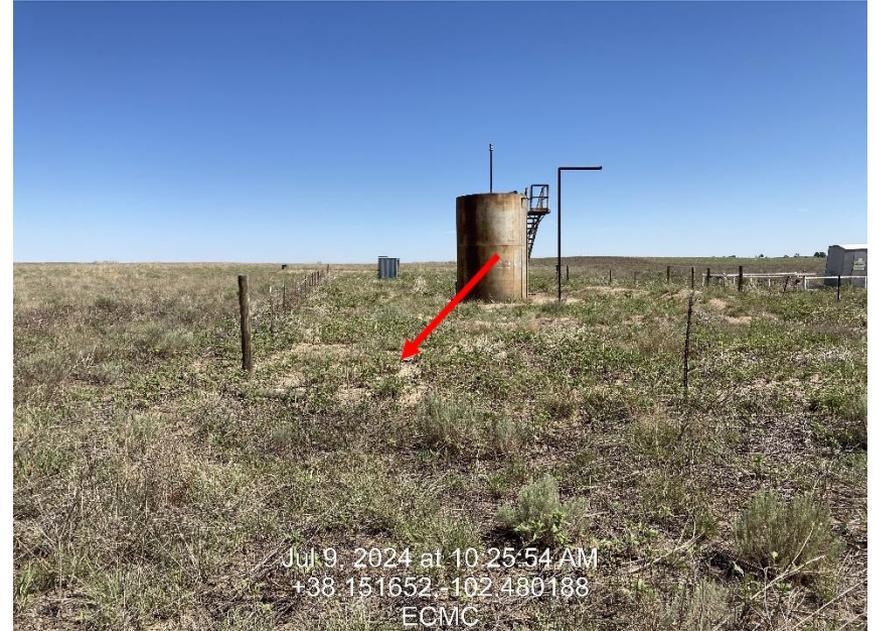
Photo 4 – Tank Battery fencing not adequately maintained

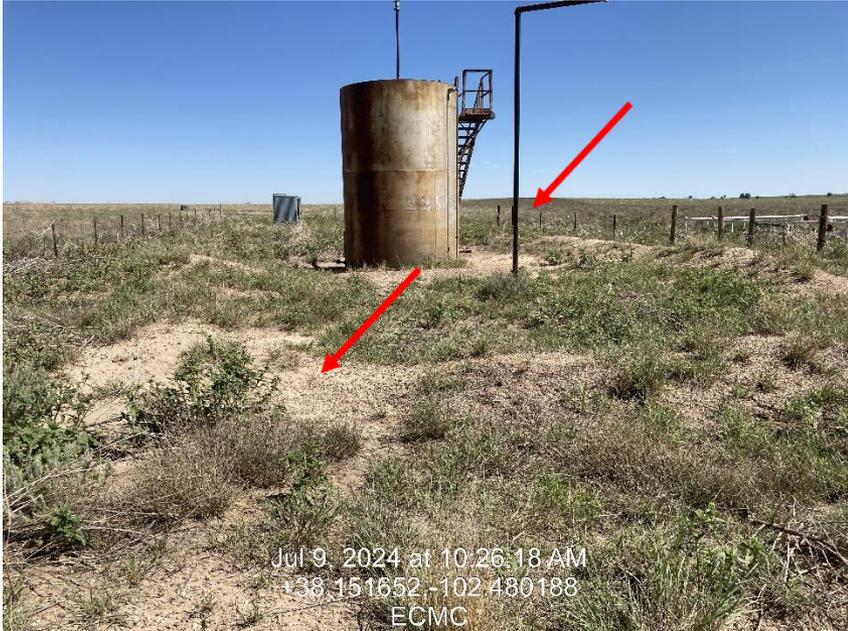
Photo 5 – Unused piping in secondary containment for Tank Battery/ Secondary containment not adequate

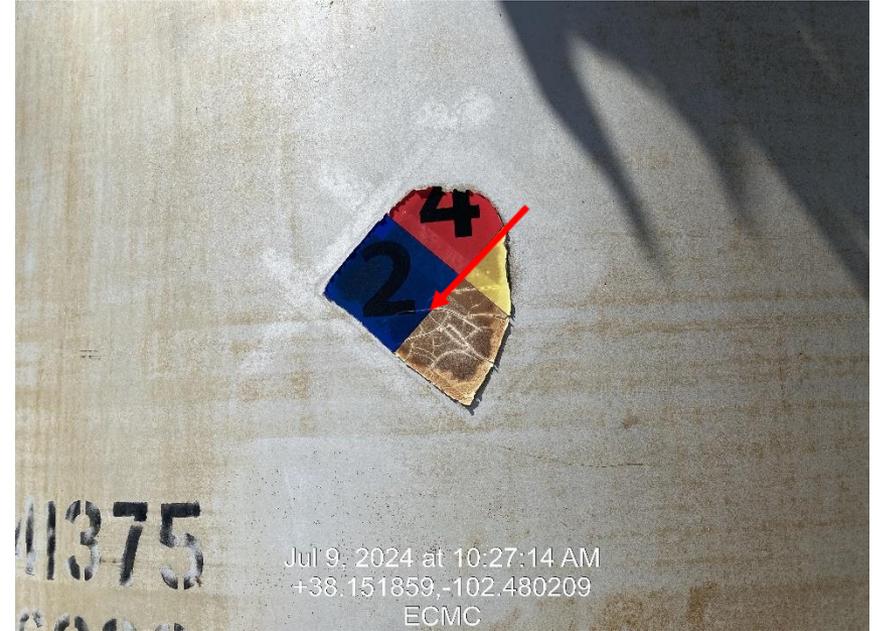
Photo 6 – Placard is illegible

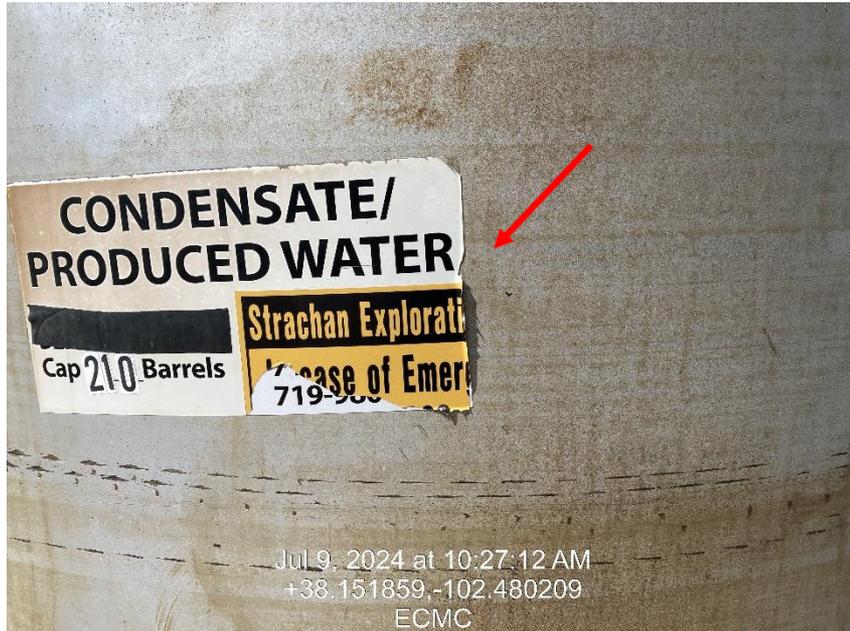
Photo 7 – Emergency Contact number illegible

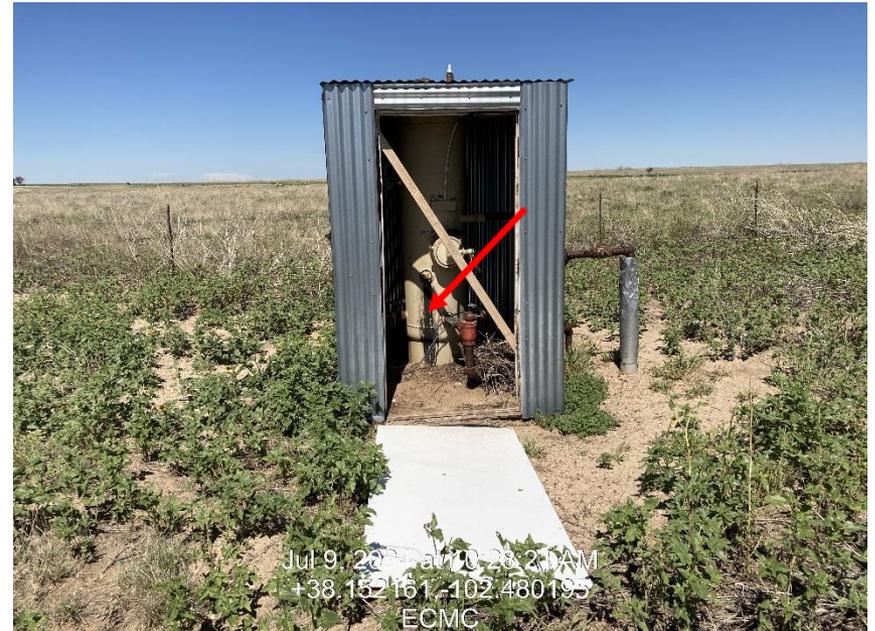
Photo 8 – Door to separator house not attached to building

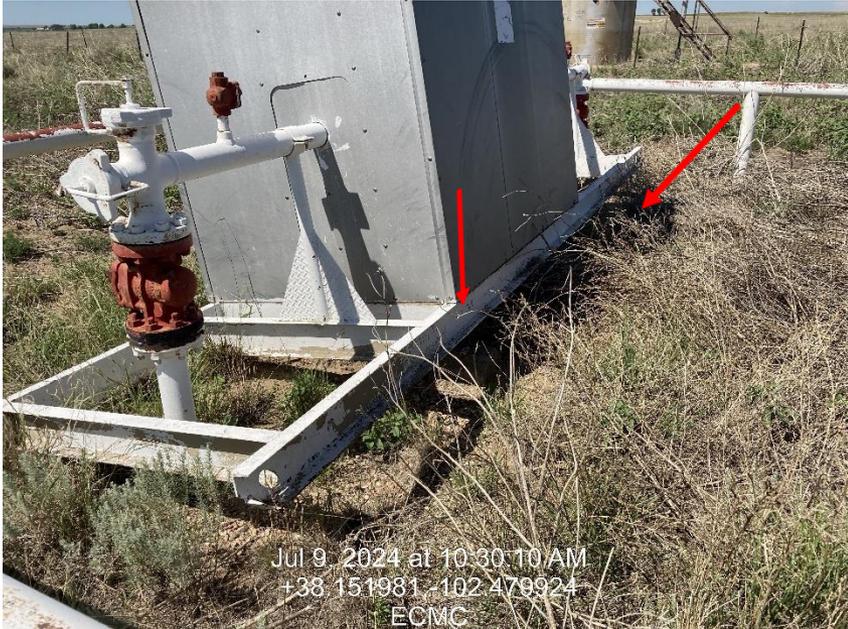
Photo 9 – Meter house leaning

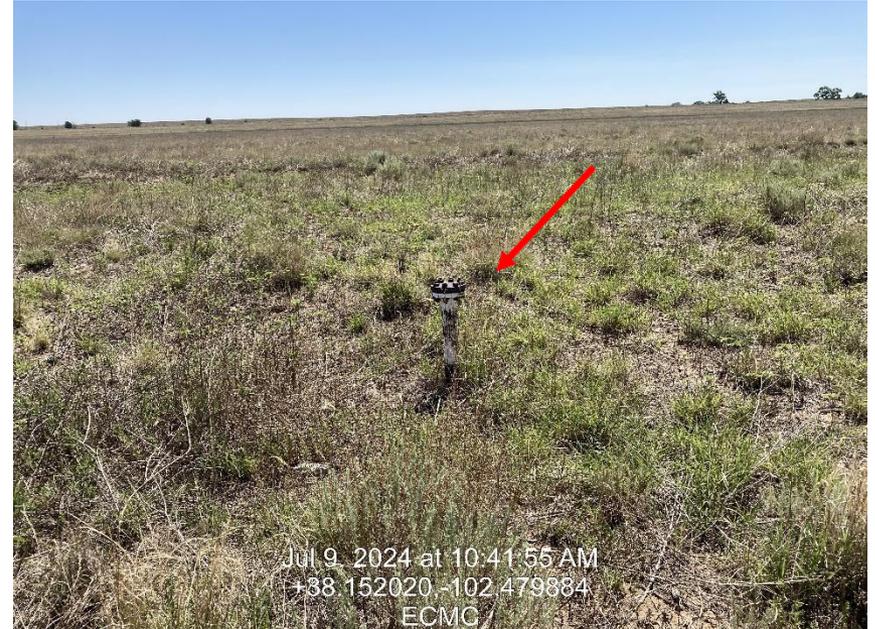
Photo 10 – Unused undefined piping

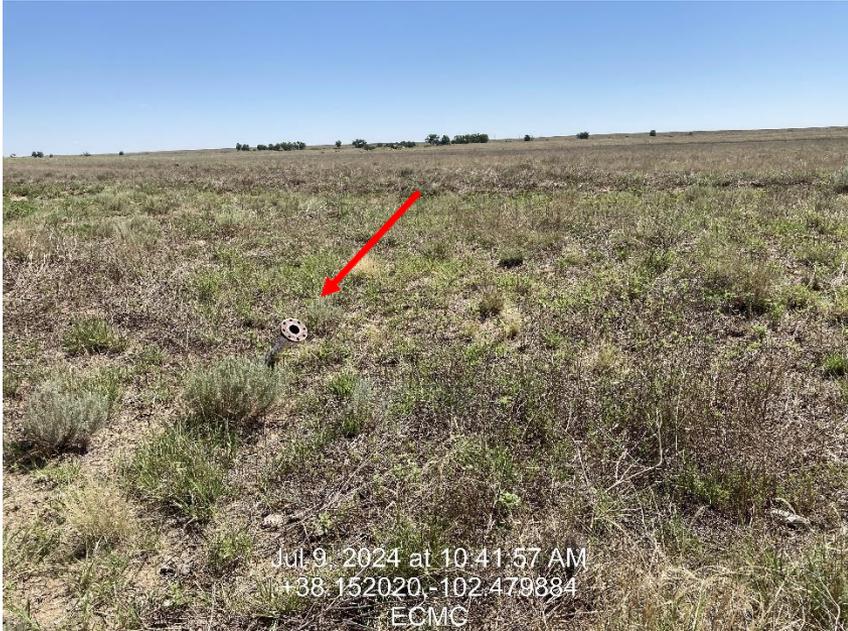
Photo 11 – Unused undefined piping

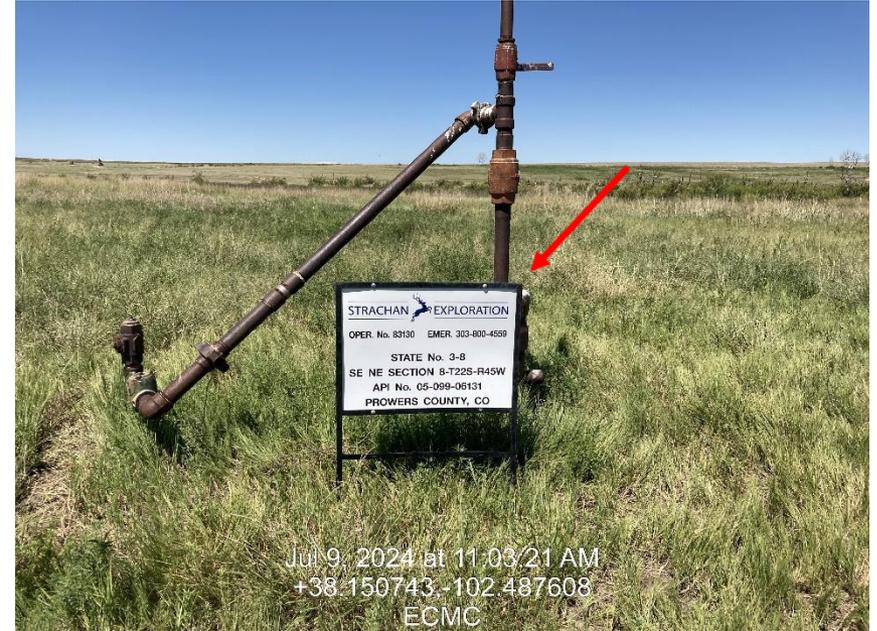
Photo 12 – State 3-8 well placard

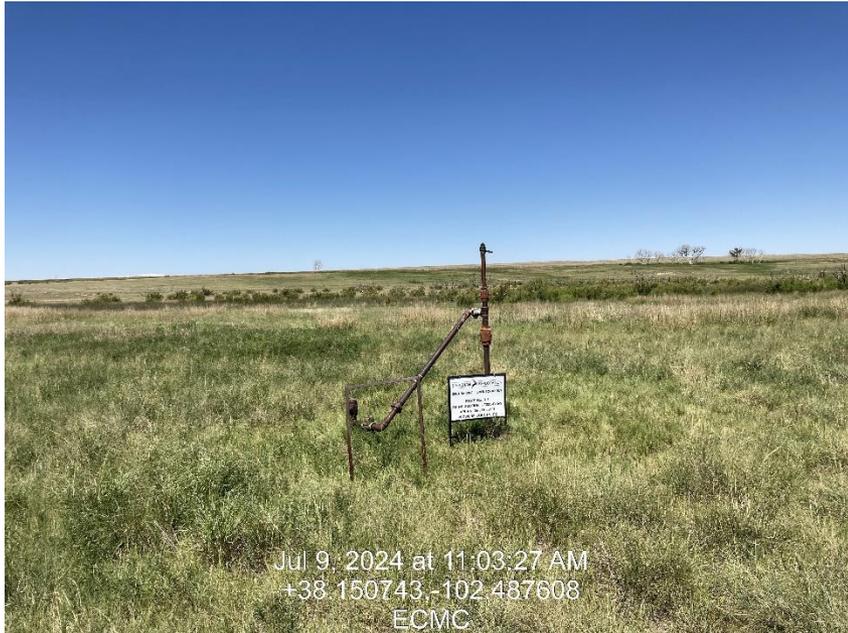
Photo 13 – State 3-8 Well and surrounding area
