Inspection Photos
Location: State 4-8
Location ID: 314190
API # 05-099-06191

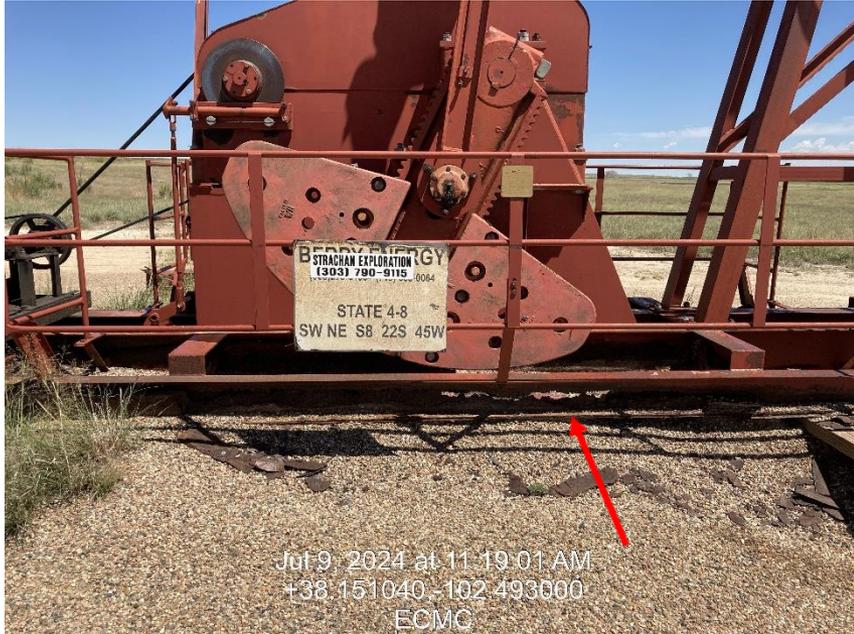
Photo 1 – Well placard, Pumping unit

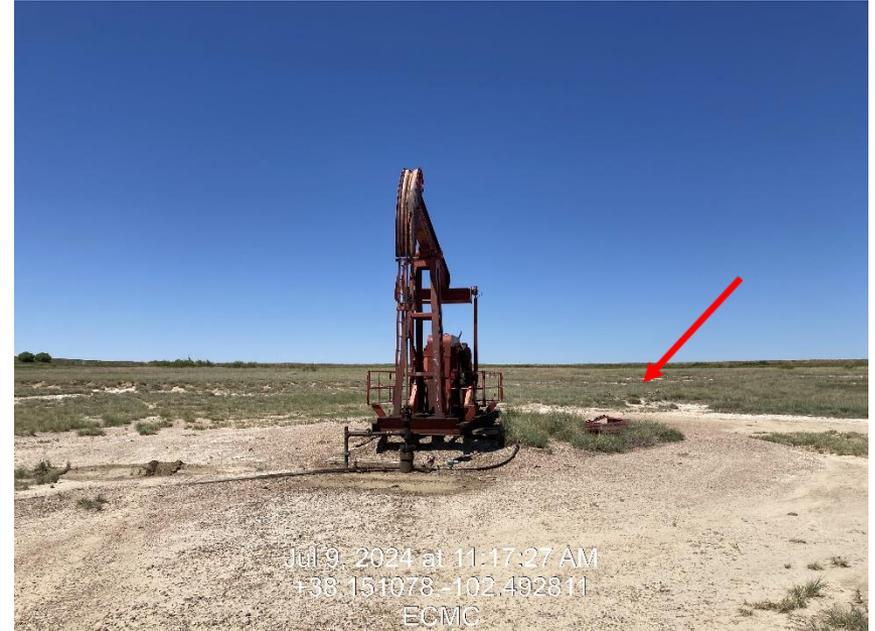
Photo 2 – Wellhead and unused equipment

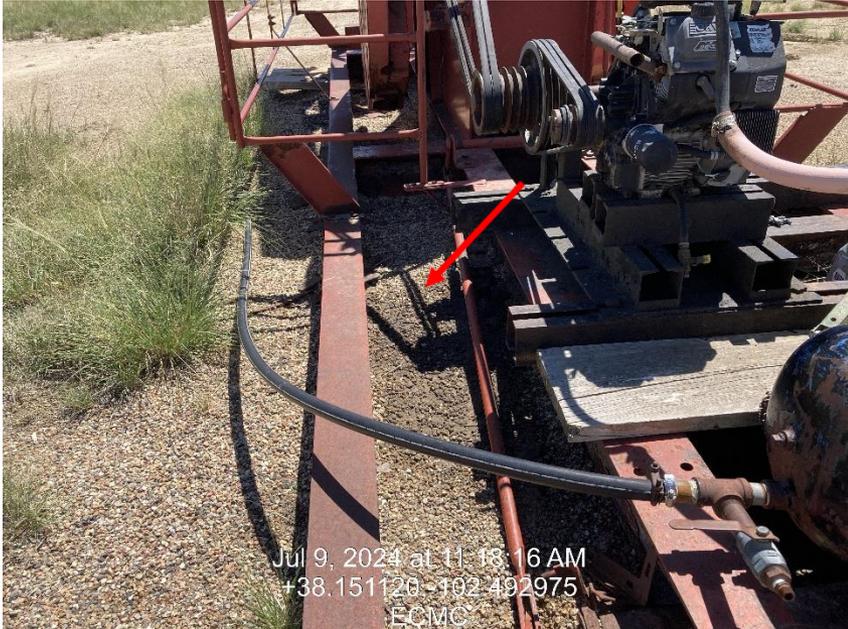
Photo 3 – Oil Stains in pumping unit frame

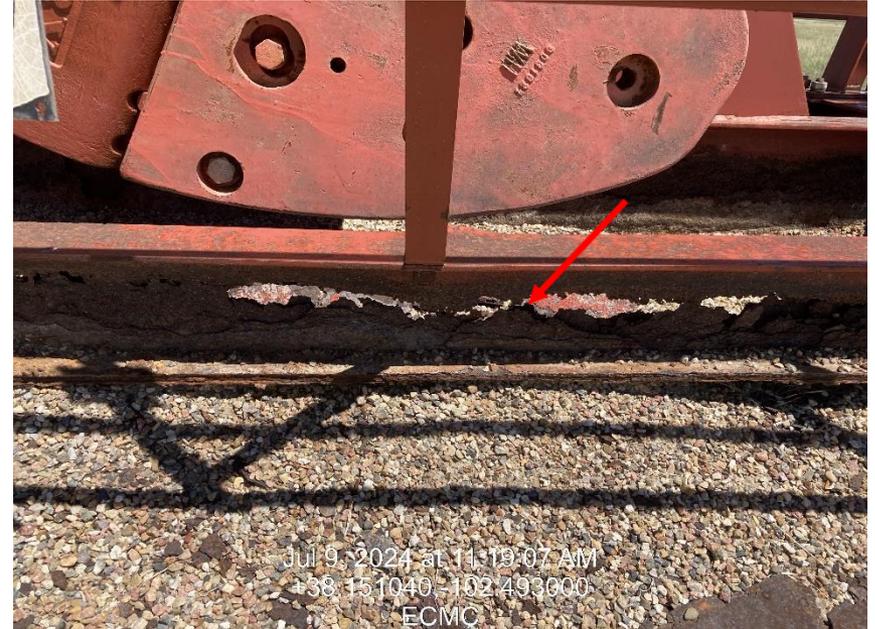
Photo 4 – Pumping Unit base is corroded.

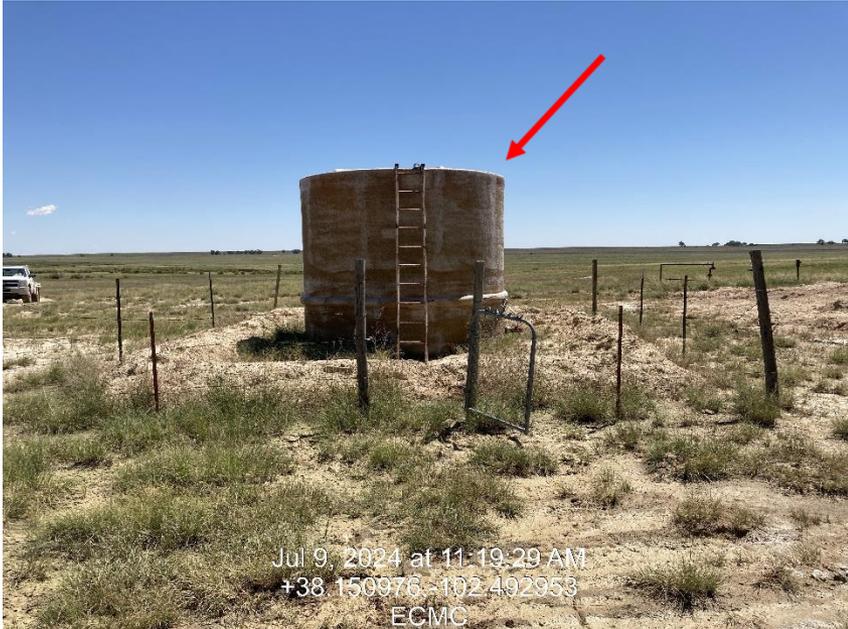
Photo 5 – Produced water Condensate tank

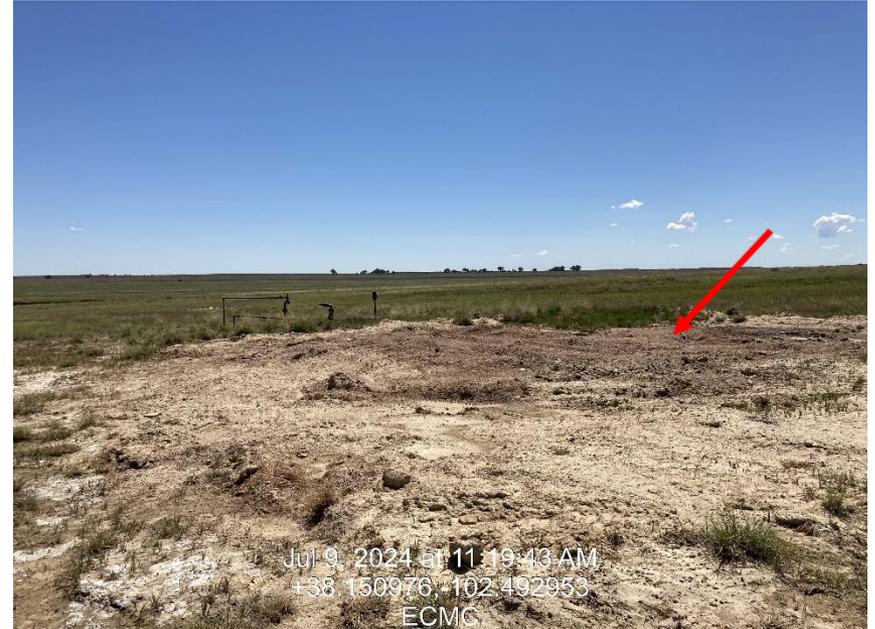
Photo 6 – Area of historical tank battery; Open Remediation # 32251

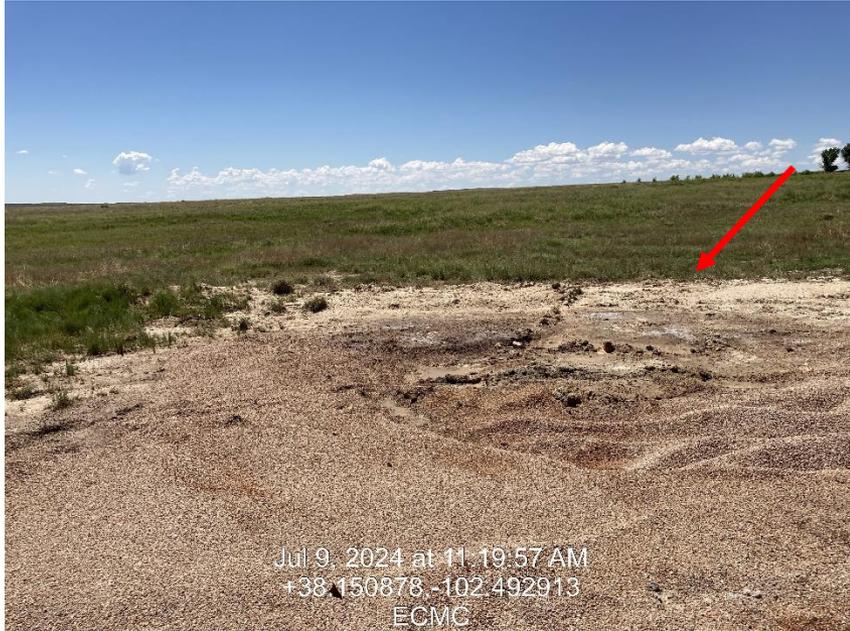
Photo 7 – Historical Tank Battery location

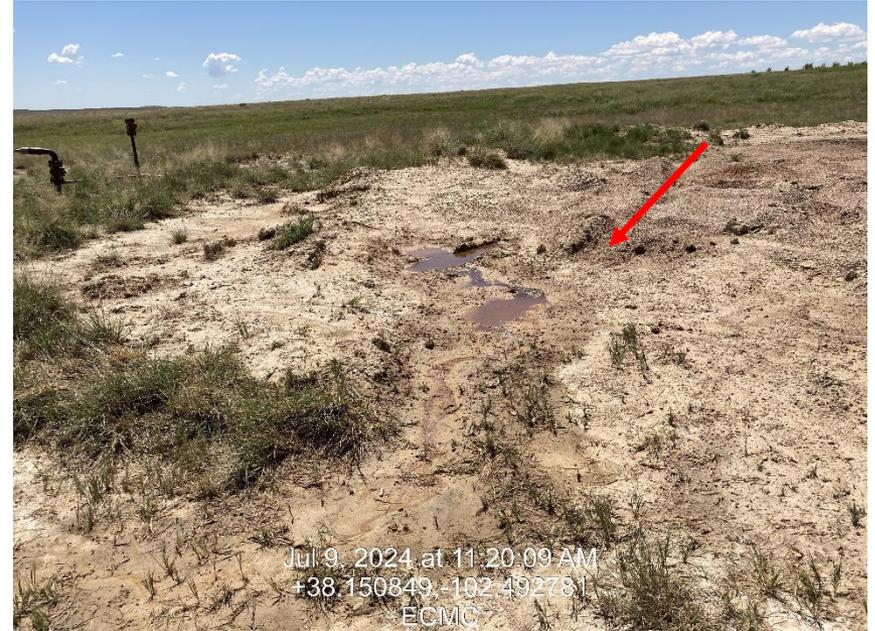
Photo 8 – Oil water mix on east end of tank battery

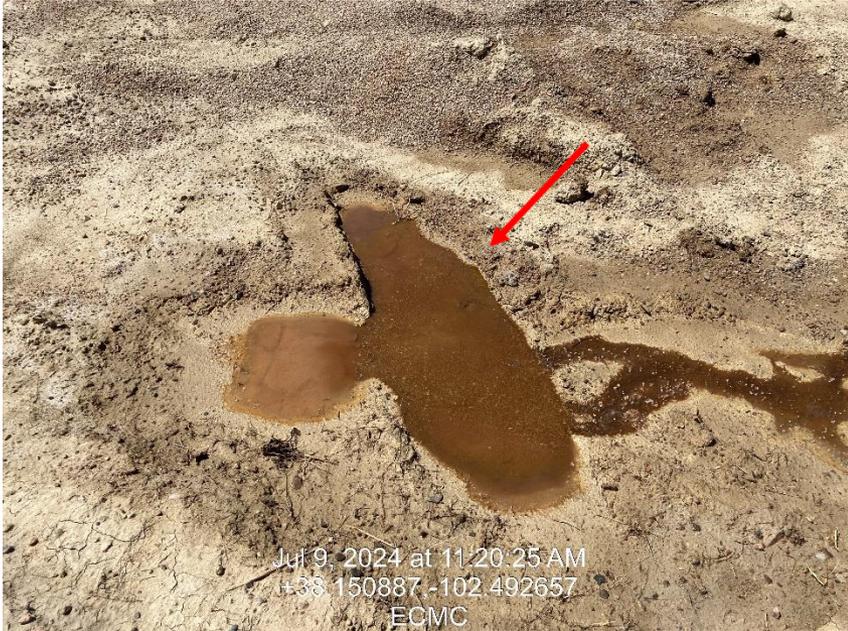
Photo 9 – Oil water mix

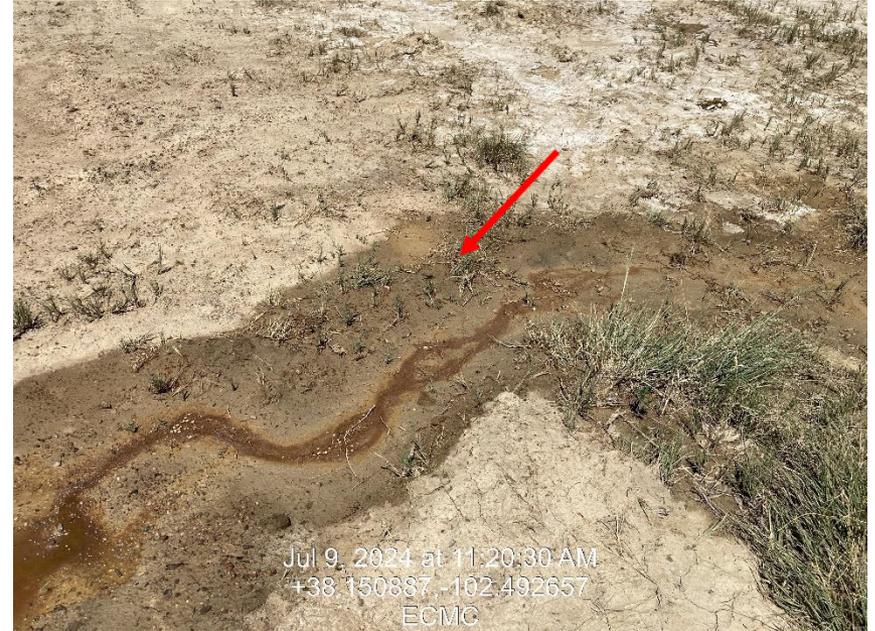
Photo 10 – Oil water mix flow path

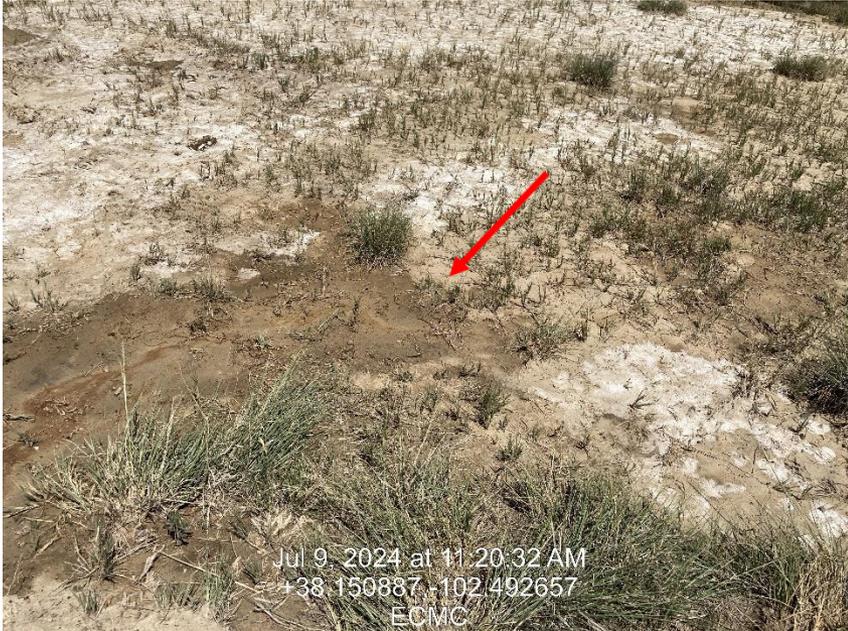
Photo 11 – Oil water mix end of flow at the time of inspection

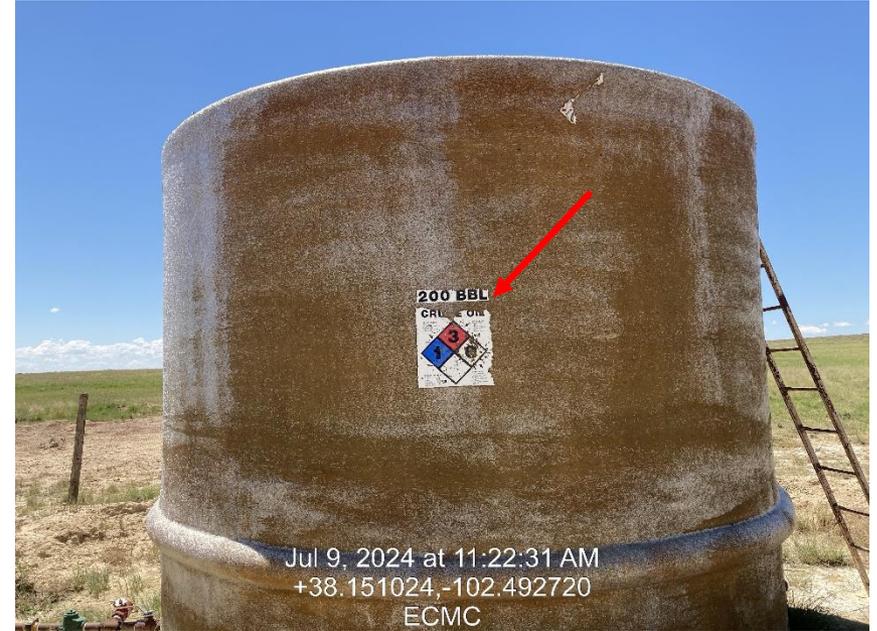
Photo 12 – Produced water tank. Placard is illegible
