Inspection Photos

Loc: 324498

Operator: **OXY USA INC**

Inspection Date: 7/9/2024

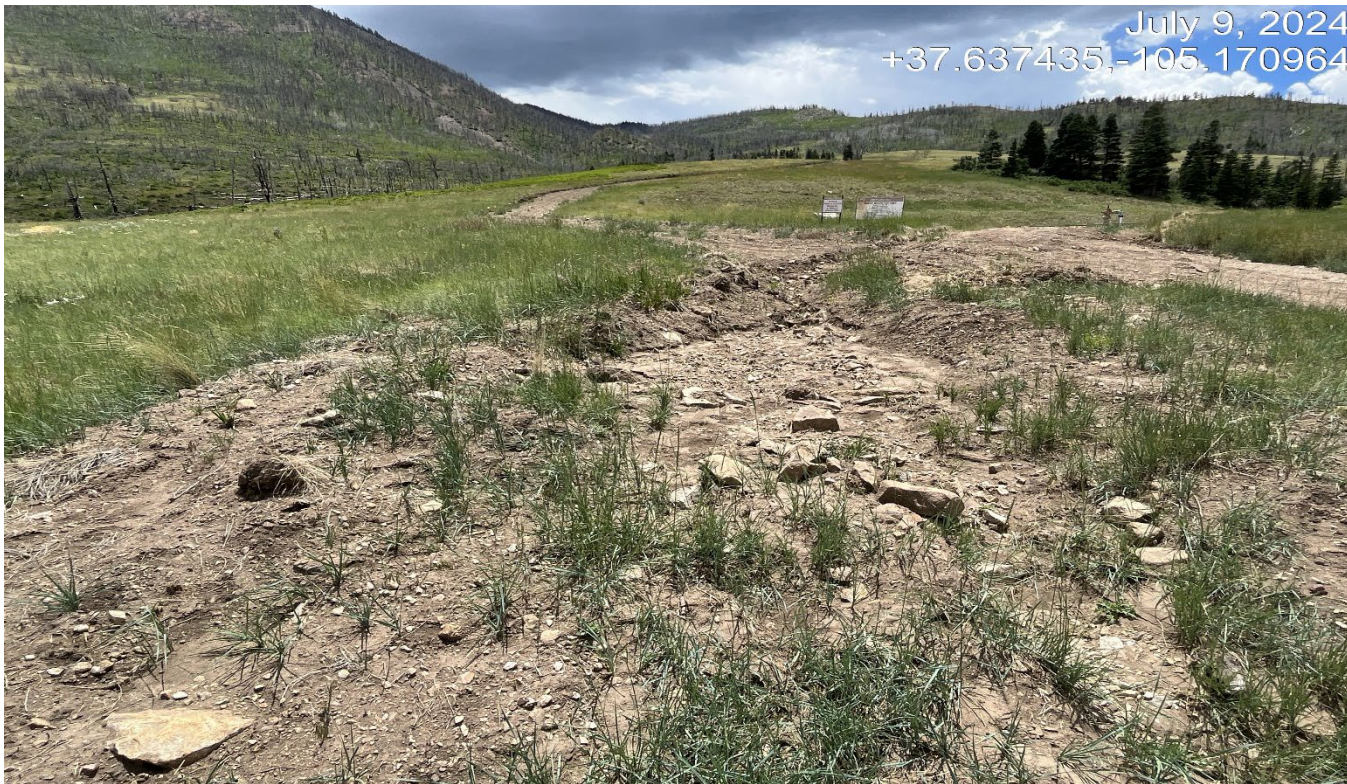
Photo 1. Facing southwest along the access road near the SMU #1-12-B . Sediment has been deposited and pushed off the road into this area creating additional disturbance.

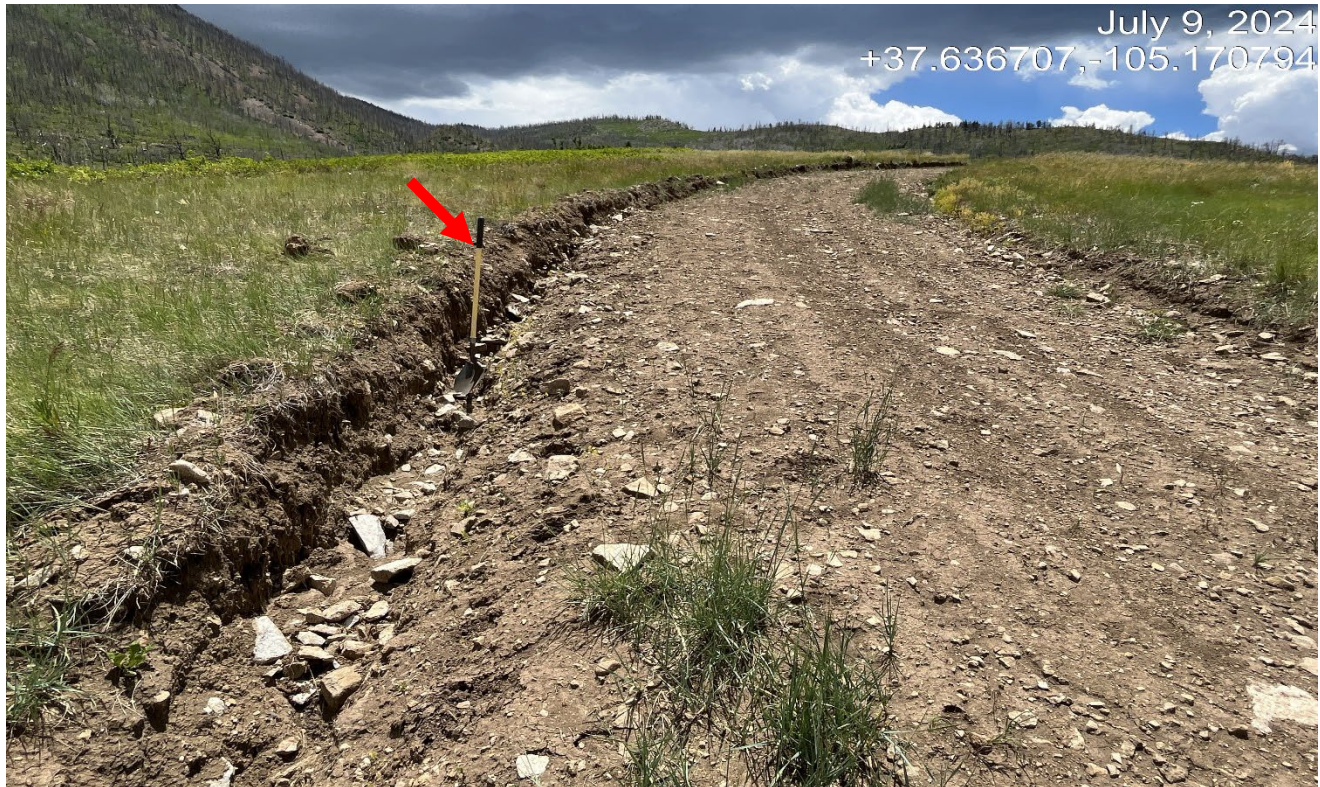
Photo 2. Facing southwest along the access road. There is erosion that has occurred along the road. Red arrow points to shovel placed in the erosion channel.

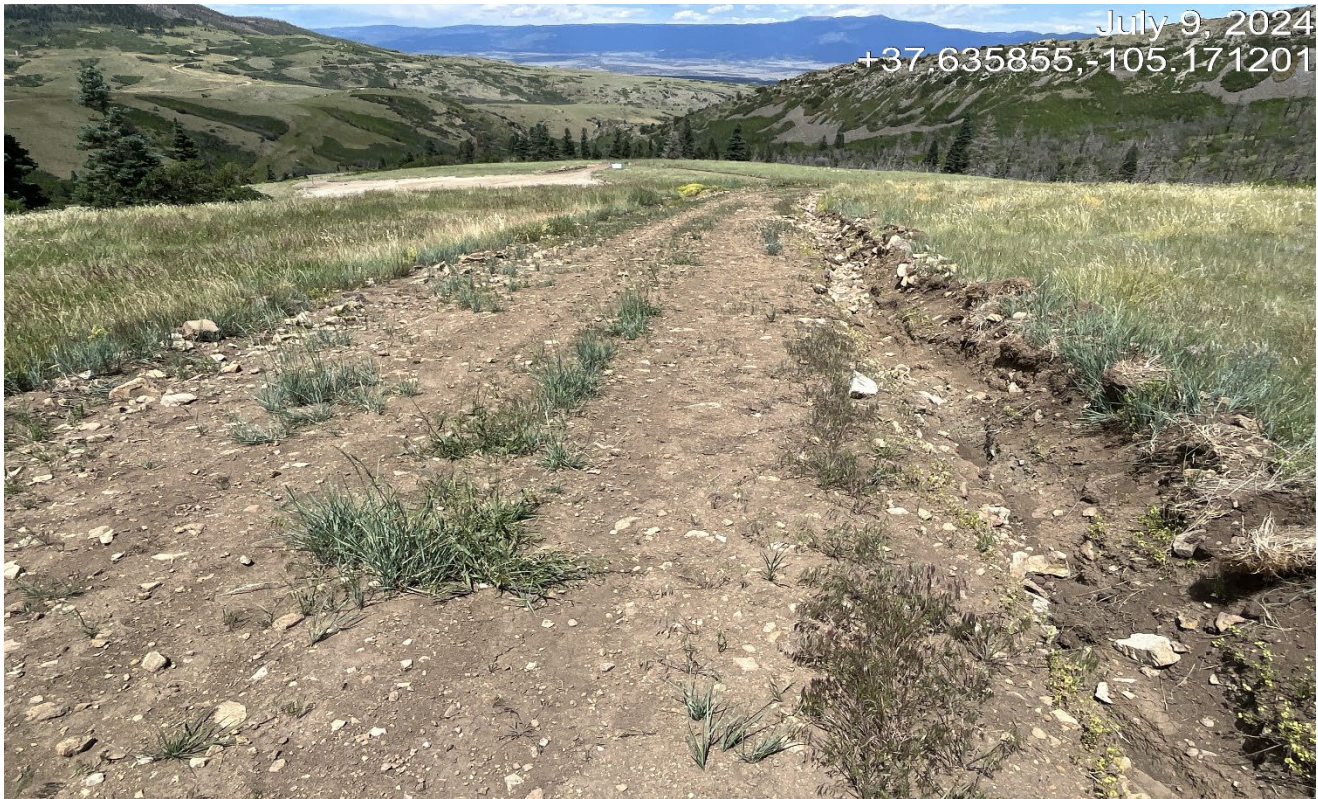
Photo 3. Facing northeast back down the access road. There are no BMP's to control erosion along this entire stretch of road

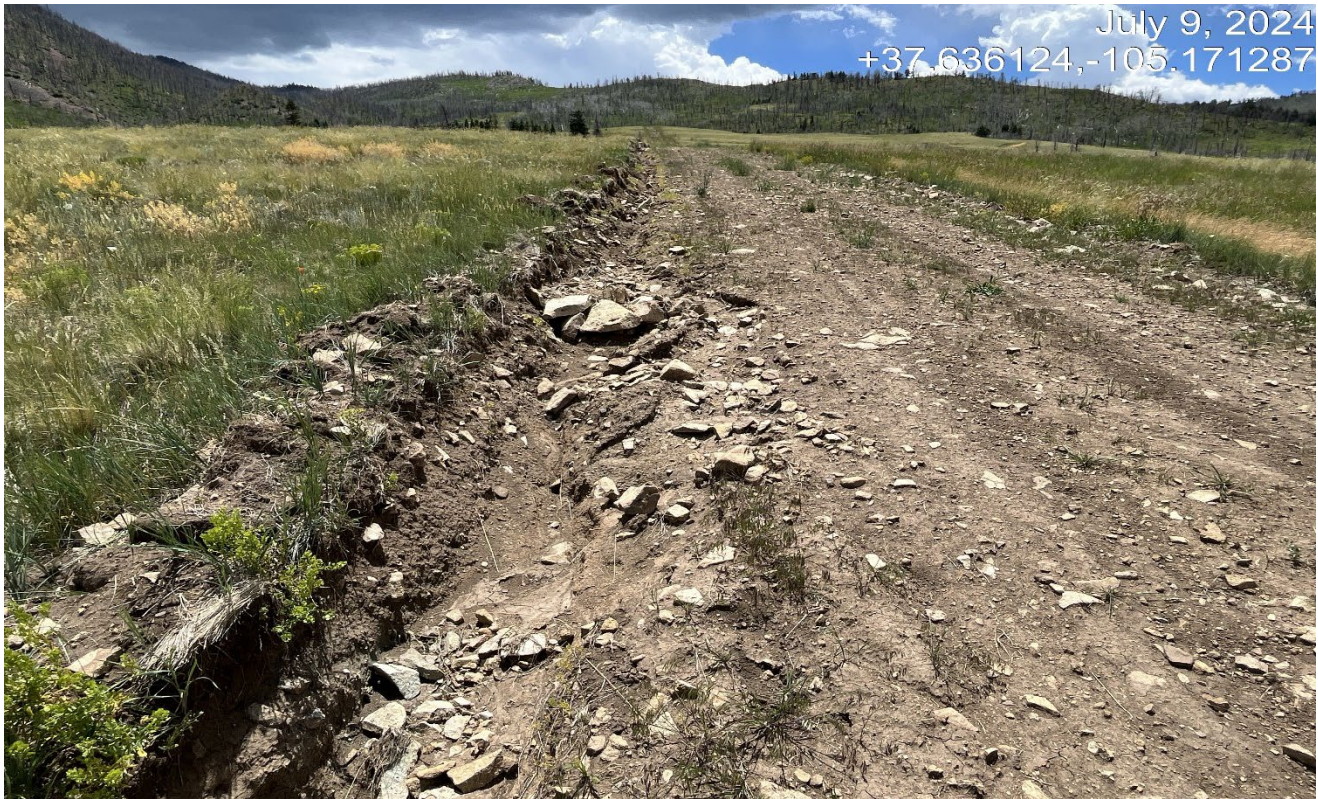
Photo 4. Facing southwest along the access road. There is erosion that has occurred along the road which has no BMP's to control erosion.

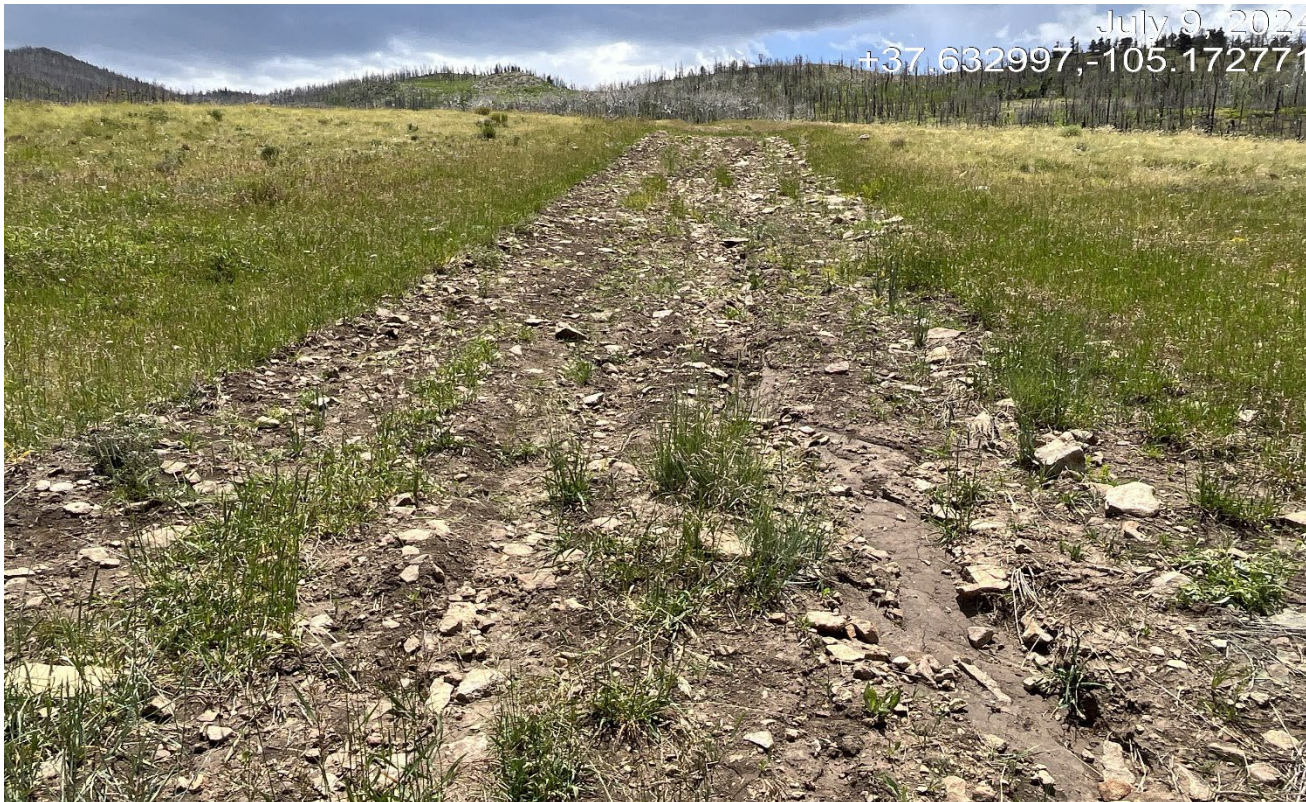
Photo 5. Facing southwest further along the access road. There is more vegetation establishment but there is still erosion along the road. Stormwater should be diverted off the road.

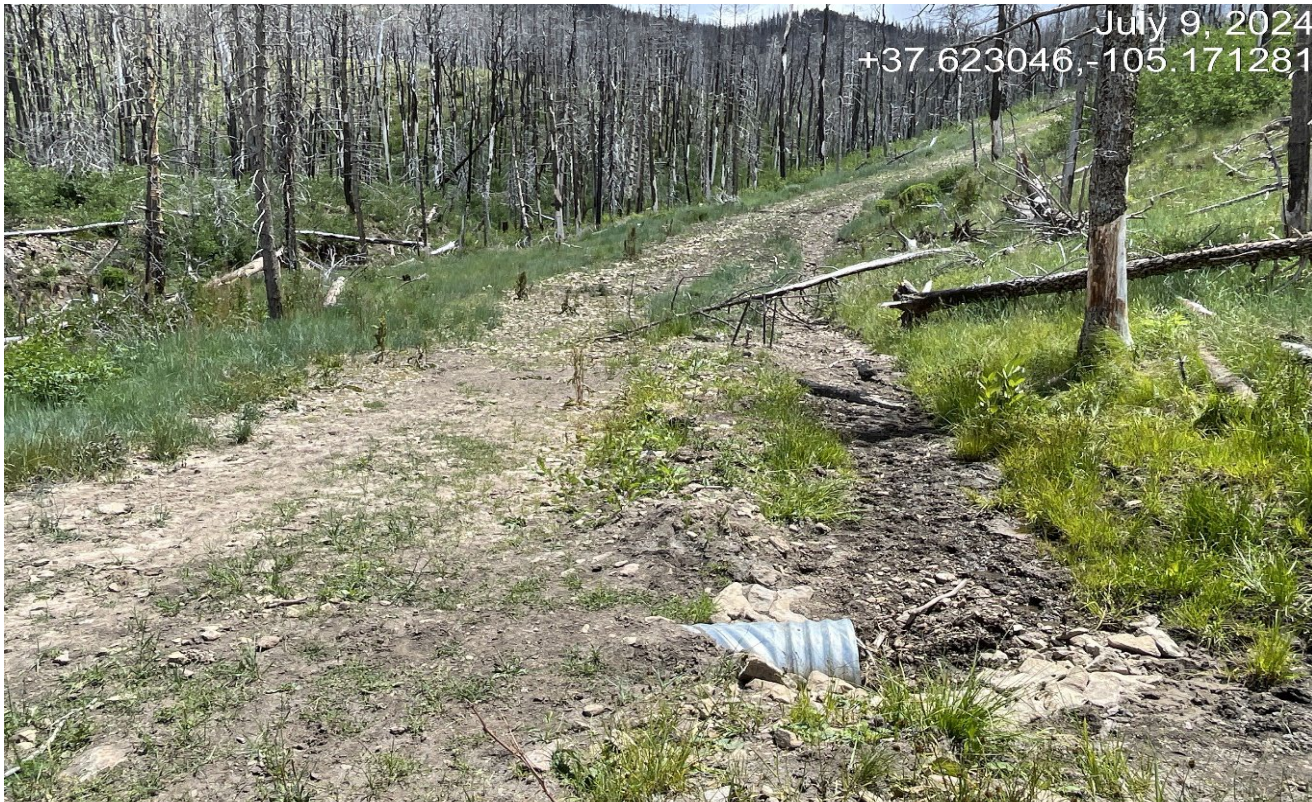
Photo 6. Facing southwest further along the access road. This culvert has filled in with sediment.

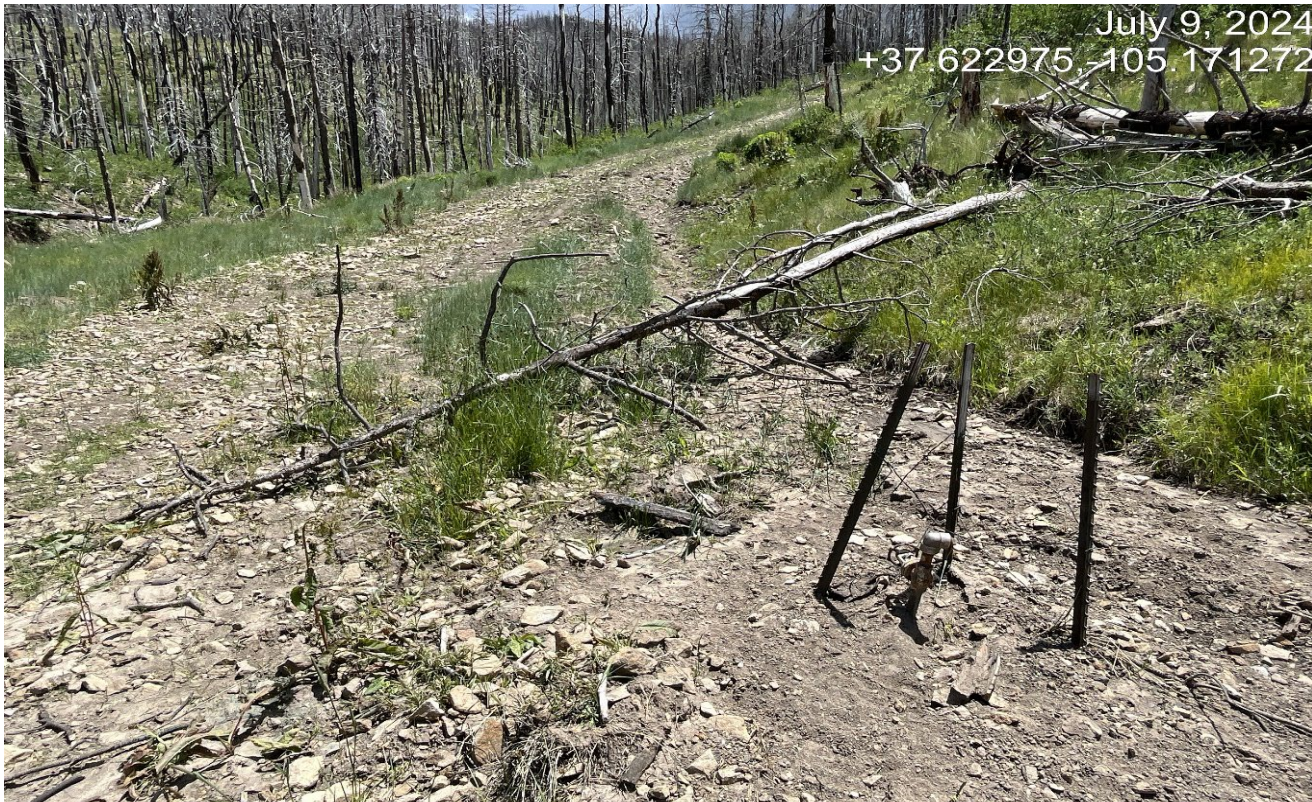
Photo 7. There is a pipe riser along the road with t-post.

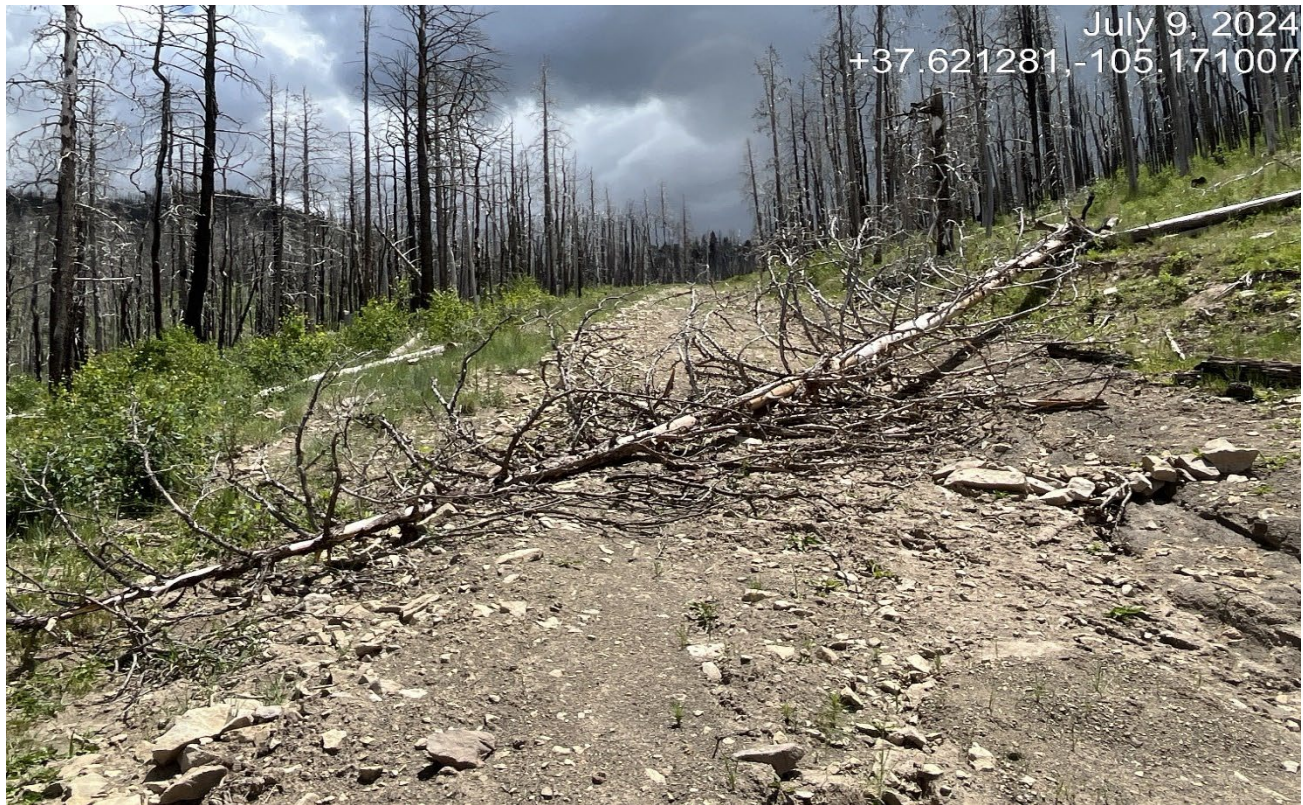
Photo 8. Facing southwest further along the access road. There is a tree that fell over blocking the road. Could not go any further to the wellsite.

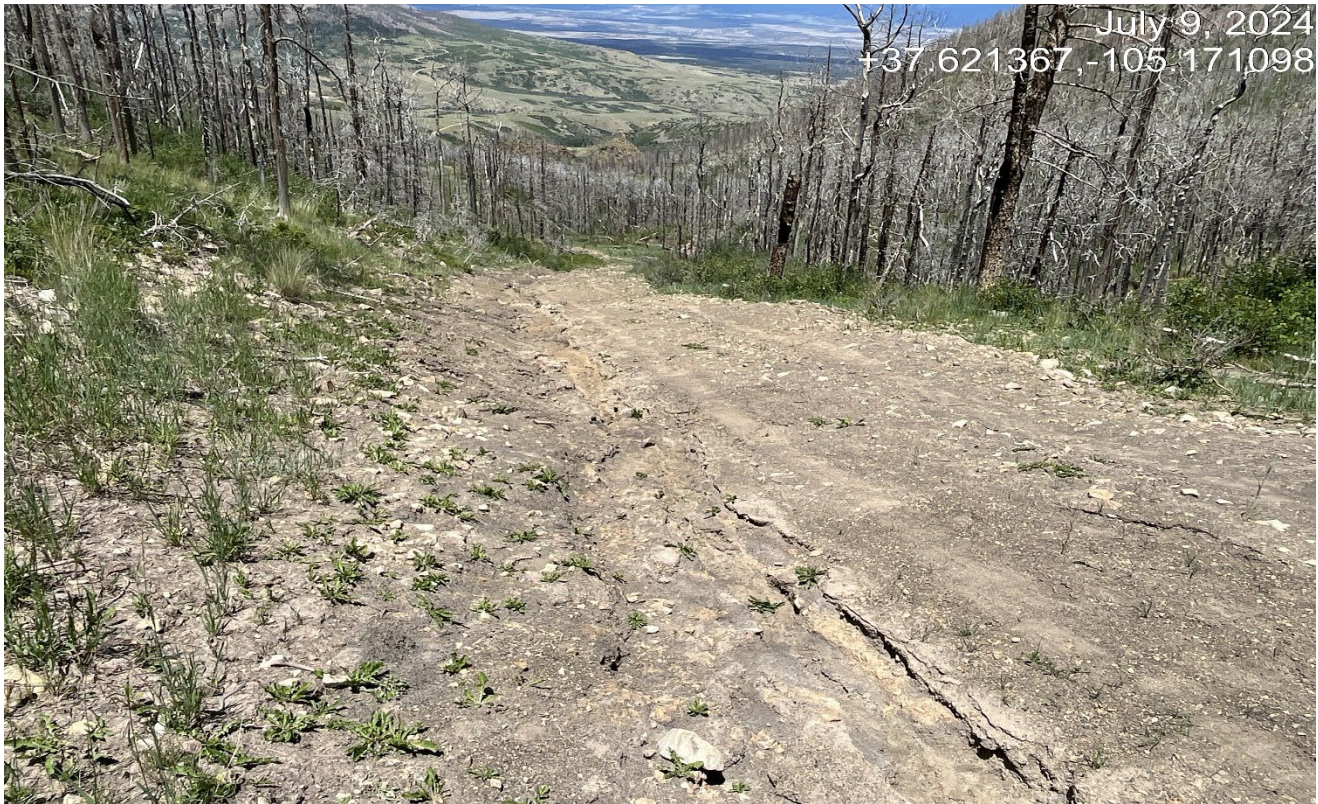
Photo 5. Facing southwest further along the access road. There are areas of erosion occurring which need to be repaired and stabilized.
