Well Site Inspection

Operator: KP KAUFFMAN COMPANY INC - 46290

Location ID: 333124

Inspection Document #: 708201405

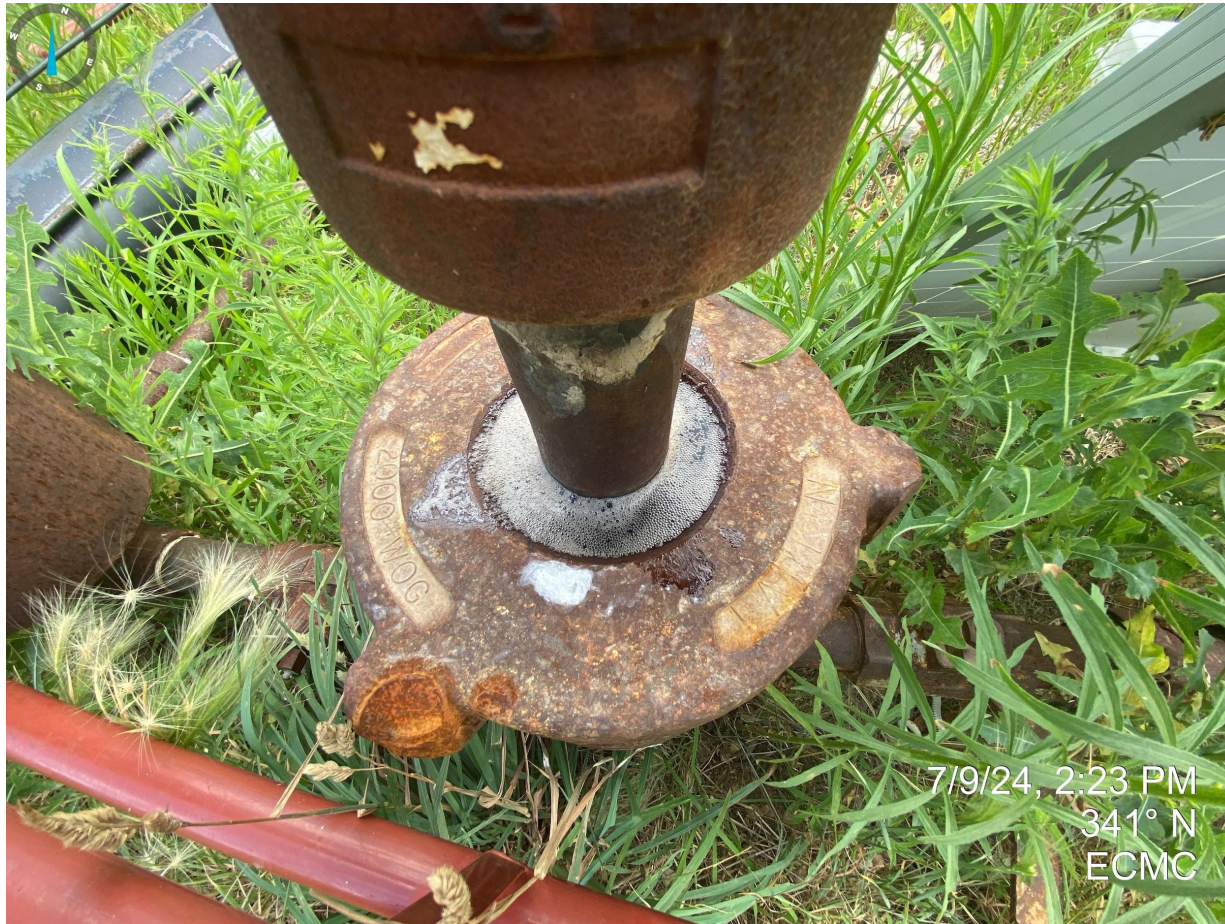
Photo 1. Venting observed as bubbles in standing fluid at casing assembly.

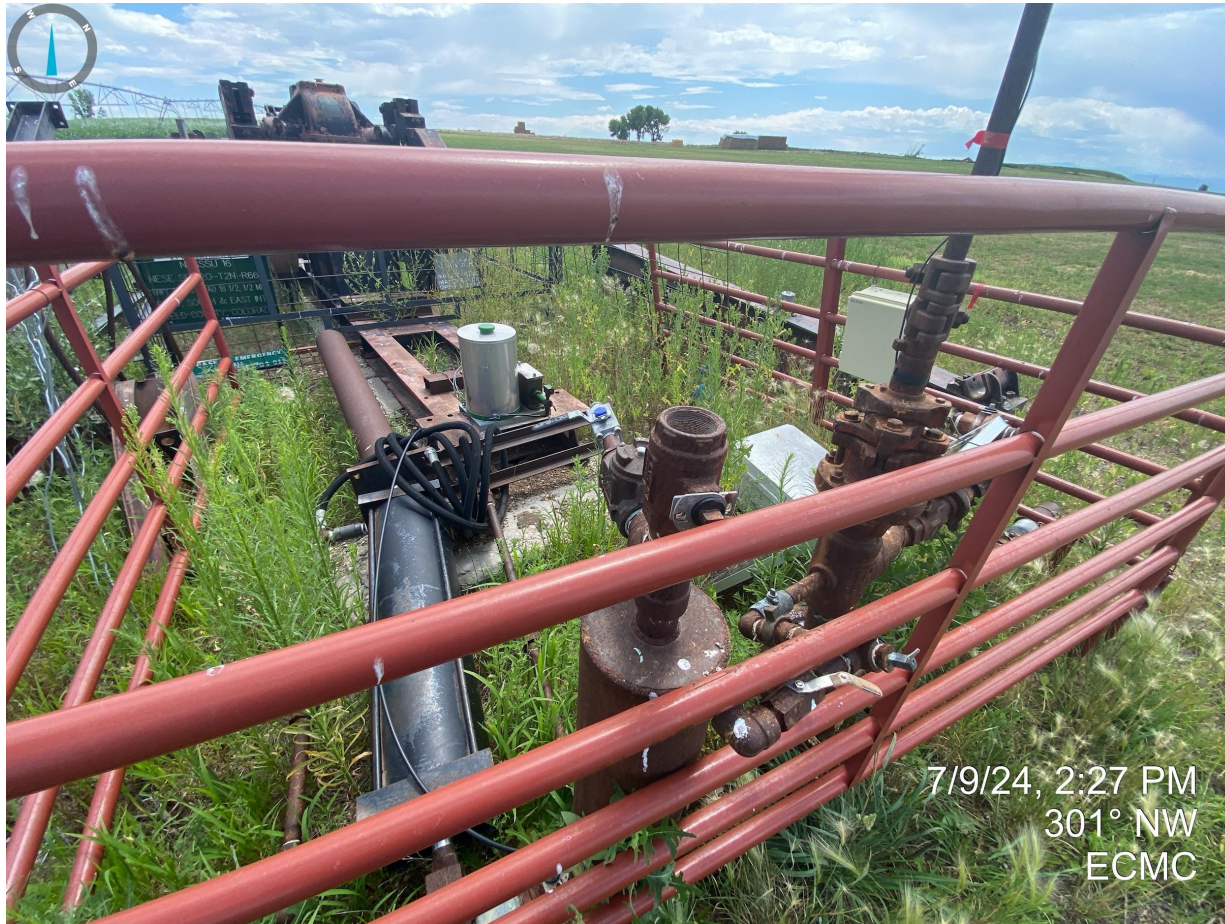
Photo 2. Pump jack is disassembled.

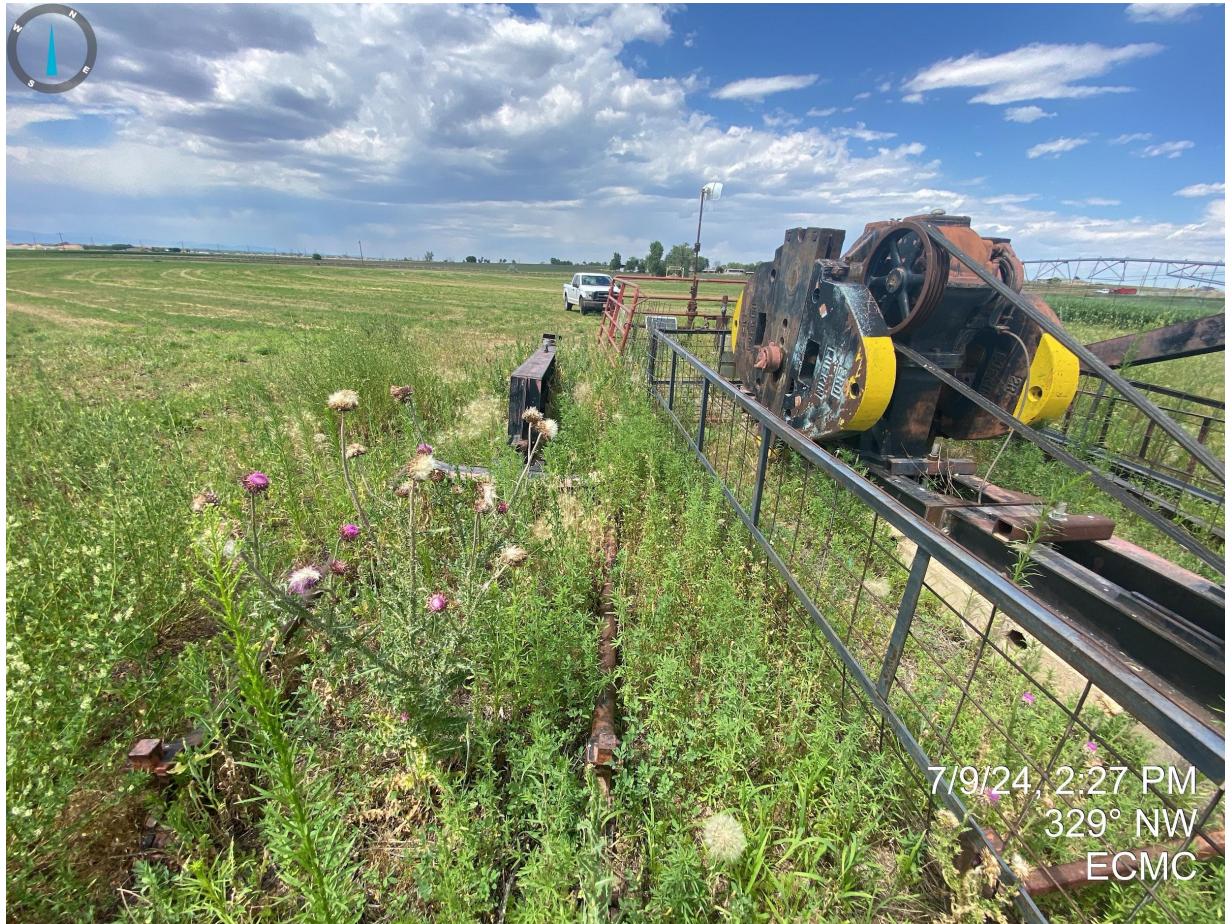
Photo 3. Unused equipment observed outside of fenced portion. Also pictured, CO List B Noxious Weed (musk thistle) and undesirable vegetation (kochia and prickly lettuce) observed around the location.

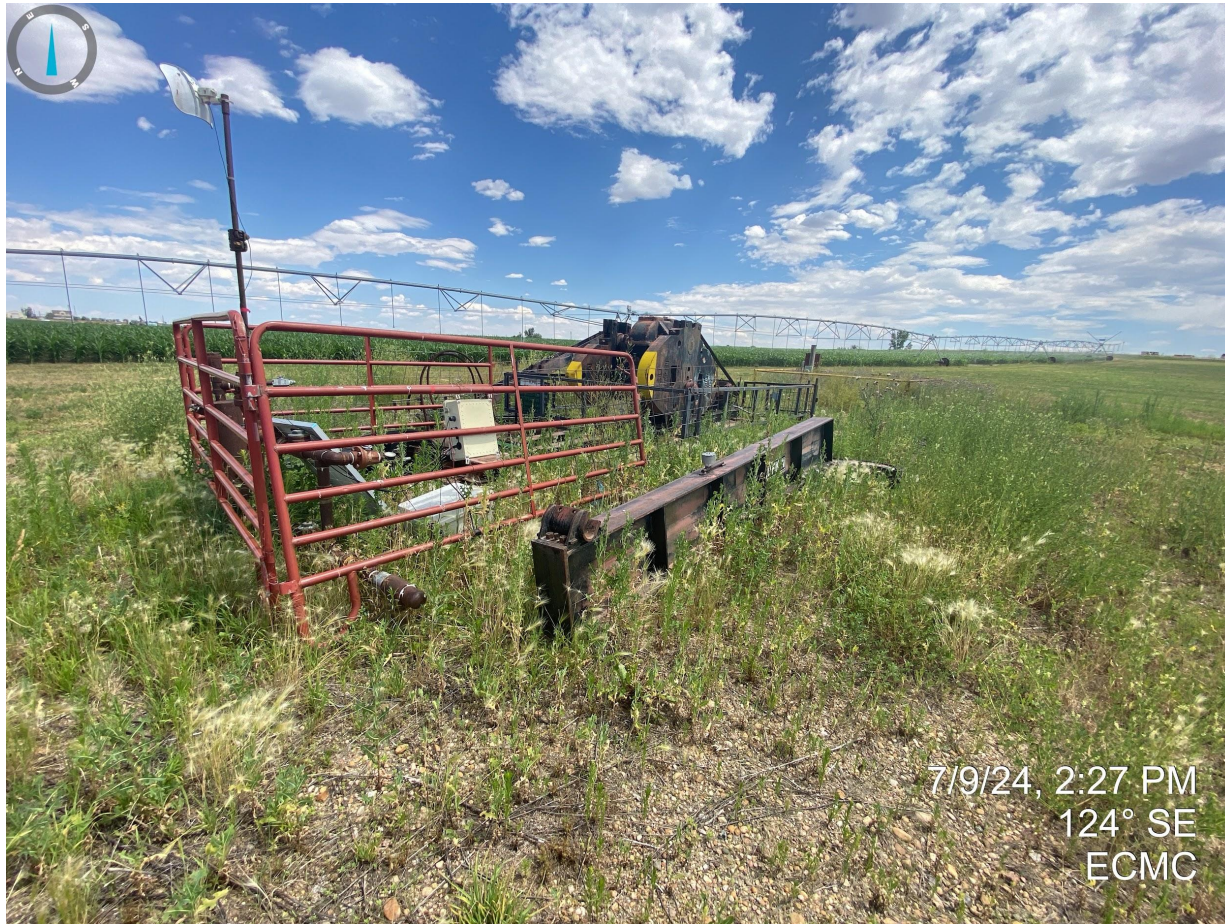
Photo 4. Continued from Photo 3; unused equipment observed.

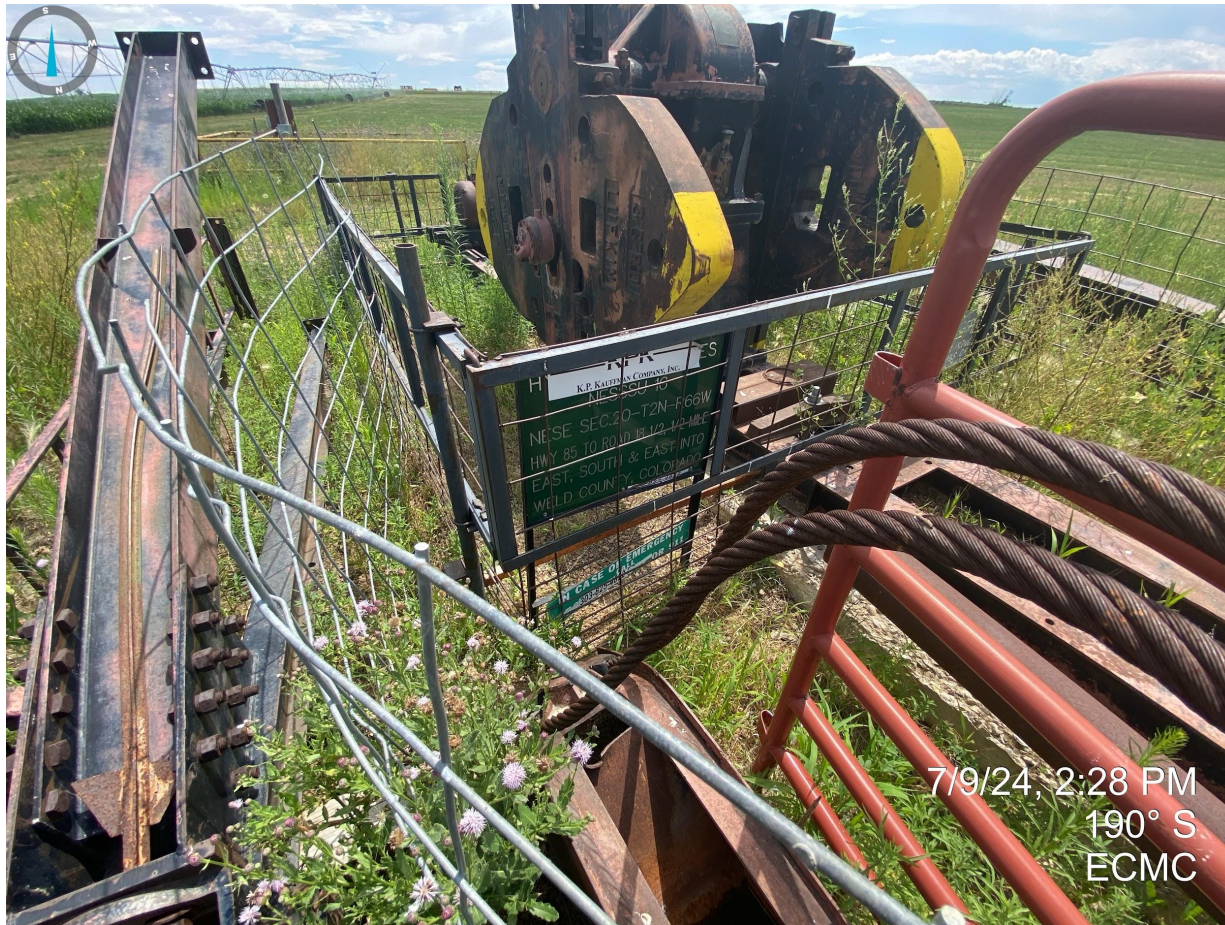
Photo 5. Unused equipment observed outside of fenced portions. Signage does not appear to have been updated to reflect the registered well name.

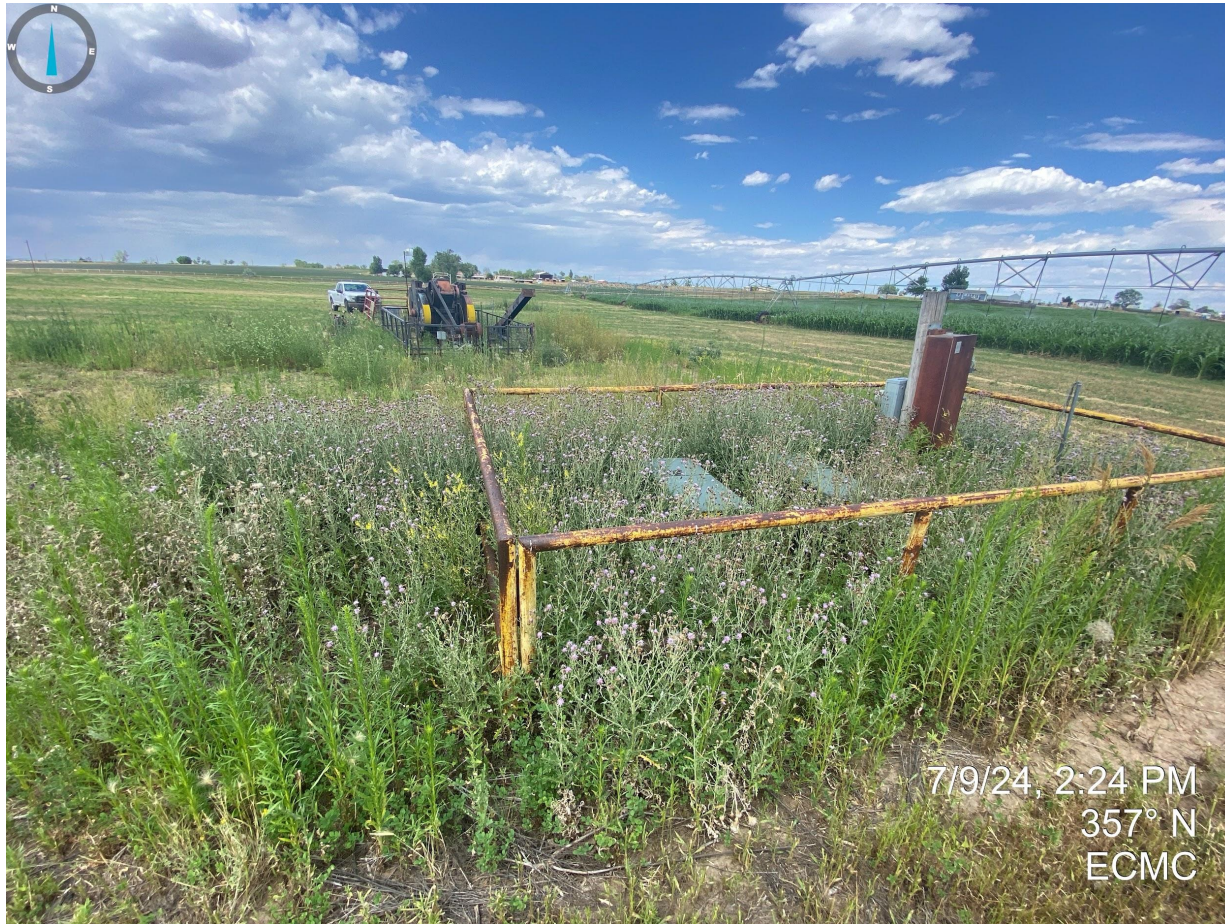
Photo 6. CO List C Noxious Weed (canada thistle) observed to be growing in and around equipment and throughout the location.
