Inspection Photos

API: 055-06012

Operator: OXY USA INC

Inspection Date: 7/9/2024

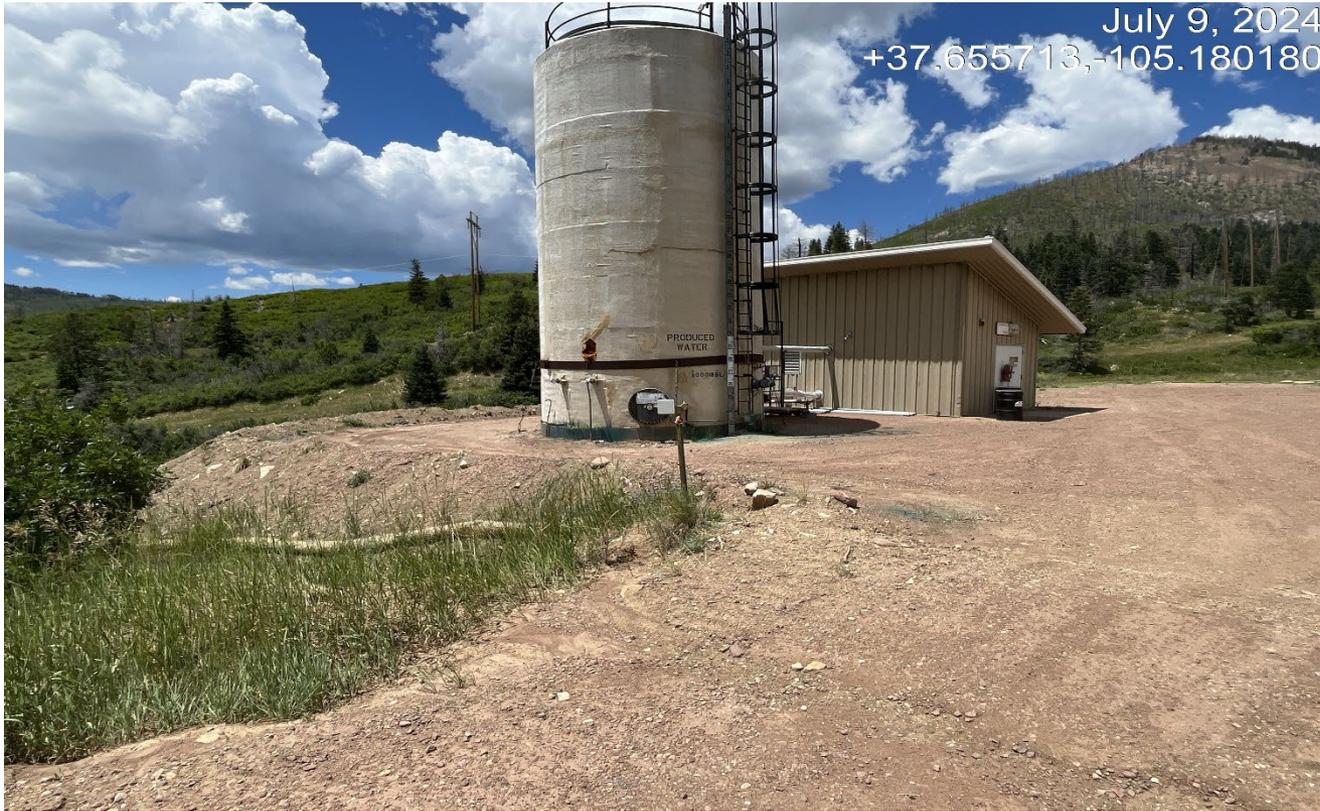
Photo 1. Facing southwest at the location.

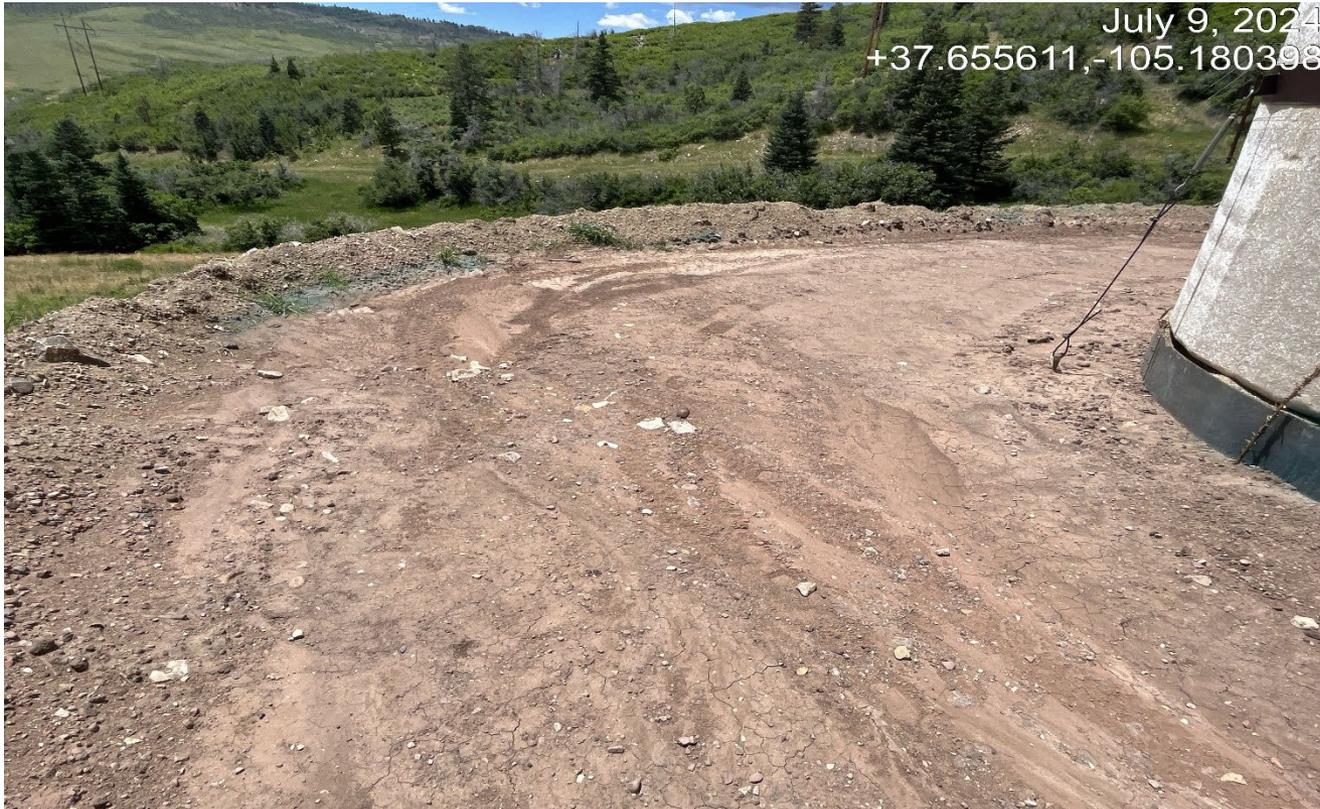
Photo 2. Facing toward the produced water tank. The secondary berm around the tank is insufficient to contain a spill. Previous corrective action was not completed.

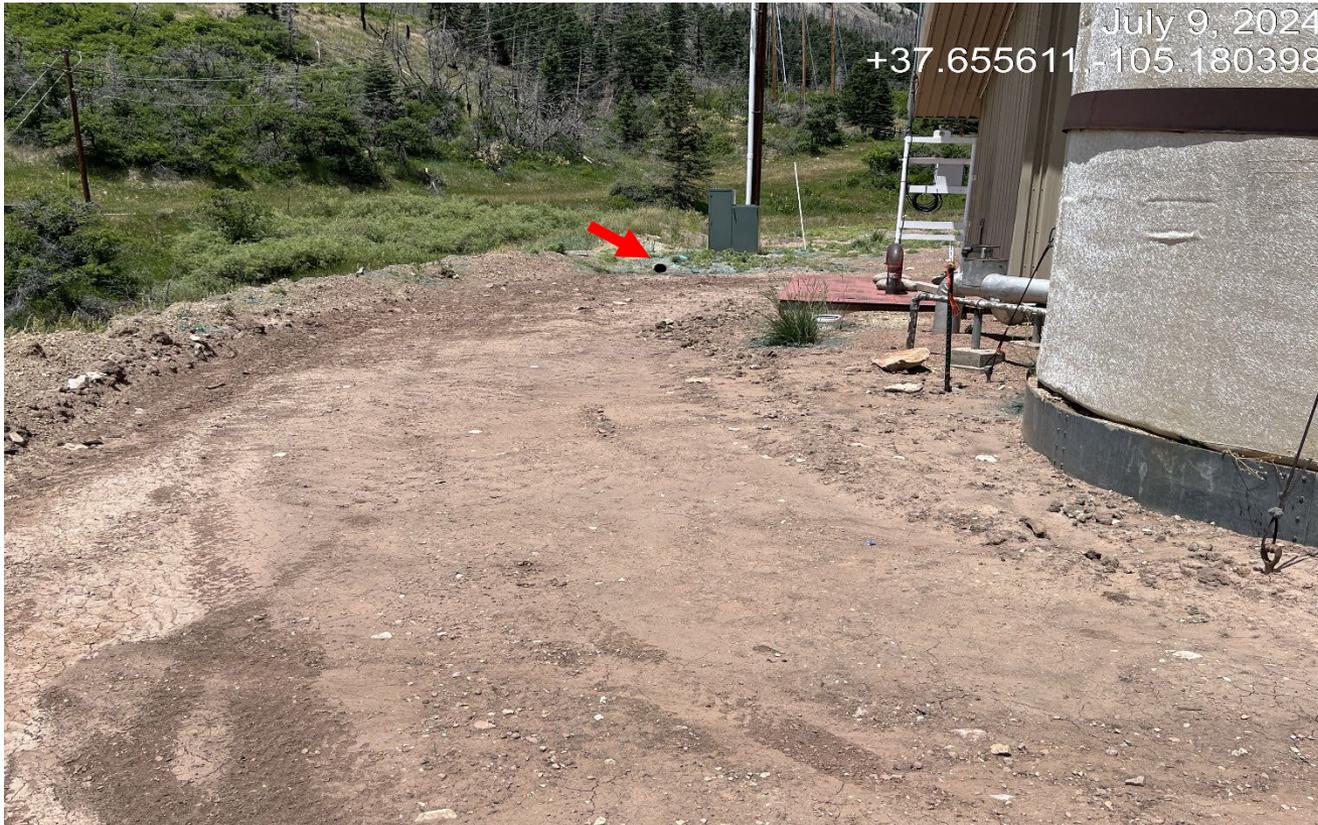
Photo 3. Facing west at the backside of the tank. The secondary containment at the tank is insufficient to contain a spill. The red arrow points to a culvert that would allow a potential spill to flow all the way toward the southwest portion of the pad near the perennial stream.

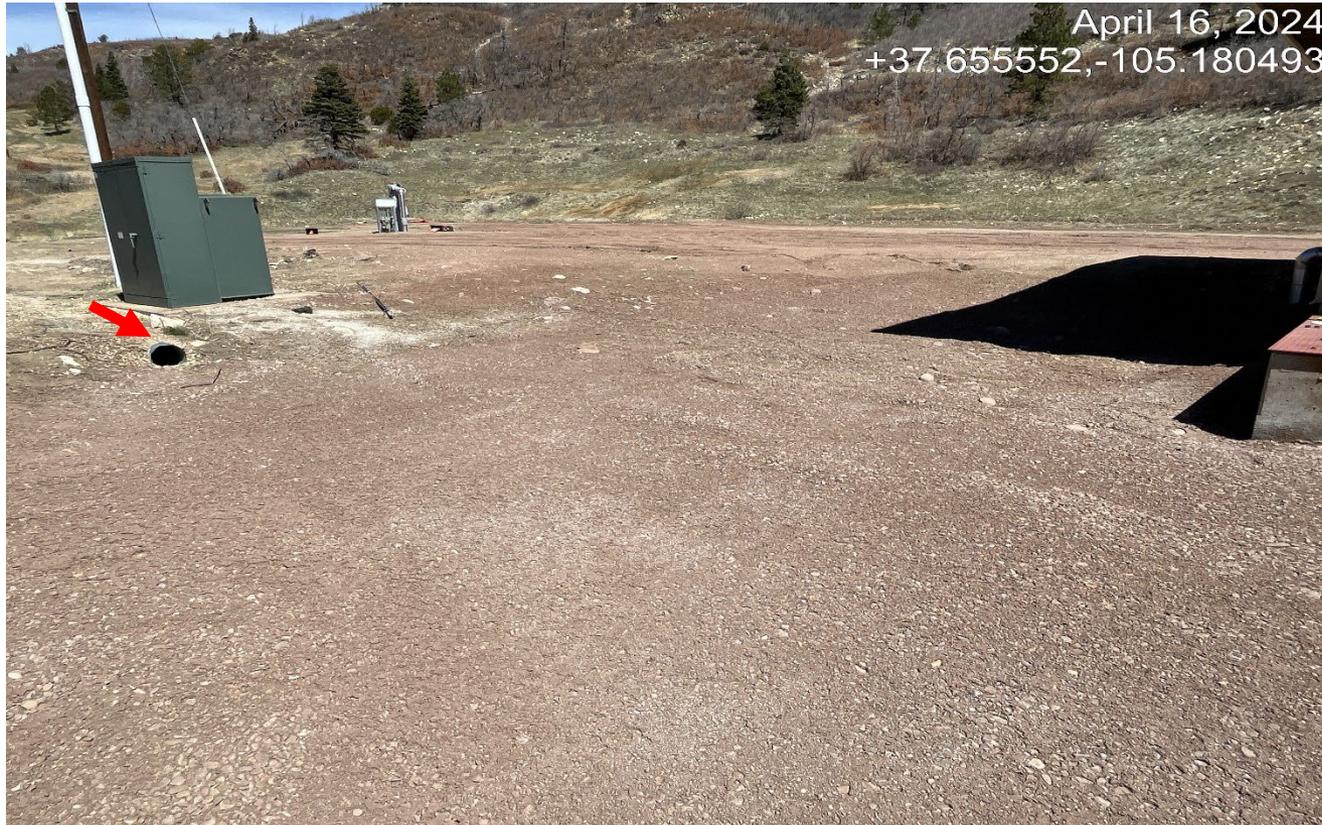
Photo 4. The remediation area where tank was located has been backfilled with sand and gravel. The red arrow points to a culvert that would allow a potential spill to flow all the way toward the southwest portion of the pad

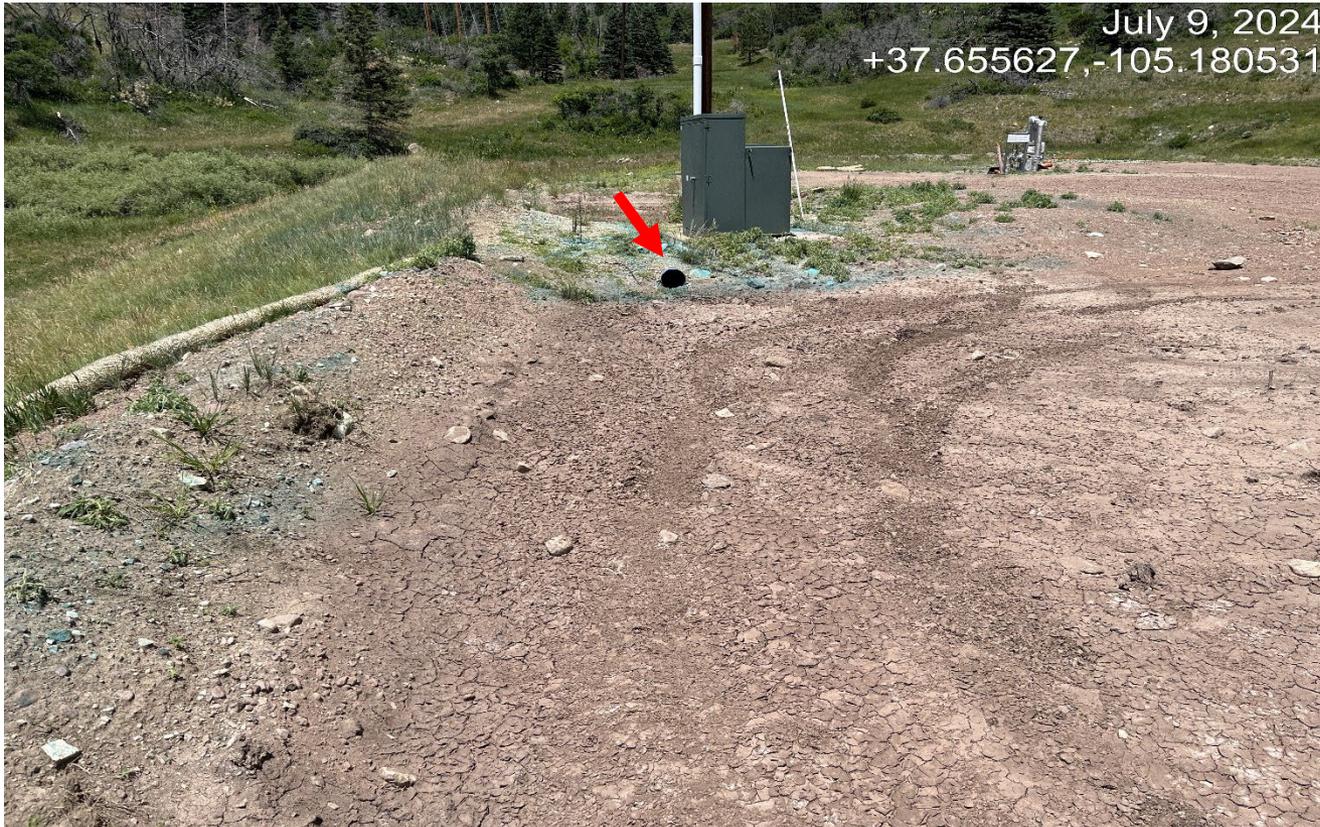
Photo 5. Wattles were installed along the southeast side but stop at this point. The red arrow points to a culvert that would allow a potential spill to flow all the way toward the southwest portion of the pad.

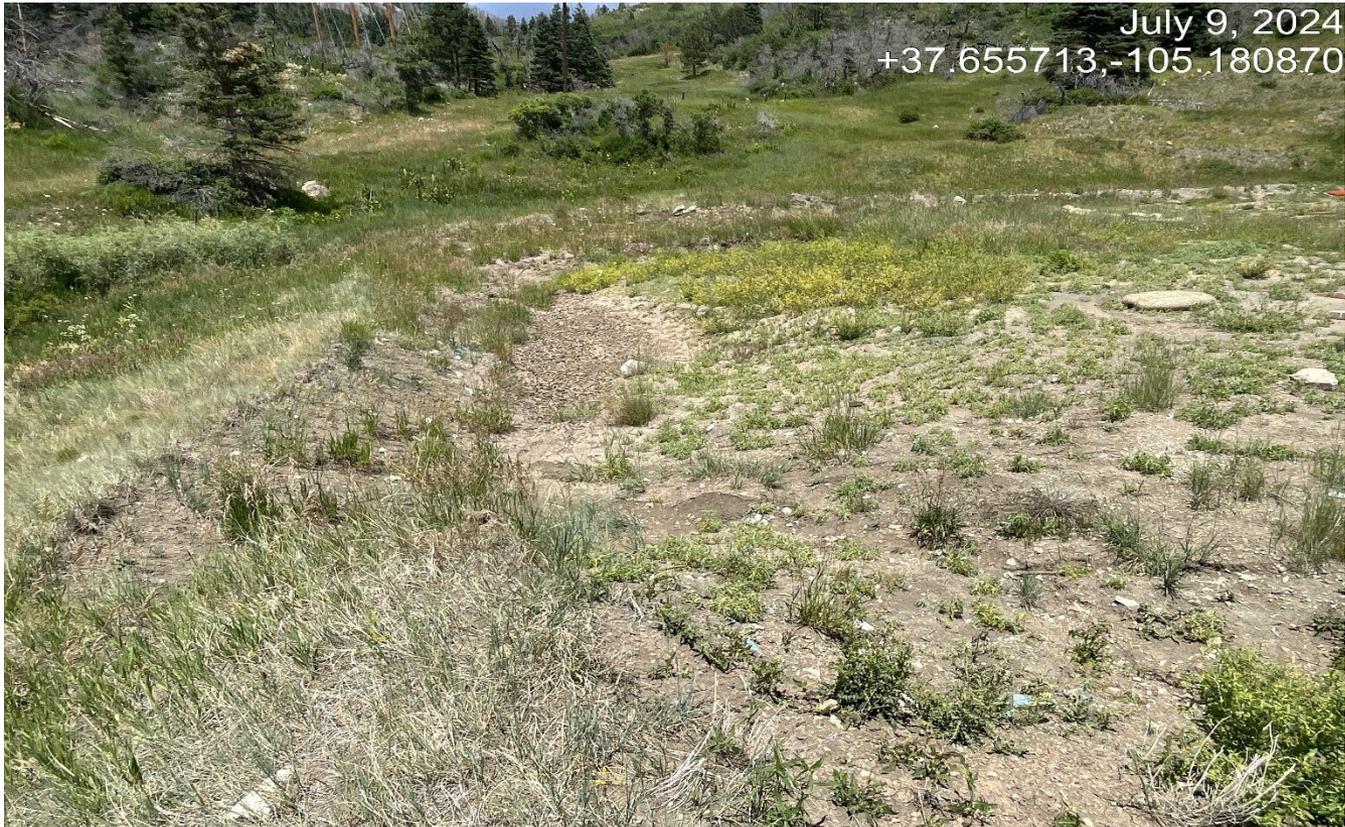
Photo 6. Facing toward the southwest portion of the pad.

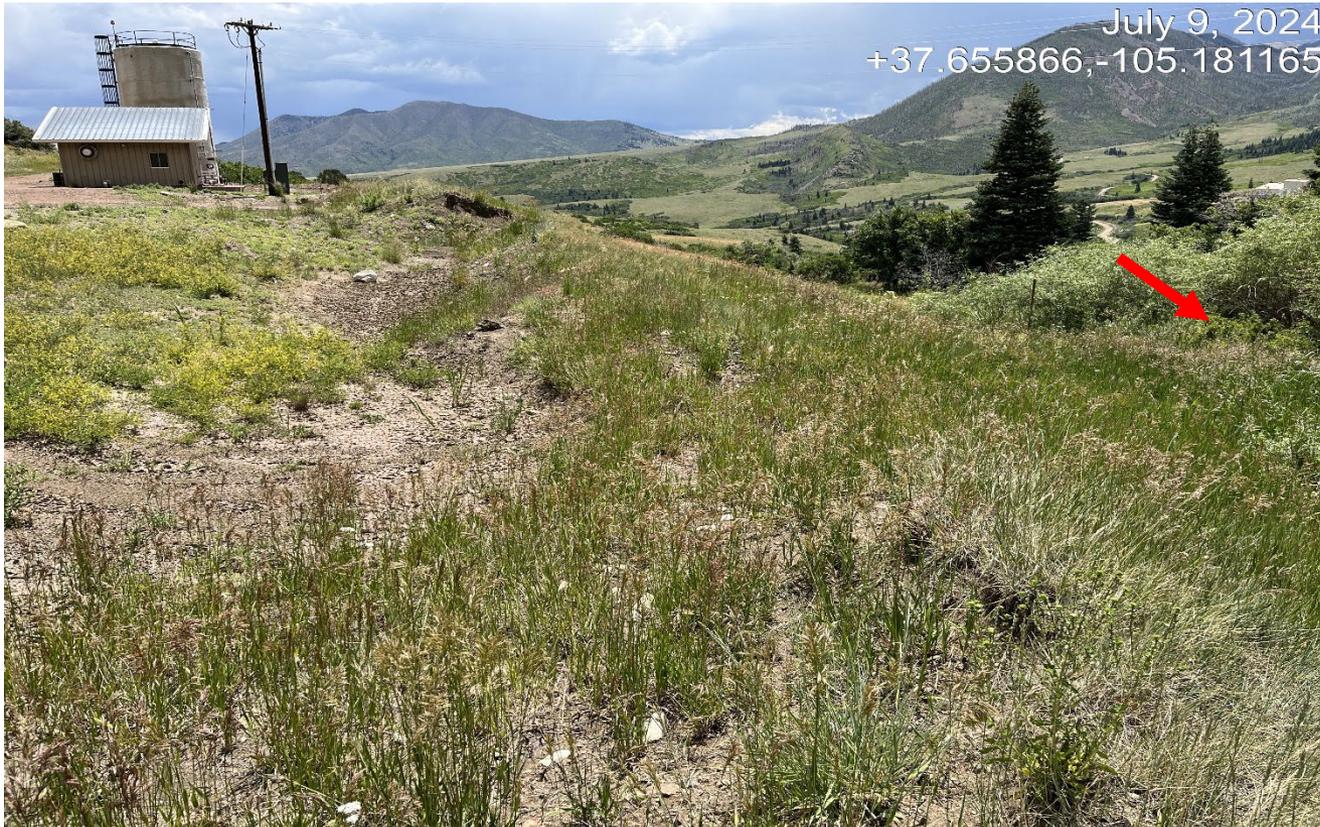
Photo 7. Facing southeast at the down gradient portion of the location. There is a creek approximately 10ft' from the edge of the location shown at red arrow.

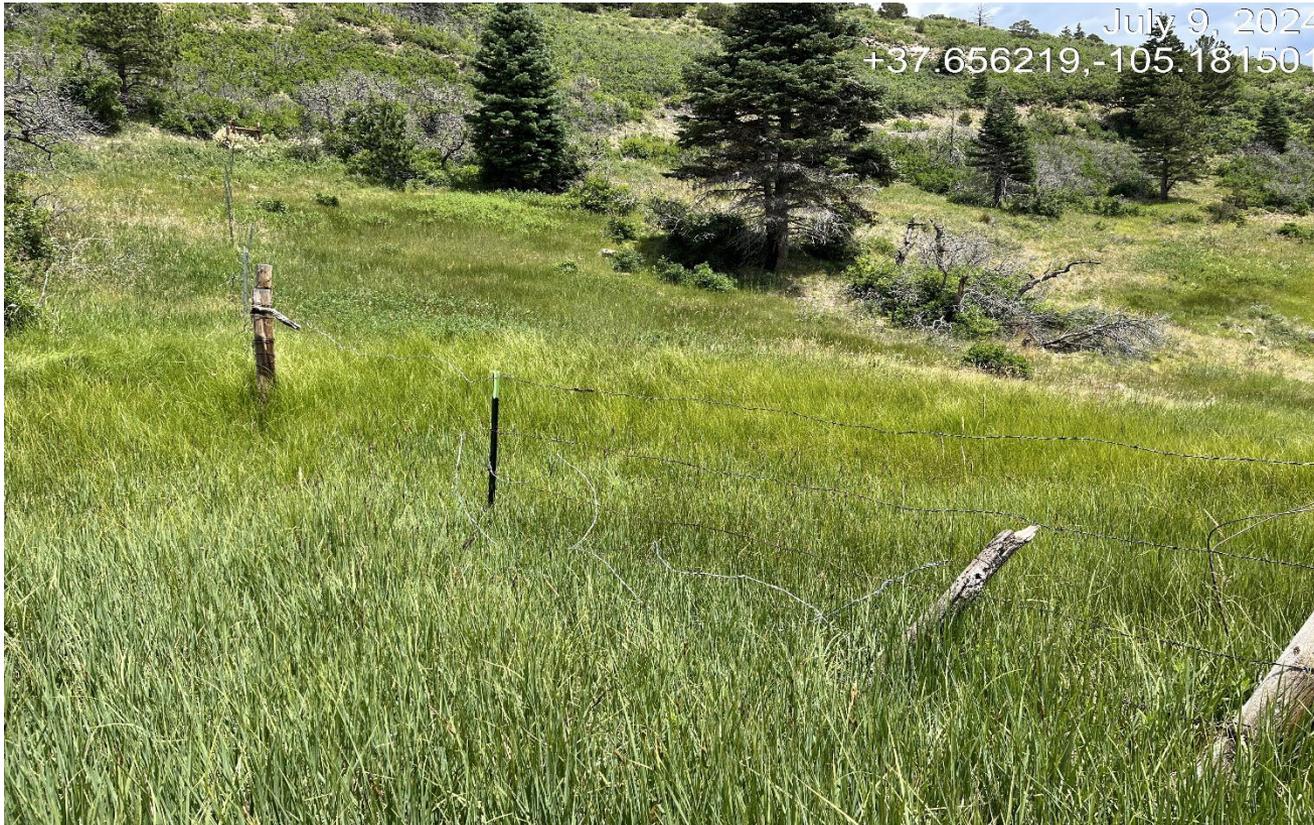
Photo 8. The perimeter fence at the west side of the location still remains in disrepair.

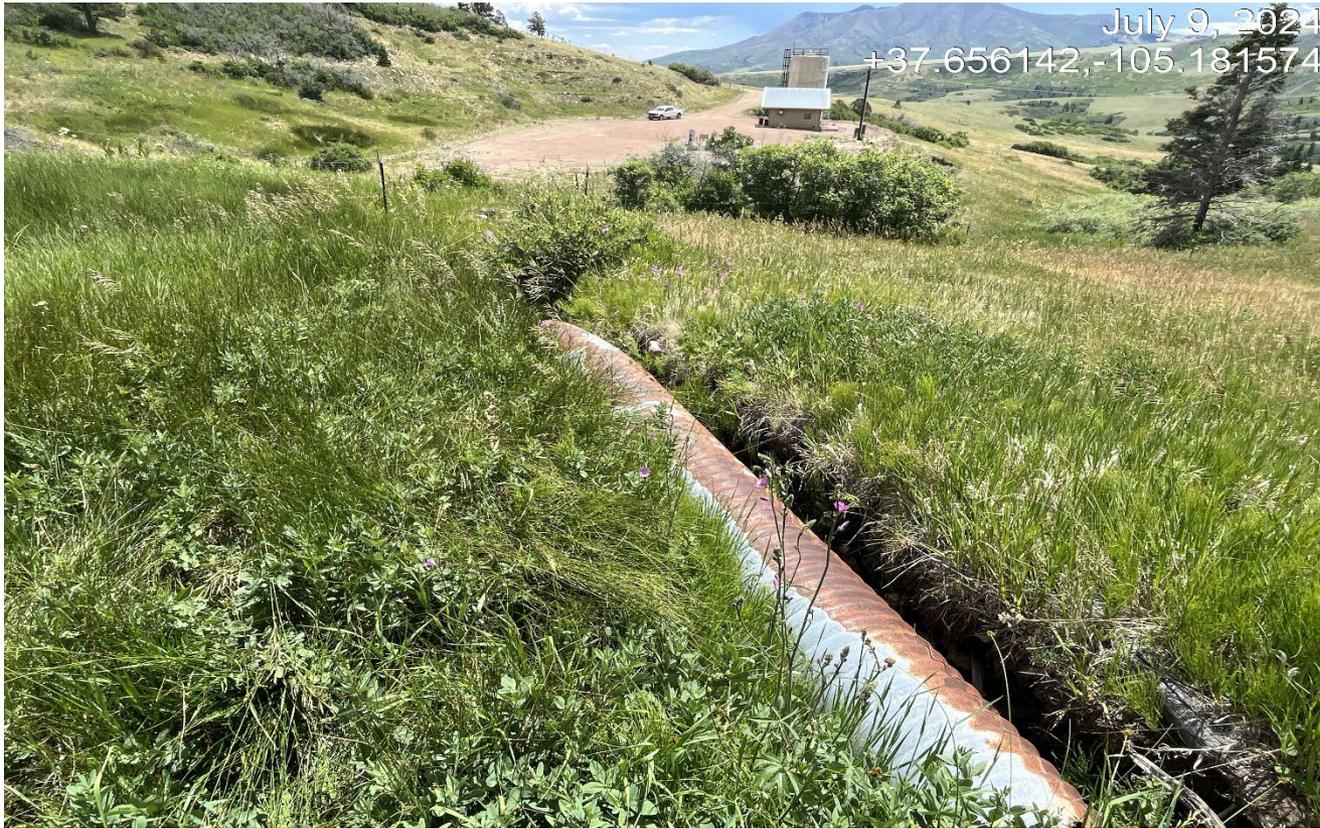
Photo 9. Standing approximately 125' west of the location along the flowline area is an eroded out culvert where the creek flows. The culvert needs repaired or removed. Previous corrective action was not completed.

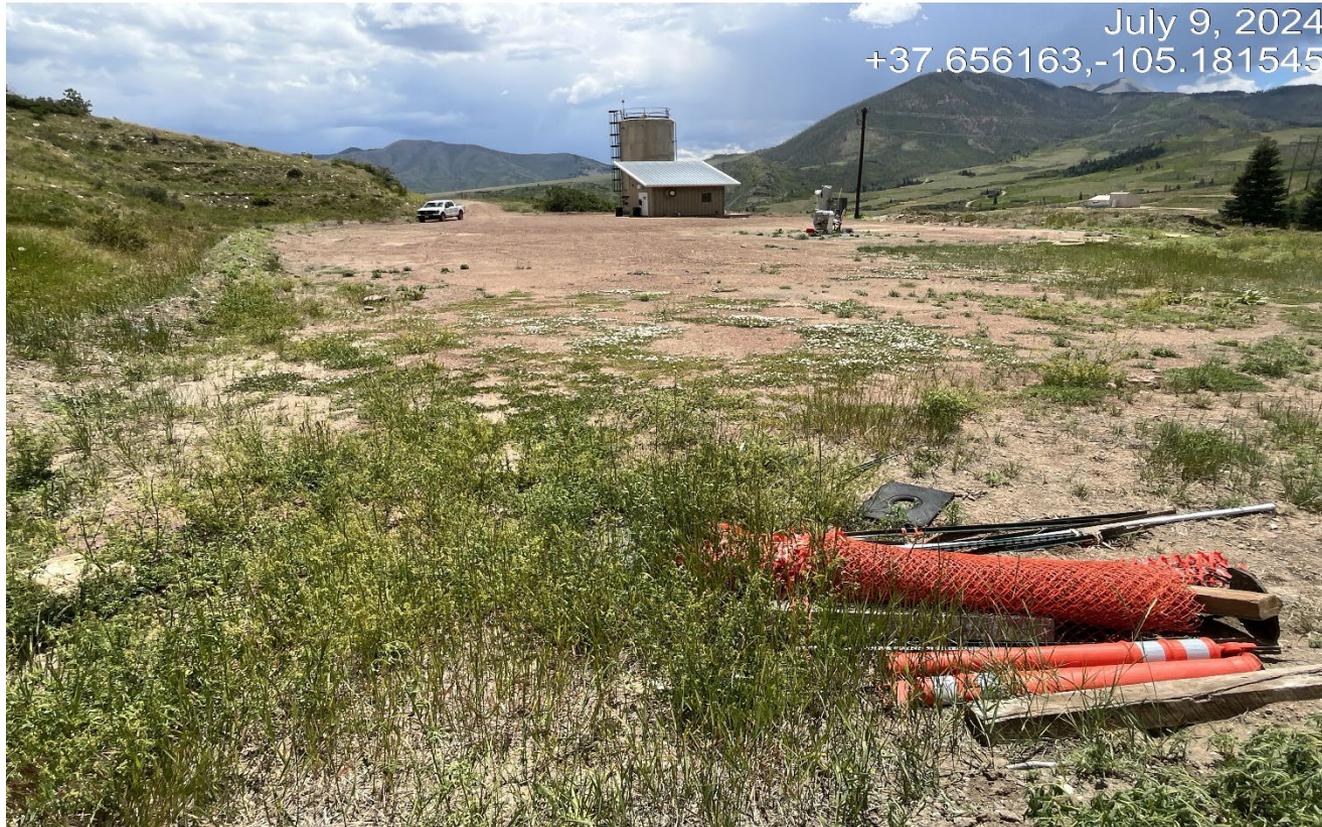
Photo 10. Facing southeast toward the location. There is a pile of orange cones and fencing at this area that needs to be removed.
