# Inspection Photos

07/11/2024

**Operator:** UTAH GAS OP LTD DBA UTAH GAS  
CORP - 10539

**Location ID:** 322443

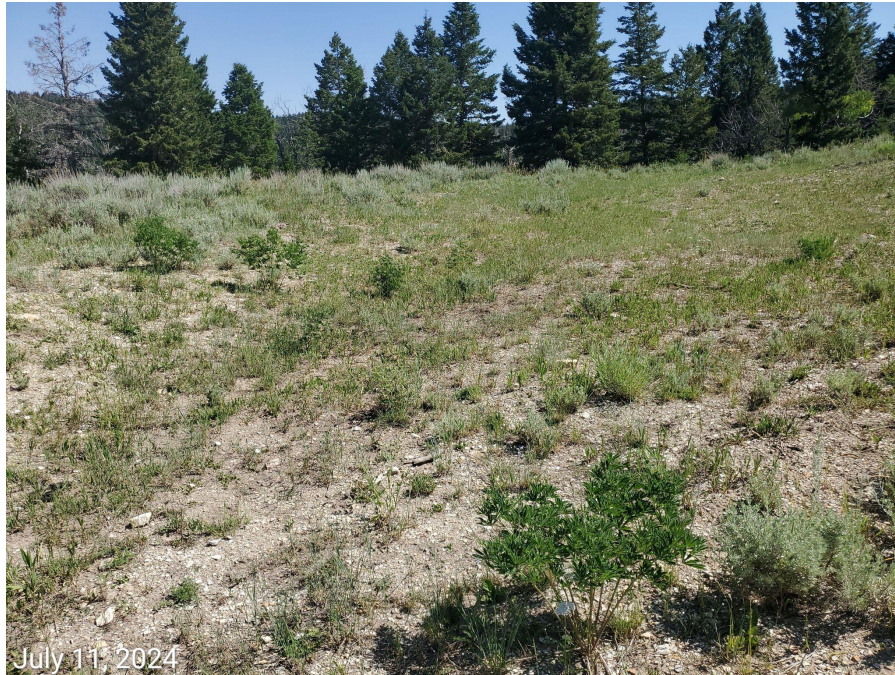
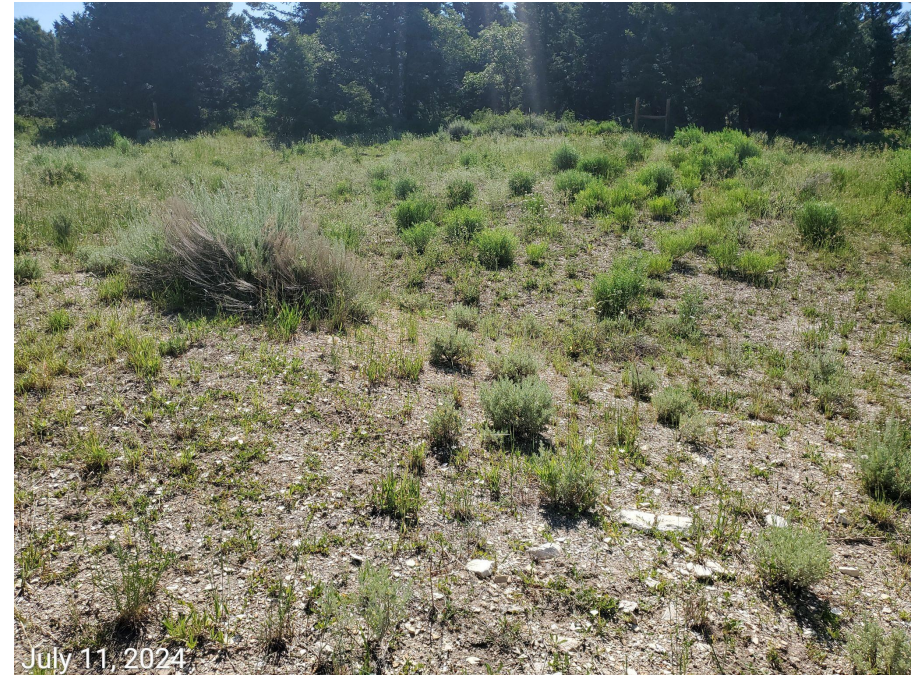
**Photo 1:** Photos taken from the central areas of the Location. Photos provide an overview of the Location facing north, east, south and west.

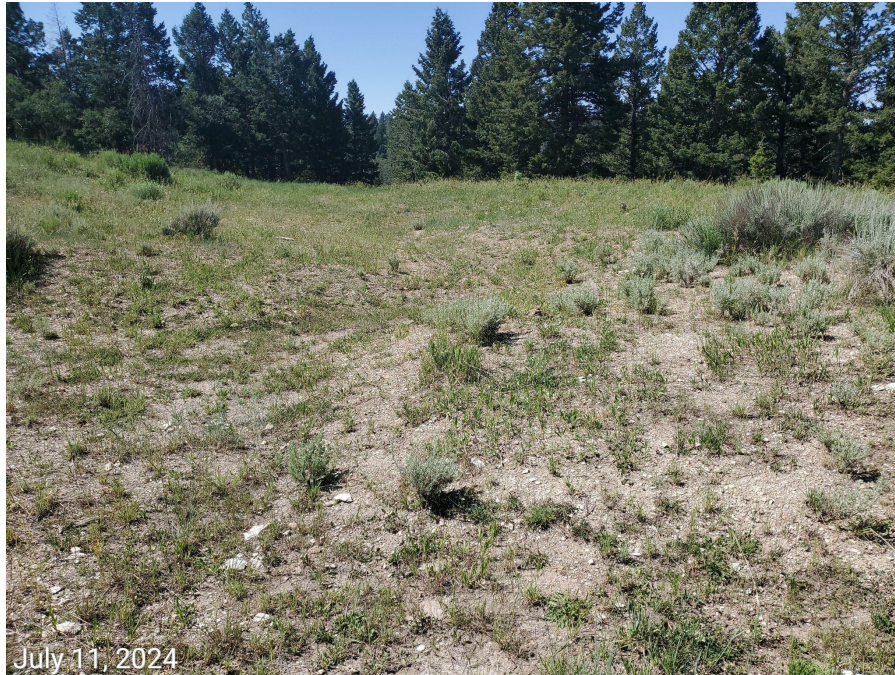
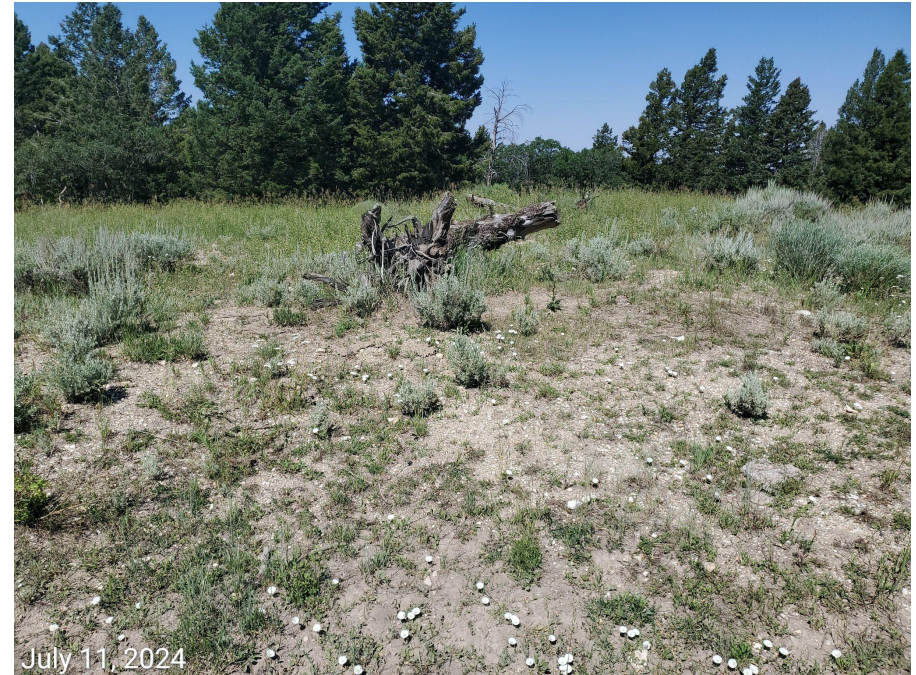
**Photo 2:** See comments under photo 1.

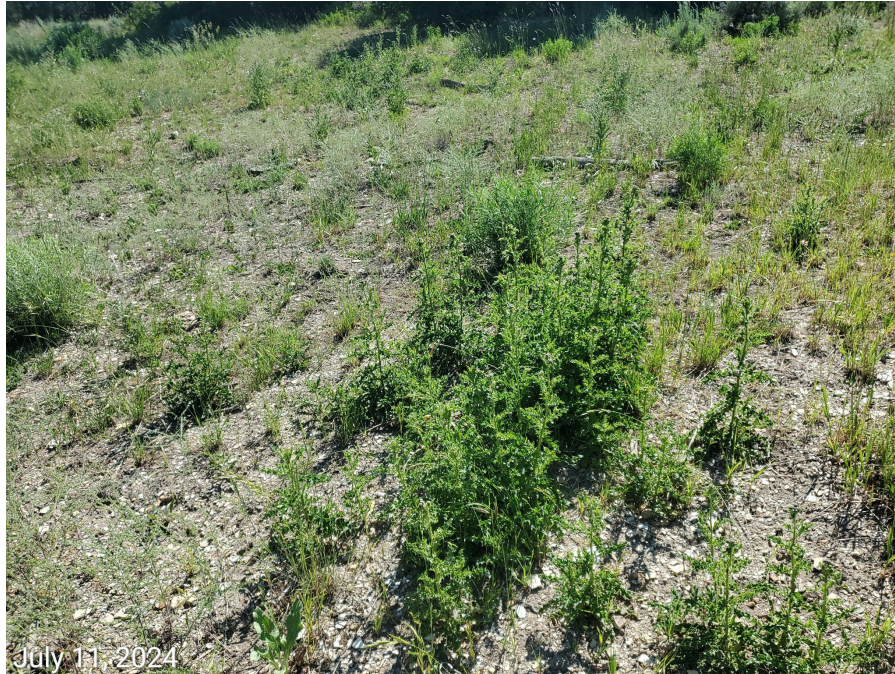
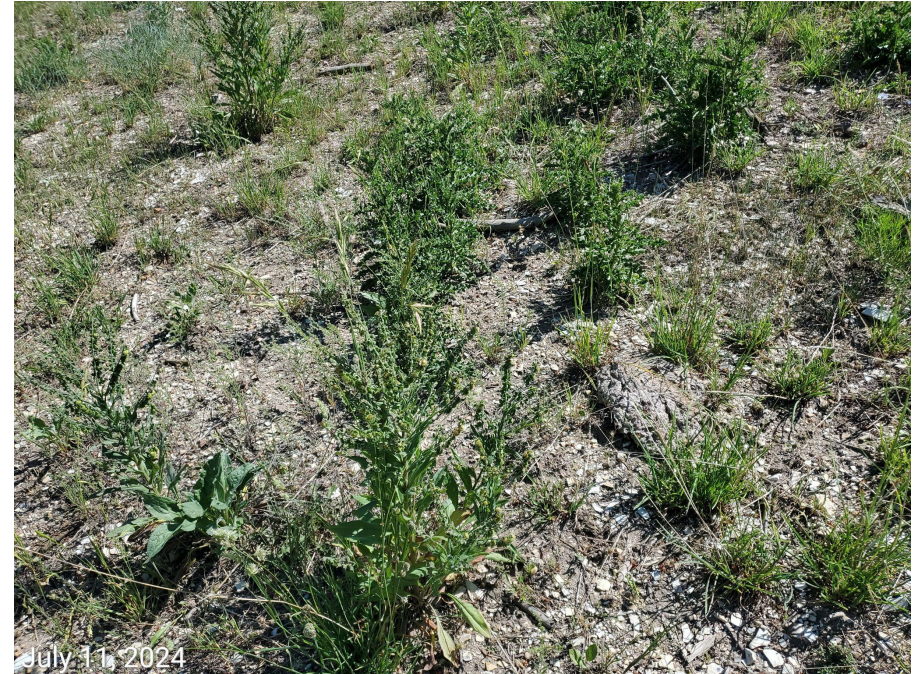
**Photo 3:** Photos 3-4 example showing Undesirable and Noxious Plant establishment observed throughout the Location; Species include Canada thistle, Bull thistles, Houndstongue, Field Bindweed.

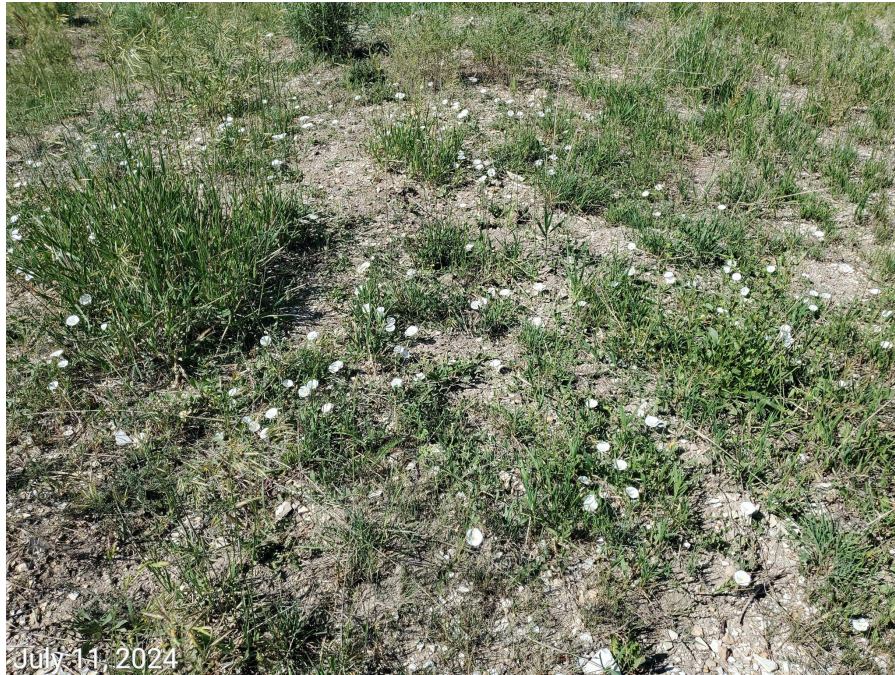
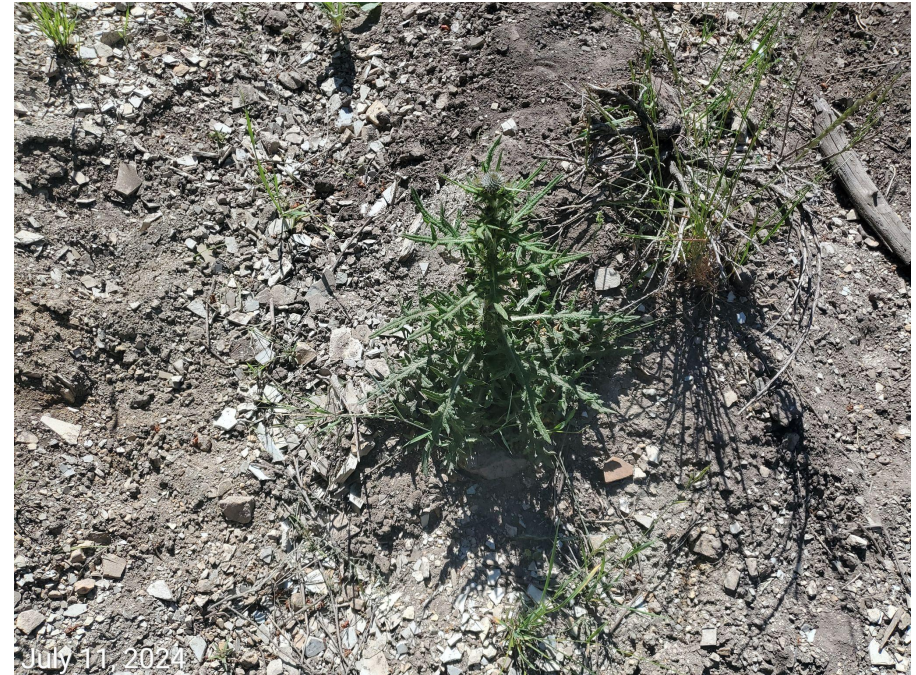
**Photo 4:** See comments under photo 3.

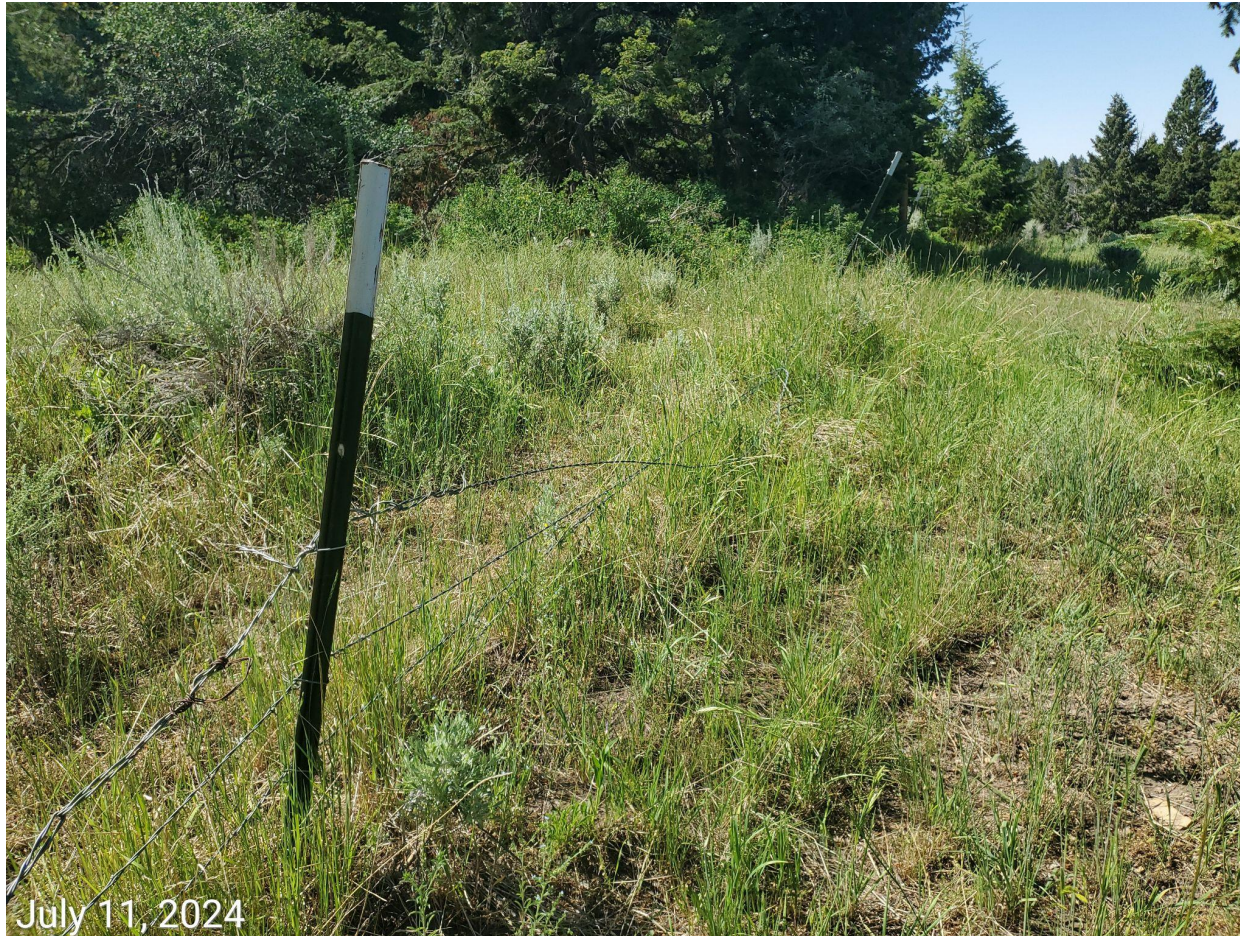
**Photo 5:** Photo example showing fence along the perimeter of the Location has not been maintained.

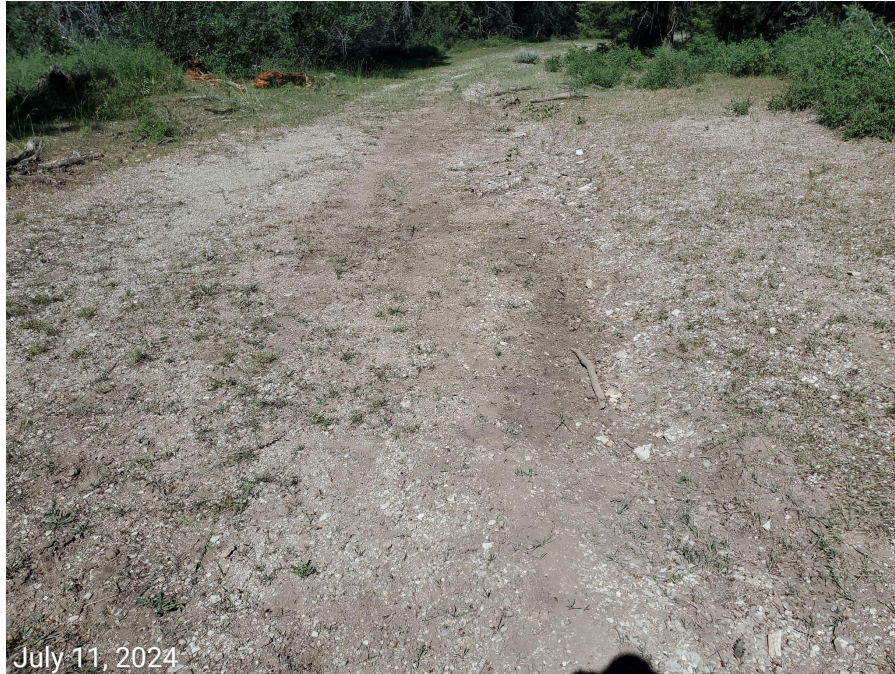
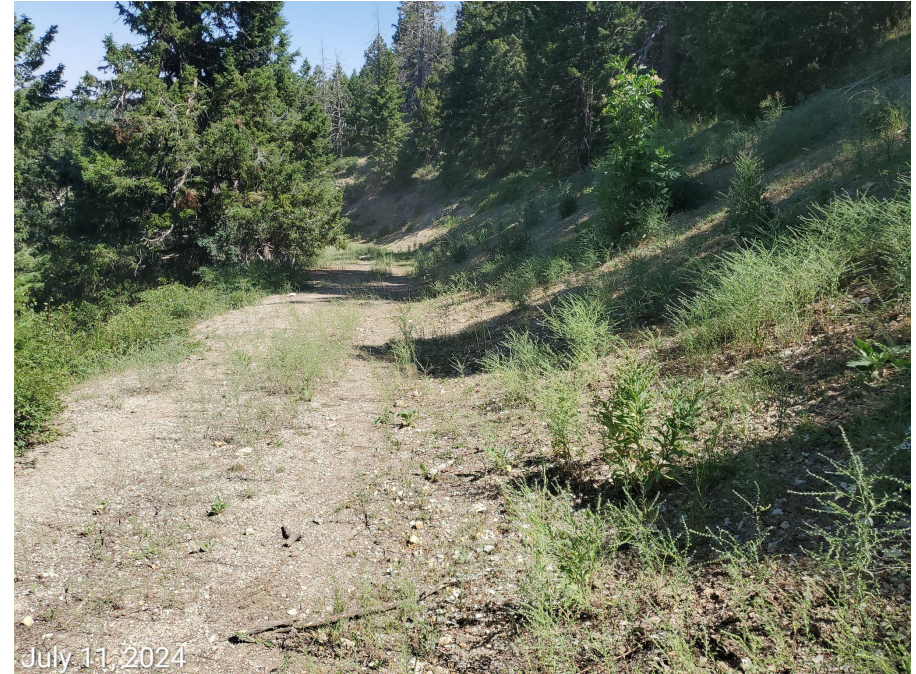
**Photo 6:** Photos 6-9 taken from the access road leading to the Location. Photos examples showing reclamation including, but not limited to, compaction alleviation, recontouring/regrading and revegetation have not been performed in accordance with 1004 Rules.

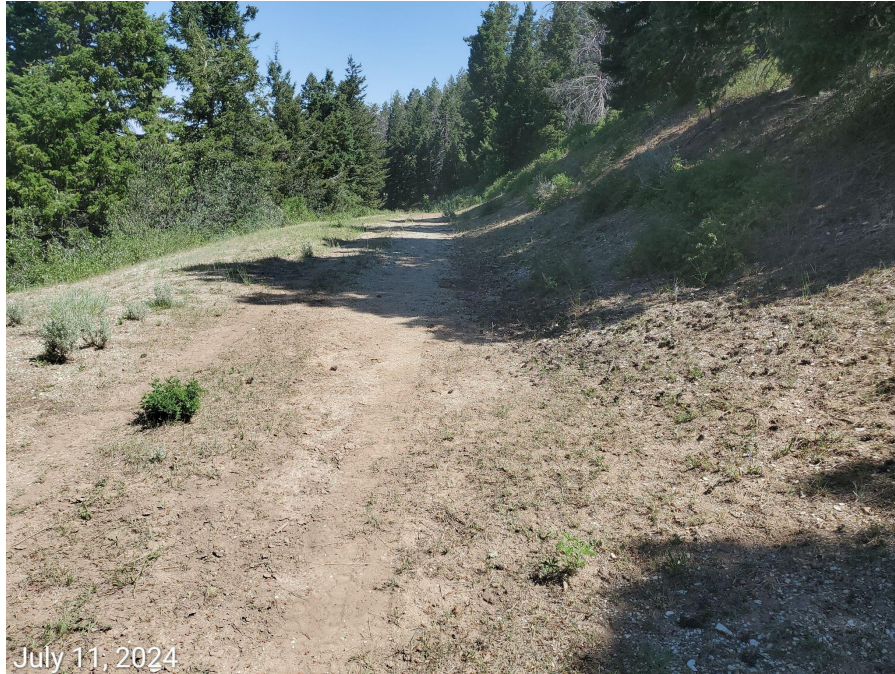
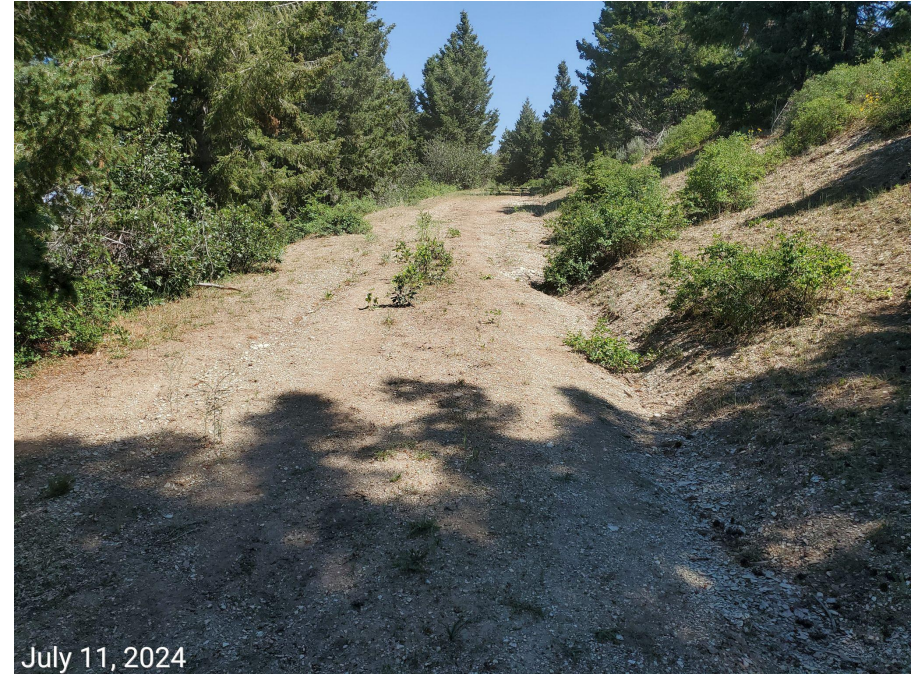
**Photo 7:** See comments under photo 6.

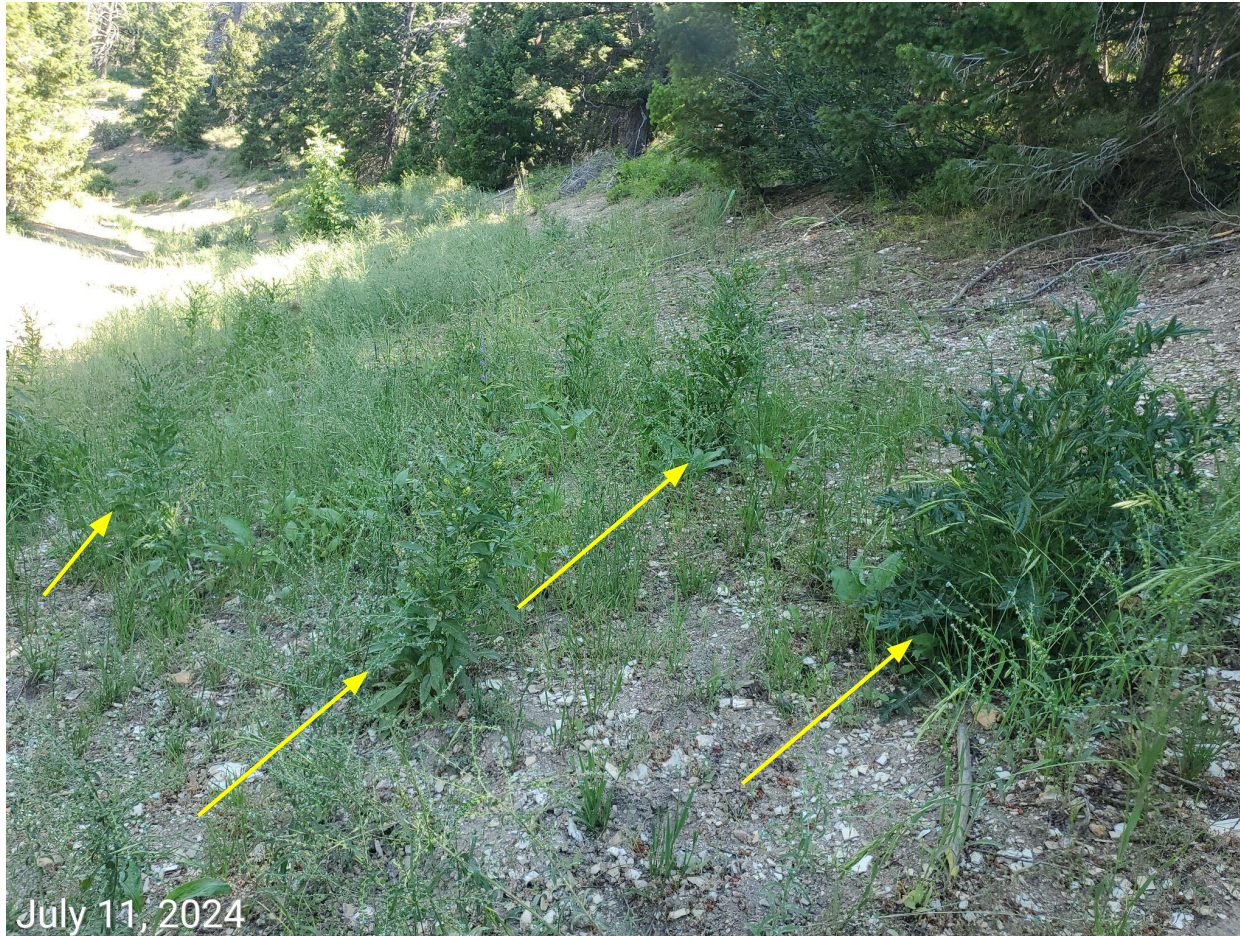
**Photo 8:** See comments under photo 6. Photo taken from the cut slopes of the access road. Vegetation along road is predominantly undesirable plant species including Houndstongue and Bull thistle as seen within this photo.

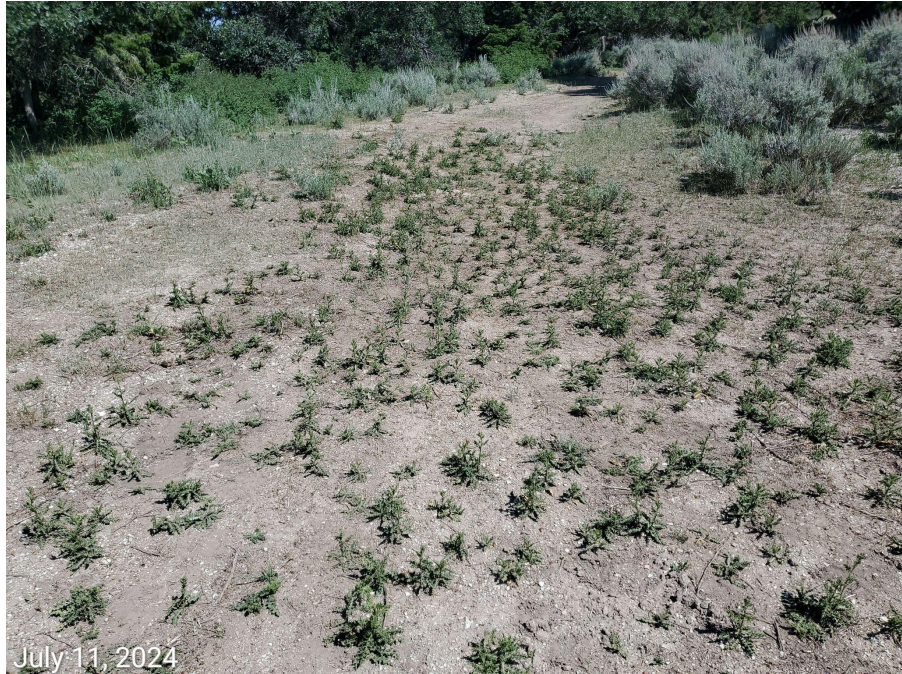
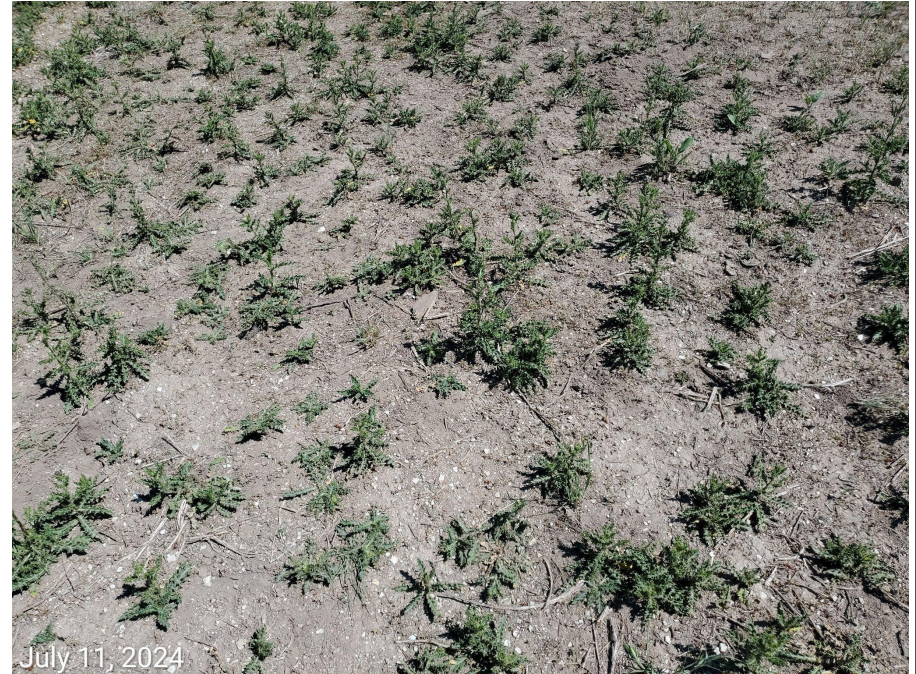
**Photo 9:** See comments under photo 6. Photo taken from the access road. Vegetation along road is predominantly undesirable plant species including Canada thistle as seen within this photo.
