Inspection Photos

Loc: 485654

Operator: BNL (ENTERPRISE) INC

Inspection Date: 7/16/2024

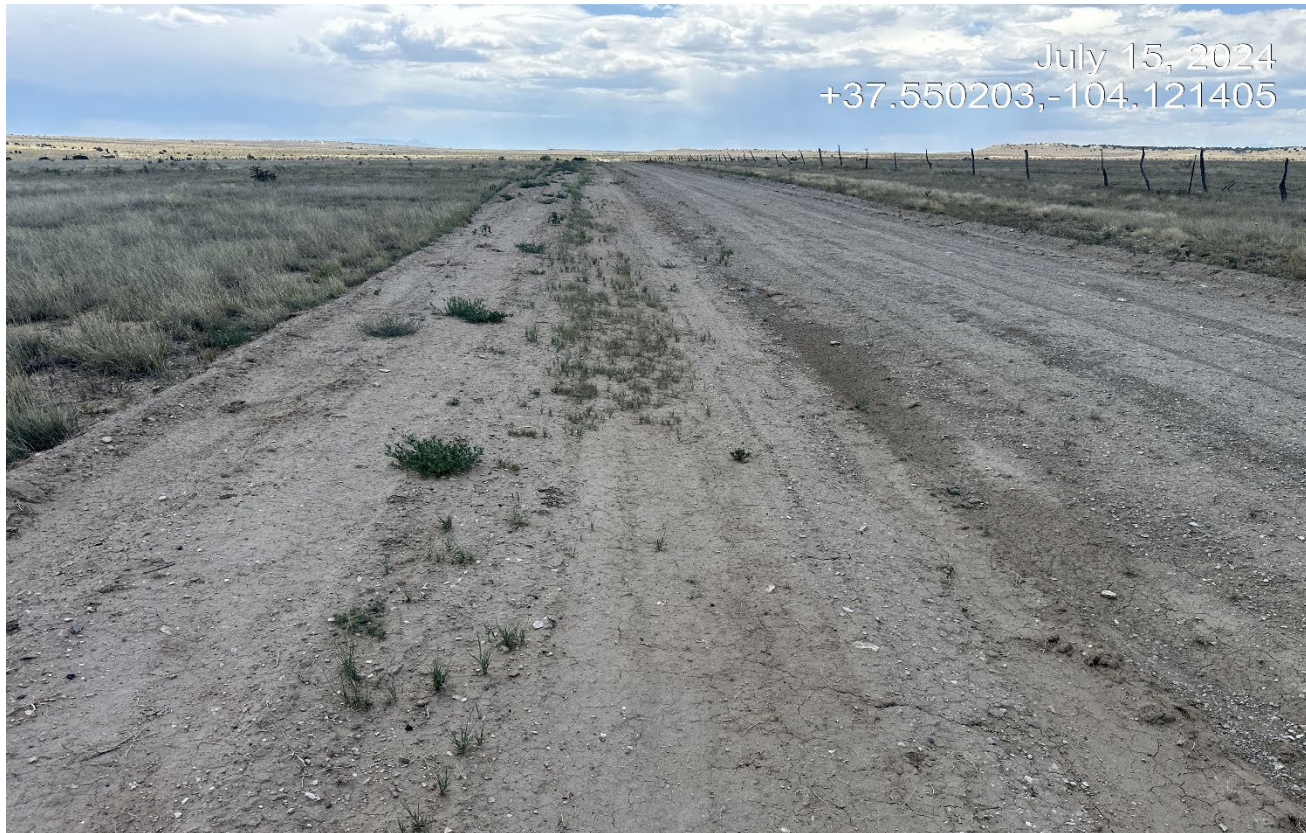
Photo 1. Facing south toward the access road. The sides of the road will need to be reclaimed. The road has been regraded and crowned since previous inspection.

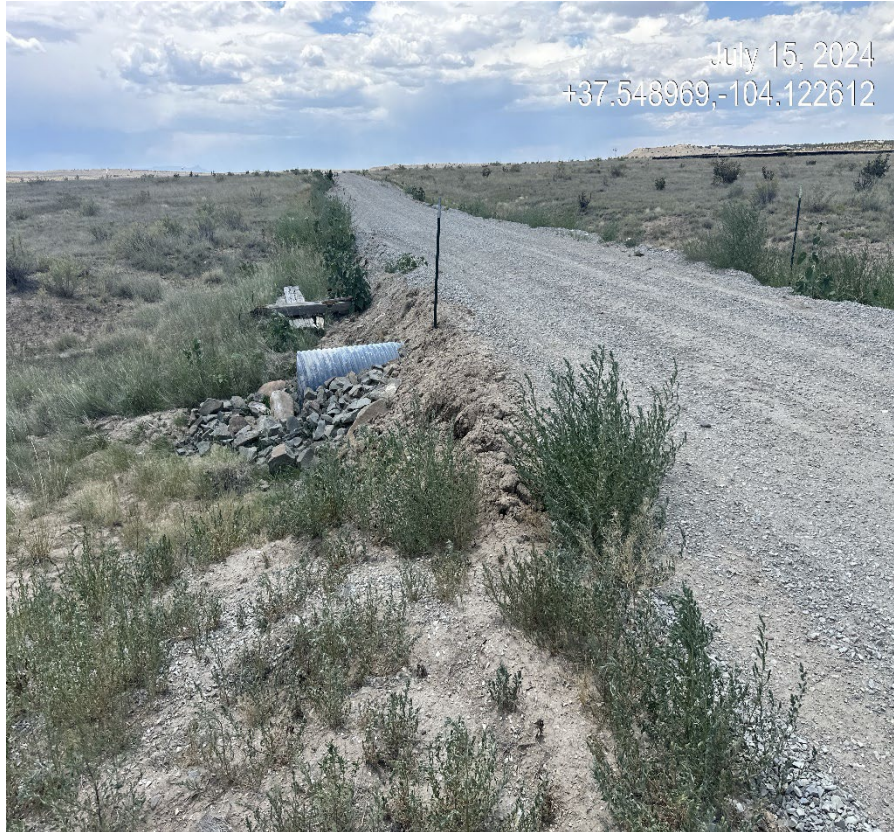
Photo 2. The culvert outlet has been repaired and outlet protection was installed, The loose soil along the embankment need to be stabilized..

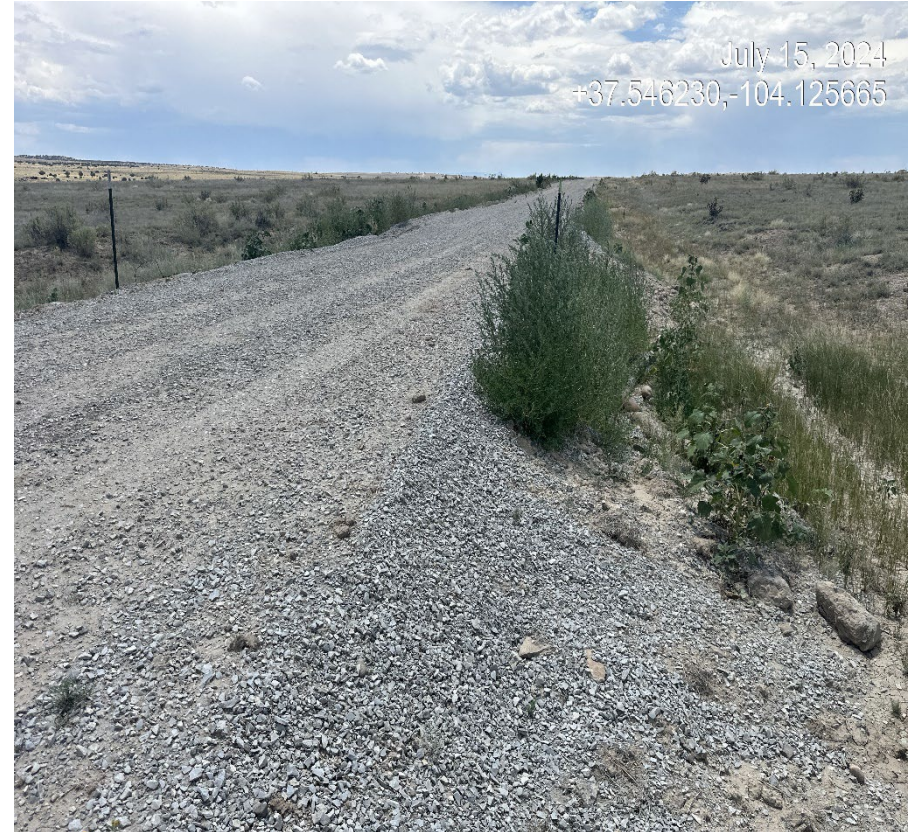
Photo 3. The embankment along the road side at the culvert is not stabilized and loose gravel is falling into the culvert.

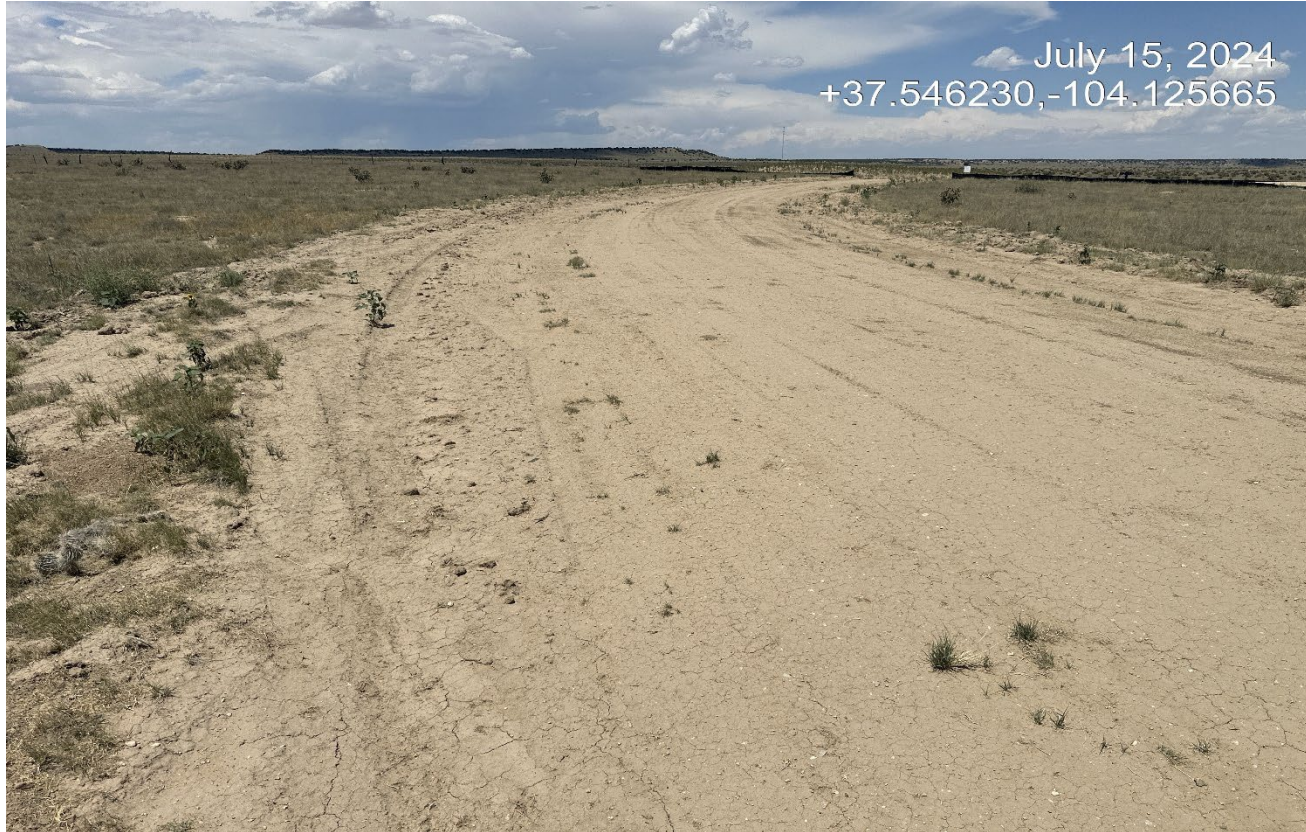
Photo 3. Facing northwest toward the access road. The side of the road needs to be seeded and stabilized. Previous corrective action was not completed.

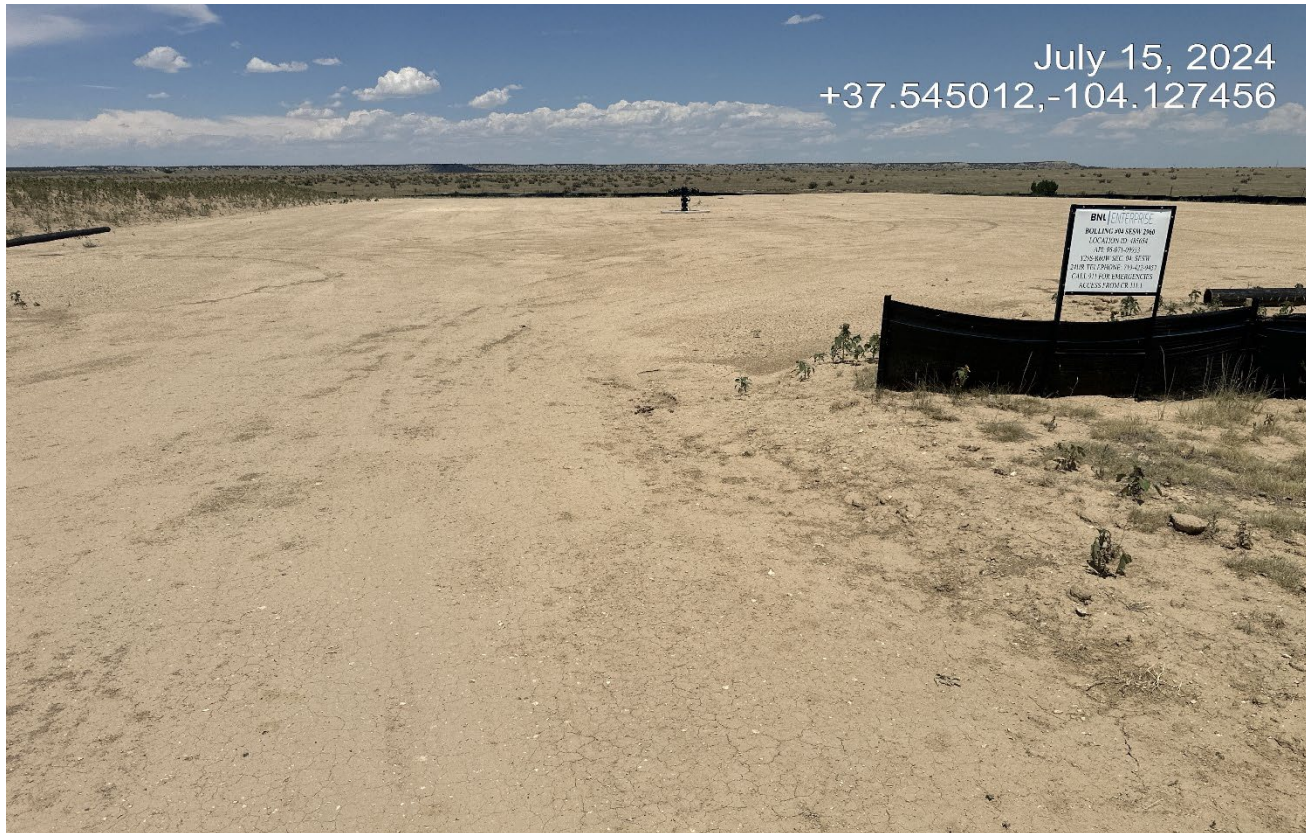
Photo 4. Facing west toward the location. Sign posted at entrance.

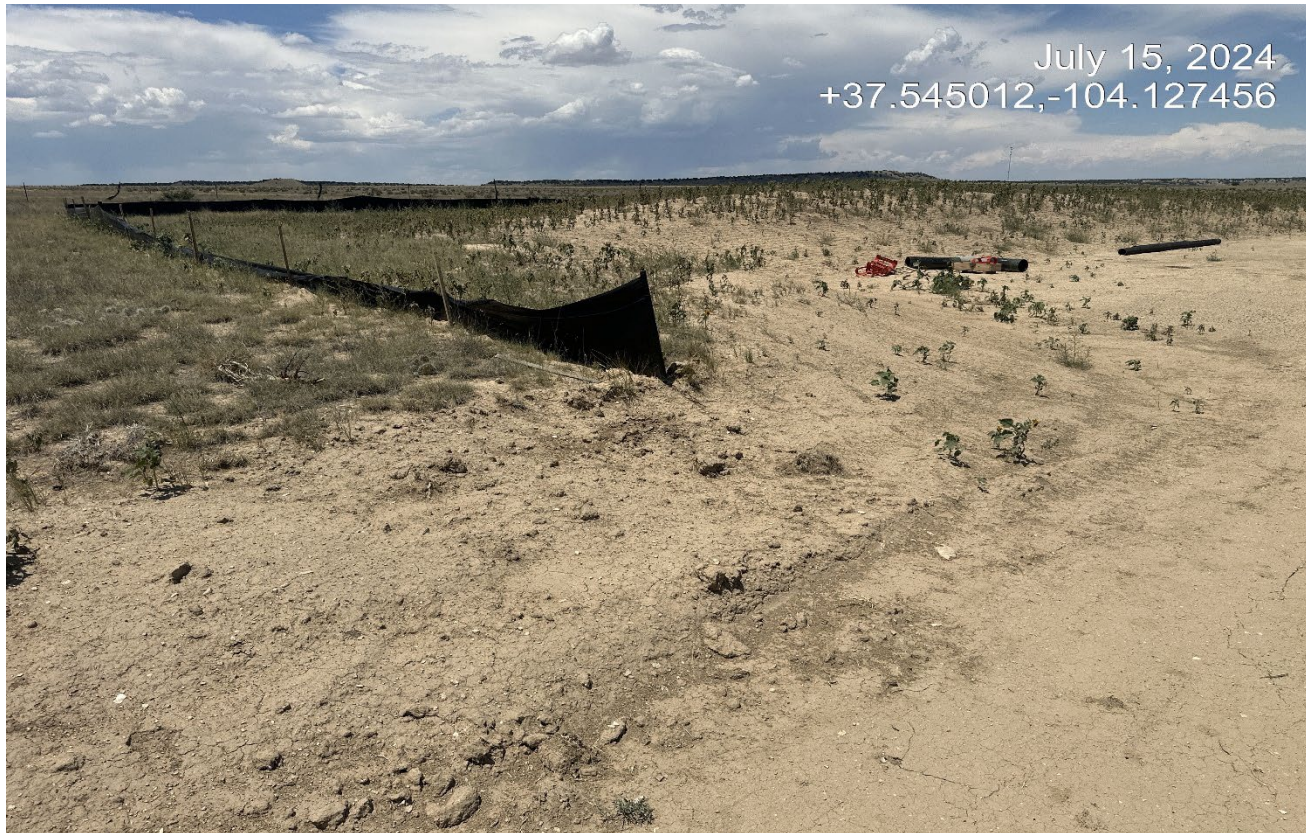
Photo 5. Facing southwest at the location. The silt fence is not maintained.

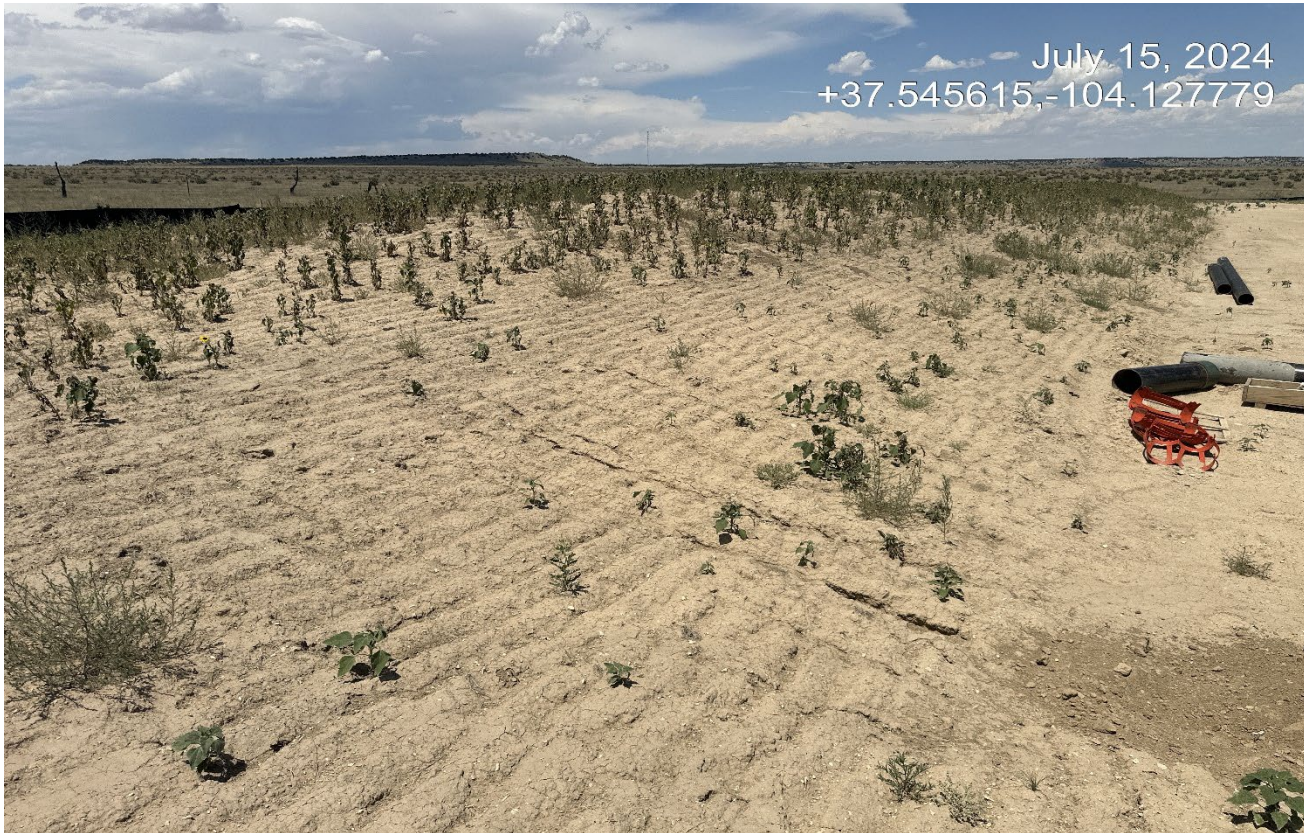
Photo 6. Facing toward the soil stock pile. The topsoil has not been seeded and stabilized and weeds are beginning to establish.

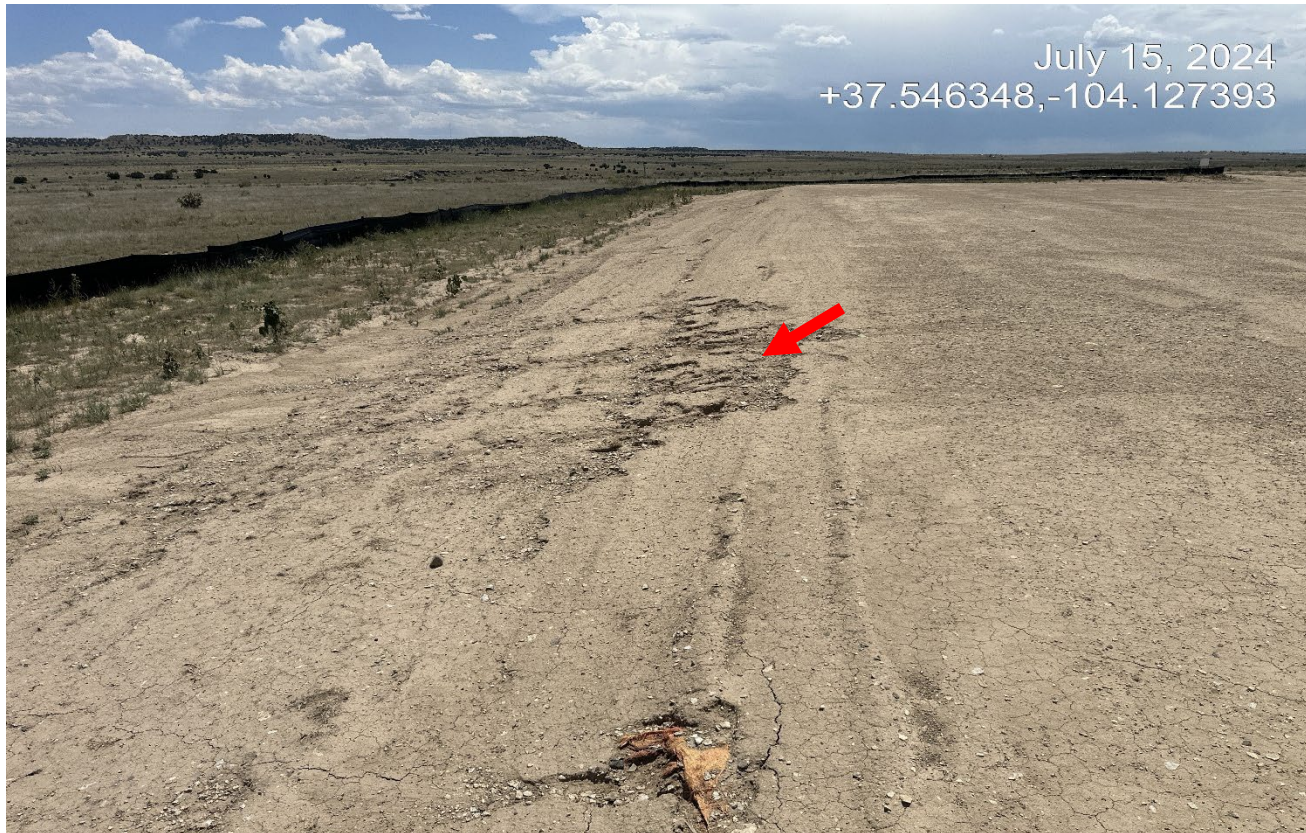
Photo 8. Facing southeast along the fill slope. There is erosion occurring shown at red arrow.

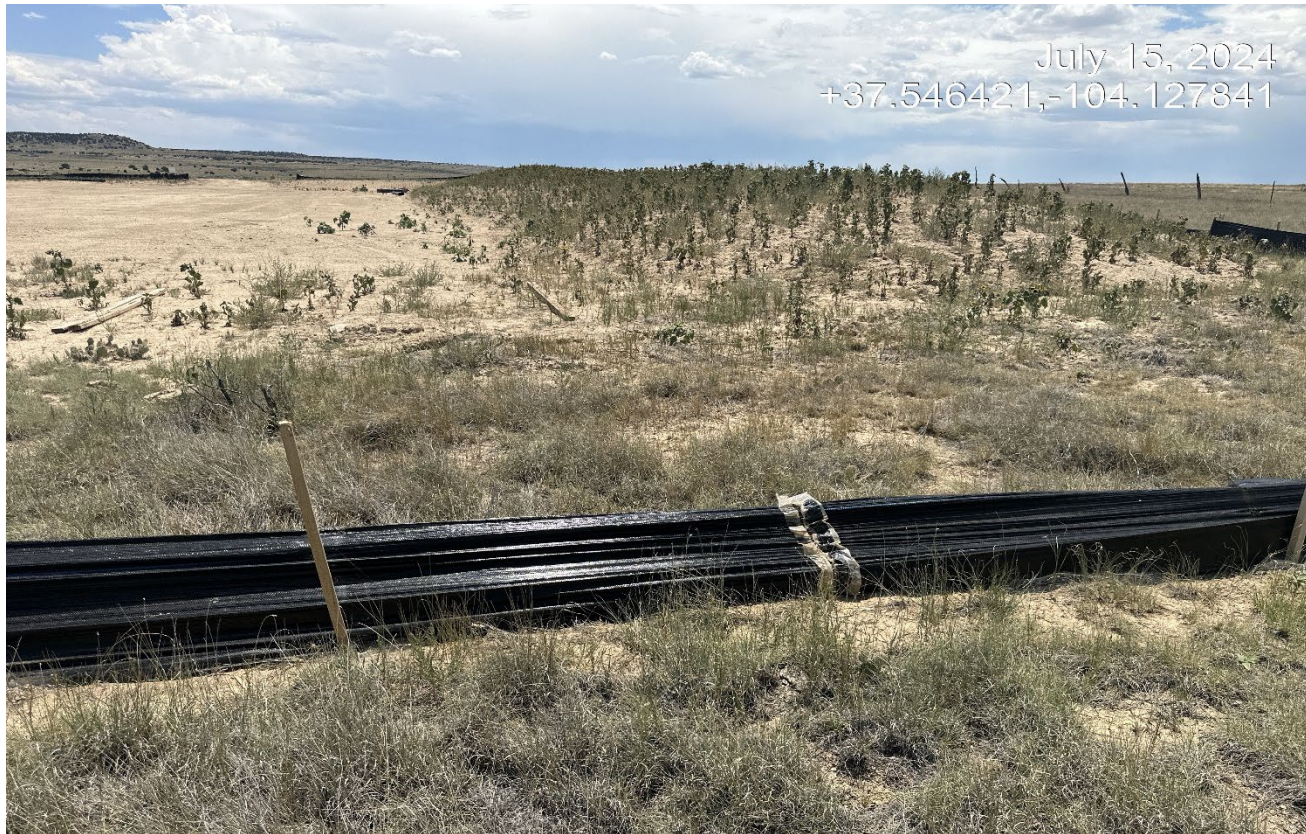
Photo 9. Southwest side of the location facing east. The silt fence is down and not maintained.

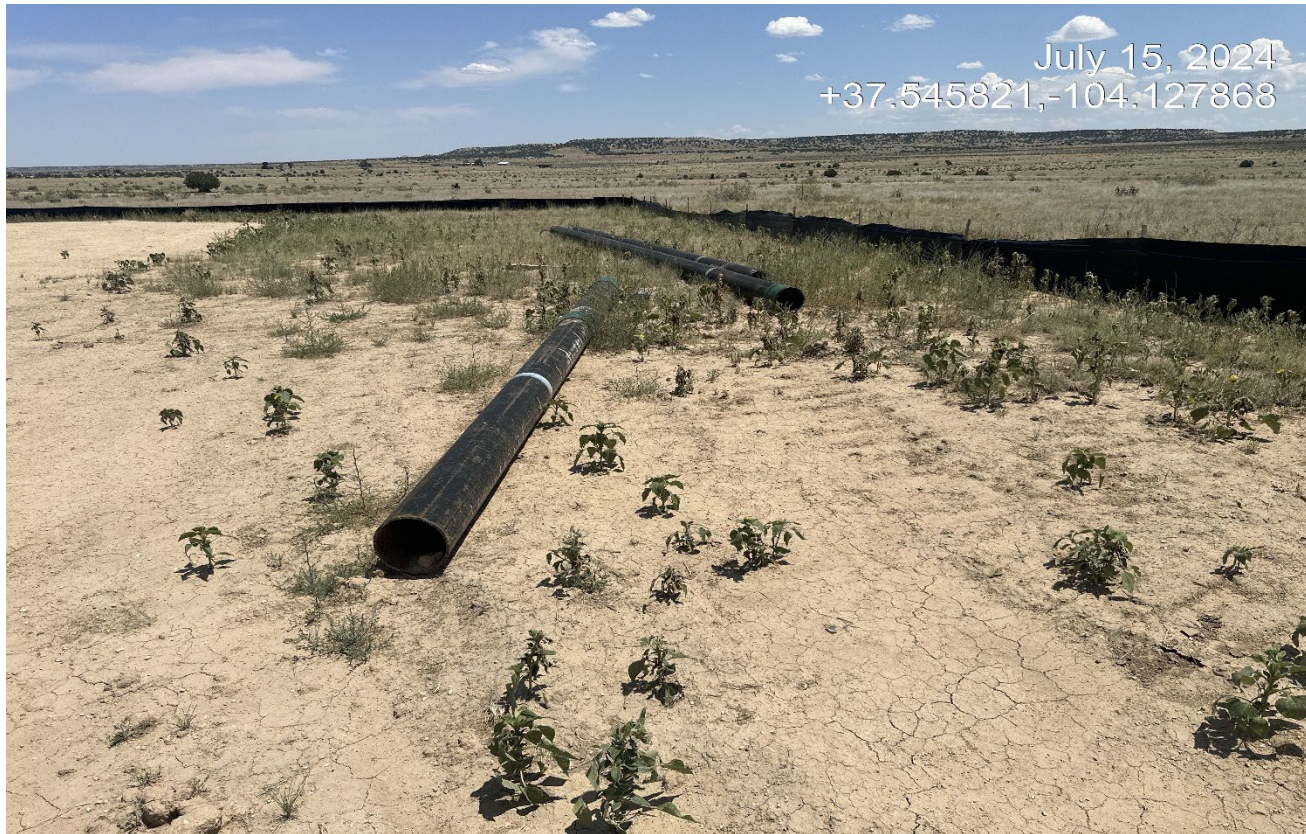
Photo 10. There is unused pipe stored at the east side of the location that must be removed.
