Inspection Photos
Location: RMF Consolidation Line
Facility ID: 480127

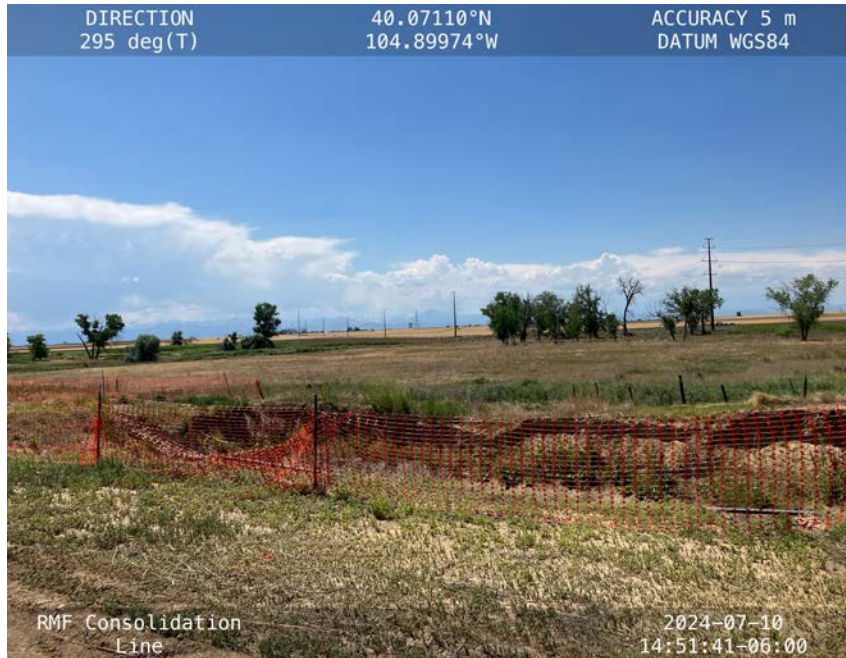
Photo 1 – Fencing surrounding the excavation

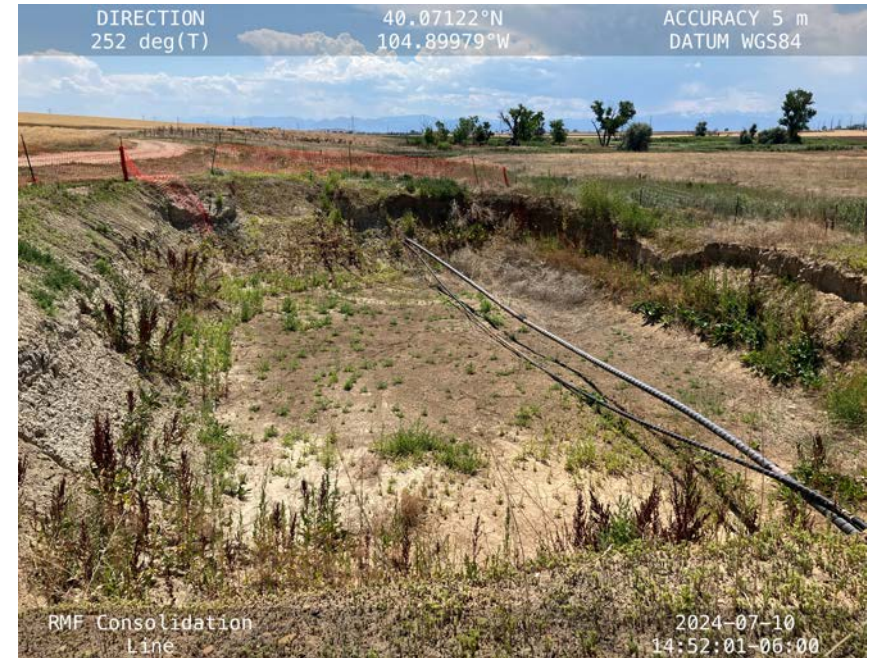
Photo 4 – Excavation and weeds

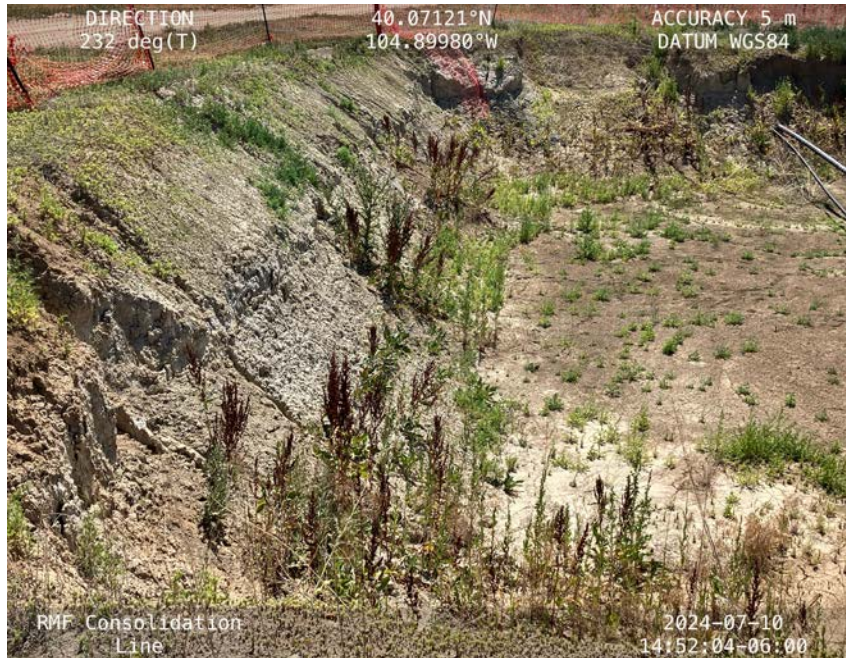
Photo 5 – Excavation and weeds

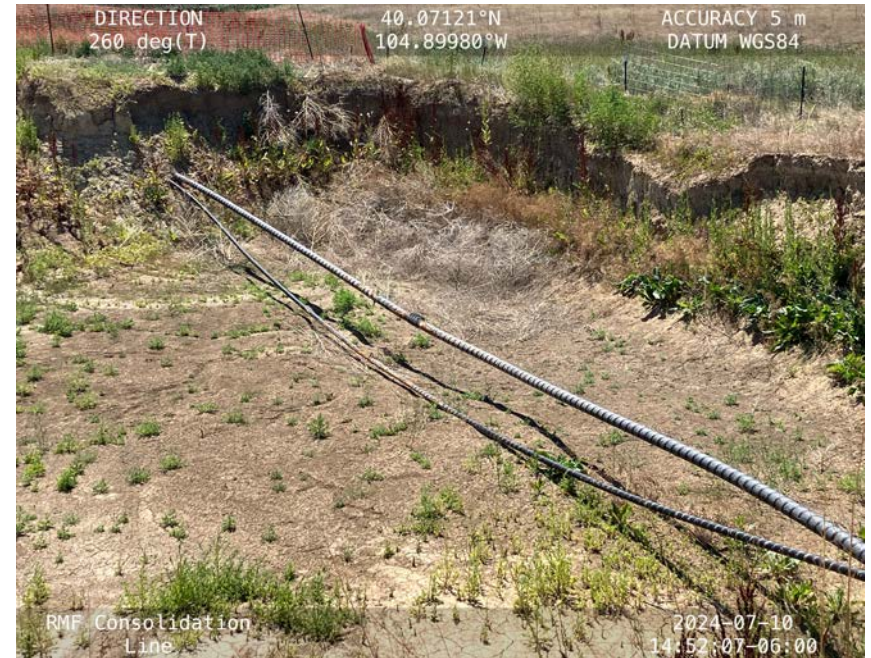
Photo 6 – Excavation and weeds

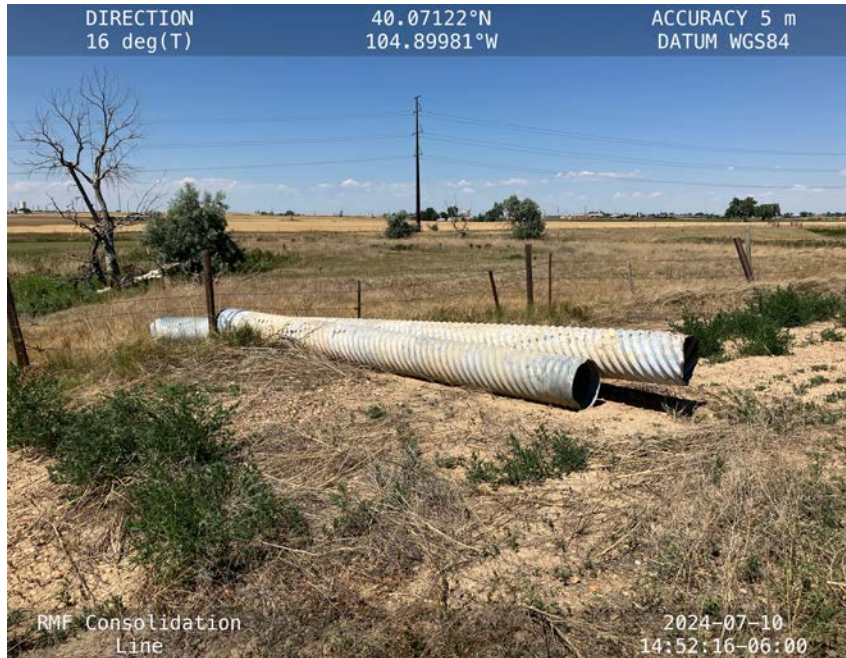
Photo 7 – Storage of piping onsite

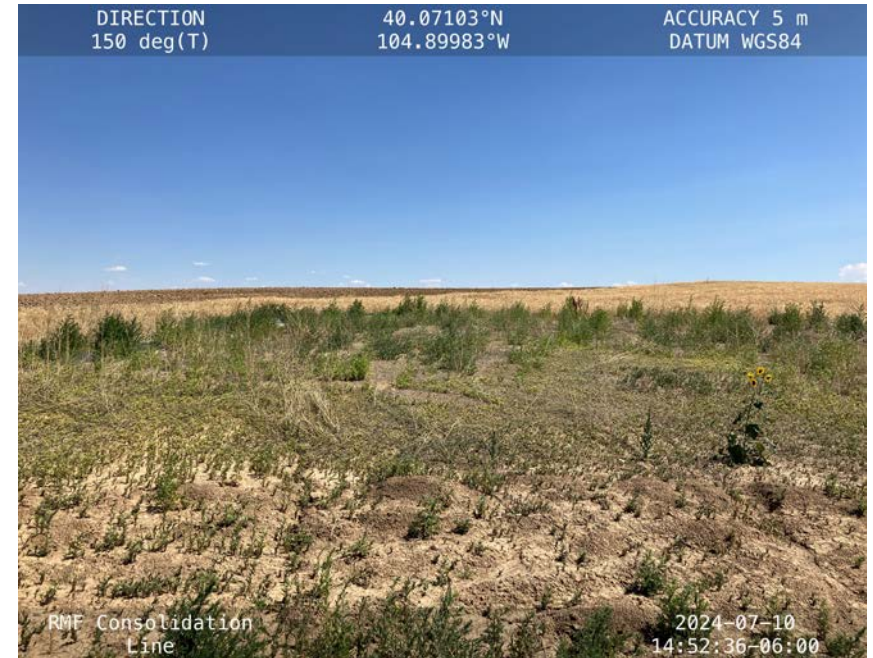
Photo 8 – Weeds

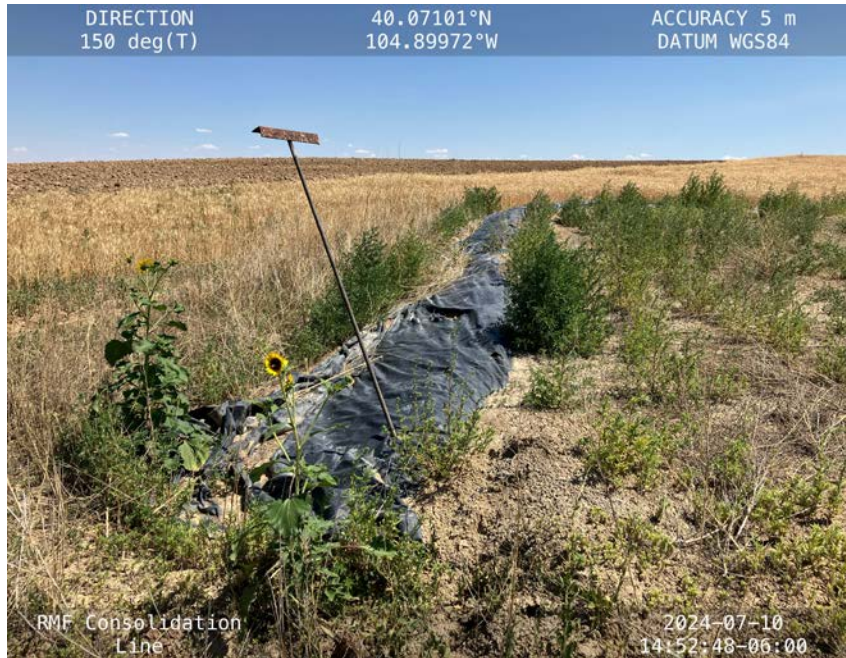
Photo 9 – Weeds and compromised liner

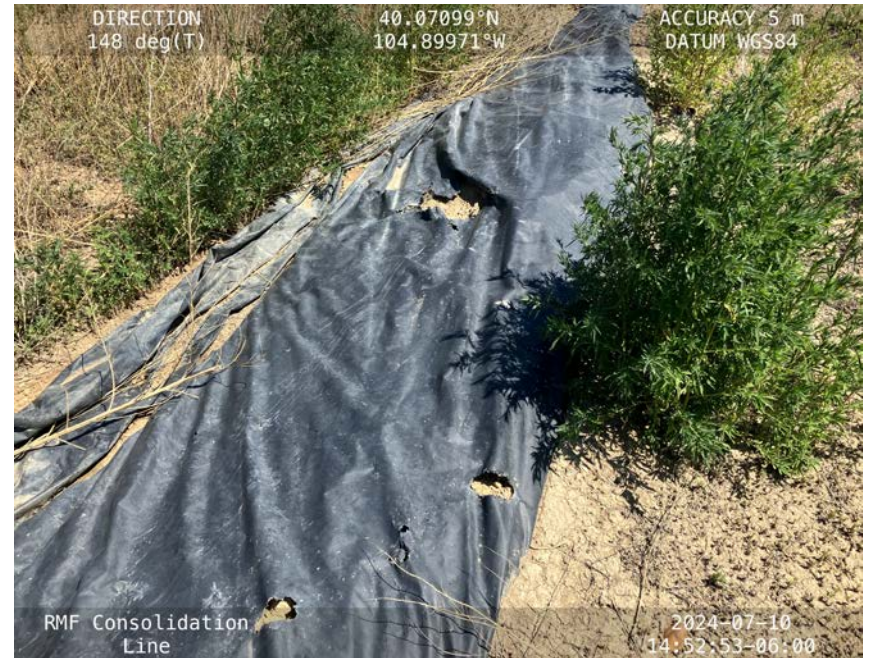
Photo 10 – Weeds and compromised liner

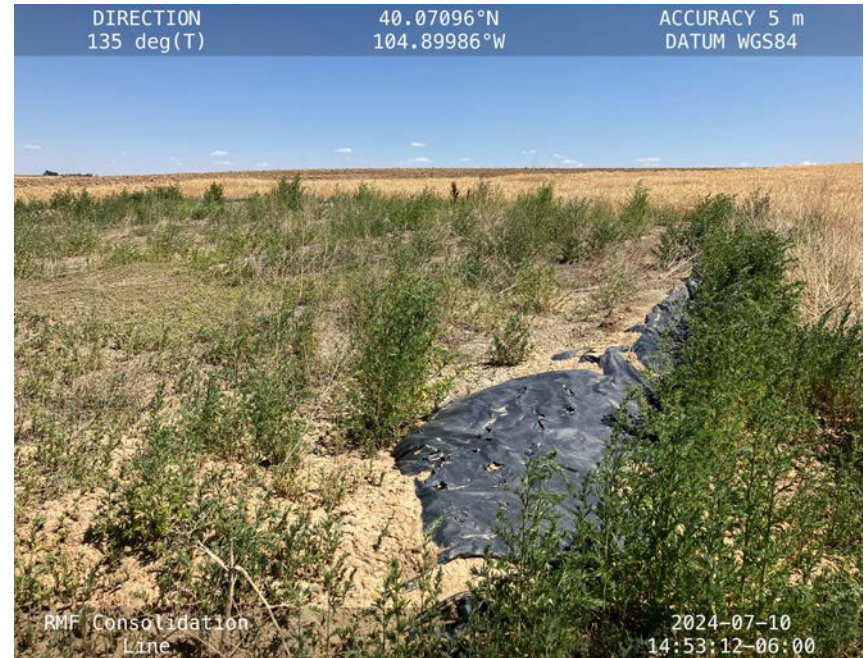
Photo 12 – Weeds and compromised liner

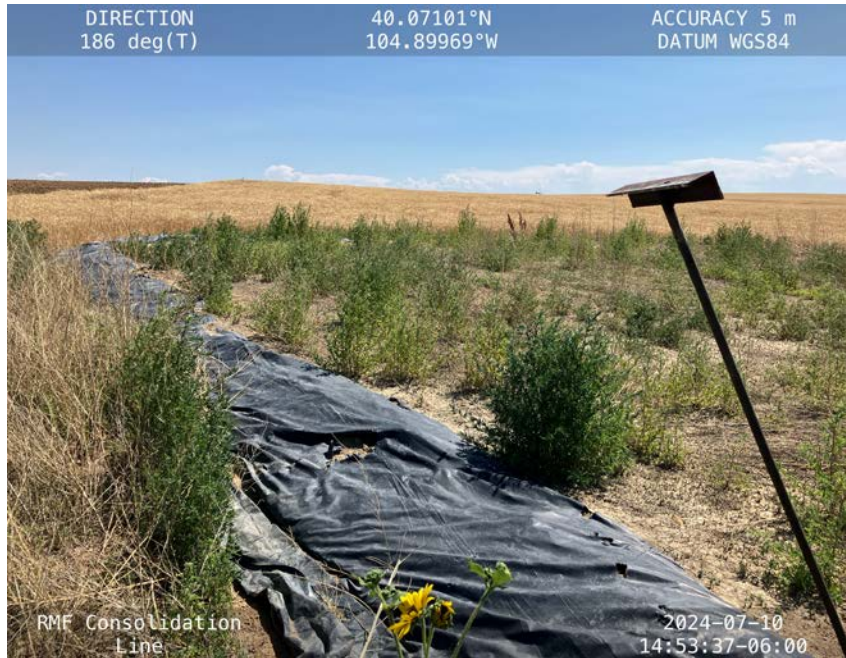
Photo 13 – Weeds and compromised liner

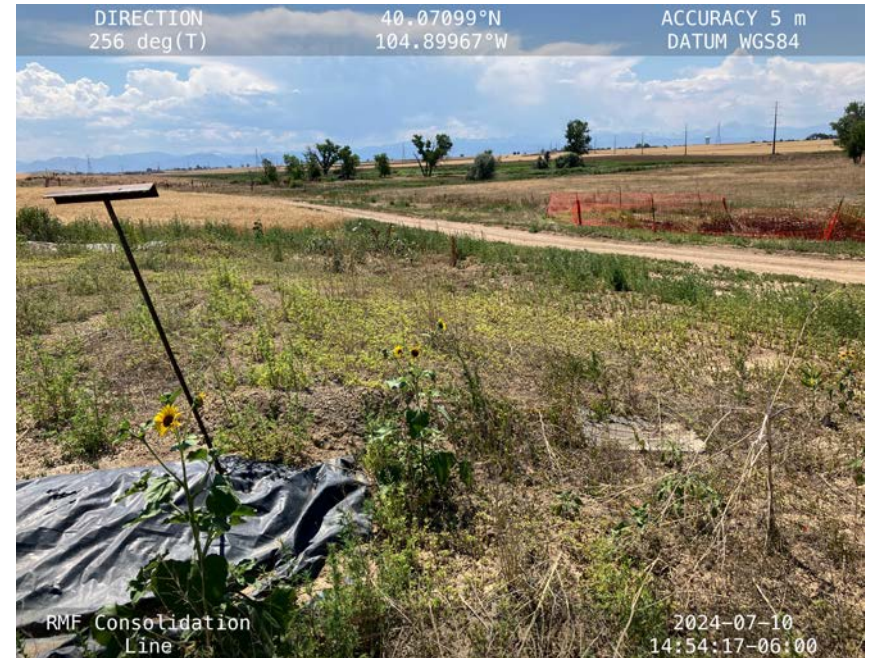
Photo 14 – Stockpile runoff of the liner
