Inspection Photos

Operator: SONTERRA ENERGY, L.L.C. #80890 /
XTO ENERGY INC #100264

Location ID: 315221

Inspection Doc: 696205995

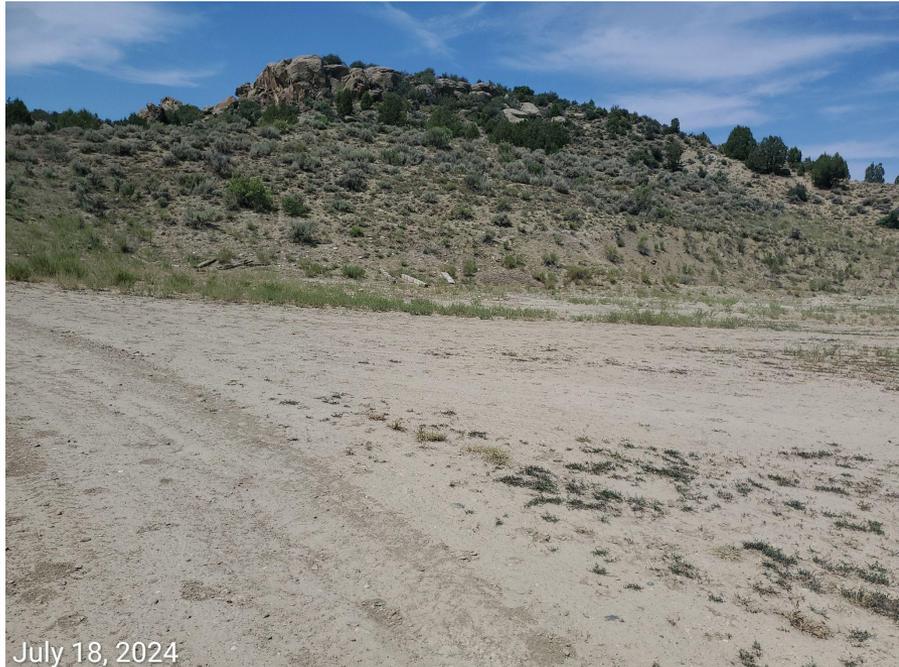
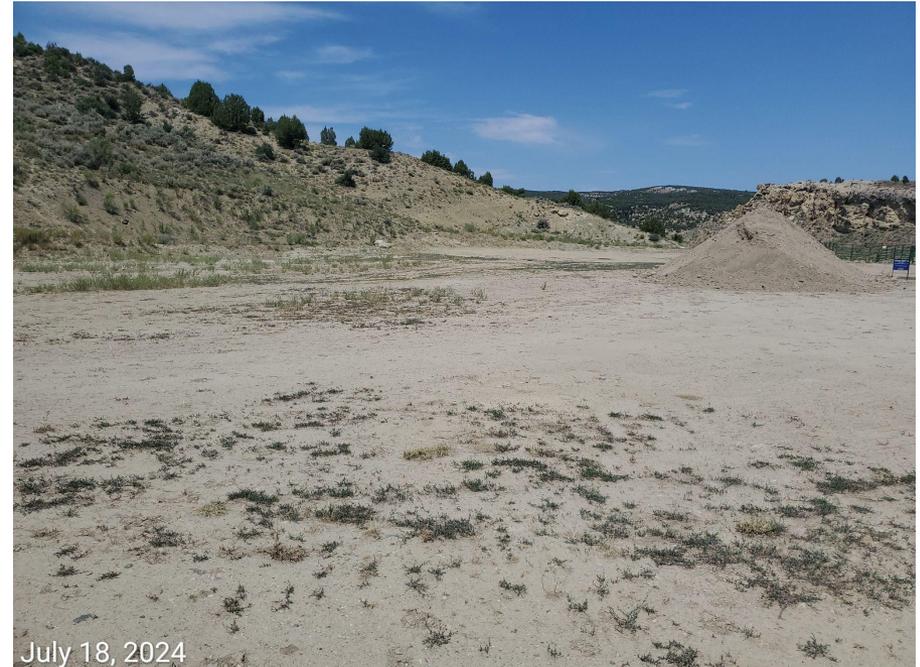
Photo 1: Photos 1-2 taken from the south end of the Location. Photos provide an overview from west, northwest, northeast to east. 1004 Reclamation work including, but not limited to, compaction alleviation, recontouring/regrading and revegetation has not been performed.

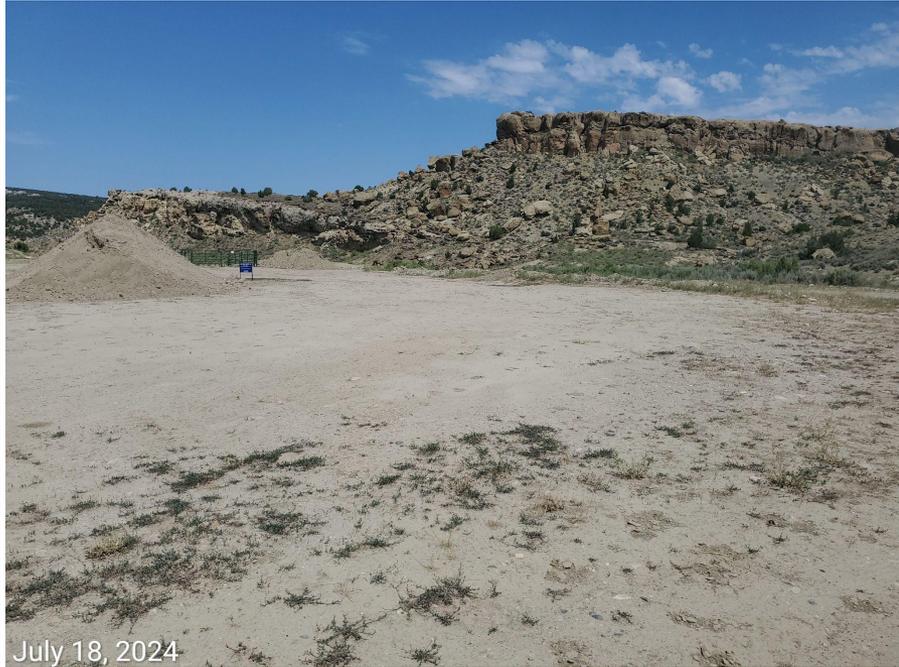
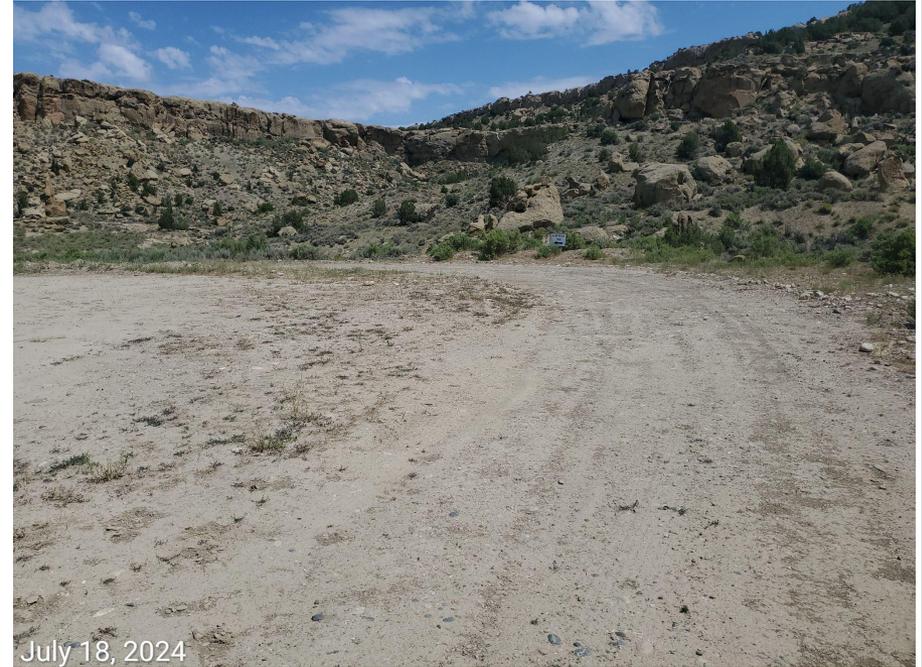
Photo 2: See comments under photo 1.

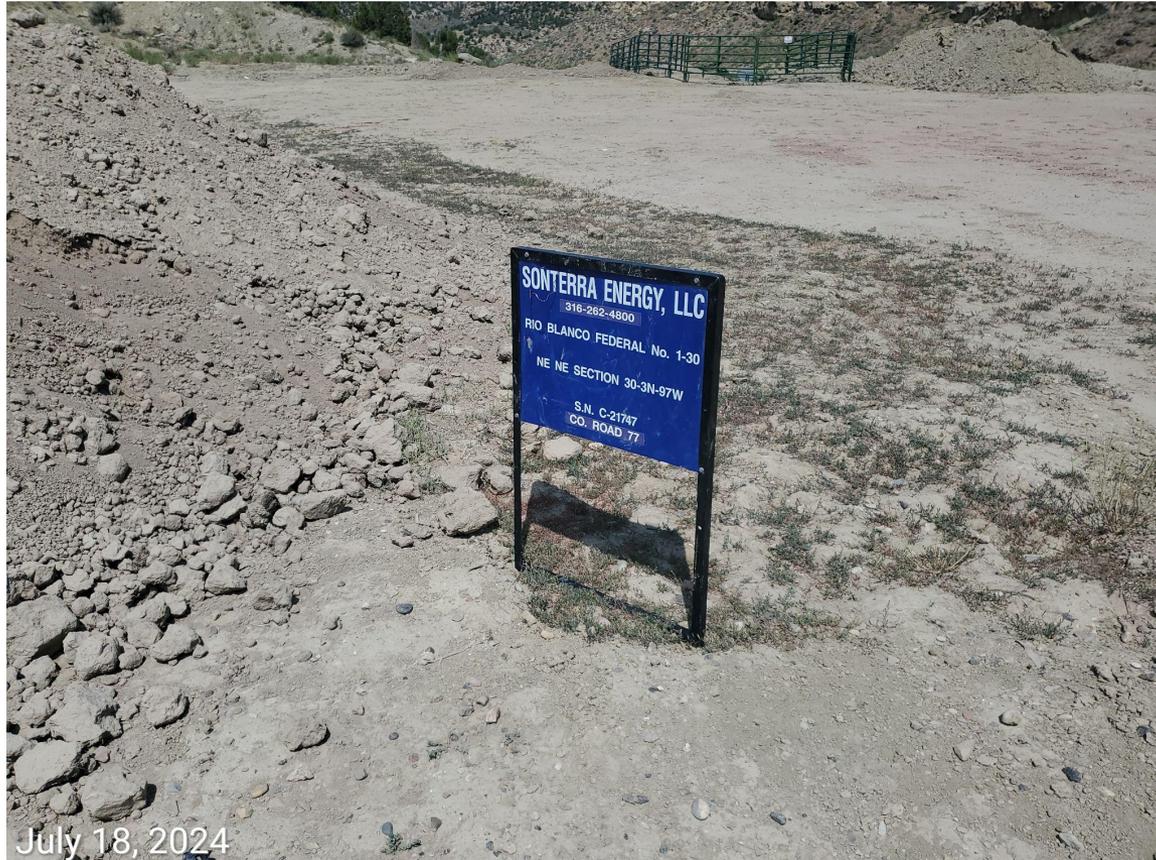
Photo 3: Photo taken from the central areas of the Location. Photo shows Sonterra Energy sign.

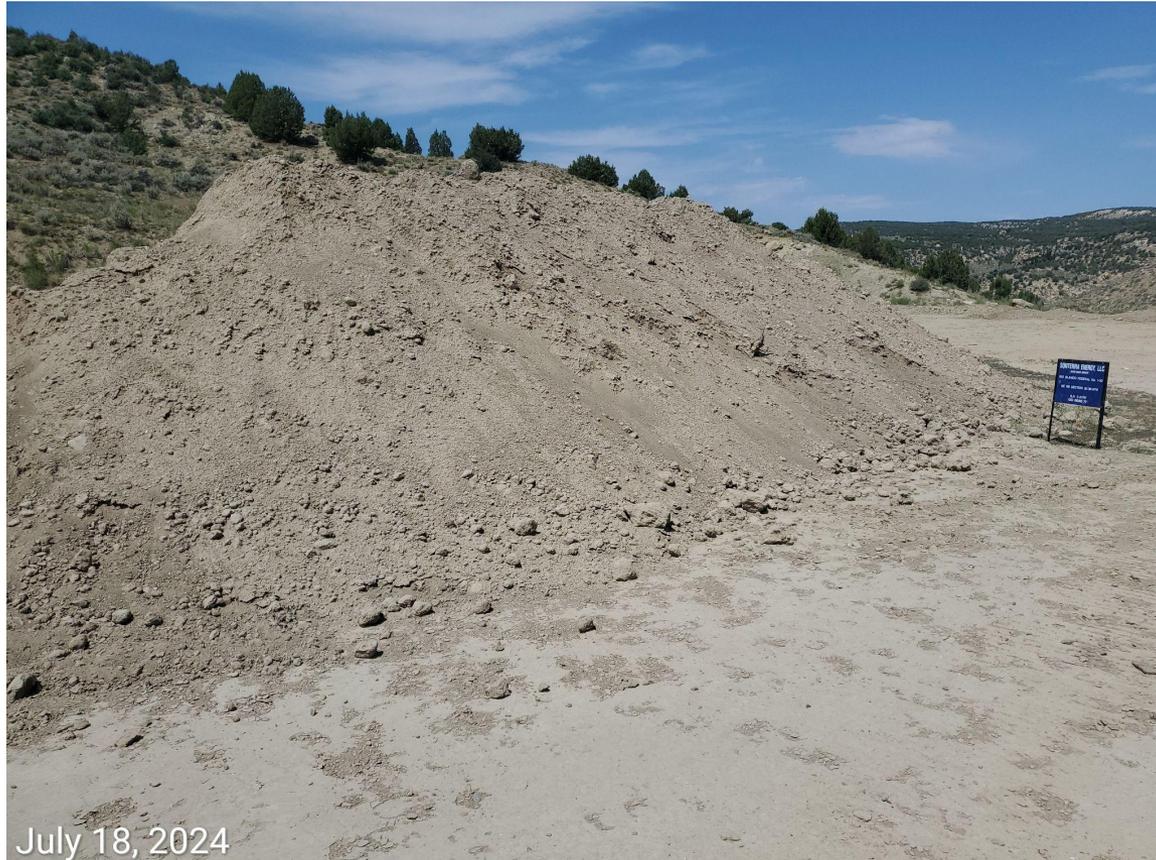
Photo 4: Photo taken from central areas of the Location, facing northwest. Photo shows remaining soil stockpile due to excavation activities on the Location. BMPs to protect the stockpile from wind/water erosion, as well as BMPs to minimize erosion, degradation and sediment transport are missing or insufficient.

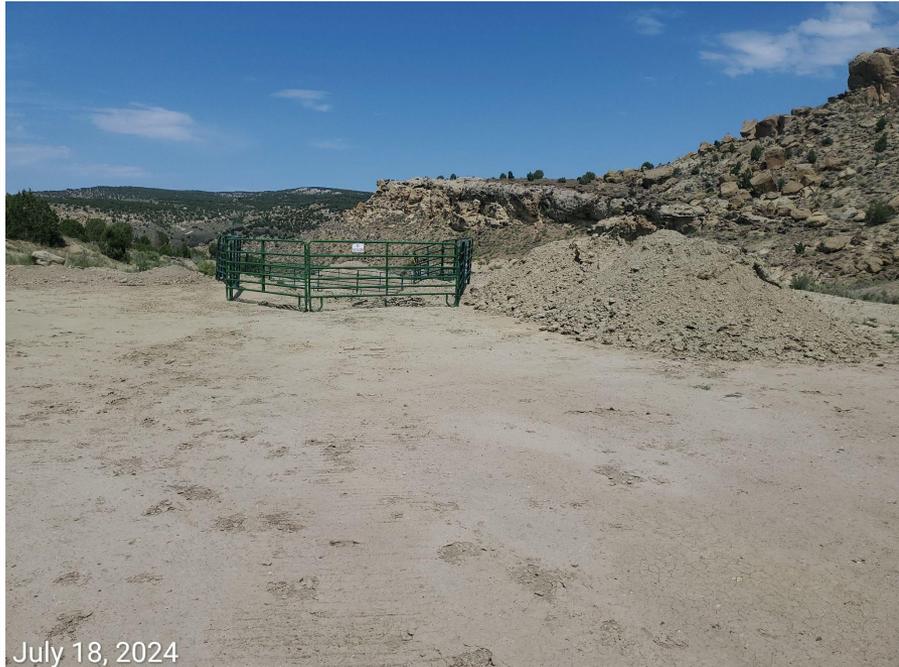
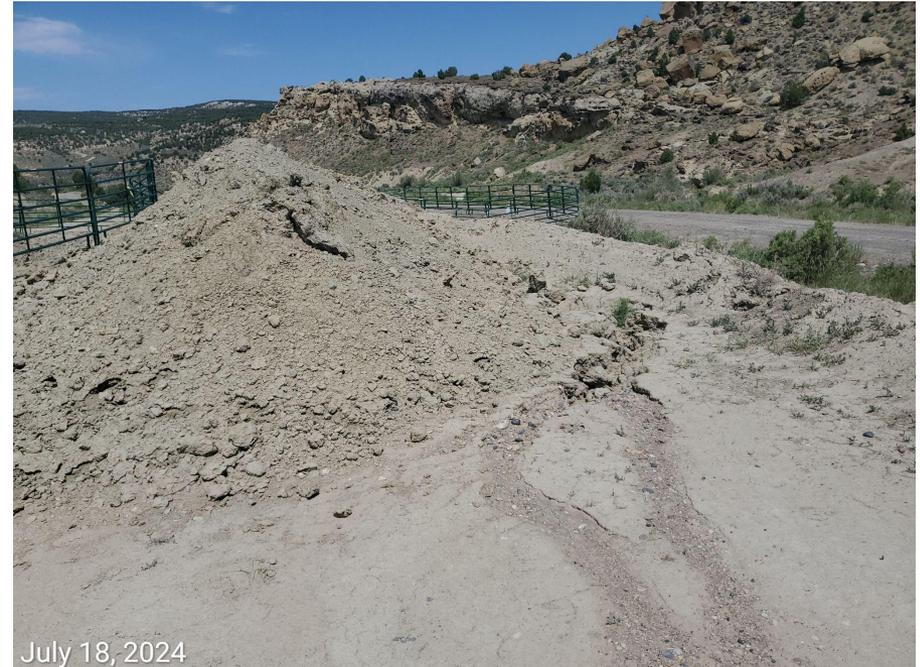
Photo 5: Photos taken from the north end of the Location, facing north. Photo left shows fencing and excavations related to plugging and abandonment operations. Photo also show soils that remain stockpiled on the Location. See comments under photo 4 regarding missing BMPs at stockpiles.

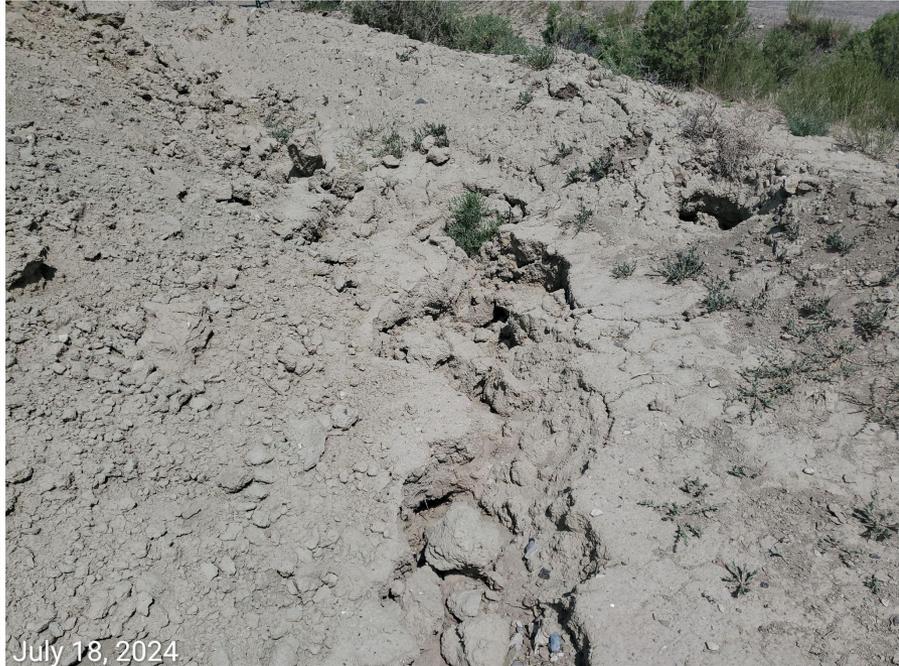
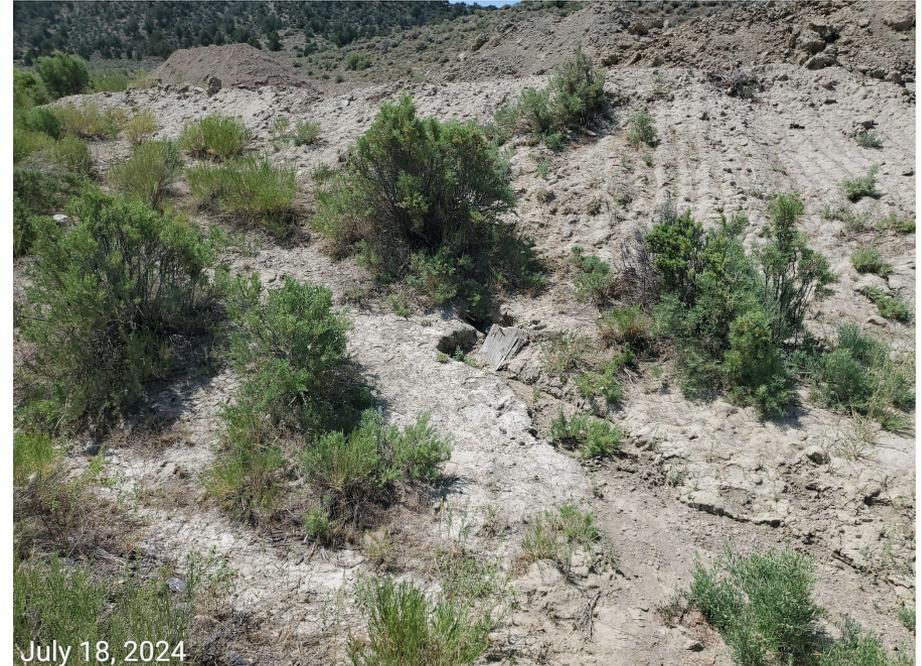
Photo 6: Photos taken from the north end of the Location. Photo shows erosion, degradation and sediment transport due to runoff on the Location. Photo left taken from toe of the soil stockpile observed in photo 5; See comments under photo 4 regarding missing BMPs at stockpiles.

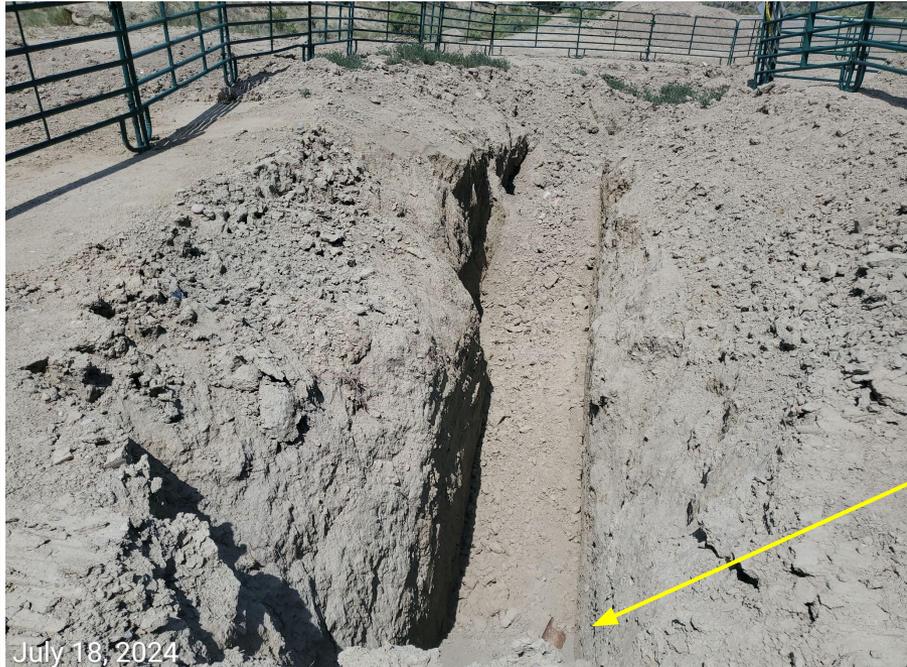
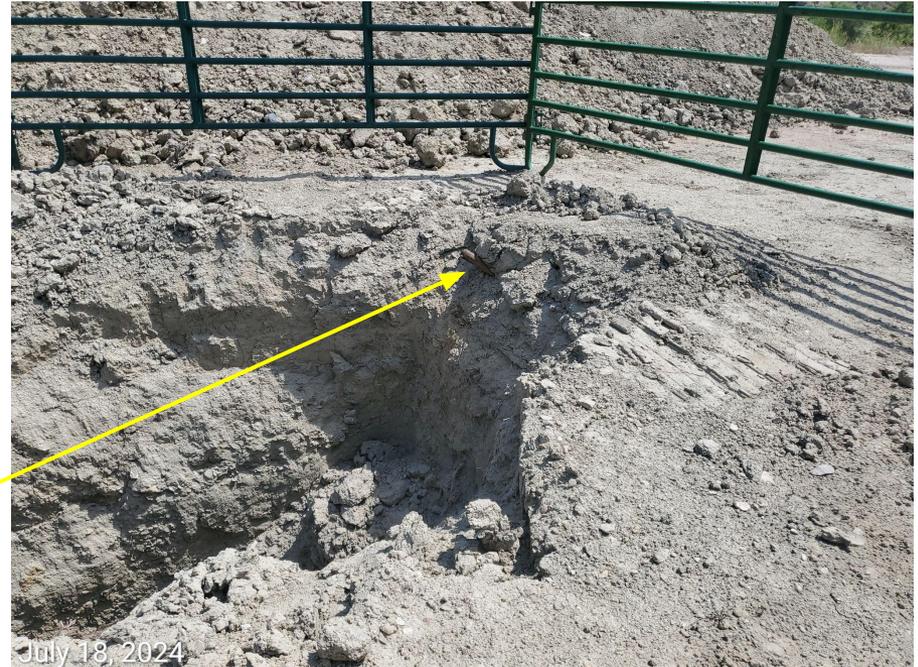
Photo 7: Photos taken from the north end of the Location. Photos show excavations related to plugging, abandonment and facility closure operations remain open; well has been plugged, and facilities have received closure- excavations require backfilling. Photo also shows exposed pipe observed within excavation.

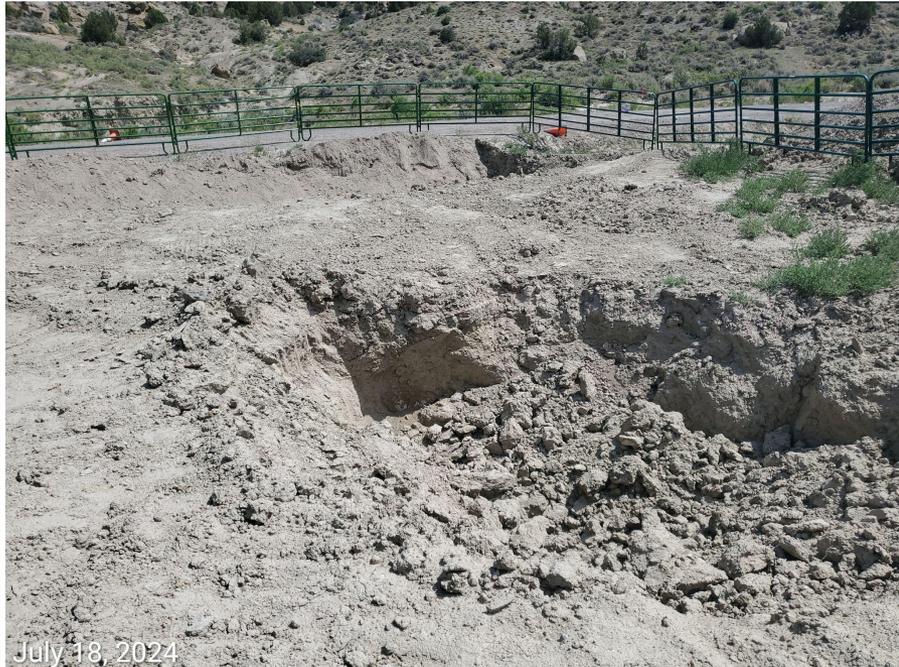
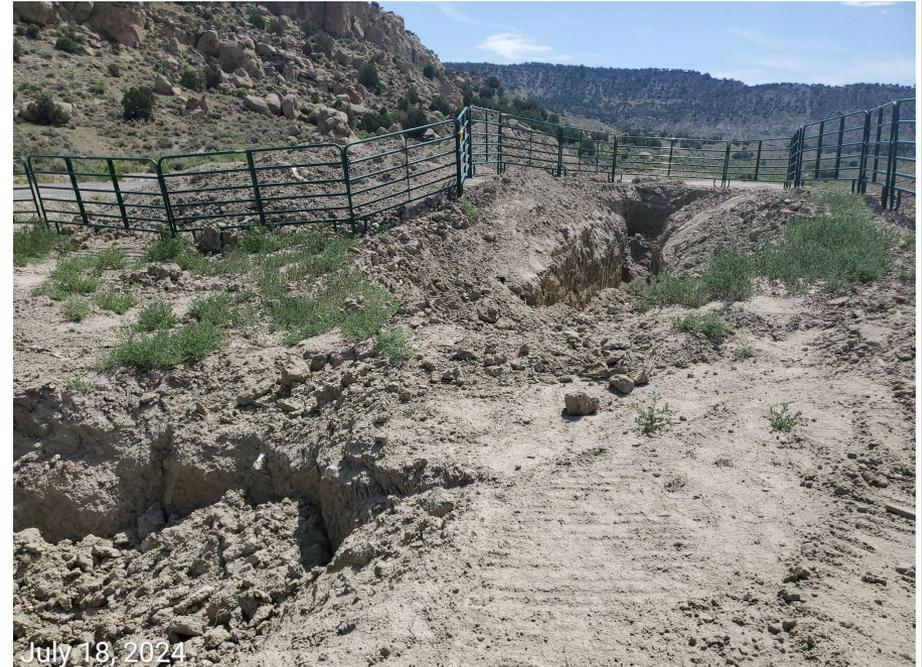
Photo 8: Photos taken from the north end of the Location, facing southeast and south. Photos show excavations related to plugging, abandonment and facility closure operations remain open; well has been plugged, and facilities have received closure- excavations require backfilling.

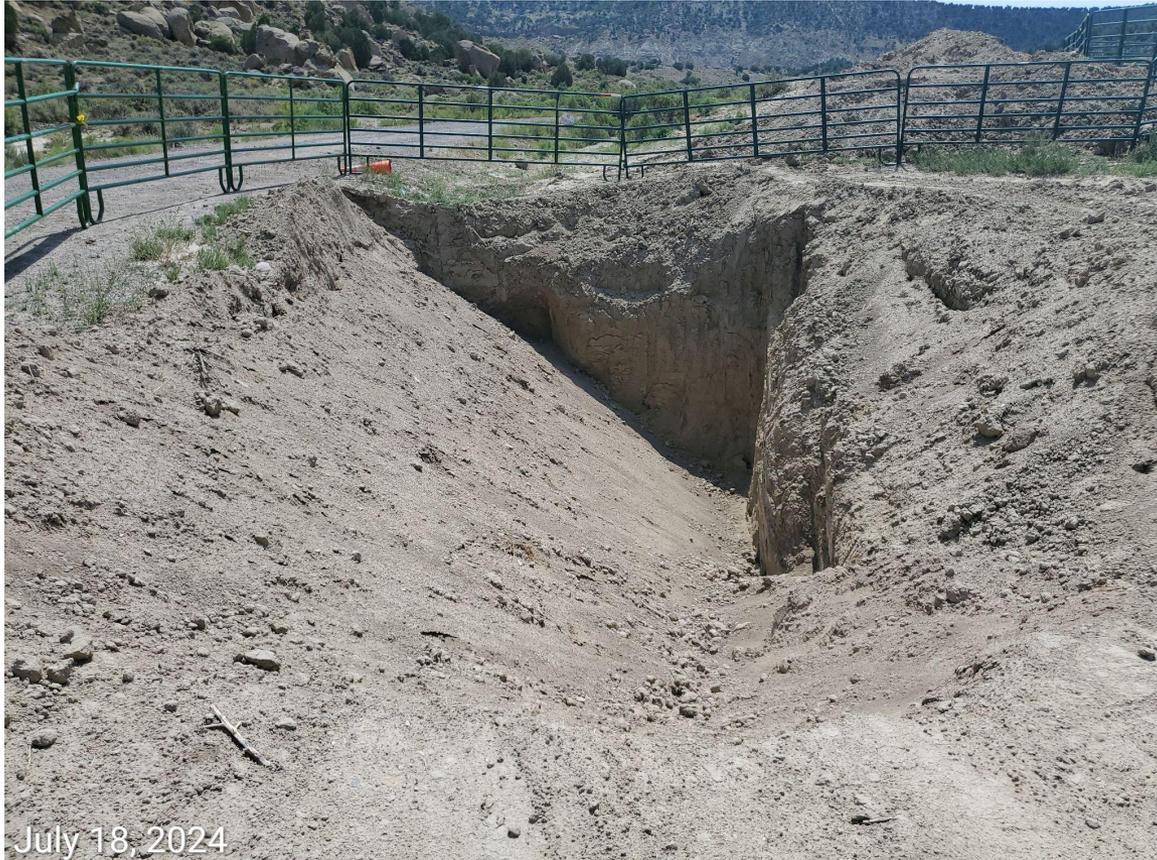
Photo 9: Photo taken from the north end of the Location, facing south. Photo show excavations related to plugging, abandonment and facility closure operations remain open; well has been plugged, and facilities have received closure- excavations require backfilling.

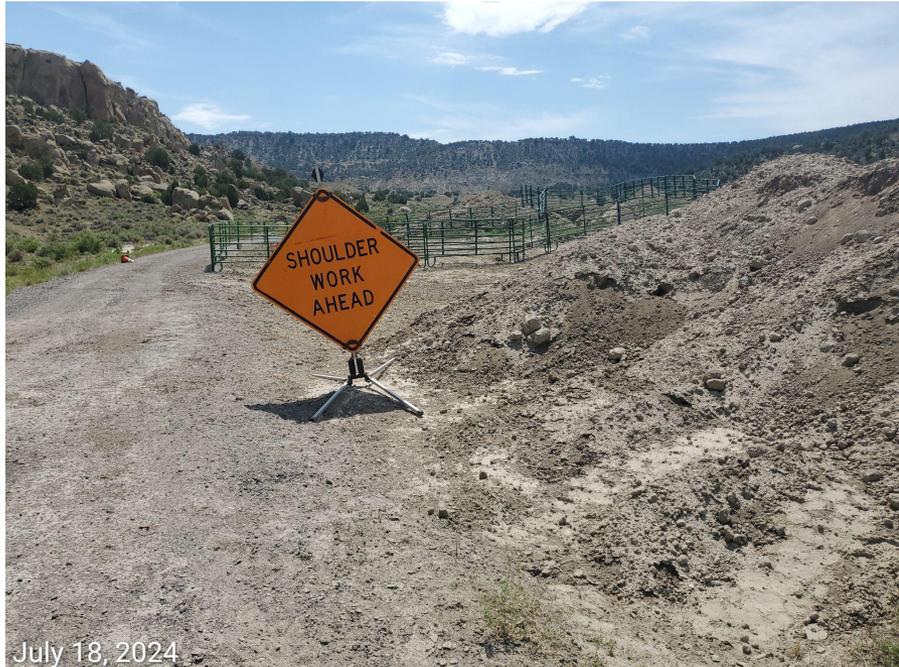
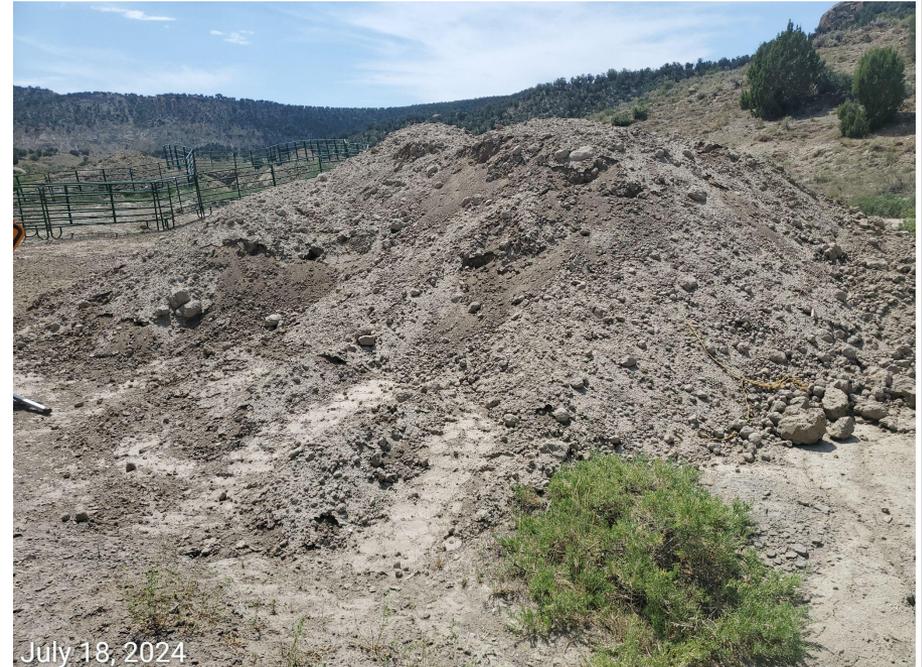
Photo 10: Photos taken from the north end of the Location, facing south and southwest. Photo shows remaining soil stockpile due to excavation activities on the Location. BMPs to protect the stockpile from wind/water erosion, as well as BMPs to minimize erosion, degradation and sediment transport are missing or insufficient.

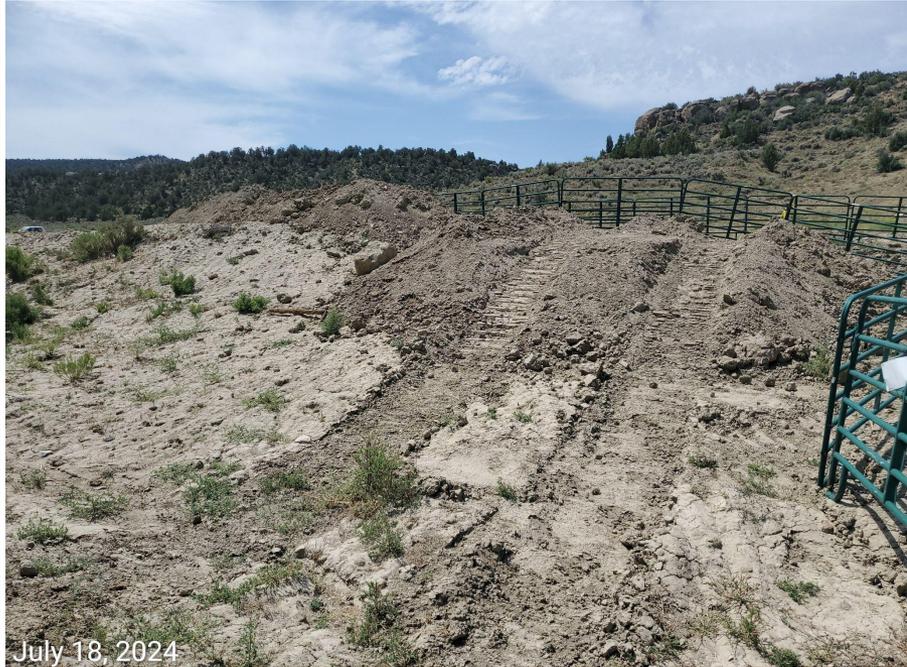
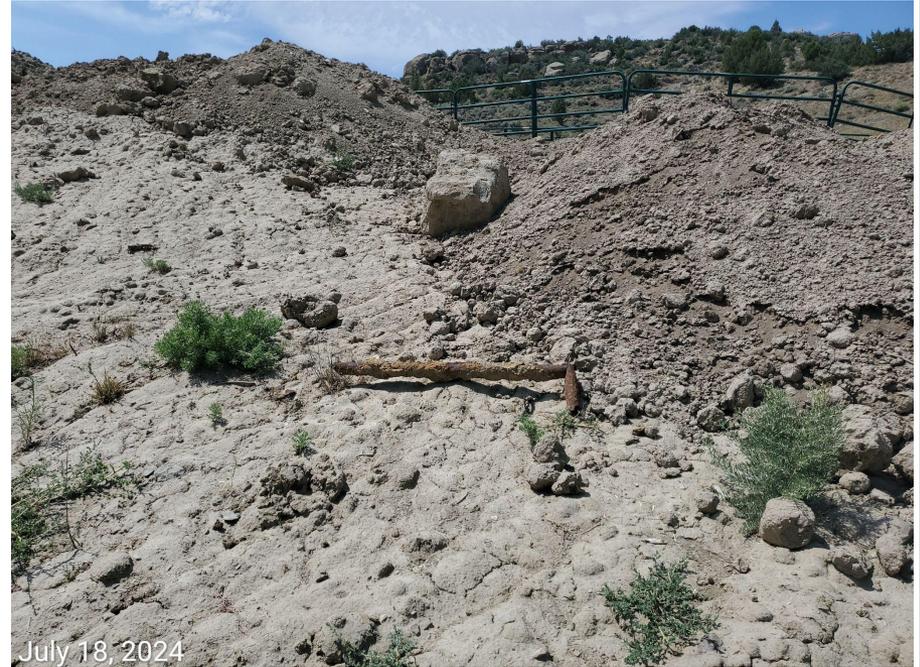
Photo 11: Photo taken from the northeast end of the Location, facing southwest and west. See comments under photo 11 regarding stockpiled soils and missing BMPs. Photo also shows pipe debris improperly stored next to the stockpiles.

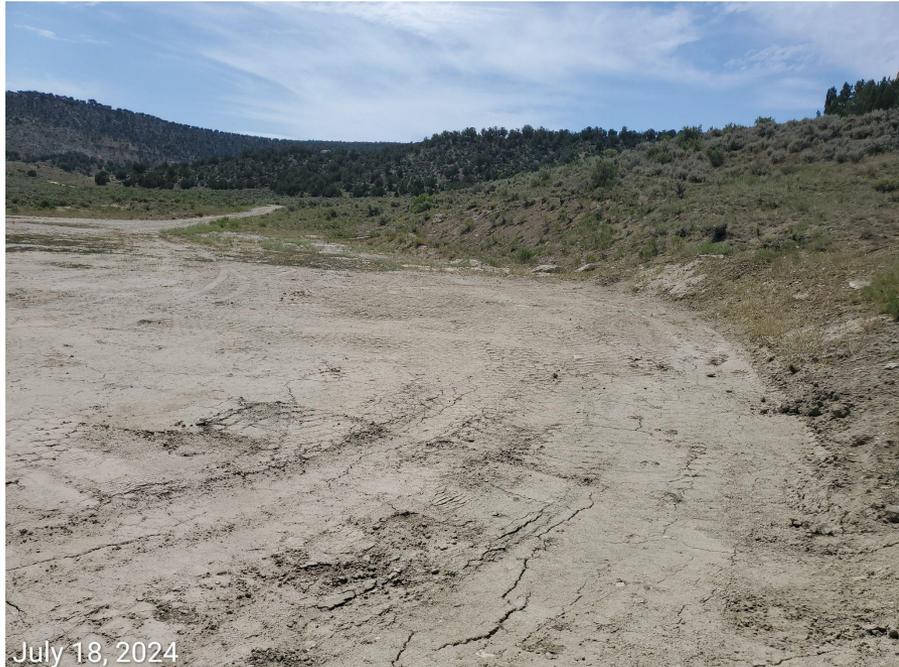
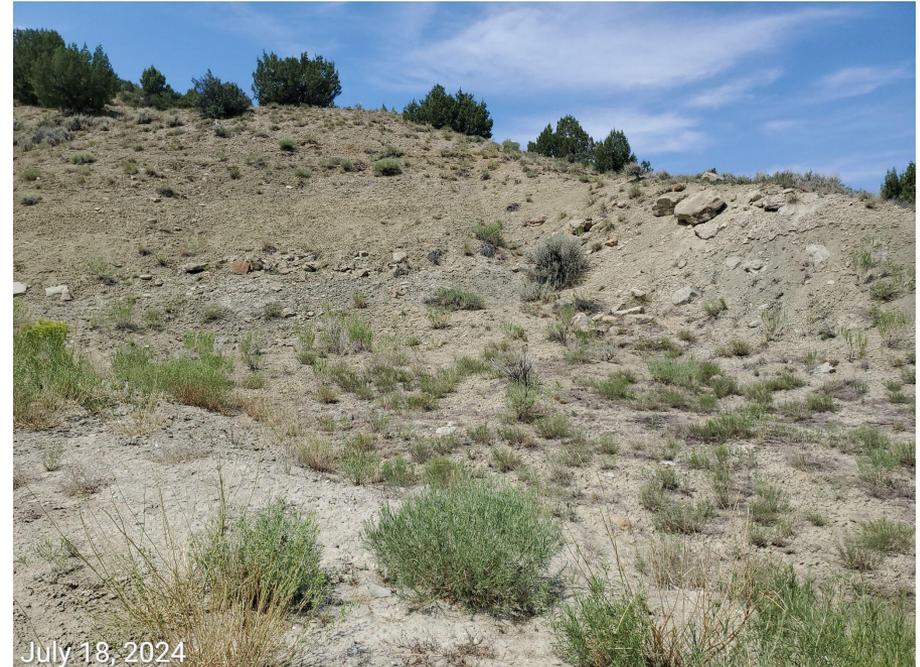
Photo 12: Photos taken from the northwest end of the Location, facing south and west. Photos examples showing remaining cut slopes on the Location. Location has not been reclaimed in accordance with 1004 Rules.

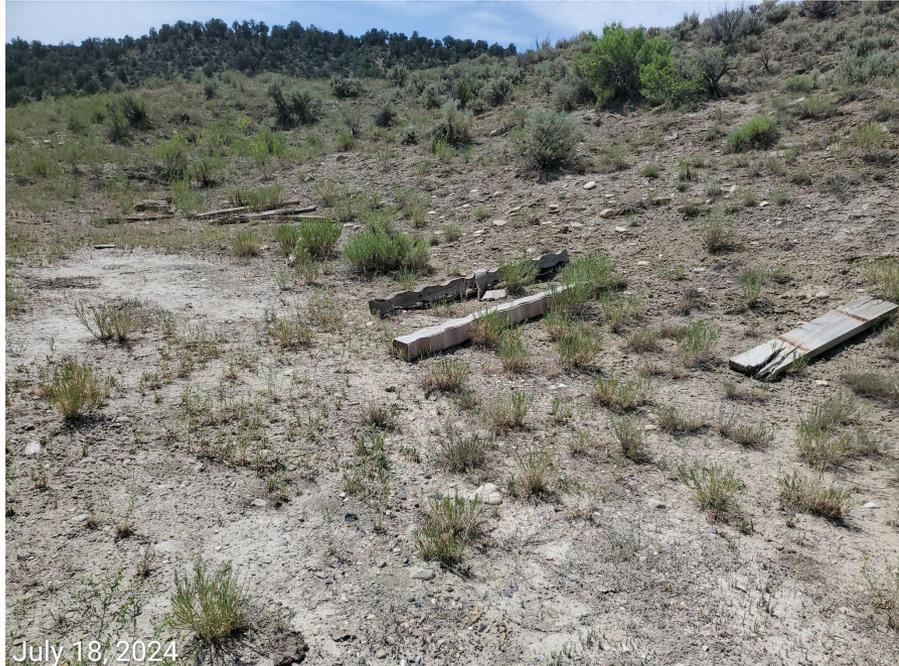
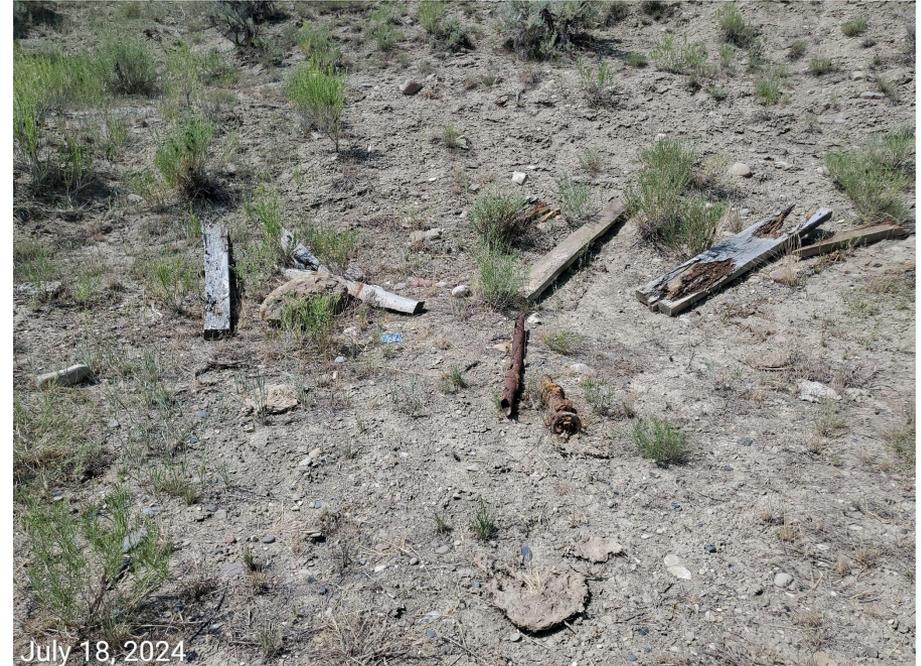
Photo 13: Photos taken from the southwest end of the Location. Photos examples showing various trash/debris remaining on the Location.
