Inspection Photos

Location: Vision Energy LLC South Shale Ridge-68S98W/14NENE

Location ID: 312598

Date: 7/2/2024

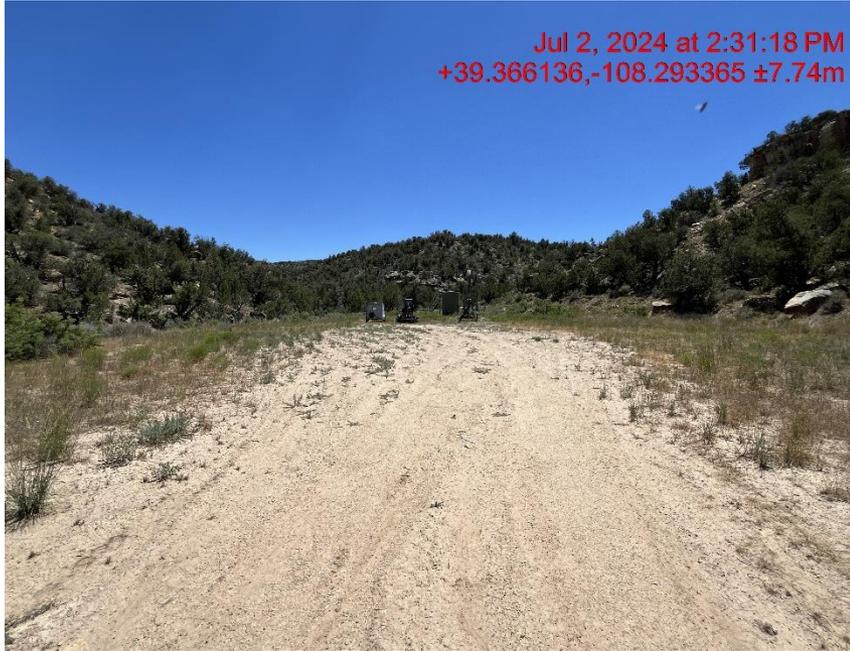
Entrance to location - Photo #03269

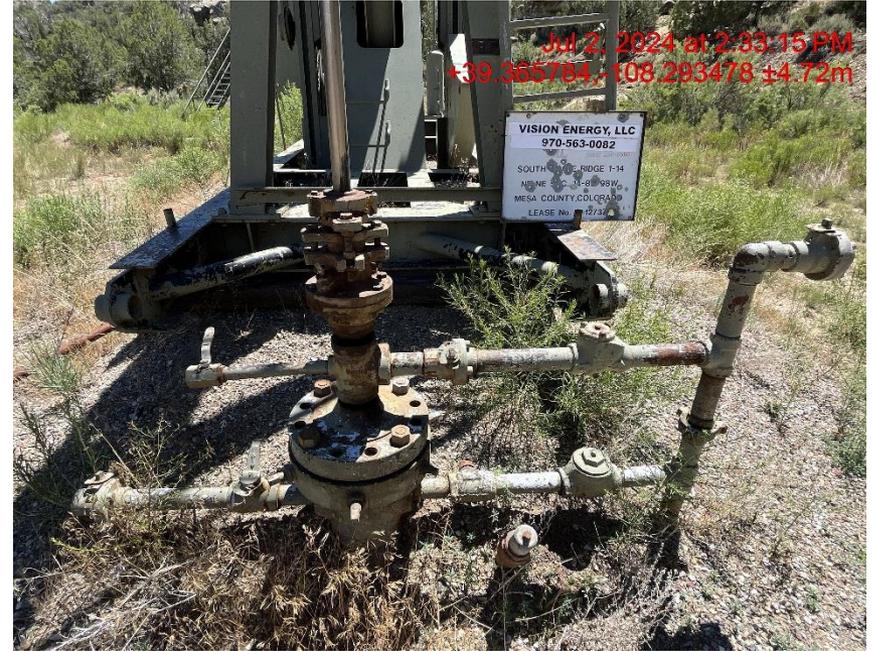
Wellhead - Photo #03272

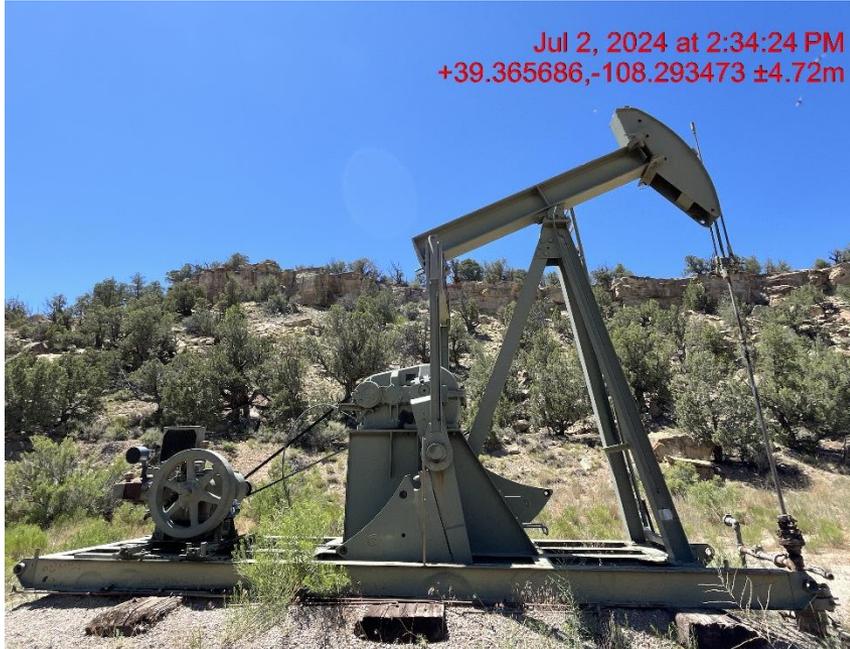
Pump Jack - Photo #03273

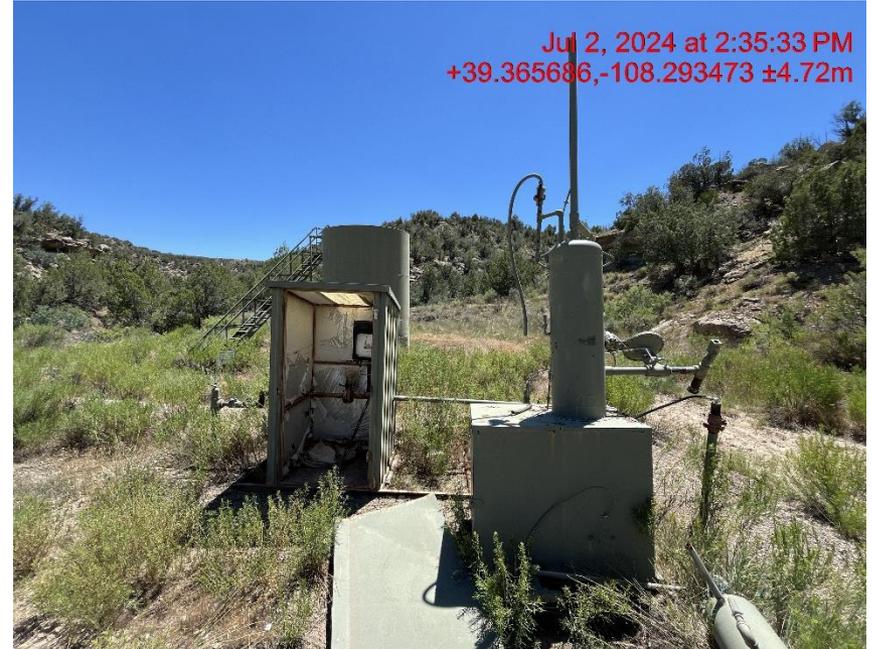
Separator/Meter run - Photo #03274

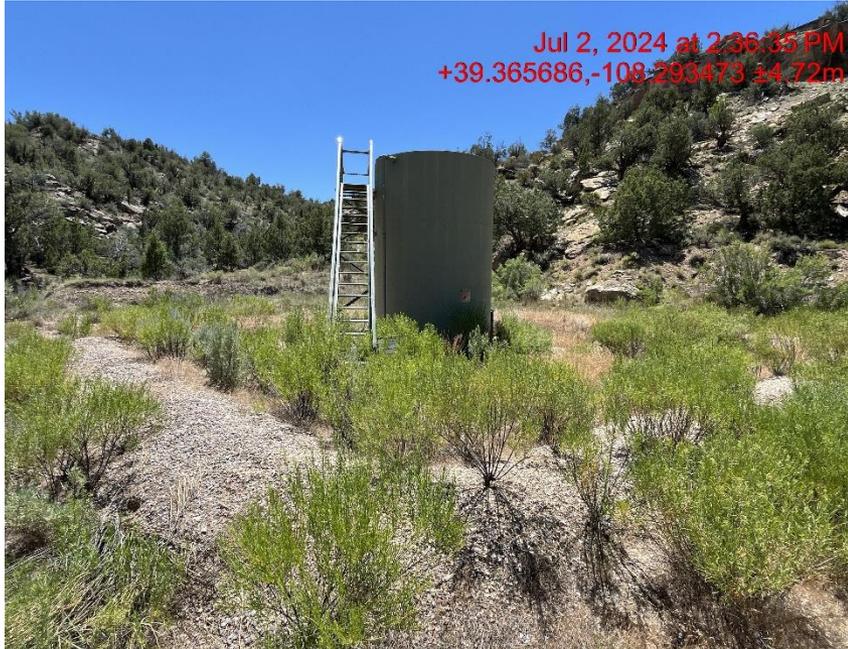
Tank battery/Inadequate berm permeability - Photo #03275

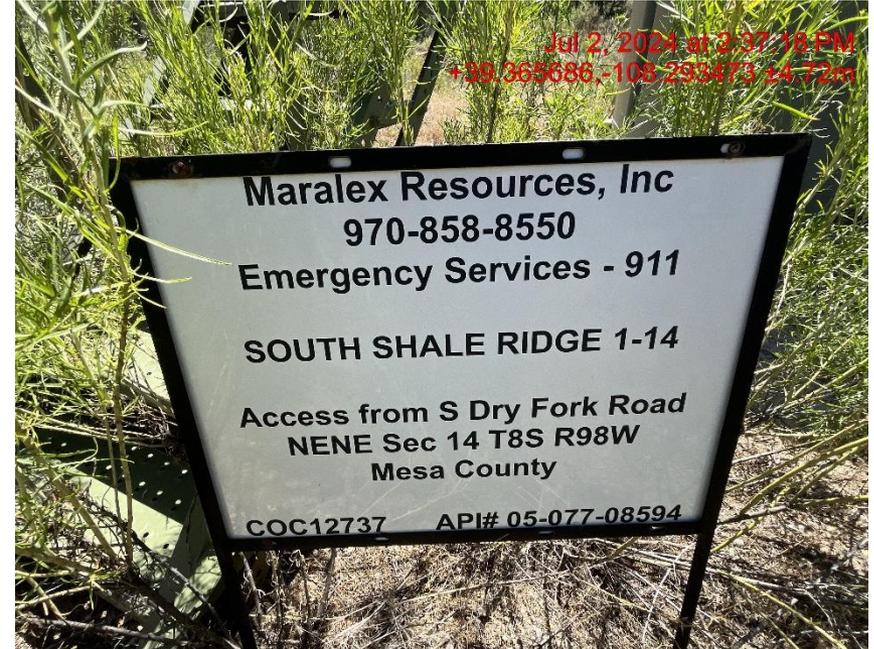
Inaccurate company information on battery sign - Photo #03276

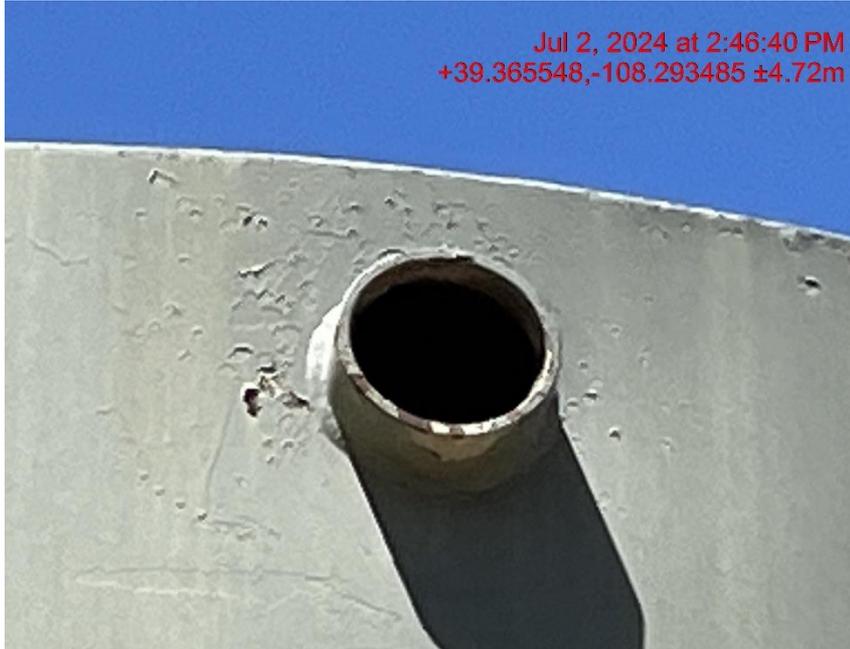
Tank port open entry to wildlife hazard - Photo #03288

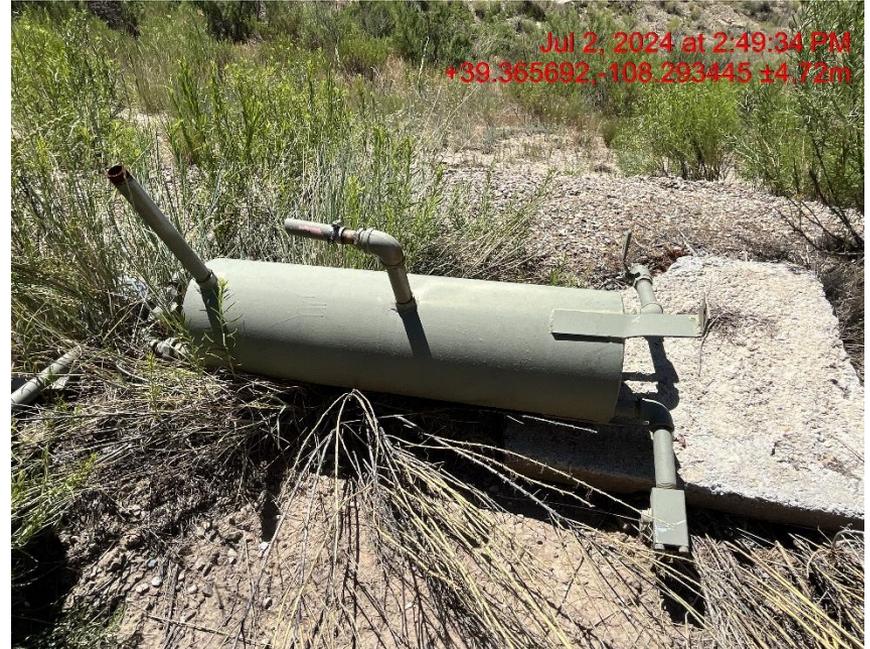
Debris - Photo #03292

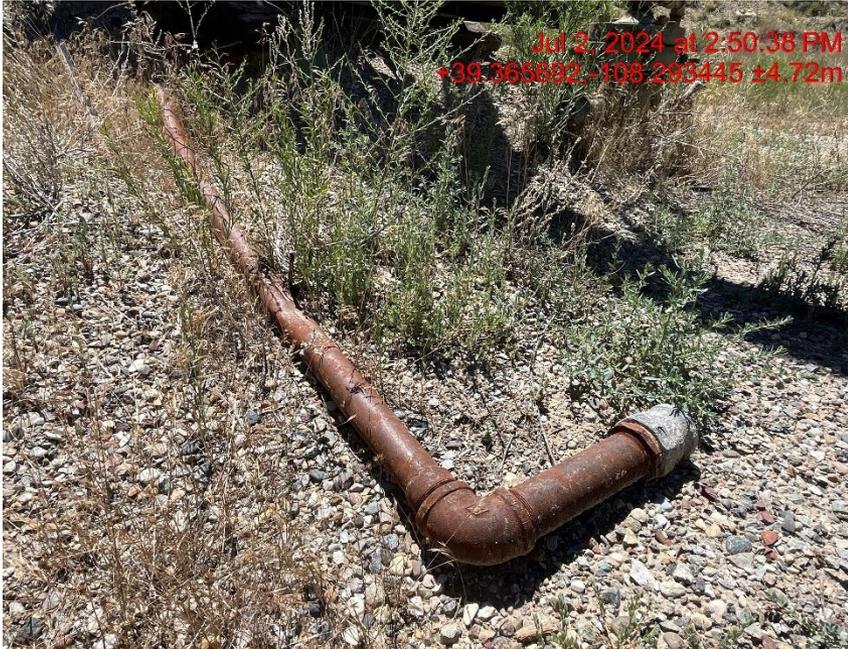
Debris - Photo #03294

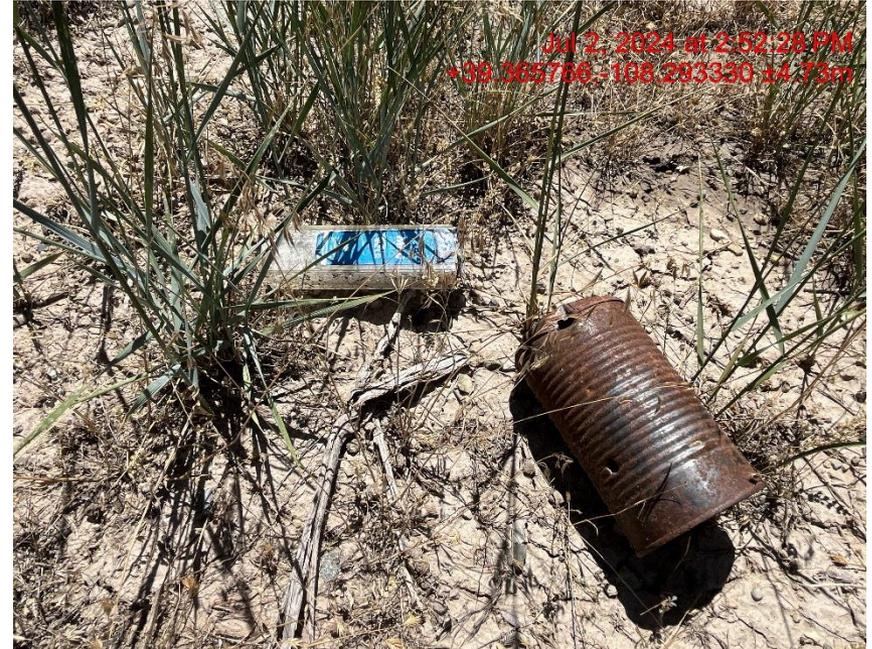
Debris - Photo #03295

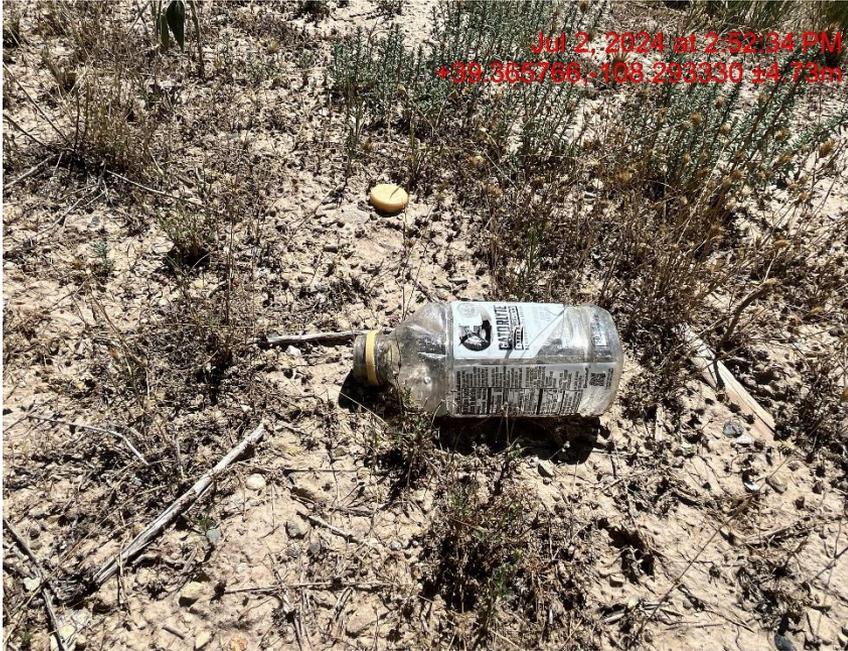
Debris - Photo #03296

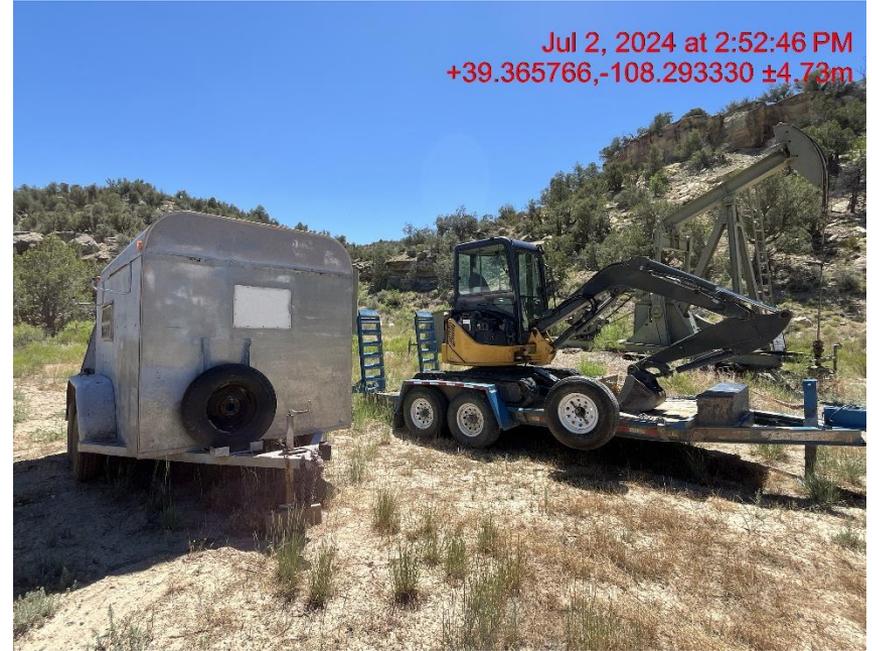
Storage of supplies/equipment - Photo #03297
