## Inspection Photos

Location: Vision Energy LLC South Shale Ridge-68S98W/14NENE

Location ID: 324270

Date: 7/2/2024

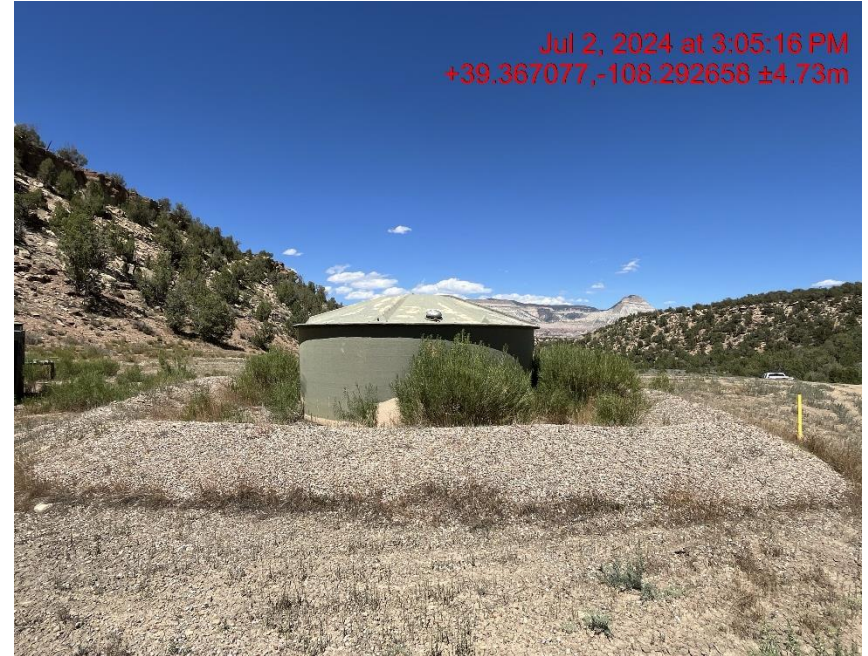
Tank Battery/Berm permeability is inadequate due to weed growth in berm - Photo #03305

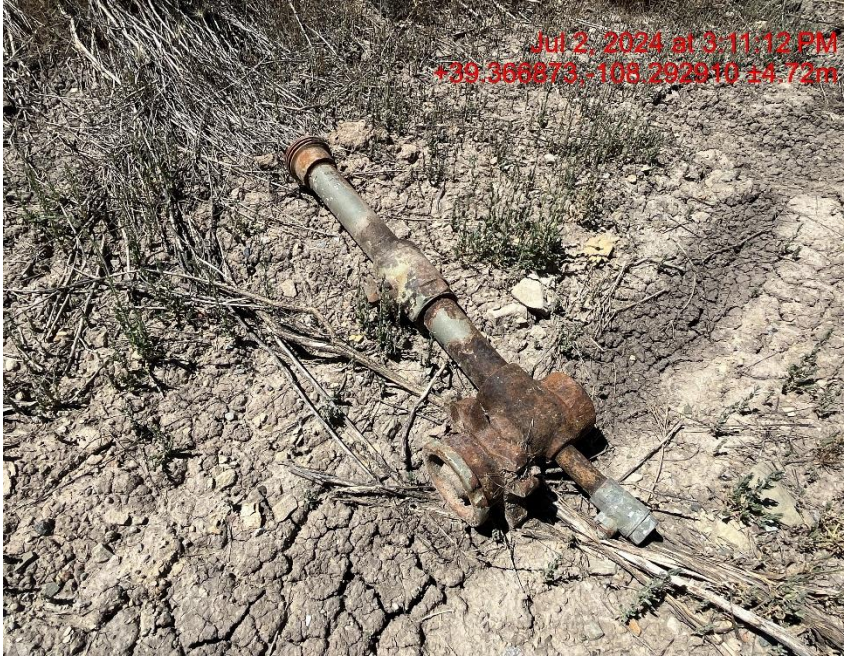
Debris - Photo #03310

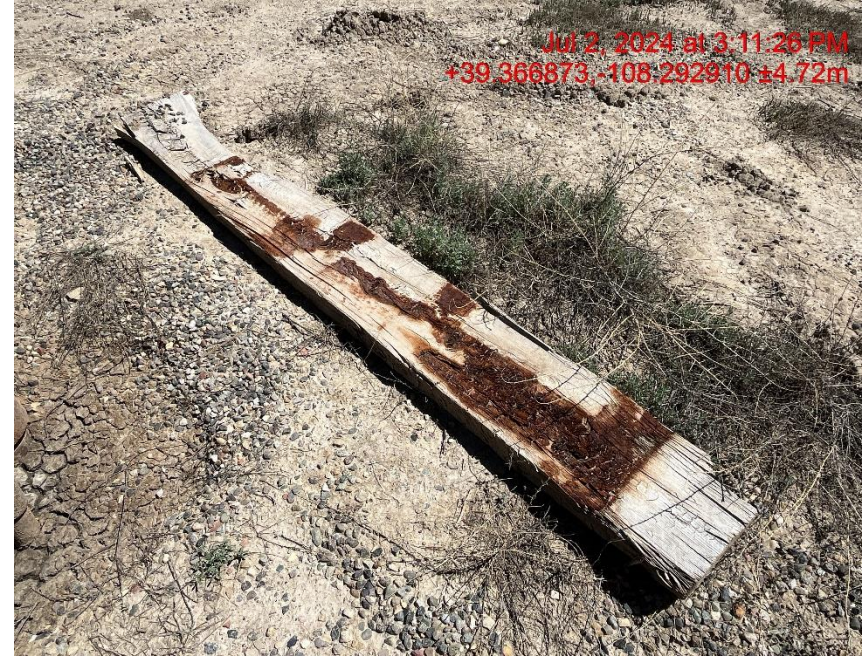
Debris - Photo #03311

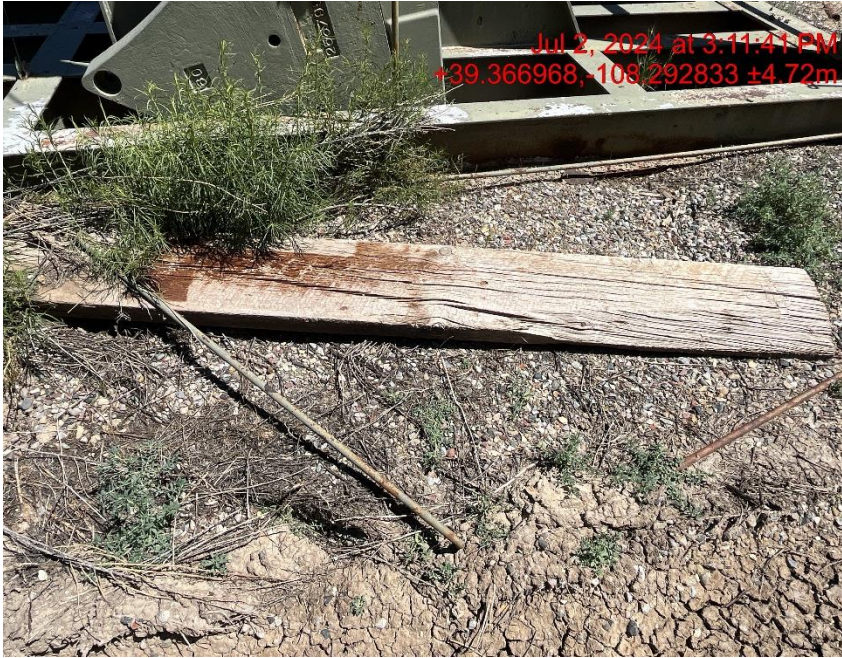
Debris - Photo #03312

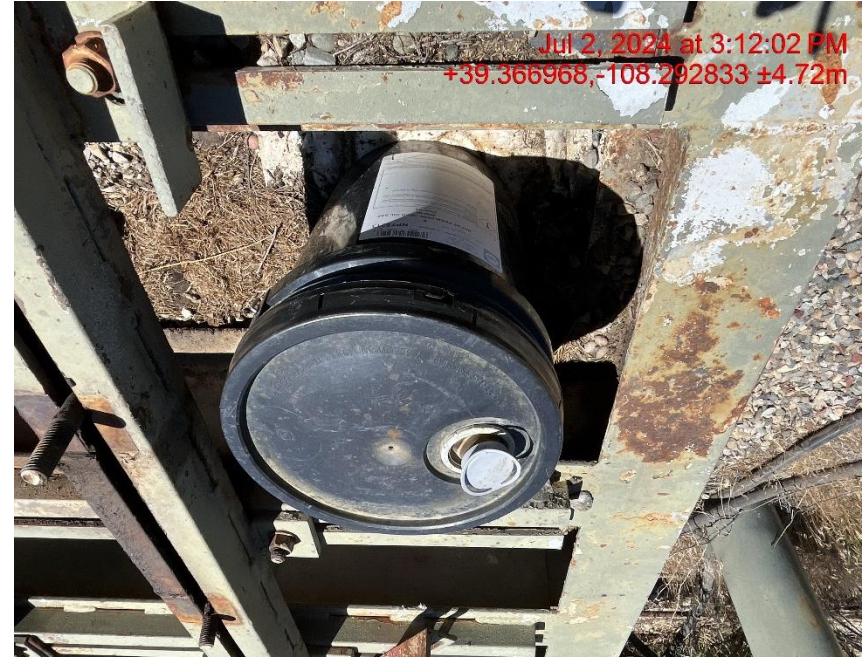
Debris - Photo #03313

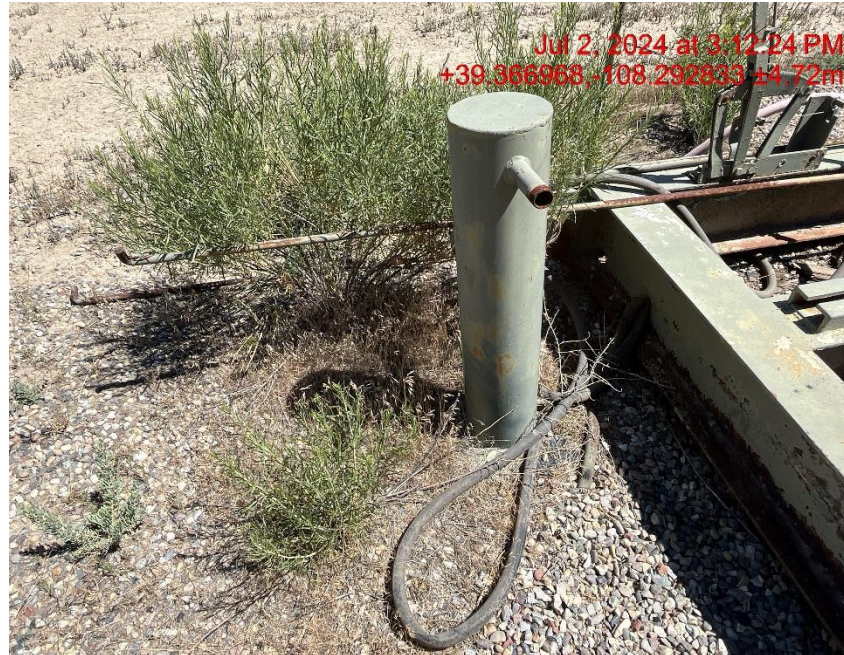
Debris - Photo #03314
