Inspection Photos

Location: TEP Rocky Mountain LLC Williams-67S96W/35SWNW

Location ID: 334409

Date: 7/9/2024

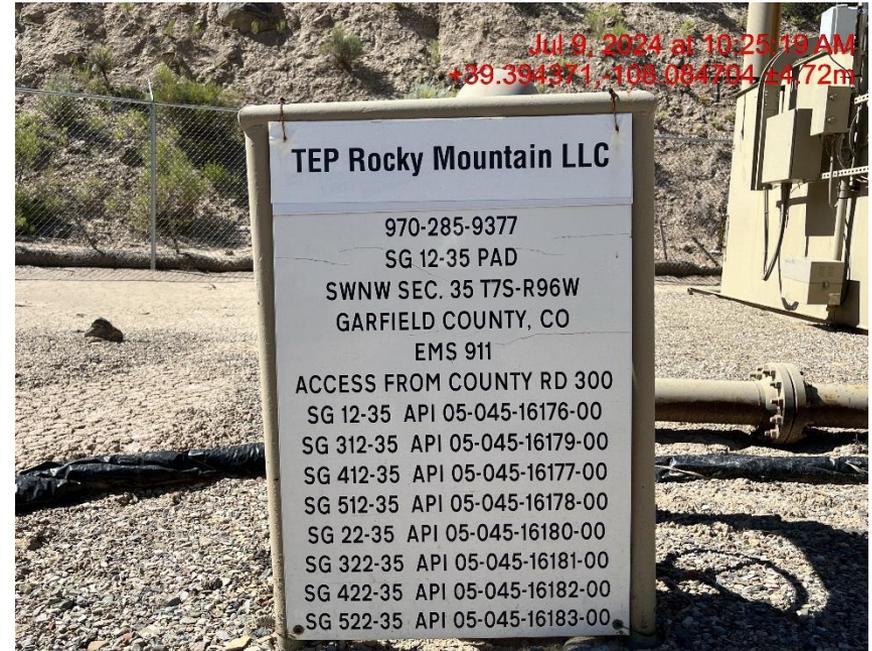
Needs moved to tank battery - Photo #03384

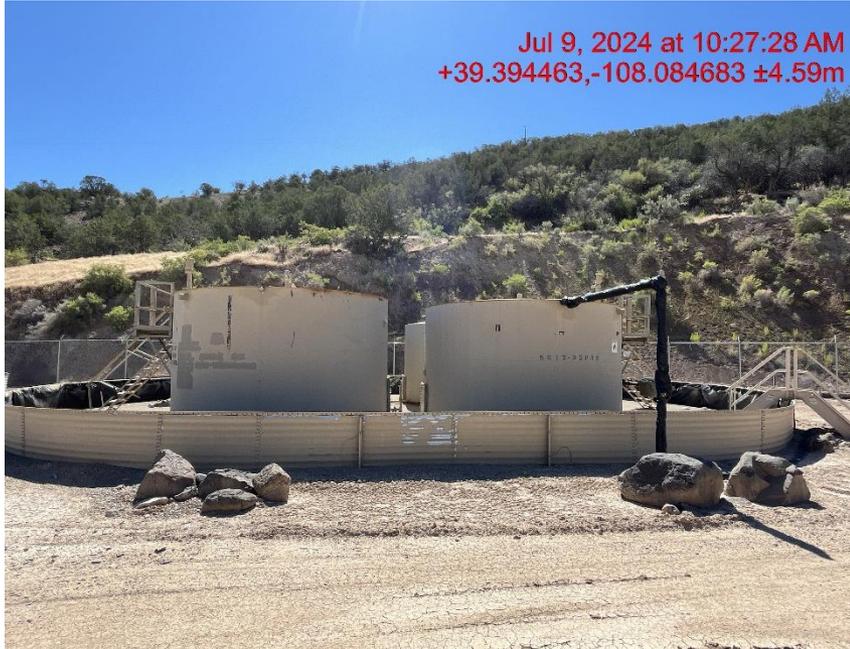
Tank battery/Missing battery sign - Photo #03385

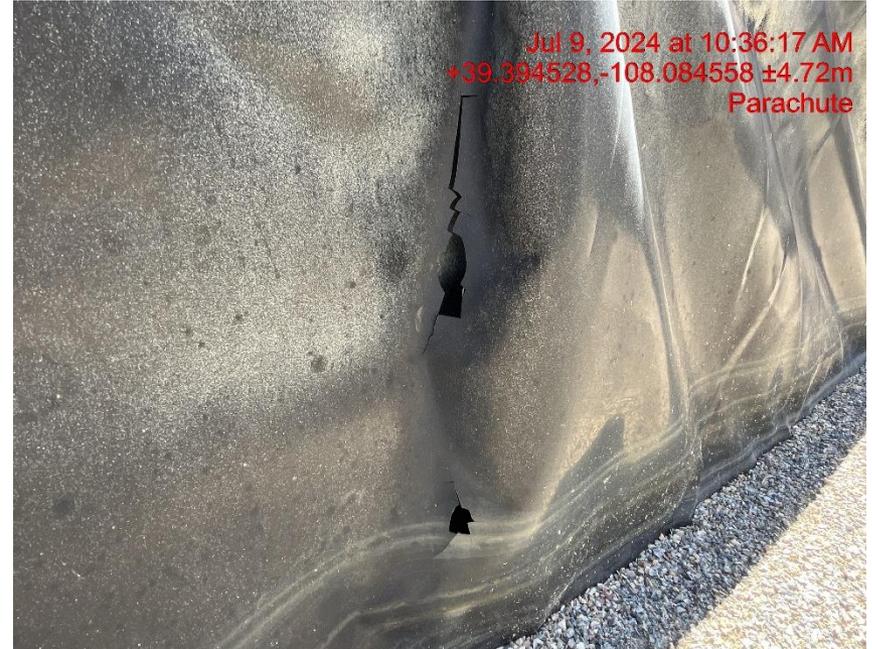
Holes in containment liner - Photo #03398

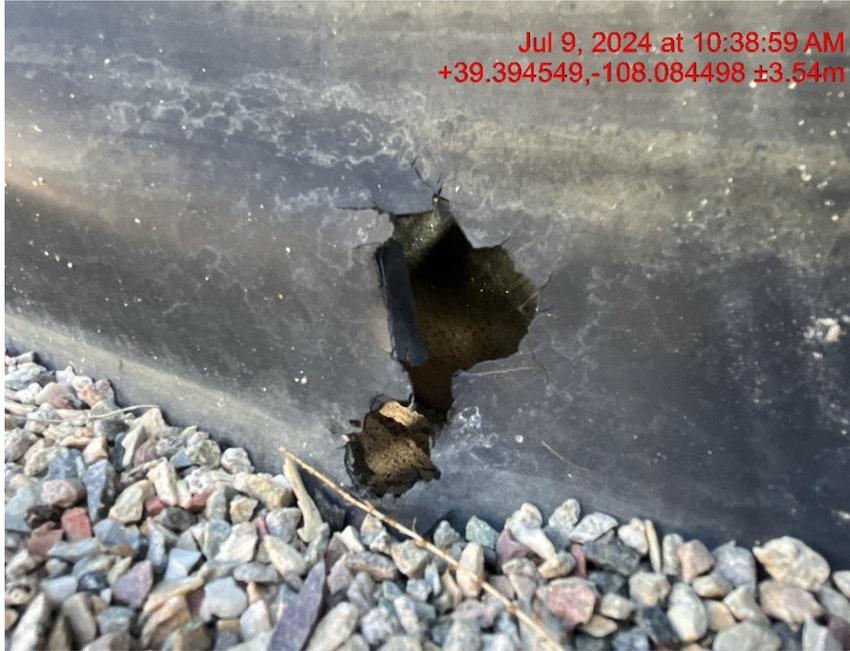
Hole in containment liner - Photo #03406

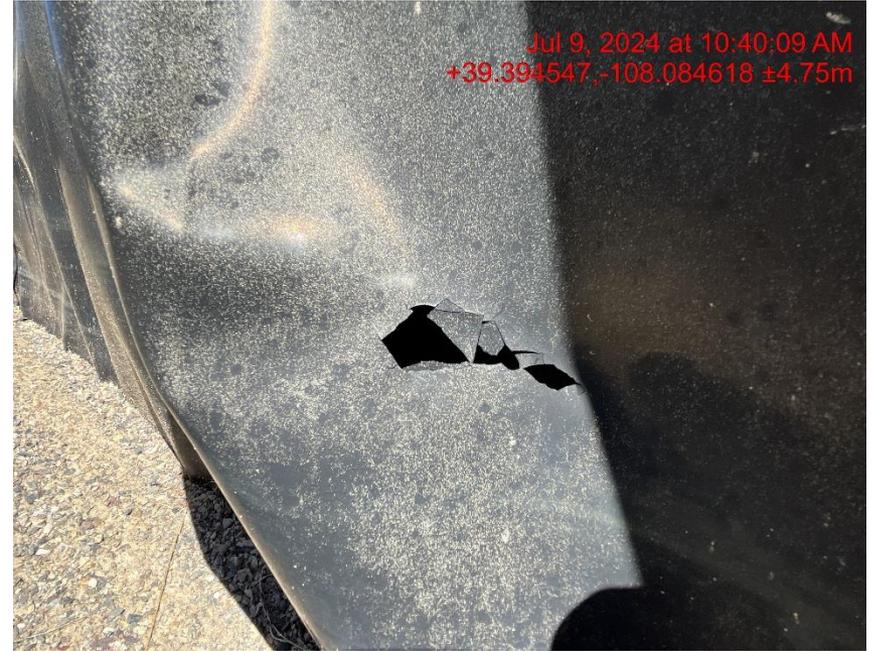
Hole in containment liner - Photo #03408

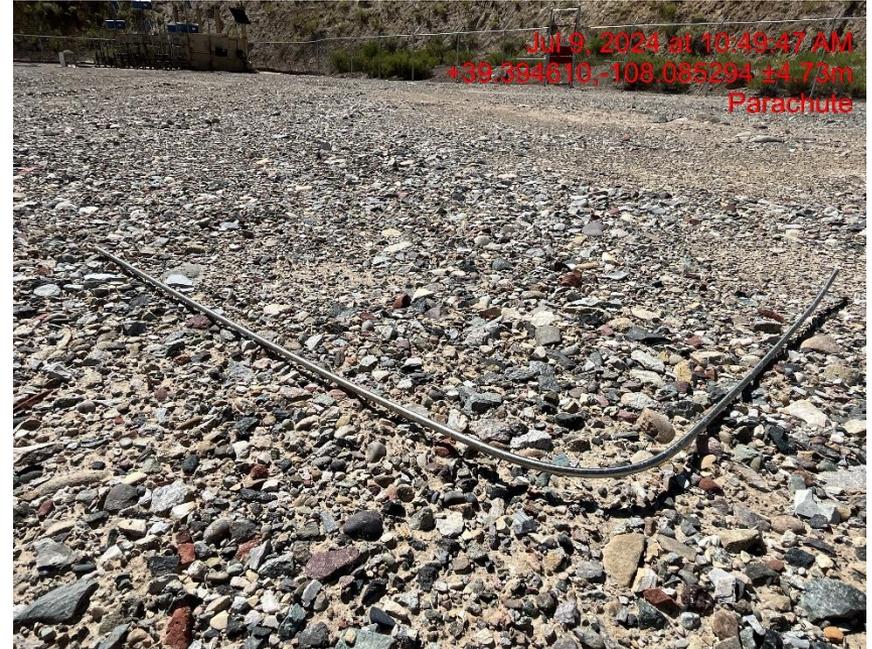
Debris - Photo #03411

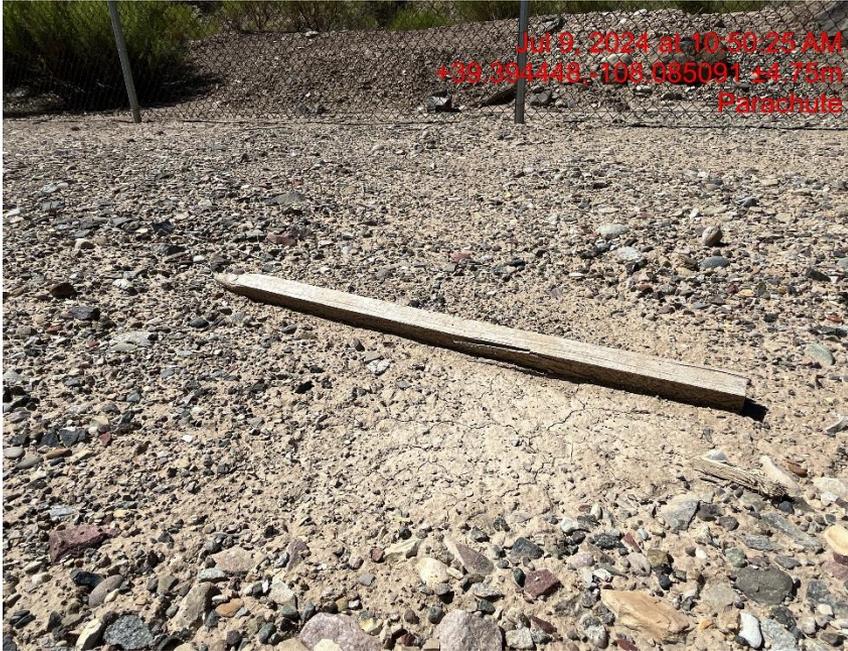
Debris - Photo #03412

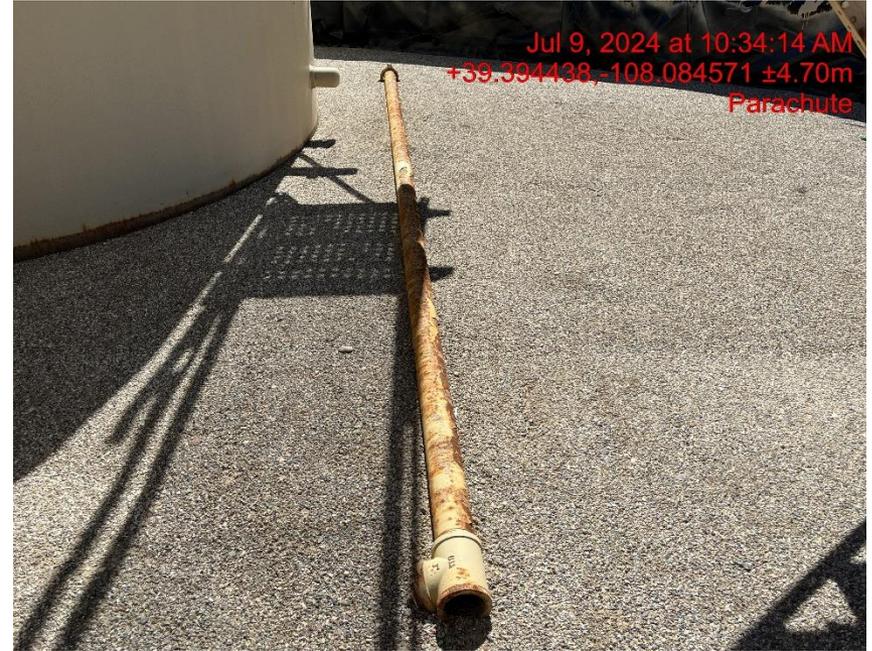
Debris - Photo #03395
