**ECMC
Environmental
Field Inspection**

KPK
K.P. KAUFFMAN COMPANY, INC.
Johnson #1 & 2 Battery
SW Section 26, T2N, R66W
Johnson County
688 WCR 13
781-832-7822

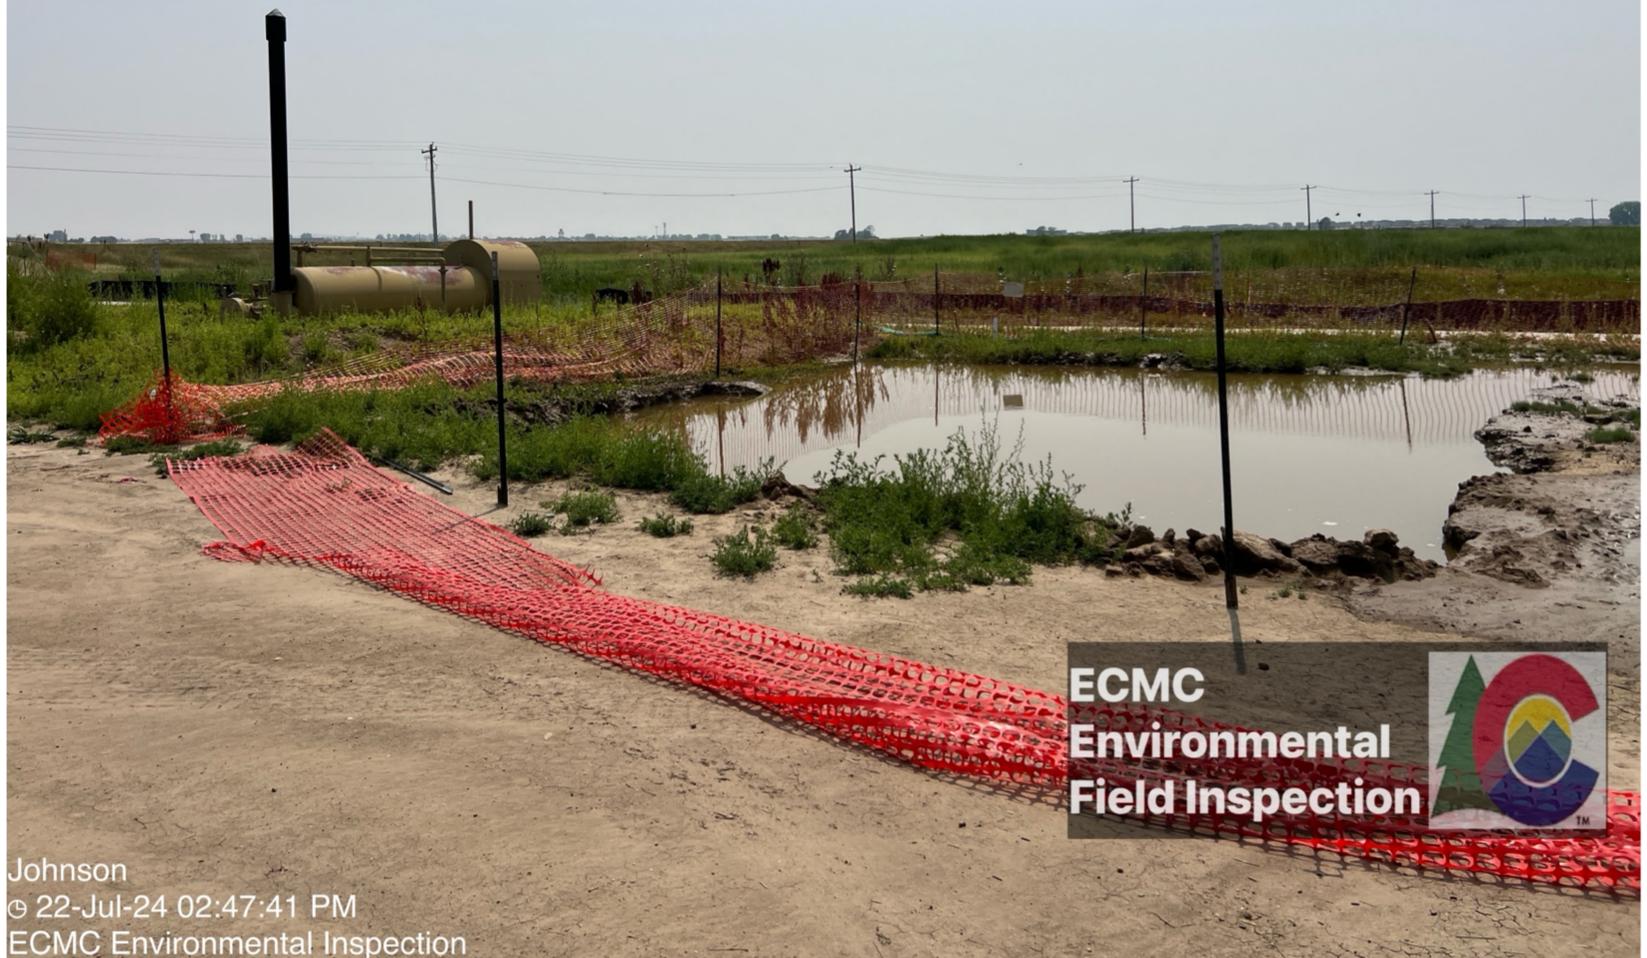
Weeds, torn/downed fencing, water within open excavation, inadequate BMPs to control runoff into open excavation

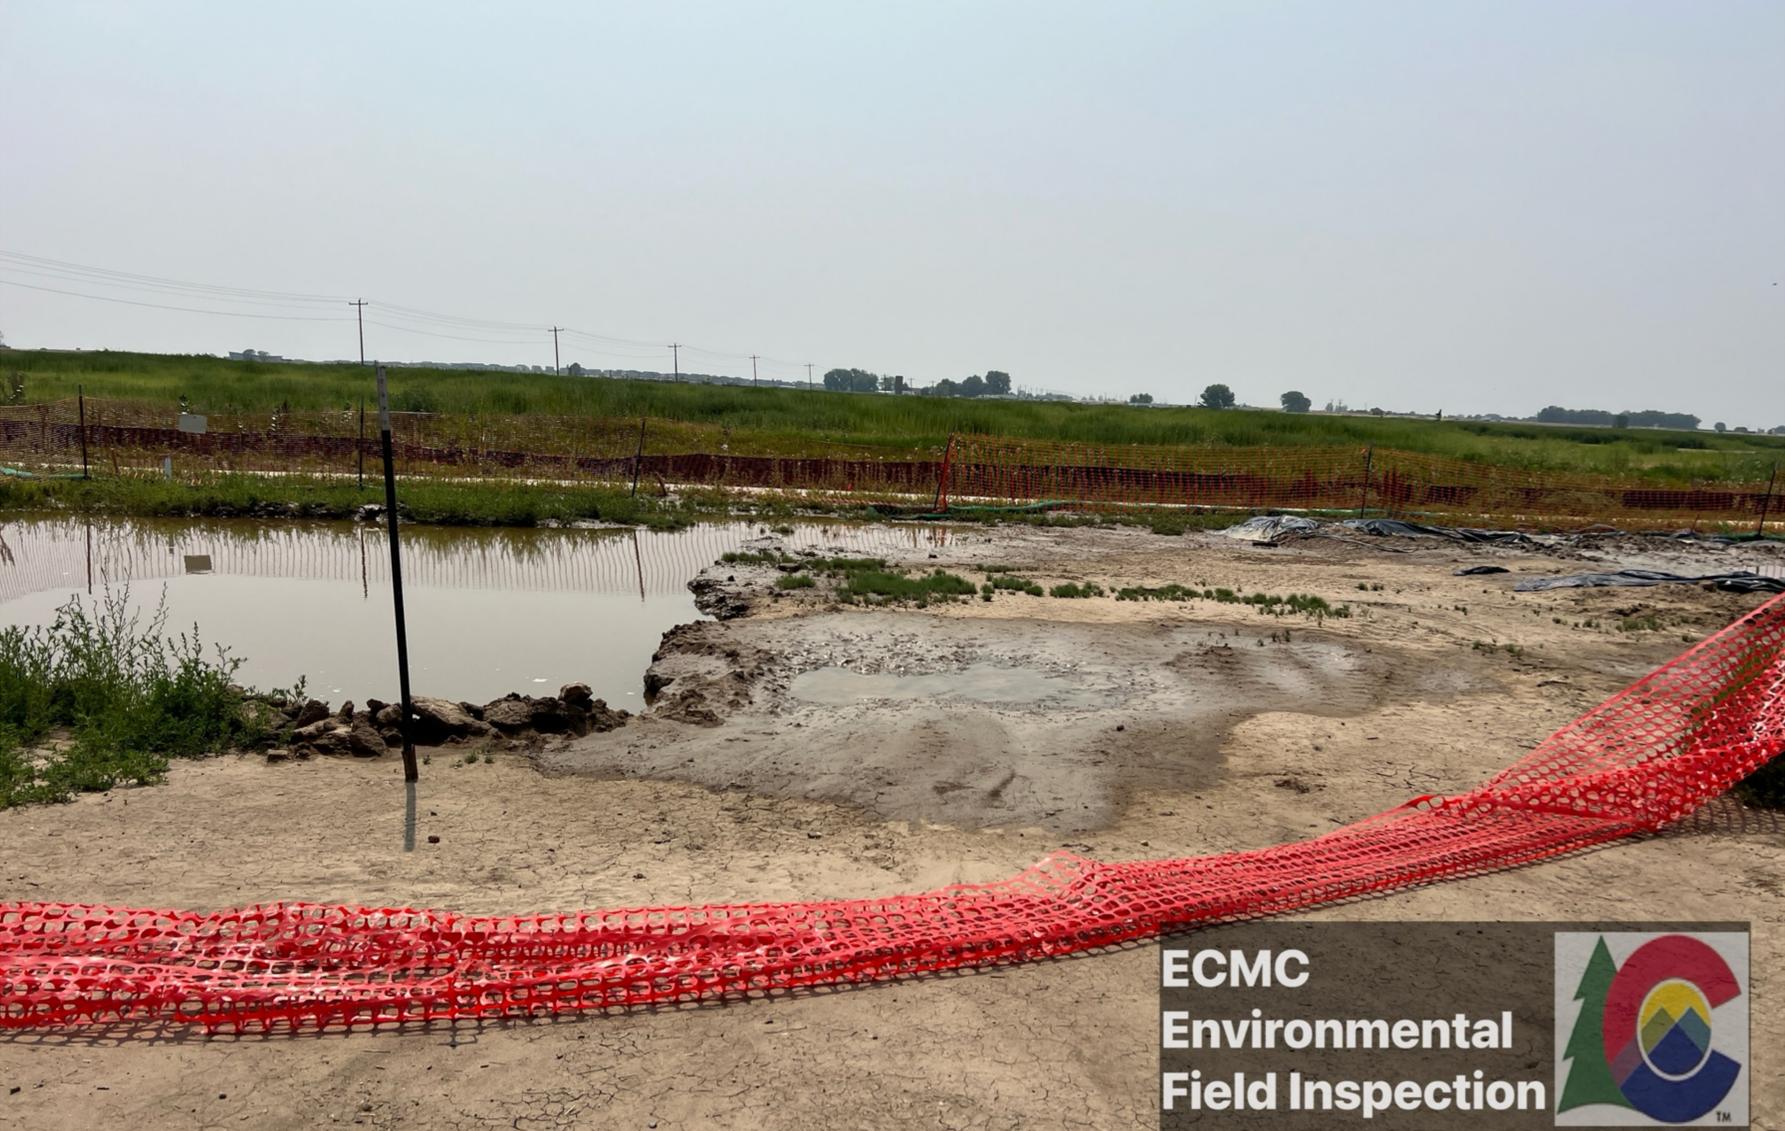
Weeds, torn/downed fencing, water within open excavation, inadequate BMPs to control runoff into open excavation, inadequate BMPs for stockpiled E&P waste, runoff from open excavation and E&P waste stockpile.

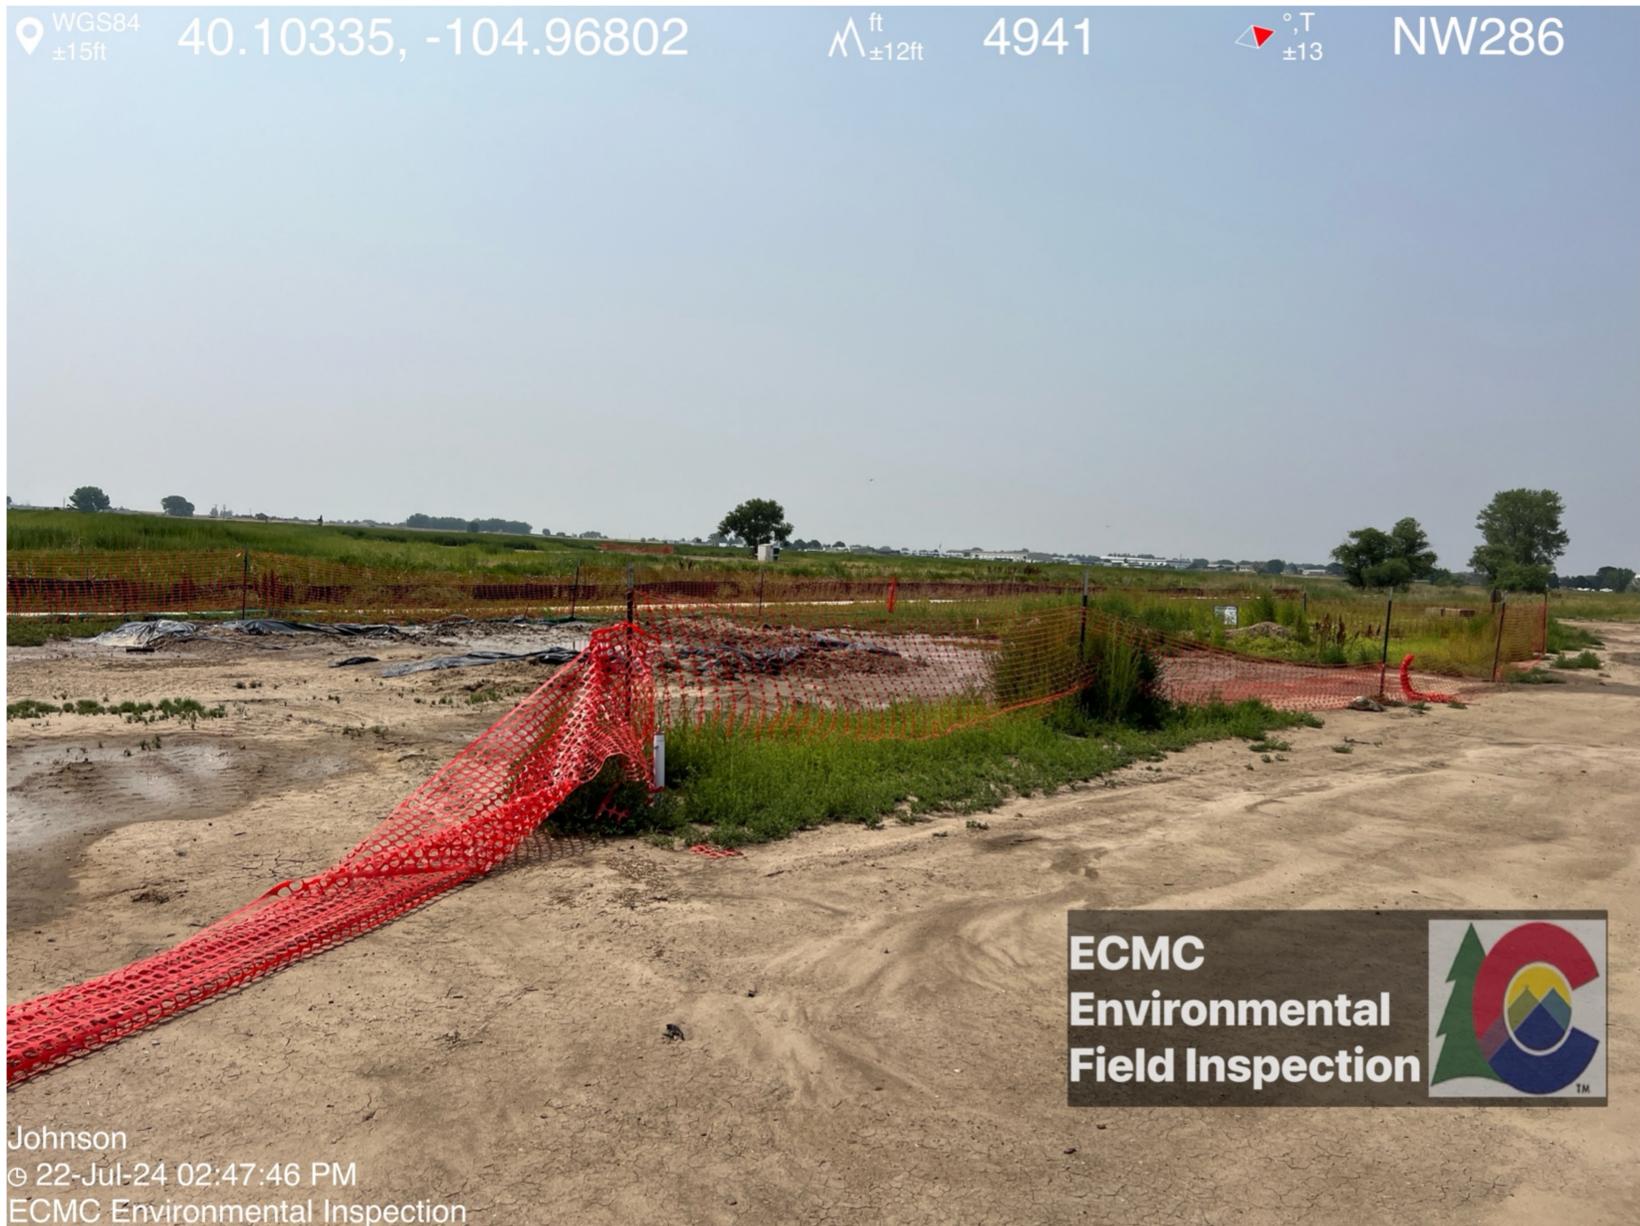
Weeds, torn/downed fencing, debris/trash (torn fencing).

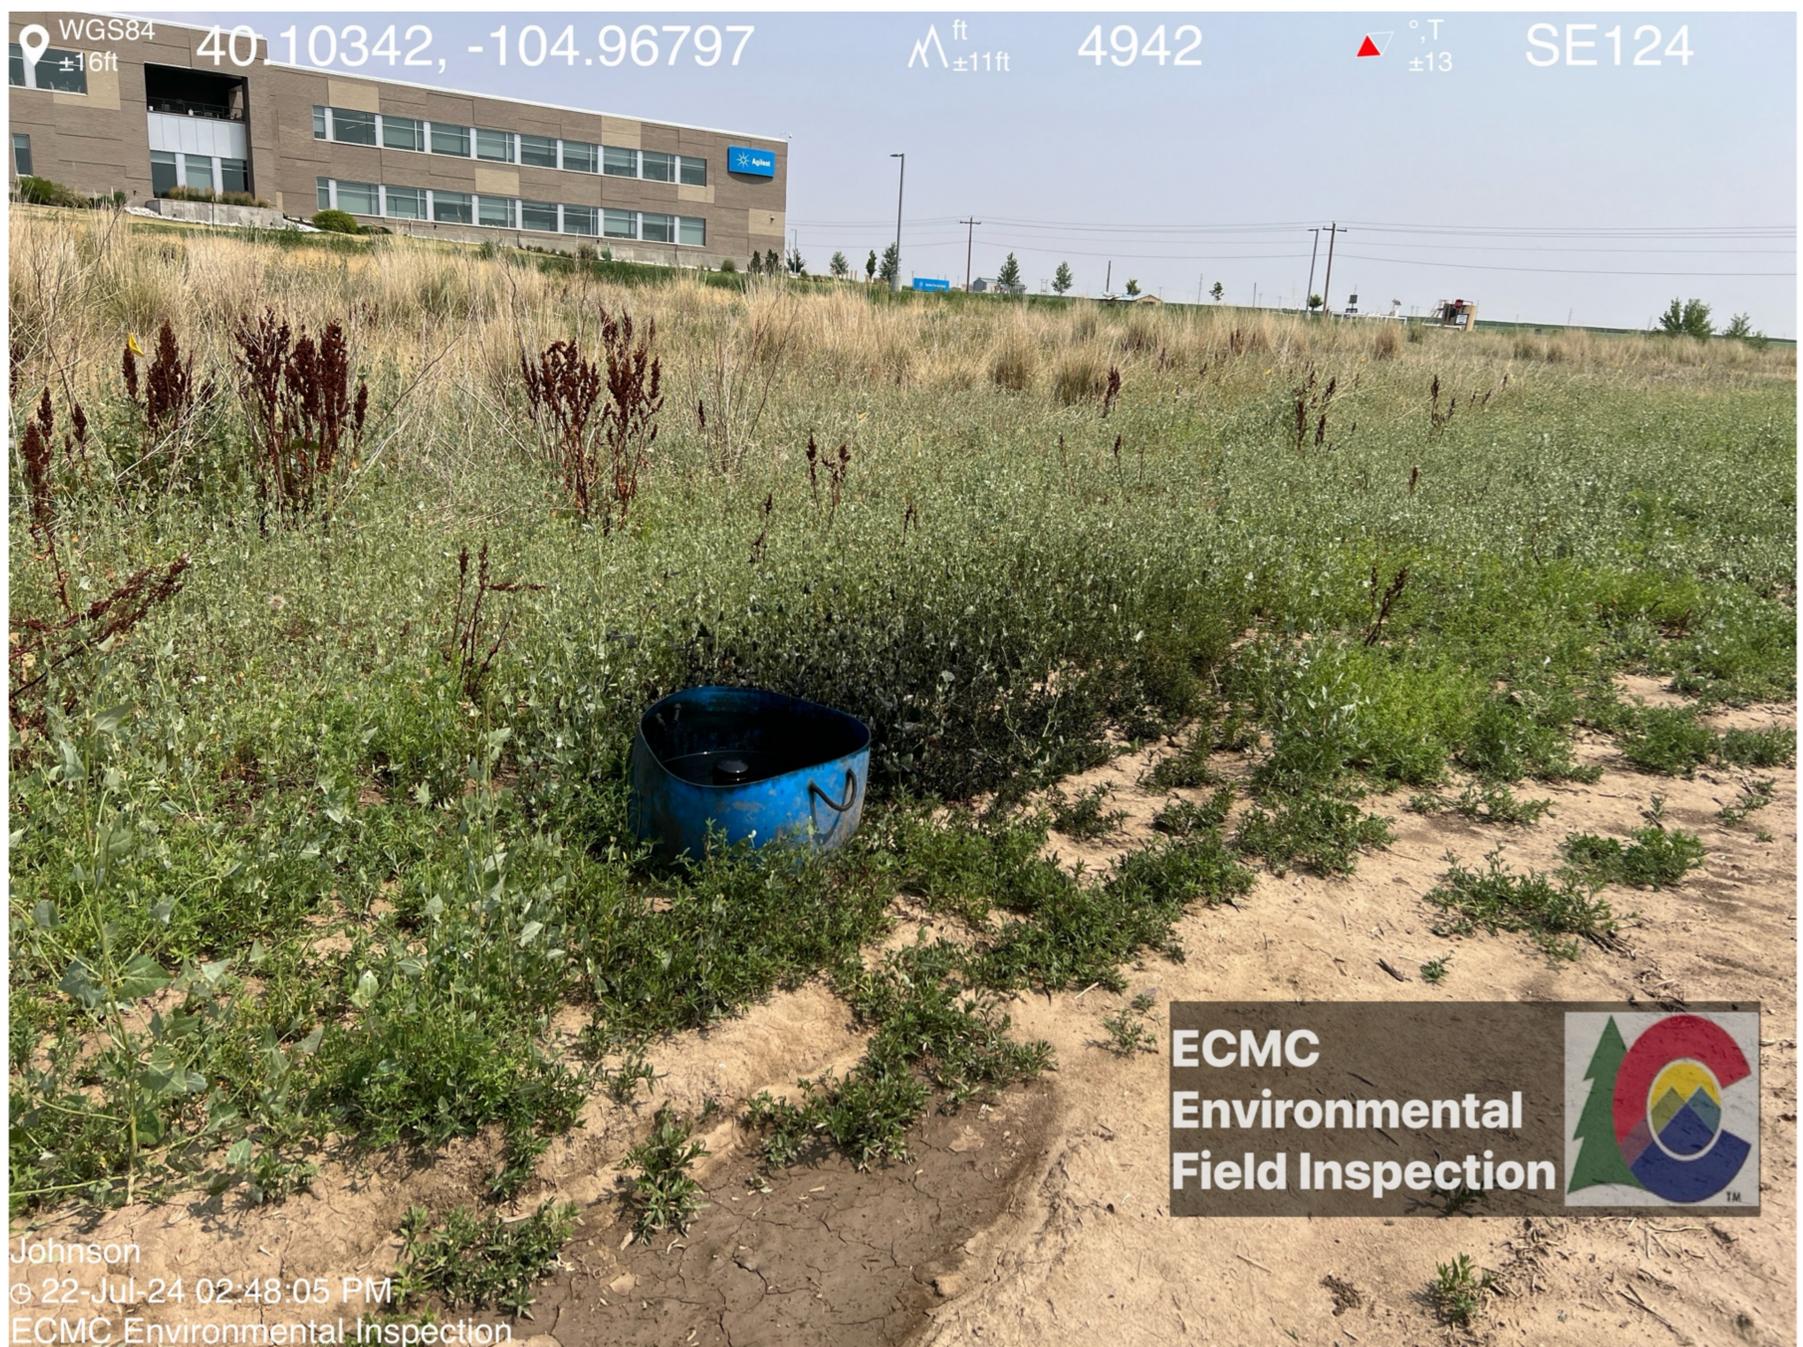
Weeds, debris/trash, stained soil, poor housekeeping

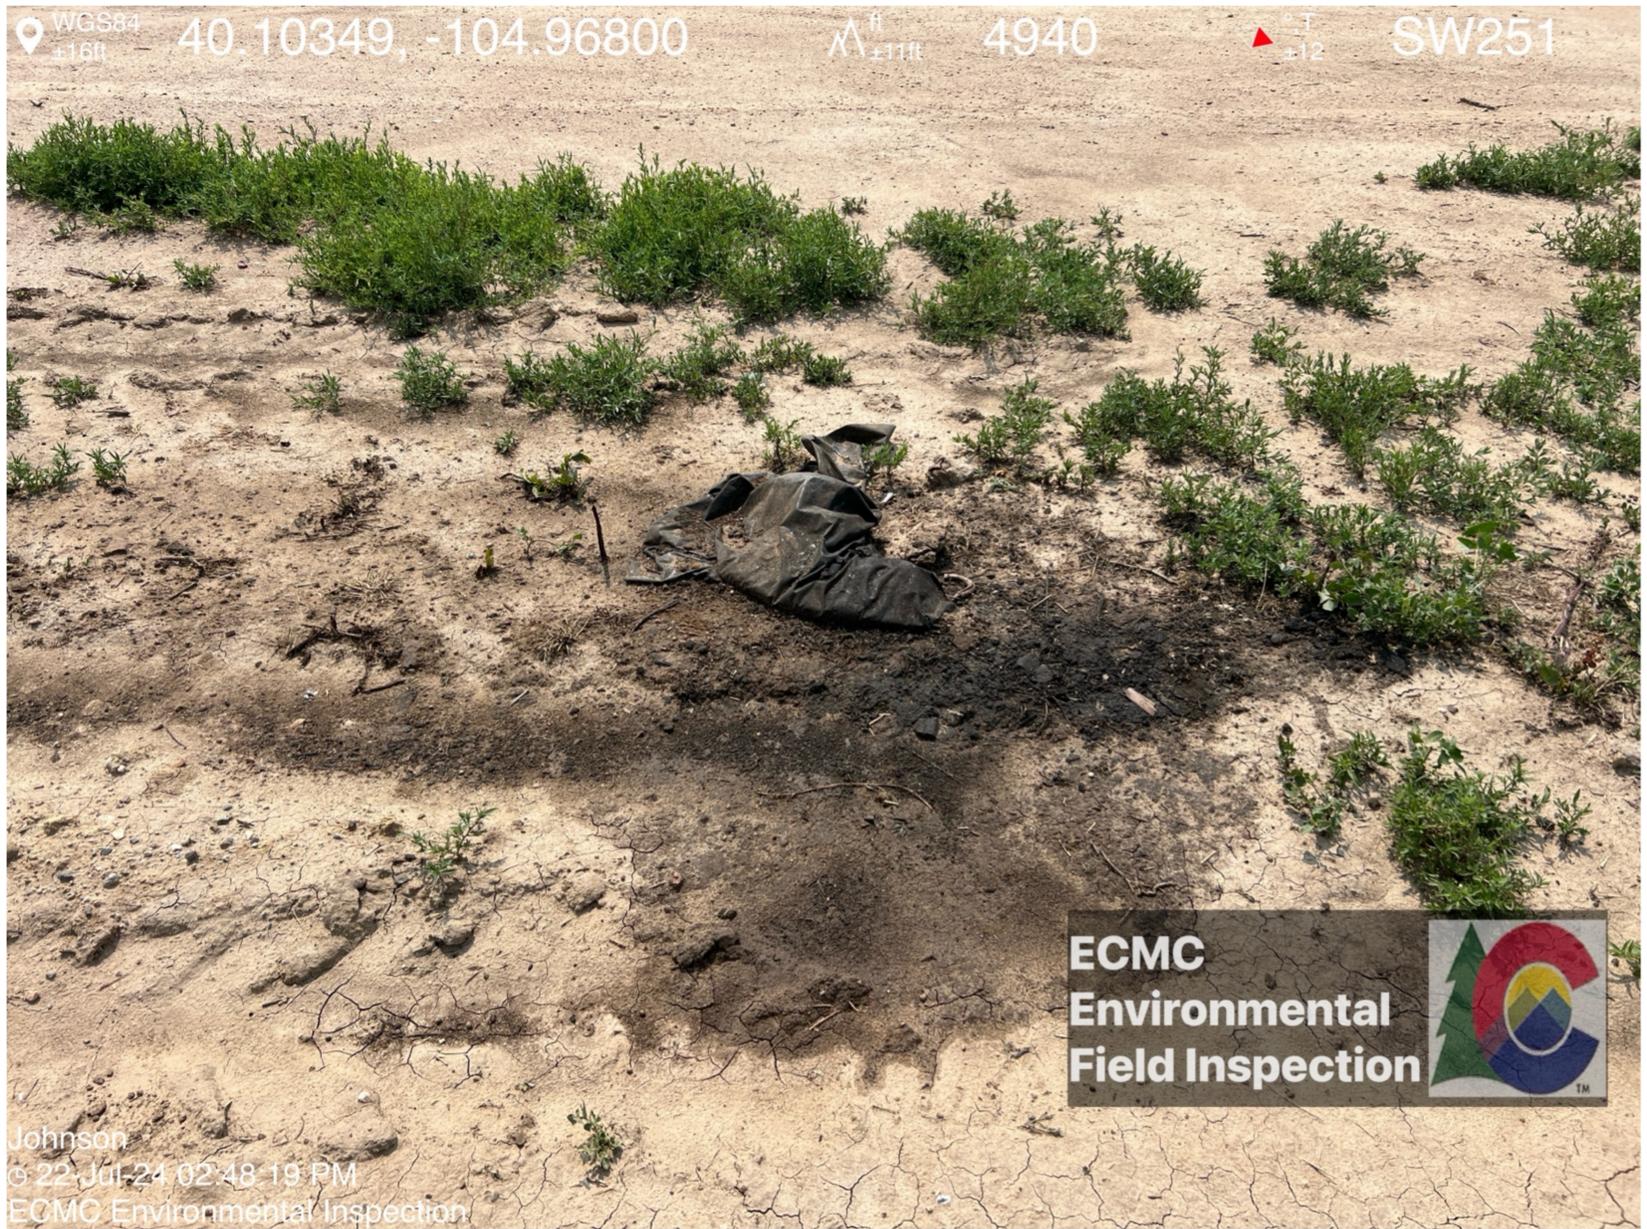
Weeds, debris/trash, stained soil, poor housekeeping

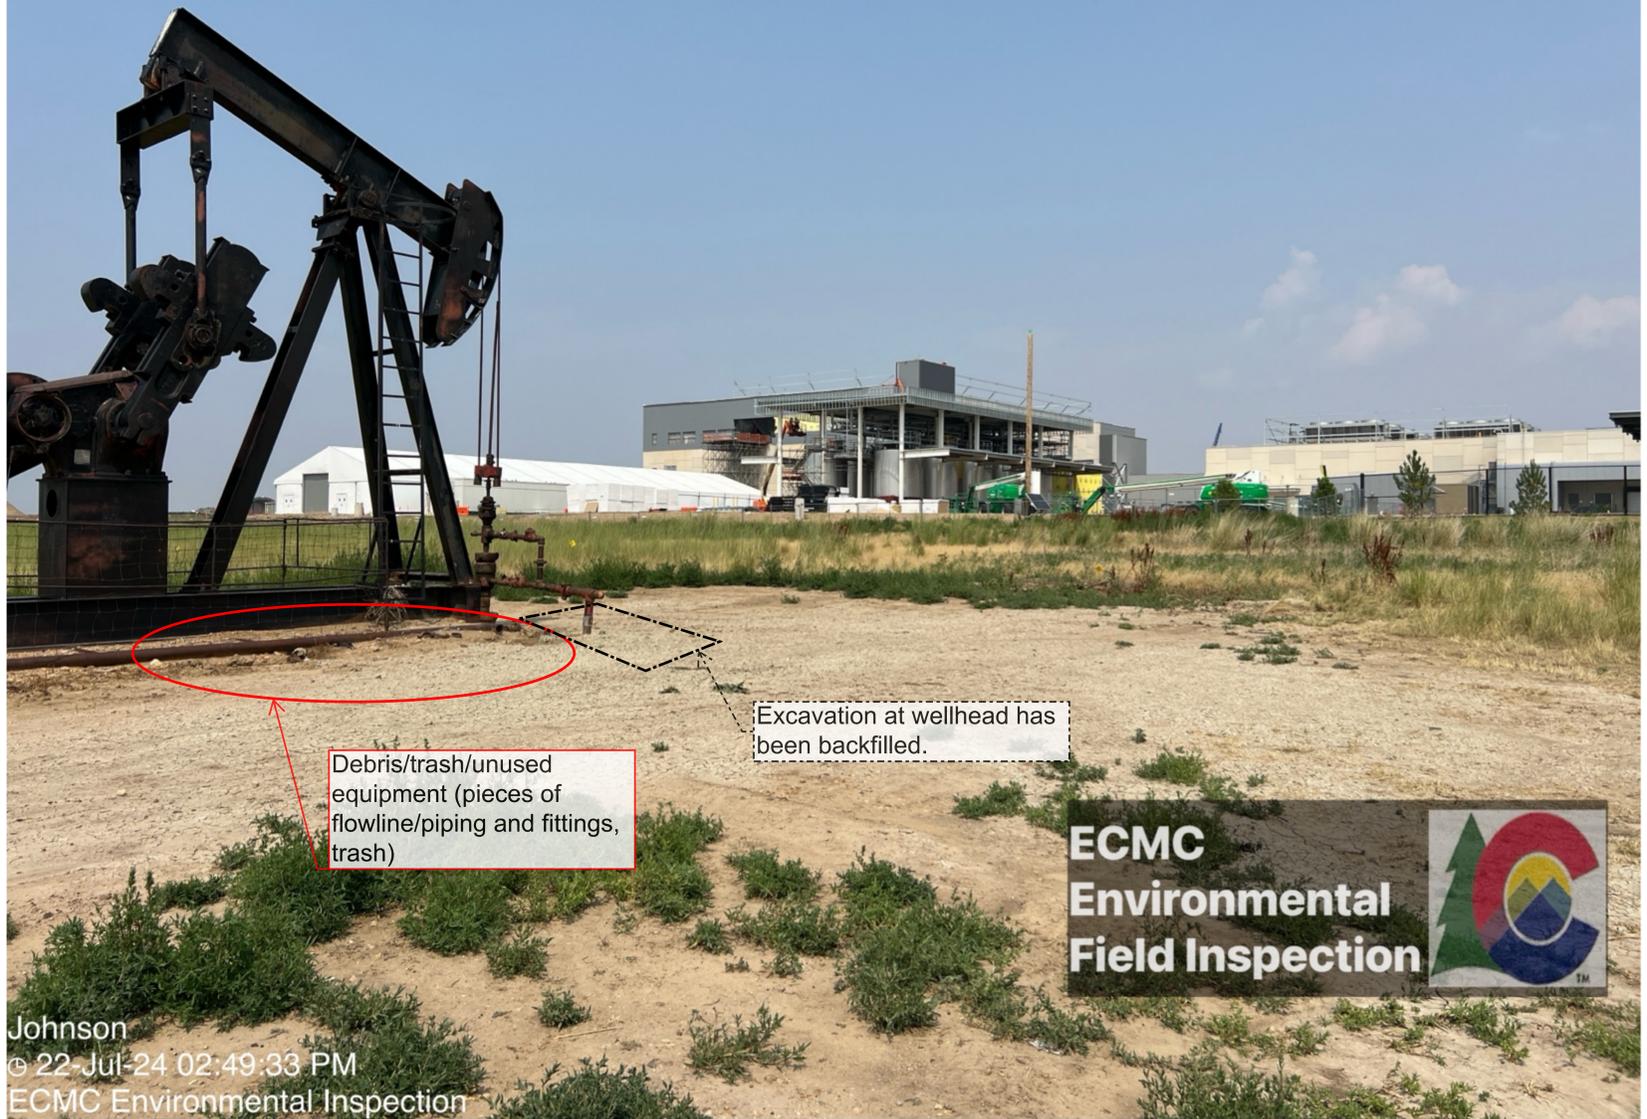
Debris/trash/unused equipment (pieces of flowline/piping and fittings, trash)

Excavation at wellhead has been backfilled.

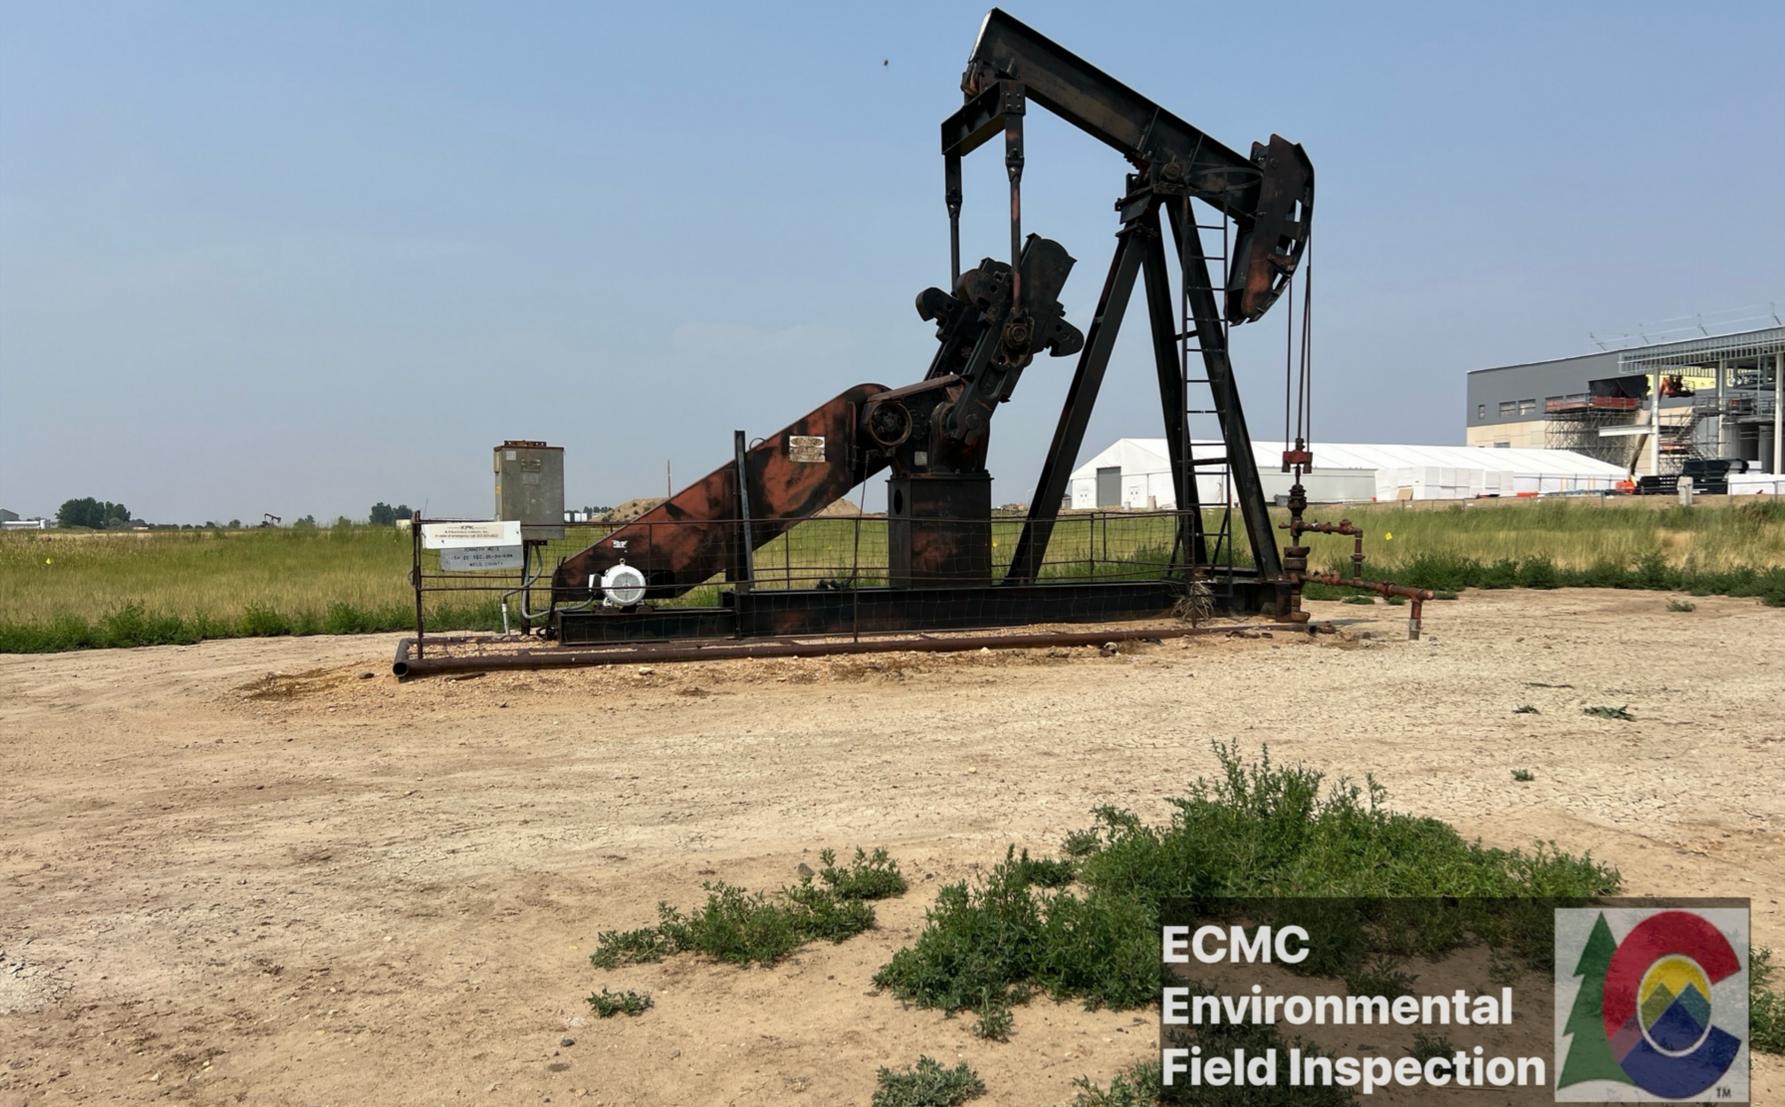
Weeds, debris/trash, stained soil, poor housekeeping

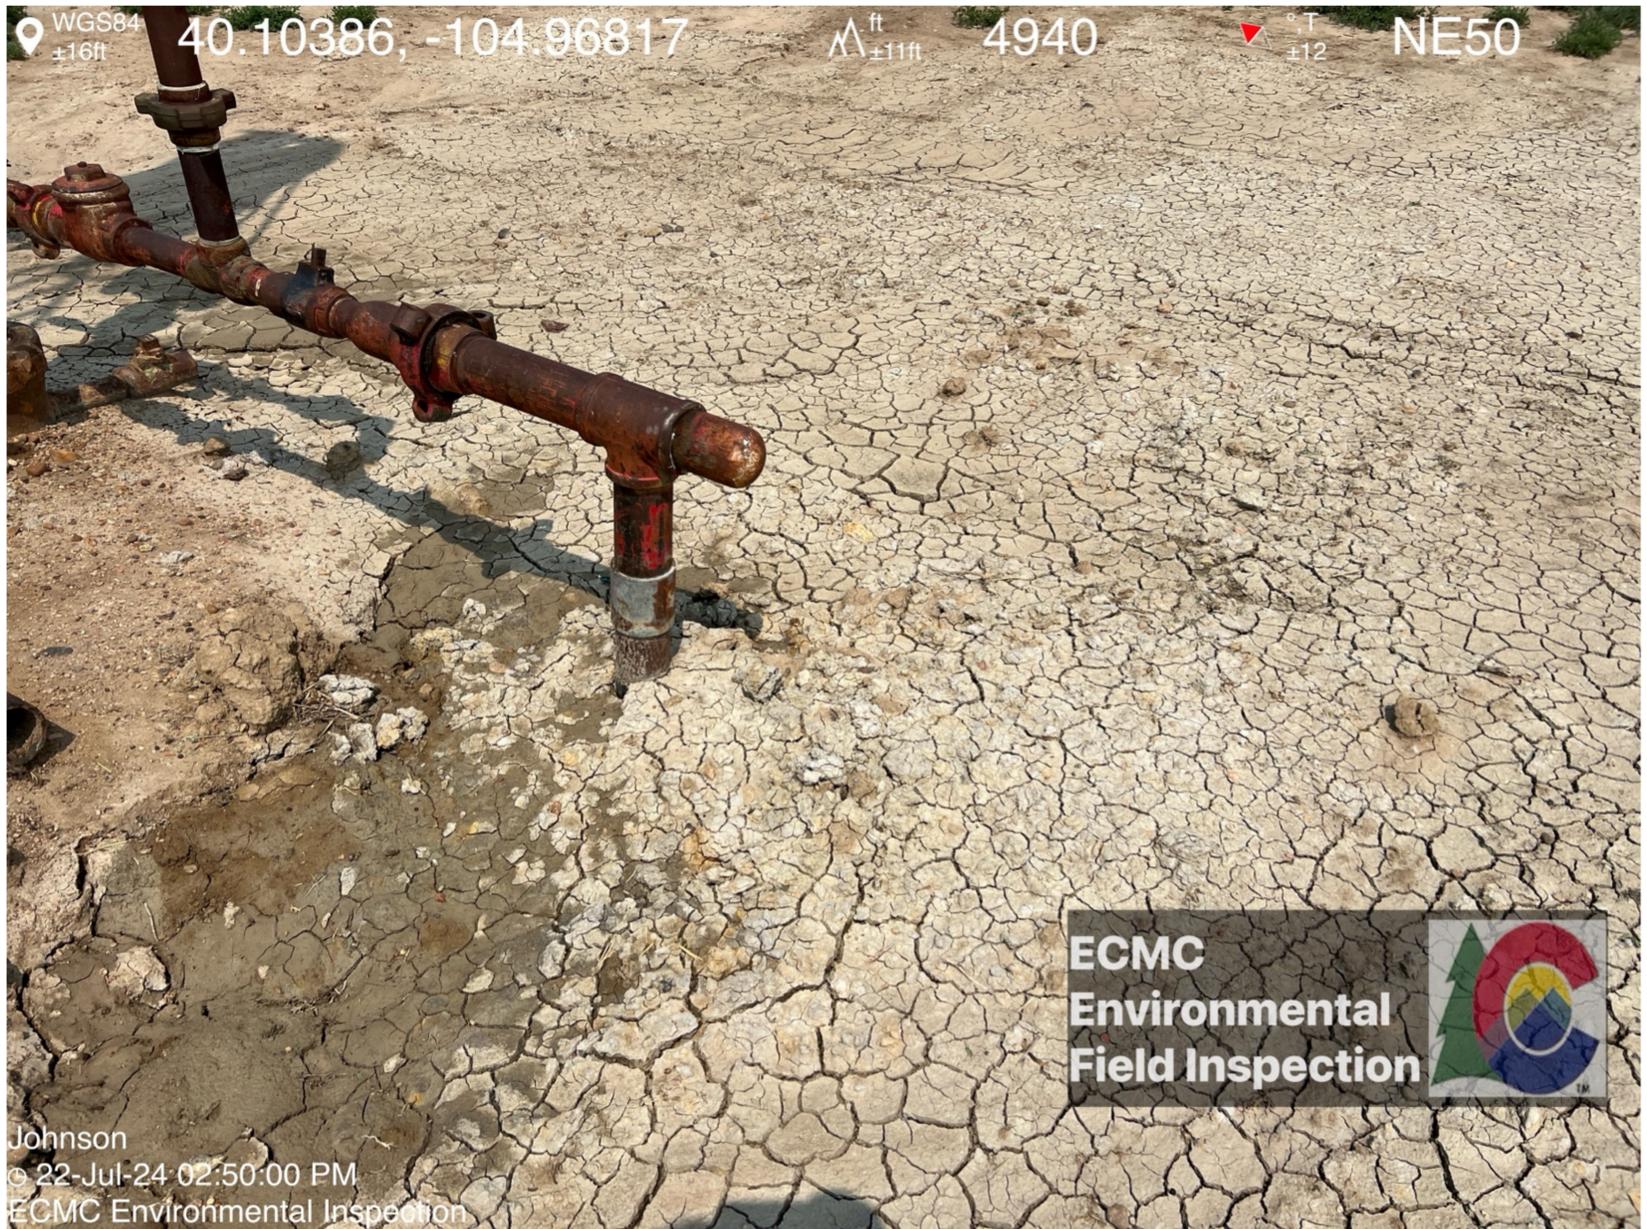
Soil at wellhead

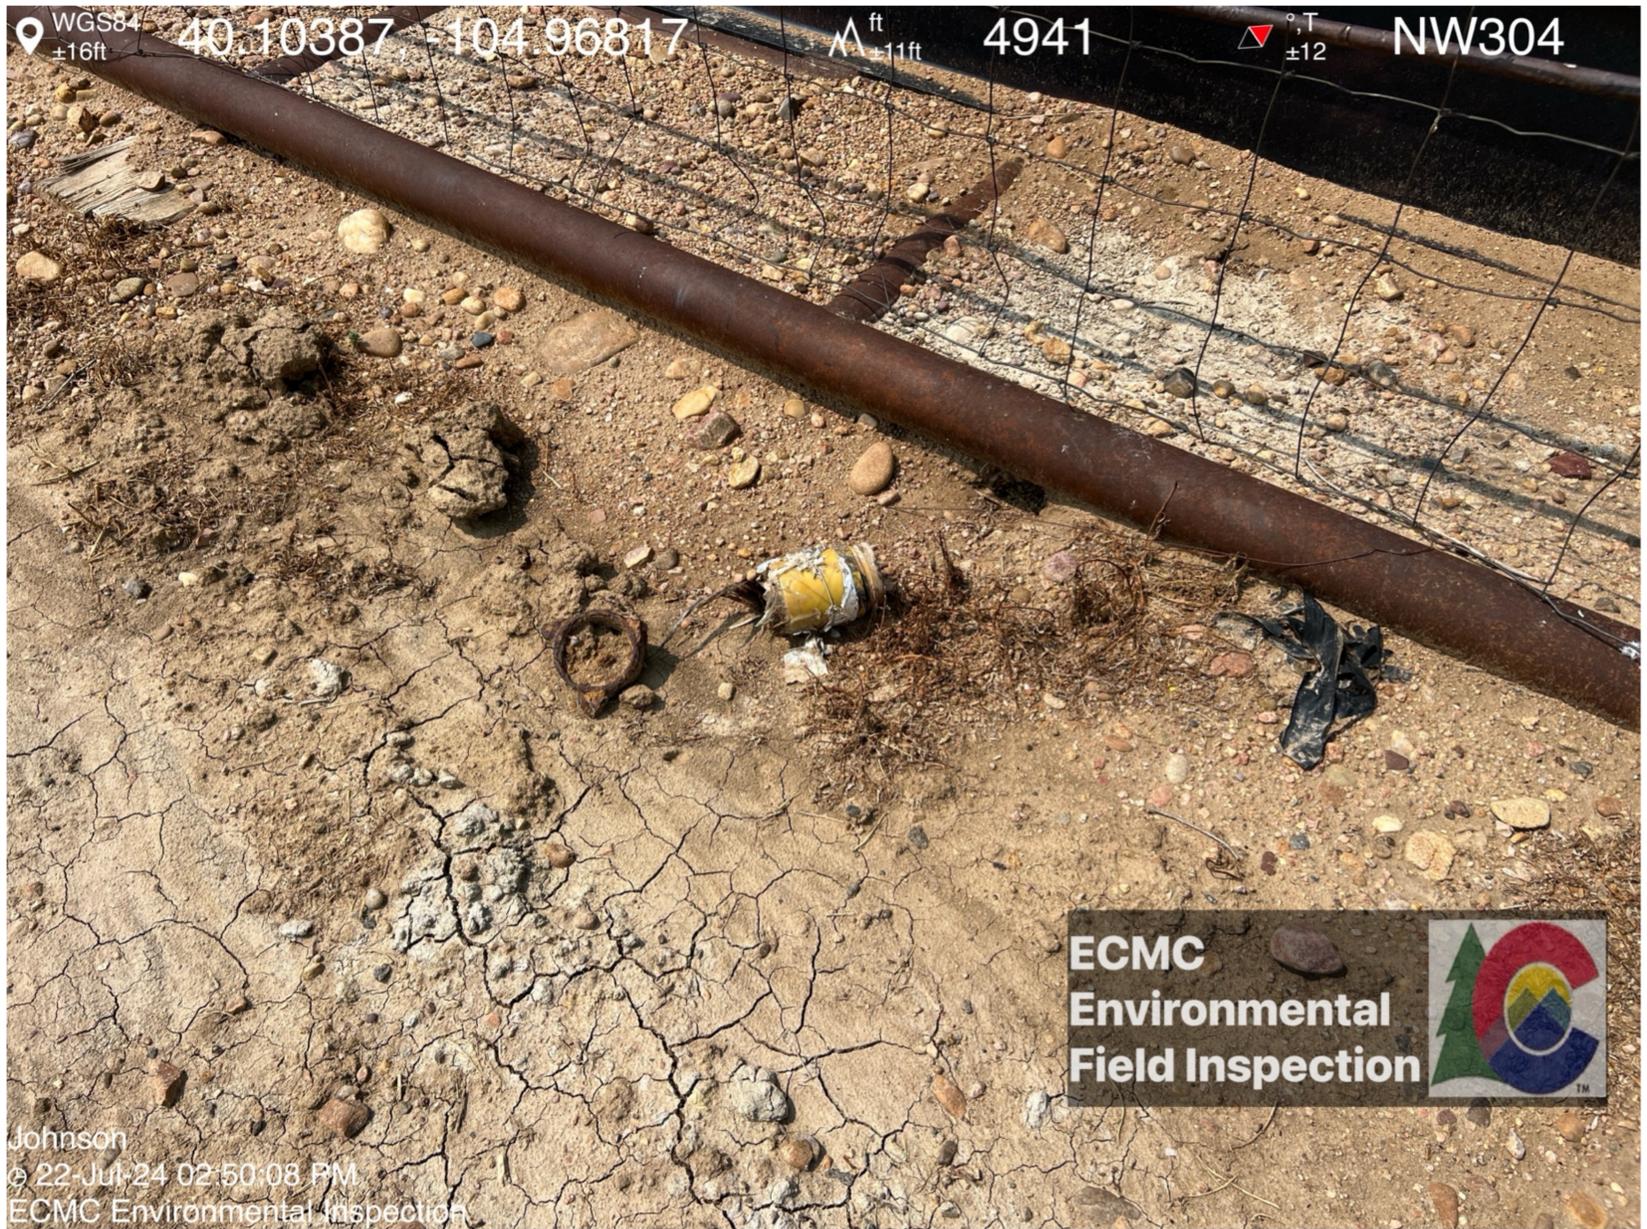
Debris/trash/unused equipment, poor housekeeping

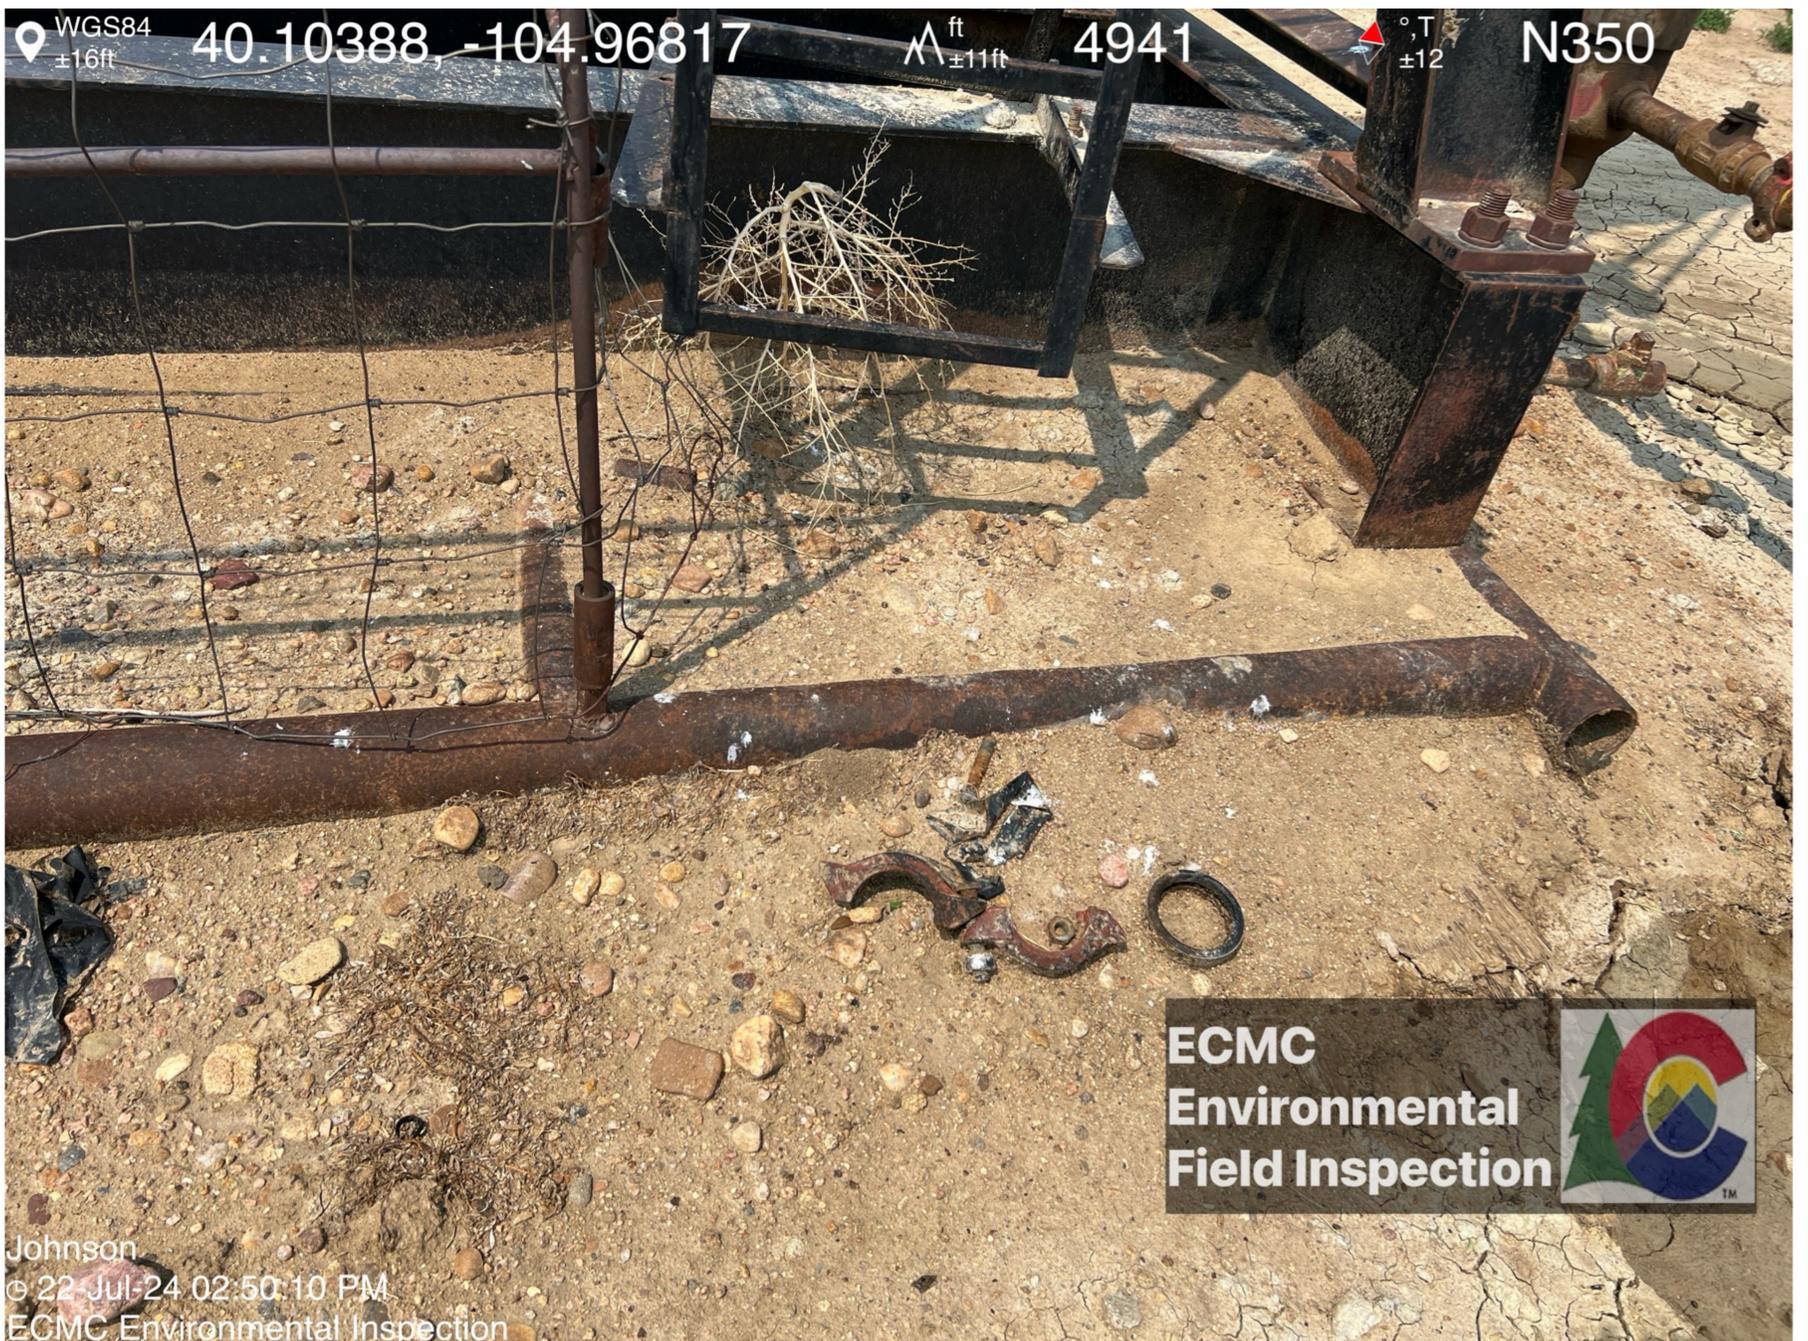
Debris/trash/unused equipment, poor housekeeping

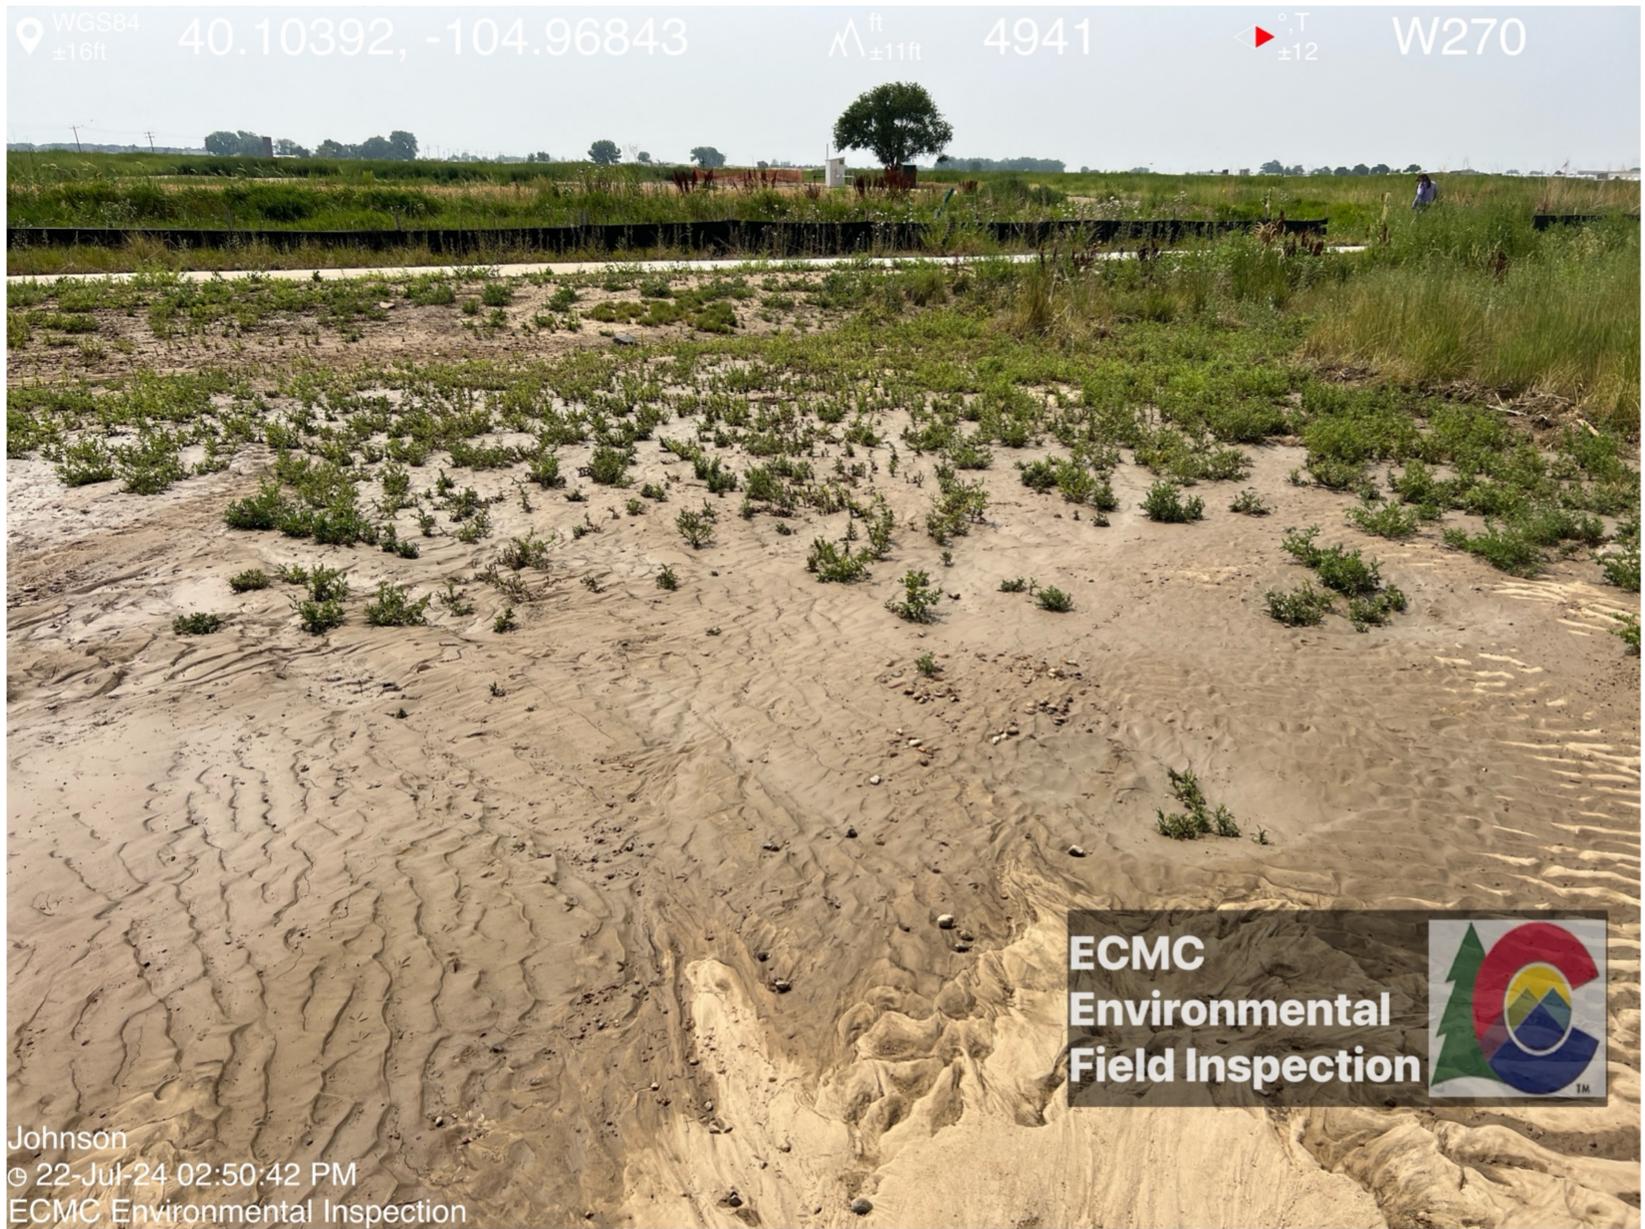
Ripple marks from runoff
