**ECMC
Environmental
Field Inspection**

KPK
K.P. KAUFFMAN COMPANY, INC.
Johnson #1 & 2 Battery
SW Section 26, T2N, R66W
Johnson County
688 WCR 13
781-832-7822

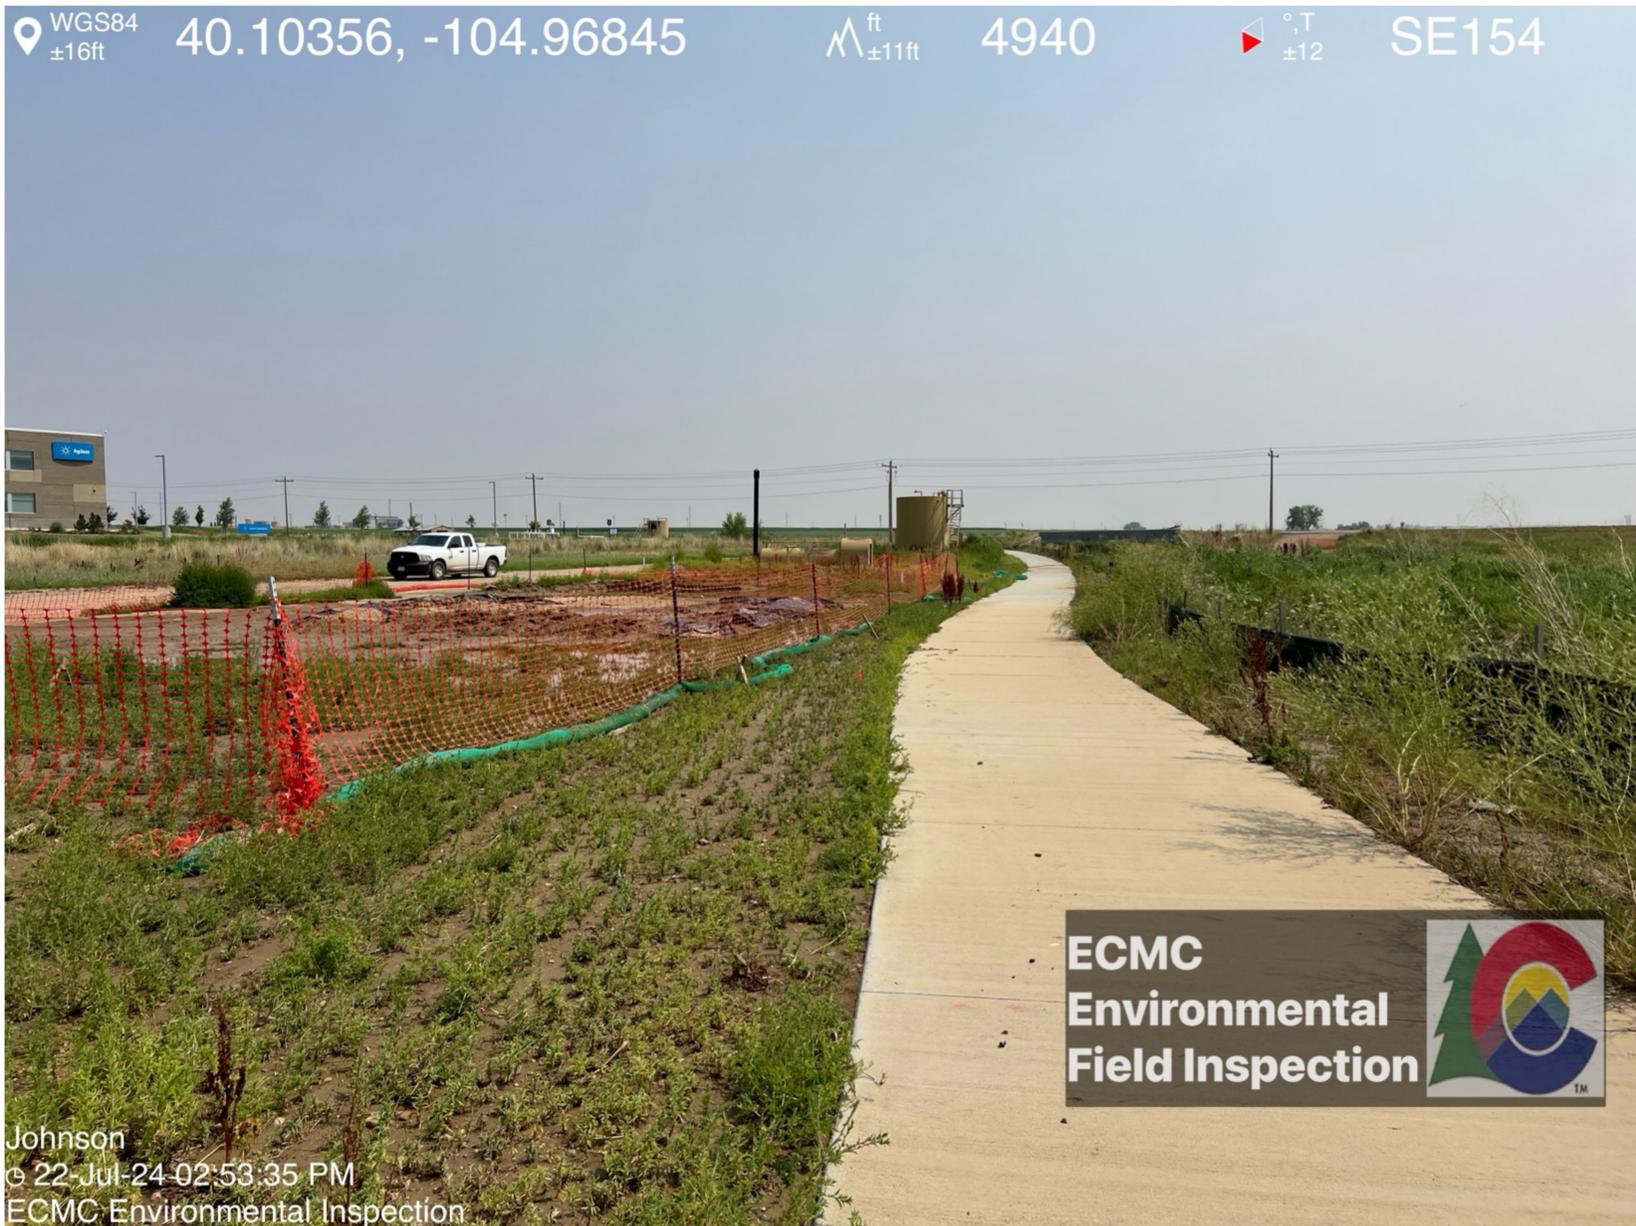
Weeds, inadequate BMPs

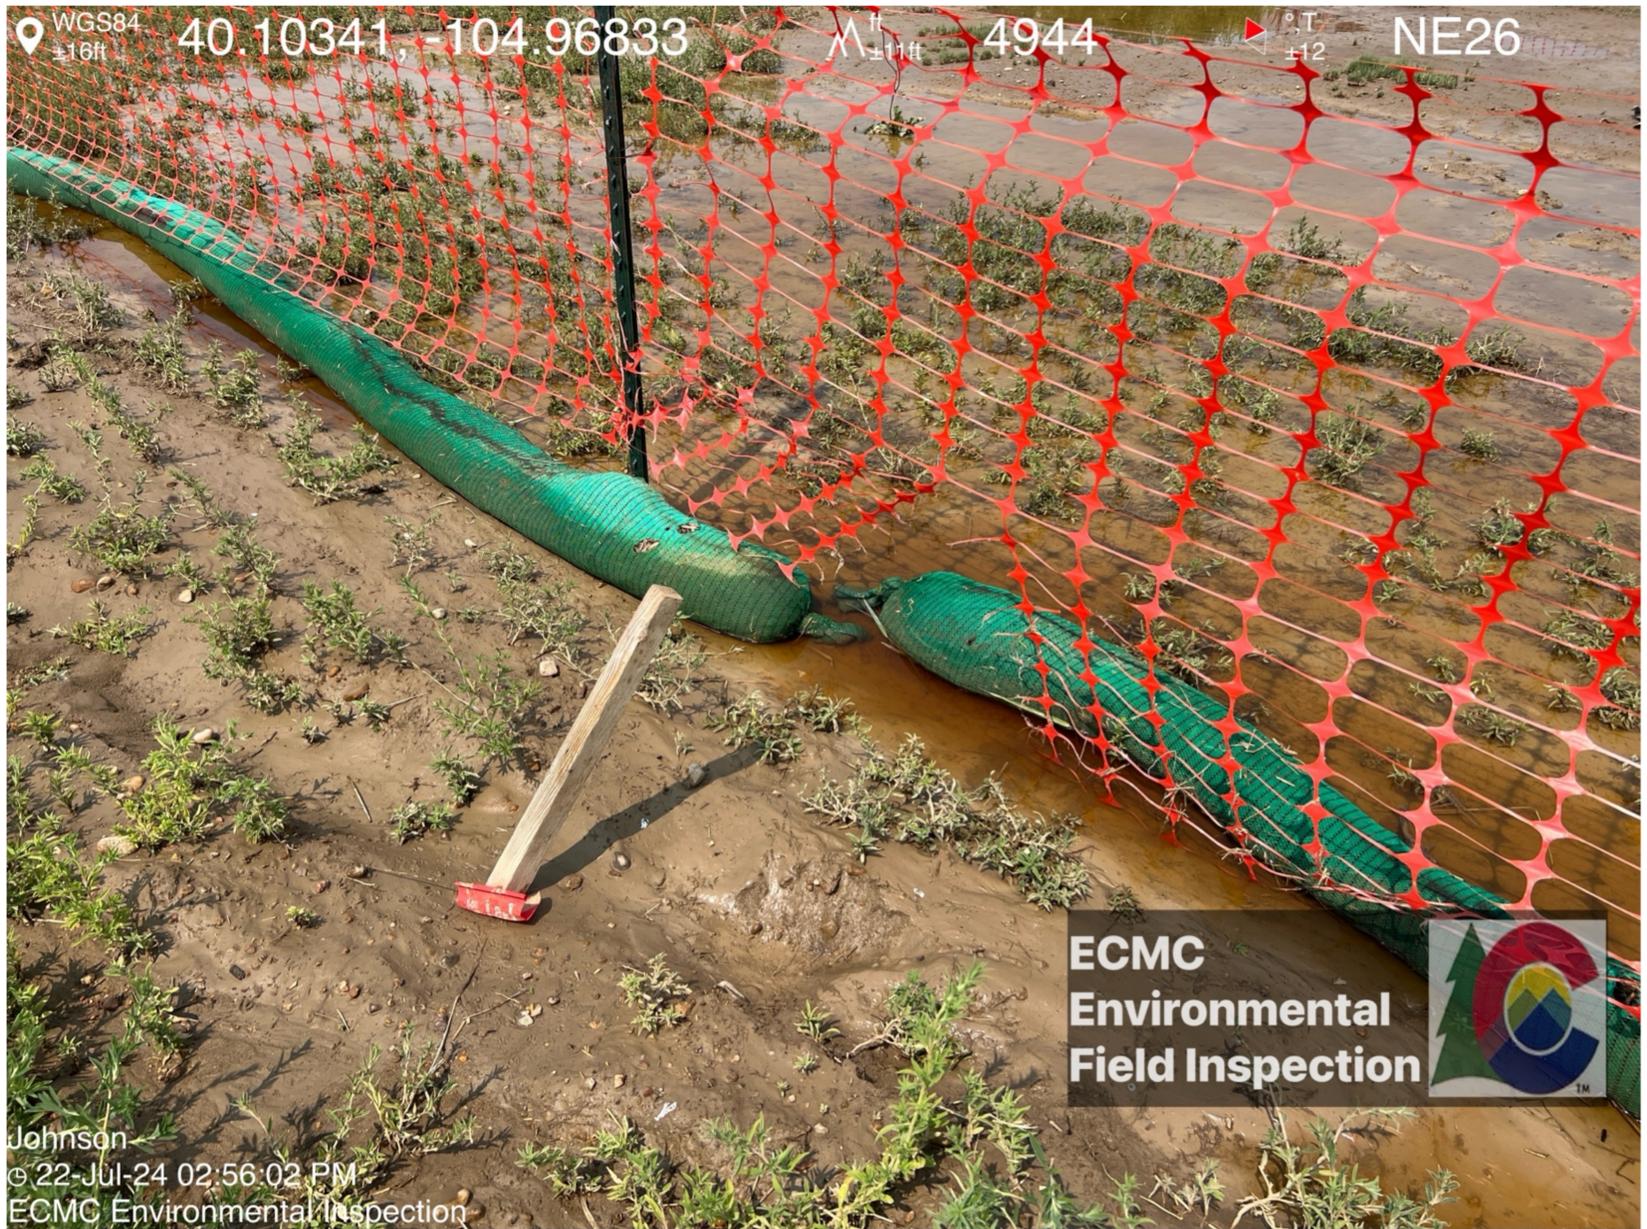
Inadequate BMPs

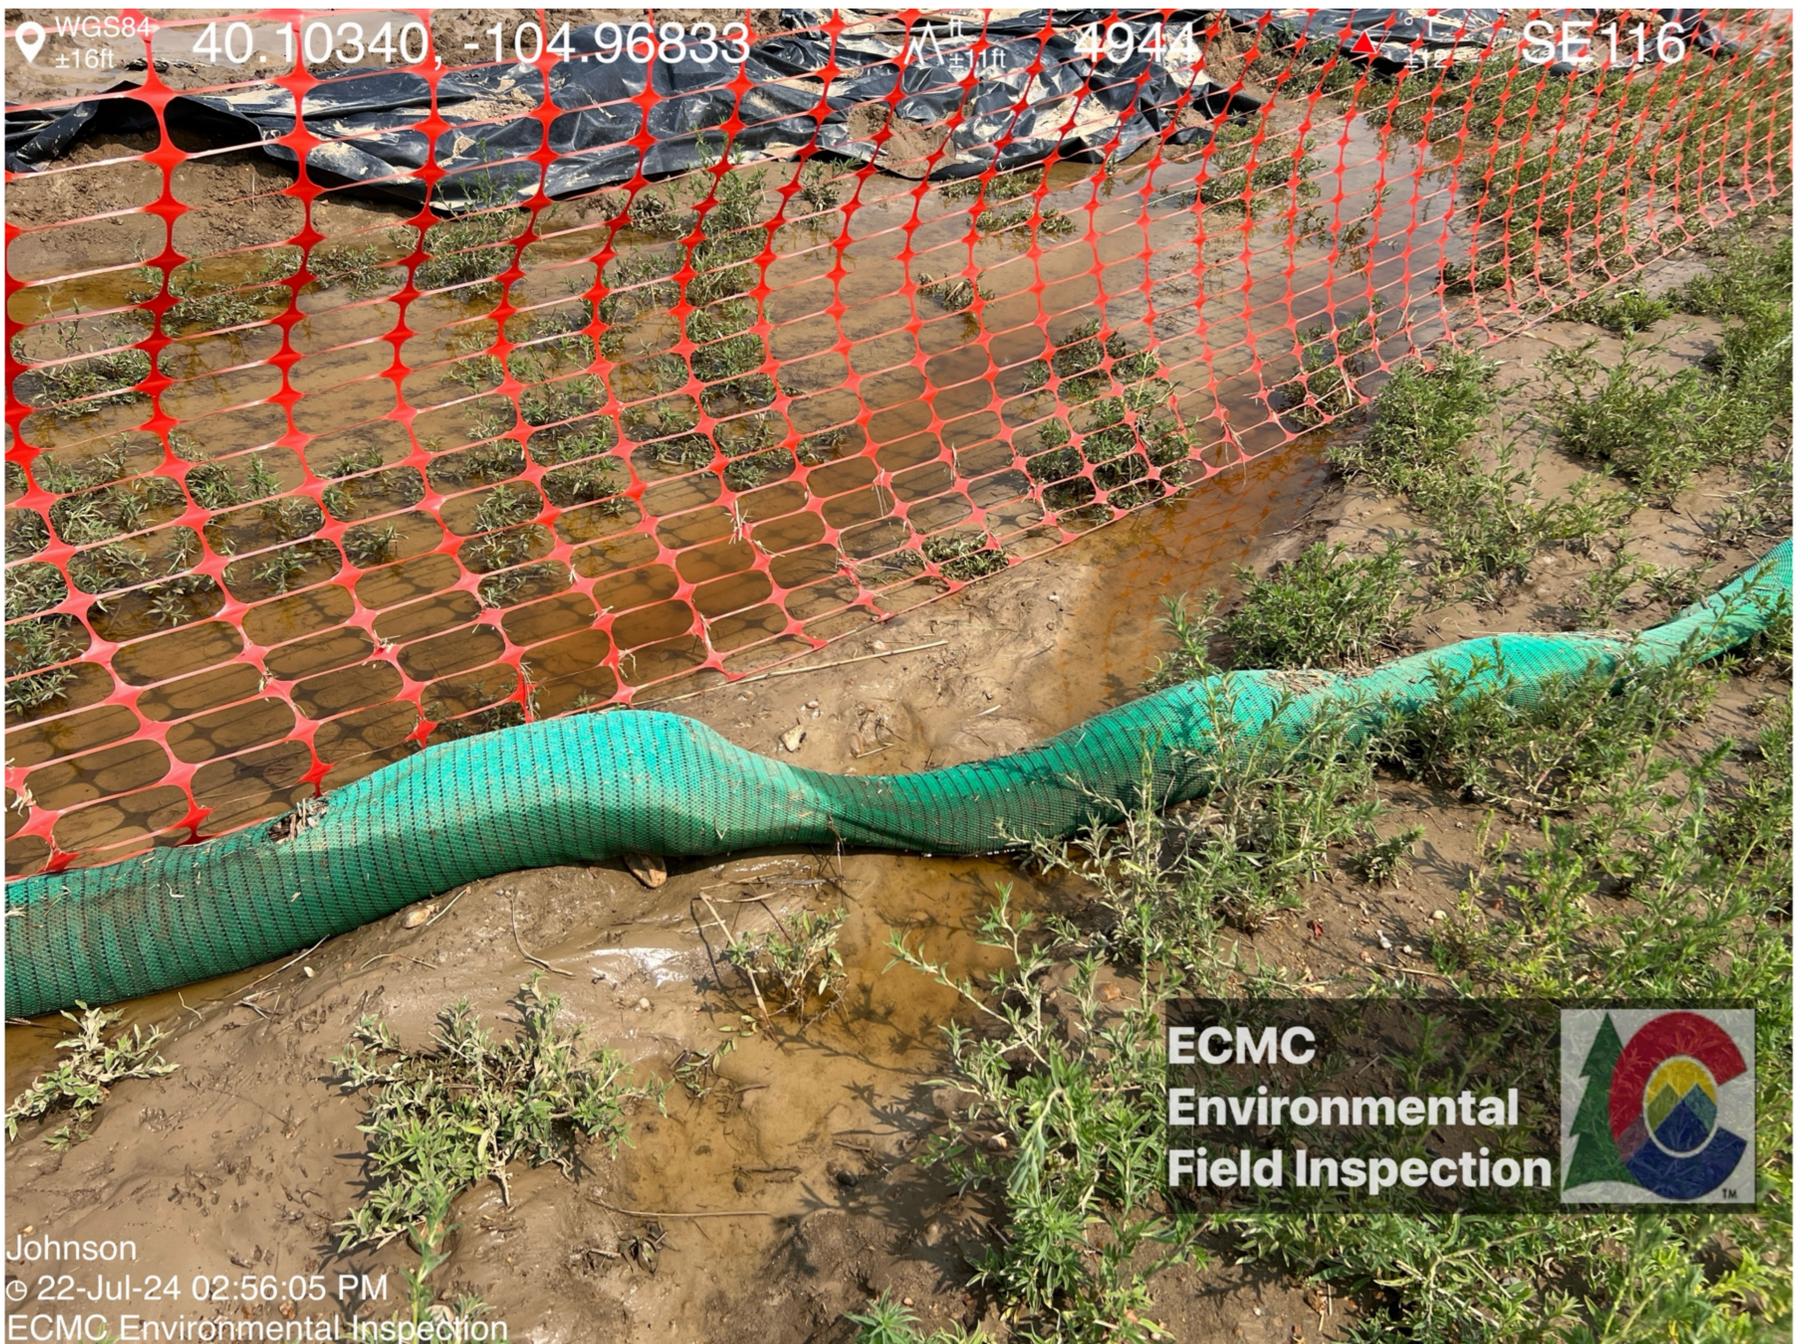
Inadequate BMPs

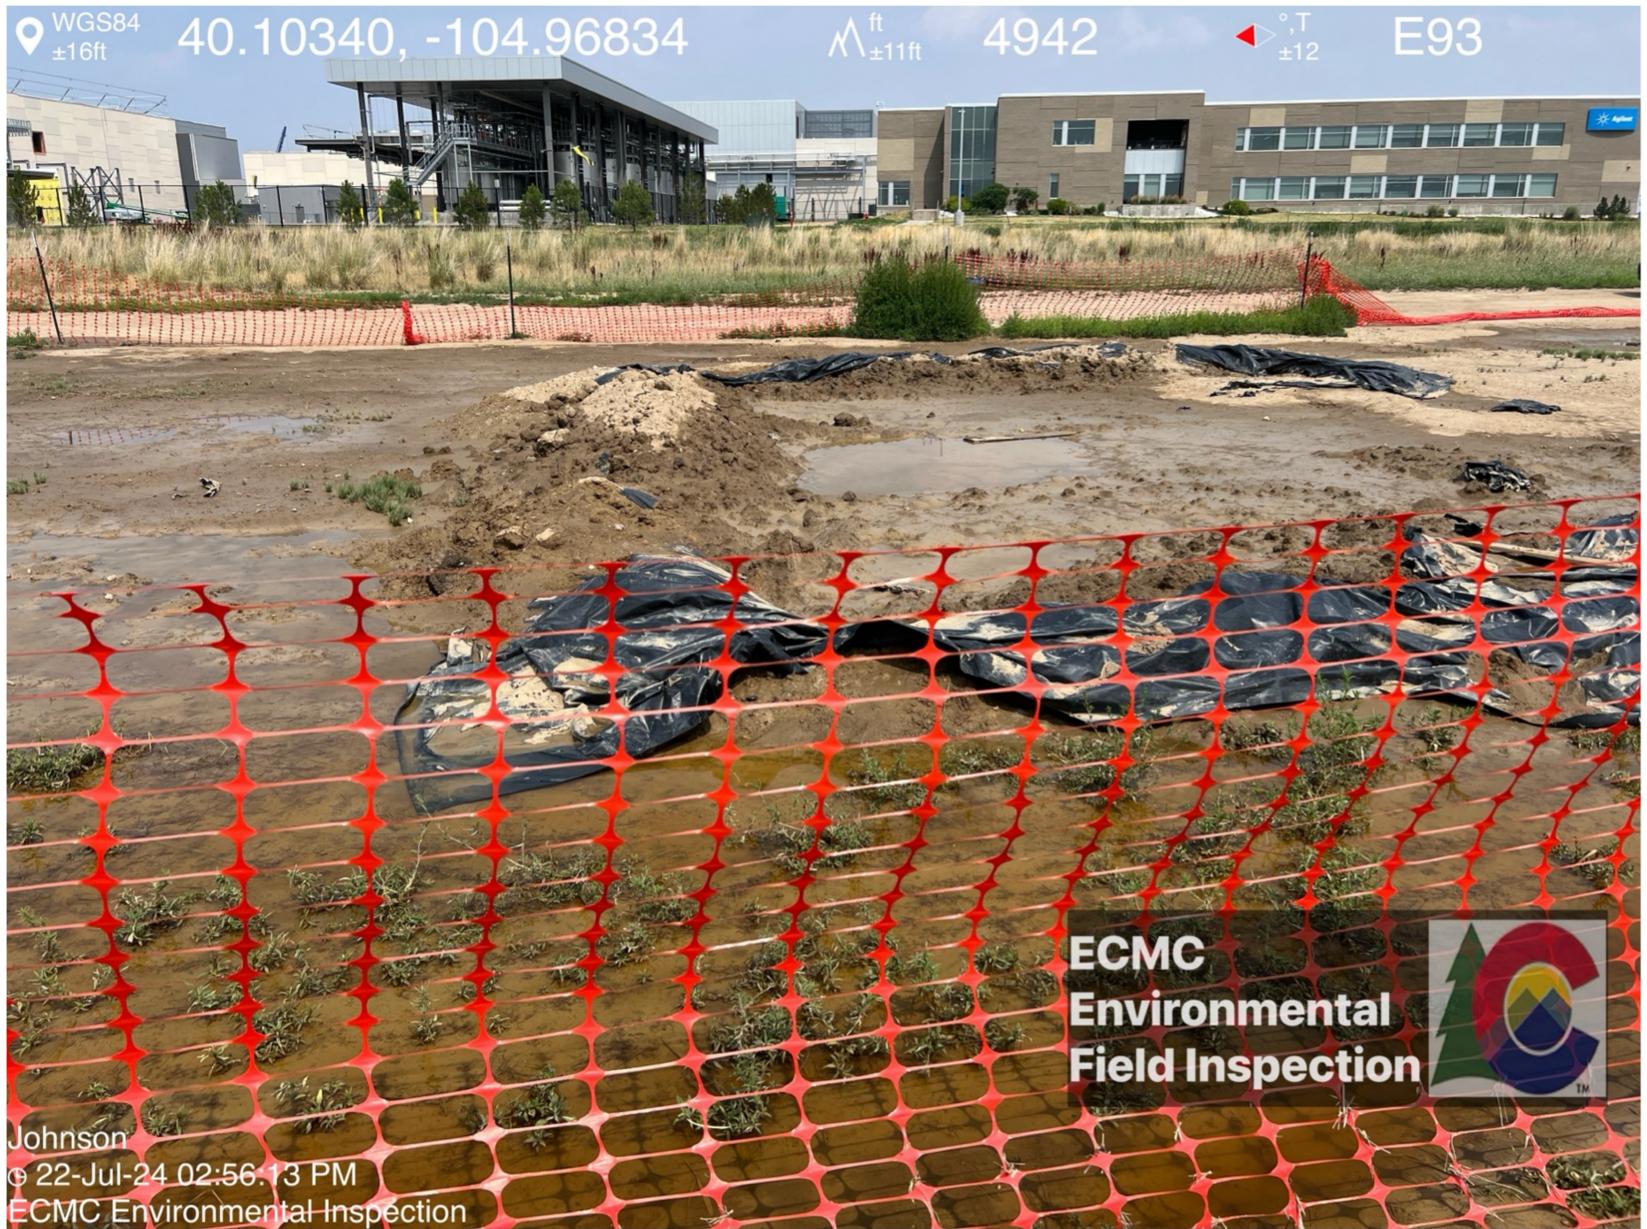
Inadequate BMPs, weeds, downed fencing

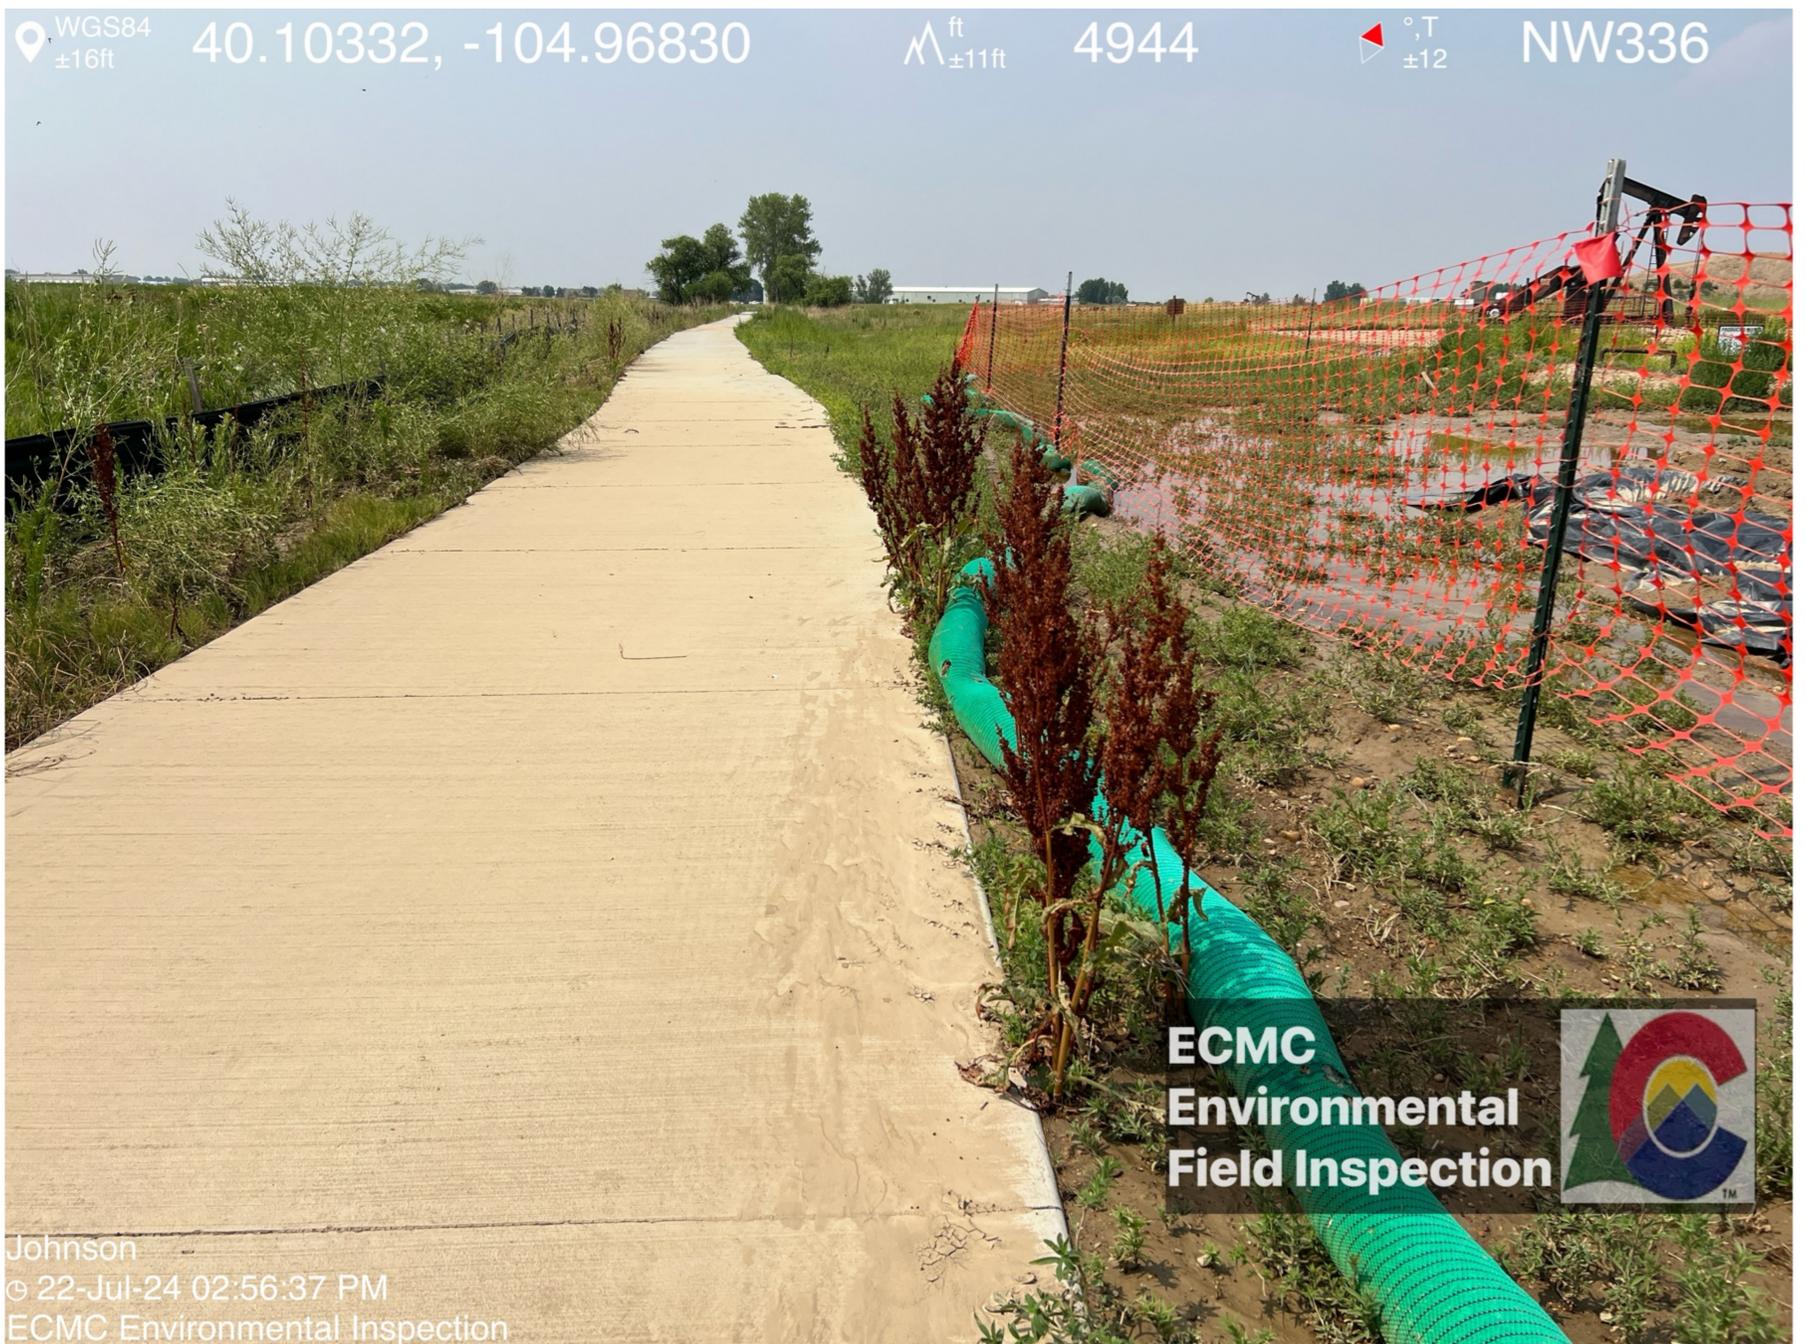
Inadequate BMPs, weeds

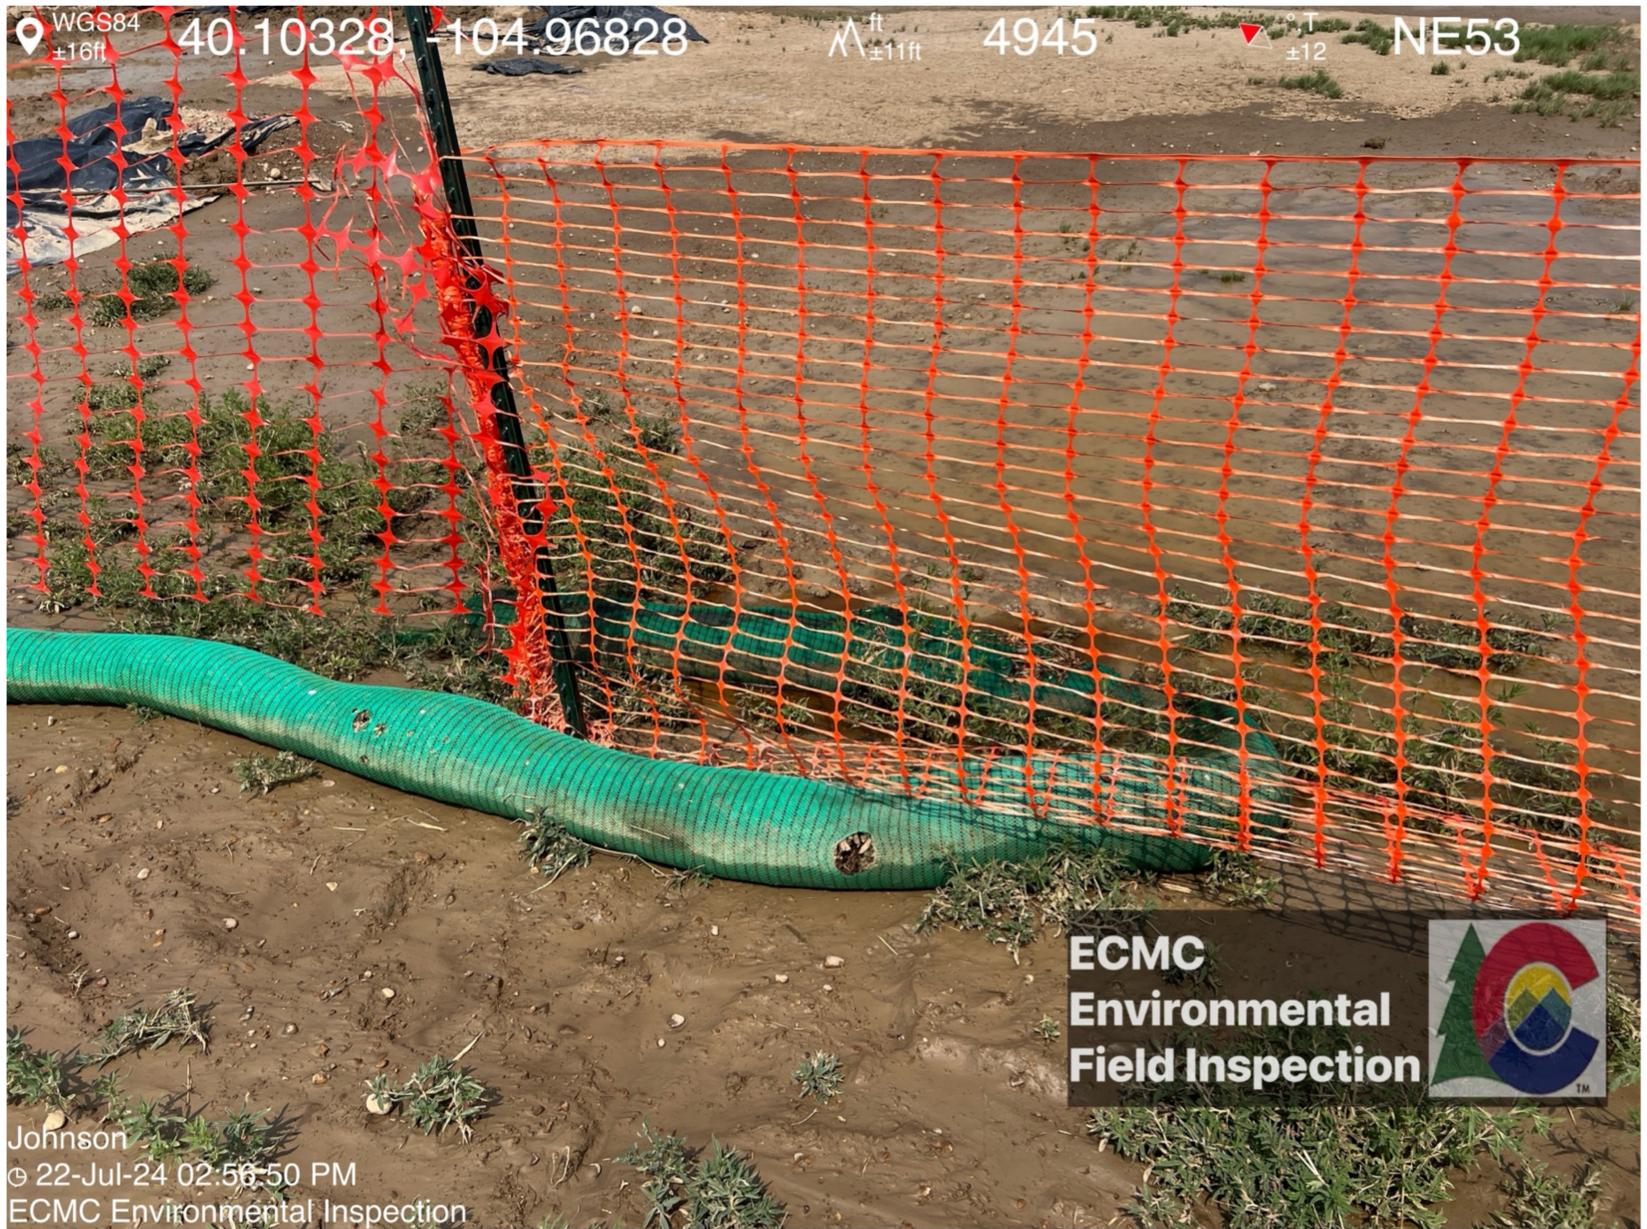
Inadequate BMPs

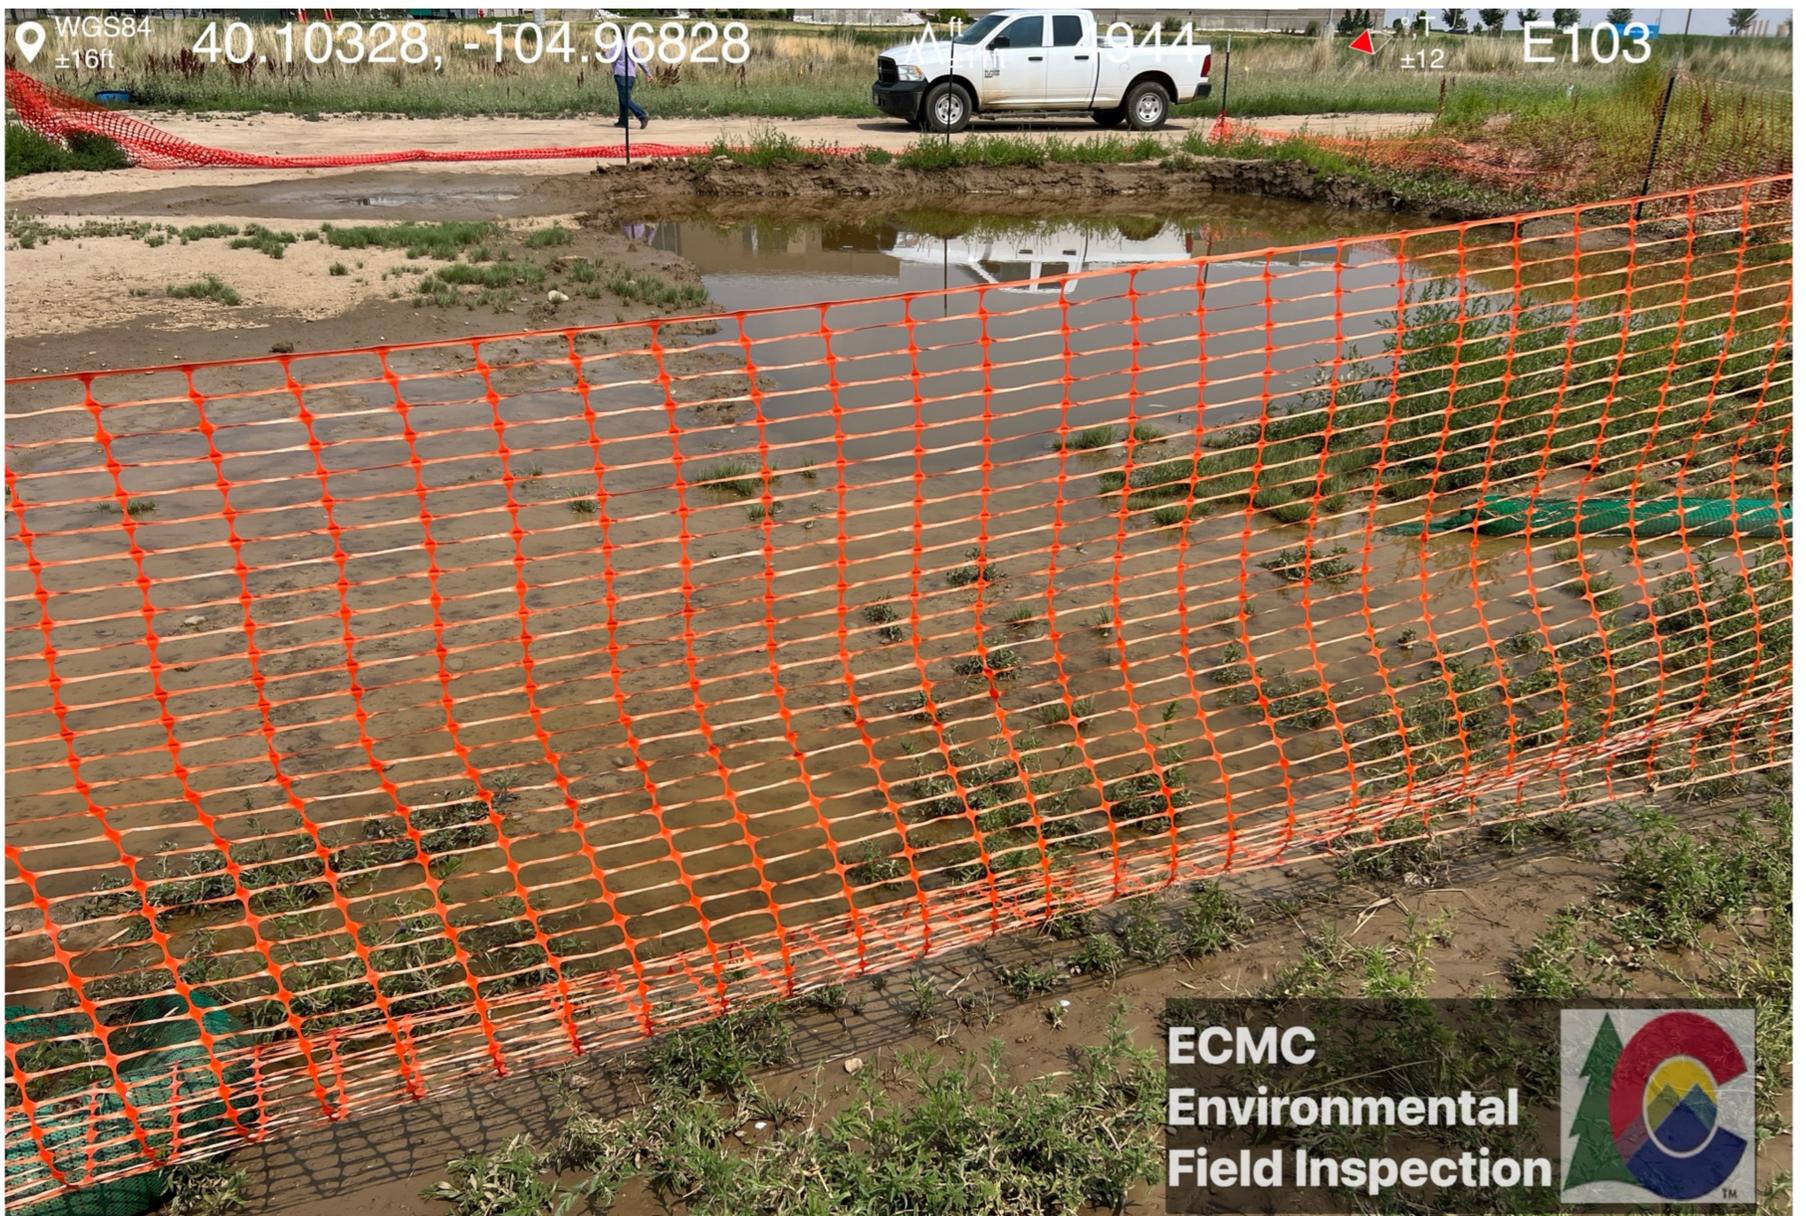
Inadequate BMPs, weeds, water overflowing from open excavation

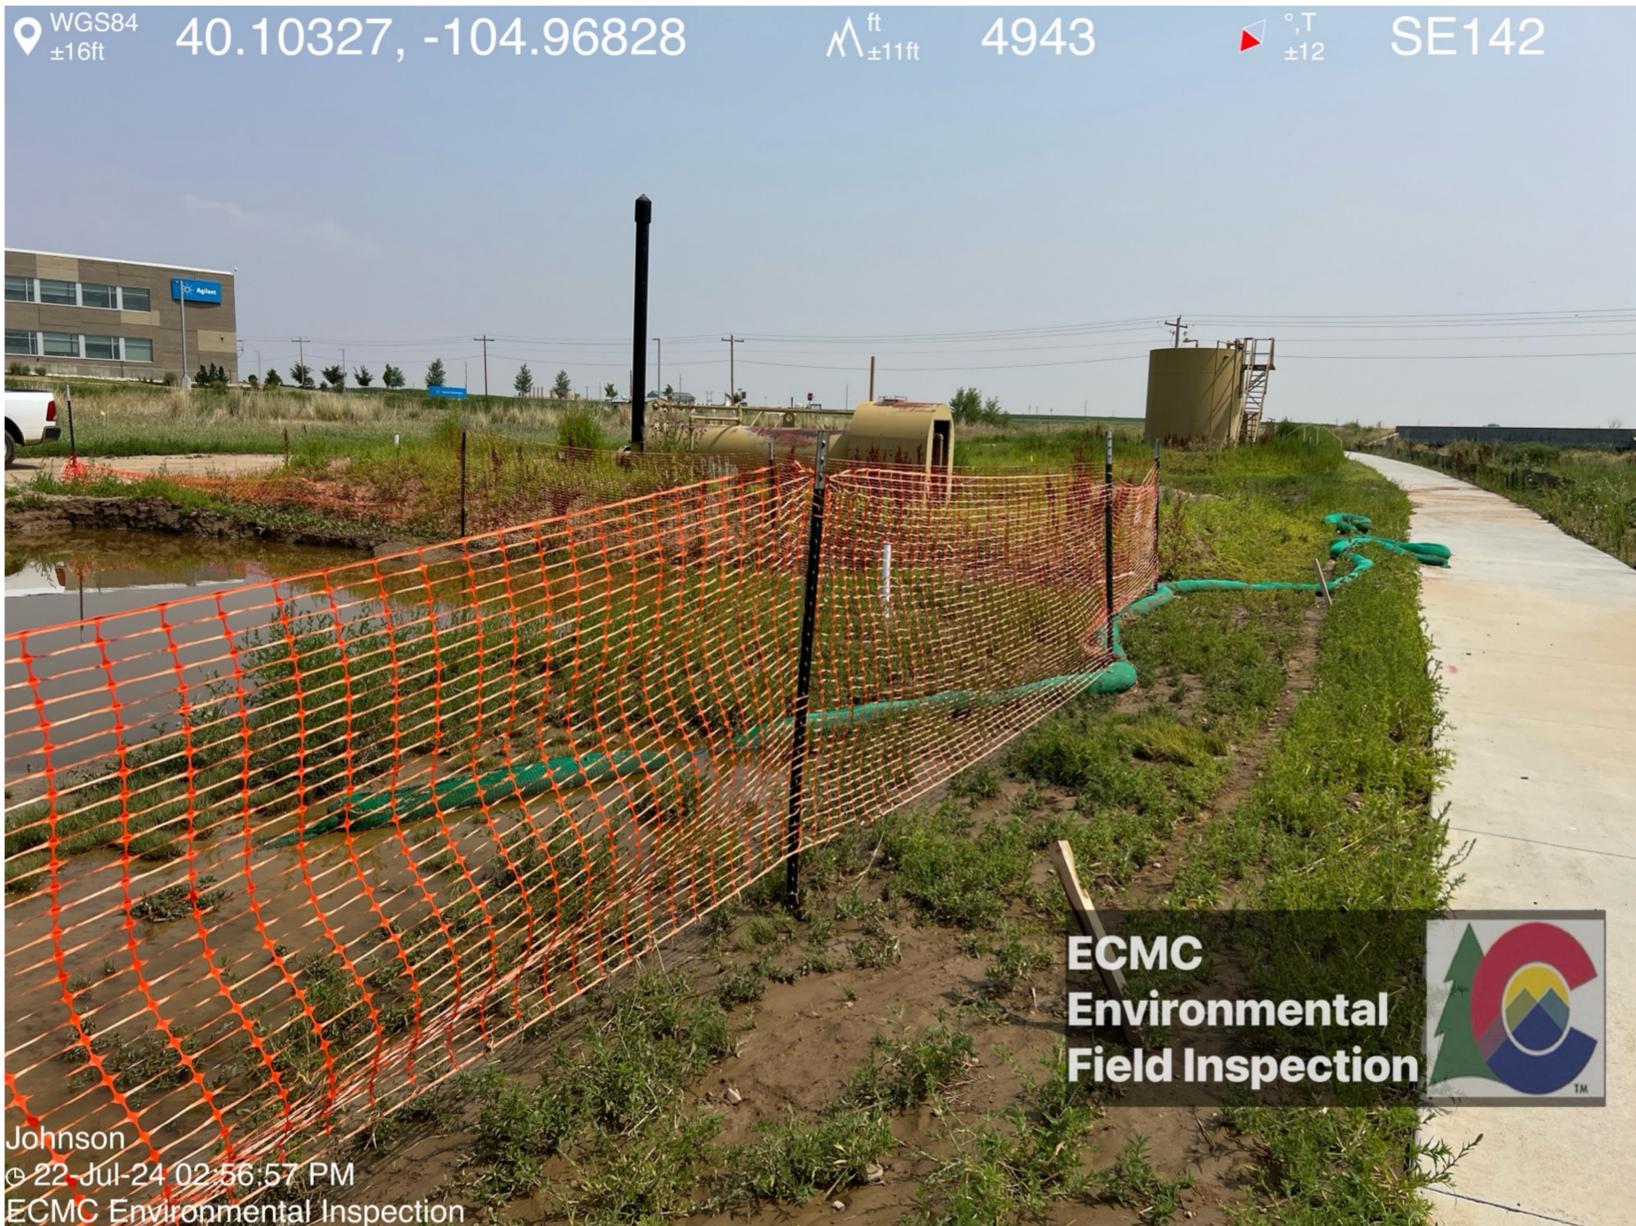
Inadequate BMPs, weeds, water overflowing from open excavation

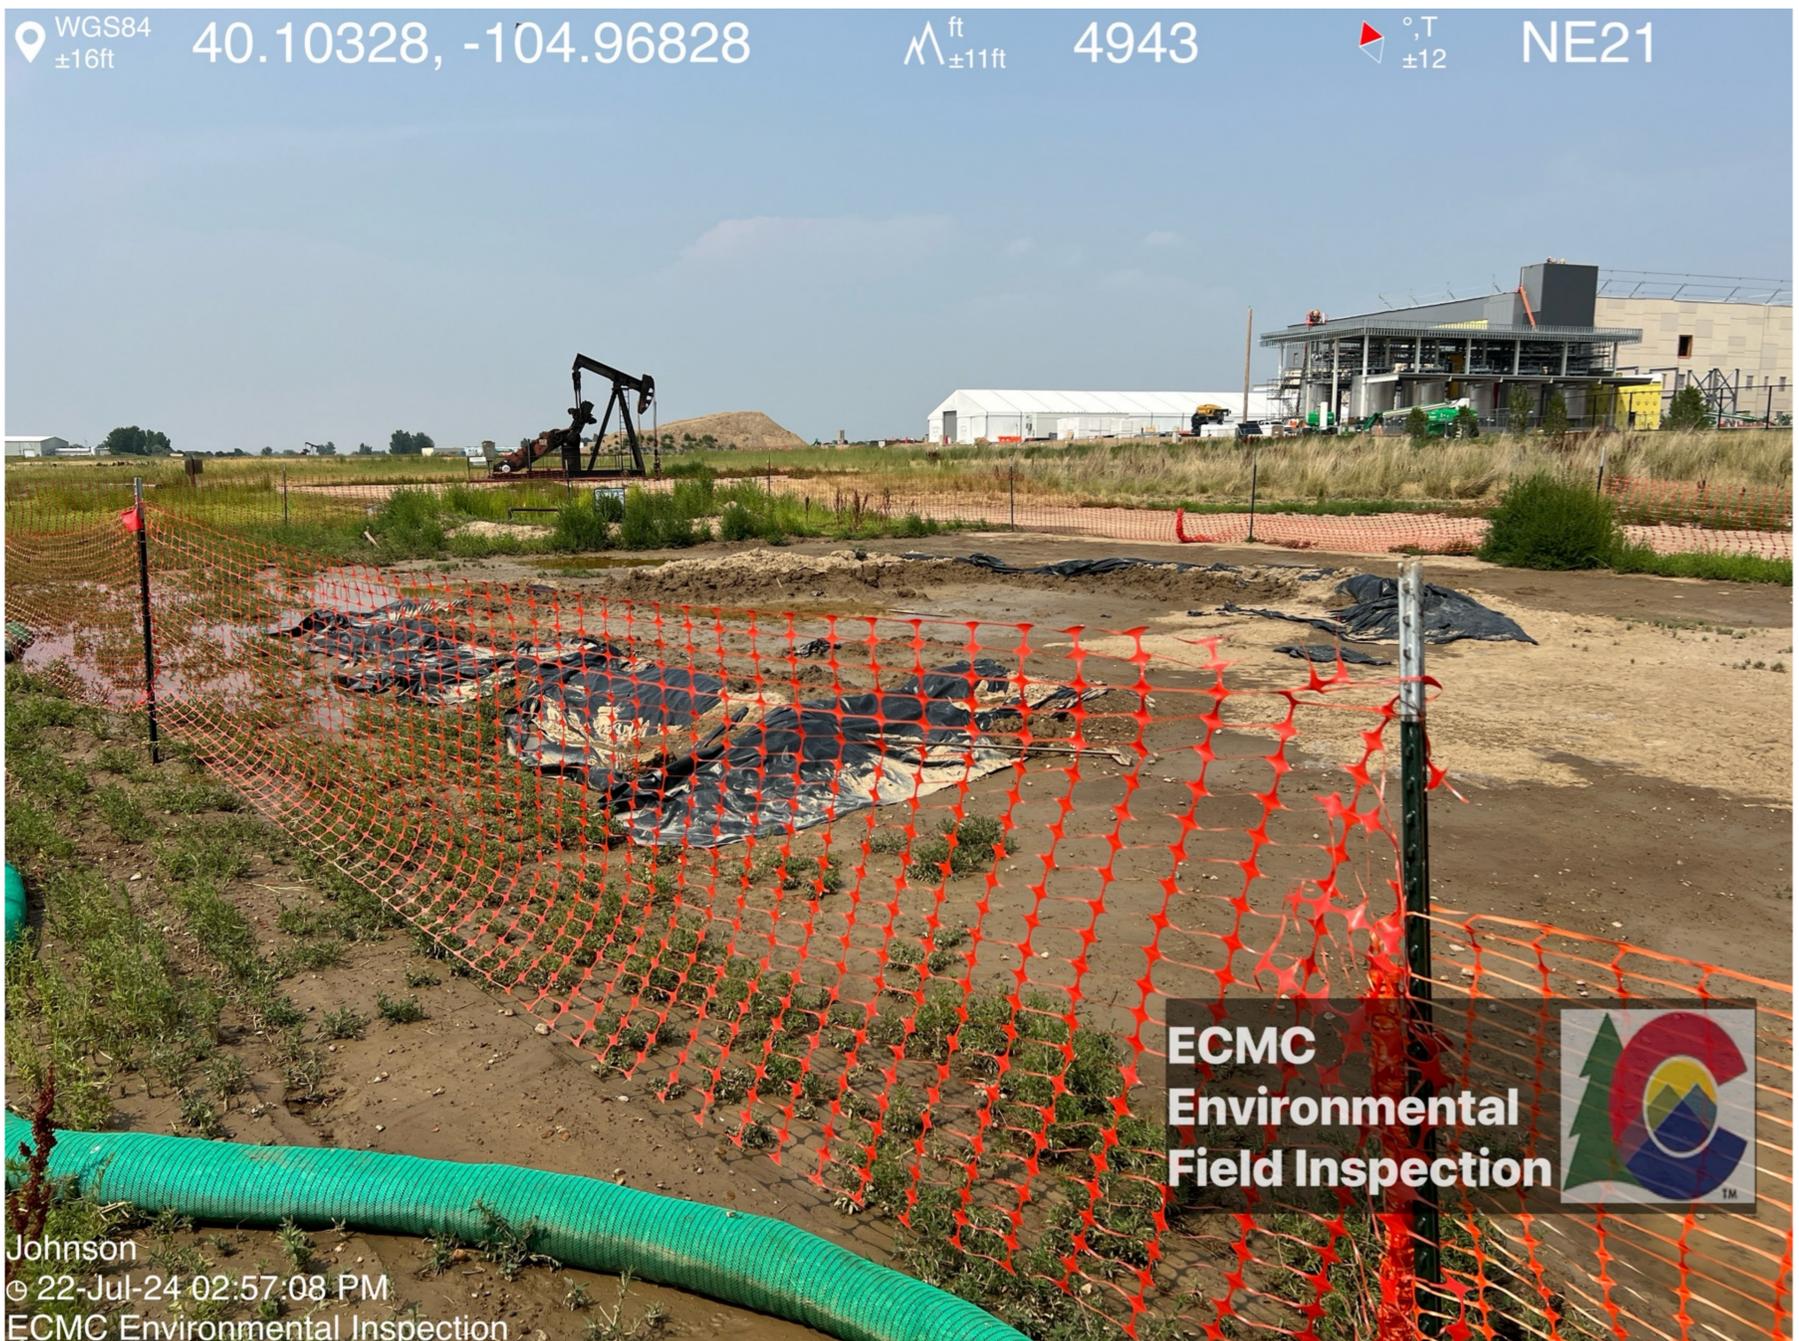
Inadequate BMPs, weeds, runoff from E&P waste stockpile

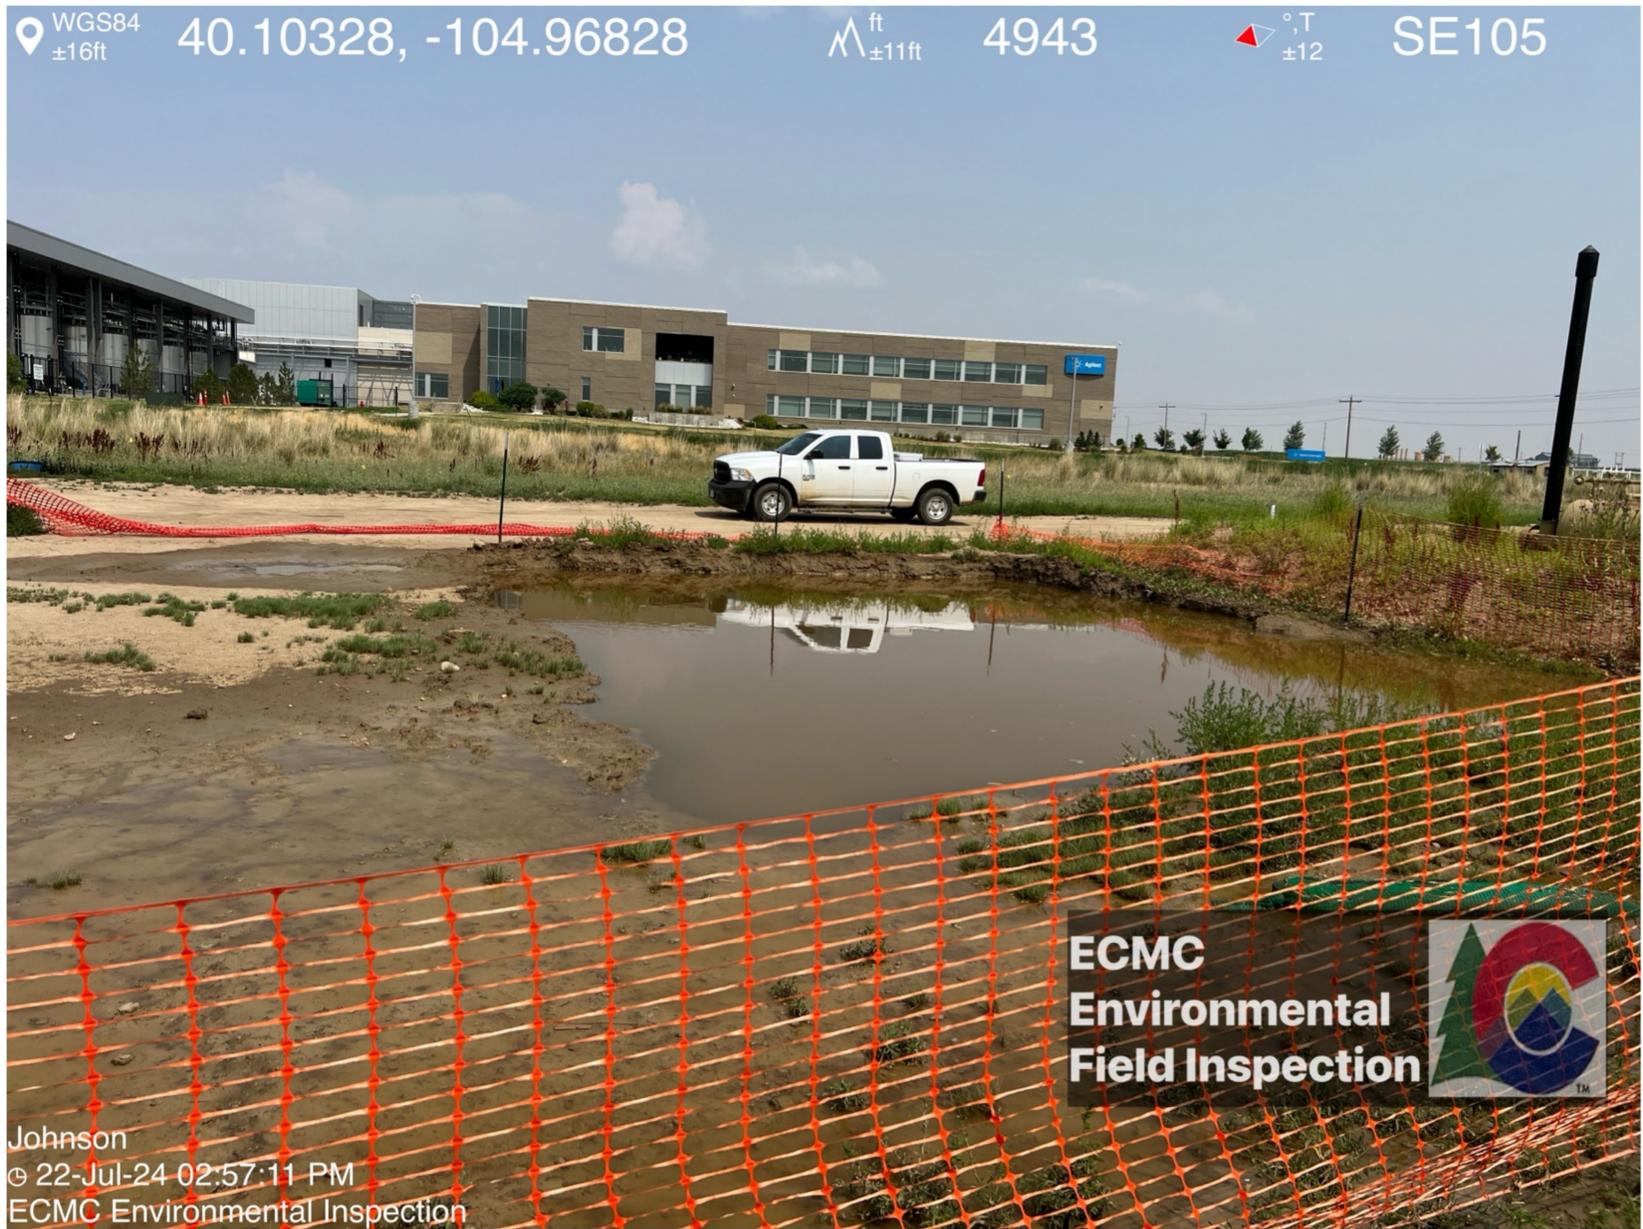
Inadequate BMPs, weeds, water overflowing from open excavation, downed fencing
