**ECMC
Environmental
Field Inspection**

KPK
K.P. KAUFFMAN COMPANY, INC.
Johnson #1 & 2 Battery
SW Section 26, T2N, R66W
Johnson County
688 WCR 13
781-832-7822

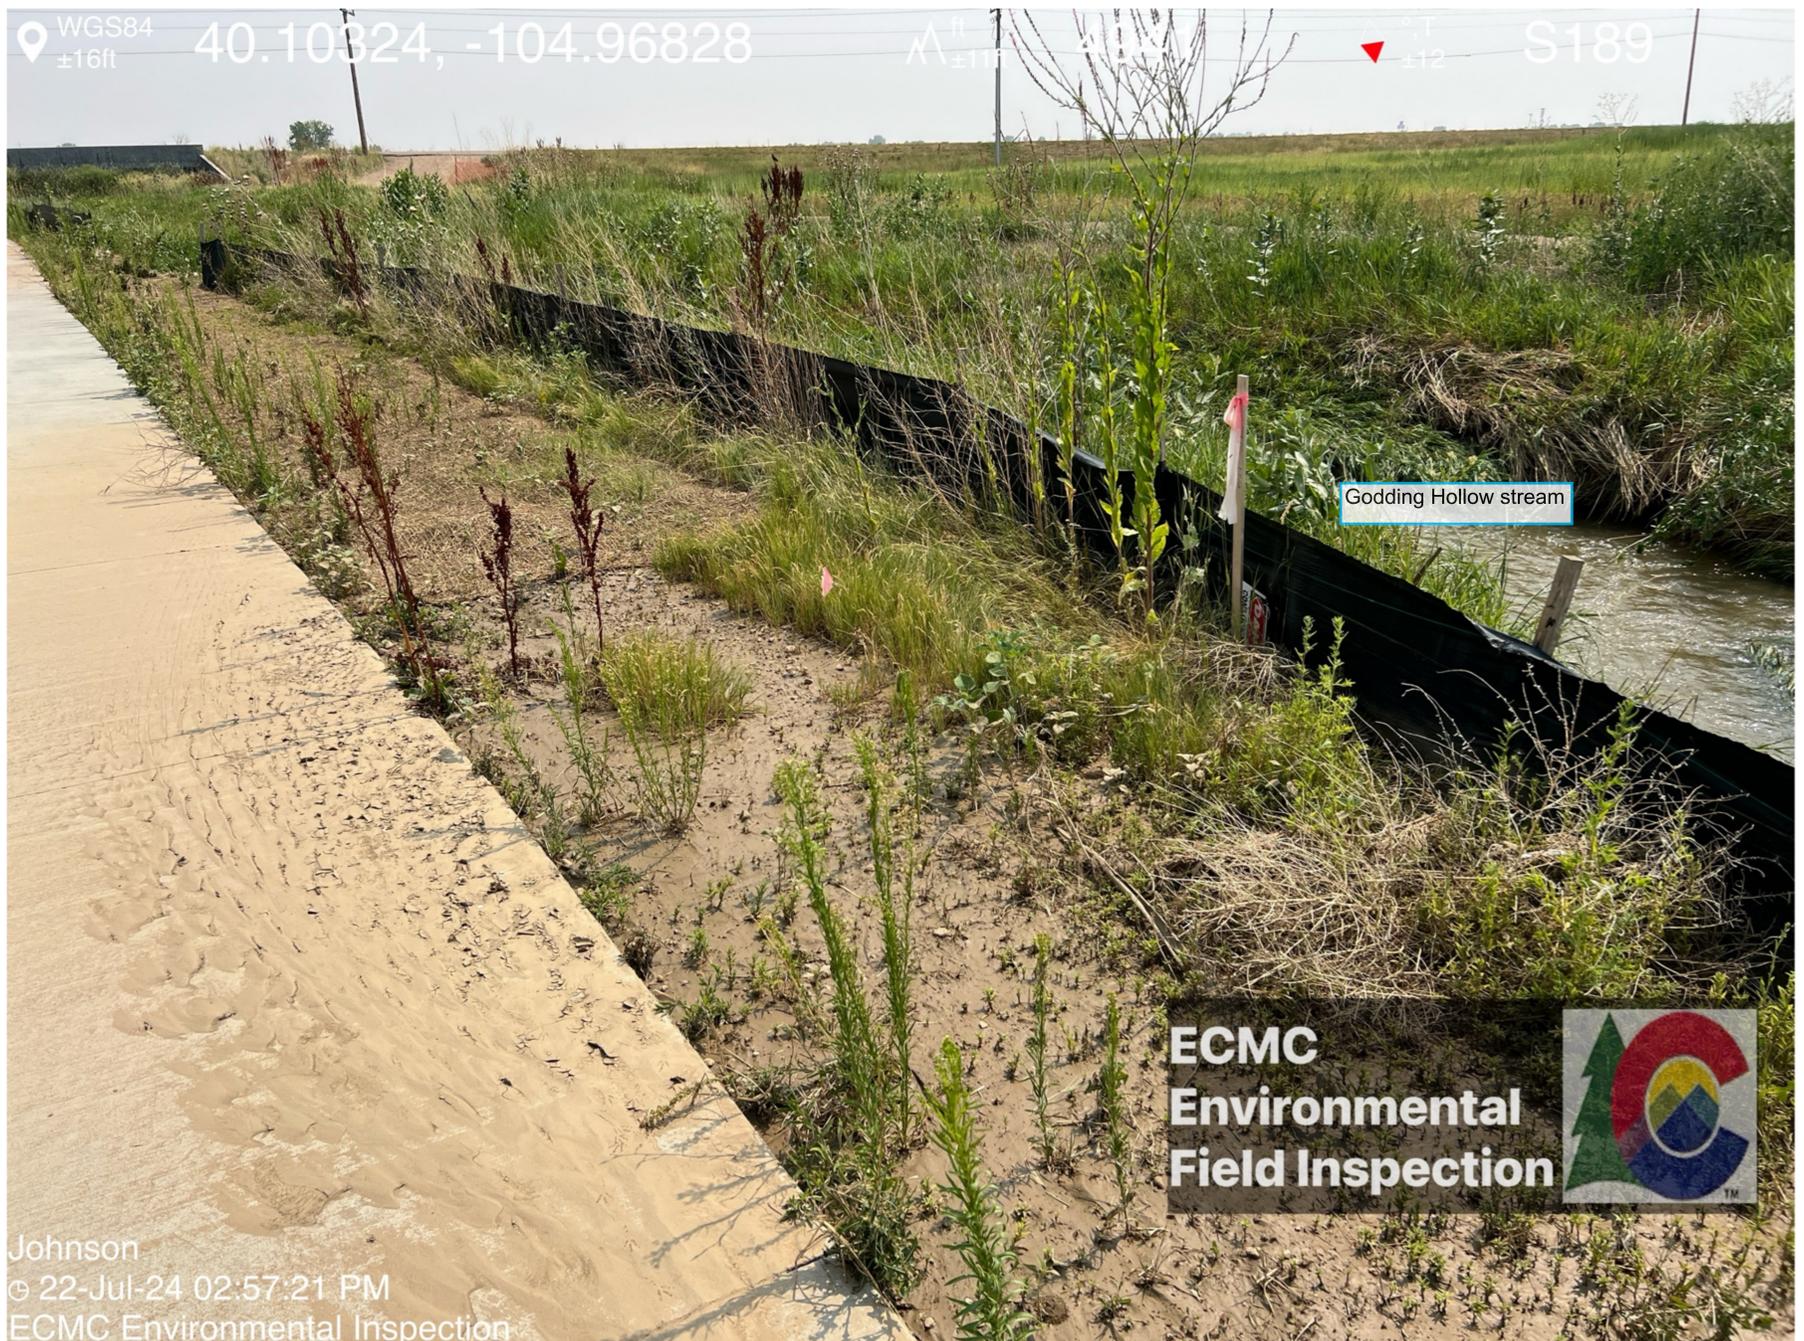
Inadequate BMPs, weeds, water overflowing from open excavation

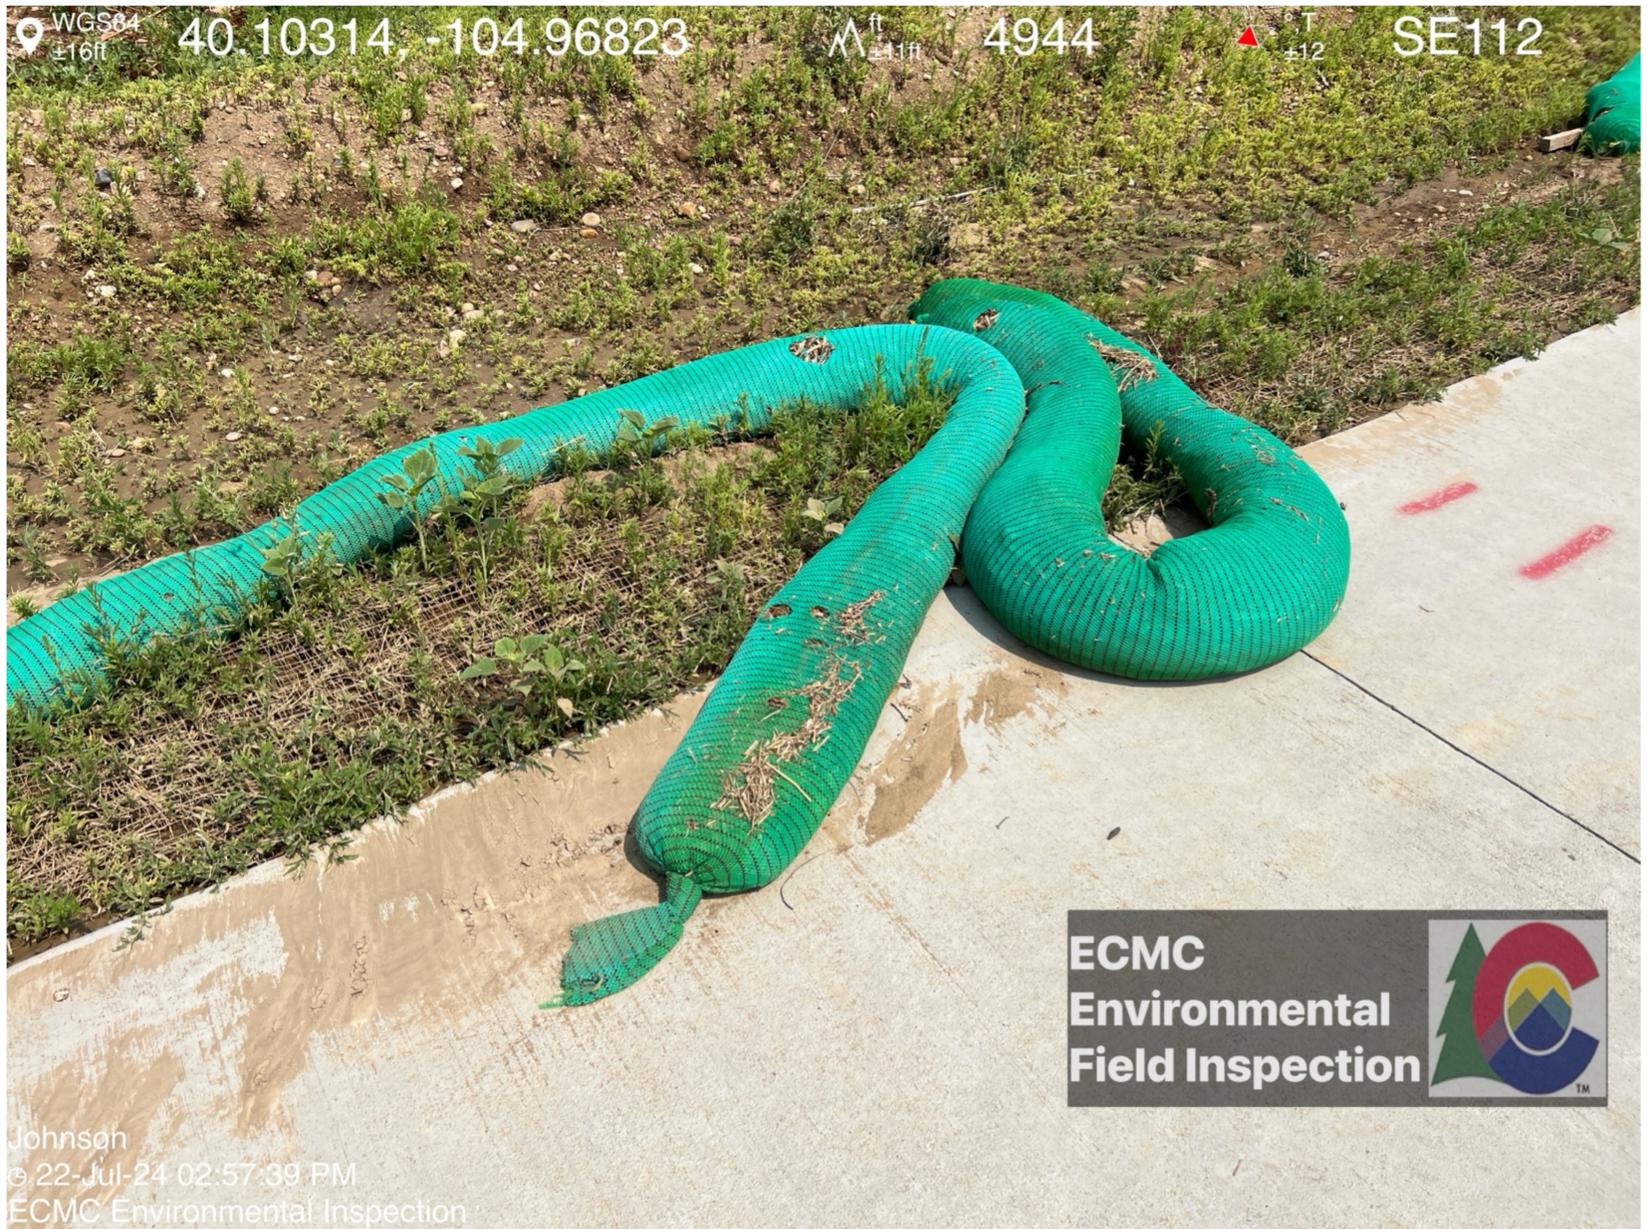
Failed/Inadequate BMPs

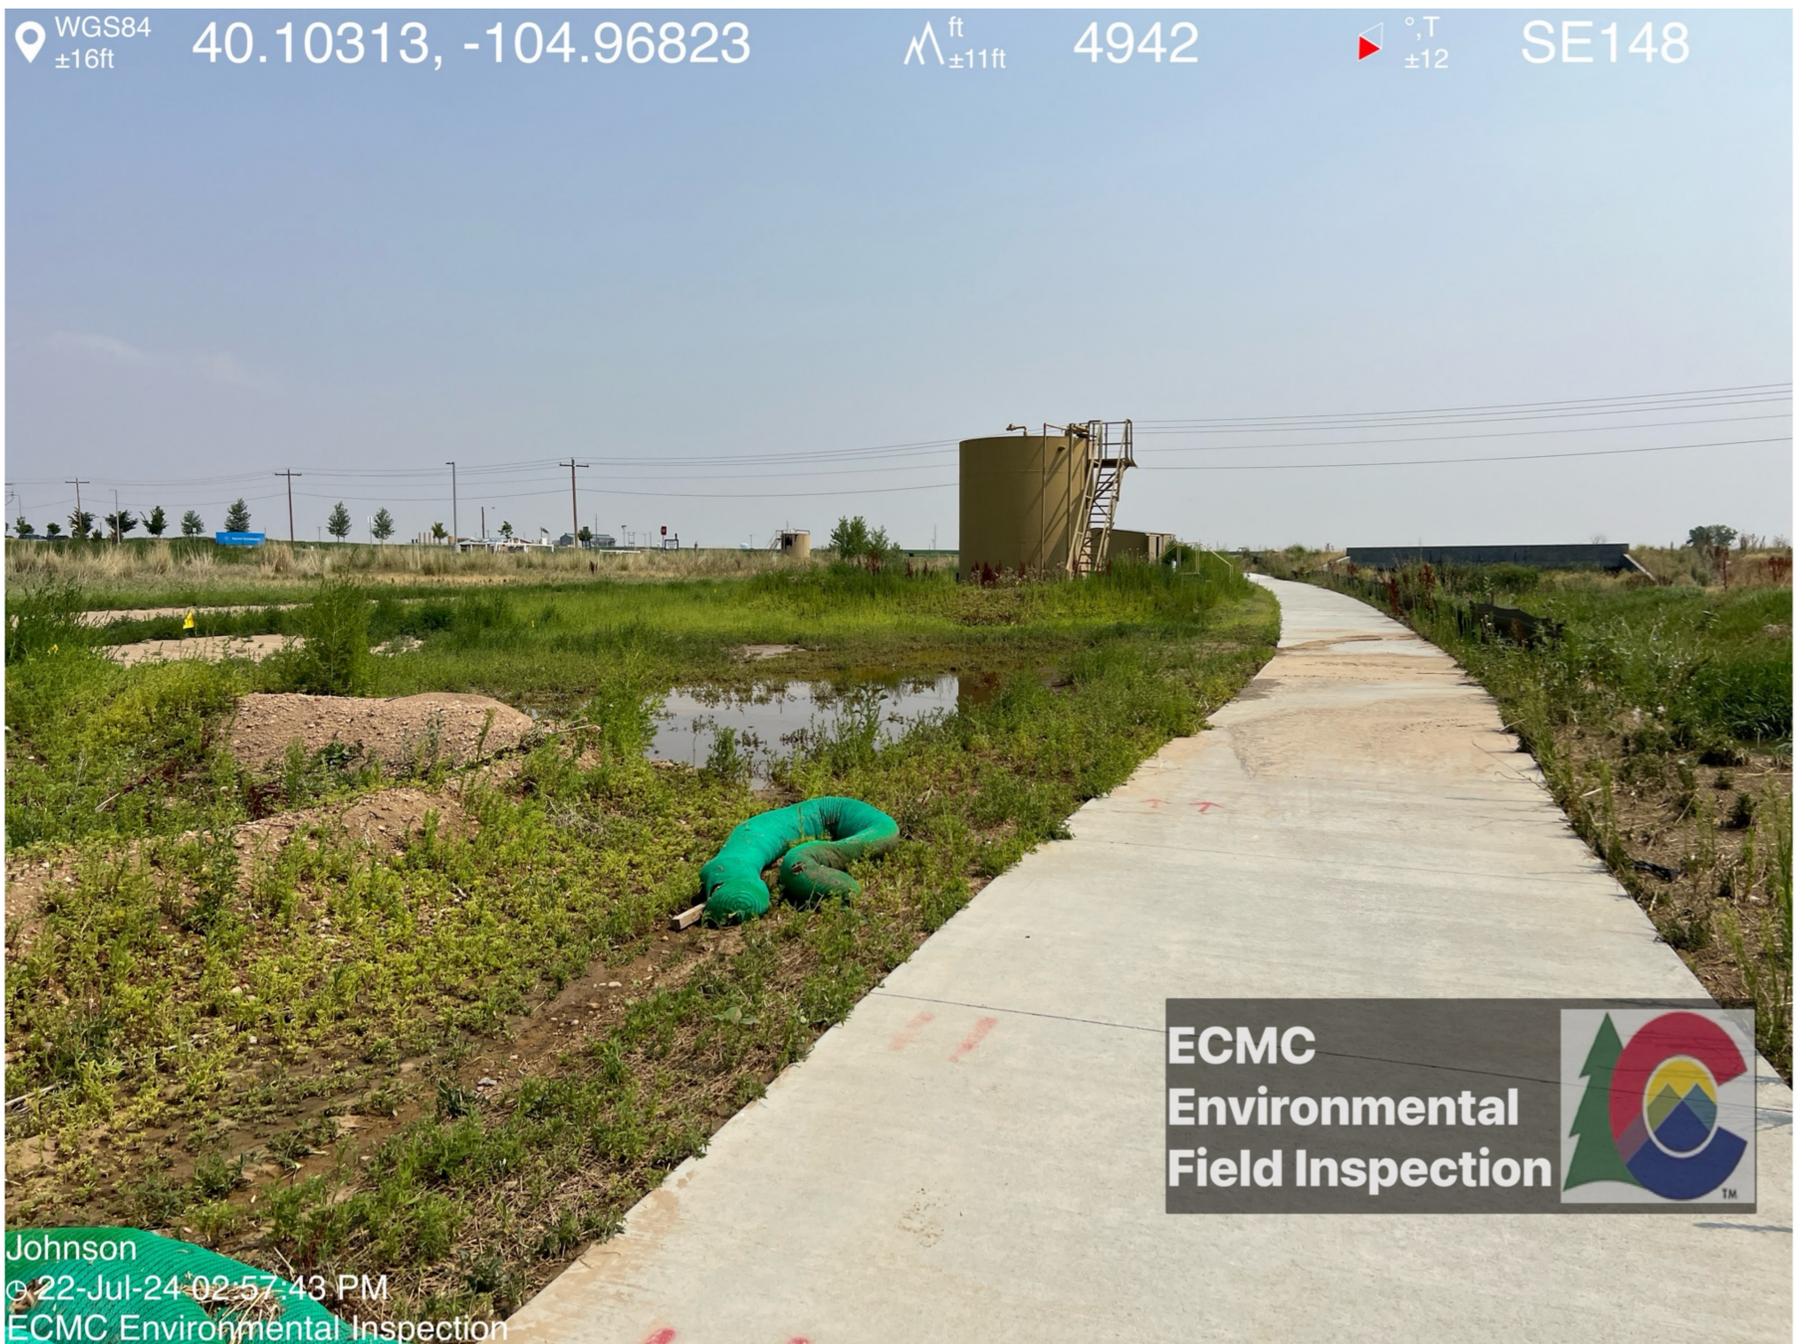
Johnson
© 22-Jul-24 02:57:43 PM
ECMC Environmental Inspection
Failed/Inadequate BMPs, weeds

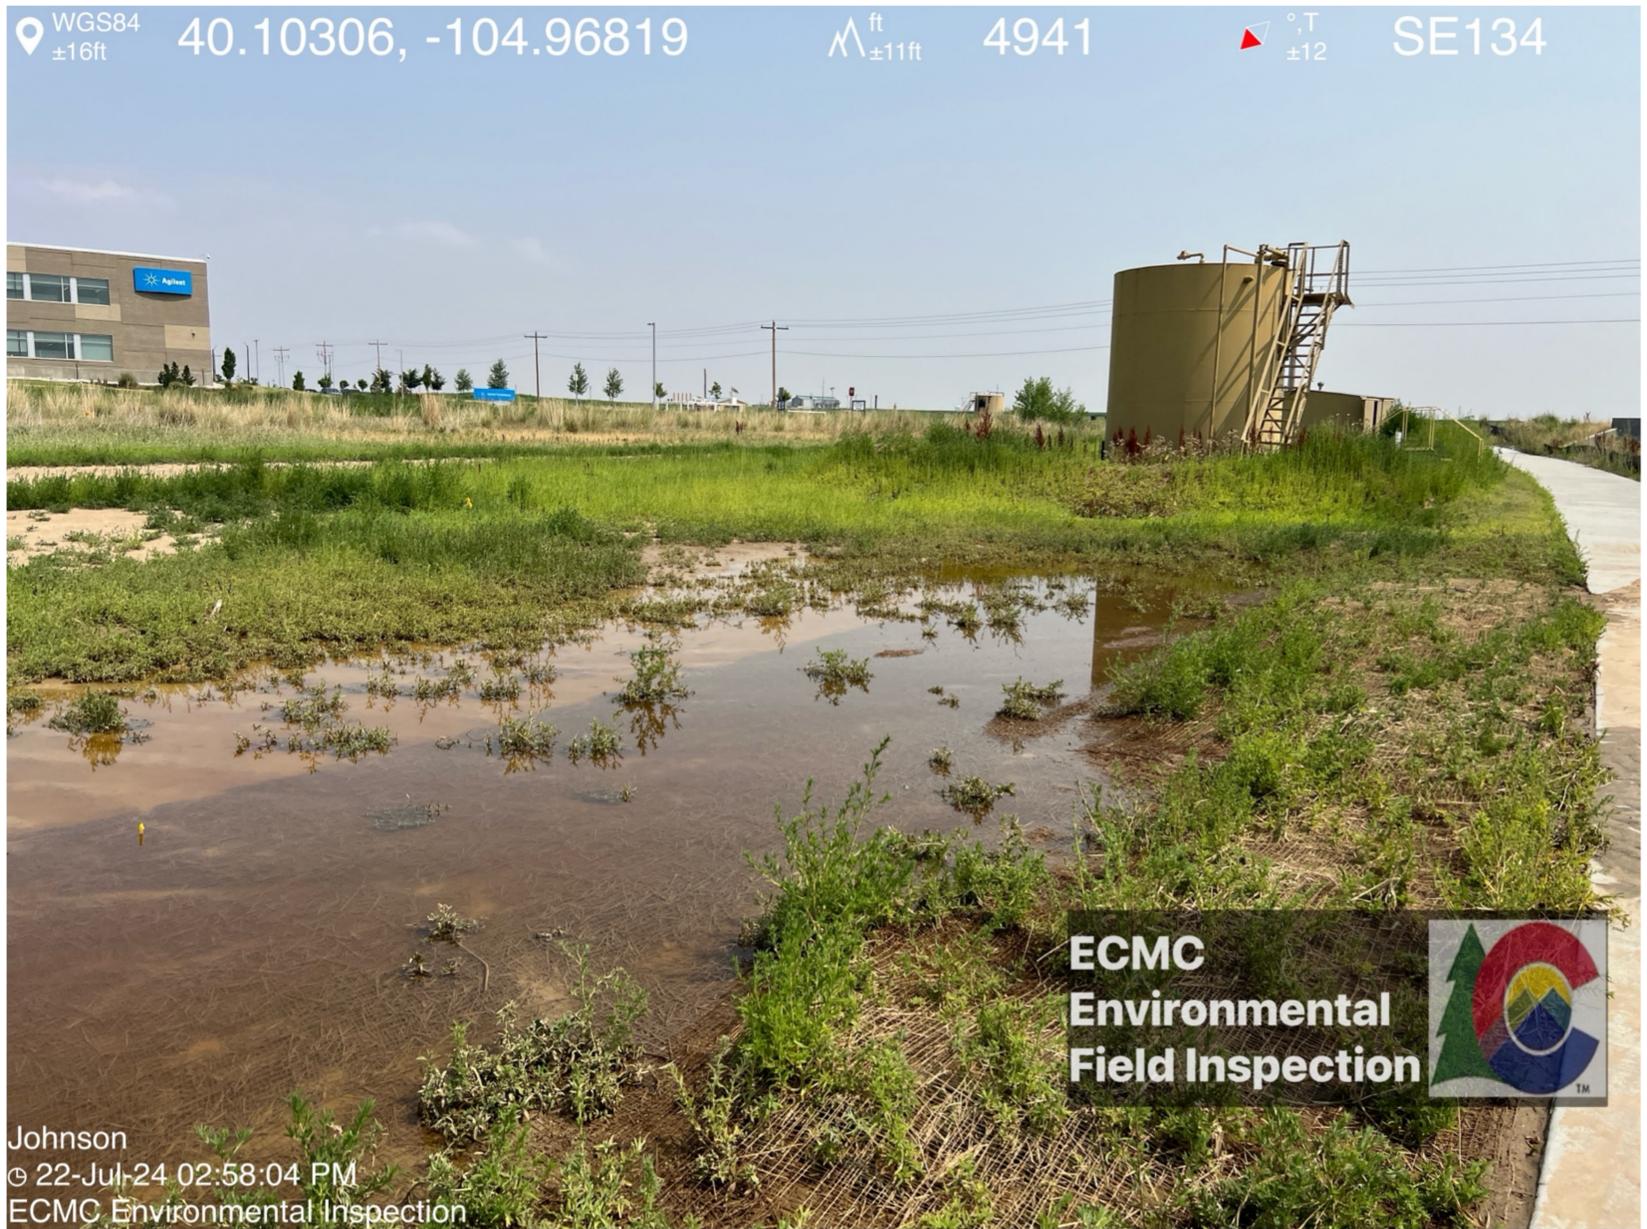
Weeds, 100-year Floodplain

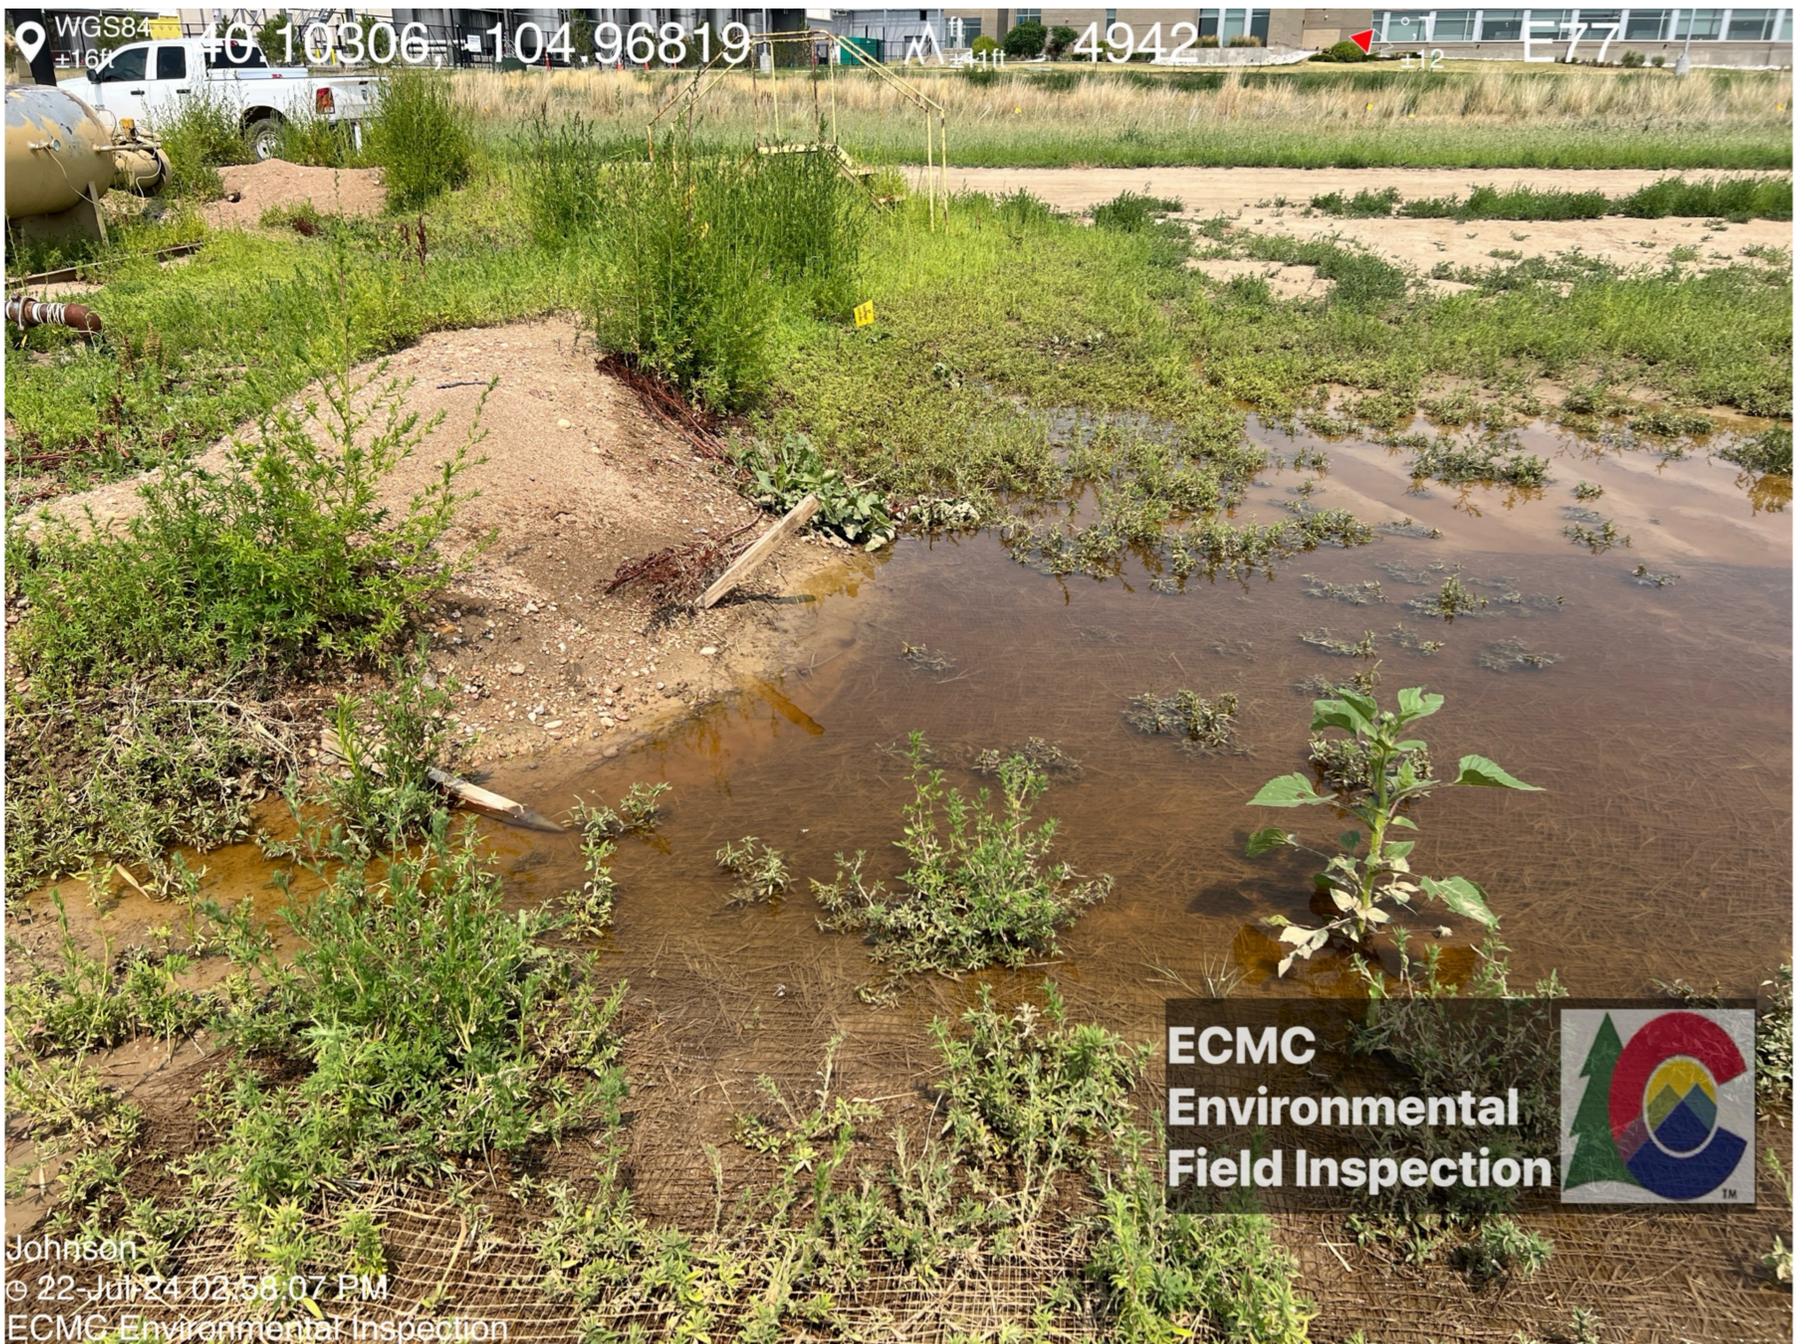
Weeds, failed/inadequate BMPs, 100-year floodplain

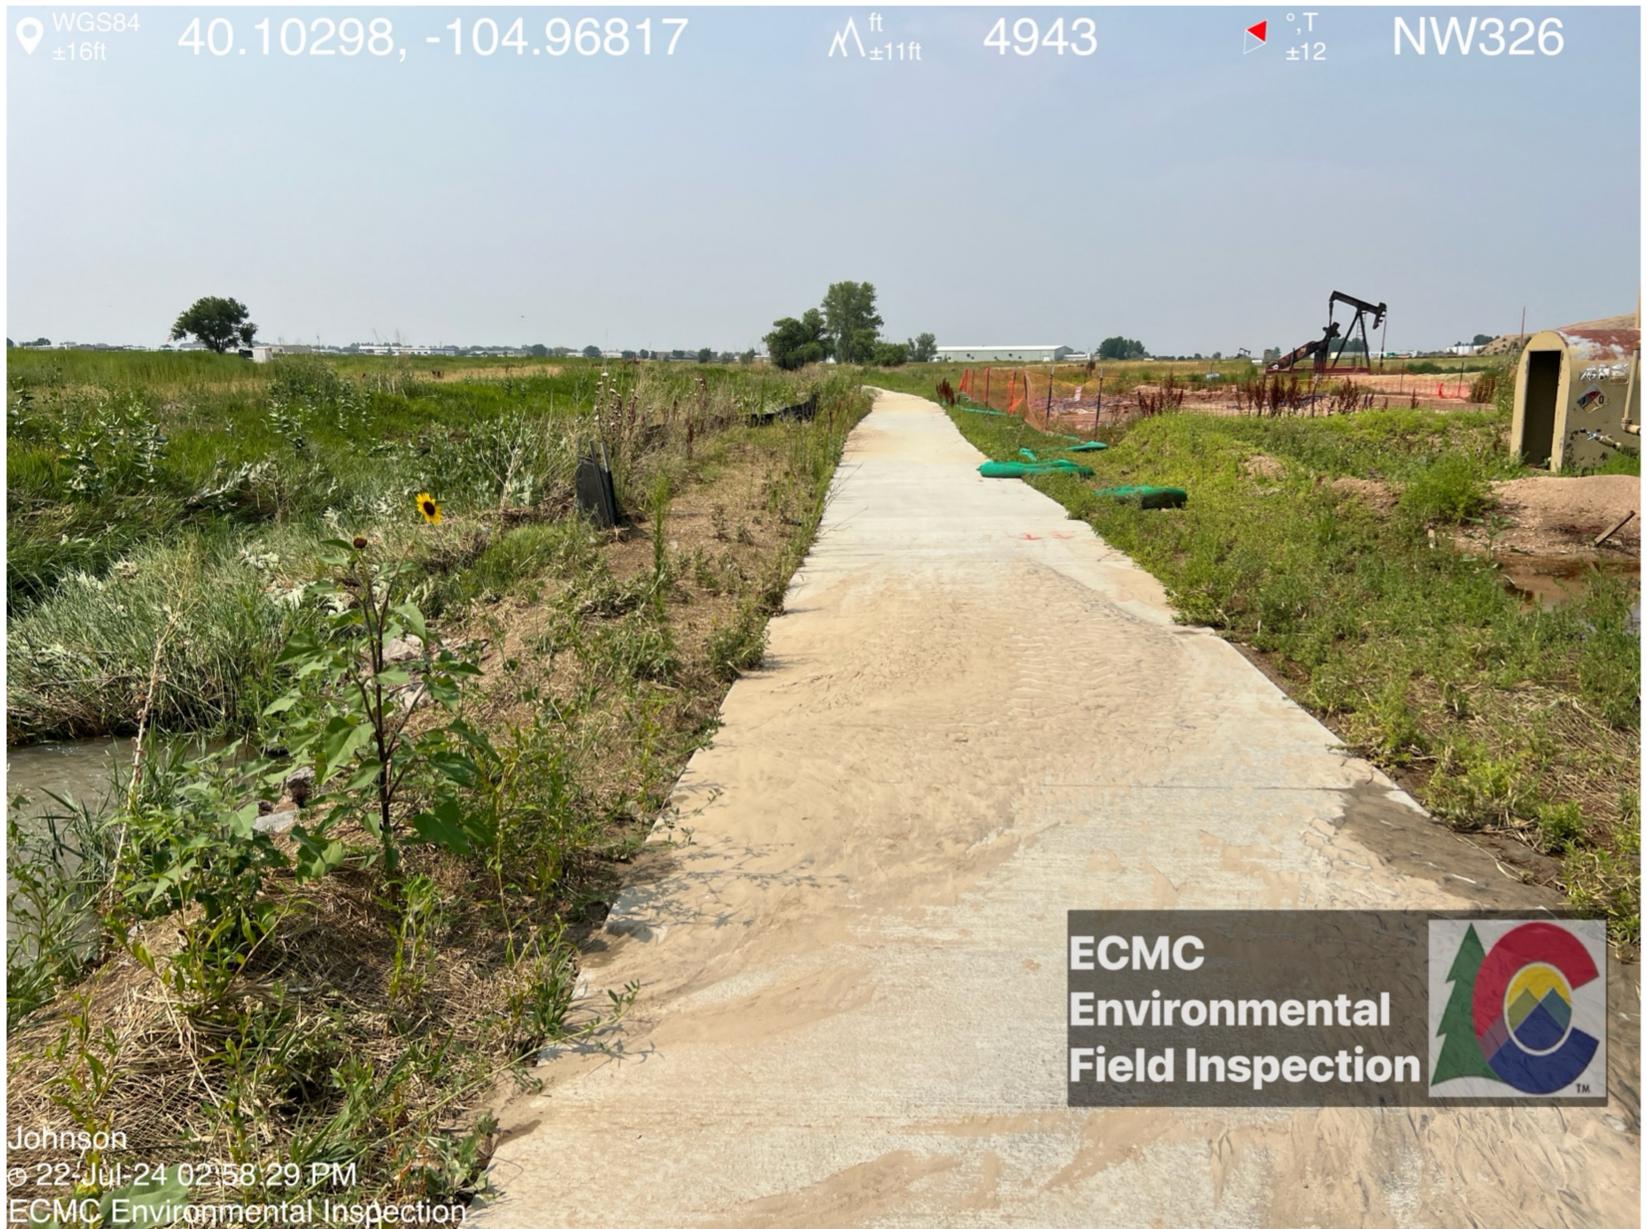
Weeds, failed/inadequate BMPs, 100-year floodplain

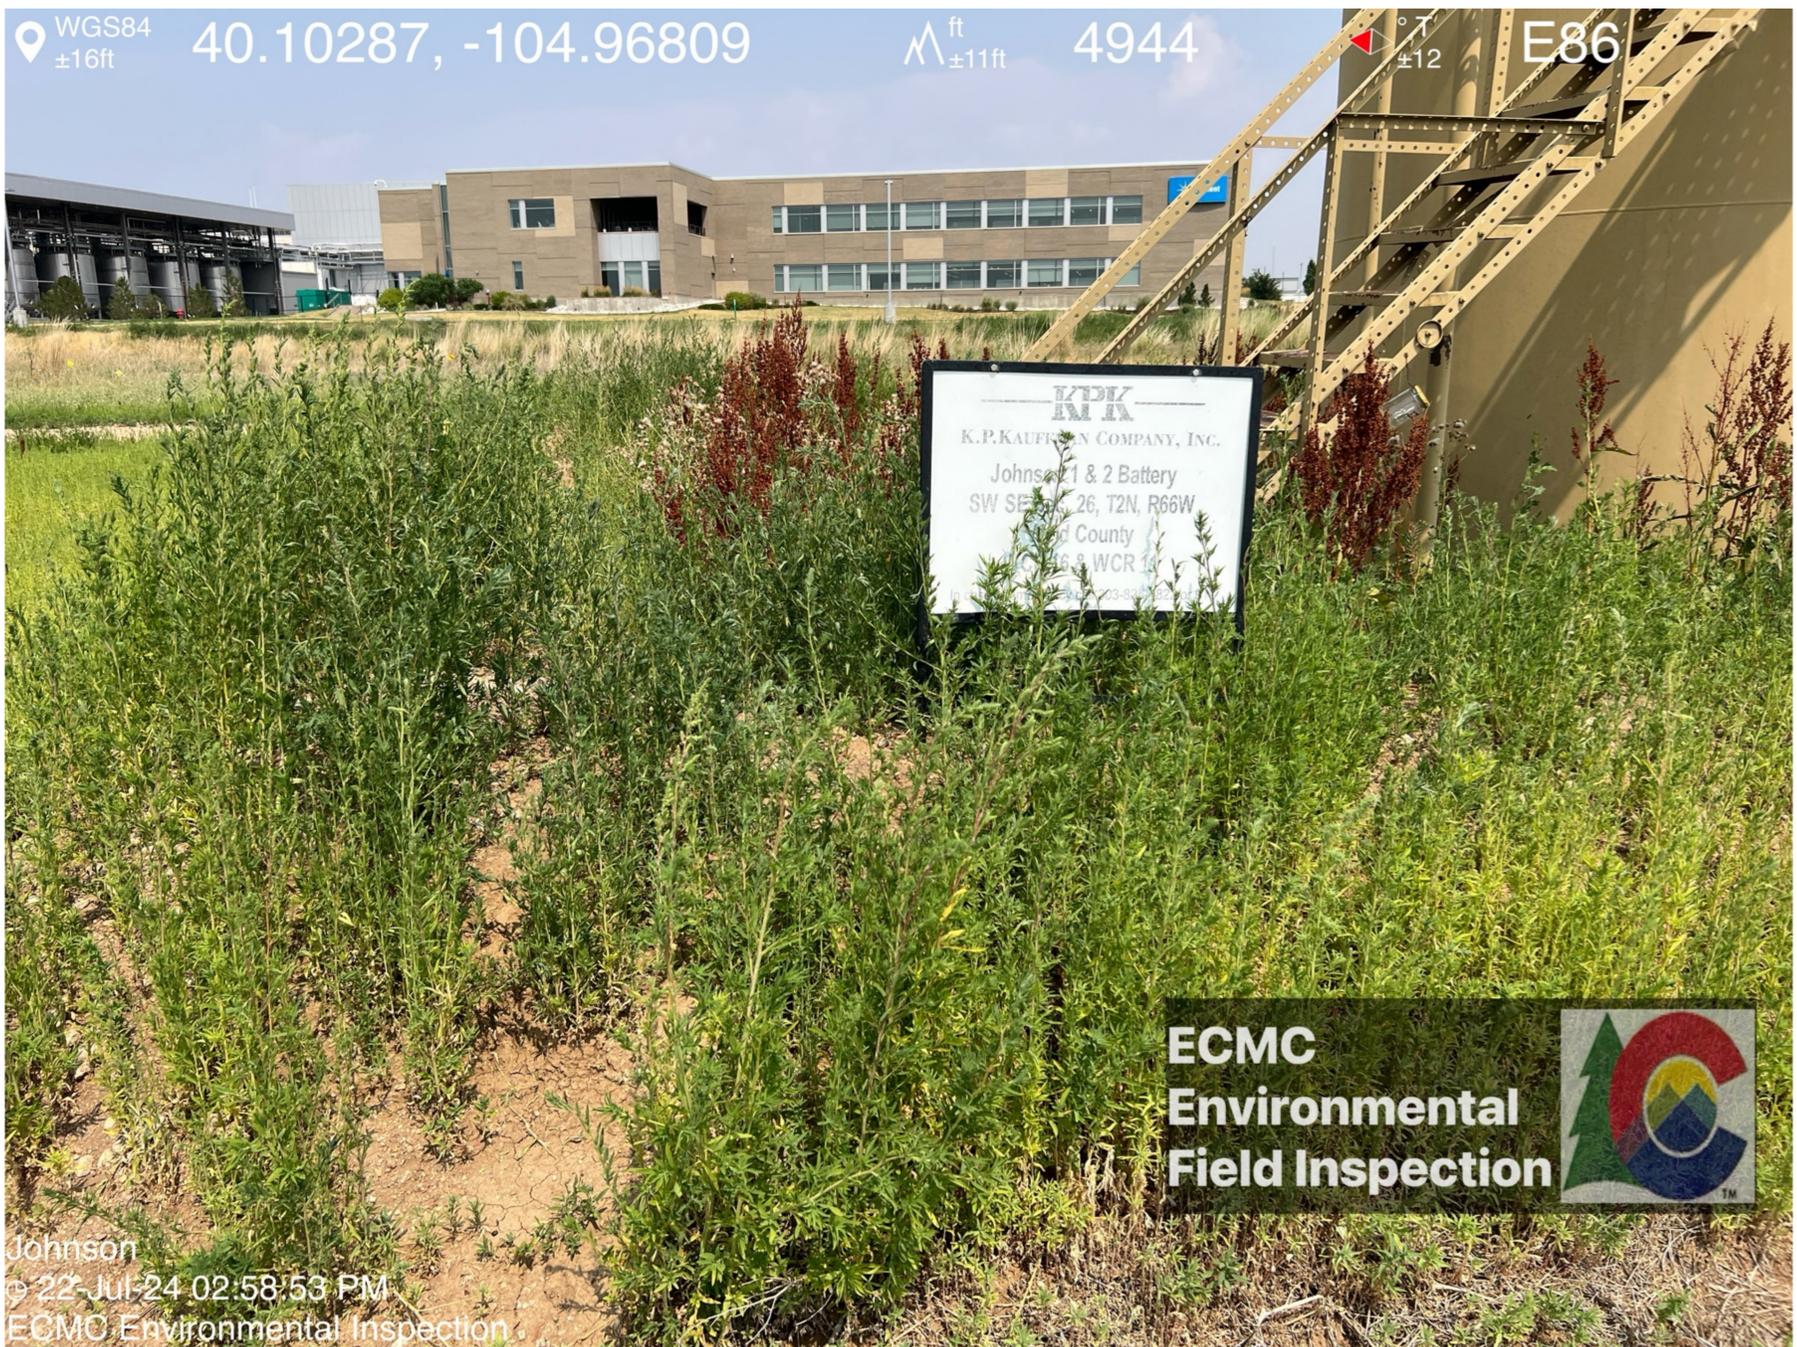
Weeds, faded signage

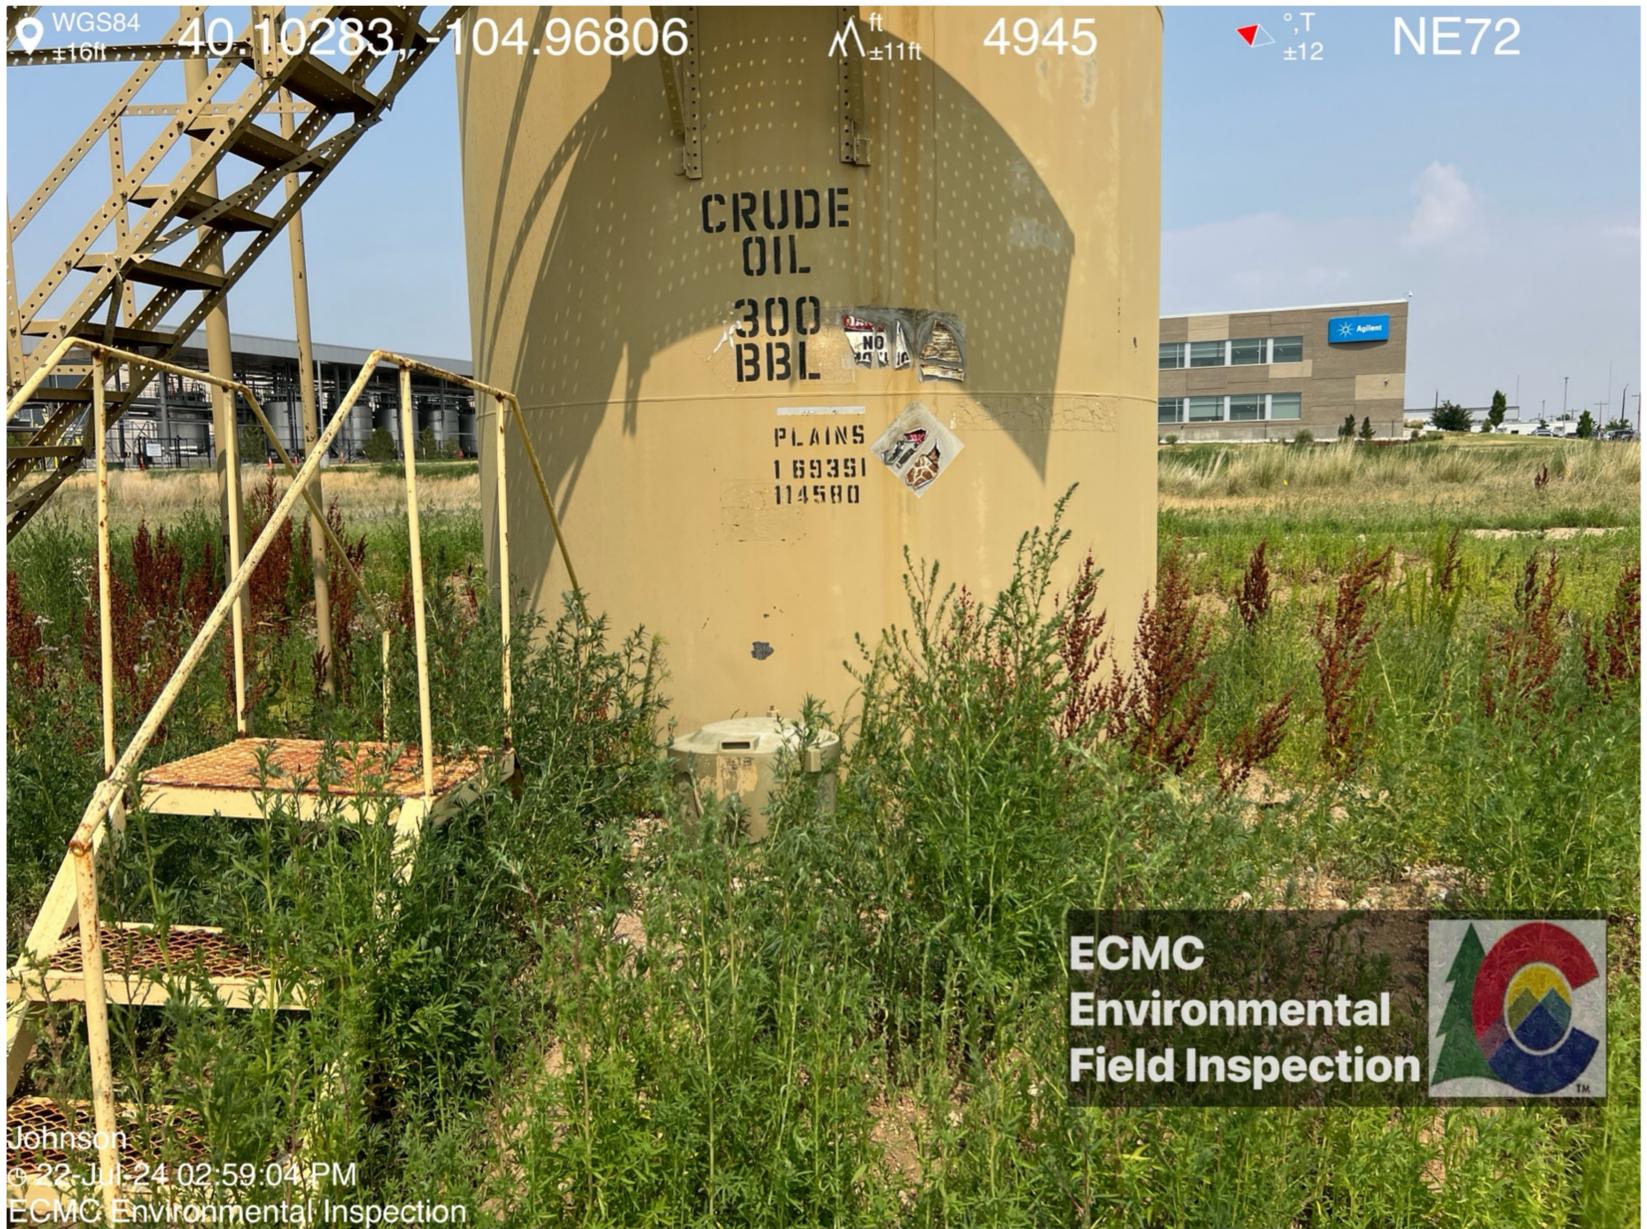
Weeds, missing/faded placards

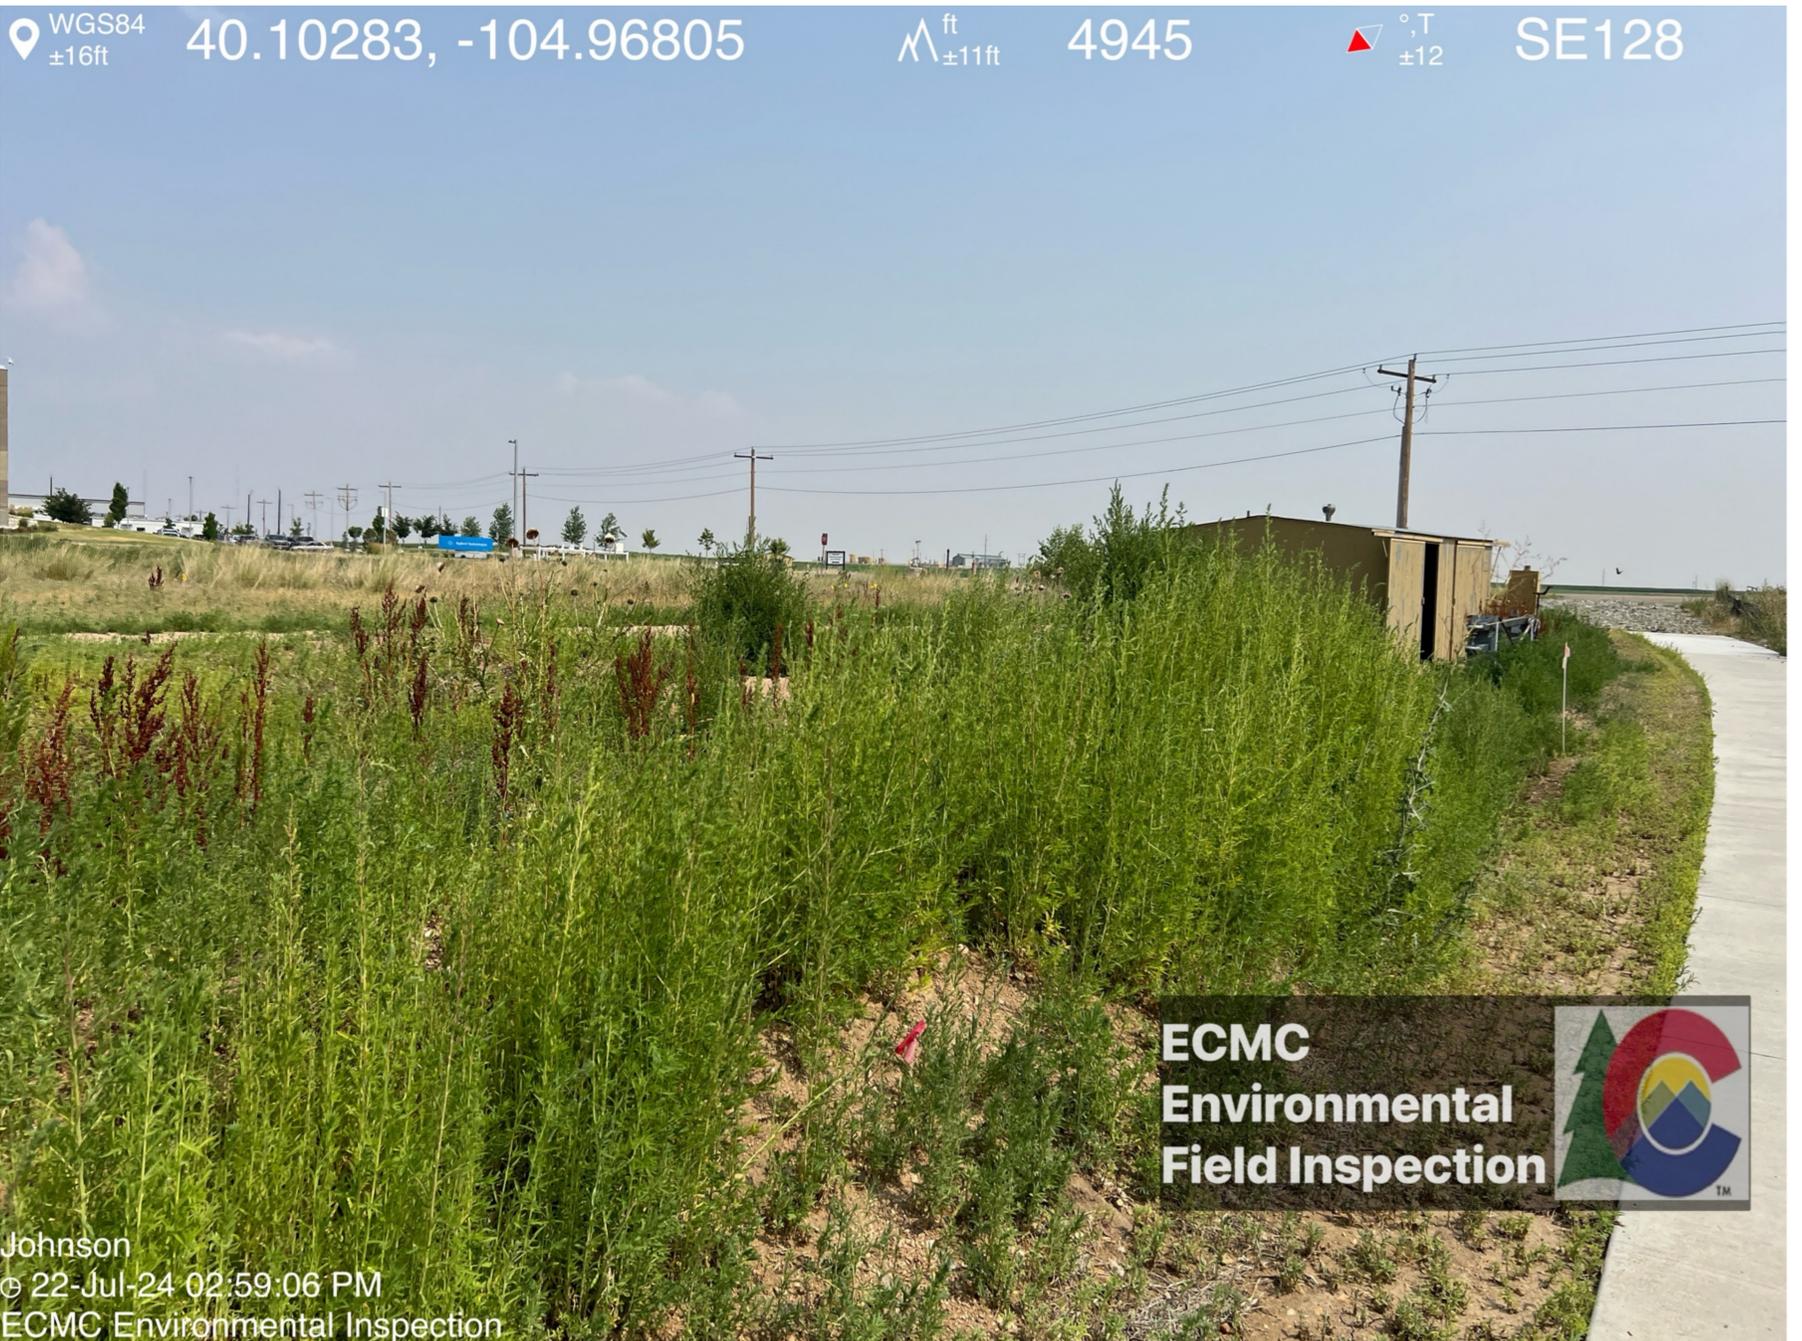
Weeds

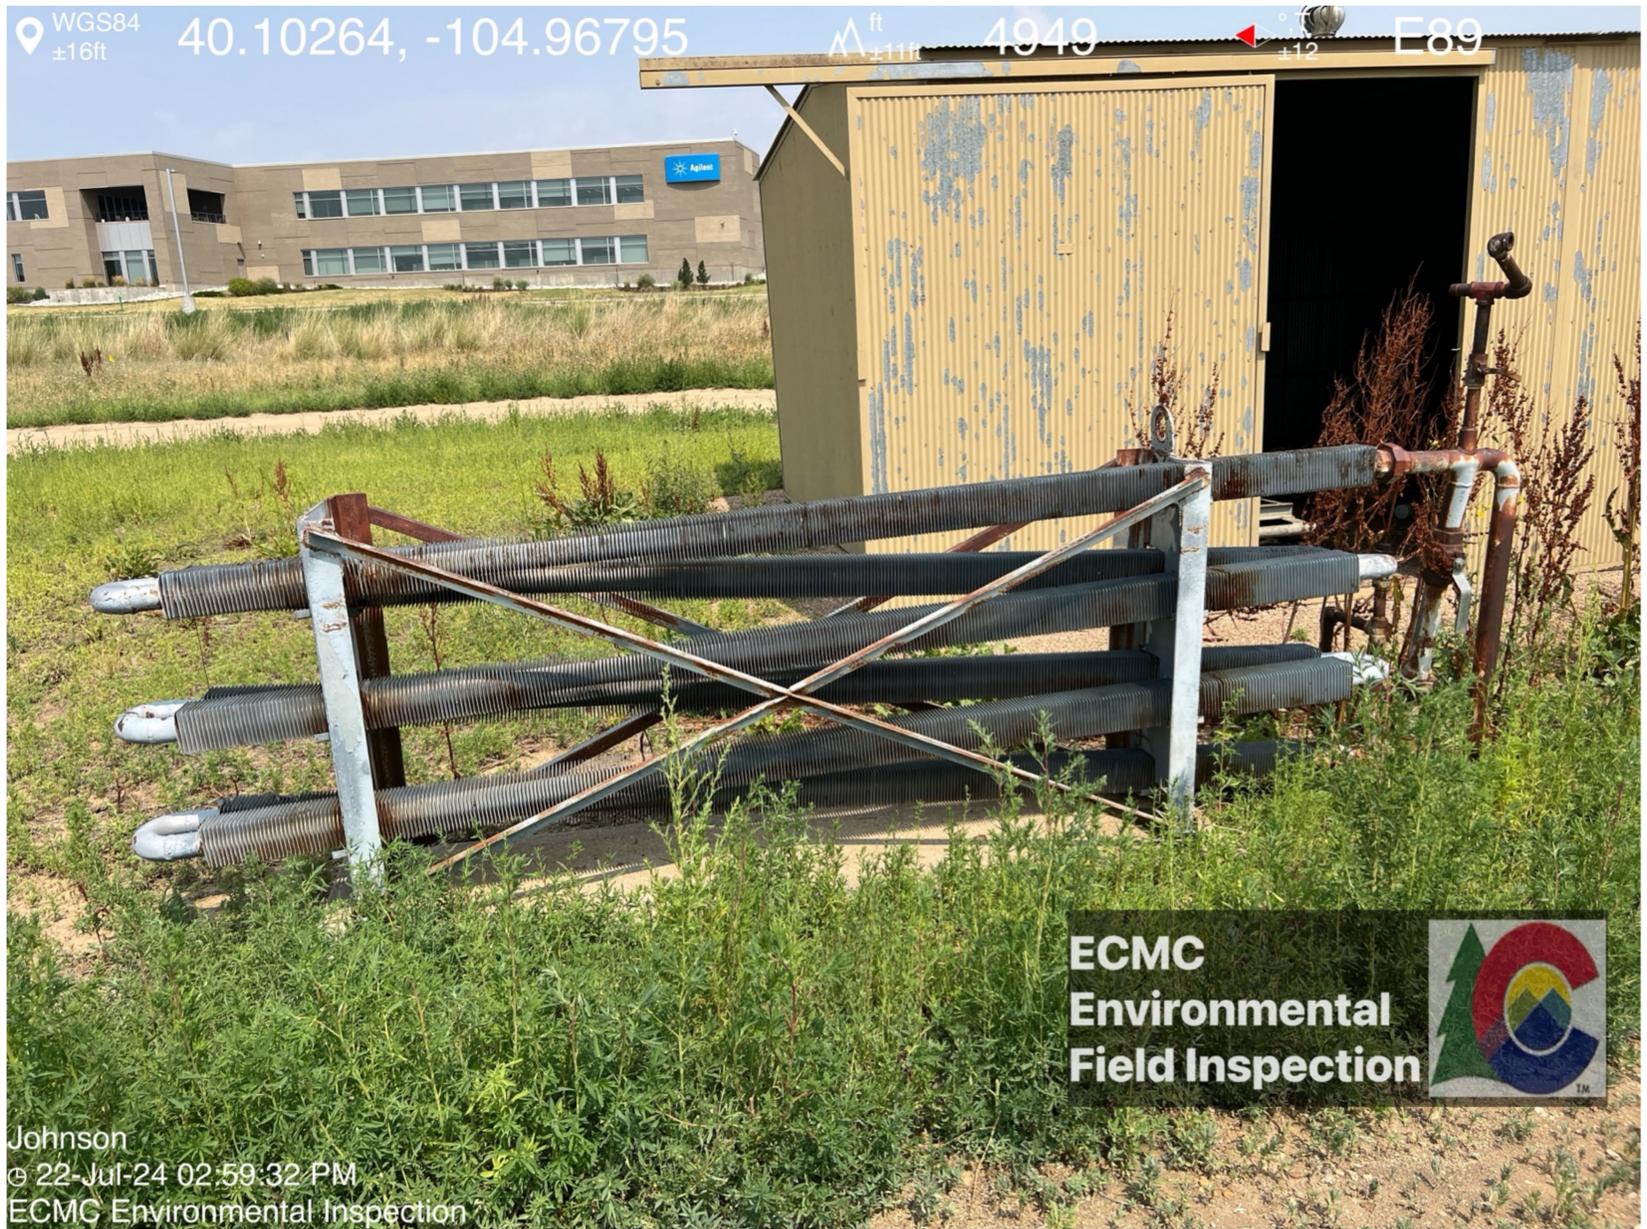
Weeds, unused equipment
