**ECMC
Environmental
Field Inspection**

KPK
K.P. KAUFFMAN COMPANY, INC.
Johnson #1 & 2 Battery
SW Section 26, T2N, R66W
Johnson County
688 WCR 13
781-832-7822

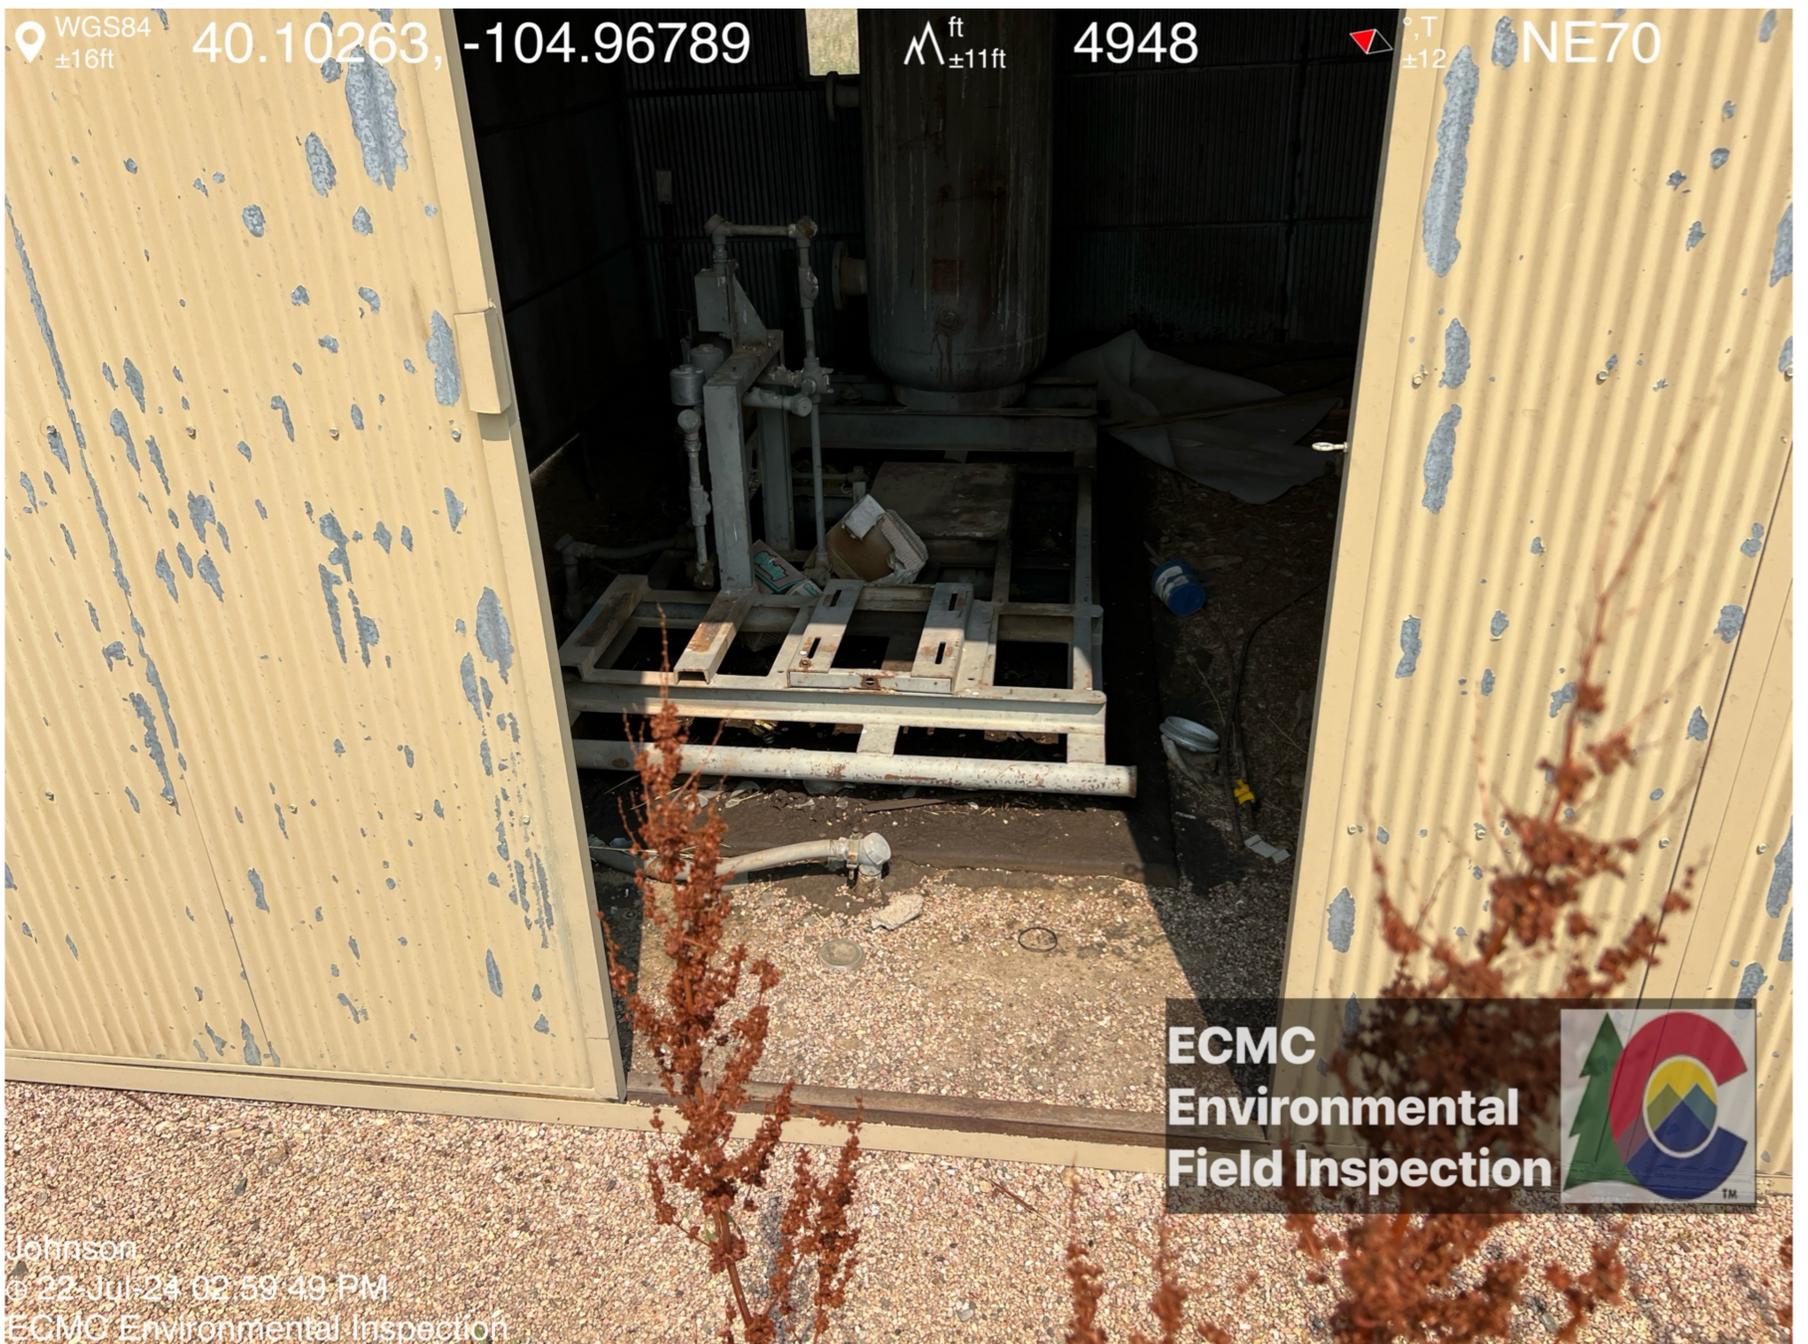
Weeds, unused equipment, trash/debris, staining

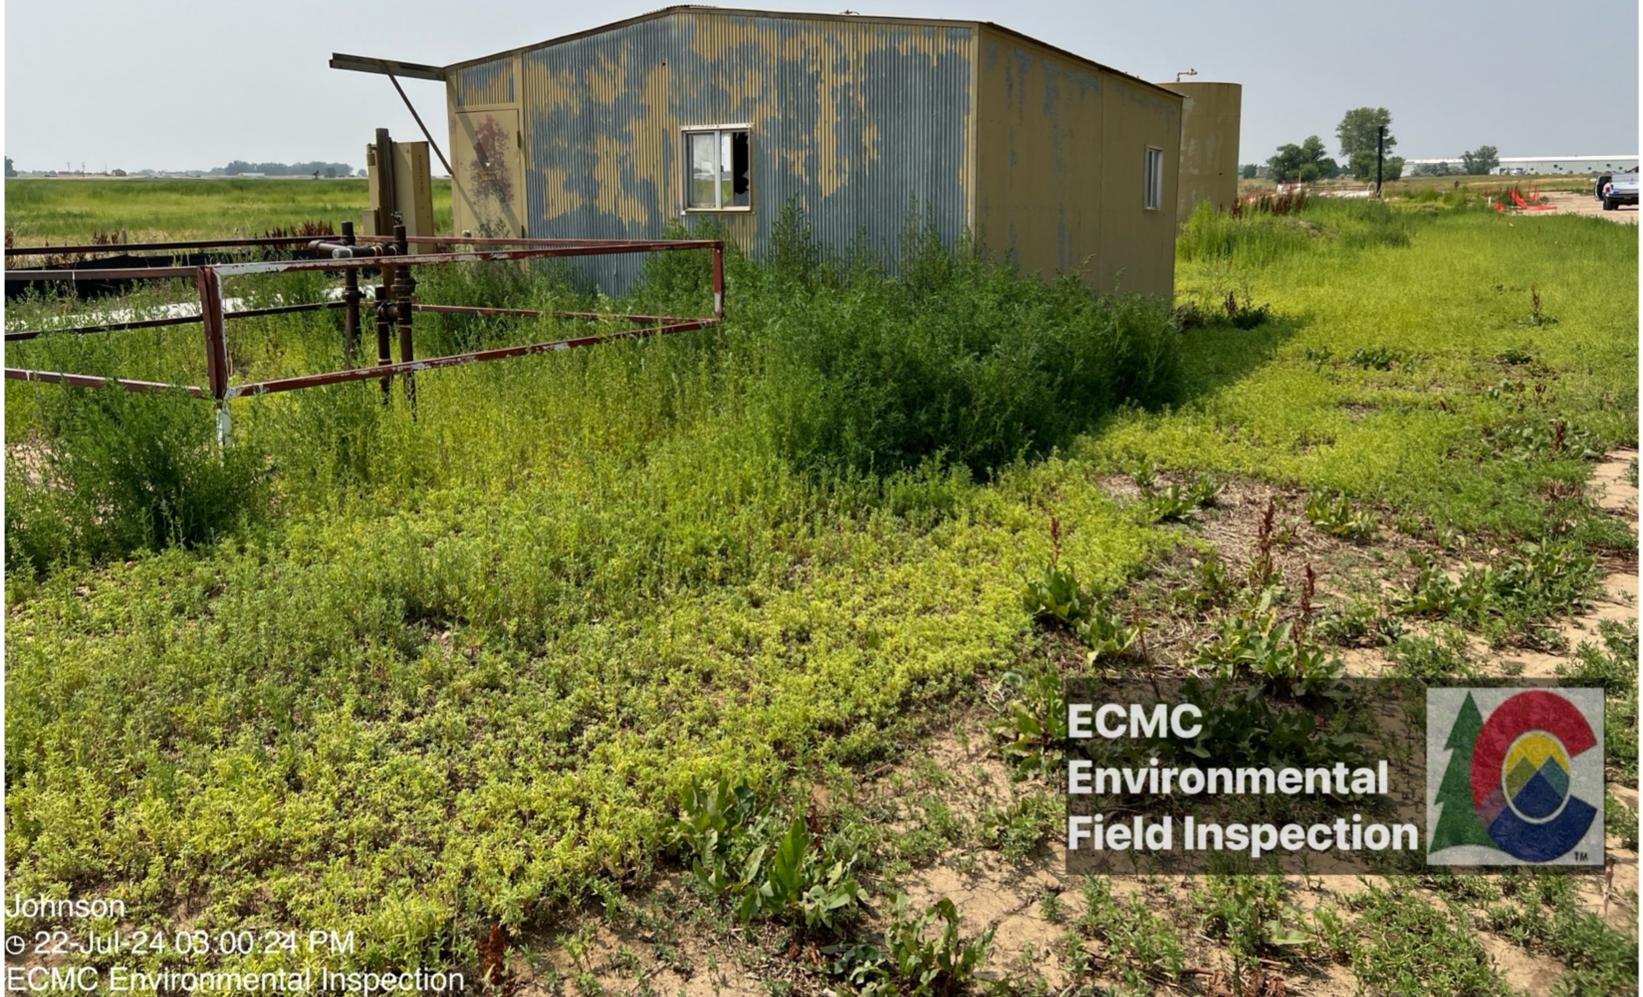
Weeds

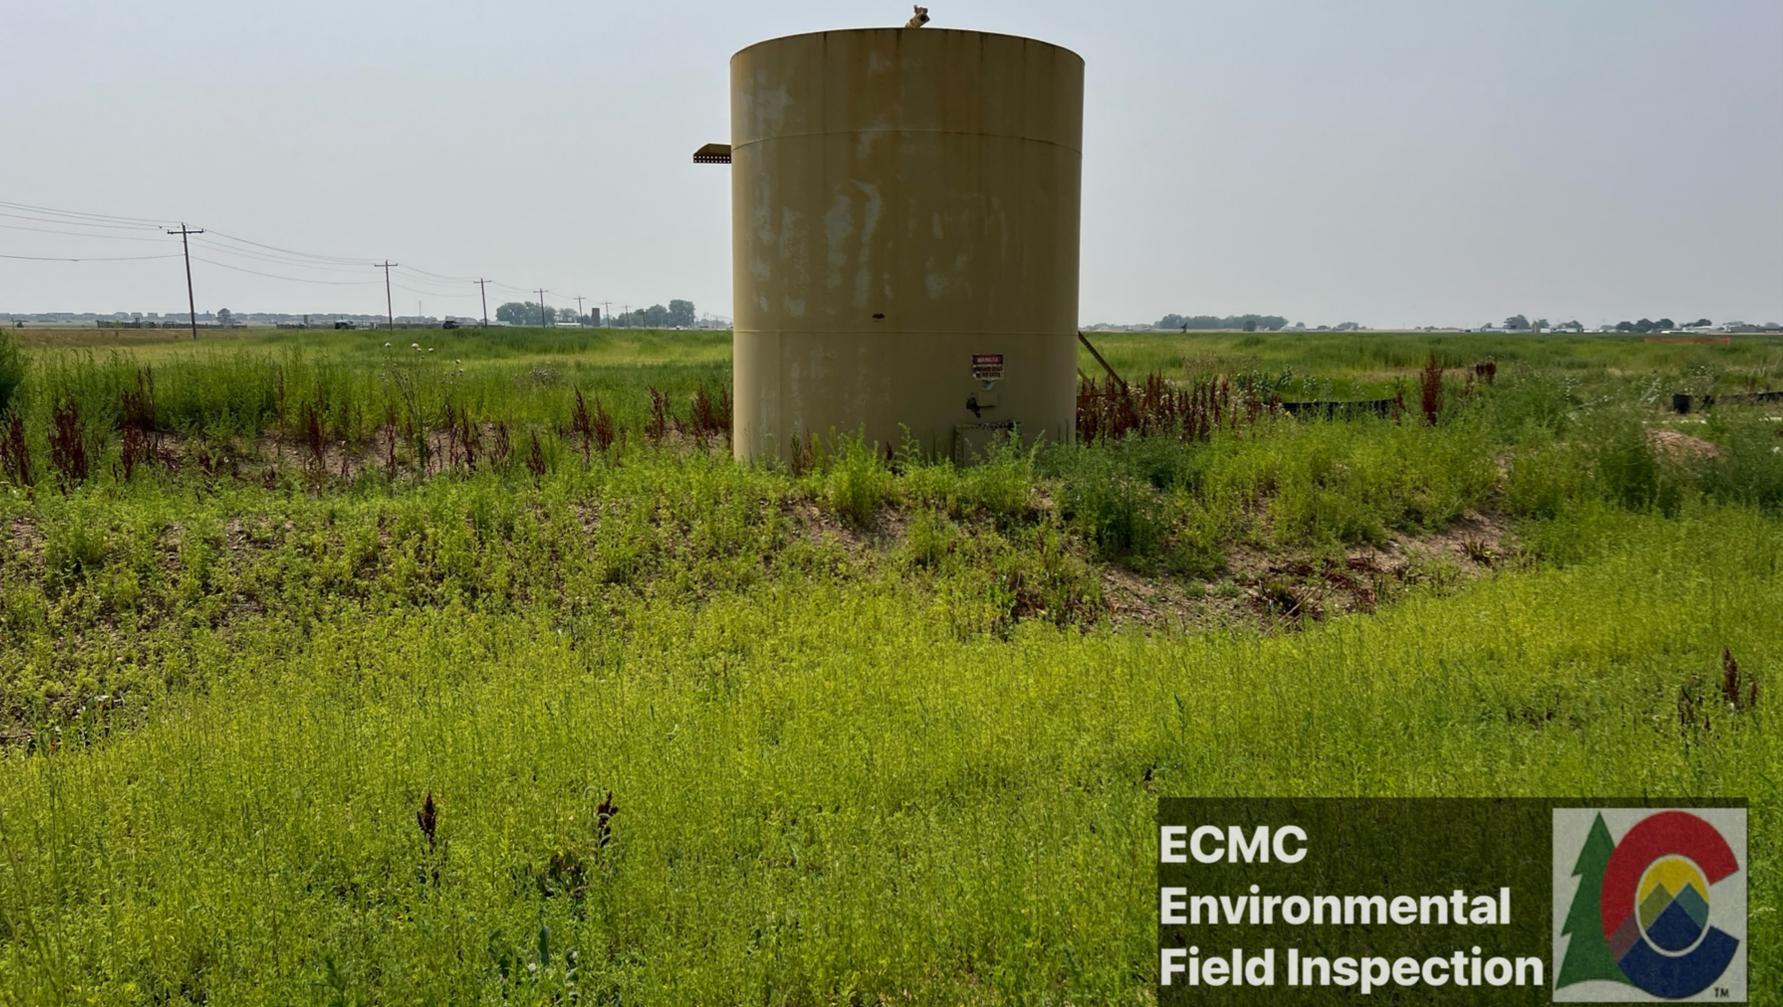
Weeds

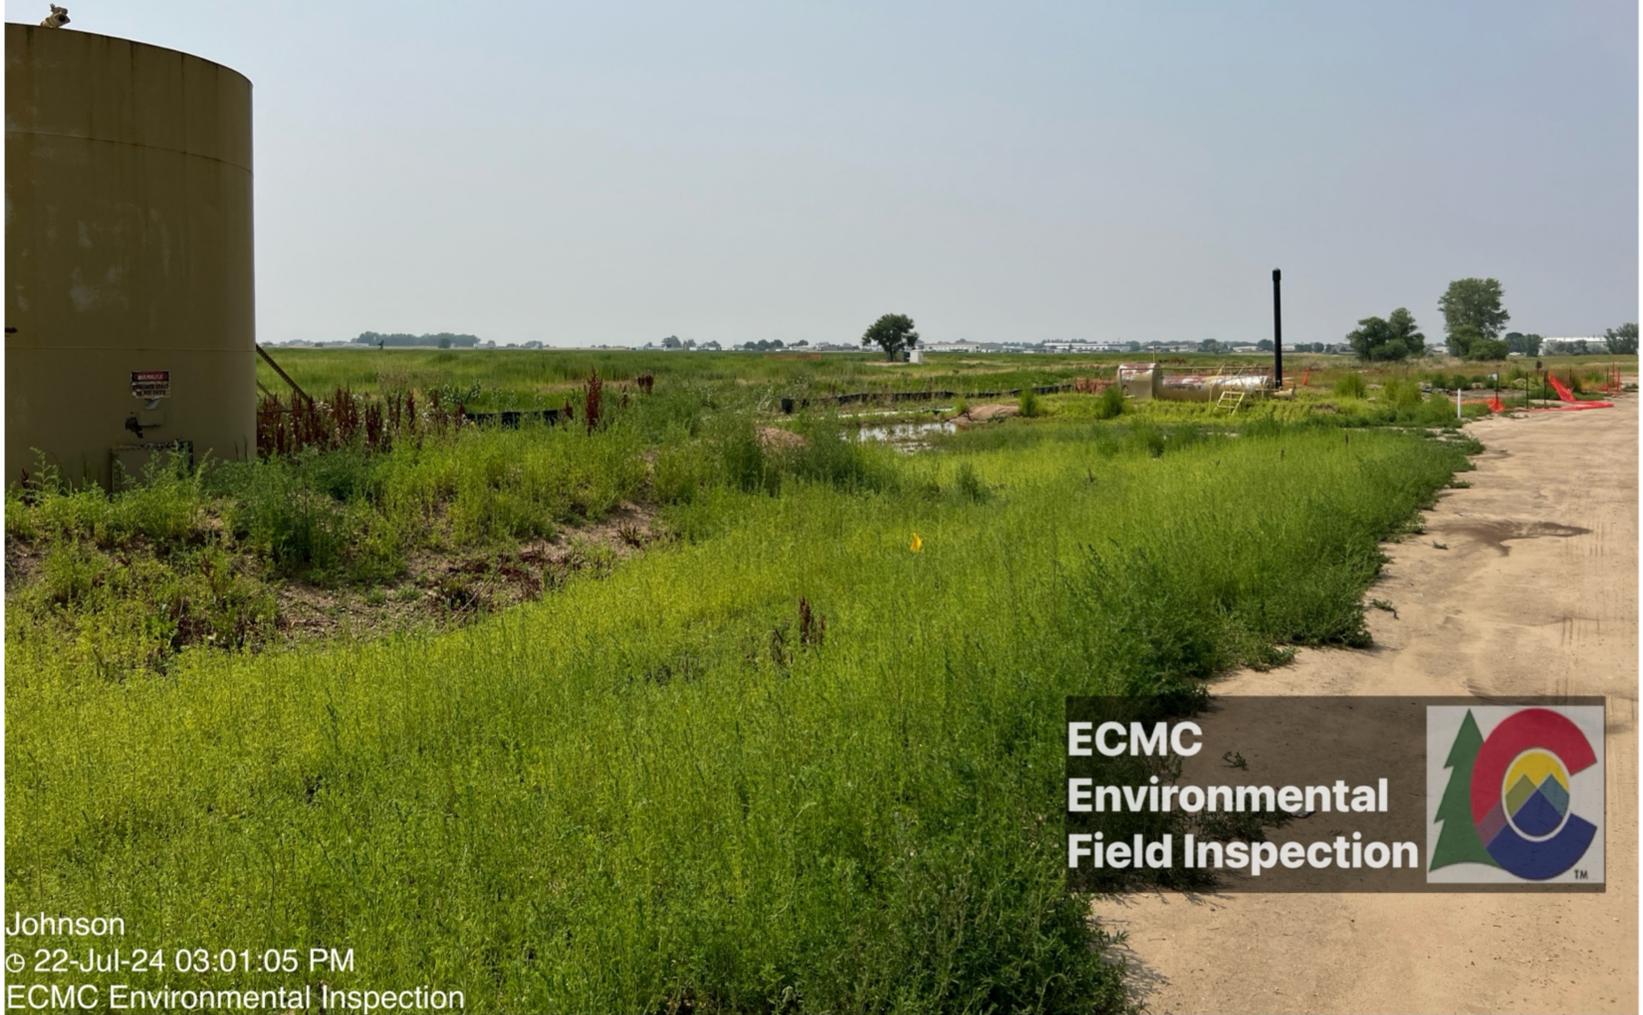
Johnson
© 22-Jul-24 03:01:05 PM
ECMC Environmental Inspection
Weeds, downed fencing

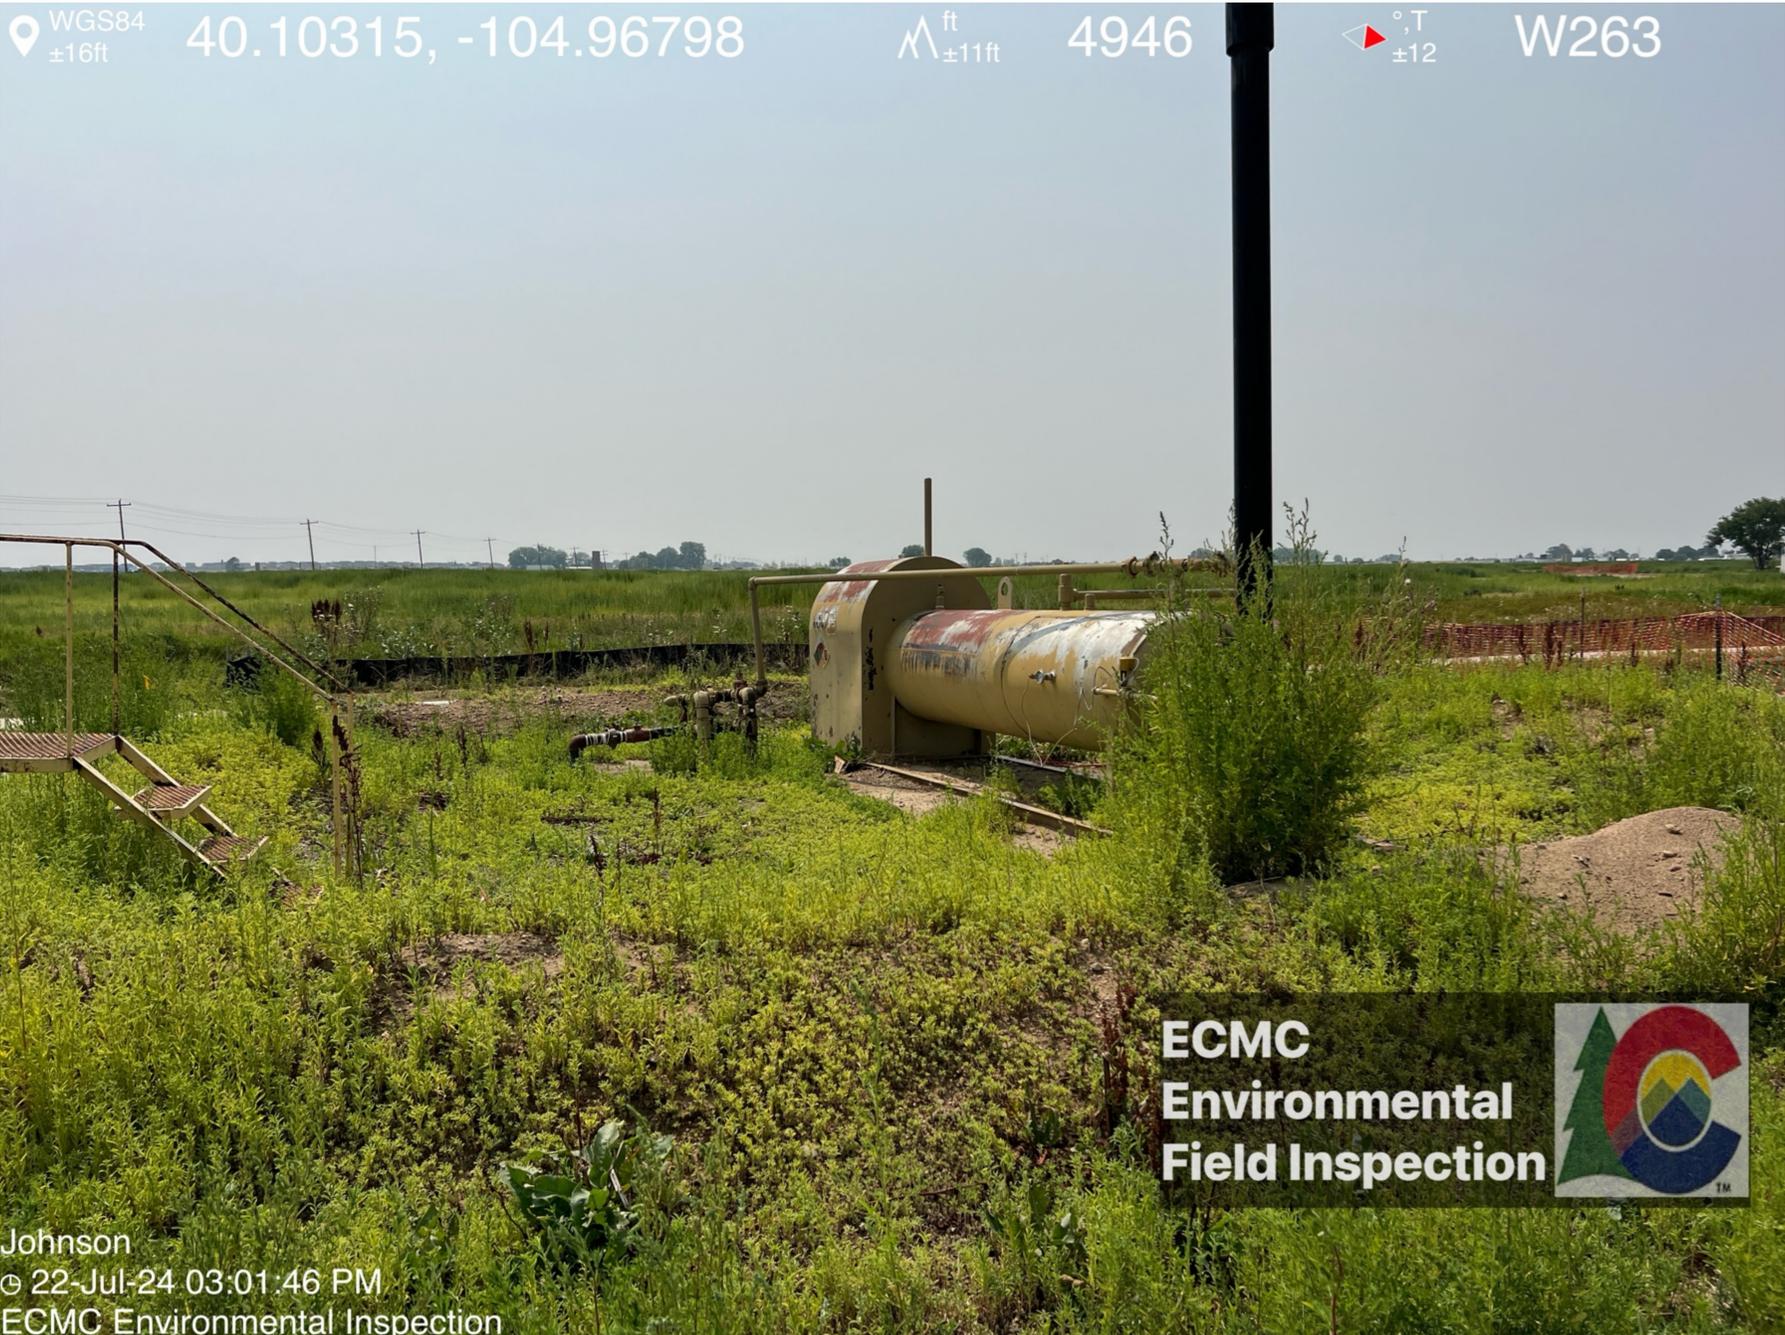
Johnson
© 22-Jul-24 03:01:46 PM
ECMC Environmental Inspection
Weeds

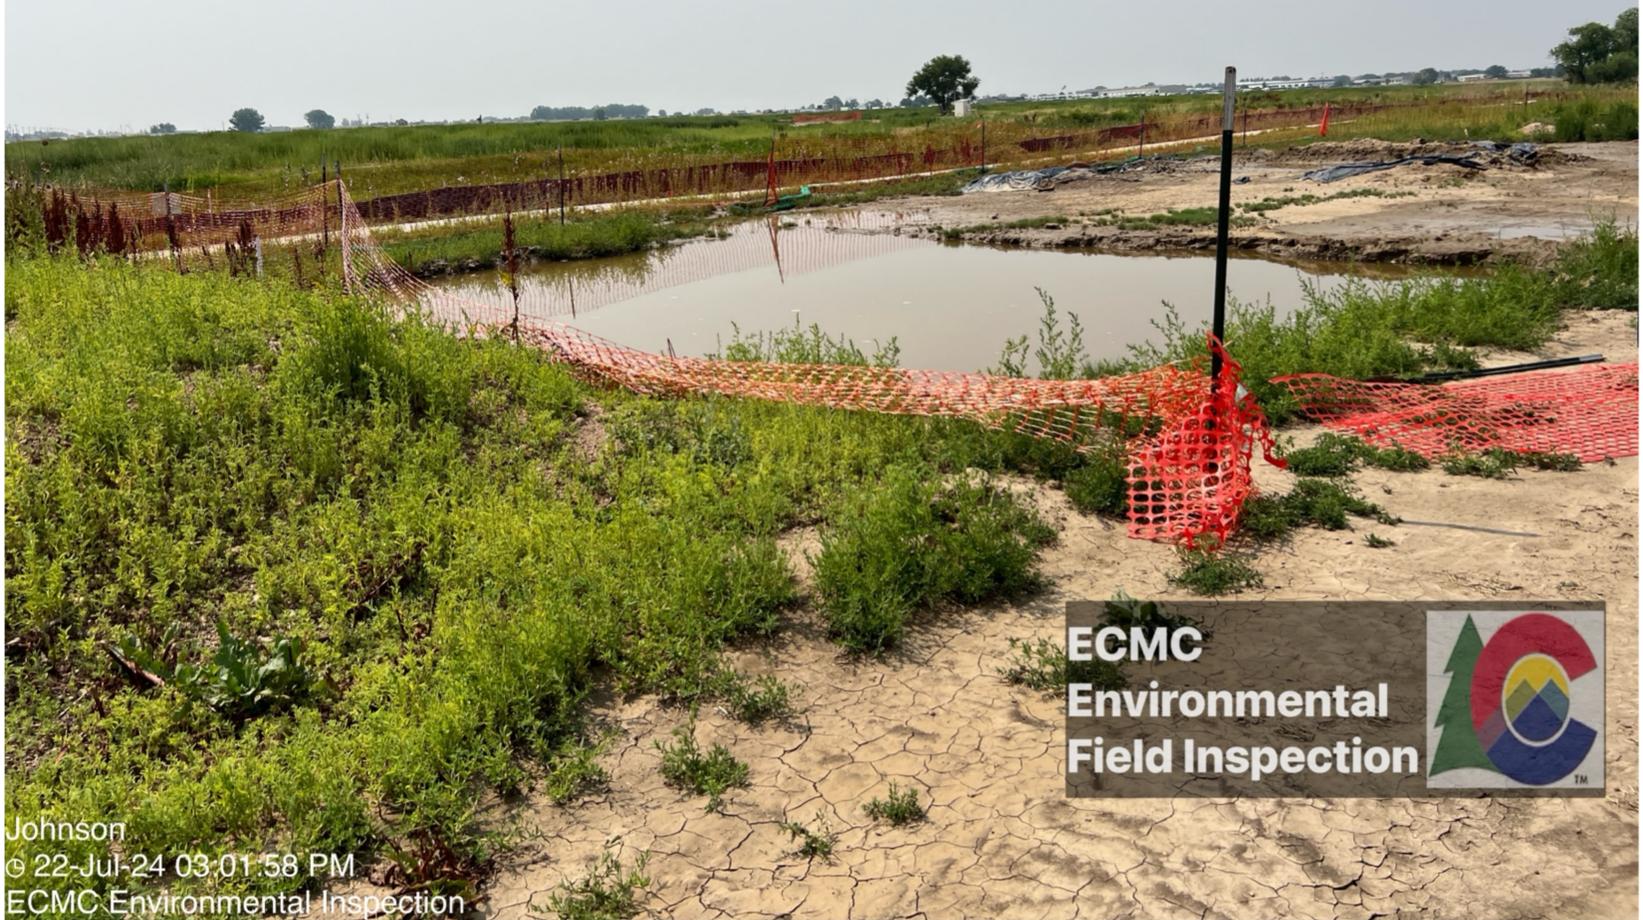
Weeds, failed/inadequate BMPs,downed/torn fencing, water overflowing from open excavation and stockpiled E&P waste, 100-year floodplain

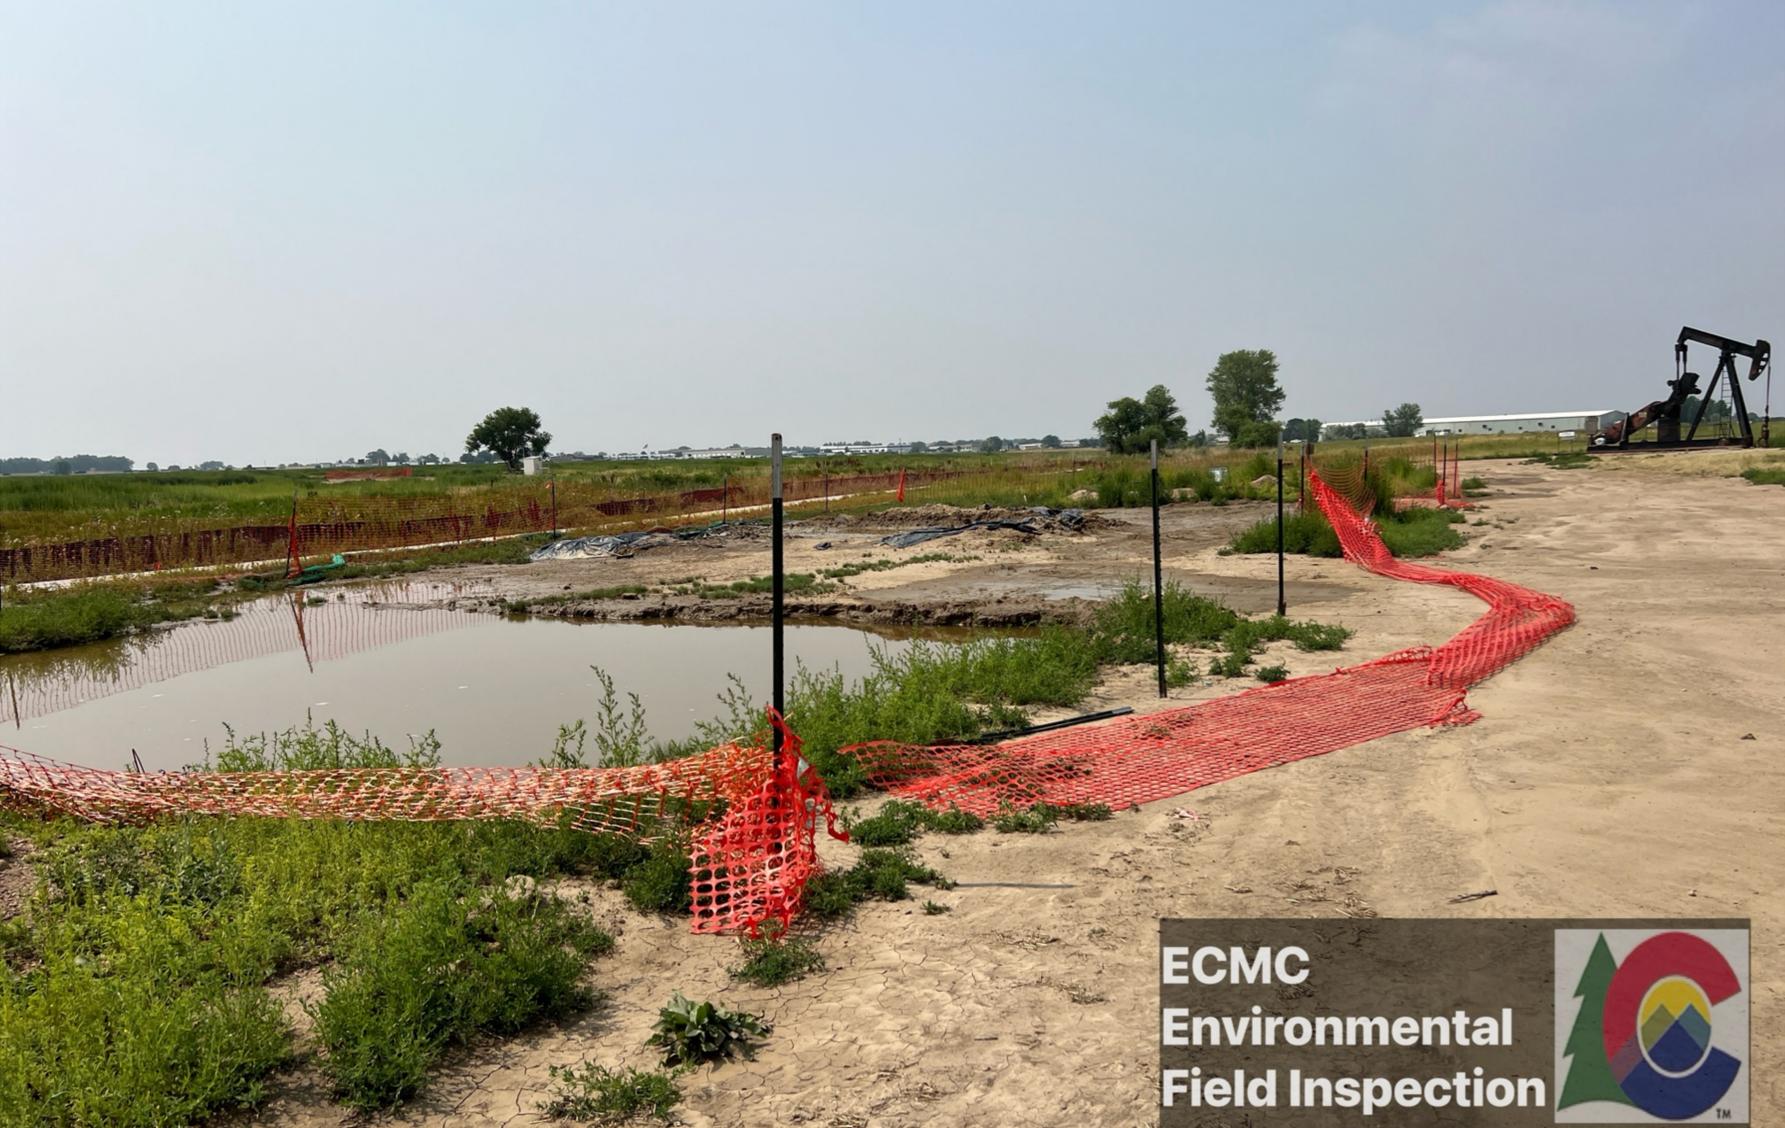
Weeds, failed/inadequate BMPs,downed/torn fencing, water overflowing from open excavation and stockpiled E&P waste, 100-year floodplain

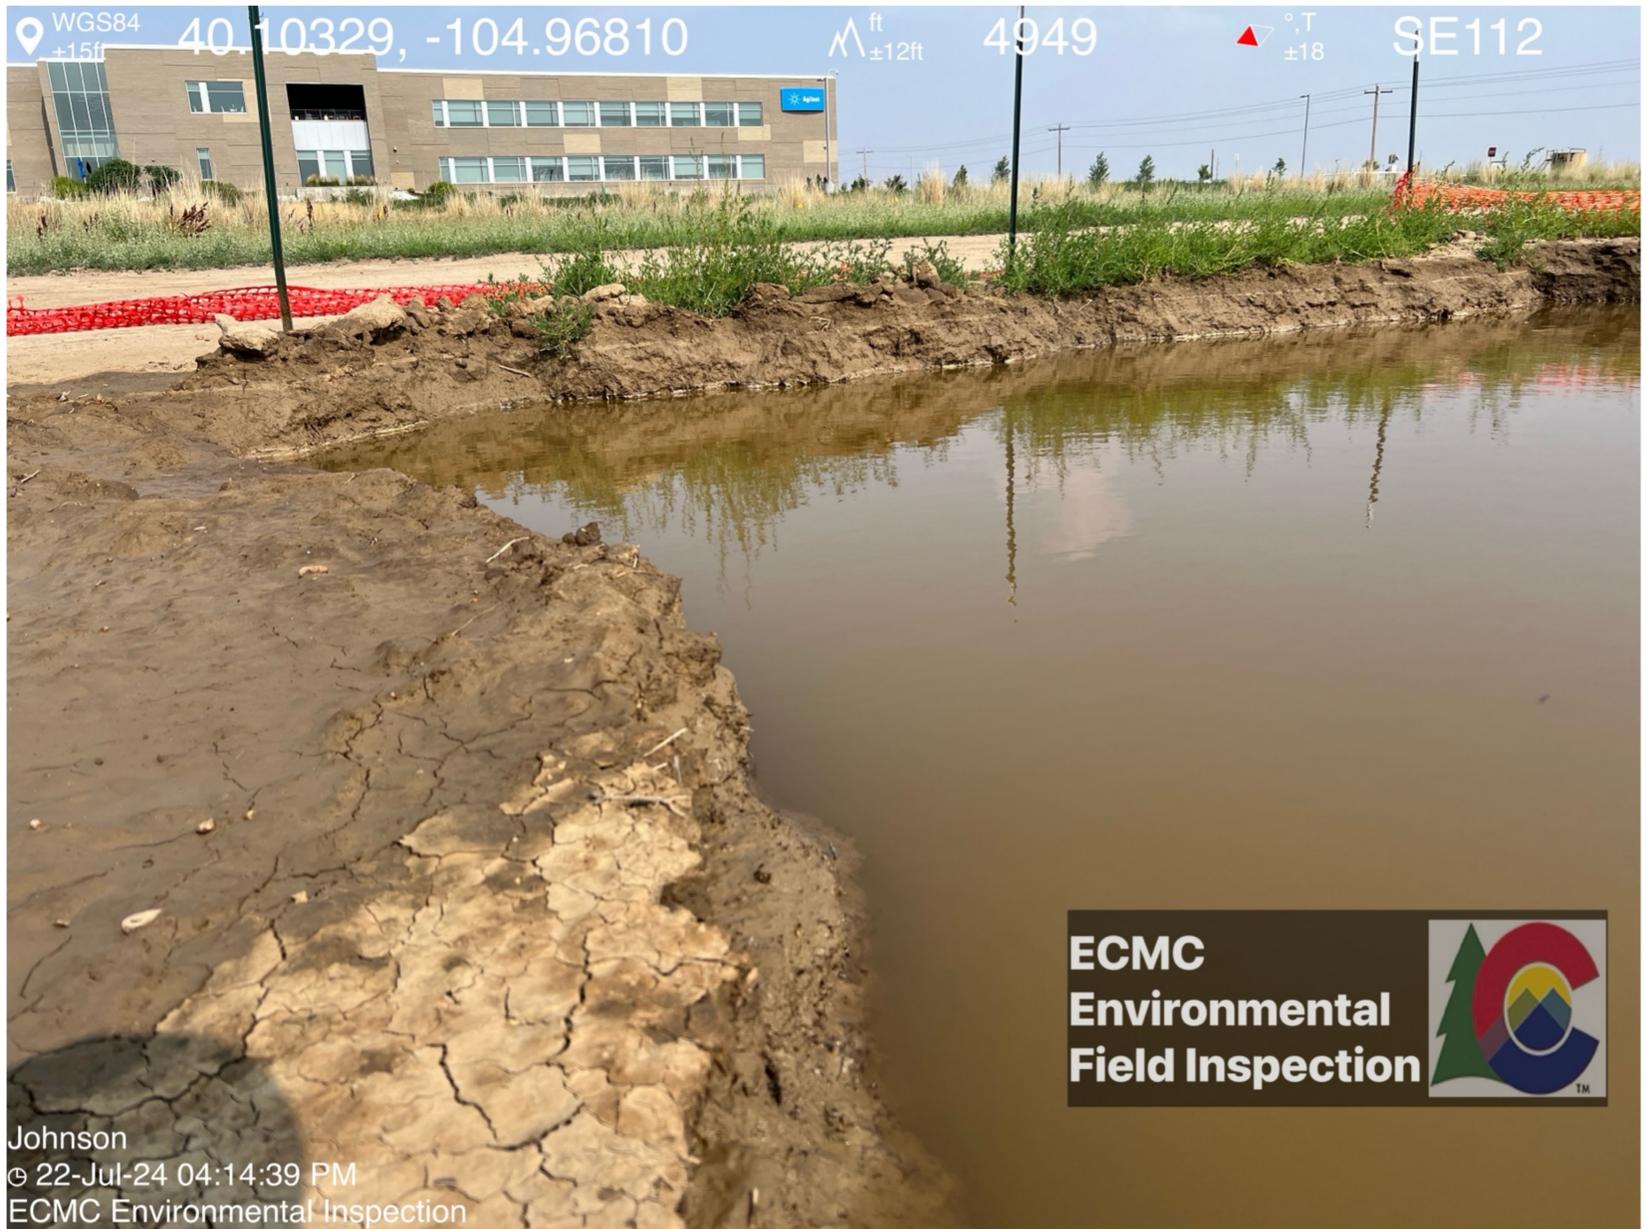
Weeds, inadequate BMPs,downed/torn fencing, open excavation

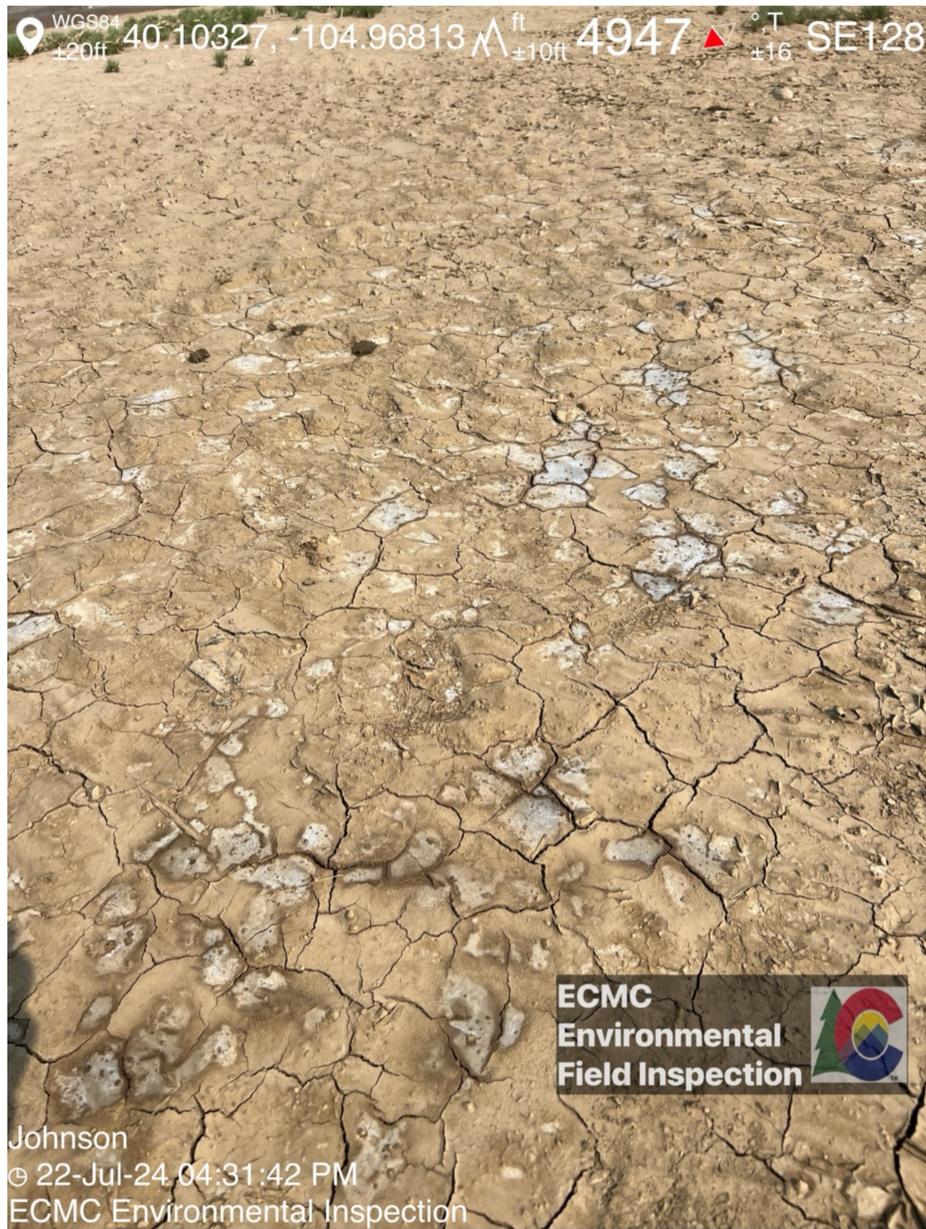
Gray/White stained soil

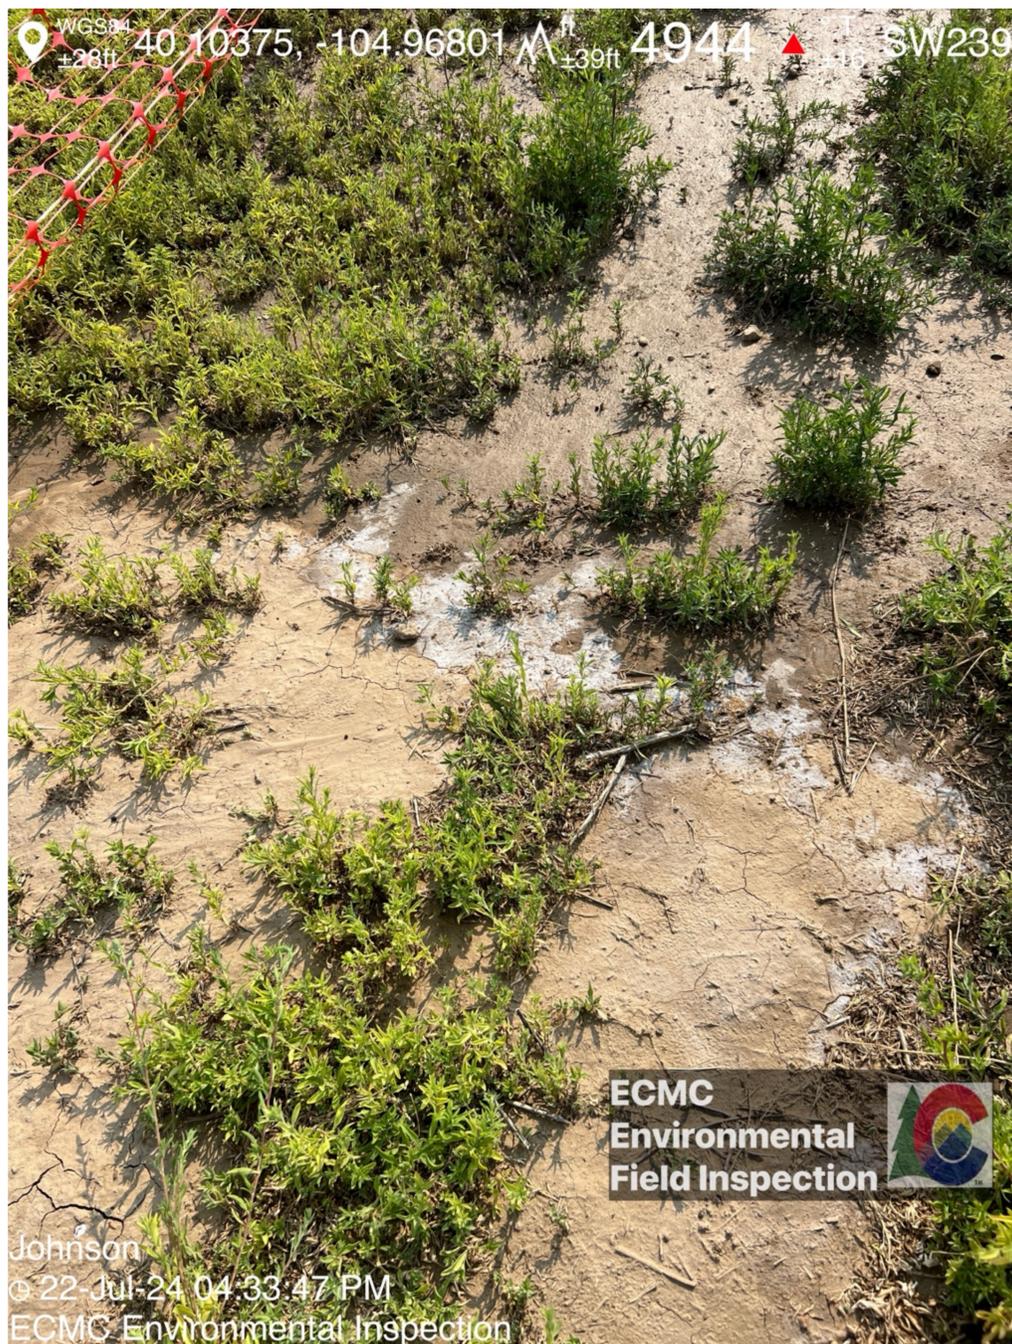
Gray/White stained soil

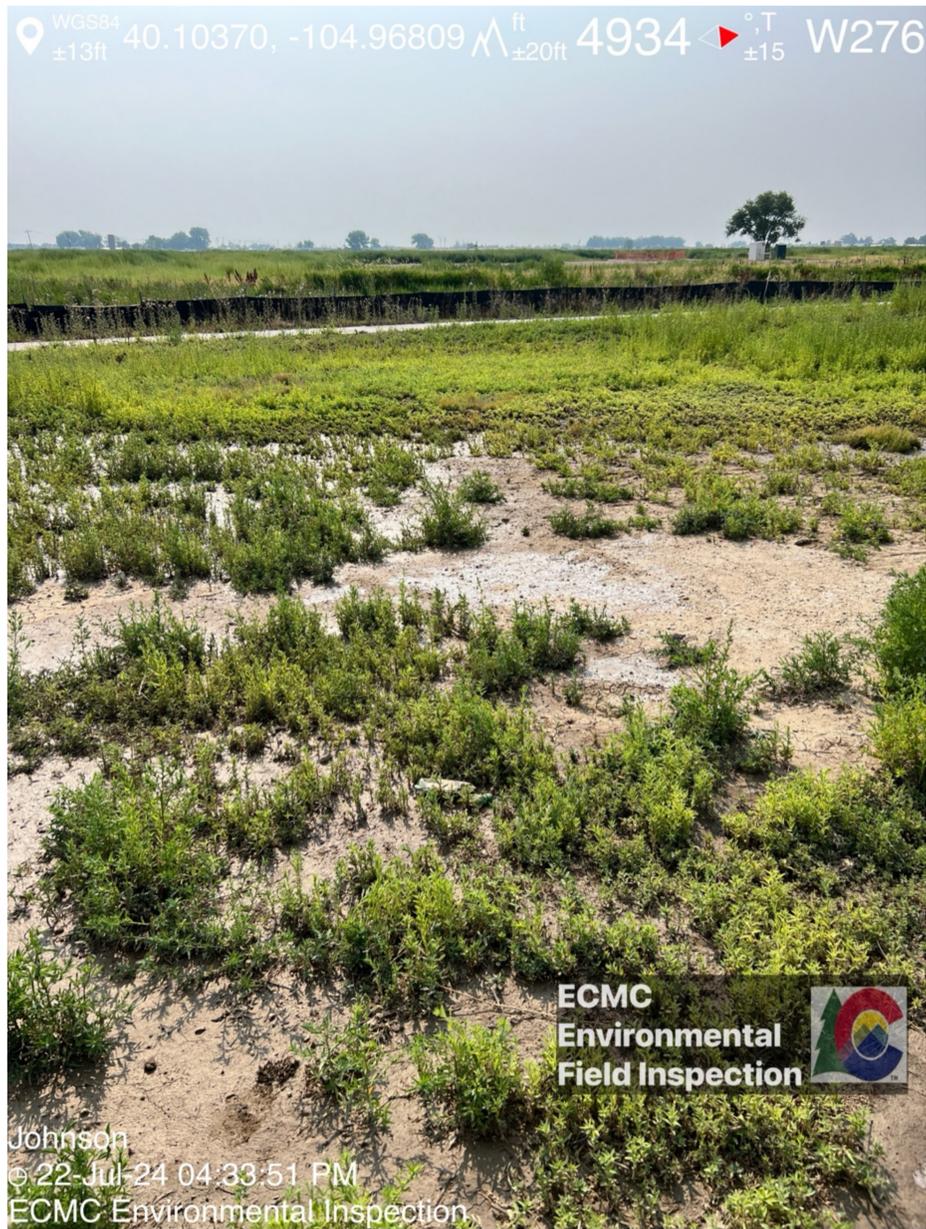
Gray/White stained soil outside fenced in work area

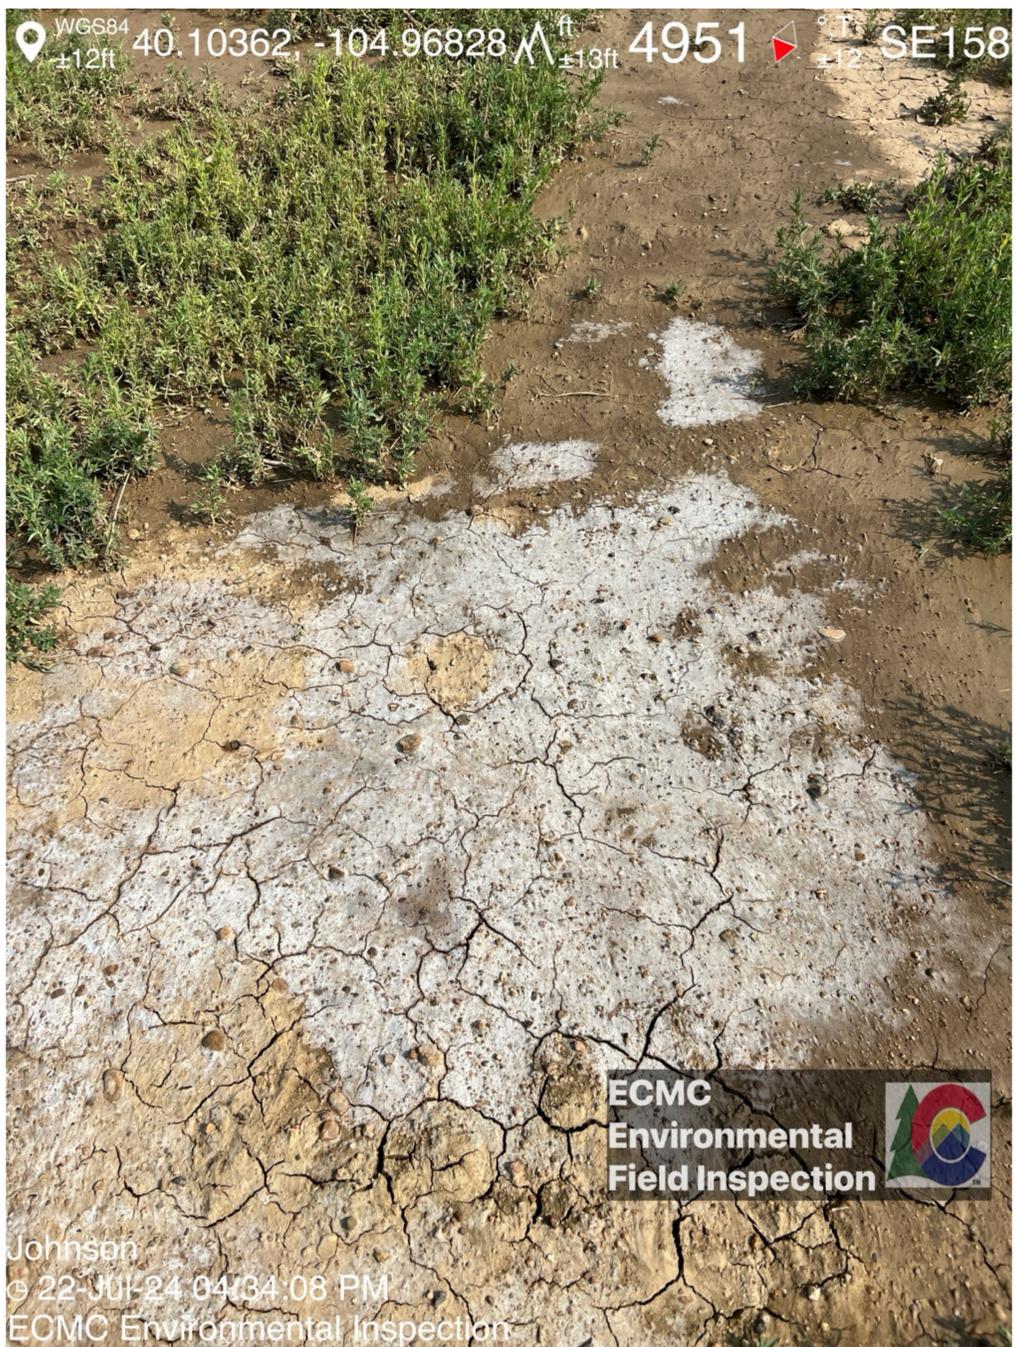
Gray/White stained soil outside fenced in work area

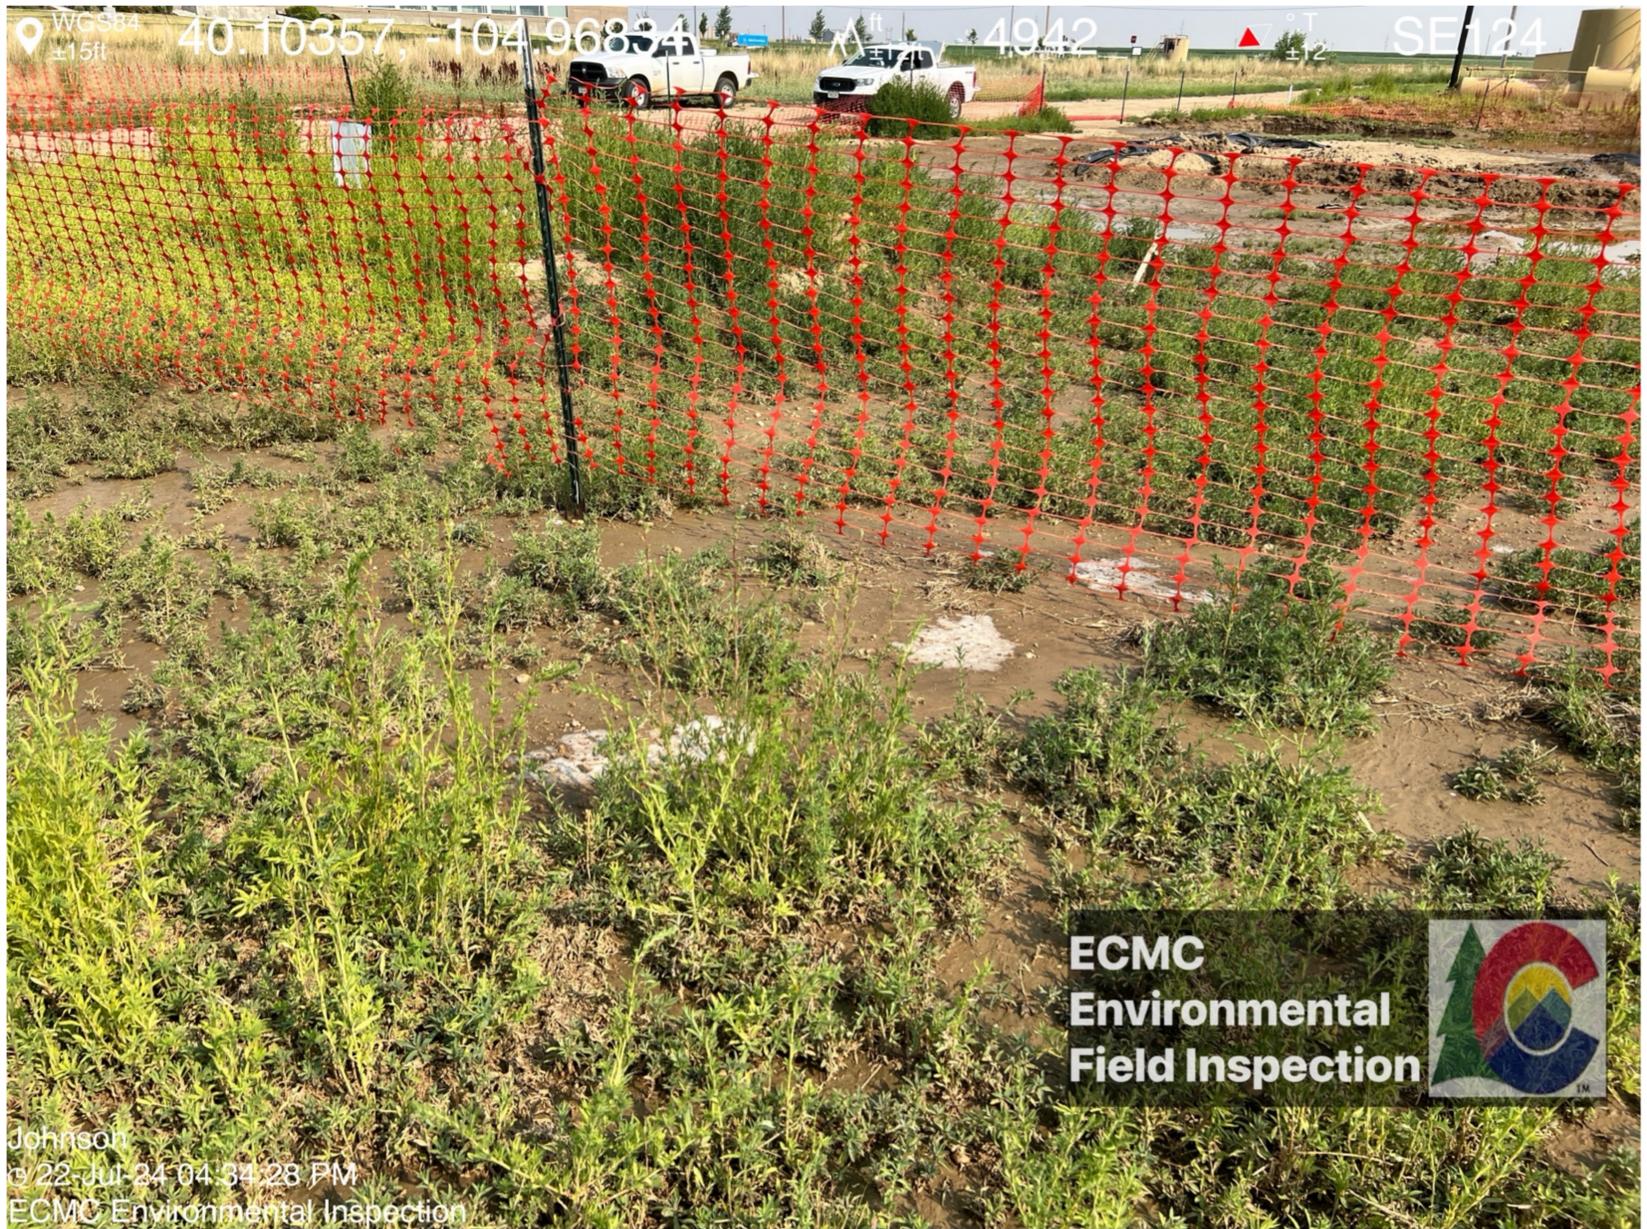
Gray/White stained soil outside fenced in work area
