**ECMC**  
**Environmental**  
**Field Inspection**

Johnson 1  
© 23-Jul-24 08:16:22 AM  
ECMC Environmental Inspection

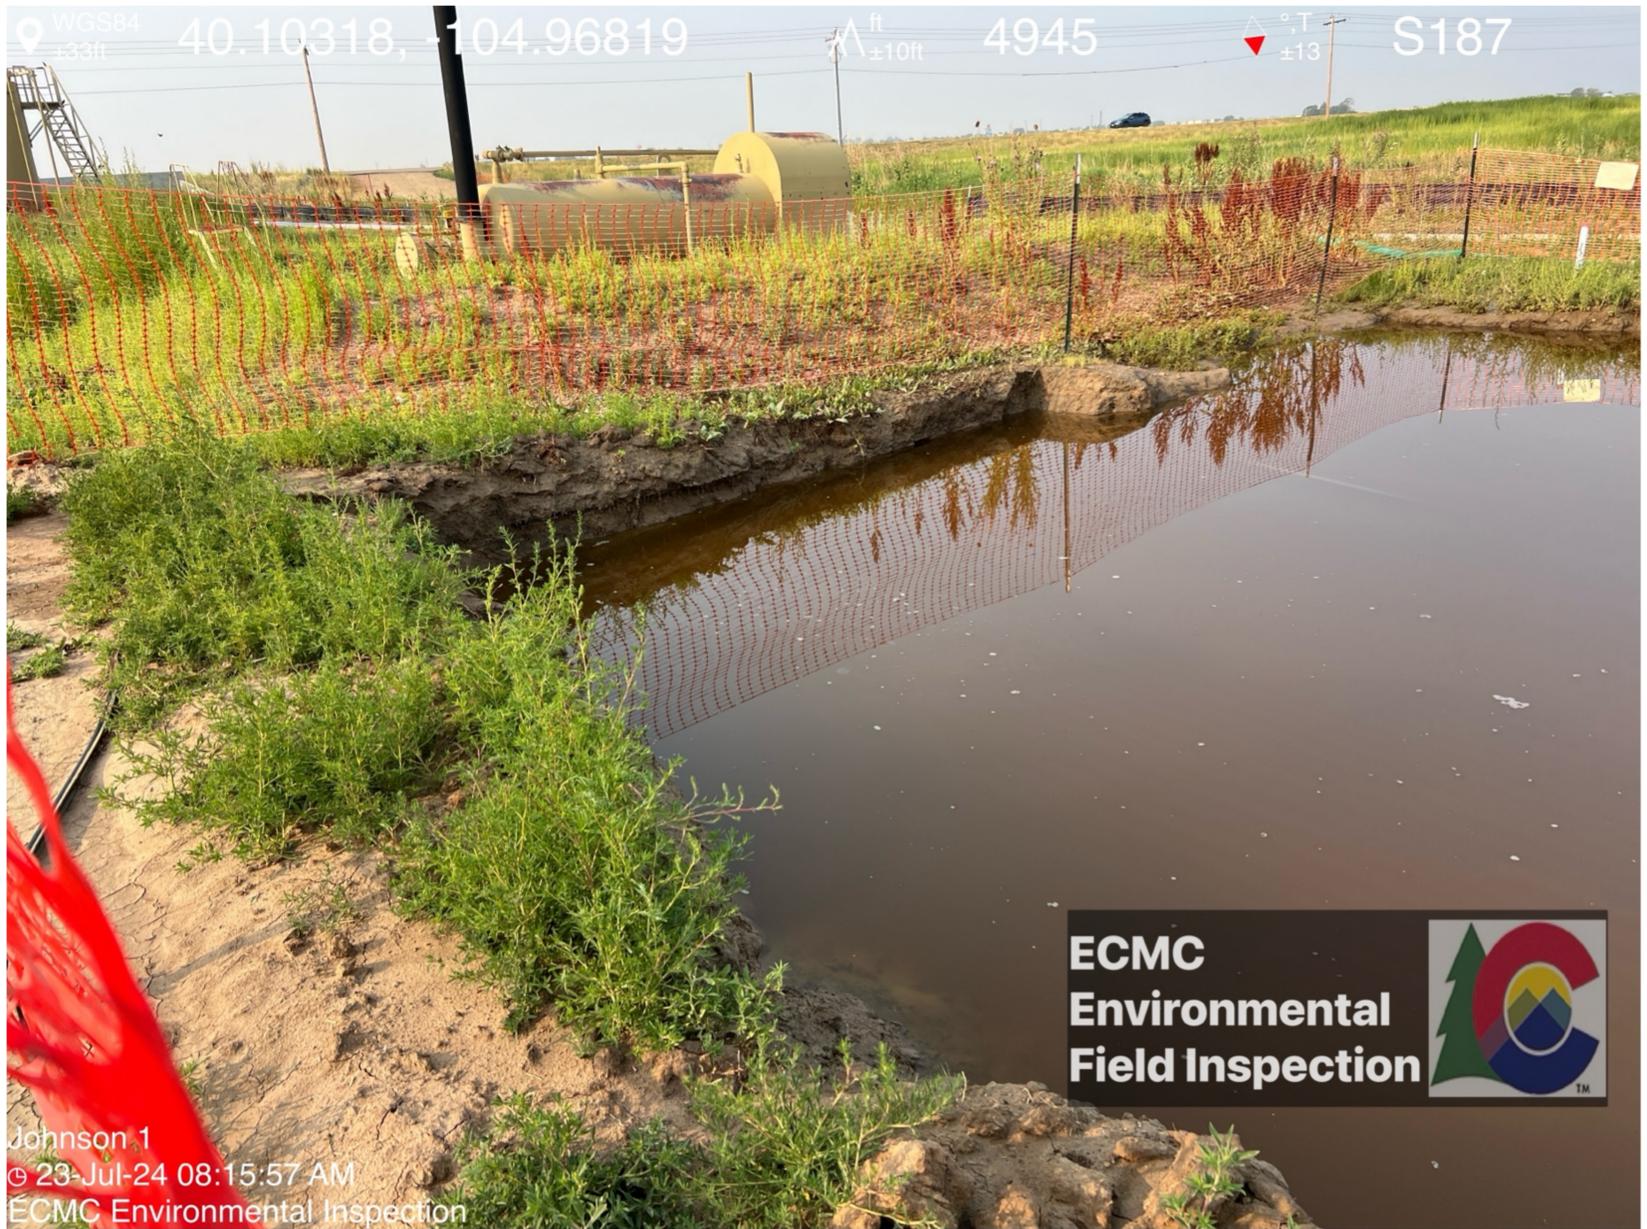
Site overview; excavation over-topped with stormwater and groundwater, weeds, inadequate BMPs.

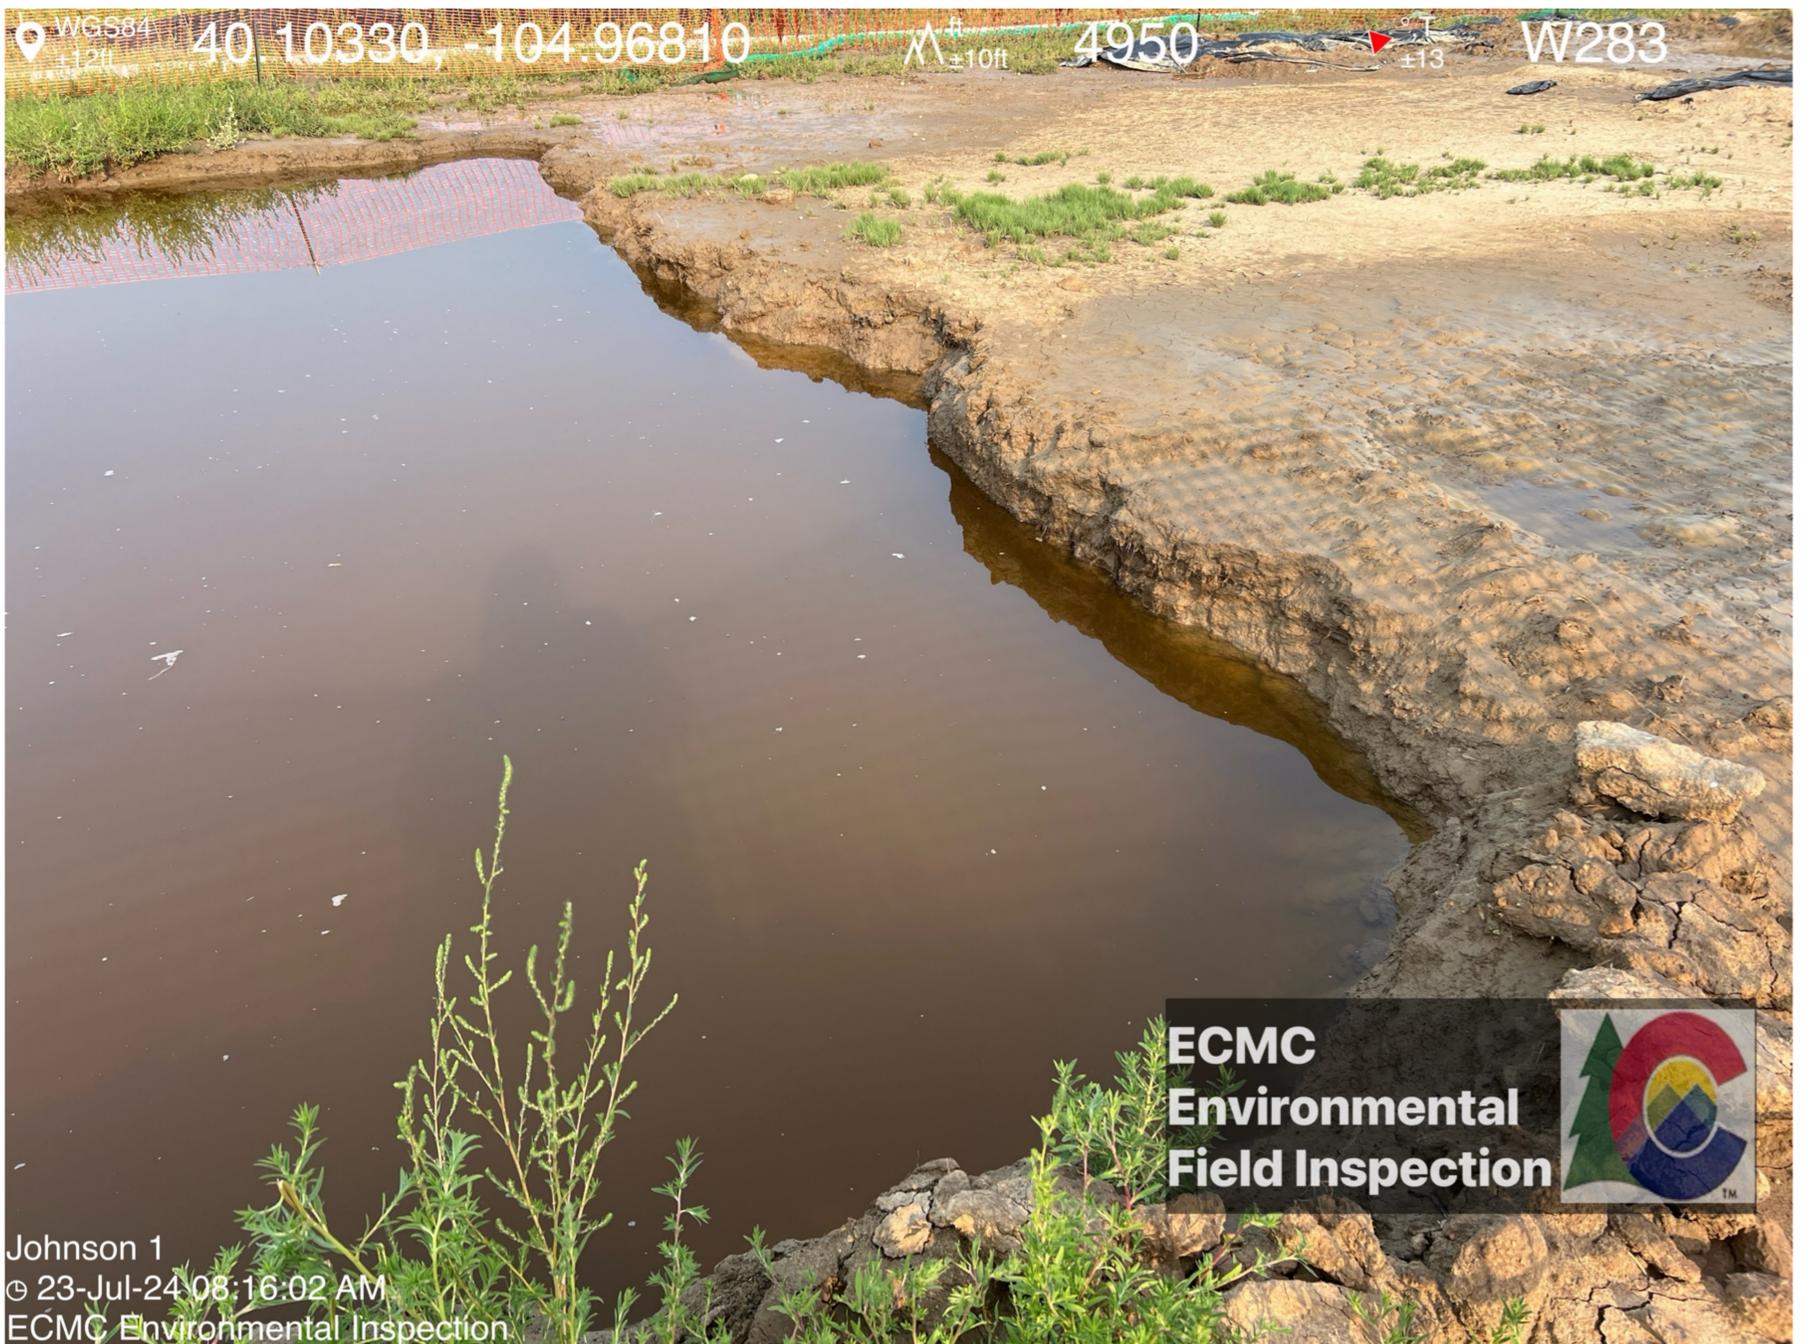
Open excavation filled with water.

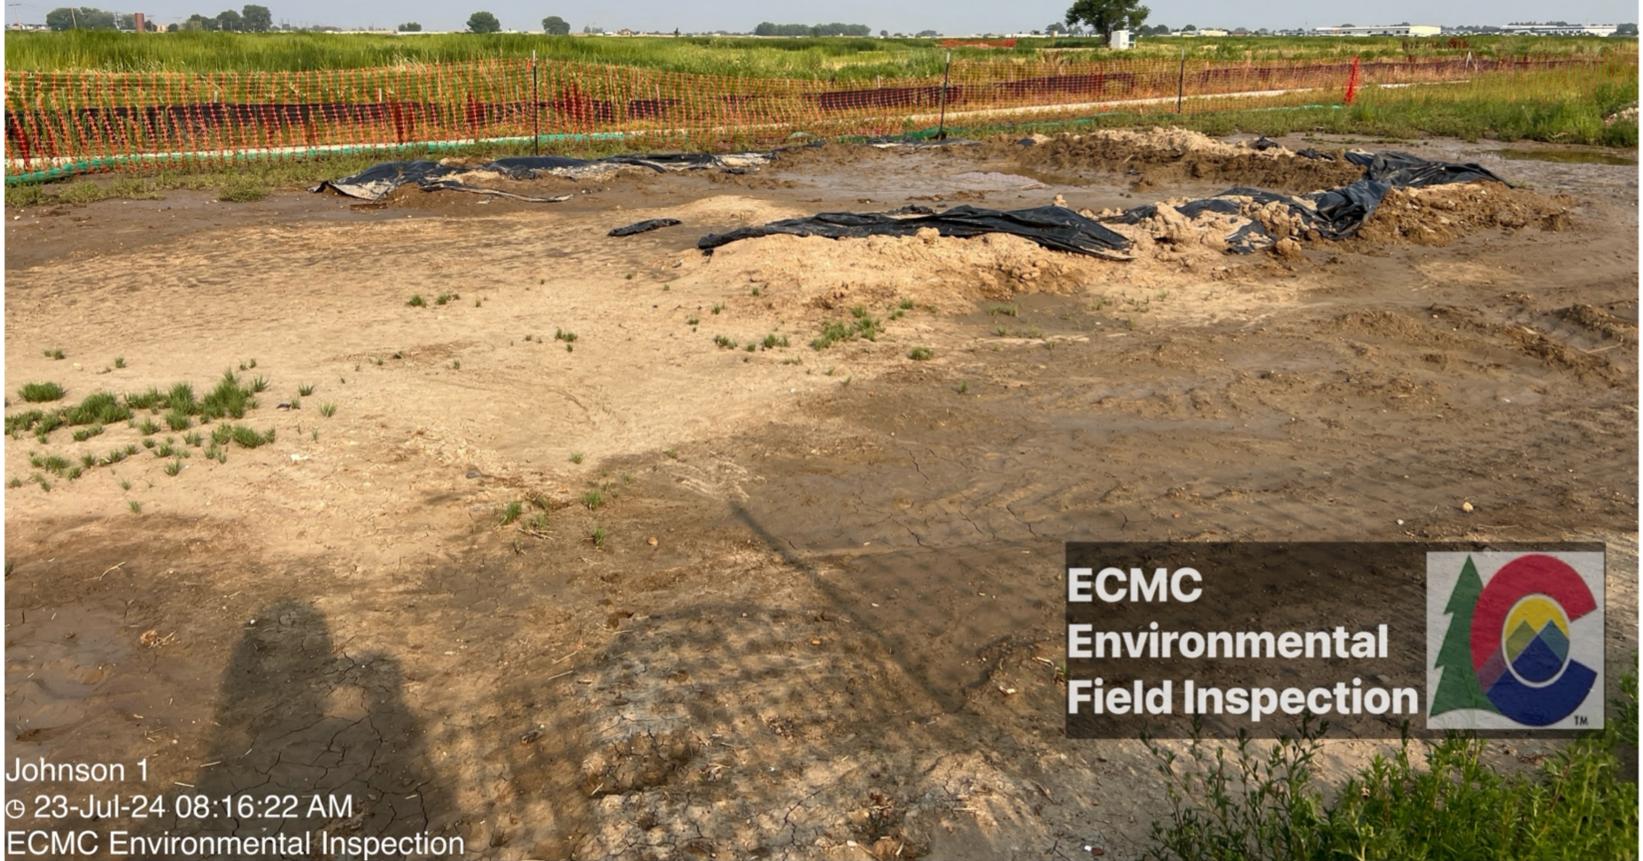
Contaminated Soil (E&P Waste) Stockpile with inadequate BMPs.

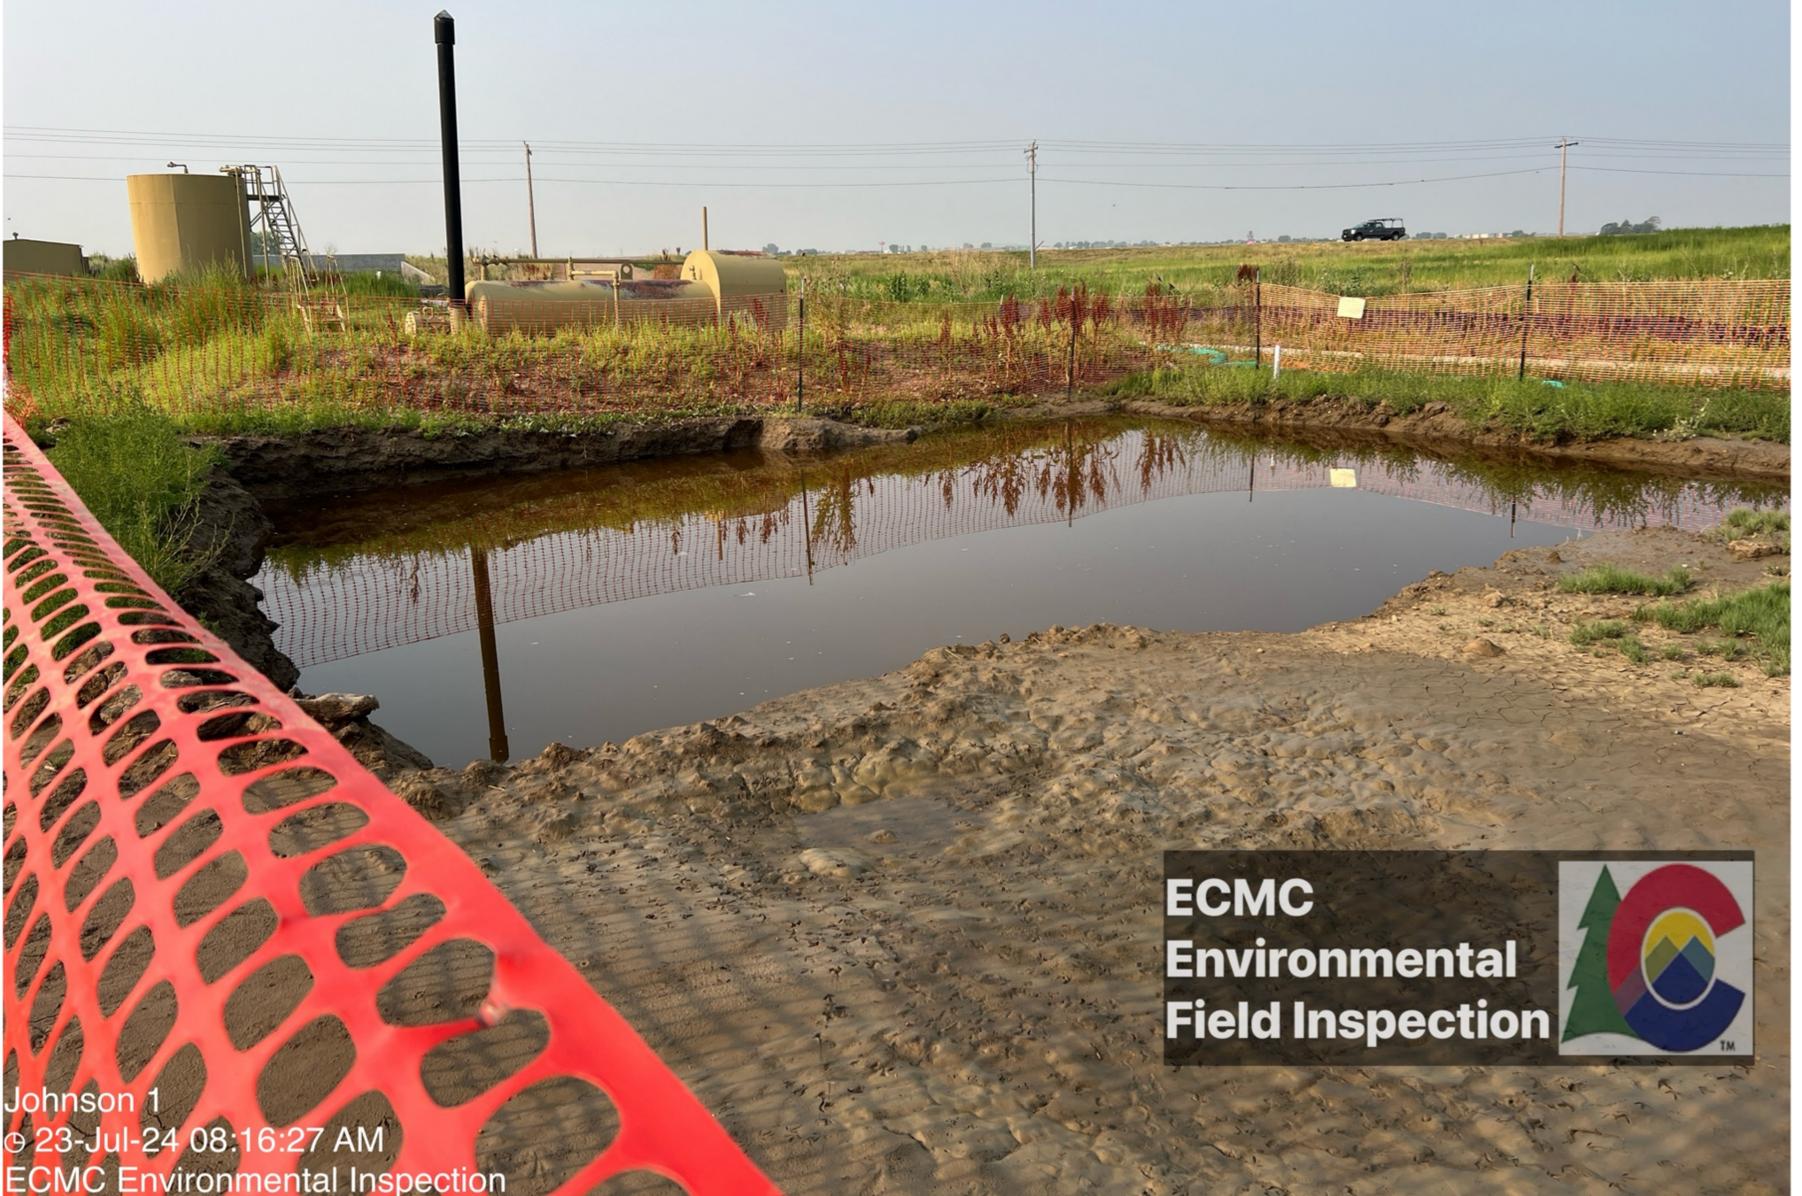
Open excavation filled with water (groundwater and surface water). Inadequate BMPs to control run-in/run-off around the excavation.

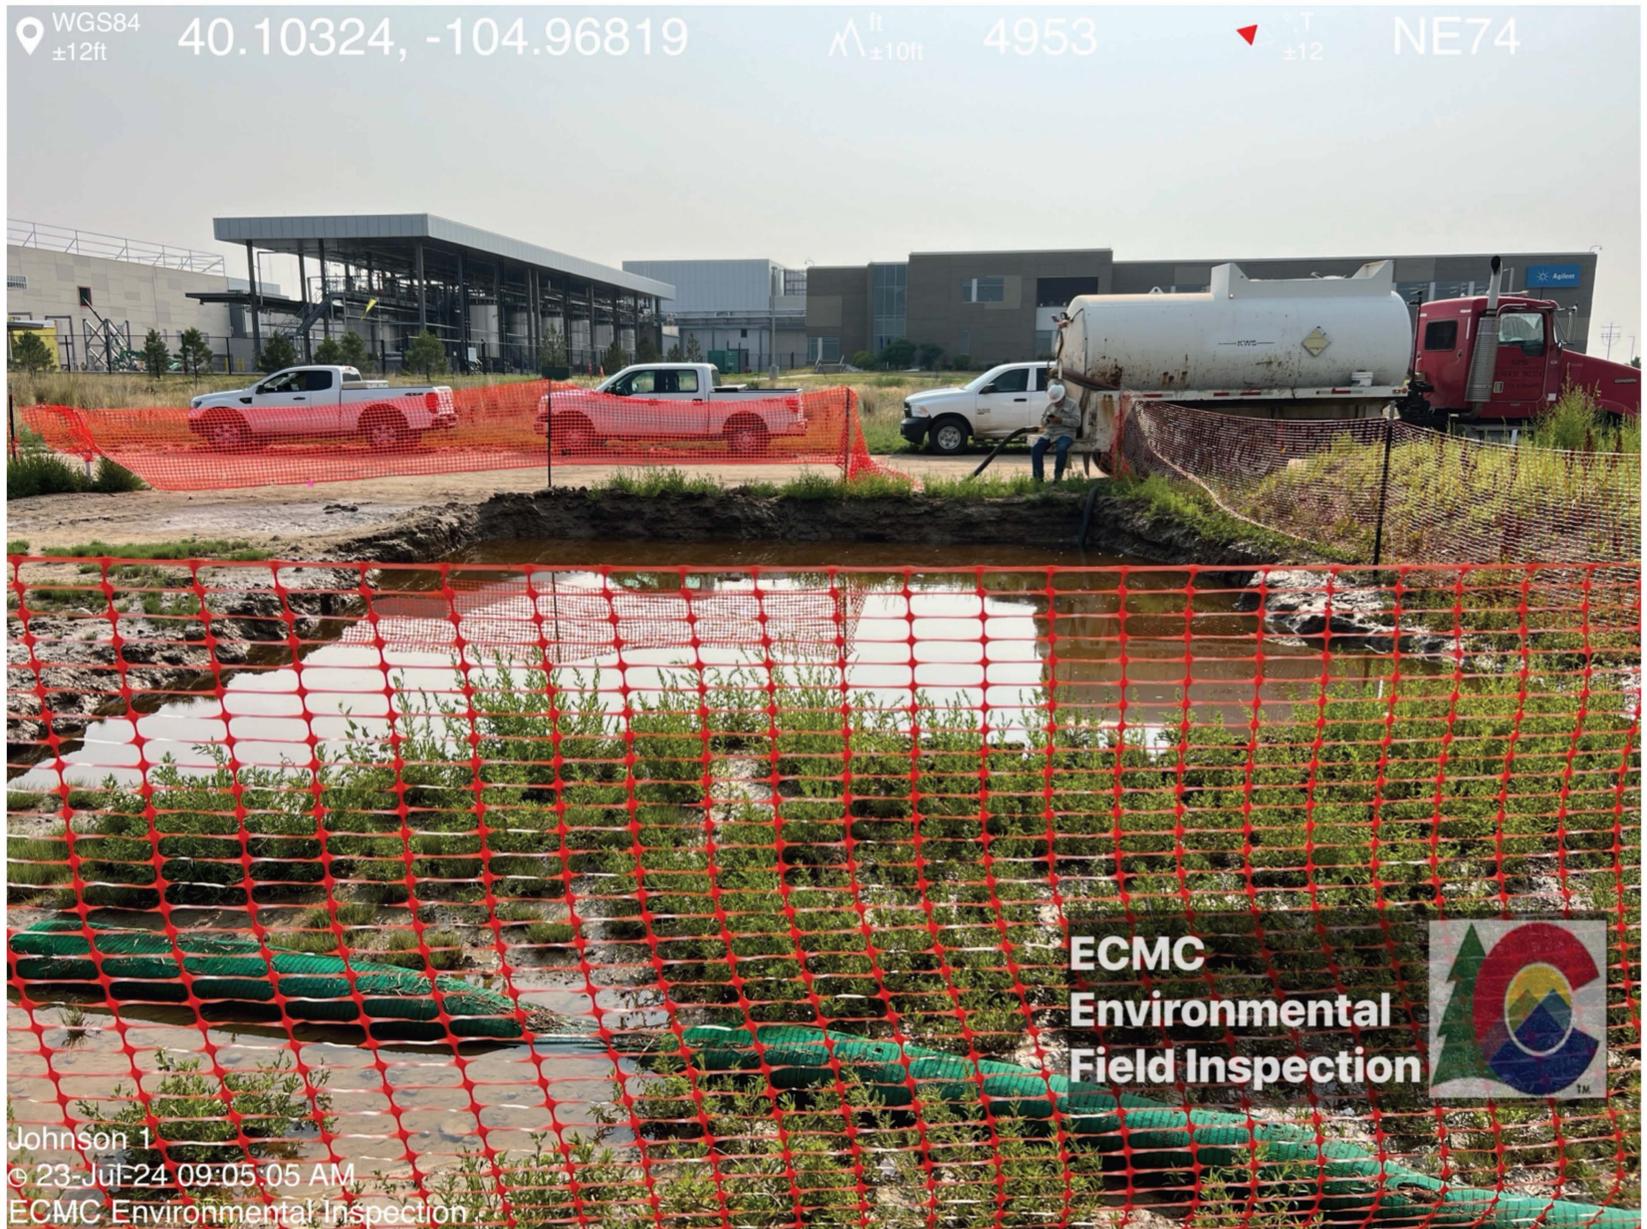
Crews returned to continue hydrovacuuming water from open excavation (Second truckload). Inadequate stormwater BMPs.

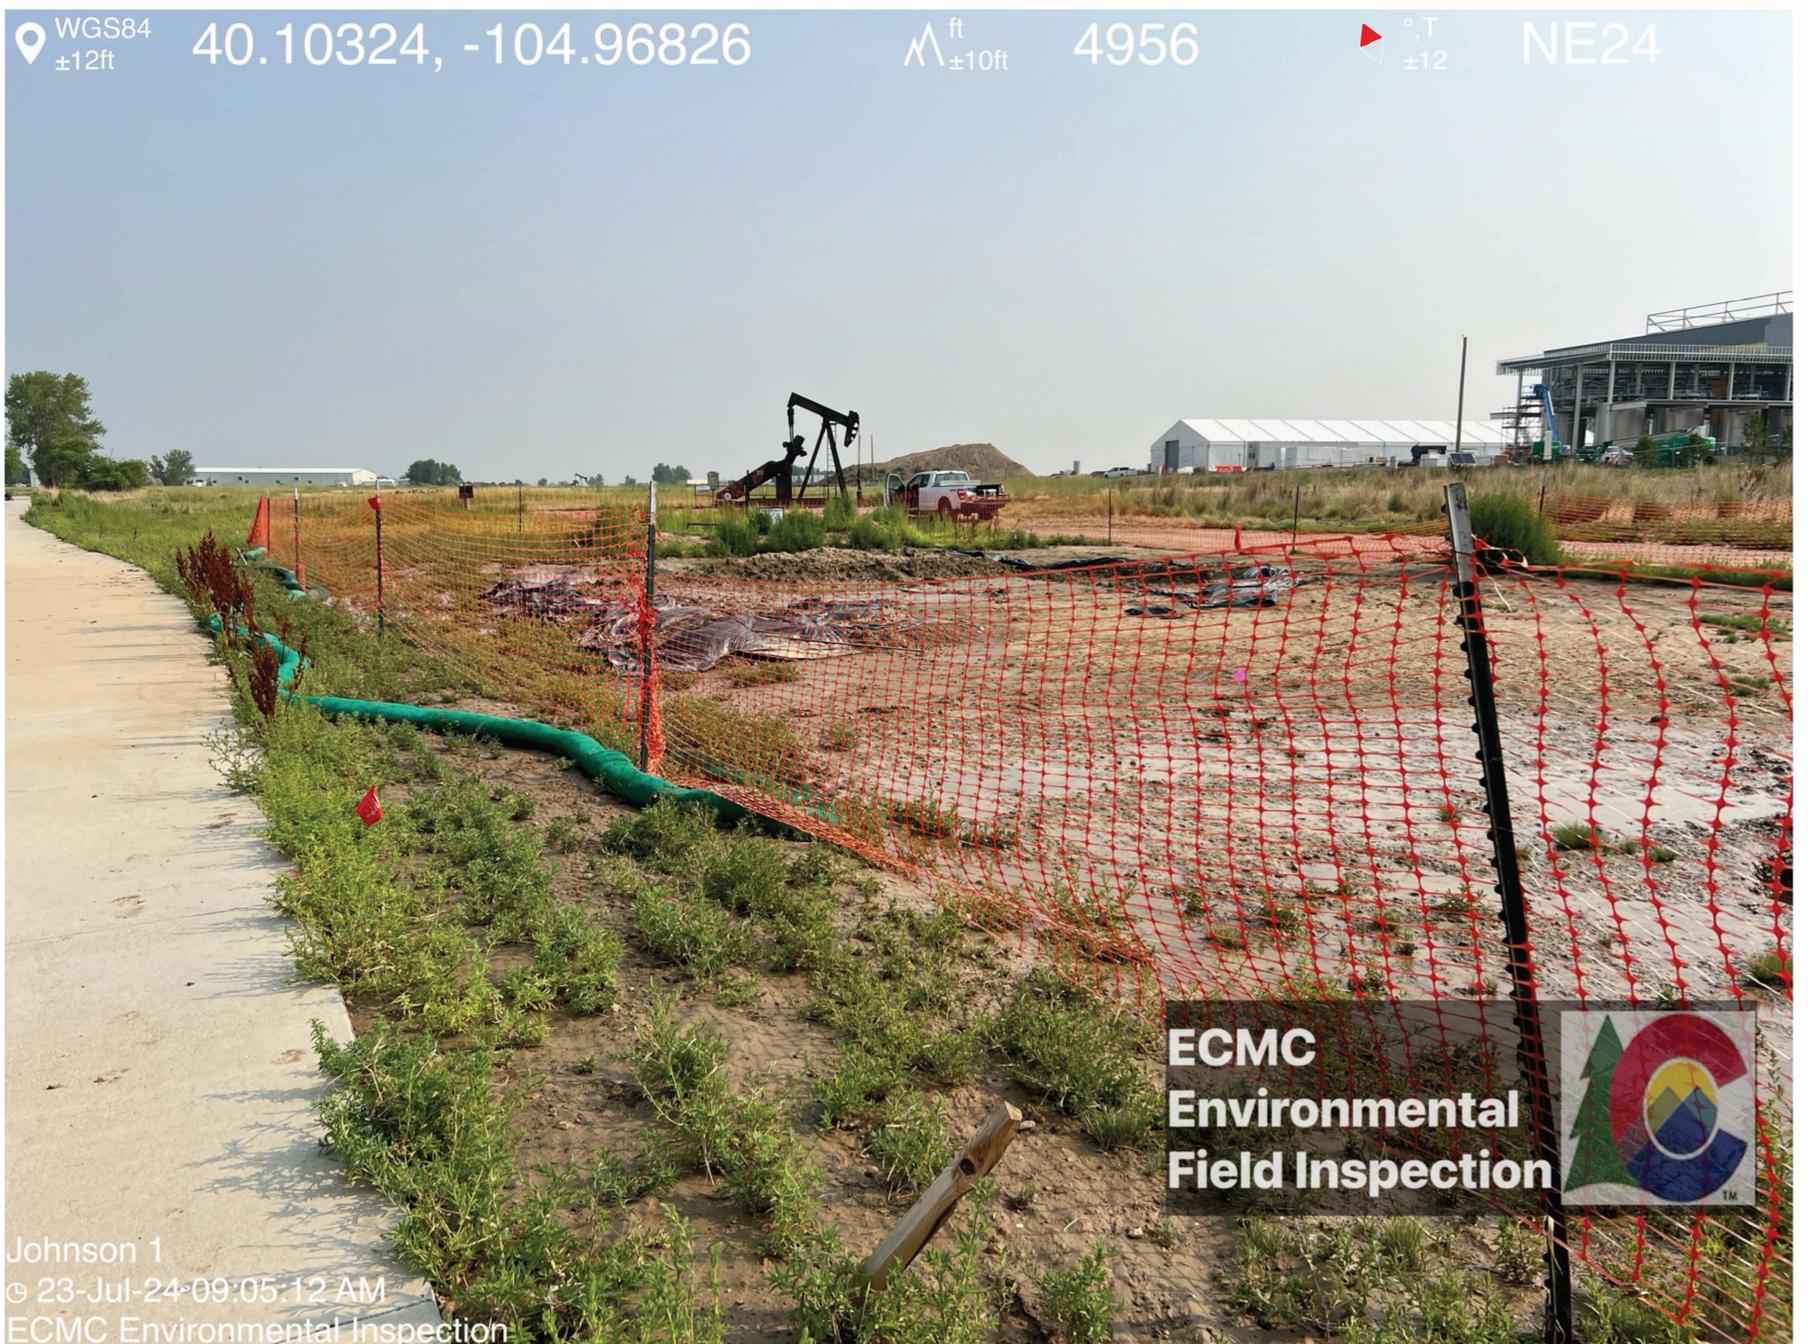
Open excavation filled with water (groundwater and surface water). Inadequate BMPs to control run-in/run-off around the excavation.

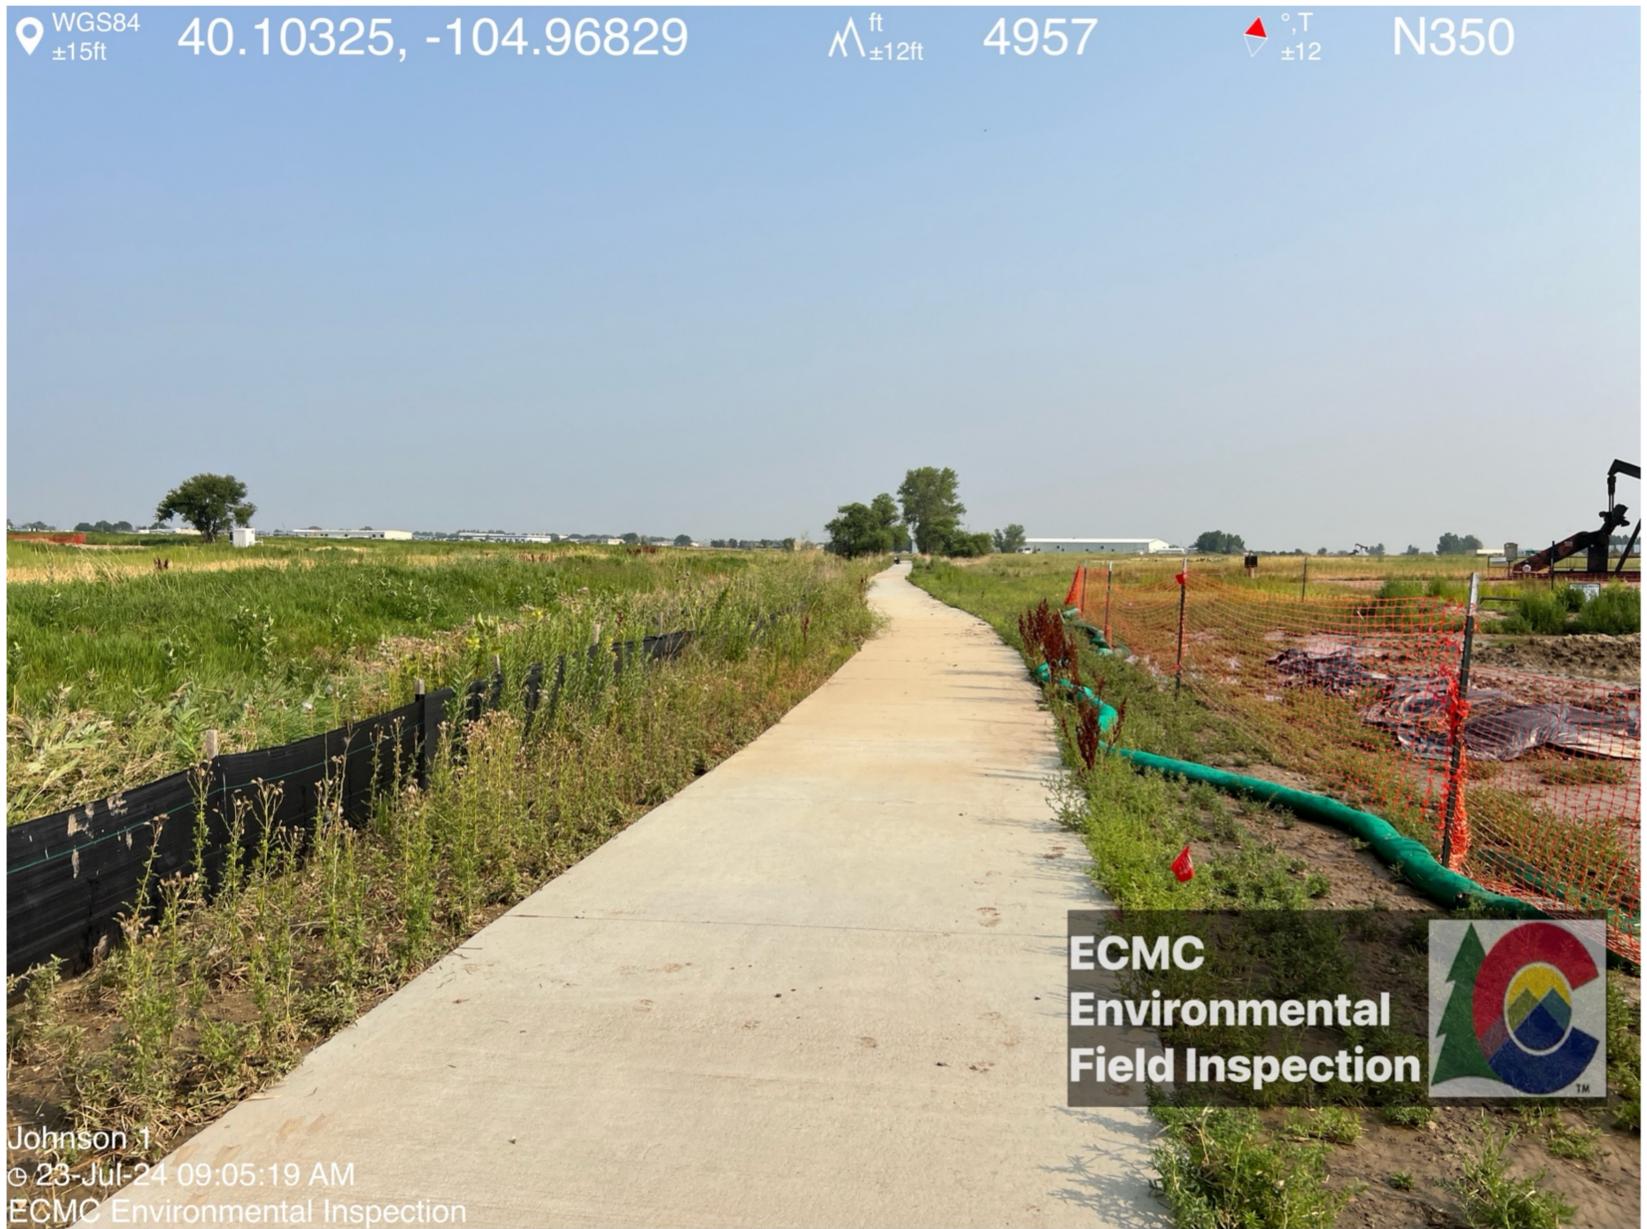
Publicly accessible walking path, inadequate BMPs to control runoff.

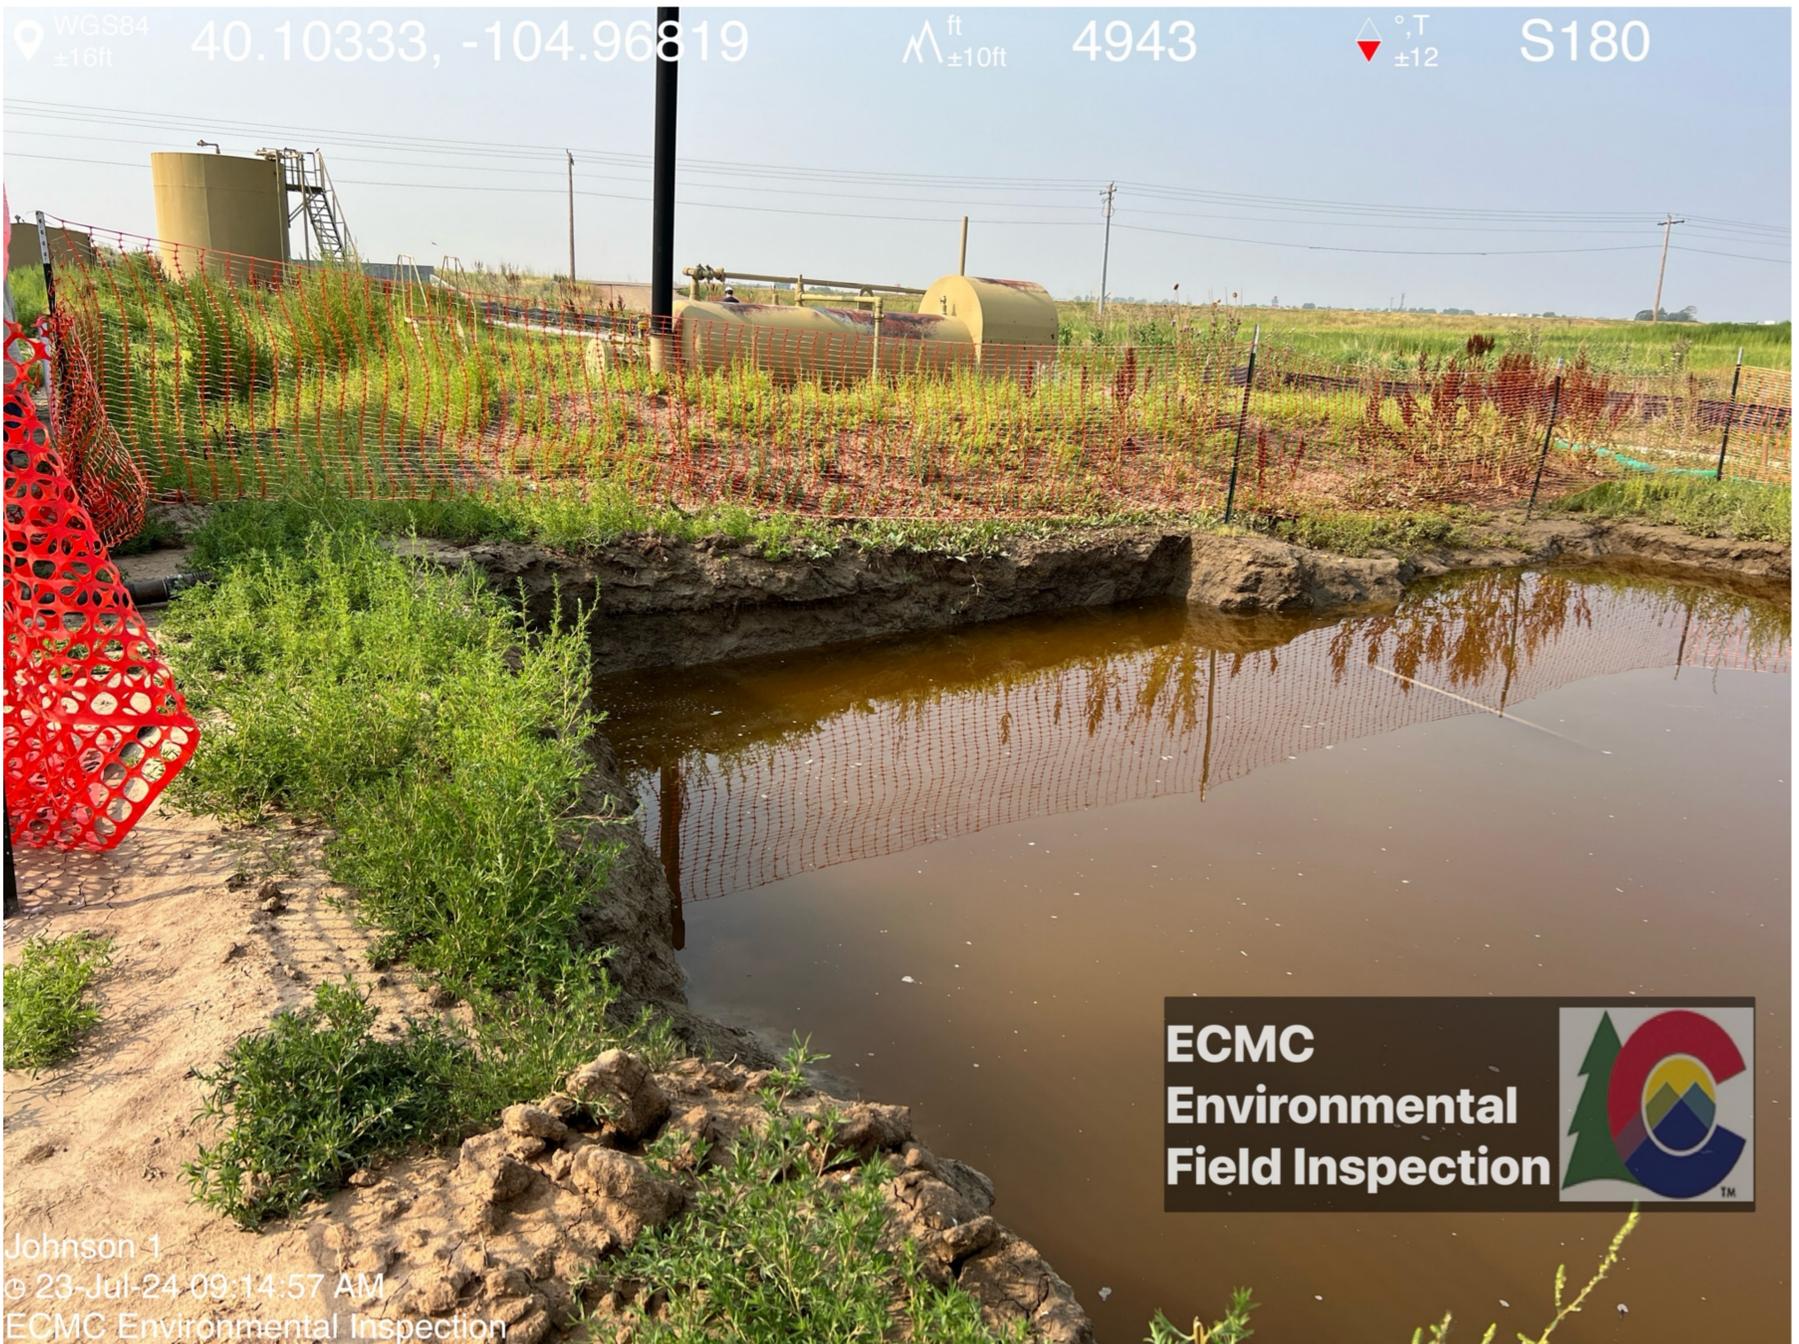
Excavation filled with surface and groundwater; note flowline bend visible in excavation, field personnel indicated additional repairs will be conducted once excavation drawn down.

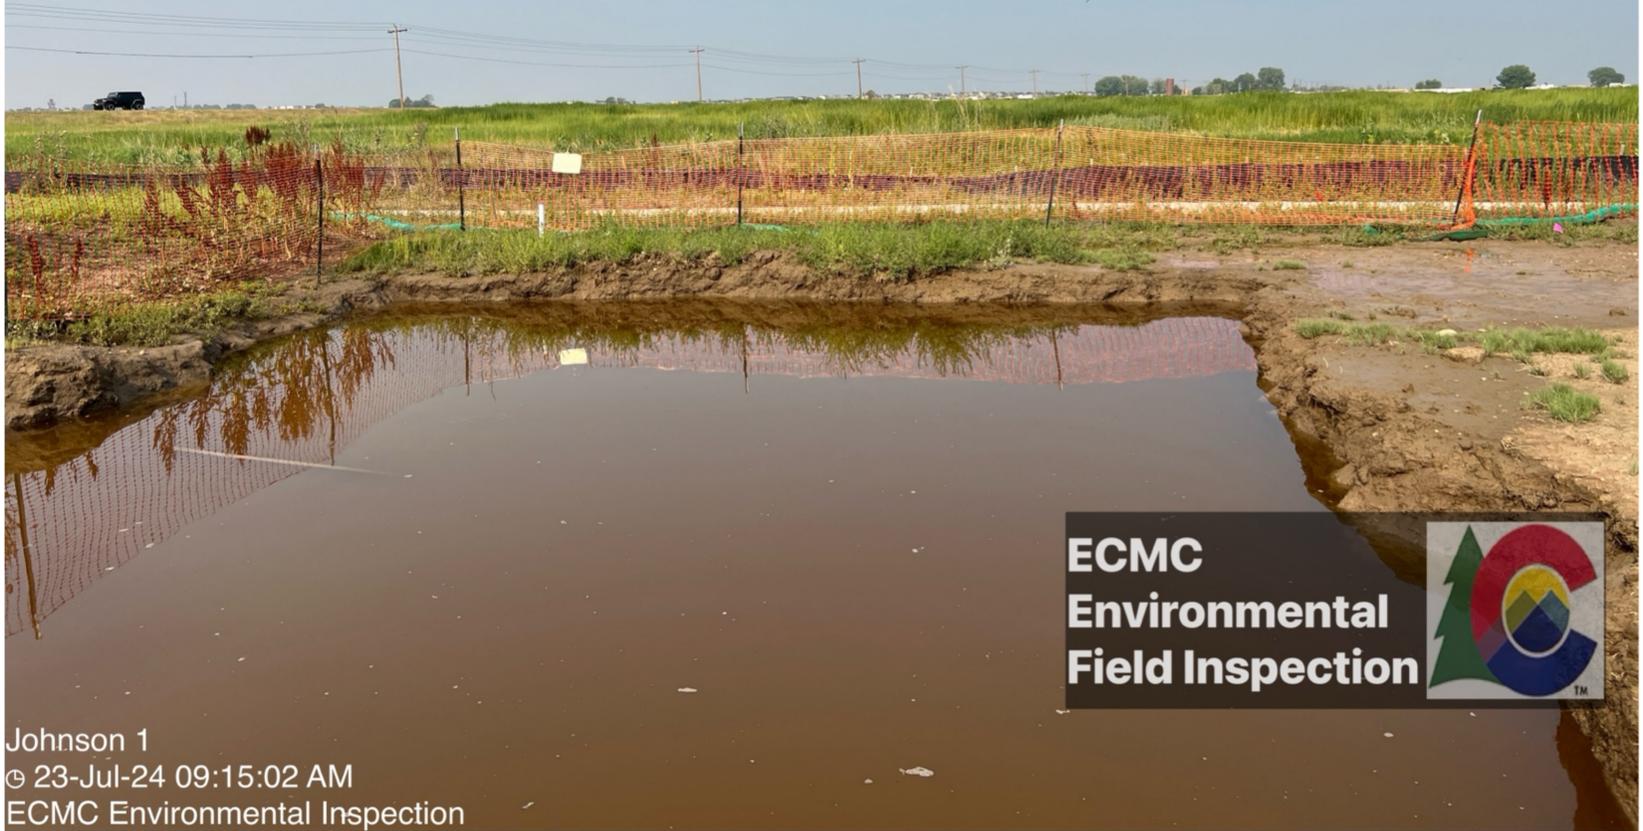
Excavation filled with surface and groundwater; note flowline bend visible in excavation, field personnel indicated additional repairs will be conducted once excavation drawn down.

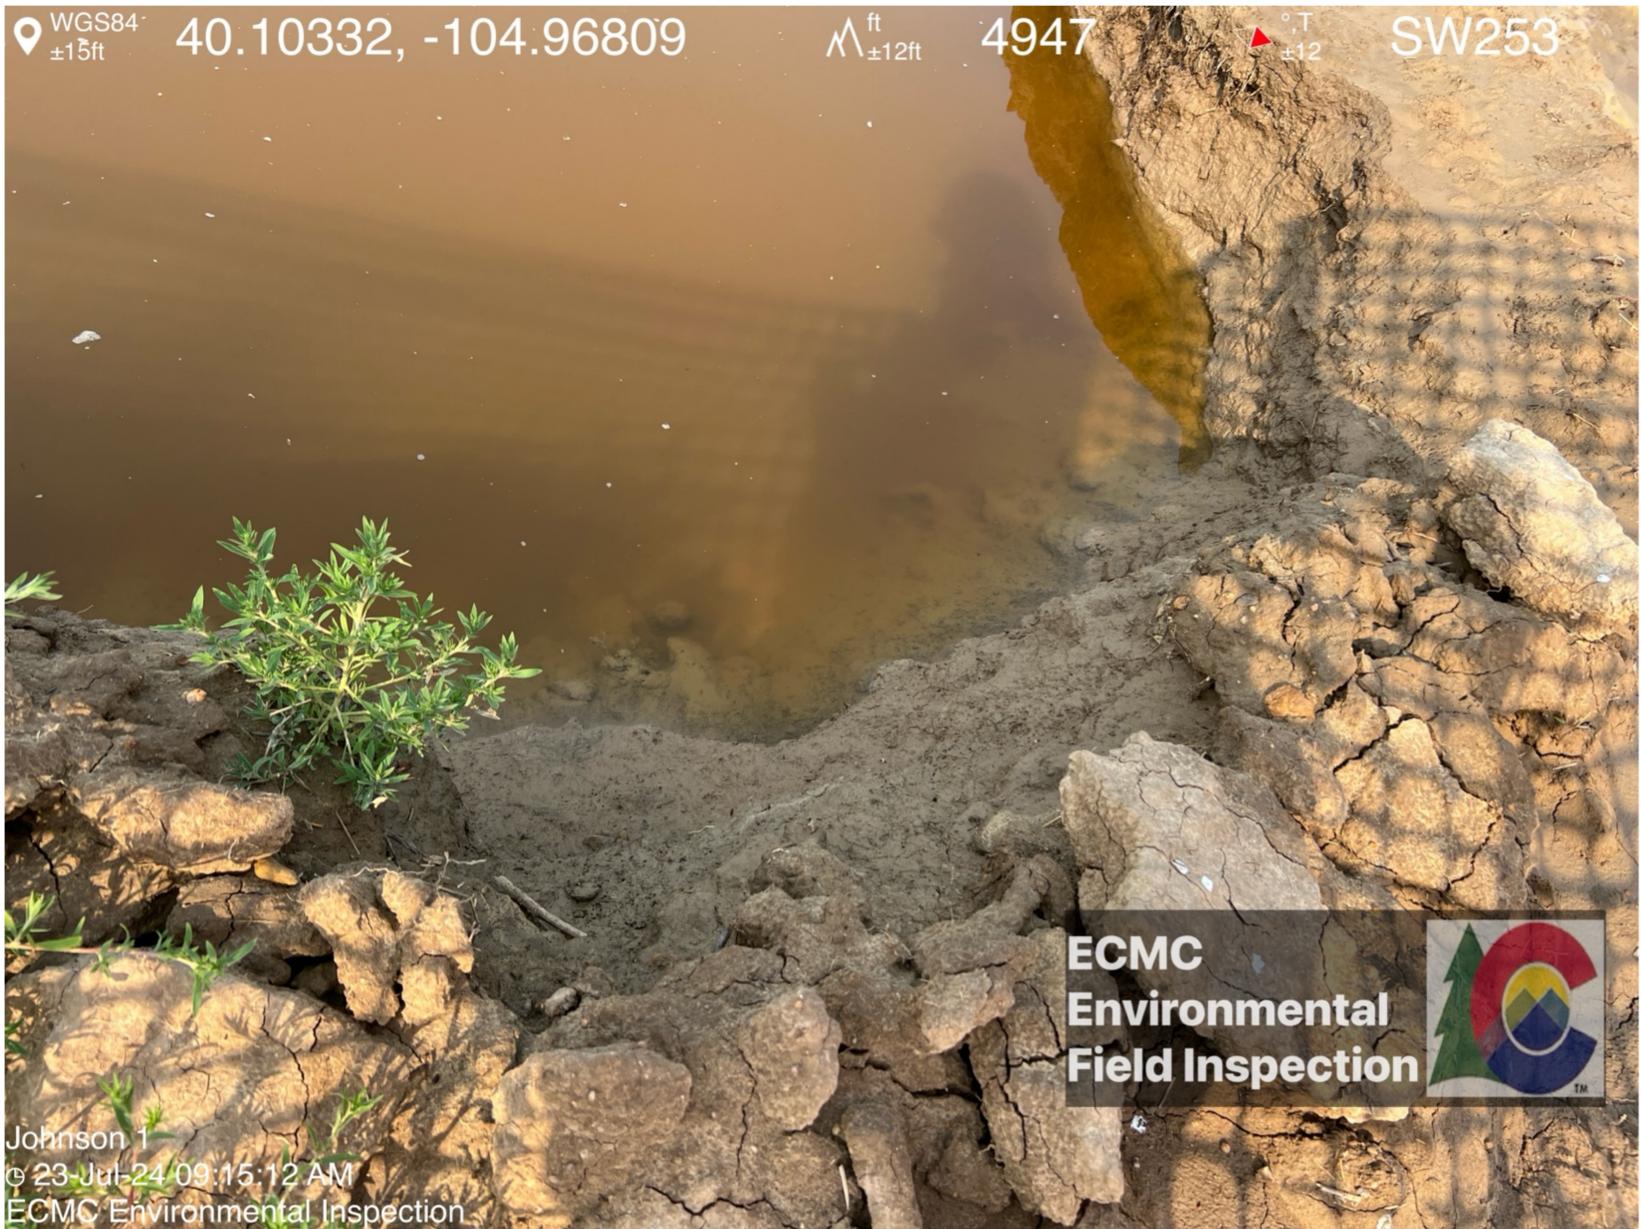
Weed growth on sidewall of excavation
