Inspection Photos

Location Name: TEP ROCKY MOUNTAIN LLC DEVER C Pad

Location #: 335551

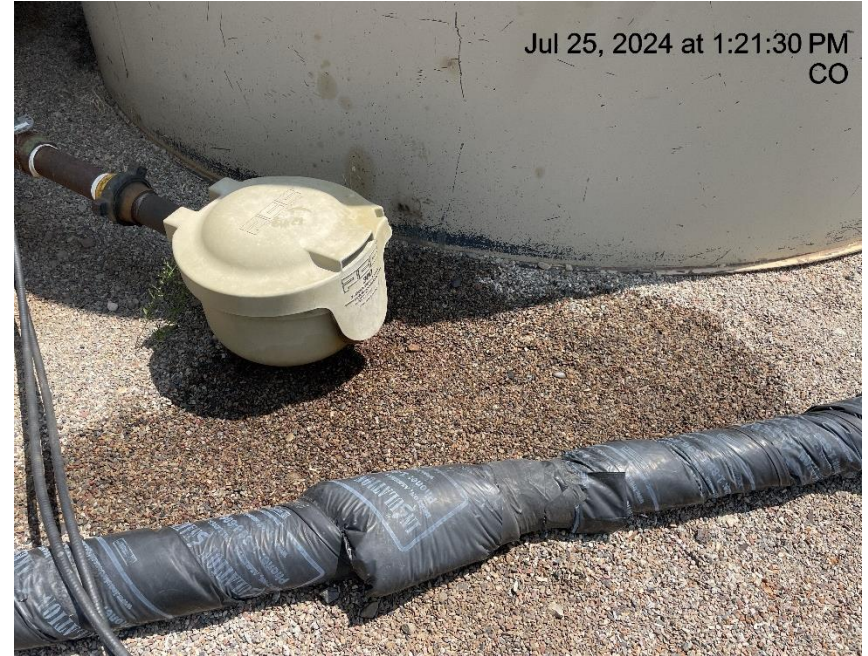
Photo # 3331 Mechanical Condition - Possible leak on load line & staining in secondary containment

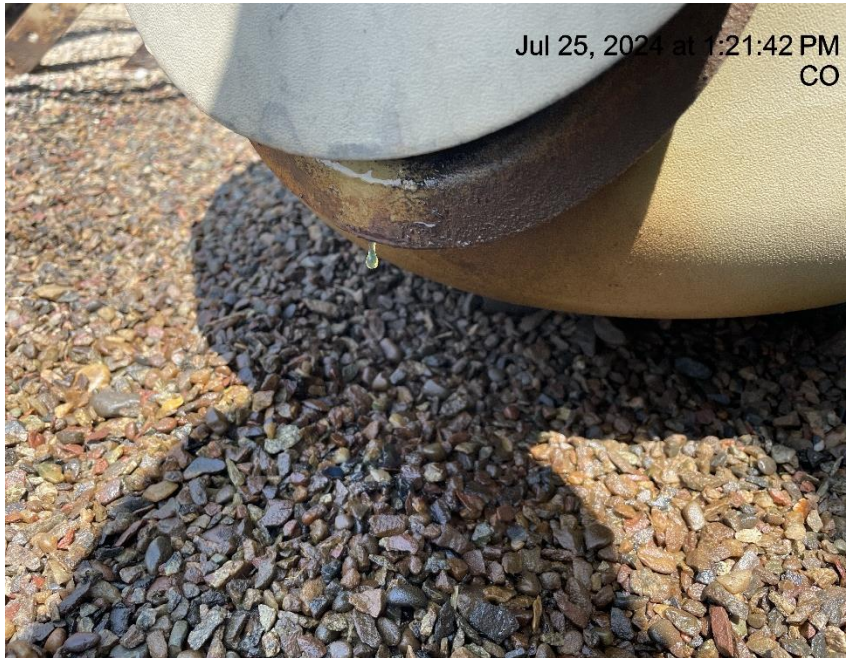
Photo # 3332 Mechanical Condition - Possible leak on load line for production tank

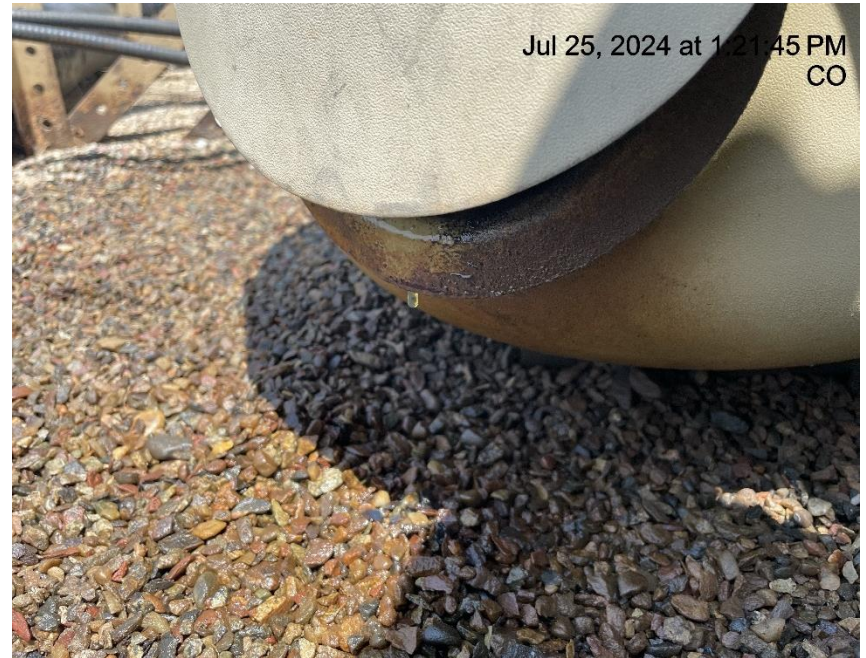
Photo # 3333 Mechanical Condition - Possible leak on load line for production tank

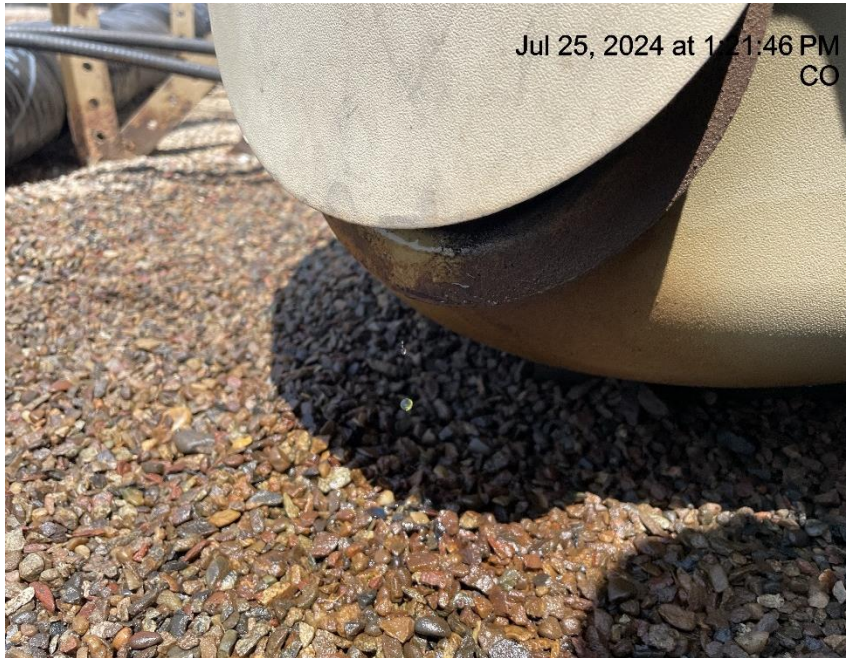
Photo # 3334 Mechanical Condition - Possible leak on load line for production tank

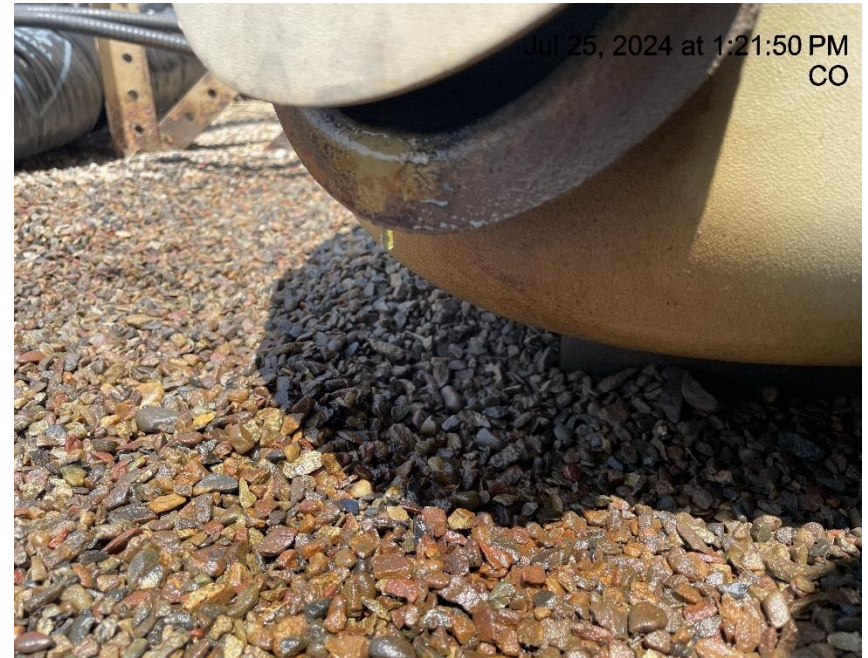
Photo # 3335 Mechanical Condition - Possible leak on load line for production tank

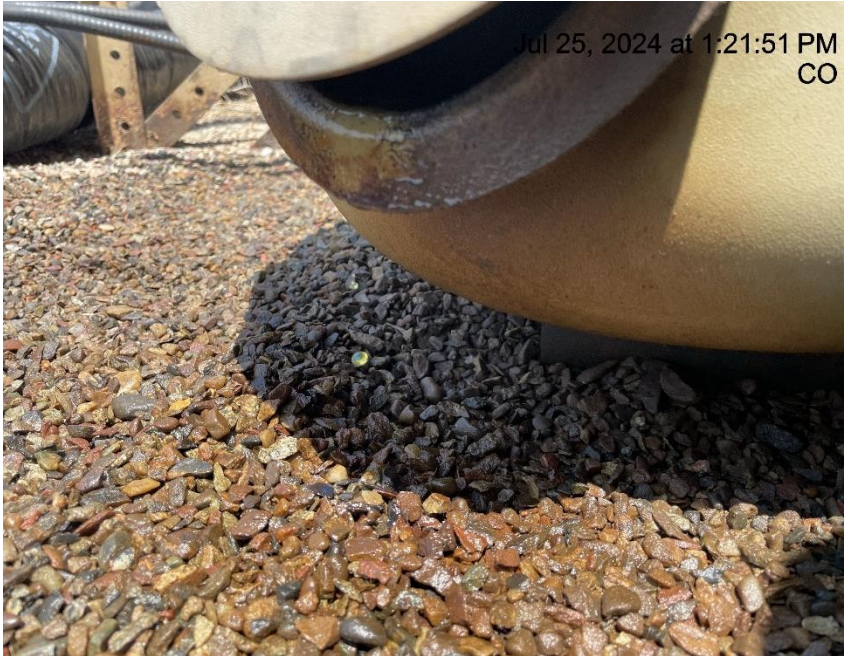
Photo # 3336 Mechanical Condition - Possible leak on load line for production tank

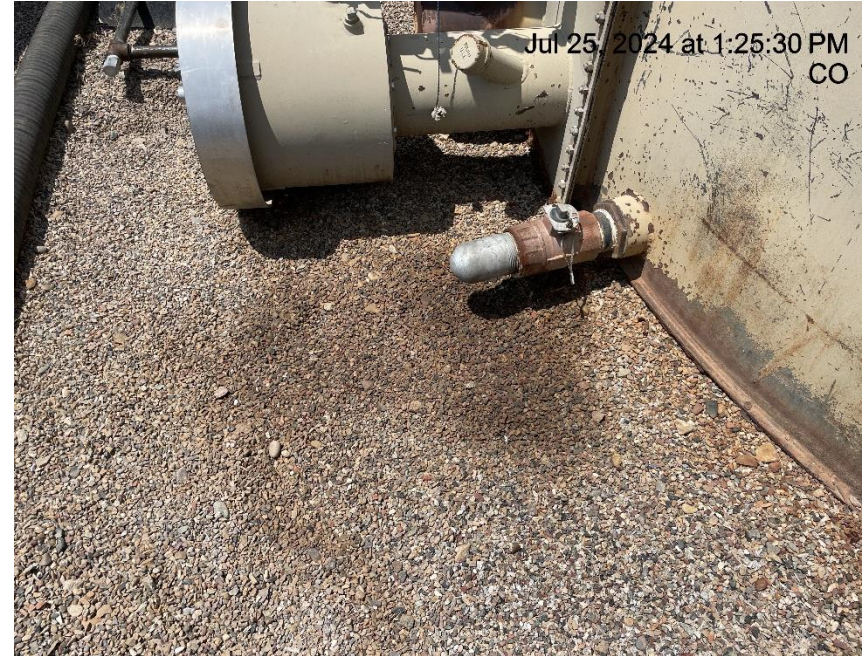
Photo # 3337 Staining in secondary containment

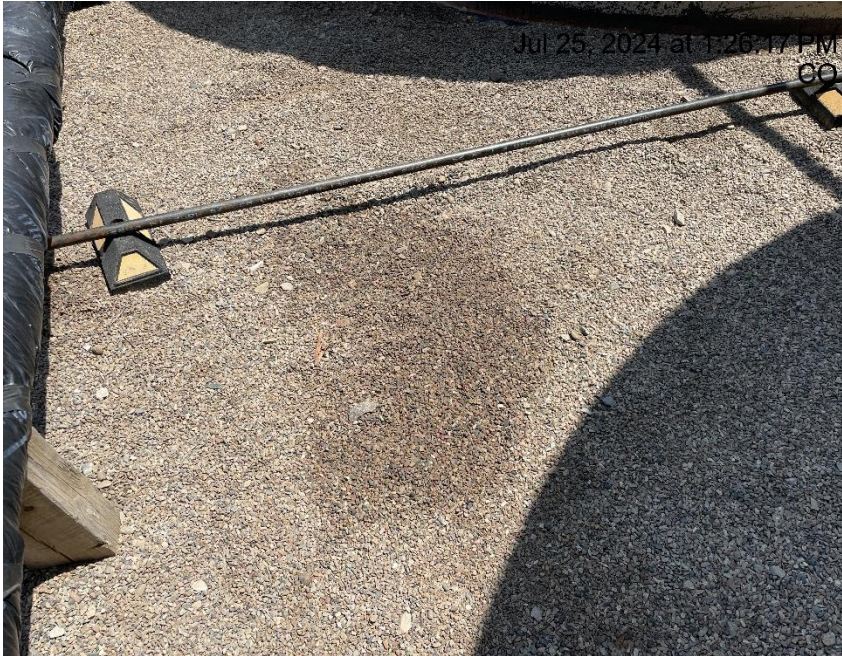
Photo # 3338 Staining in secondary containment

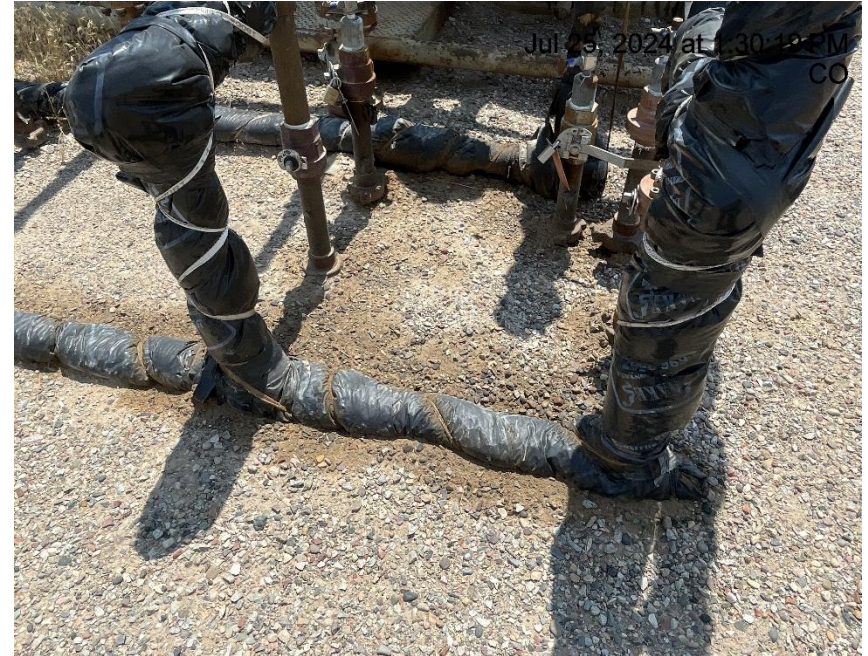
Photo # 3339 Staining near production unit

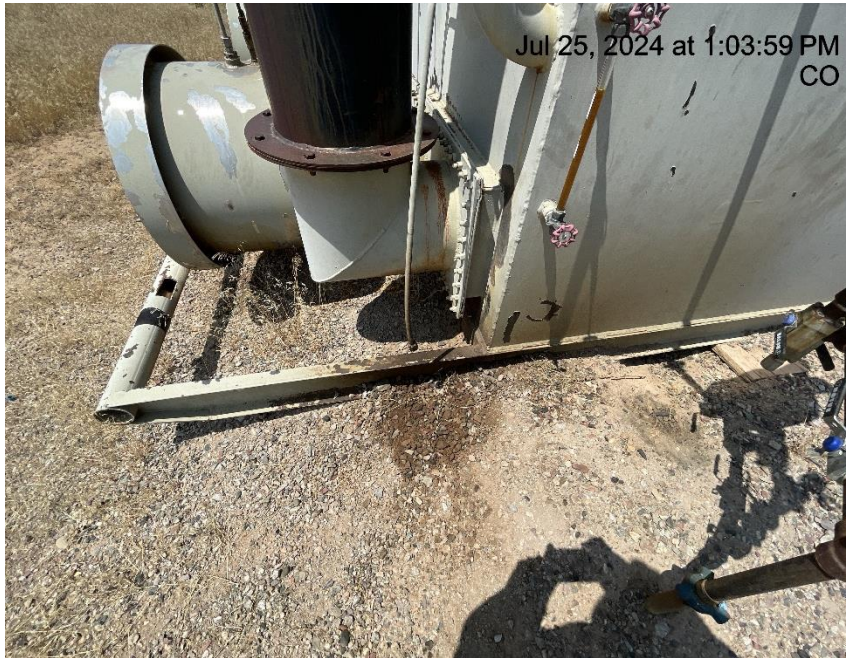
Photo # 3340 Staining near production unit

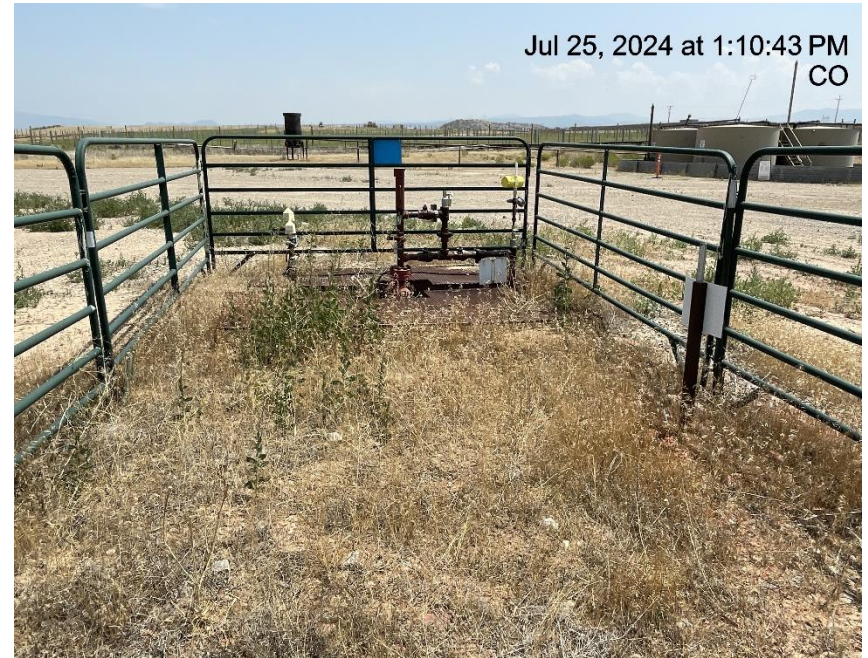
Photo # 3341 Dead weeds/debris near wellheads that is causing a fire hazard

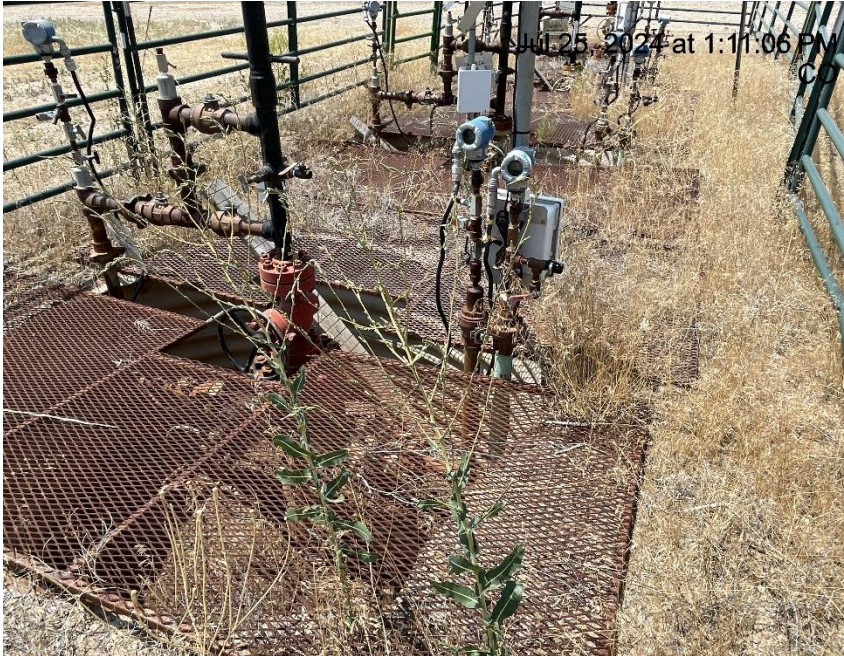
Photo # 3342 Dead weeds/debris near wellheads that is causing a fire hazard

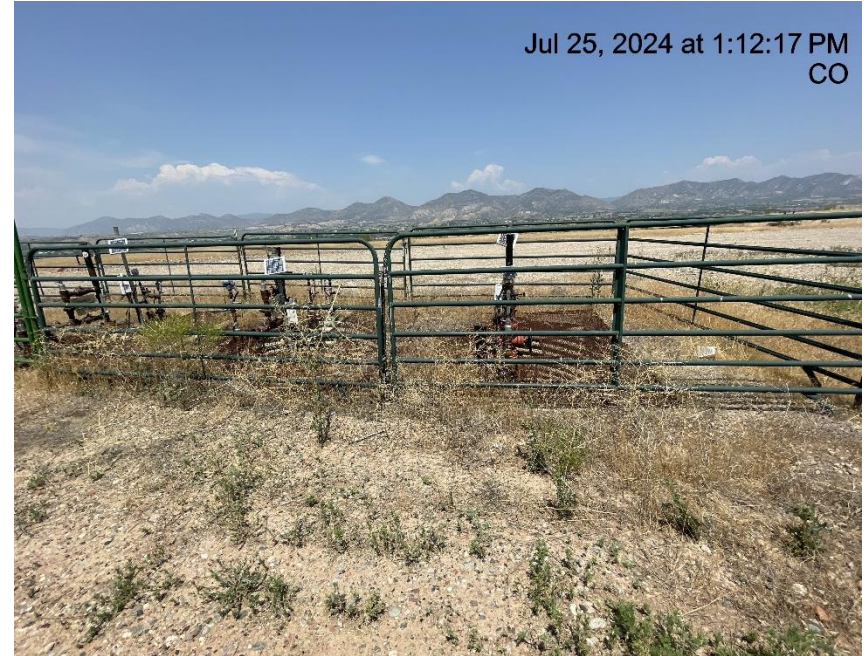
Photo # 3343 Dead weeds/debris near wellheads that is causing a fire hazard

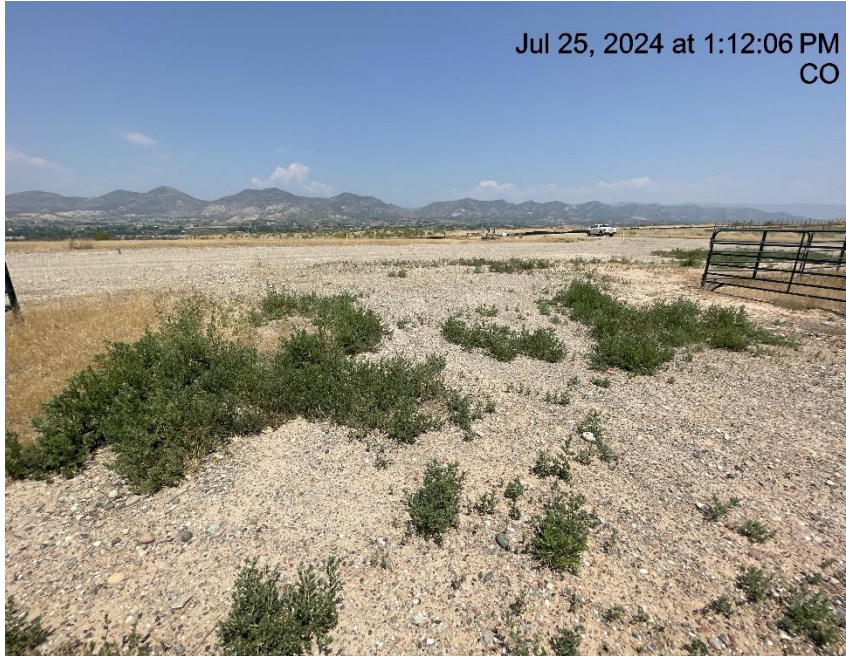
Photo # 3344 Weeds/undesirable plant species on location

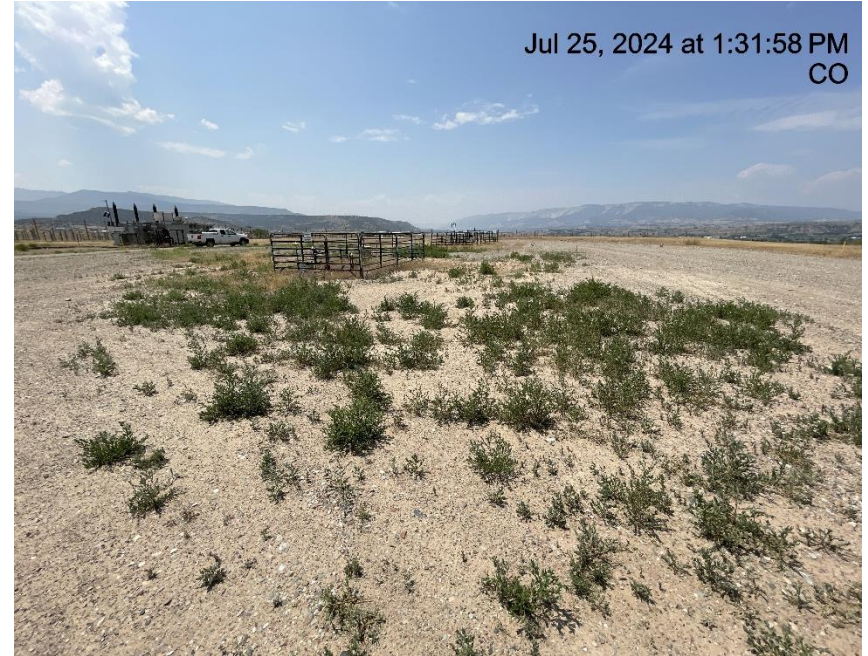
Photo # 3345 Weeds/undesirable plant species on location

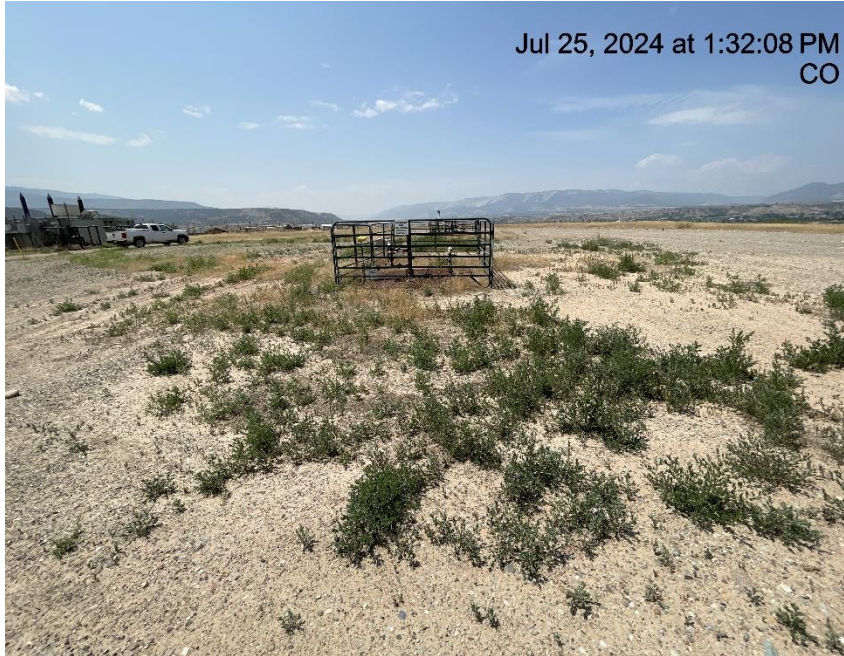
Photo # 3346 Weeds/undesirable plant species on location

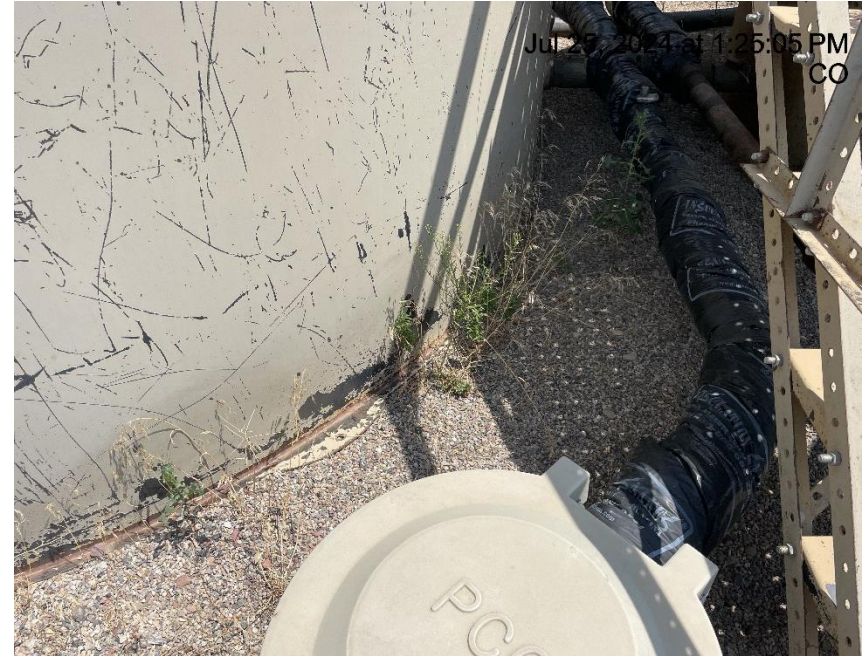
Photo # 3347 Small amount of weeds in secondary containment

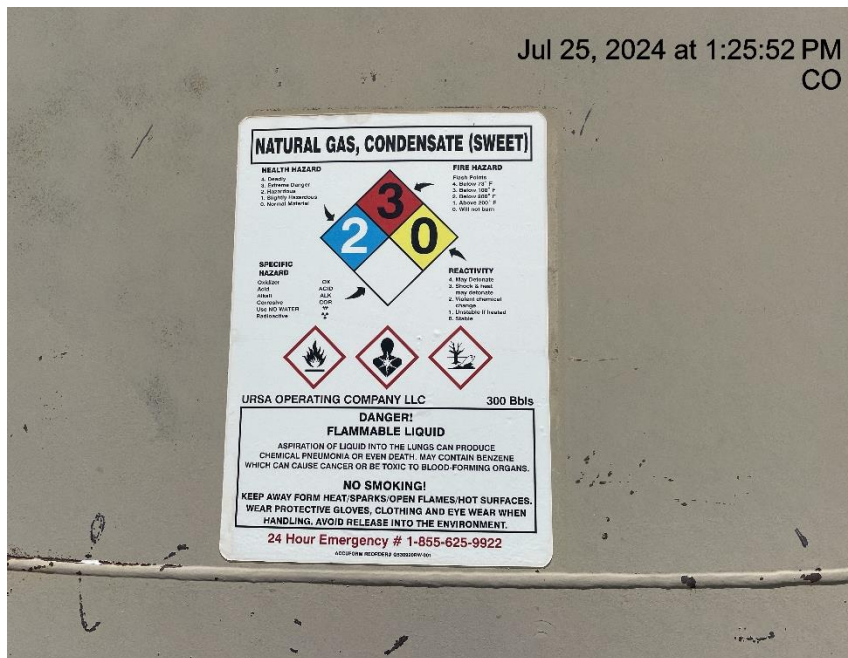
Photo # 3348 Tank label contains inaccurate info/does not comply with CECMC rules

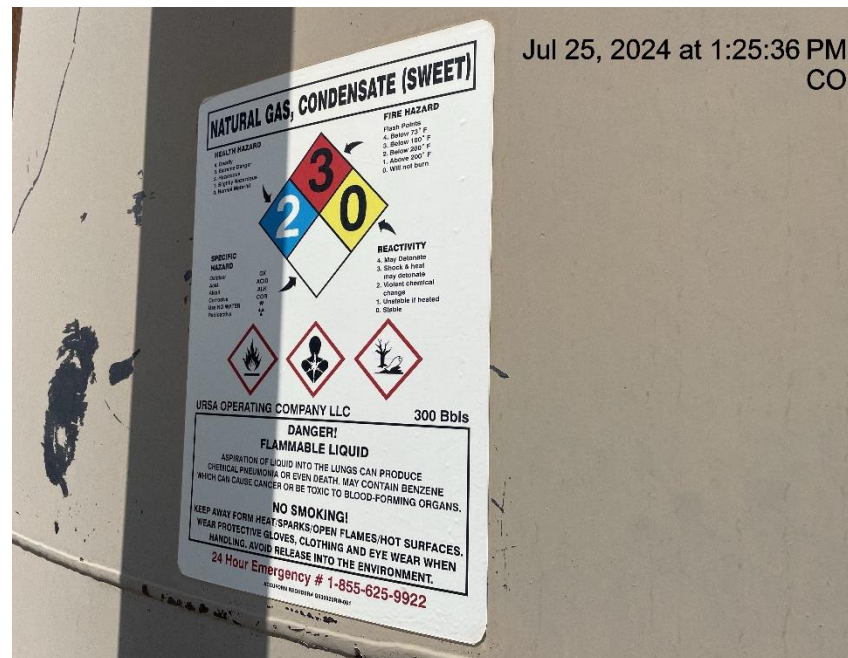
Photo # 3349 Tank label contains inaccurate info/does not comply with CECMC rules

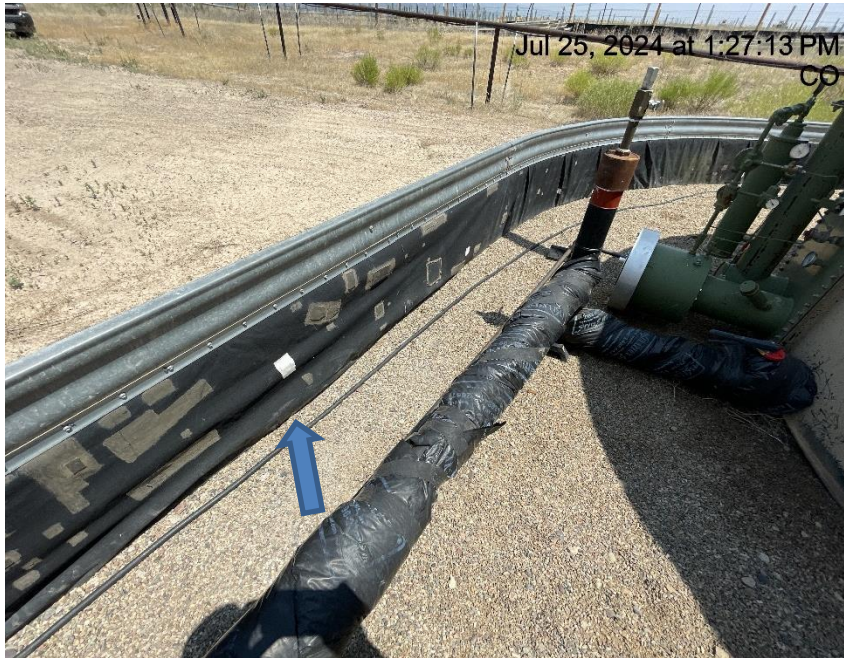
Photo # 3350 Hole in liner/liner needs maintenance

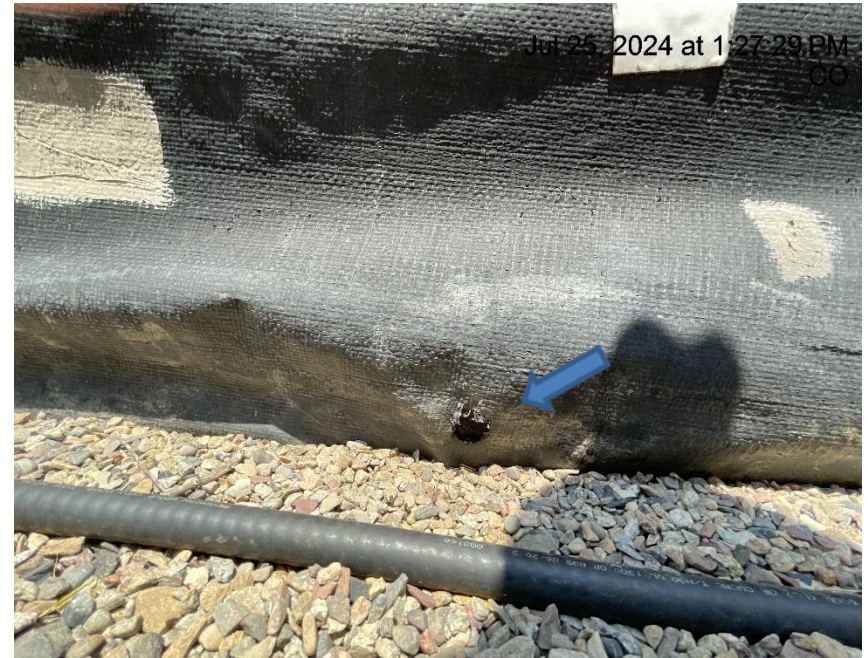
Photo # 3351 Hole in liner/liner needs maintenance

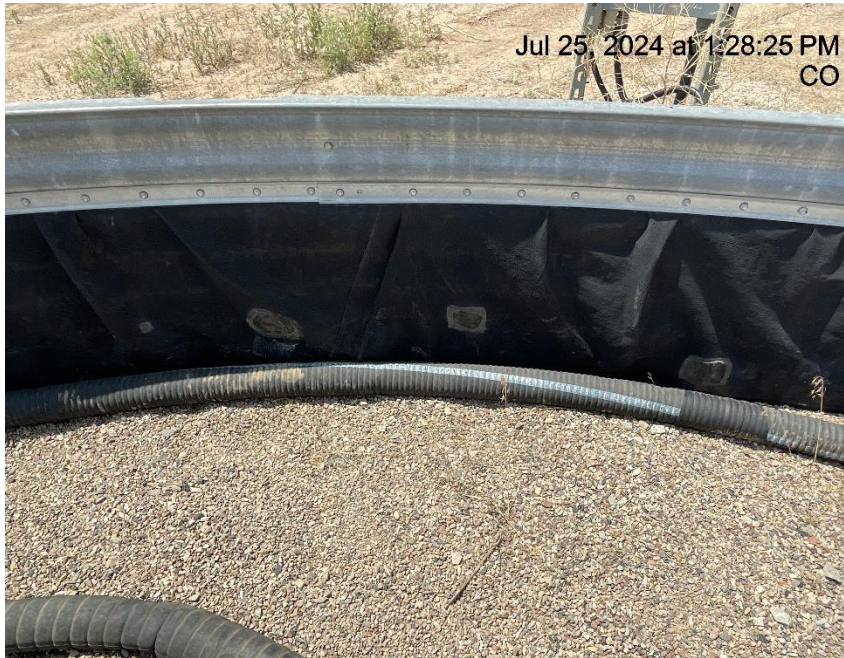
Photo # 3352 Unused hose

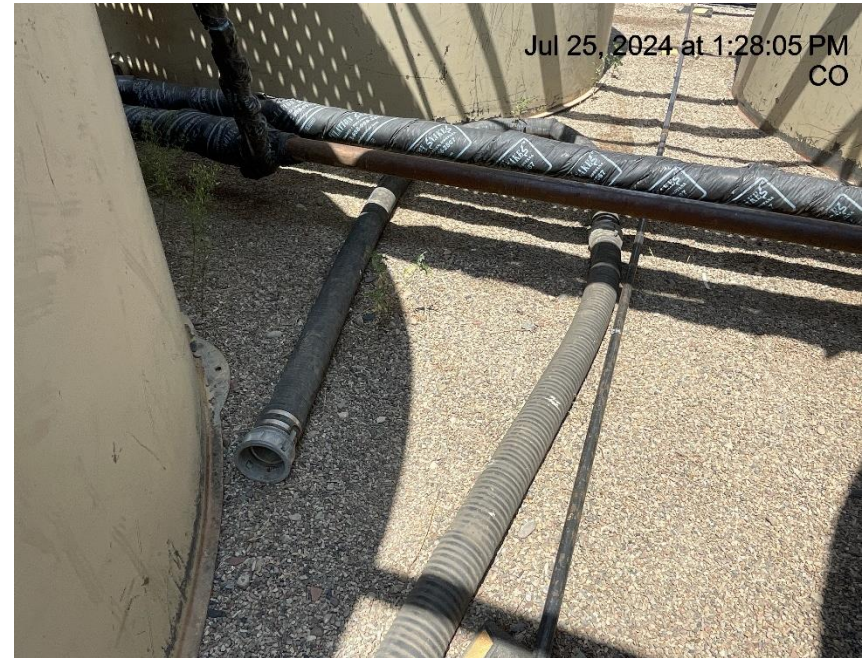
Photo # 3353 Unused hose

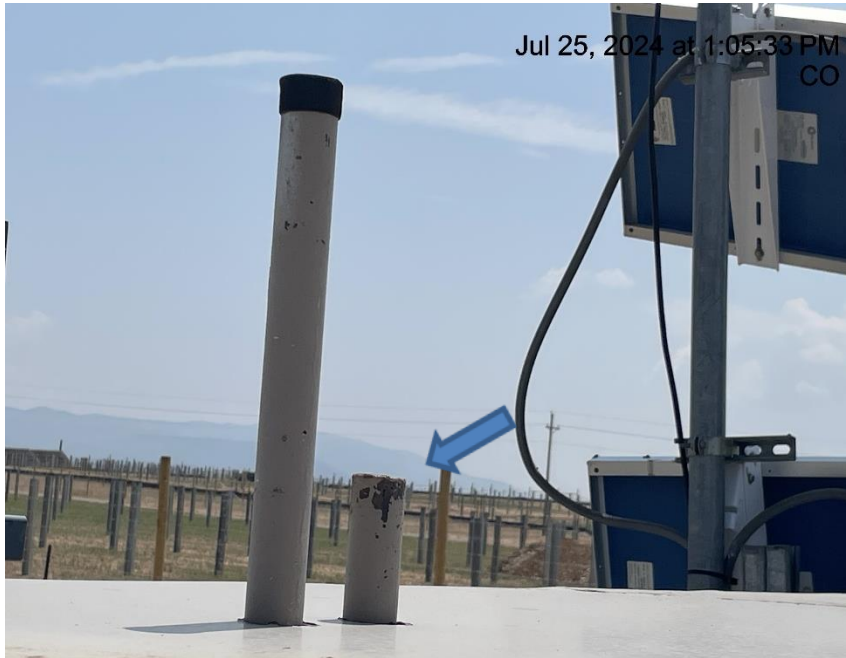
Photo # 3354 PRV vent line does not comply with CECMC pressure safety device rules

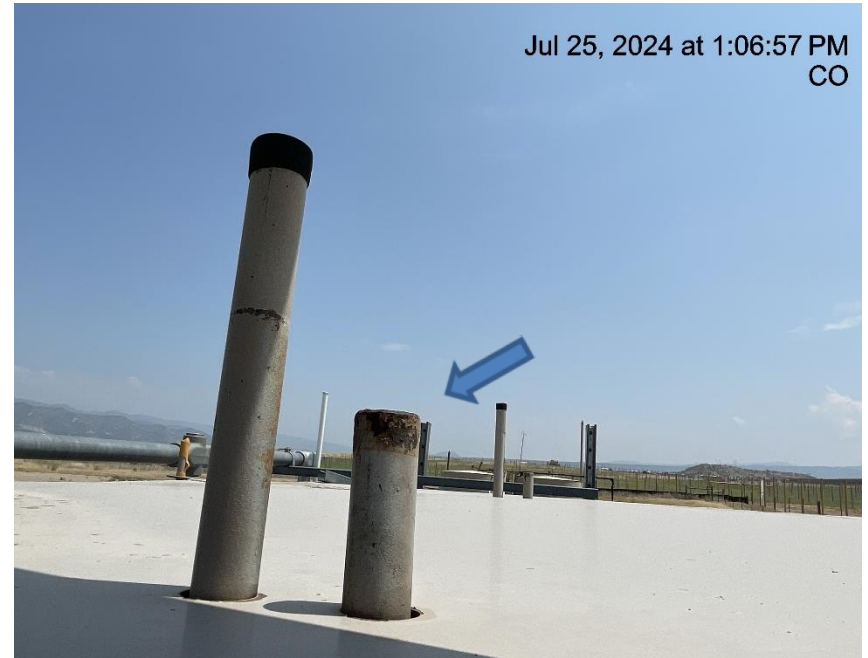
Photo # 3355 PRV vent line does not comply with CECMC pressure safety device rules

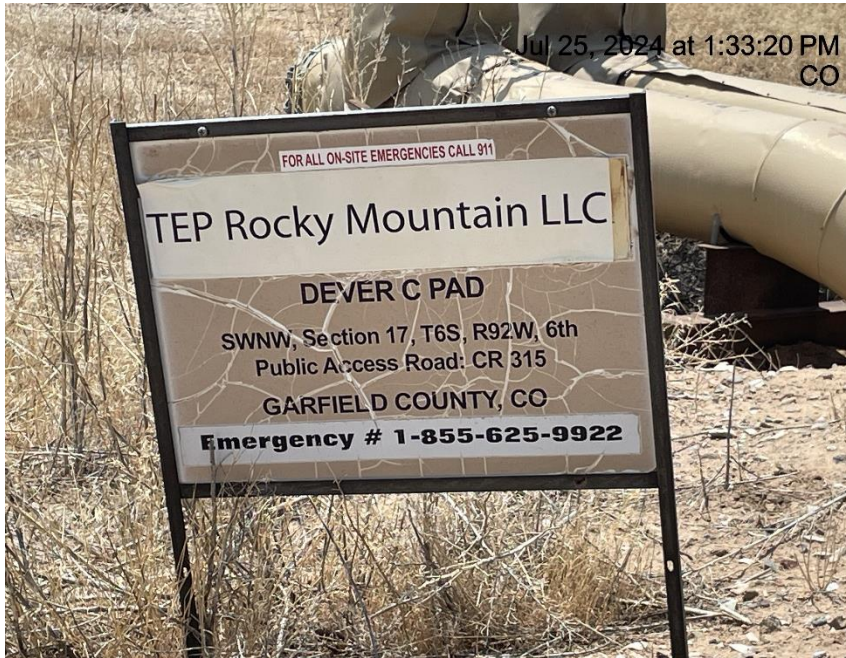
Photo # 3356 Sign at entrance to location has an emergency # that is disconnected/sign does not comply with CECMC signage rules
