Inspection Photos

ID: 478058

Operator: OGRIS OPERATING LLC

Inspection Date: 7/22/2024

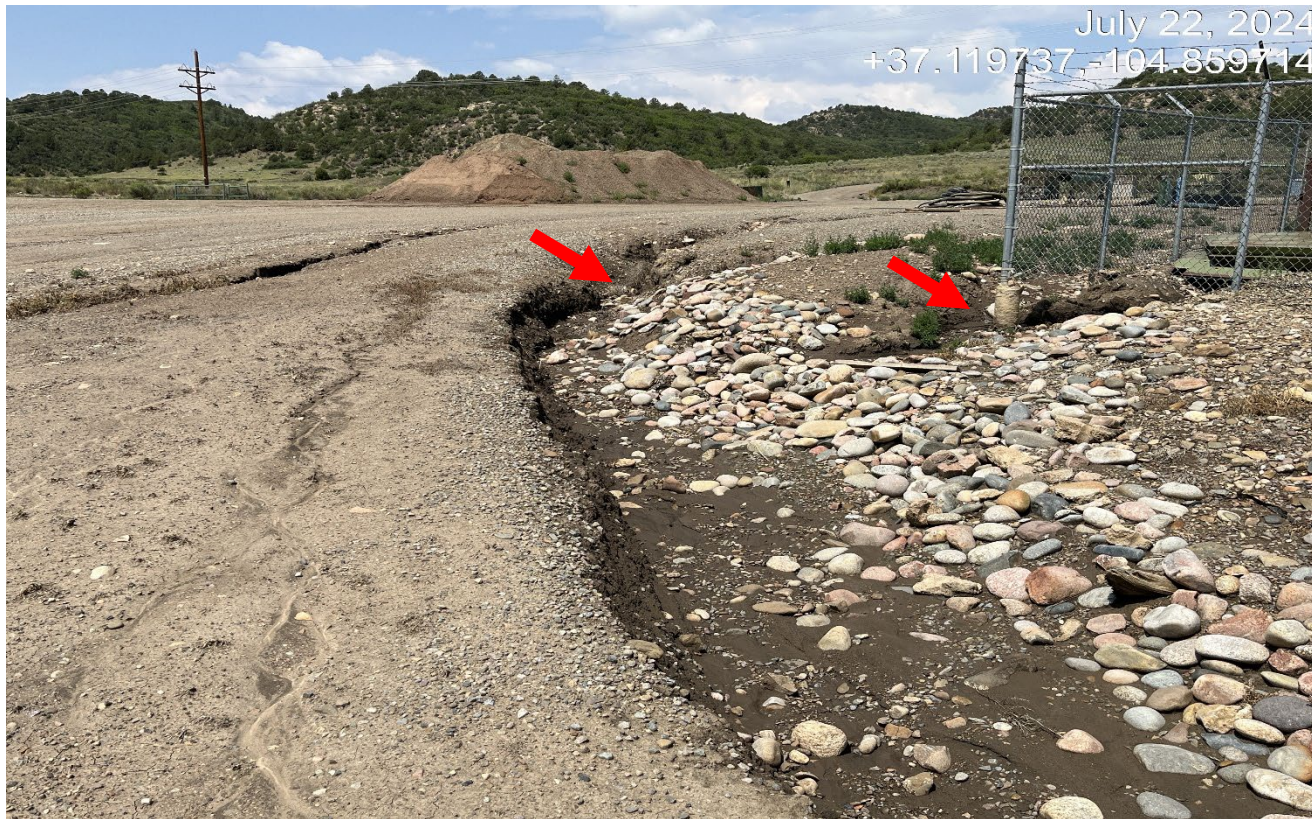
Photo 1. Facing west at the road to the production facility. There is erosion along this area and the round rock has washed out. Angular rock would be better for erosion control..

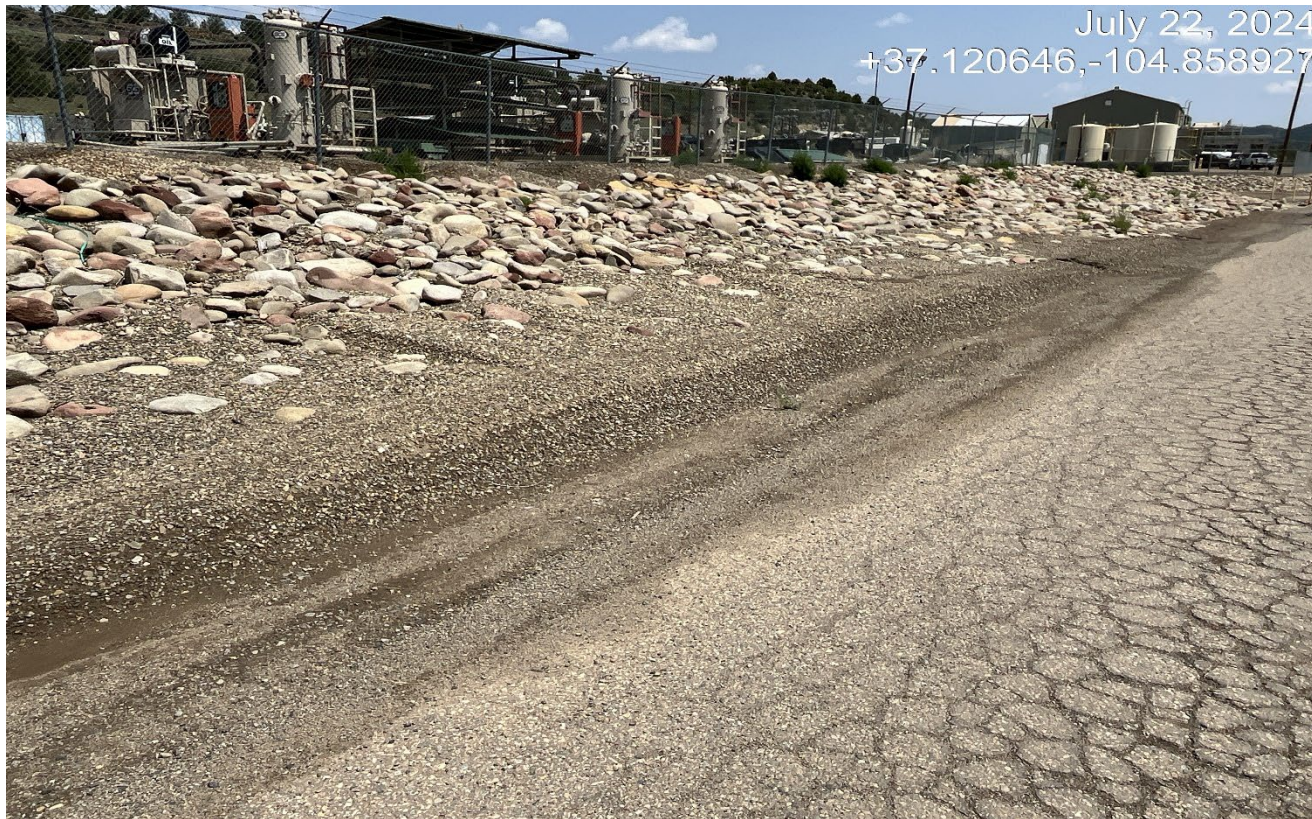
Photo 2. There is sediment that has filled in along the road side from the production facility.

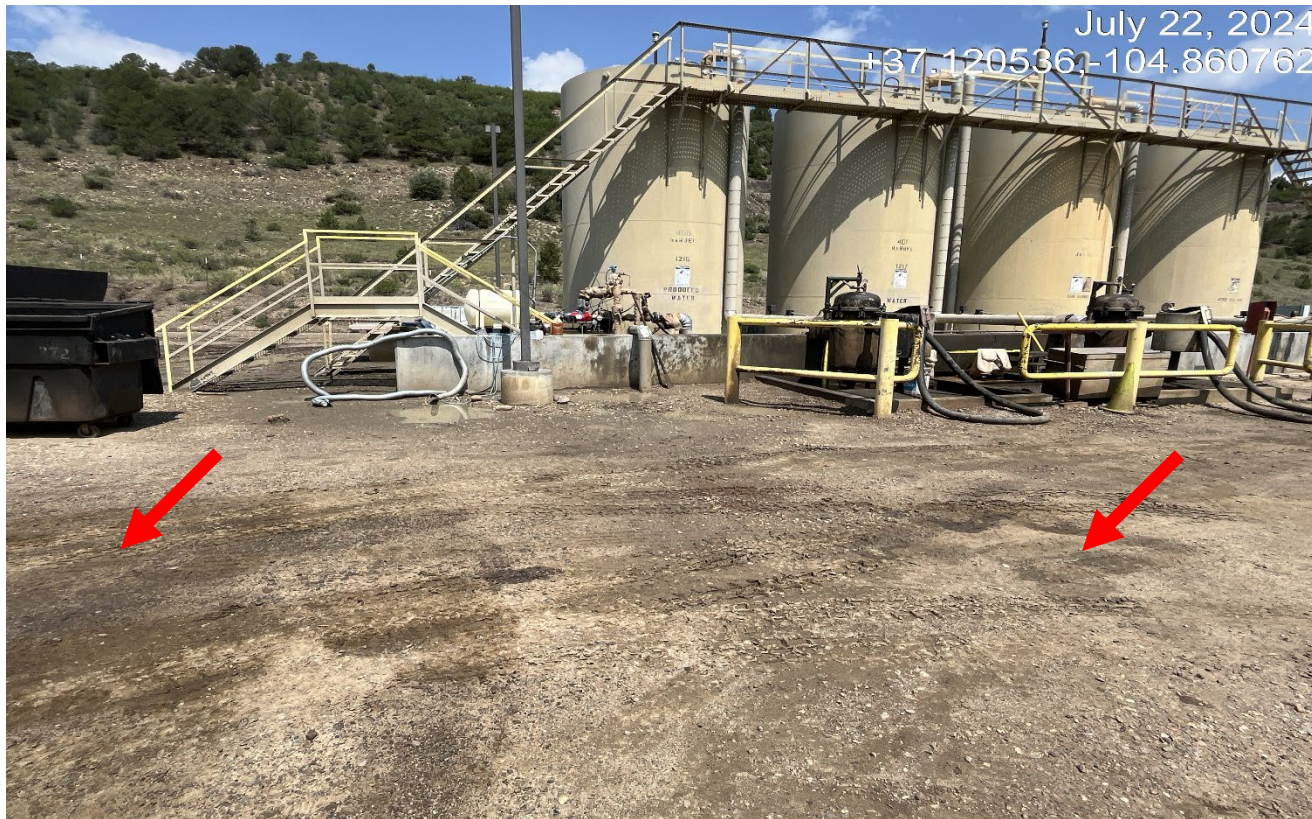
Photo 3. Facing northwest toward the tank battery. There are oil stained soils in this area that must be cleaned up.

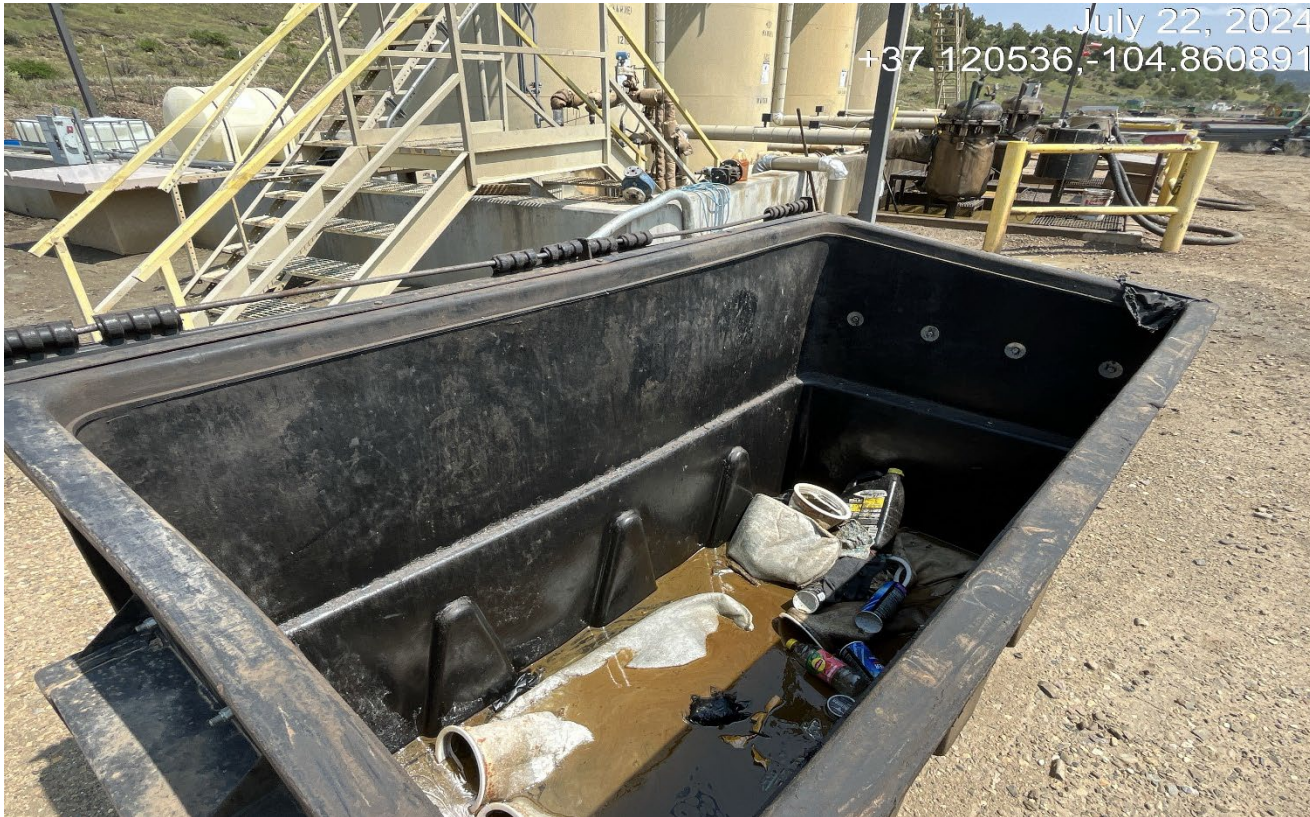
Photo 4. There is oily fluids inside this plastic container which has no netting to prevent wildlife entry.

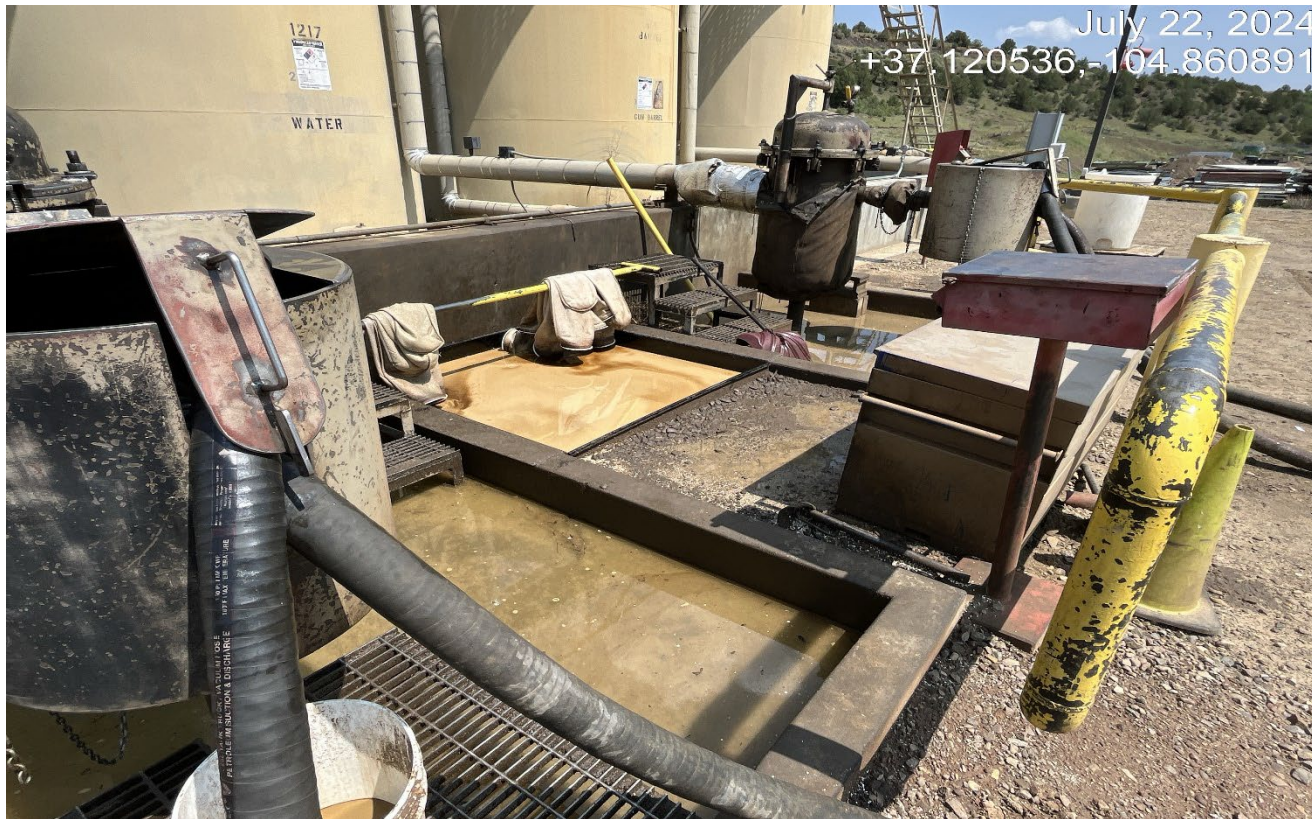
Photo 5. There is oily fluids in the secondary containment that has spilled over onto the ground. Additionally netting must be installed to prevent wildlife entry.

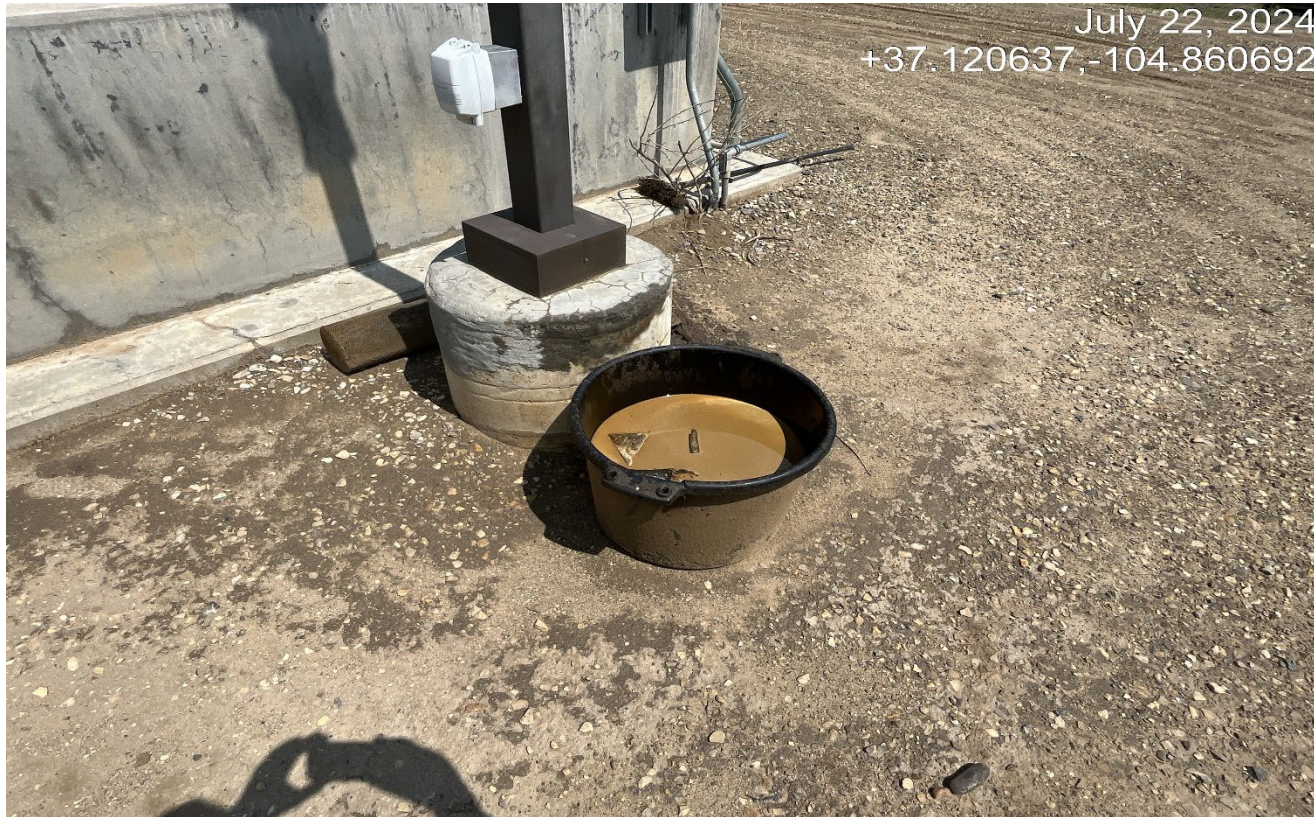
Photo 6. There is a bucket of oily fluid at the northeast side of the tank battery that needs to be disposed and contained in secondary containment with netting.

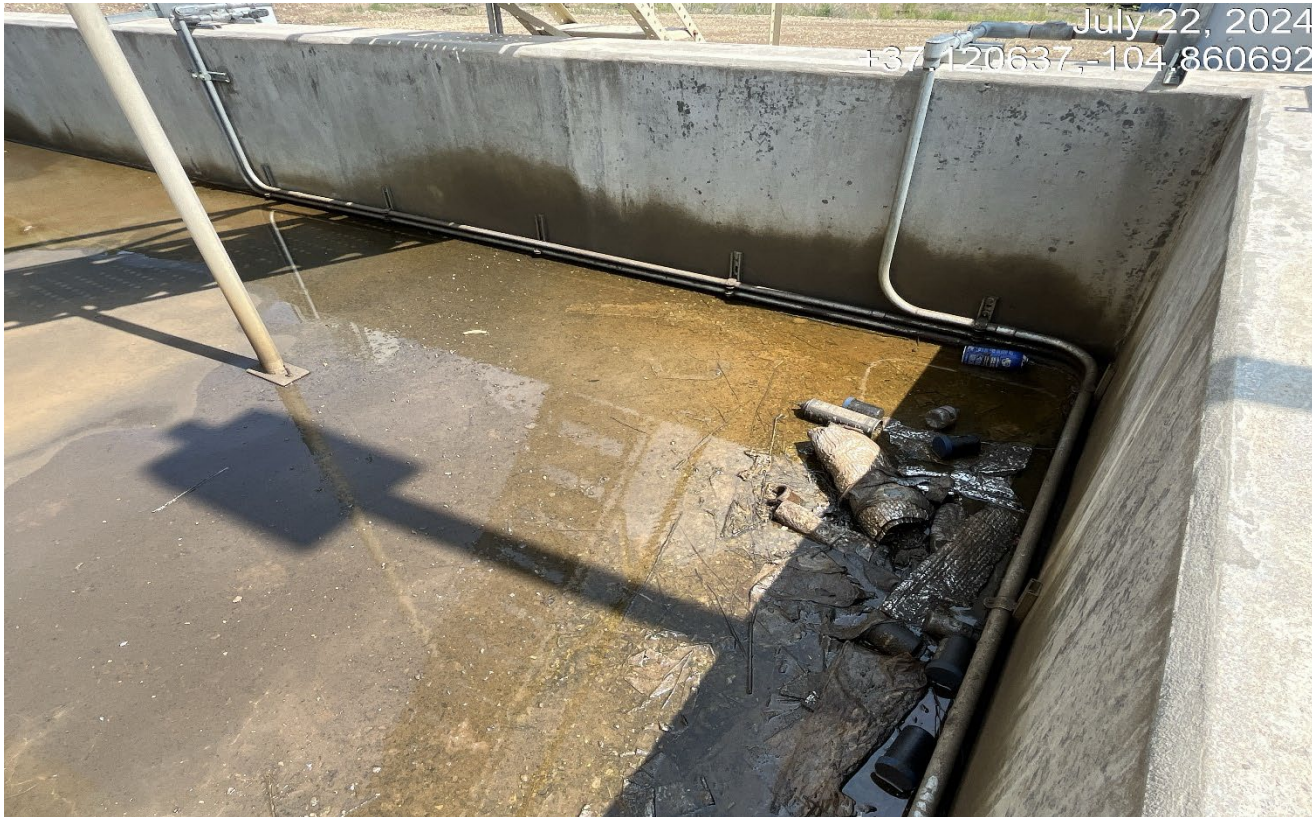
Photo 7. There is trash and empty cans in the containment that need to be disposed.

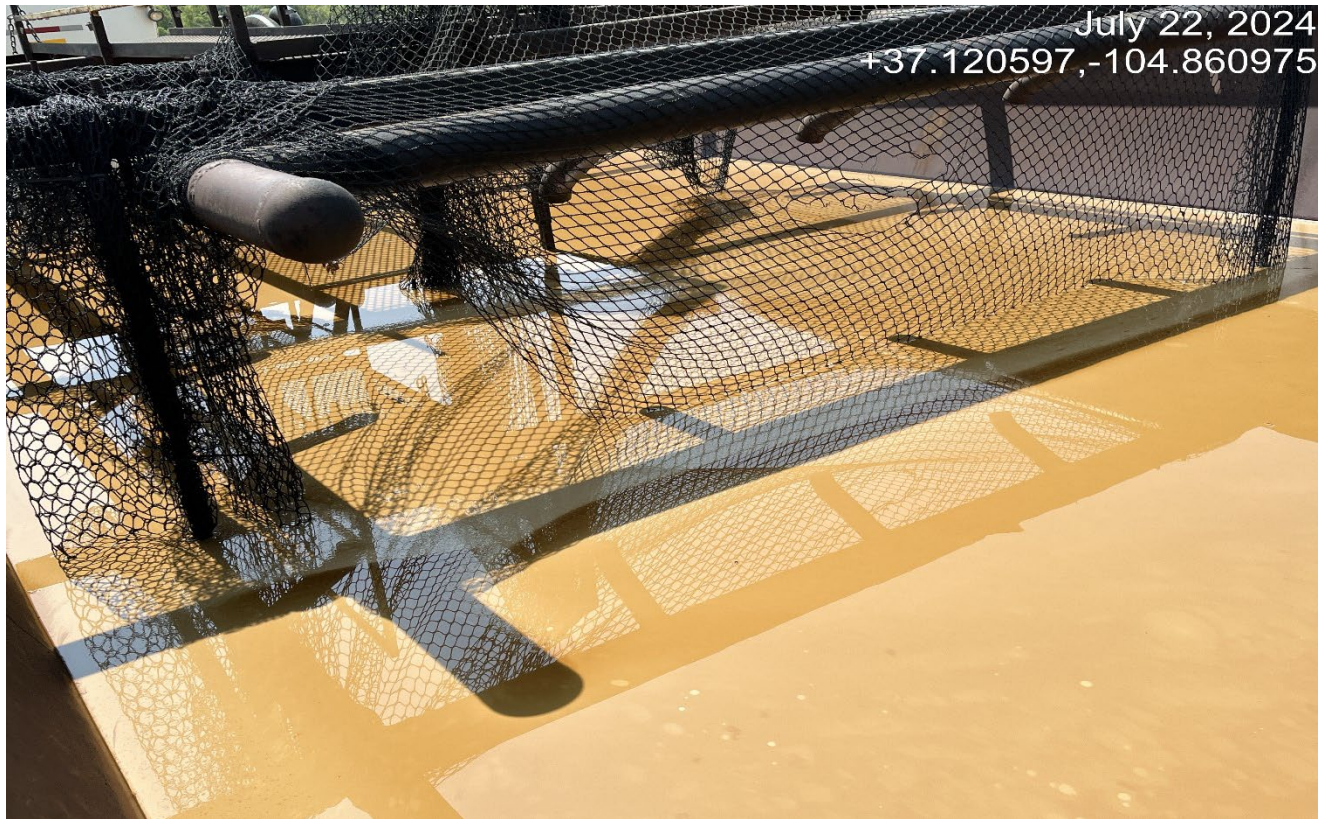
Photo 8. The netting on the open top tank is not maintained.
