# Inspection Photos

ID: 312120

Operator: XTO ENERGY INC

Inspection Date: 7/22/2024

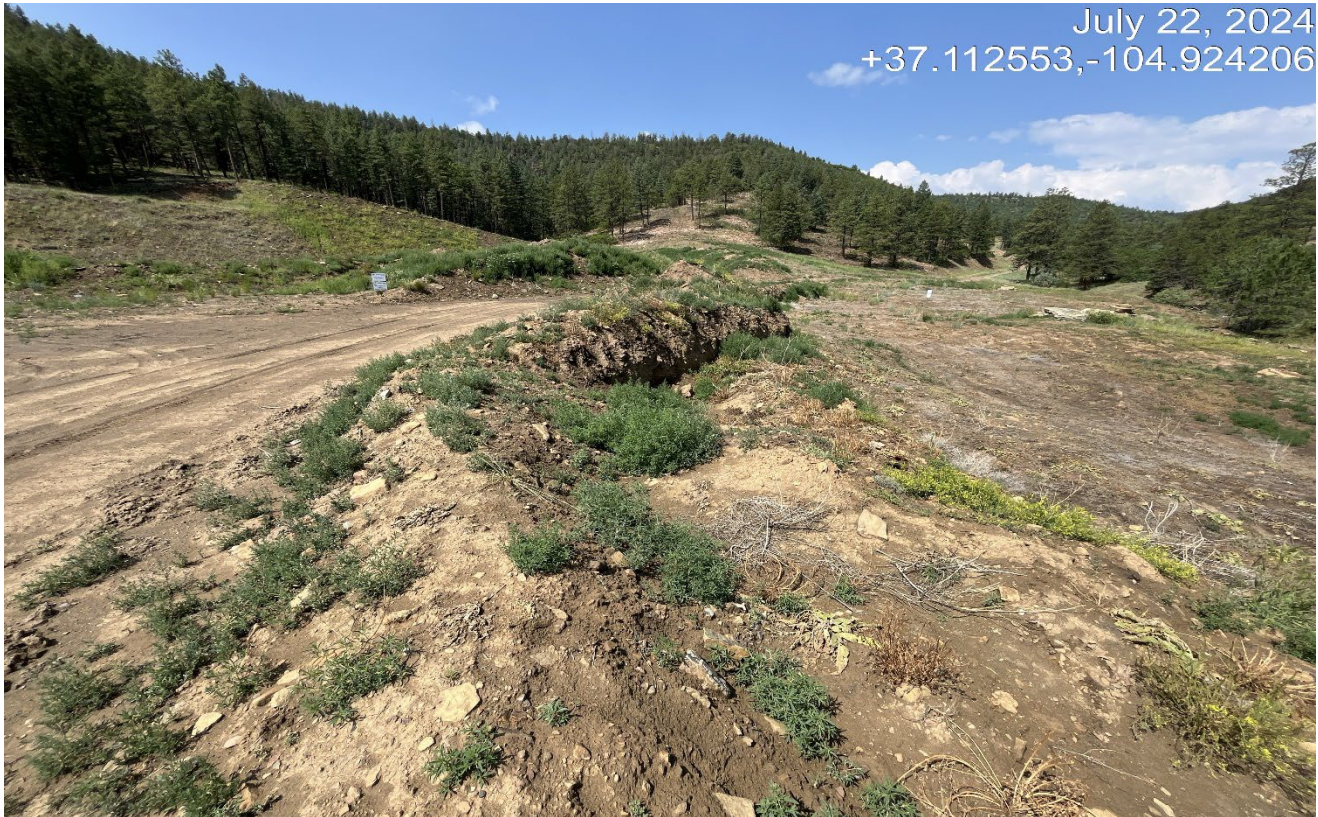
**Photo 1.** Facing west toward the location. The bottom portion of the location needs to be reclaimed with proper recontouring and stabilization.

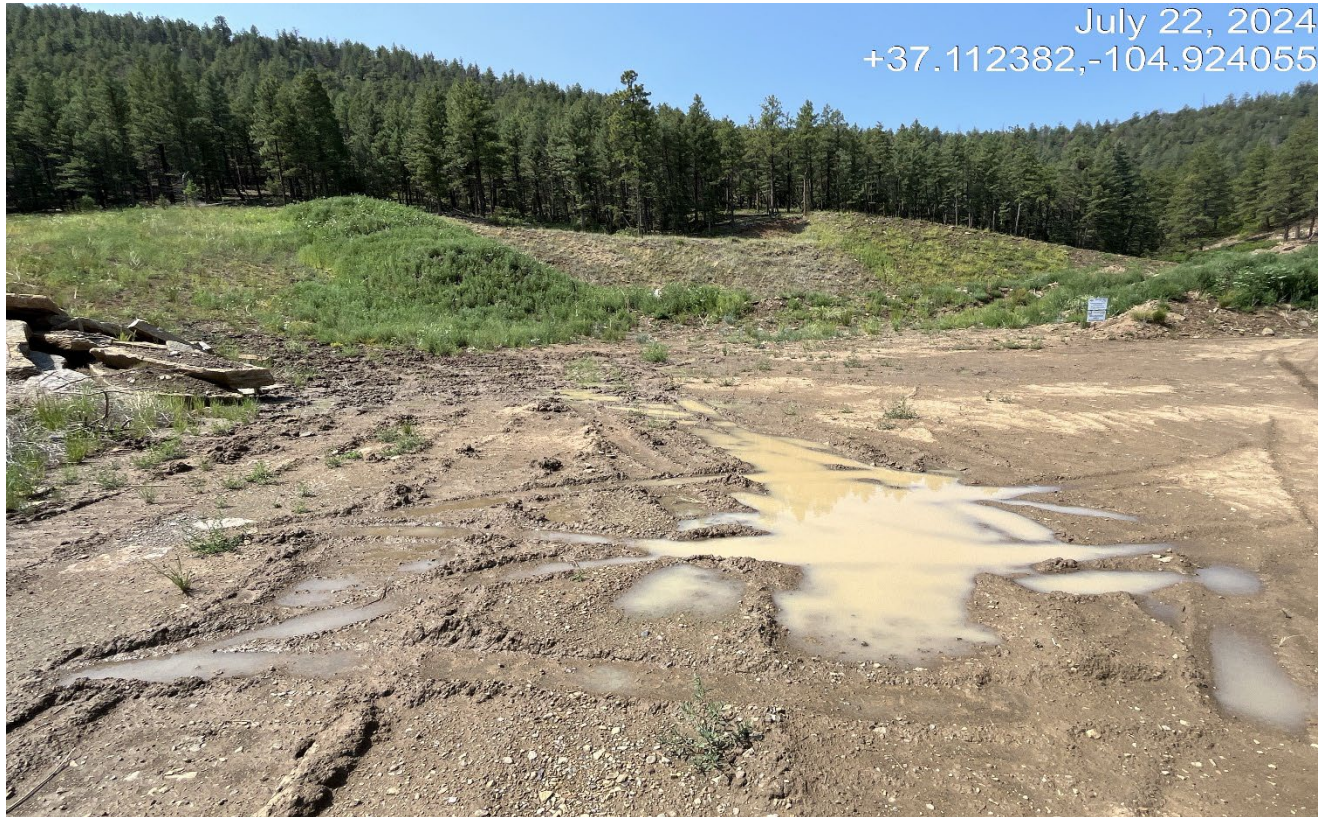
**Photo 2.** Facing southwest at the location.

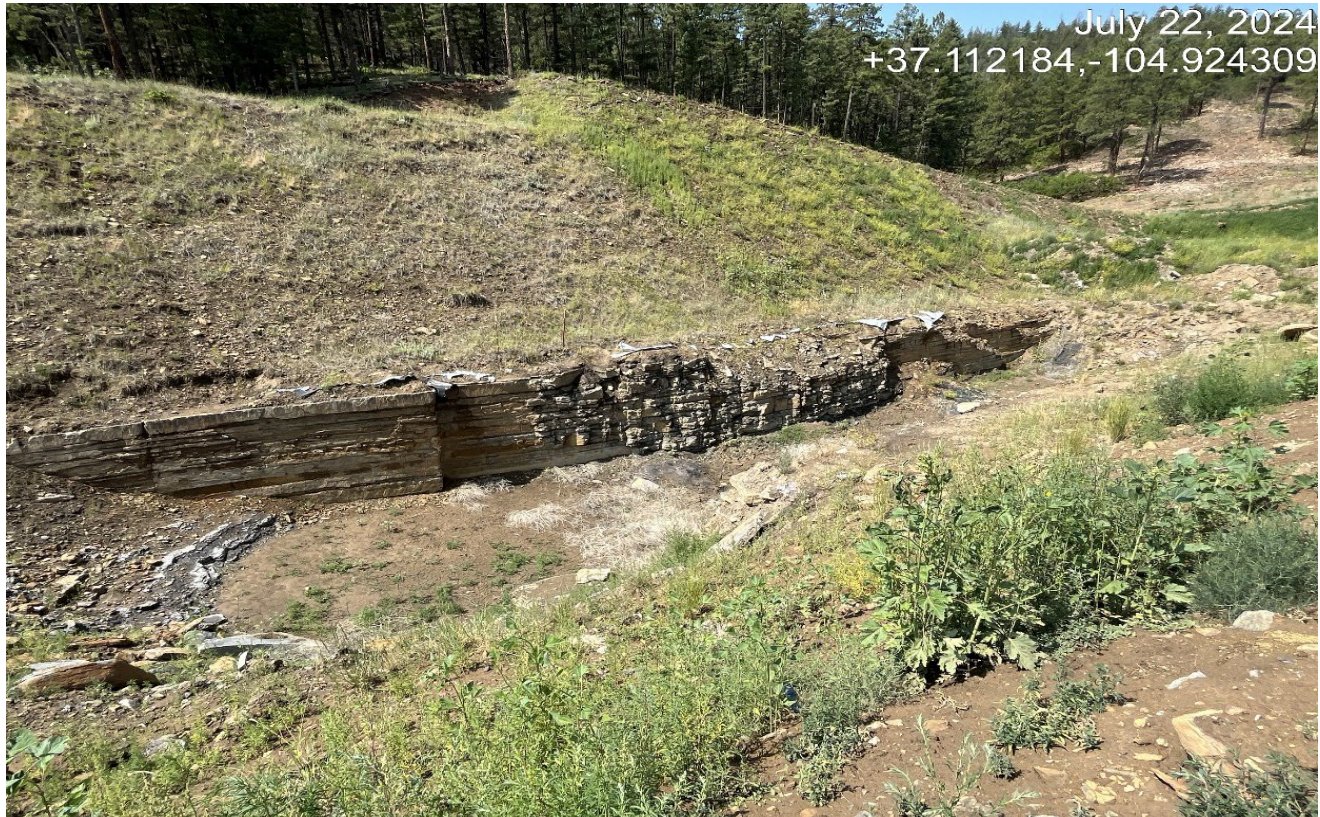
**Photo 3.** Facing toward the open pit which is still in process of remediation.

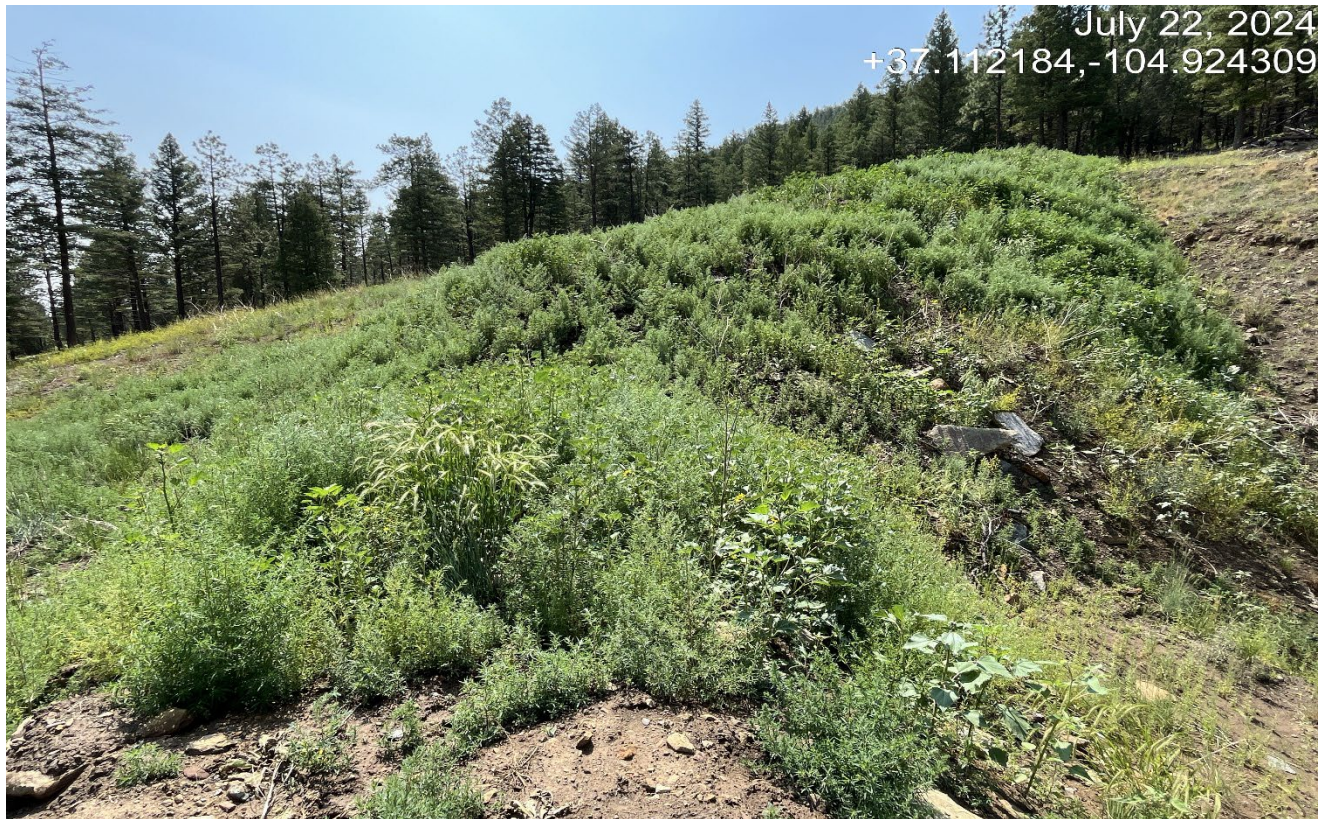
**Photo 3.** Facing southeast toward the soil pile. There are undesirable weeds growing throughout this area that will need to be controlled.

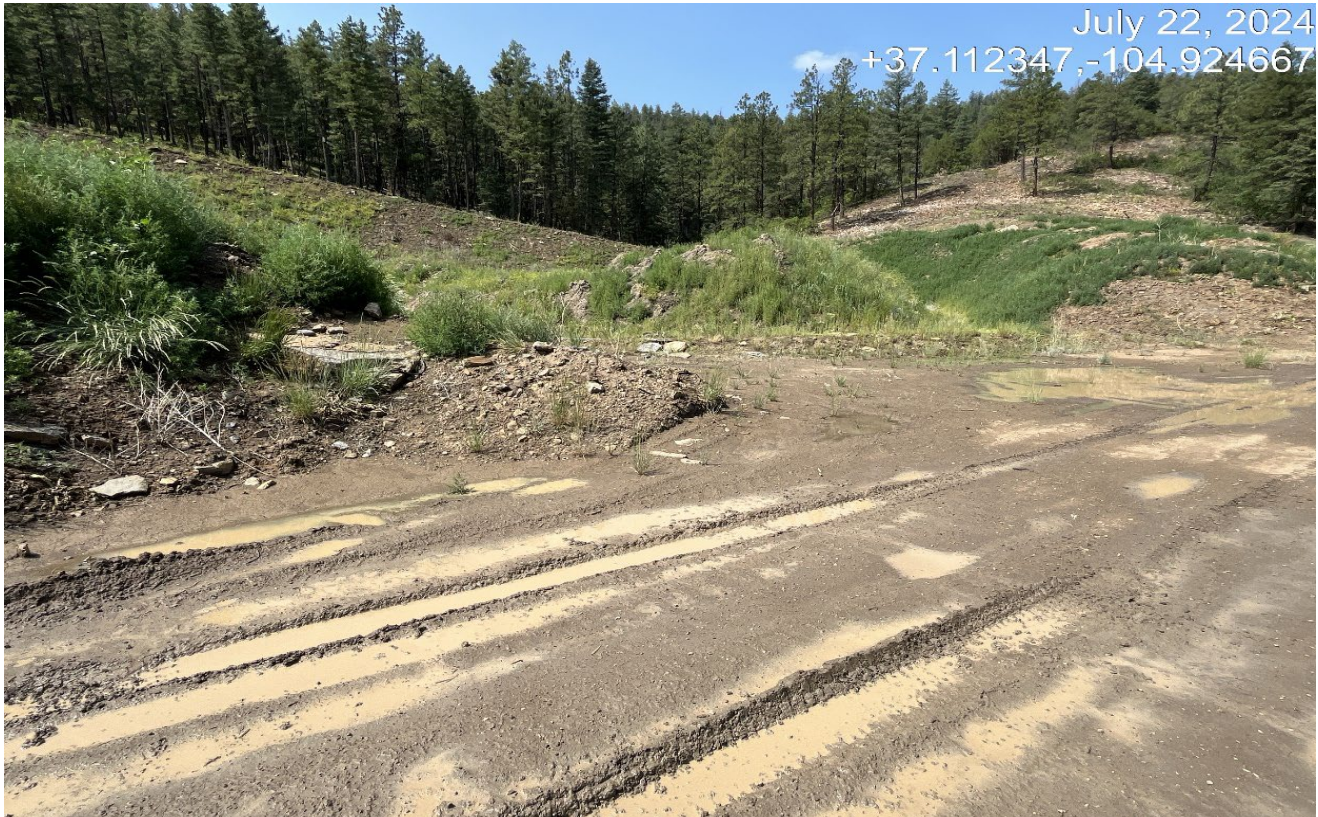
**Photo 4.** Facing southwest at the location.

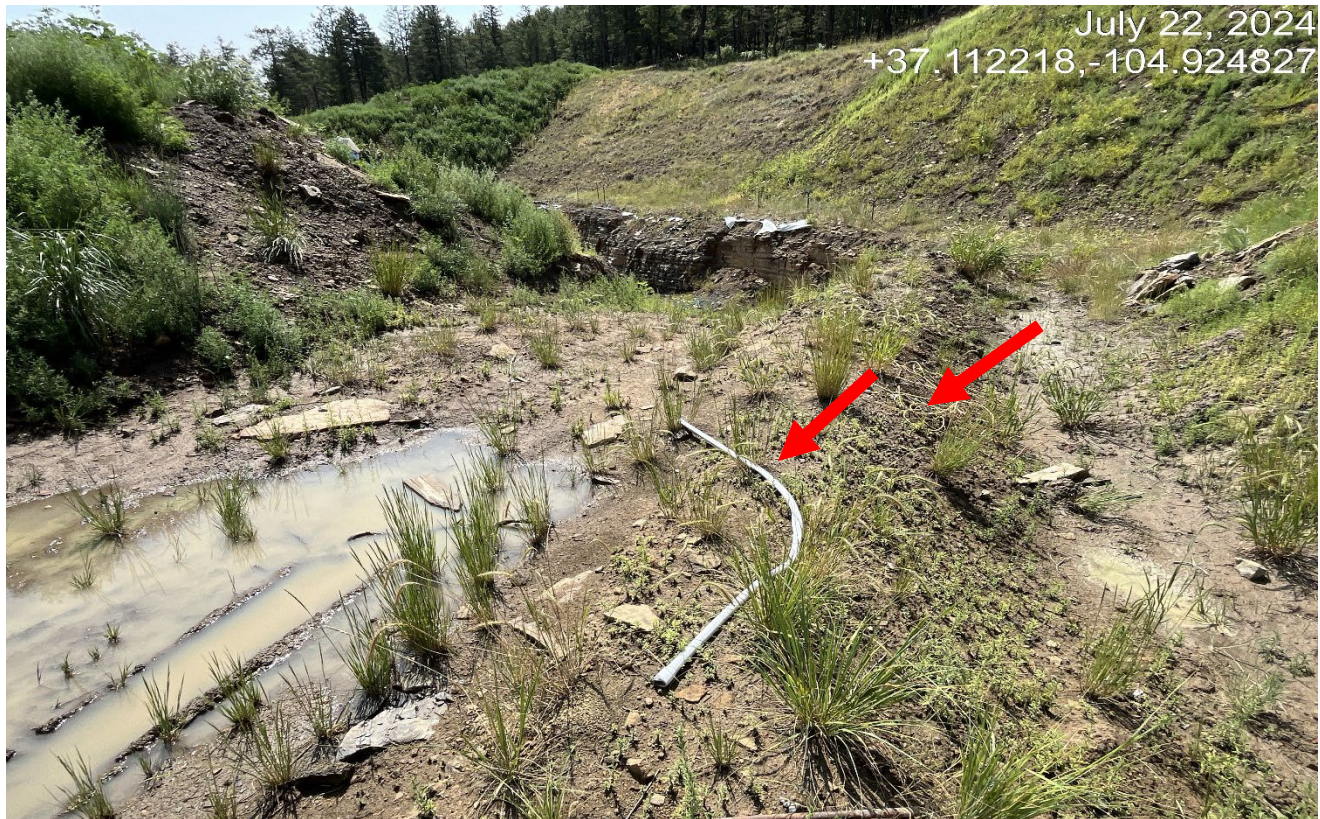
**Photo 5.** There is pipe and wire shown at red arrows that need to be removed..

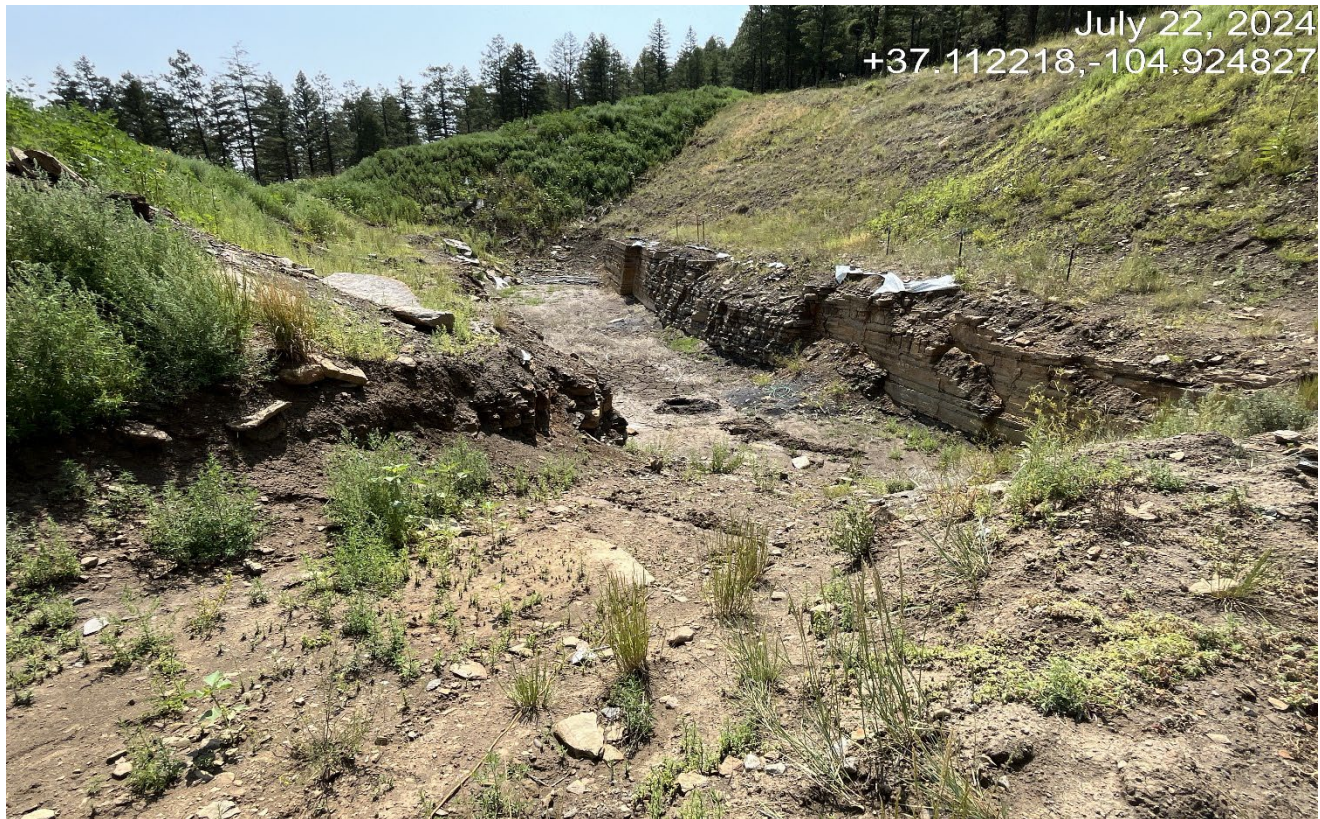
**Photo 7.** Facing toward the open pit at the base of the cut slope..

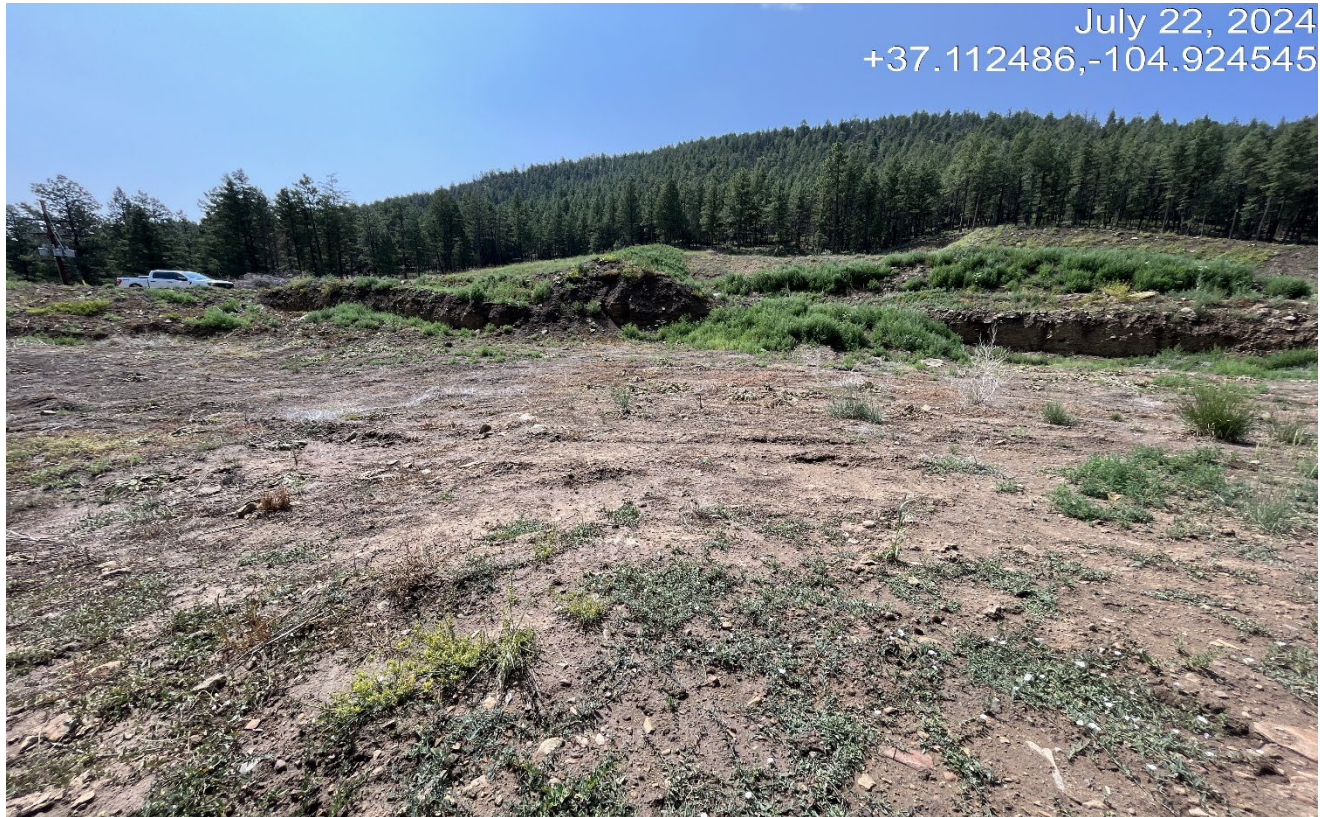
**Photo 8.** North side of the location facing southeast.

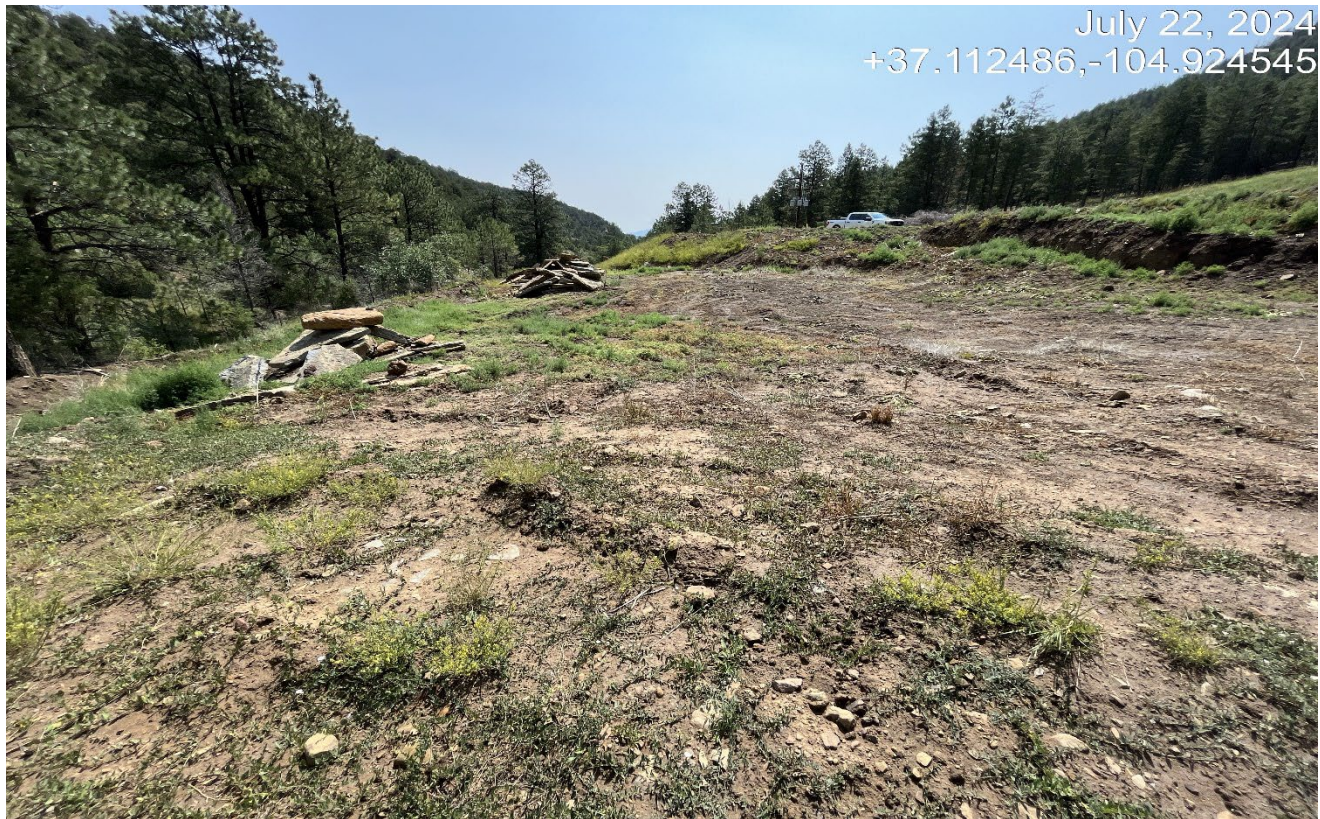
**Photo 9.** North side of the location facing east. The bottom portion of the location needs to be reclaimed with proper recontouring and stabilization.
